## **NATIONAL TRANSPORTATION SAFETY BOARD**

### **Group Chairman's Factual Report**

## **POWERPLANTS**

ERA21FA346

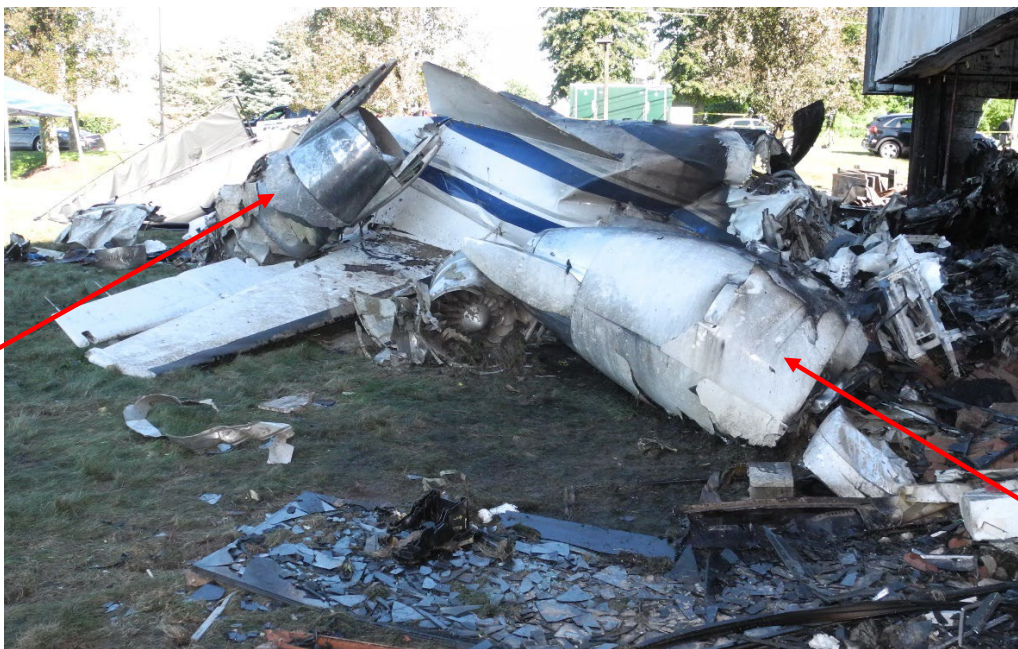
The empennage of the airplane was located outside of the building. Approximately the last 20 feet of the empennage was intact and inverted. The LH engine was still attached to the pylon and in position on the empennage ([Photo 1](#)). The RH engine was separated from the engine mount and found resting on the left horizontal stabilizer in a nose-down orientation ([Photo 2](#)). The airframe engine mount beam and associated structure was present however it was impact and thermally damaged. Neither engine displayed signs of uncontainment. The thrust reversers of both engines were still attached, and in their stowed position.

**Photo 1** - RH & LH Engine - On-scene and In-Situ - View from side - Note inverted fuselage

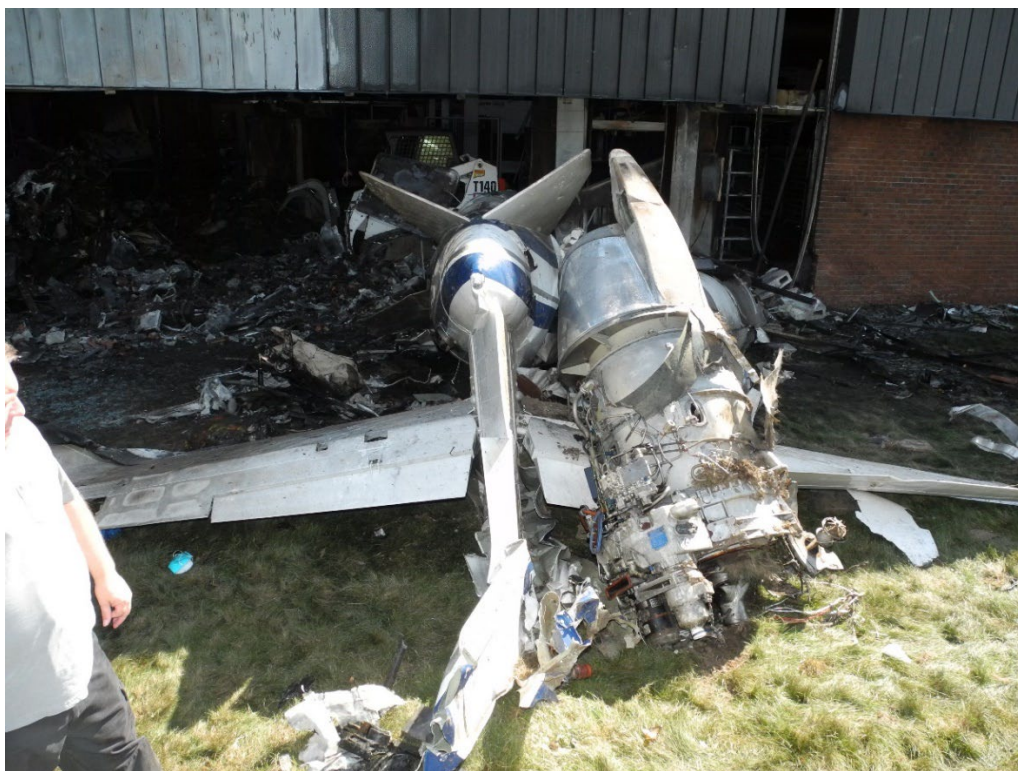
**Photo 2** - RH Engine In-Situ - View from aft. LH engine in background. Note inverted empennage

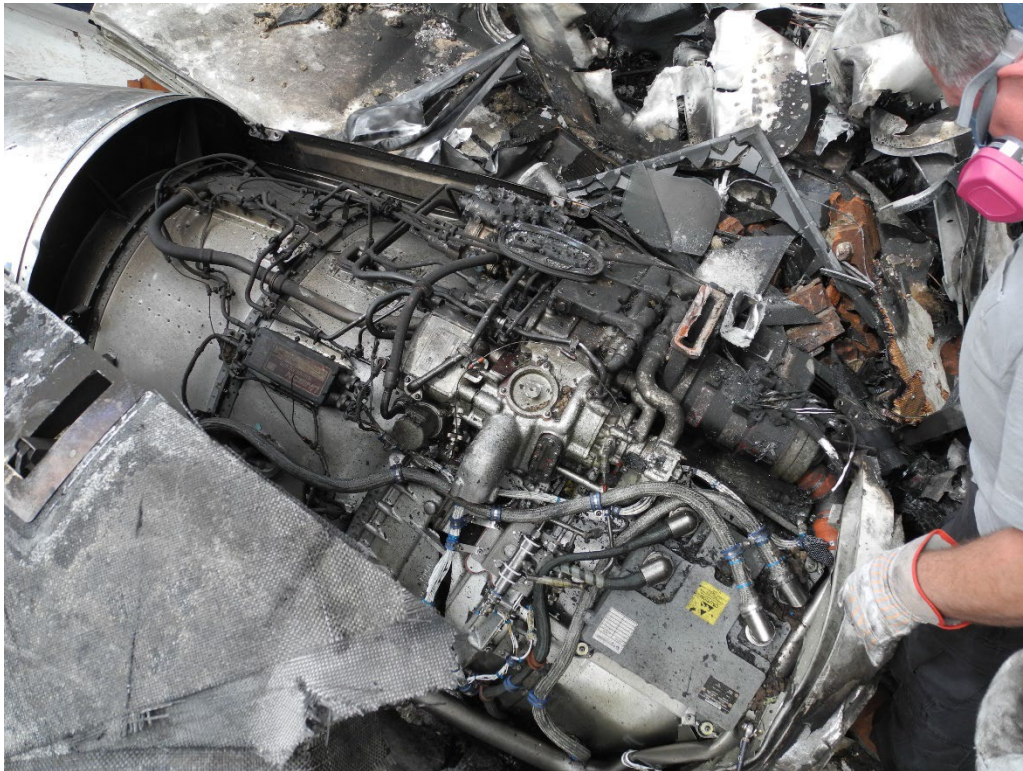
The LH engine was complete and still intact. The inlet cowl was crushed and separated and located directly in front of the engine. The cowl doors were in place and latched; however, they displayed thermal distress between the 4 and 7 o'clock location (this was the top surface as oriented in the wreckage, which is consistent with a post event fire). There was a ground fire in the vicinity of the nacelle and the distress was consistent with an external heat source. In the area of the cowl that exhibited thermal distress, the engine externals and ancillary components exhibited a black sooty deposit ([Photo 3](#)).

**Photo 3** - LH Engine - Sooty deposits on external components

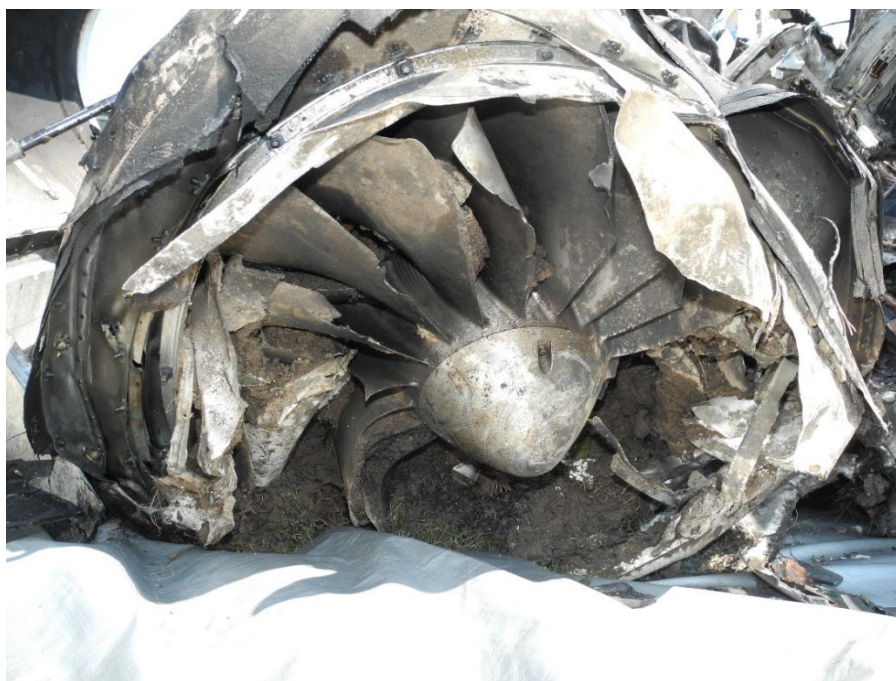
From 7 to 11 o'clock, the external and ancillary components were free of sooty deposits. The arc between 11 and 3 o'clock could not be observed. There were no observed fluid leaks or hot spots on the engine in the areas that were visible. The intermediate case was fractured between 6 and 10 o'clock. No in-flight soot streaking, indicative of in-flight fire was observed on the nacelle exterior surfaces. The fan case was crushed, consistent with a frontal impact on the top side of the engine. Approximately 75% of adjacent fan blades were significantly bent in the direction opposite of rotation ([Photo 4](#)), consistent with a higher power rotation during impact. Five fan blades were fractured near the root, four of which were consecutive. Most of the fan blades exhibited sharp tears on the leading edges.

**Photo 4** - LH Engine - Fan blades

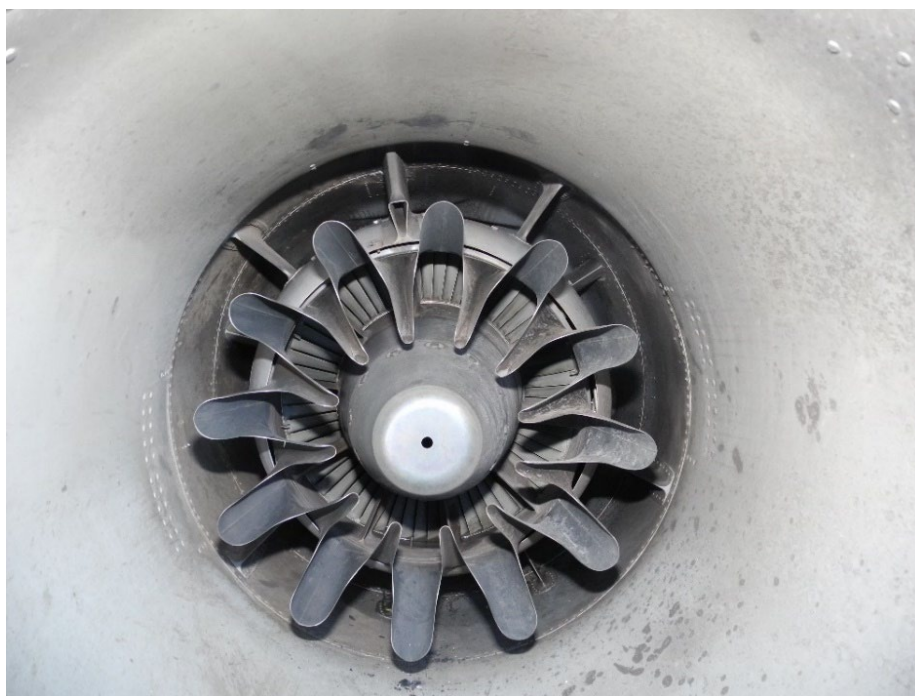
The 3<sup>rd</sup> stage low-pressure turbine (LPT) blades and mixer did not exhibit any damage ([Photo 5](#)).

**Photo 5** - LH Engine - Low pressure turbine - No damage

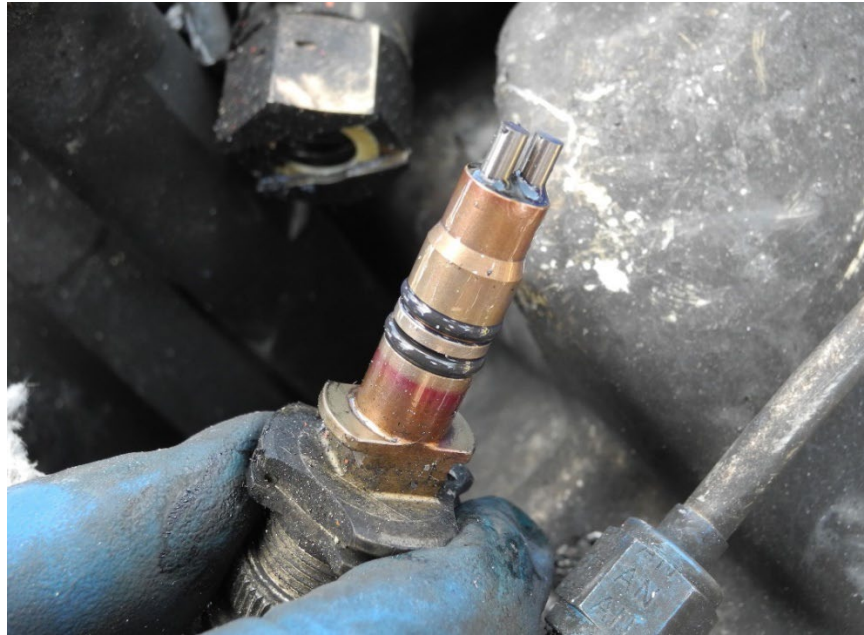
**Photo 6** - LH Engine chip detector - Clean

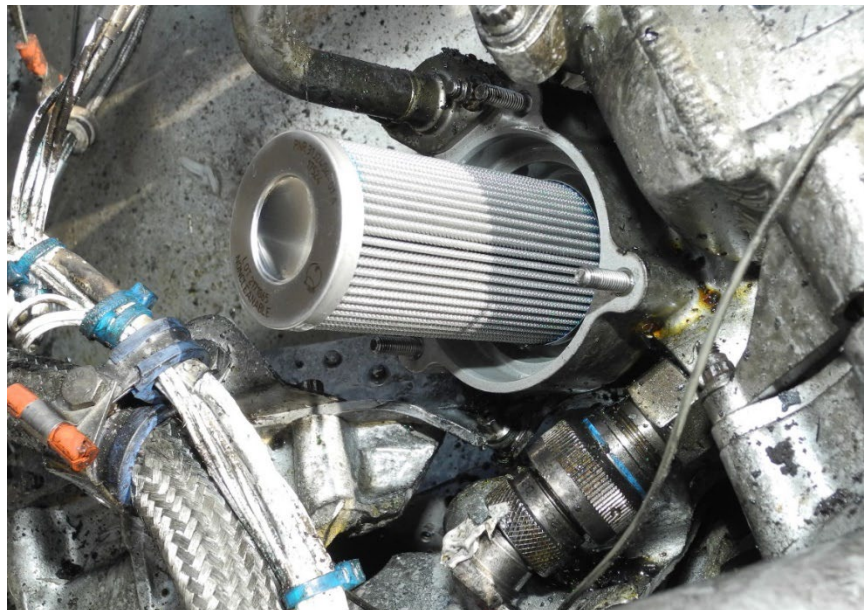
**Photo 7** - LH Engine fuel filter - Clean

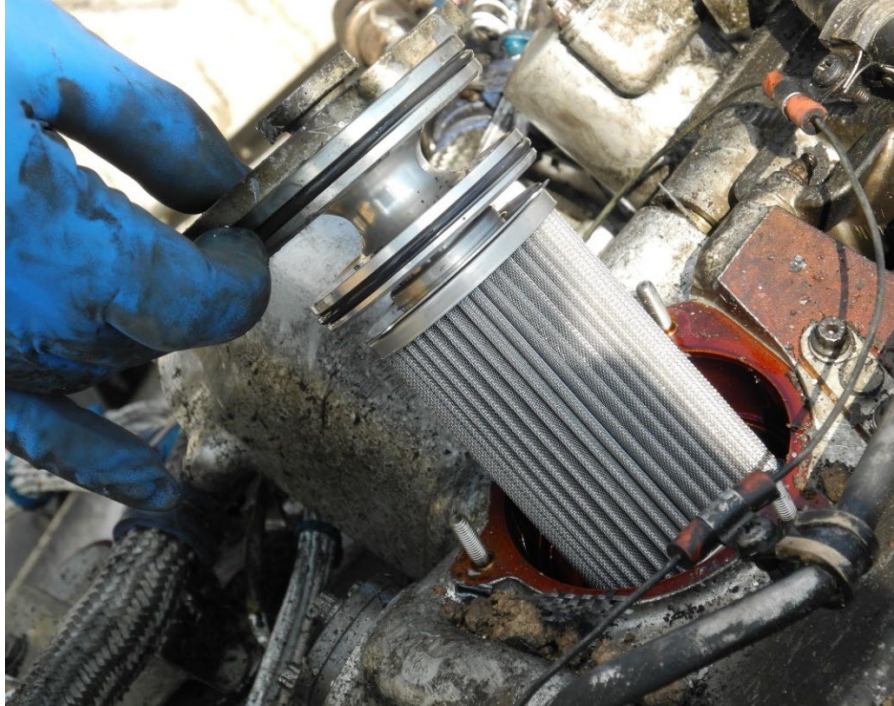
**Photo 8** - LH Engine oil filter - Clean

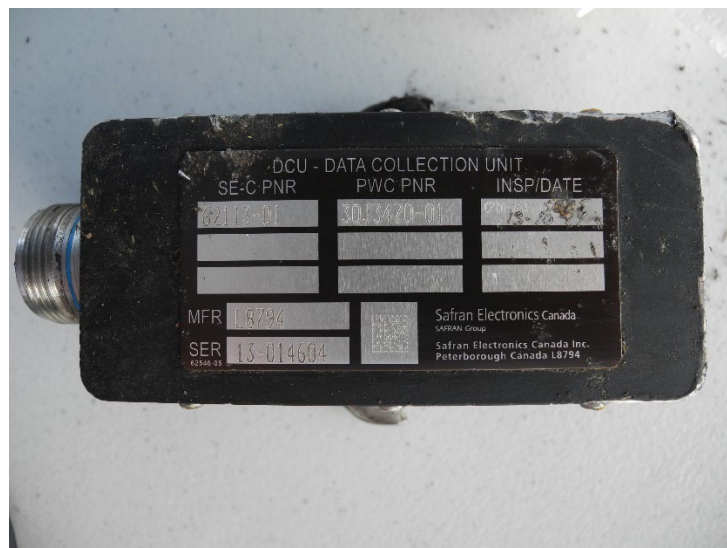
**Photo 9** - LH DCU

The LH engine DCU P/N 30J3470-01, S/N 13-014604 was separated from its mounting location; however, it was still attached to its electrical connector. It was removed and retained for download and data analysis.

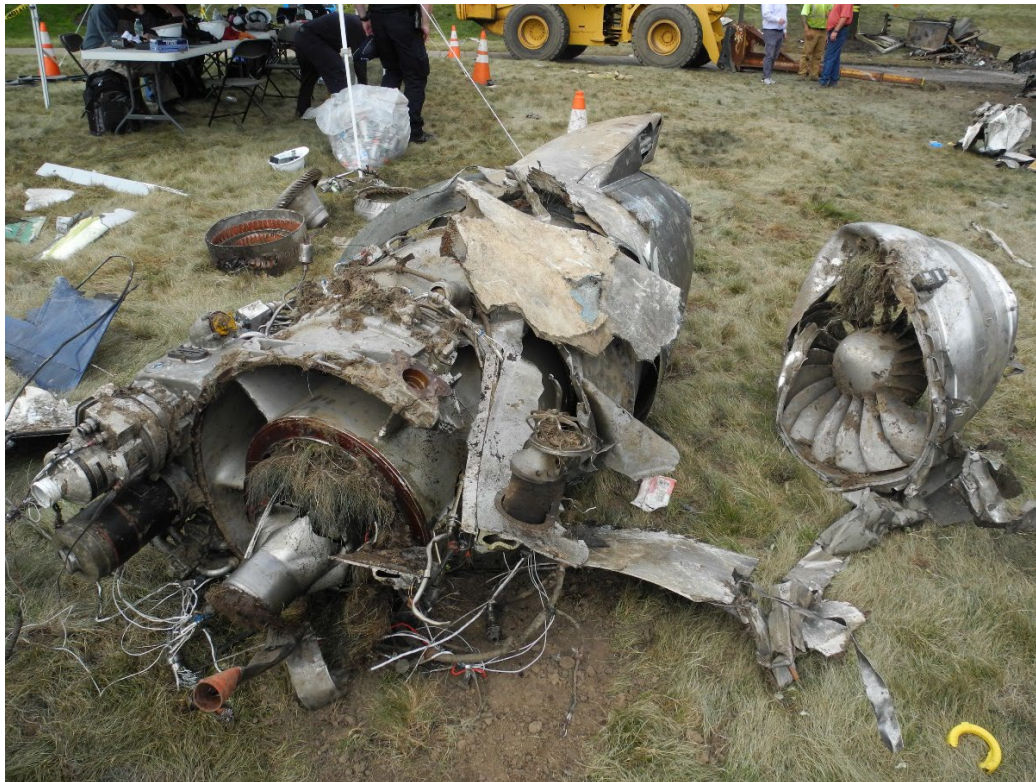
The RH engine (ref. [Photo 2](#)) cowling was not attached to the engine but was found fractured in the debris field ([Photo 10](#)).

**Photo 10** – RH cowling parts retrieved from field and placed with engine

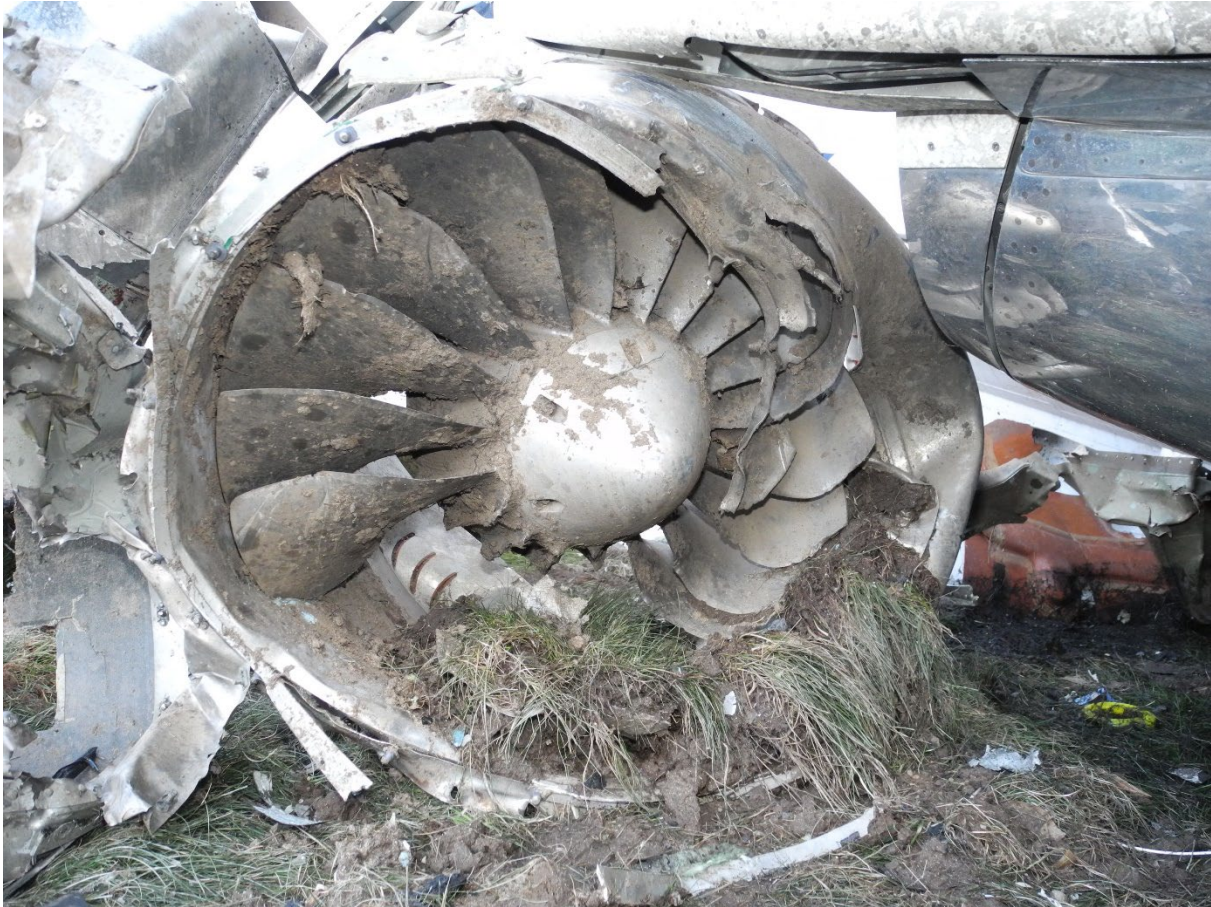
The fan disk and the fan case had separated from the engine and were found nested together in the debris field. Most of the fan blades were bent in the direction opposite of rotation, of which 4 consecutive ones were fractured near the root ([Photo 11](#)), consistent with a higher power rotation during impact. The fan case was crushed, consistent with a frontal impact on the top side of the engine.

**Photo 11** - RH engine fan disk and fan case - Separated from engine

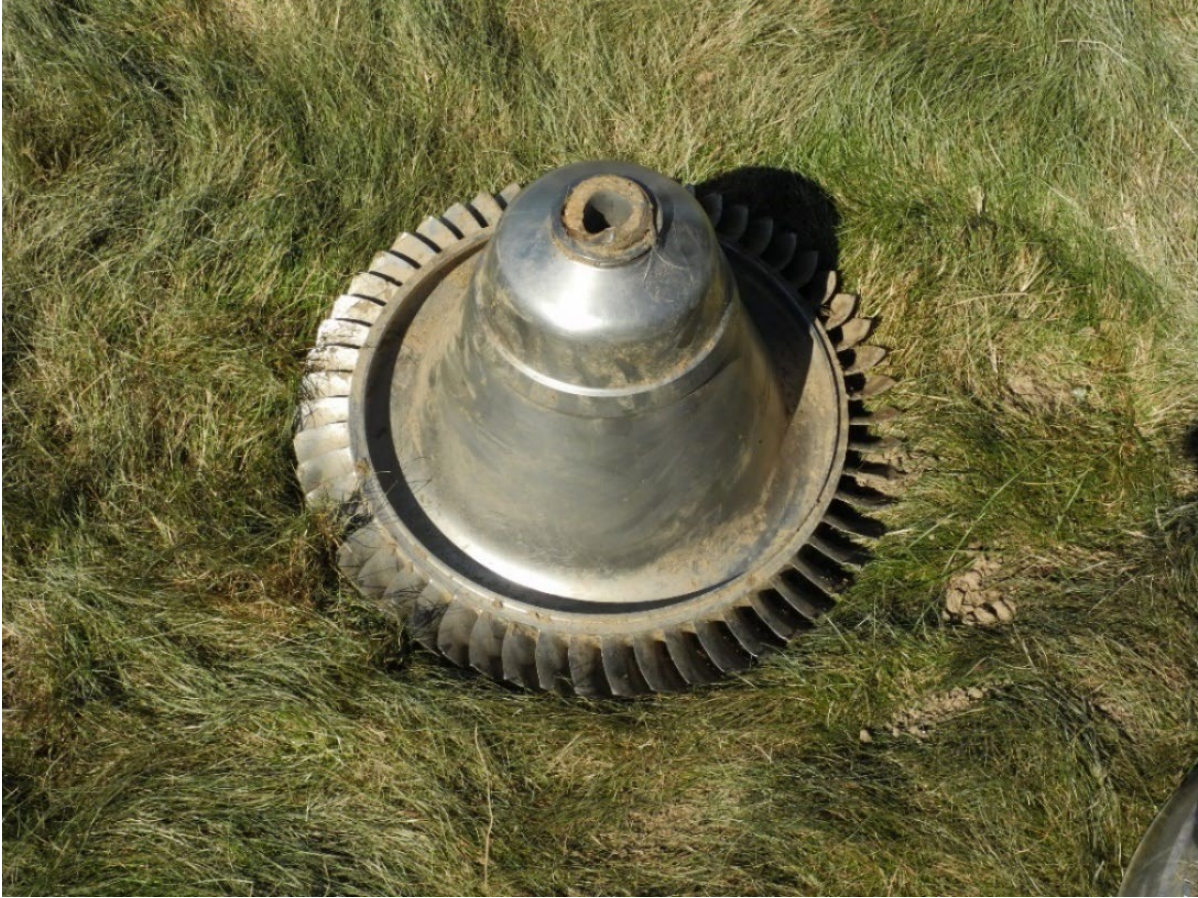
The LPC rotor and hub ([Photo 12](#)) were found intact and loose in the debris field. Approximately  $\frac{3}{4}$  of the blades of the LPC rotor were bent in the direction opposite of rotation, similar to the pattern of blade bending seen on the fan disk. The LPC stator airfoils were all bent in the direction of rotation and in the approximate plane of the blades there were static impact marks consistent with airfoil shapes. The fan blade air seal track was rotationally scored, consistent with contact against the rotating fan blade tips.

**Photo 12** - RH Engine LPC rotor and hub

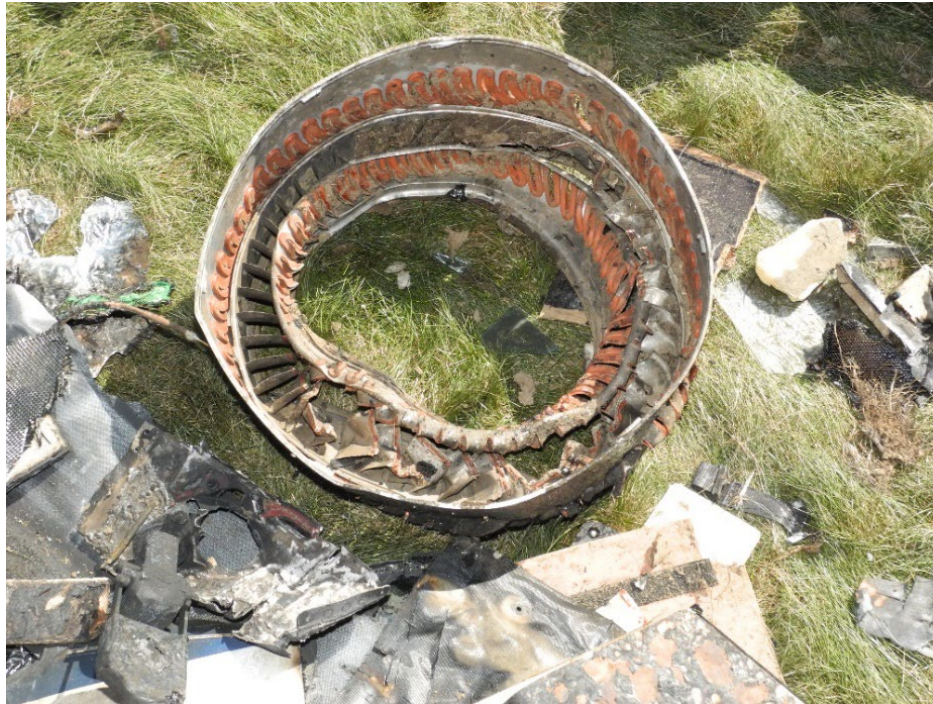
The inner stator core ([Photo 13](#)), consisting of the LPC inlet guide vanes, their inner shroud and the inner shroud of the fan exit vanes was found in the debris field. Thirty-seven of the 60 individual fan exit vanes were found distributed along the wreckage path ([Photo 14](#)) starting near the initial ground impact point.

**Photo 13** - RH engine inner stator core

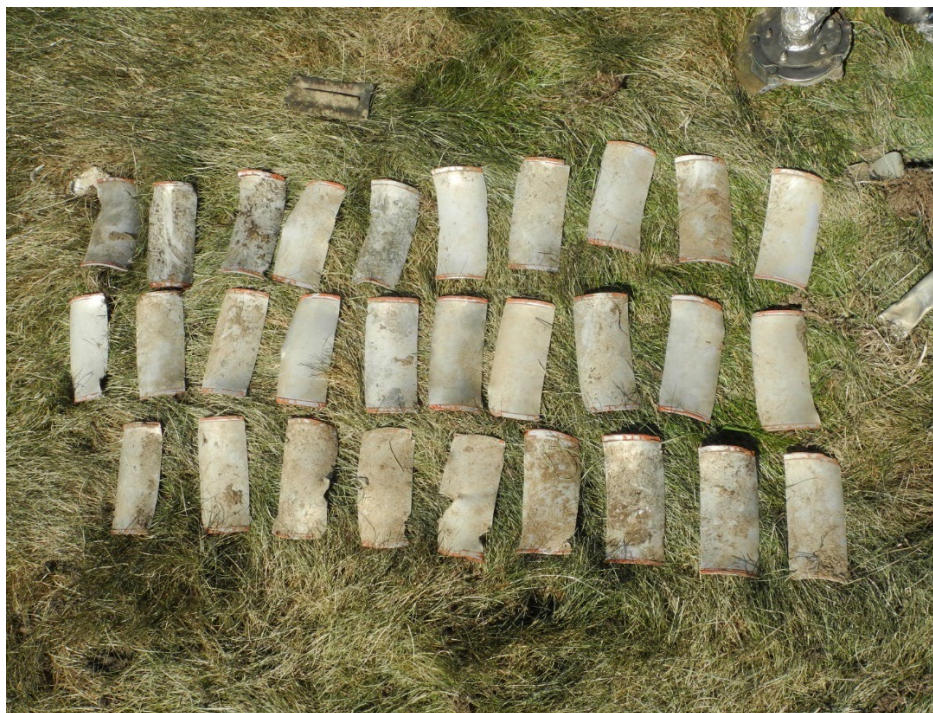
**Photo 14** - RH engine fan exit guide vanes - Collected from debris field

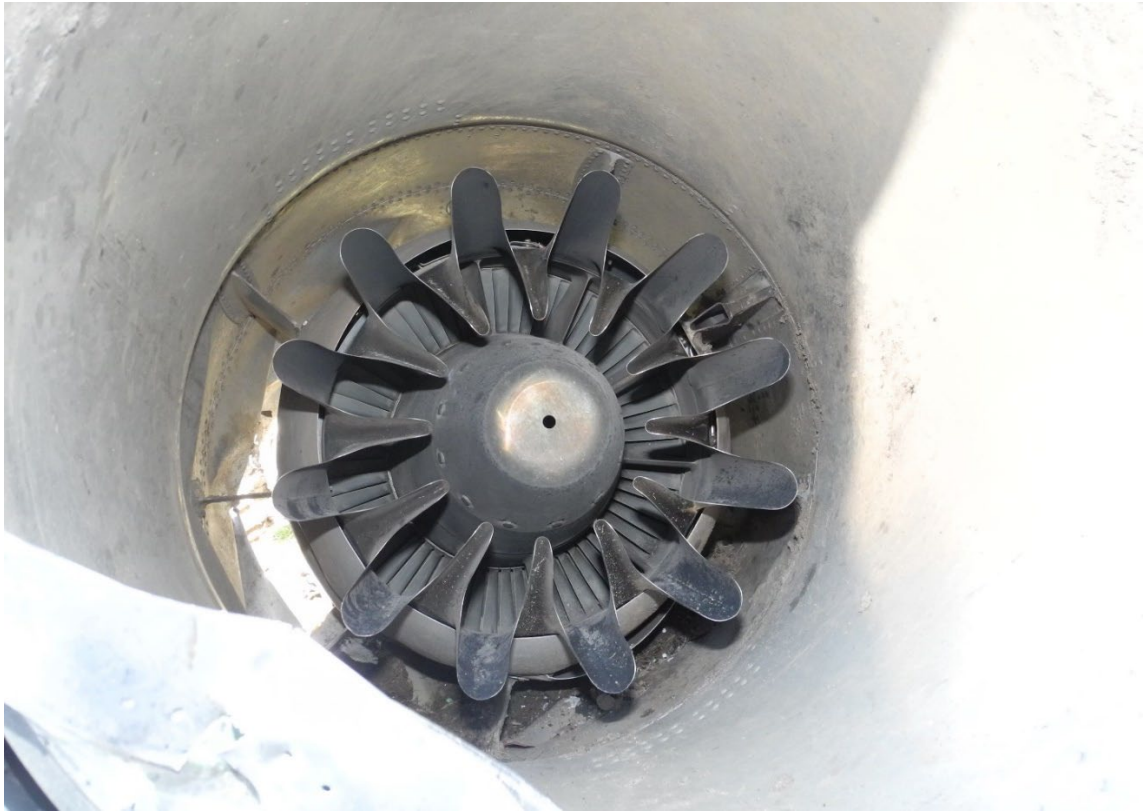
The 3<sup>rd</sup> stage LPT blades and mixer did not exhibit any damage ([Photo 15](#)).

**Photo 15** - RH engine last stage LPT blades and mixer

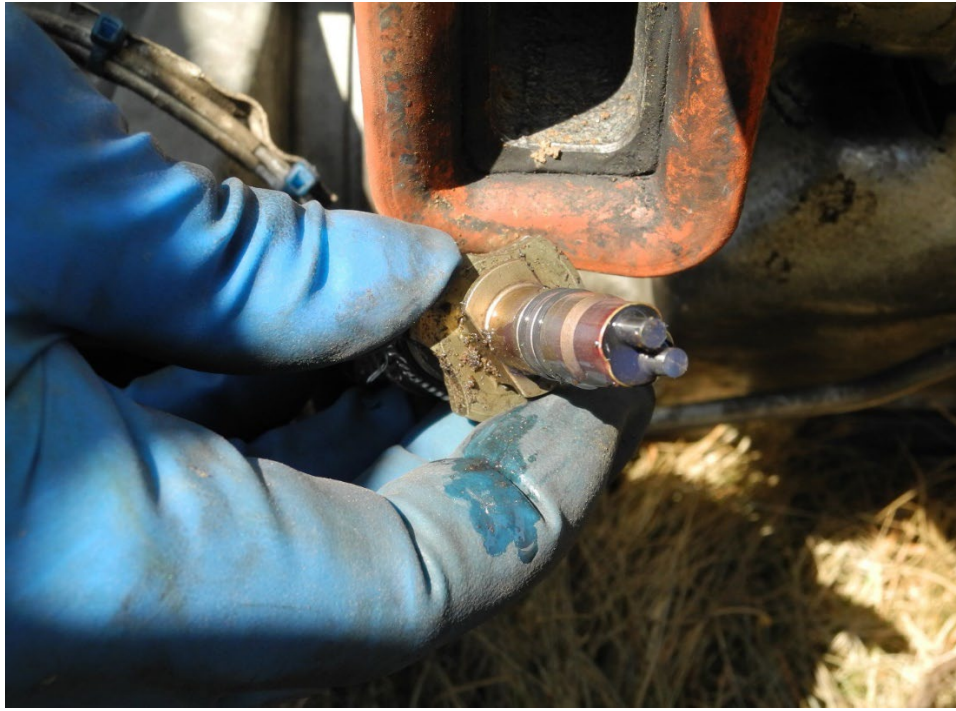
**Photo 16** - RH engine chip detector - Clean

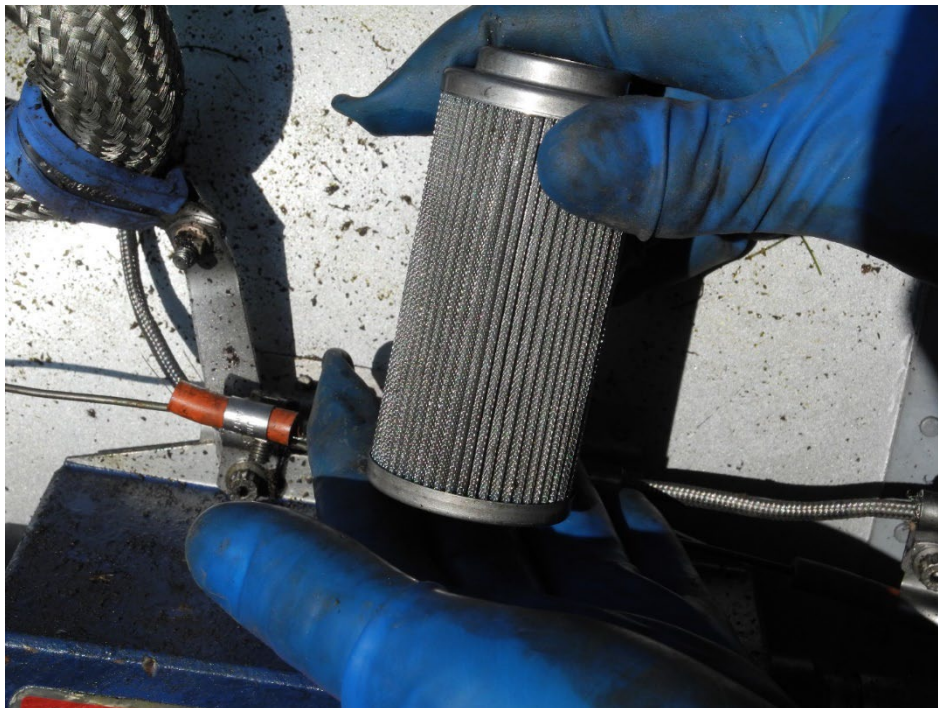
**Photo 17** - RH engine fuel filter - Clean

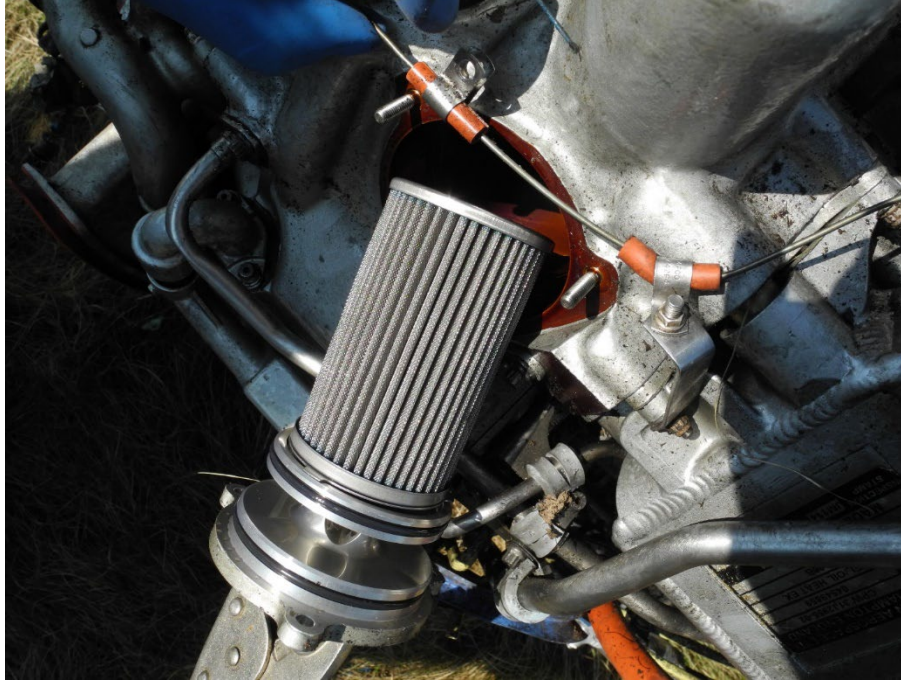
**Photo 18** - RH Engine oil filter - Clean

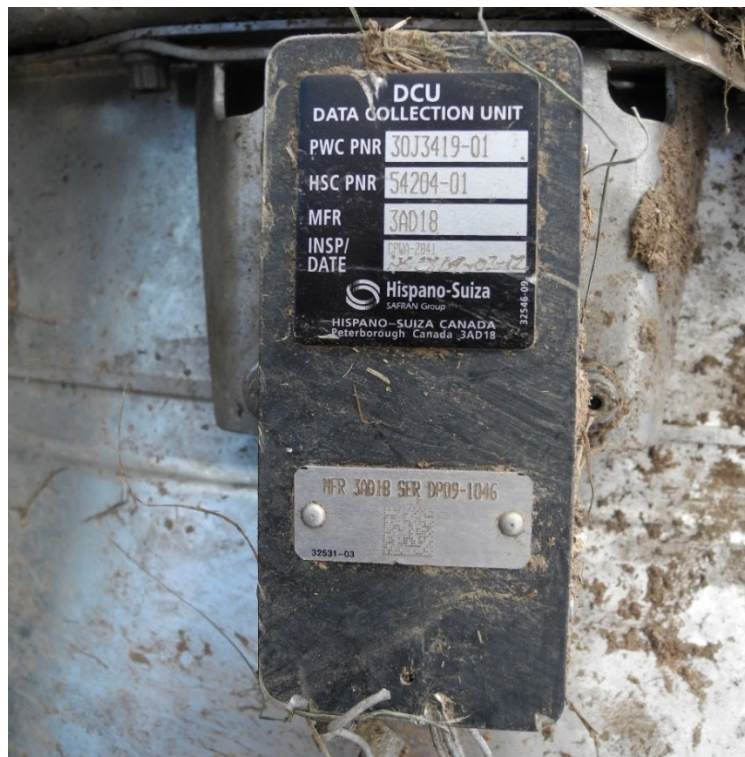
**Photo 19** - RH Engine DCU

The electrical connector of the RH engine DCU, P/N 30J3419-01, S/N DP09-1046 (**Photo 19**) was separated, exposing the internal components and wires. It was removed for download and data analysis.

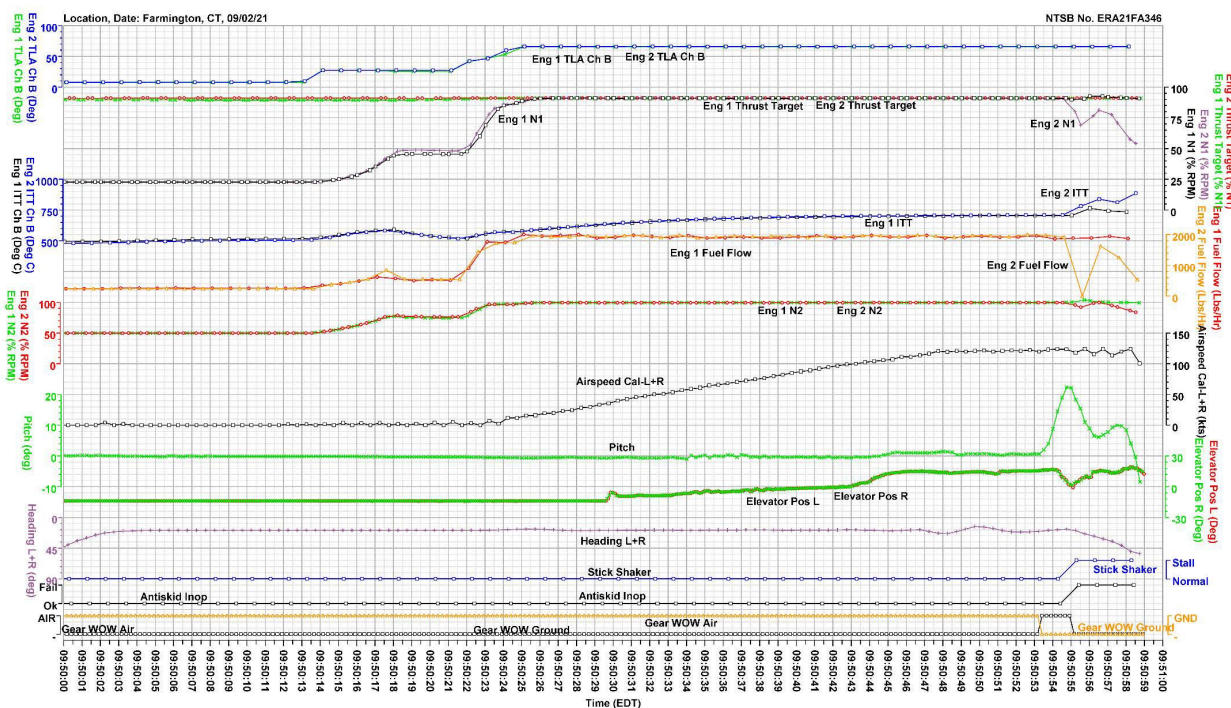
**Figure 2** - FDR Plot of takeoff and engine parameters

During the takeoff roll at about 9:50:14, the engine TLAs advanced from an idle power setting of 7 degrees to 27 degrees and the engines accelerated and stabilized at 45% N1 with the aircraft still stationary on the runway. At 9:50:22 the engine TLAs increased again, and the aircraft started its takeoff roll. During the two power increase commands via the TLA, both engines accelerated smoothly and in unison, consistent with normal operation.

During the takeoff, both engines reached their target take-off engine speeds with 90.9% N1, 99.3% N2, interstage turbine temperature (ITT) of 710 degrees C and fuel flow approximately 1850 pounds per hour (pph). According to PWC, these values were normal for the specific ambient conditions. Additionally, a review of the two previous take-offs revealed that the parameters were similar to the values observed during this takeoff.

At approximately 9:50:55.5, the RH engine N1 began a significant, immediate, and uncommanded decrease, while the ITT increased, and fuel flow decreased, consistent with sudden damage to the engine. The RH engine N2 core speed also moderately decreased to about 92%. This suggests that the N1 spool, of which the fan and LPC are parts, was damaged, consistent with impact damage from an external source, rather than an internal engine failure.

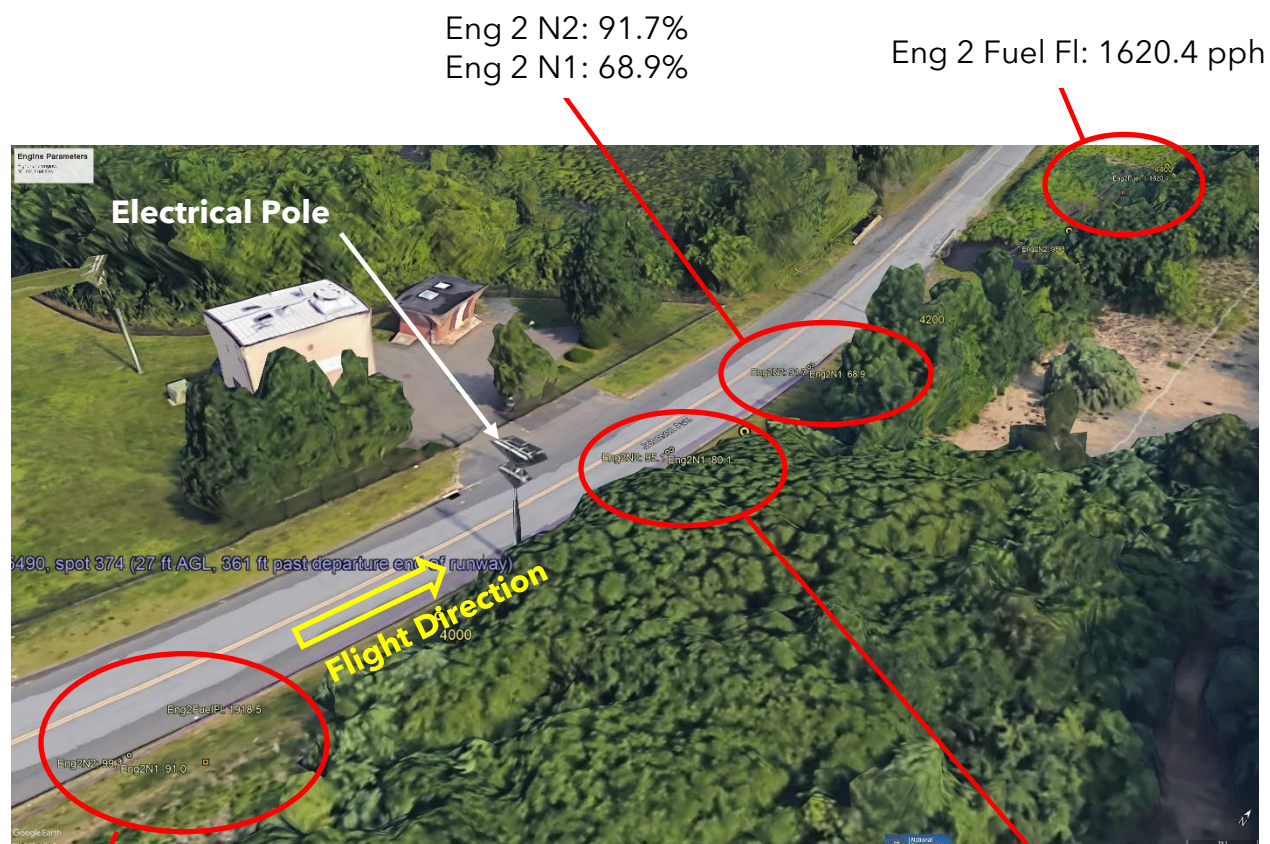
**Figure 3** - GPS image of area near electrical pole

A review of the GPS data is shown on [Figure 3](#). This map depicts the parameters of the RH engine overlaid onto the GPS location when it occurred. The engine data is highlighted and expanded on the figure for clarity. The flight's ground path is shown as a purple line. The flight direction is highlighted in yellow. The data shows the RH engine operating normally before striking the electrical pole (Eng 2 N2: 99.4%, Eng 2 N1: 91.0%, Eng 2 Fuel Fl: 1918.5 pph) and then in a degraded manner immediately after the electrical pole (Eng 2 N2: 95.1%, Eng 2 N1: 80.1%). The next location after the impact shows an even more degraded engine condition of (Eng 2 N2: 91.7%, Eng 2 N1: 68.9%).

The data shows that both engines were operating normally during idle, take-off roll and takeoff up to the point where the aircraft struck the electrical pole. Only the RH engine was affected, which is consistent with the findings in the debris field.
