# National Transportation Safety Board

ERA21FA346

## **AIRCRAFT SYSTEMS**

Group Chair's Factual Report

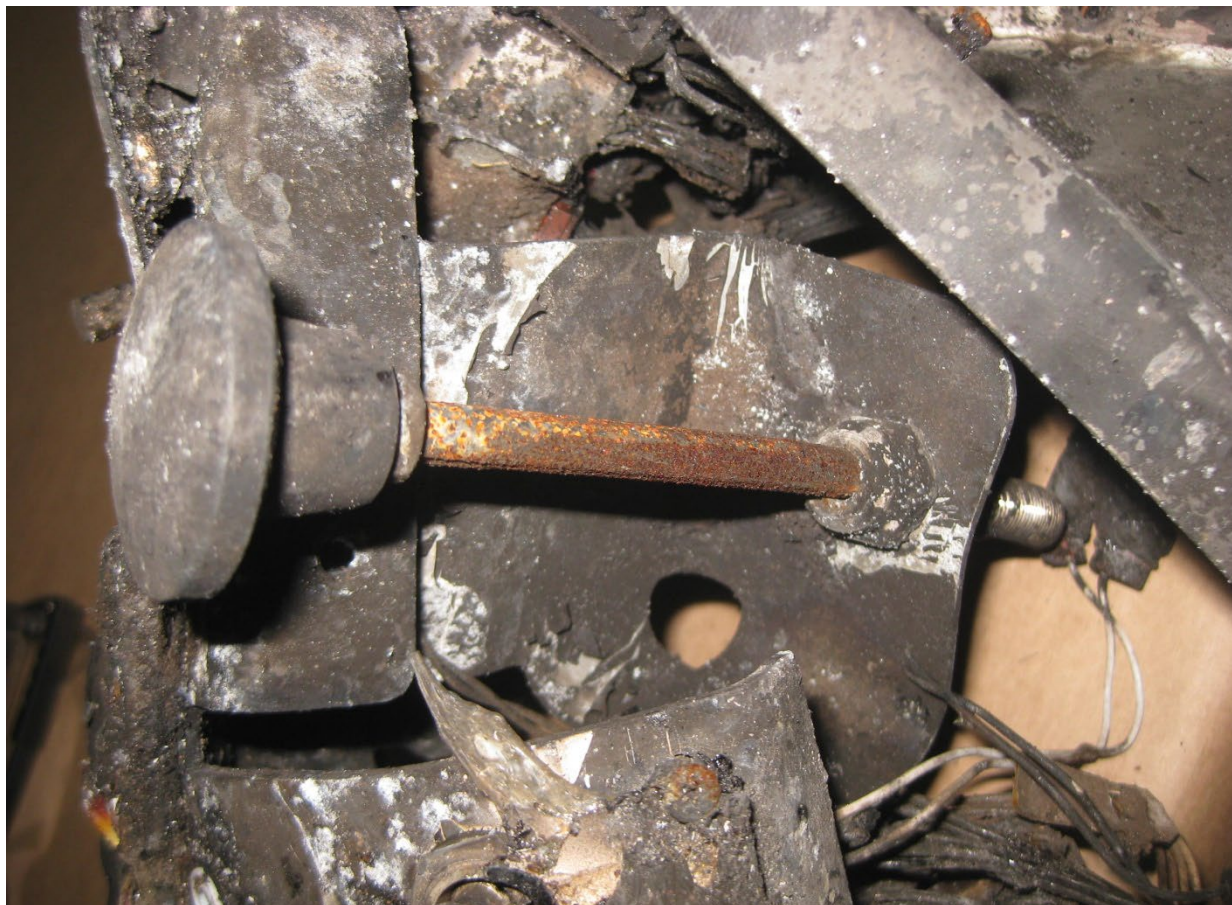
The airplane's flight deck parking brake knob was identified in the wreckage. The knob was still attached to the tilt panel. The knob was jammed and extended approximately 2.5 inches from the base of the tilt panel. The knob exhibited fire damage and was slightly bent. See Figure 6.

**Figure 6.** The flight deck parking brake knob, as identified in the airplane wreckage.

A portion of the threaded shroud was noted at the end of the knob handle, on the back of the tilt panel flange, measured at approximately  $1\frac{7}{8}$  inches.

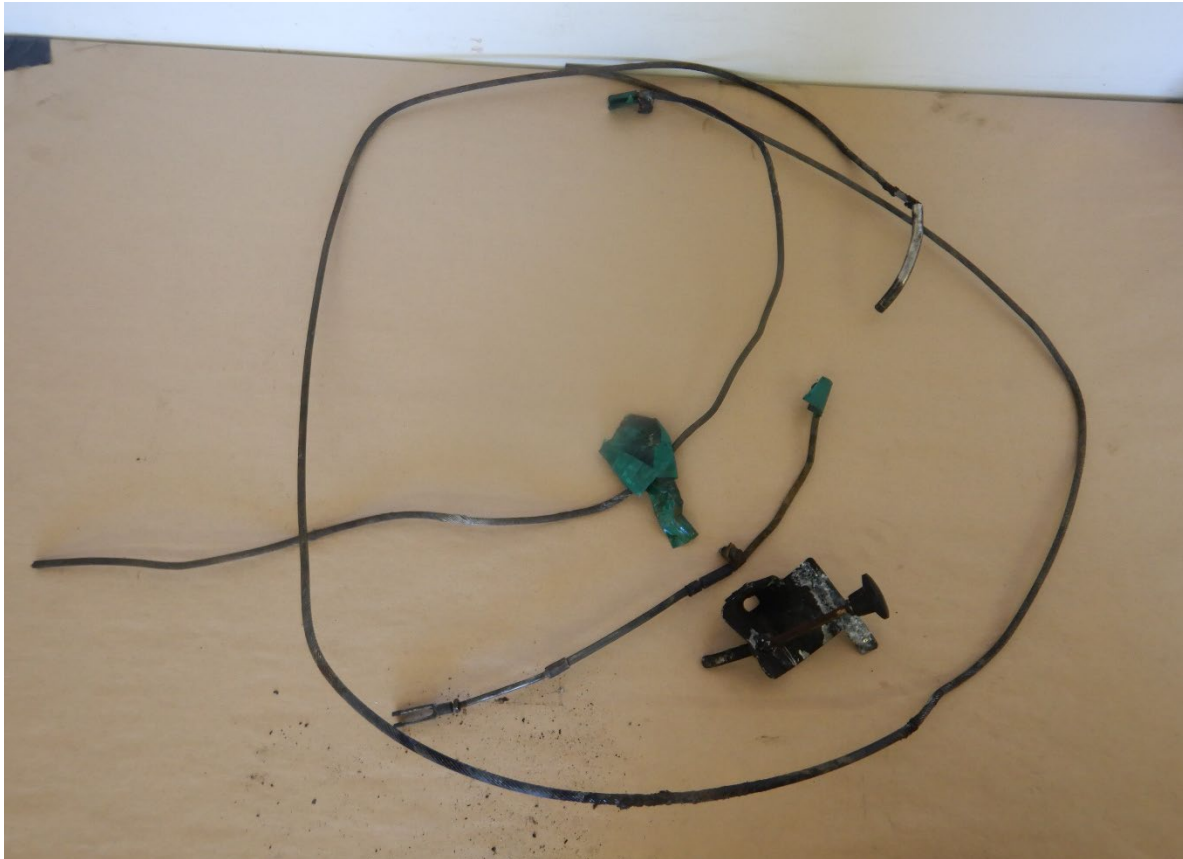
An approximate 102-inch section of the parking brake cable was identified in the wreckage. The part number 67-2531-2019 was marked on the cable. One end of

the cable had a portion of bent shroud on it. The shroud length was approximately 4 inches. The length of the threaded portion on the fractured end of the shroud was approximately  $\frac{1}{8}$  inch. See Figure 7.

**Figure 7.** Portions of the parking brake cable (and parking brake knob), as found.

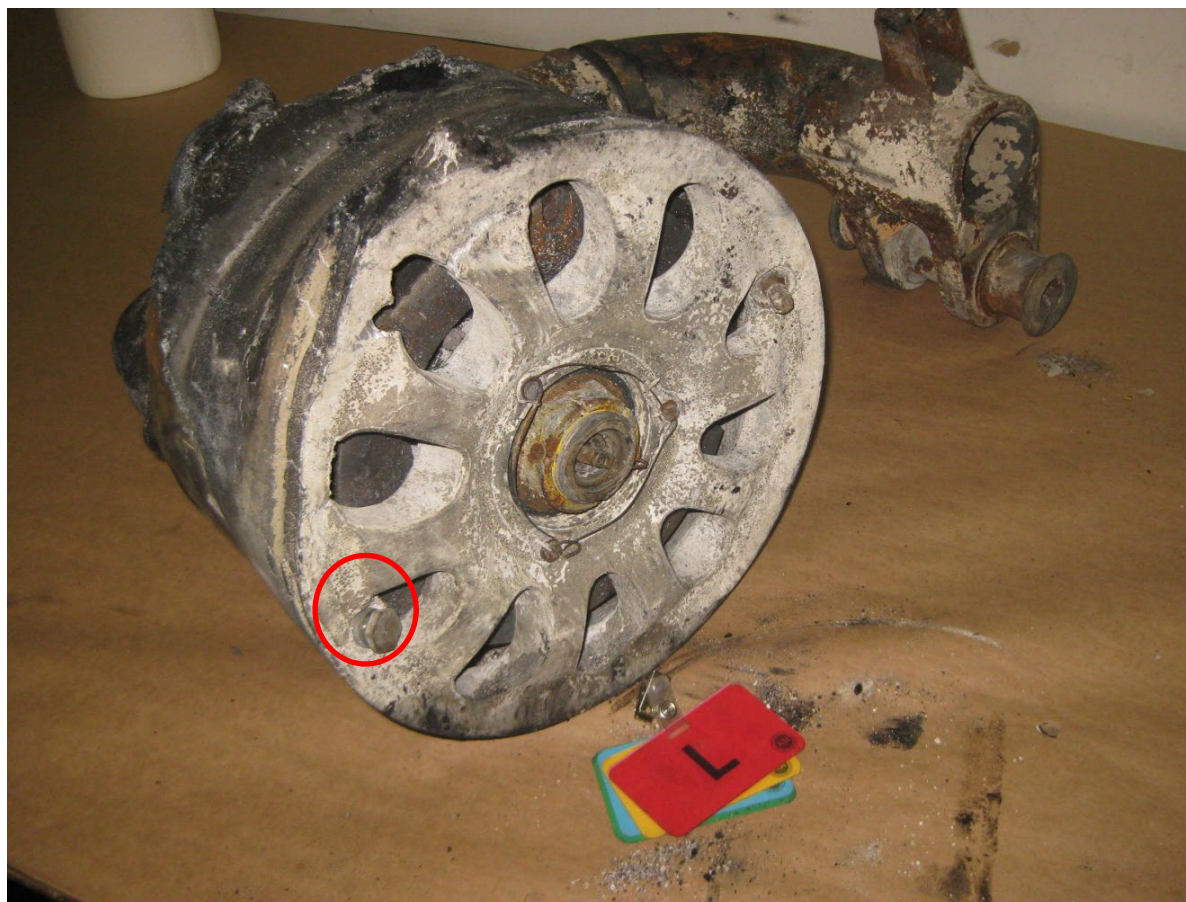
The left wheel and brake assembly was examined. To examine the brake components, the wheel and heat shield were removed from the assembly. The left wheel and brake assembly remained attached to the left main landing gear trailing link. See Figure 8.

**Figure 8.** The left main landing gear wheel assembly and trailing link. The overinflation plug is circled in red.

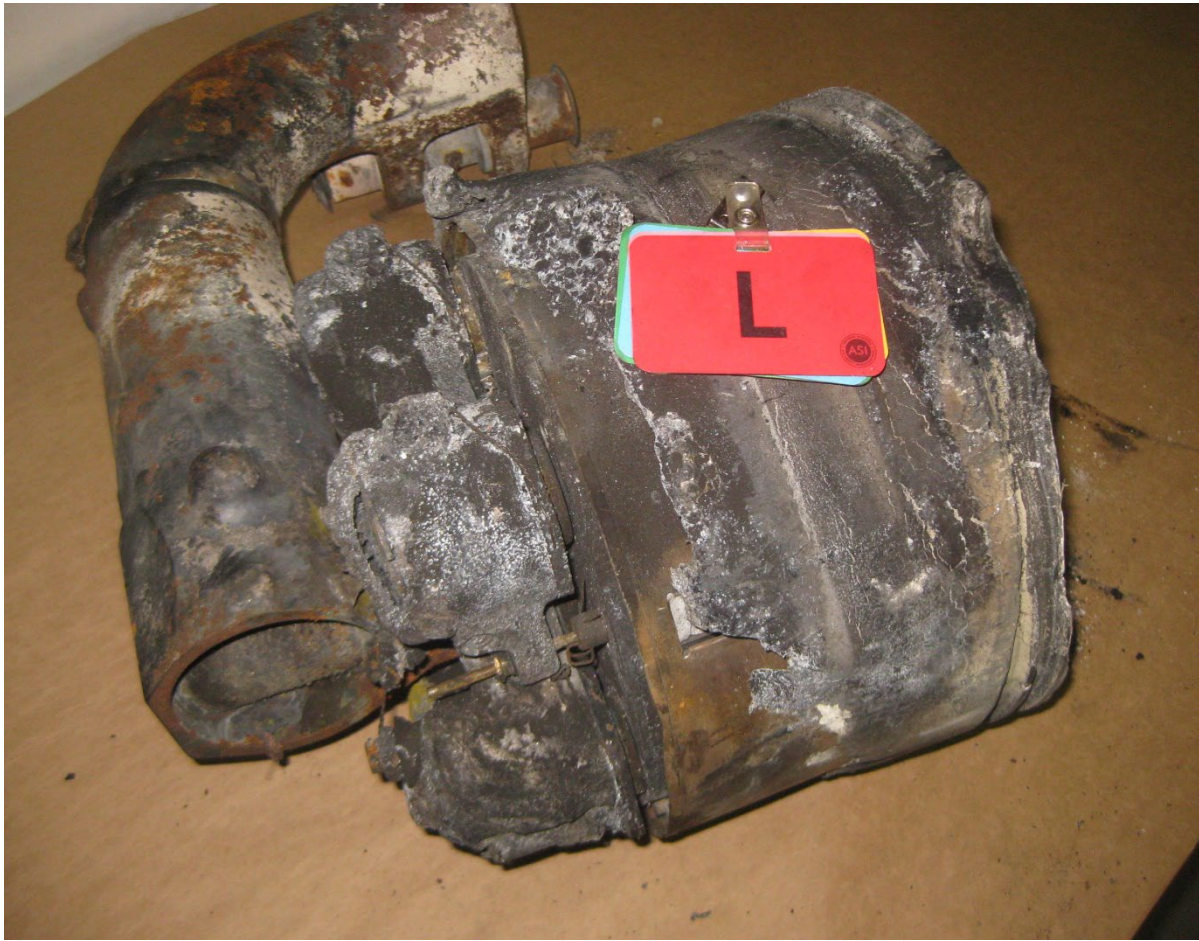
The extension on the five hydraulic brake pistons was negligible. The left main brake housing exhibited extreme post-impact thermal damage. The three rotor assemblies were free to move on the brake stack. The brake stack was not disassembled so a detailed brake stack examination was not accomplished. The left main brake stators remained attached to the brake housing. The left main gear assembly hub cap was missing, and the retainer screws were noted in place. The left brake stack was secured with a piece of wood and the wheel retaining nut for storage. See Figure 9.

**Figure 9.** The left wheel and brake assembly.

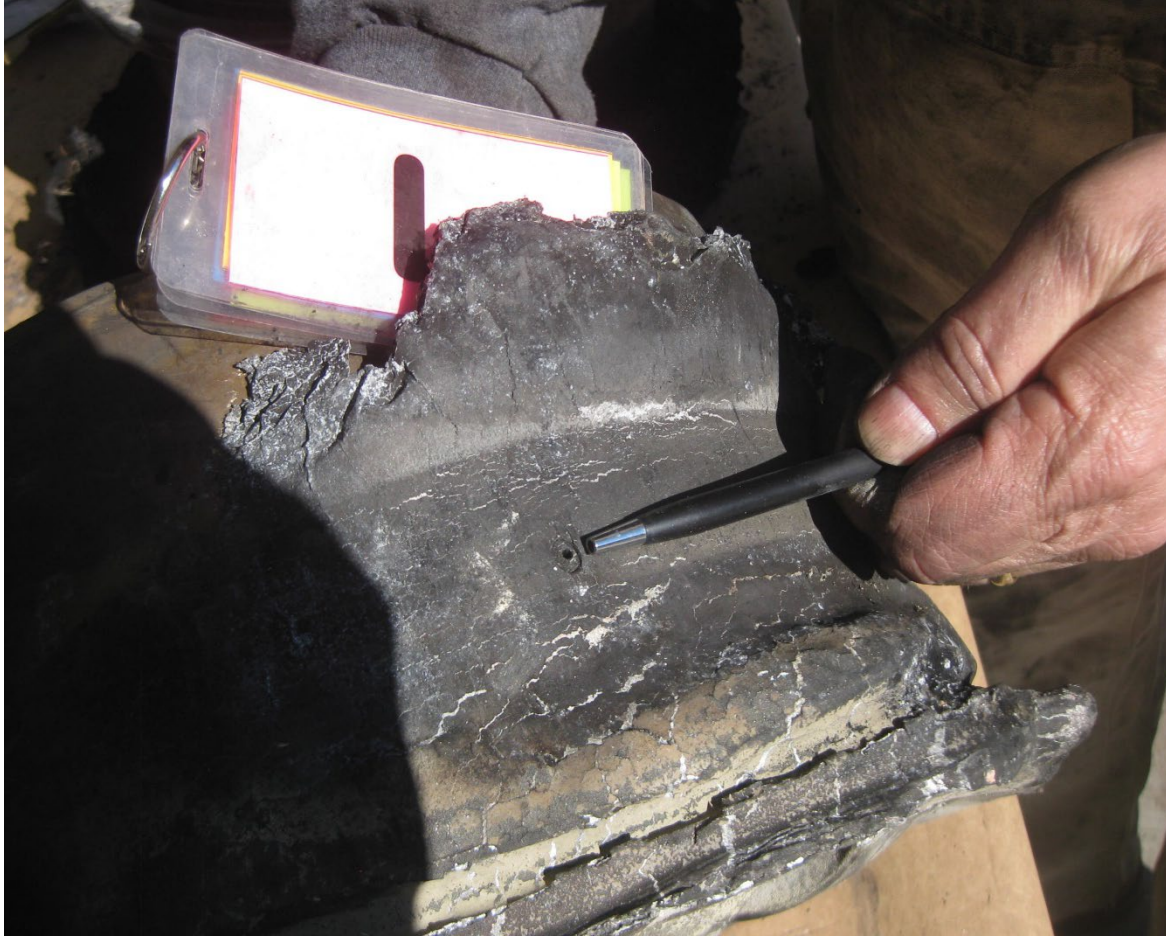
Three fuse plug holes were noted on the outside of the wheel hub. One of the three holes was open and clear; the other two were plugged. See Figure 10.

**Figure 10.** An opened fuse plug hole on the left wheel.

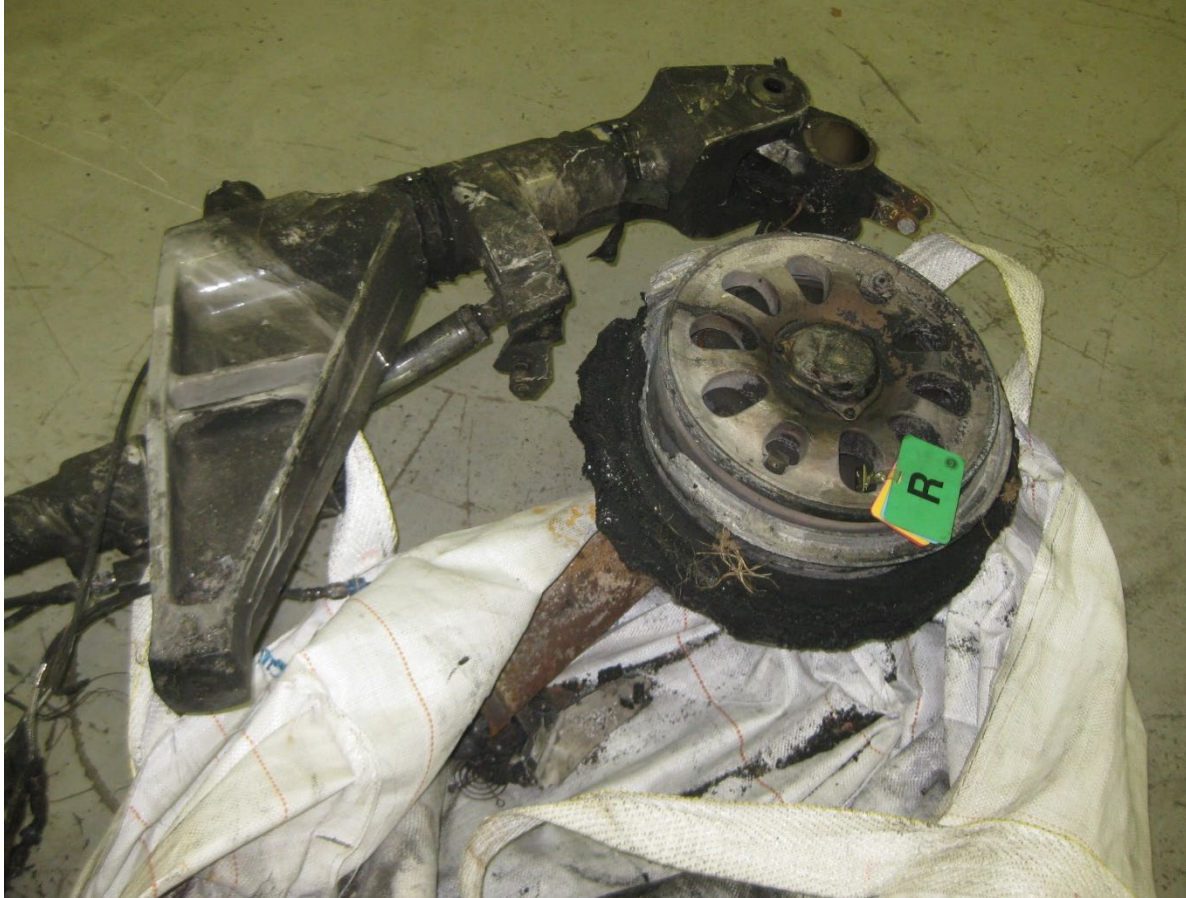
A portion (bead wiring) of the right tire material was still attached to the wheel. The right wheel and brake assemblies remained attached to the right main landing gear trailing link and trunnion. See Figure 11.

**Figure 11.** The right landing gear, tire remnants, and wheel assembly.

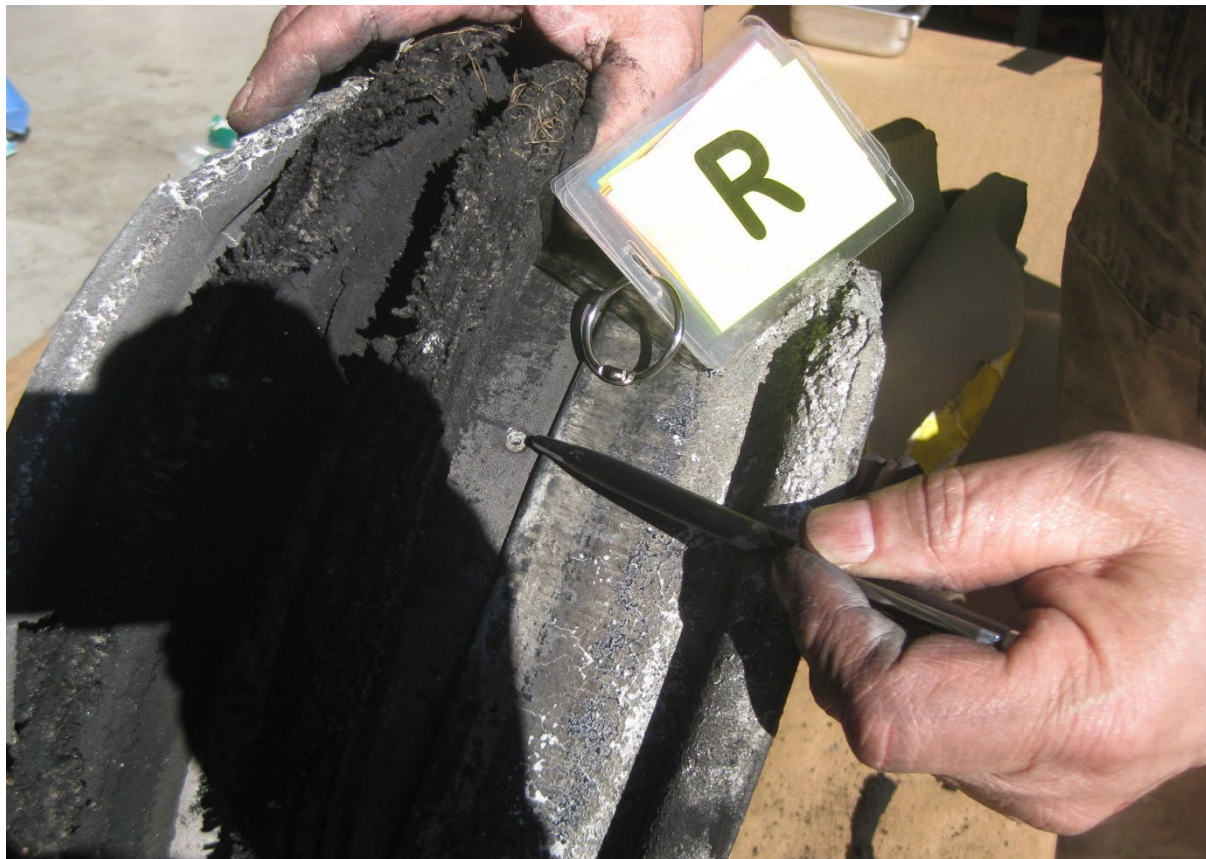
Three fuse plug holes were noted on the outside of the wheel hub. Two of the three holes were open and clear; the other hole was plugged. See Figure 12.

**Figure 12.** An opened fuse plug hole on the right wheel.

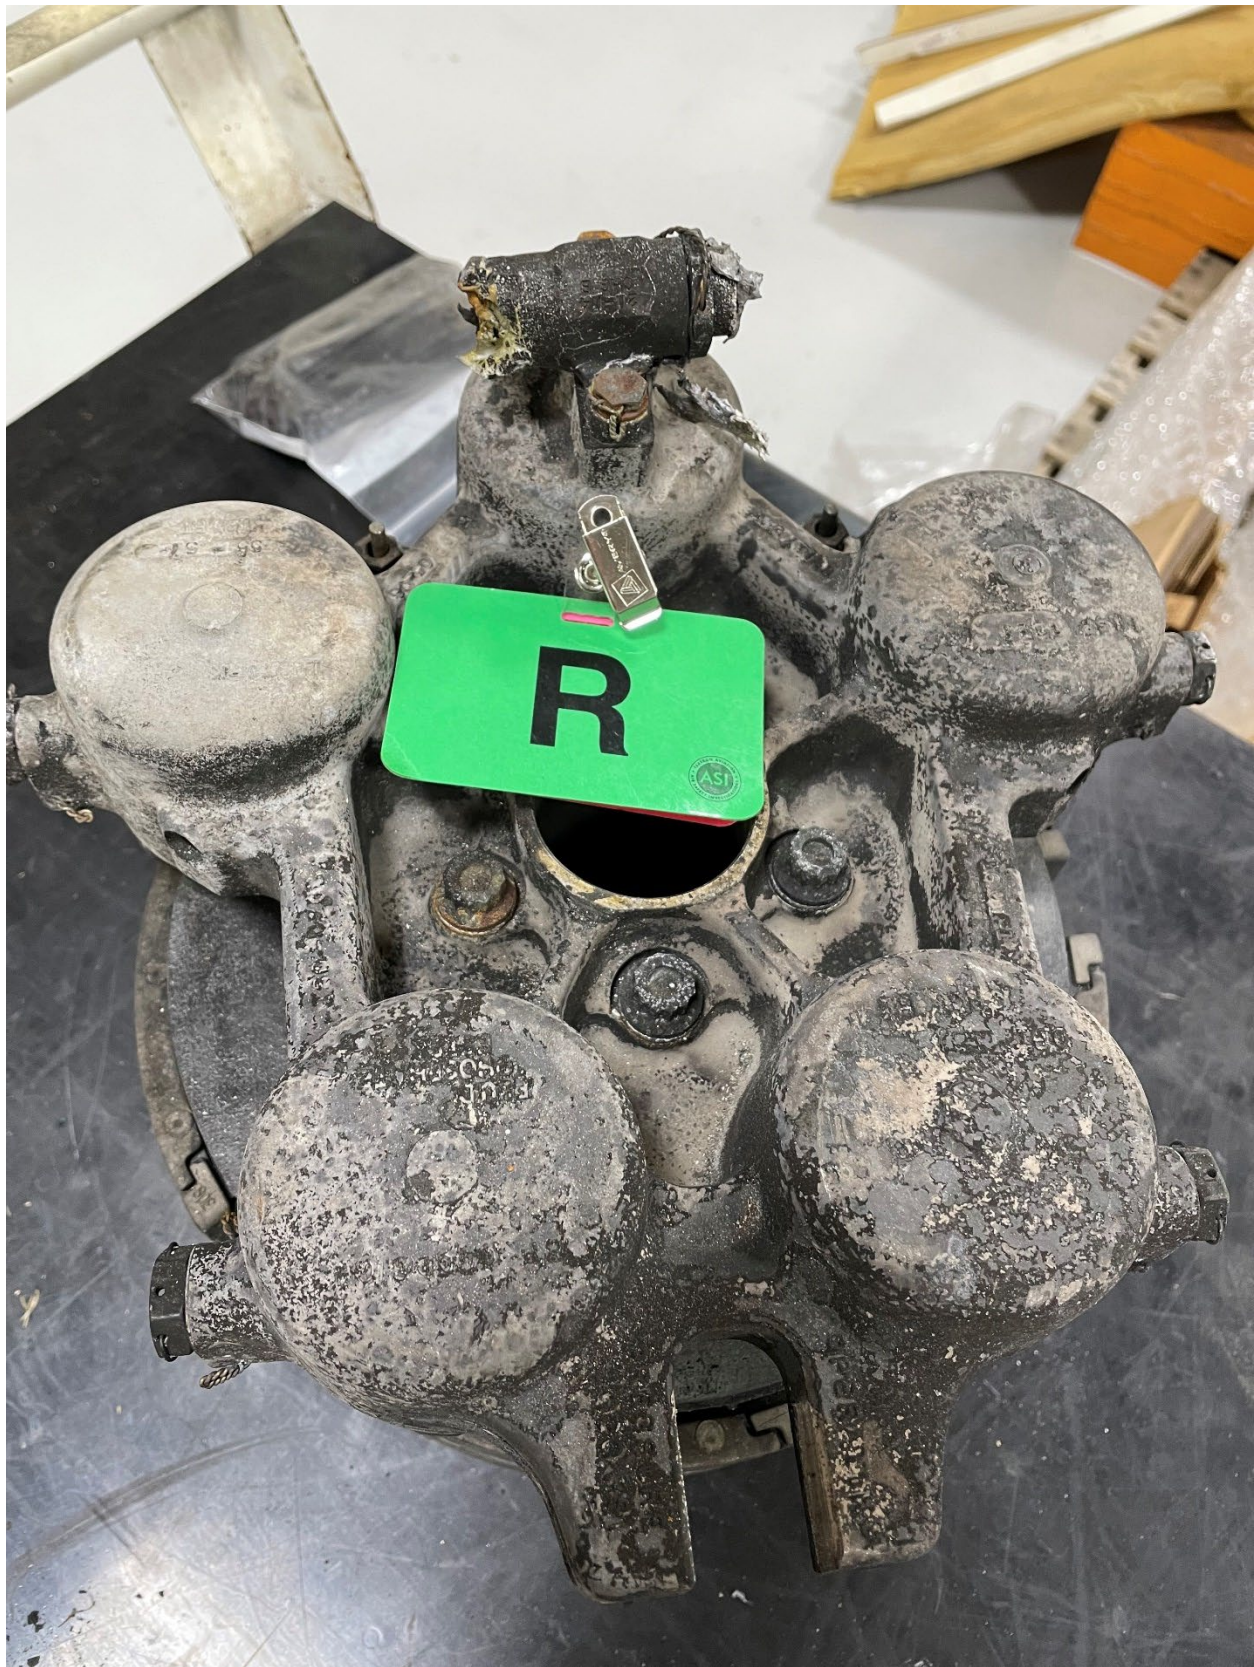
There was no evidence of fluid leaks on the brake assembly. The assembly remained attached to the right main landing gear trunnion/axle during shipment. The brake assembly was removed from the axle. The brakes could not be pressurized because the shuttle valve and adjuster assemblies were compromised (by impact and thermal damage) and would leak. See Figure 13.

**Figure 13.** Right brake assembly.

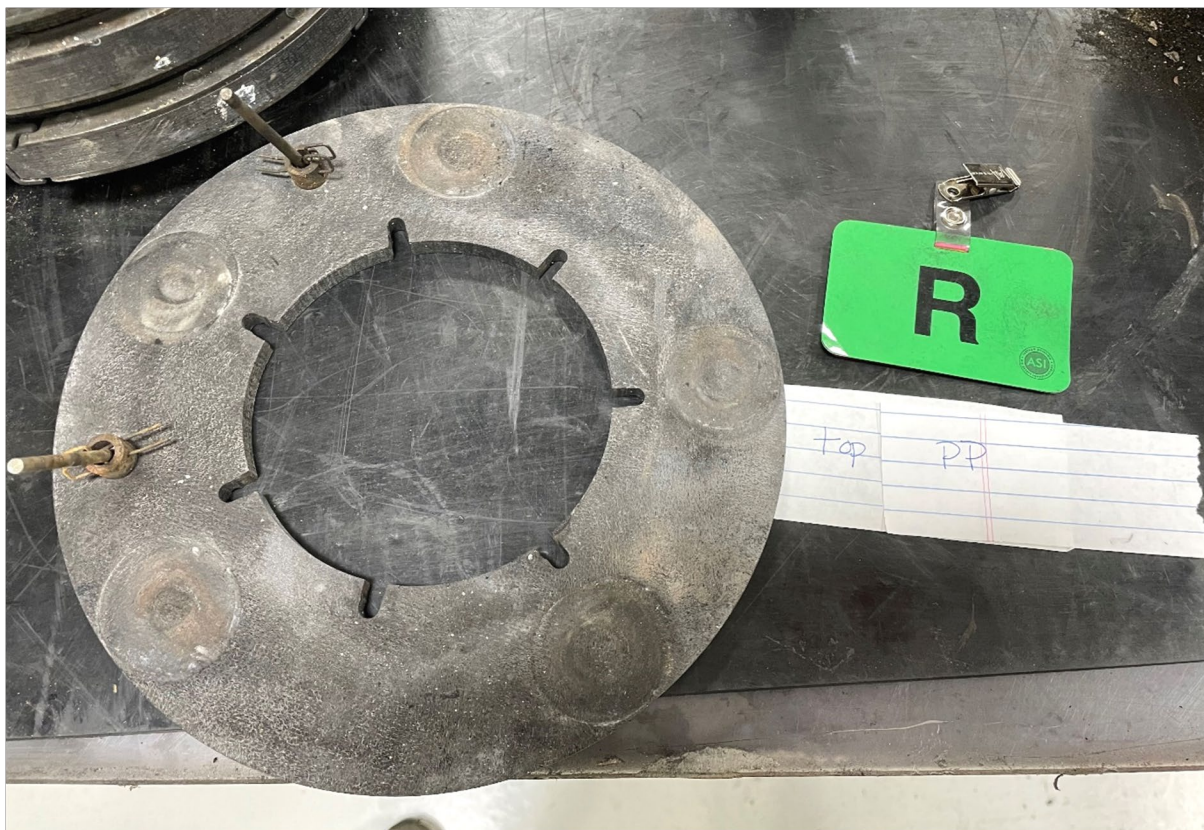
The brake stack was disassembled. The pressure plate showed normal wear. See Figure 14. The stators and rotors were examined. The wear was considered normal. The stators and rotors did not exhibit any sign of oxidation or deterioration. One of the drive grooves on stator 2 exhibited minor mechanical damage to the carbon.

**Figure 14.** The right brake assembly pressure plate, top side, after disassembly.

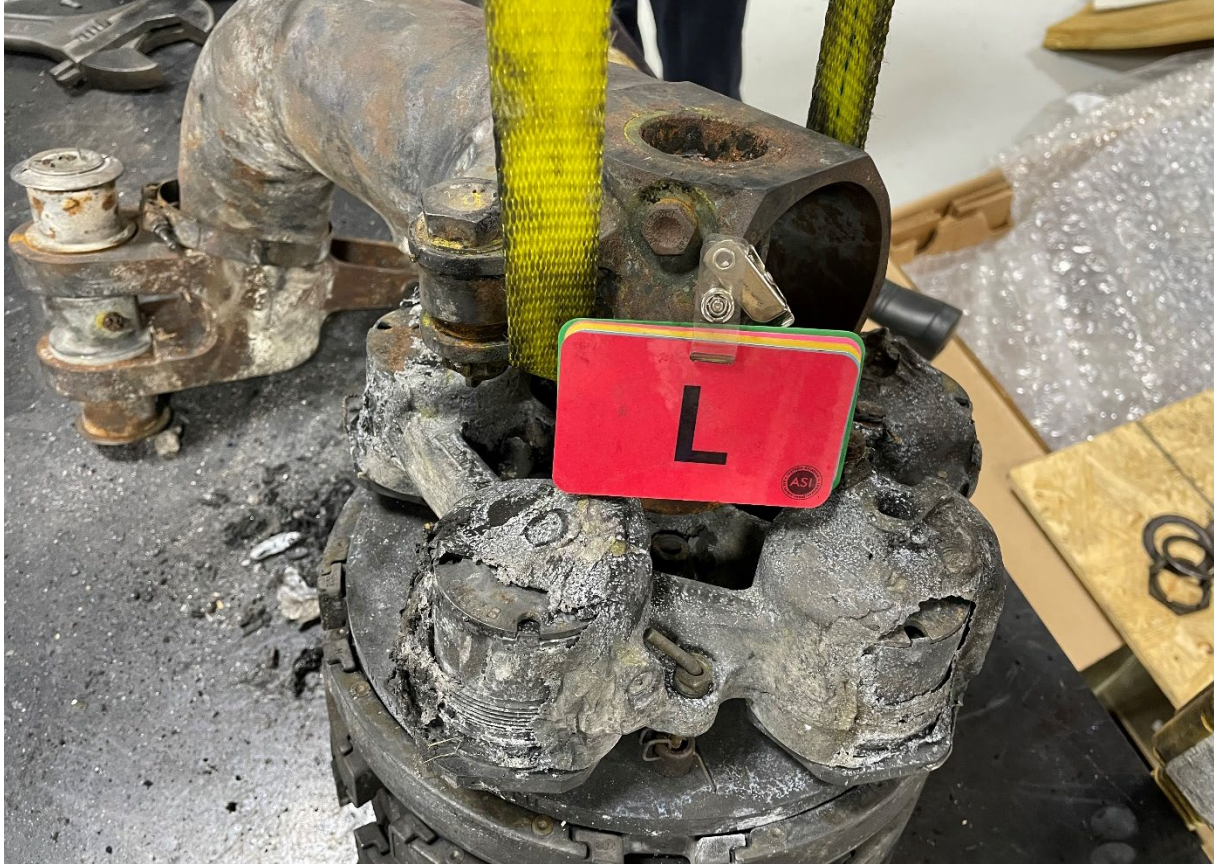
The left brake assembly was examined. There was no evidence of fluid leaks. The left brake assembly remained attached to the left main landing gear trunnion/axle during shipment. The brake assembly could not easily be removed from the axle. To gain access to the brake stack, the back side of the torque plate was cutoff using a plasma torch. The brakes could not be pressurized because the shuttle valve was missing and extreme thermal damage to the brake housing exposed the piston cavities. The shuttle valve bolts and their lockwire remained. See Figure 15.

**Figure 15.** Left brake assembly and damage to the brake piston housings.

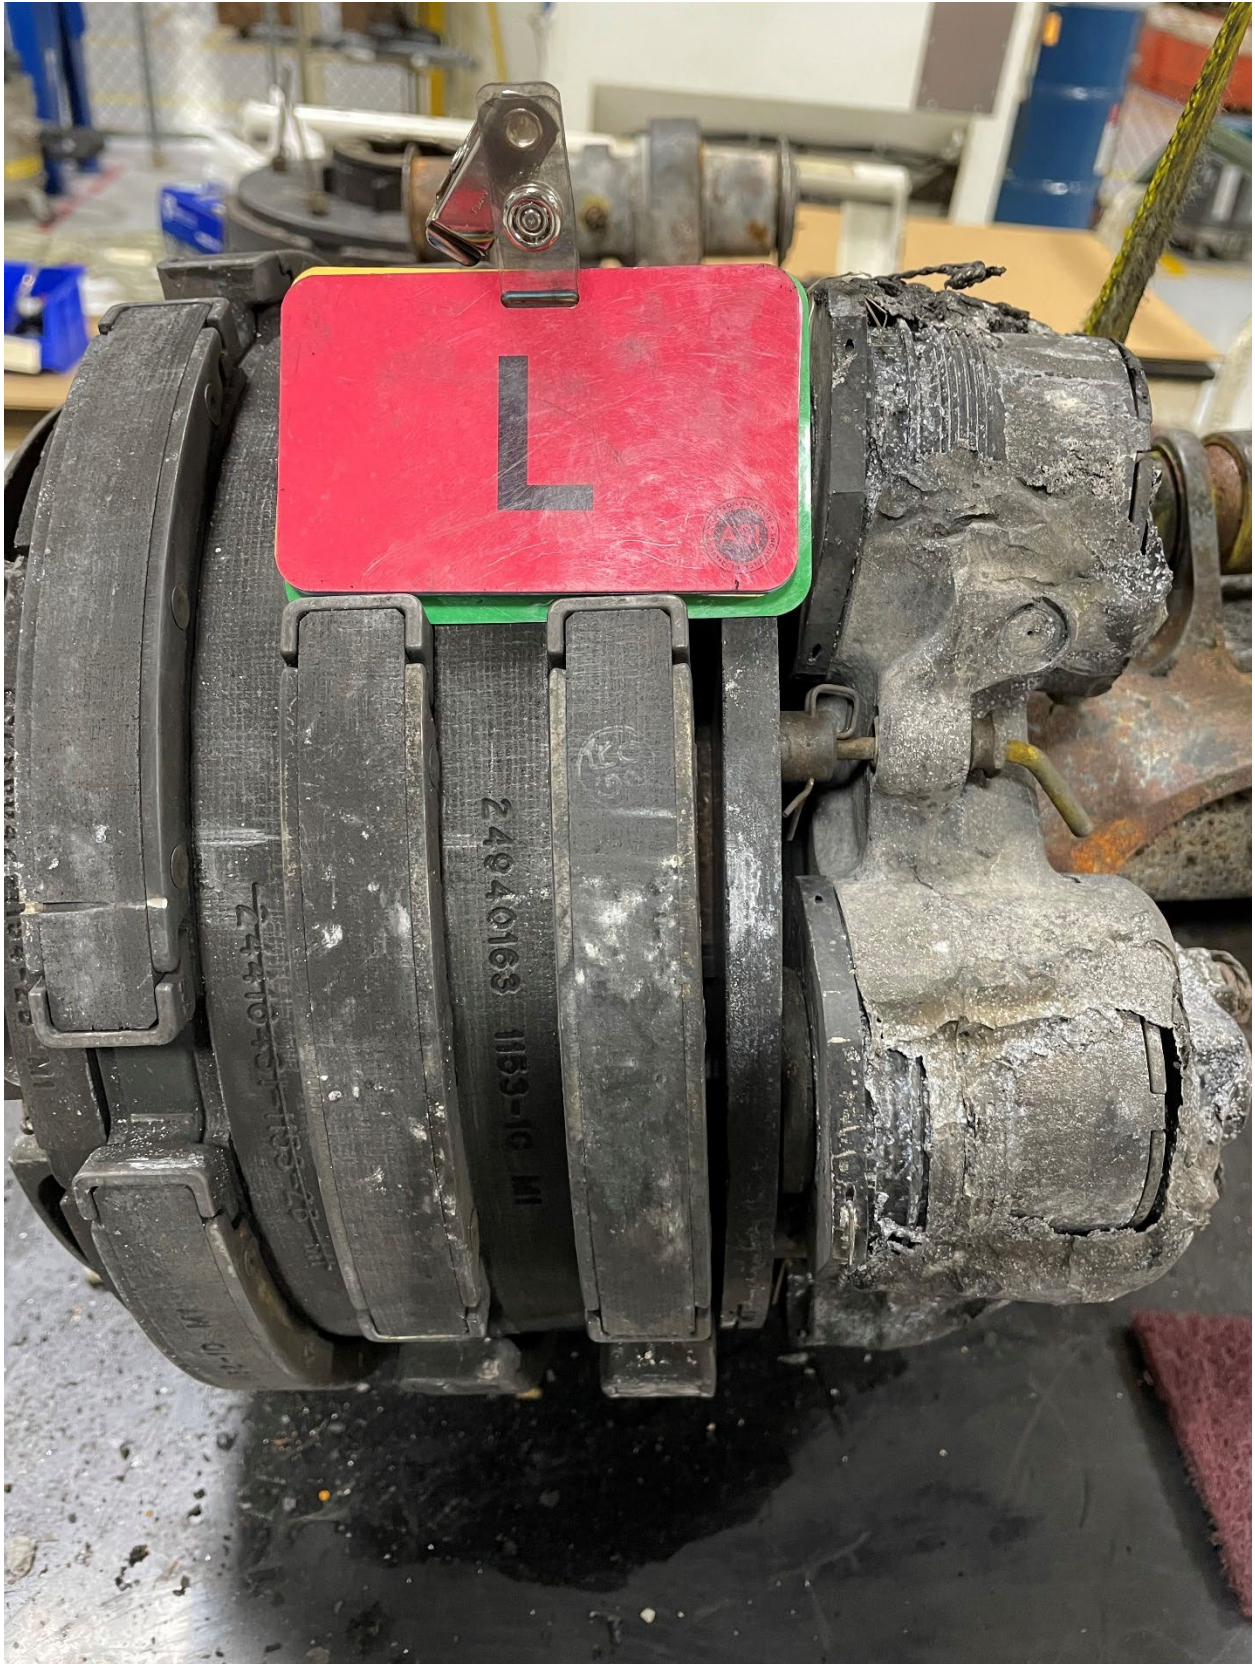
The wear pin (right of shuttle valve) was bent and could not be measured. The wear pin (left of shuttle valve) was measured at 0.941 inches. (Caliper V0429 was used for the measurement.) The measurement was taken without hydraulic pressure applied to the brake stack. The pistons appeared to be fully retracted. See Figure 16.

**Figure 16.** Left brake assembly, stators, and rotors.

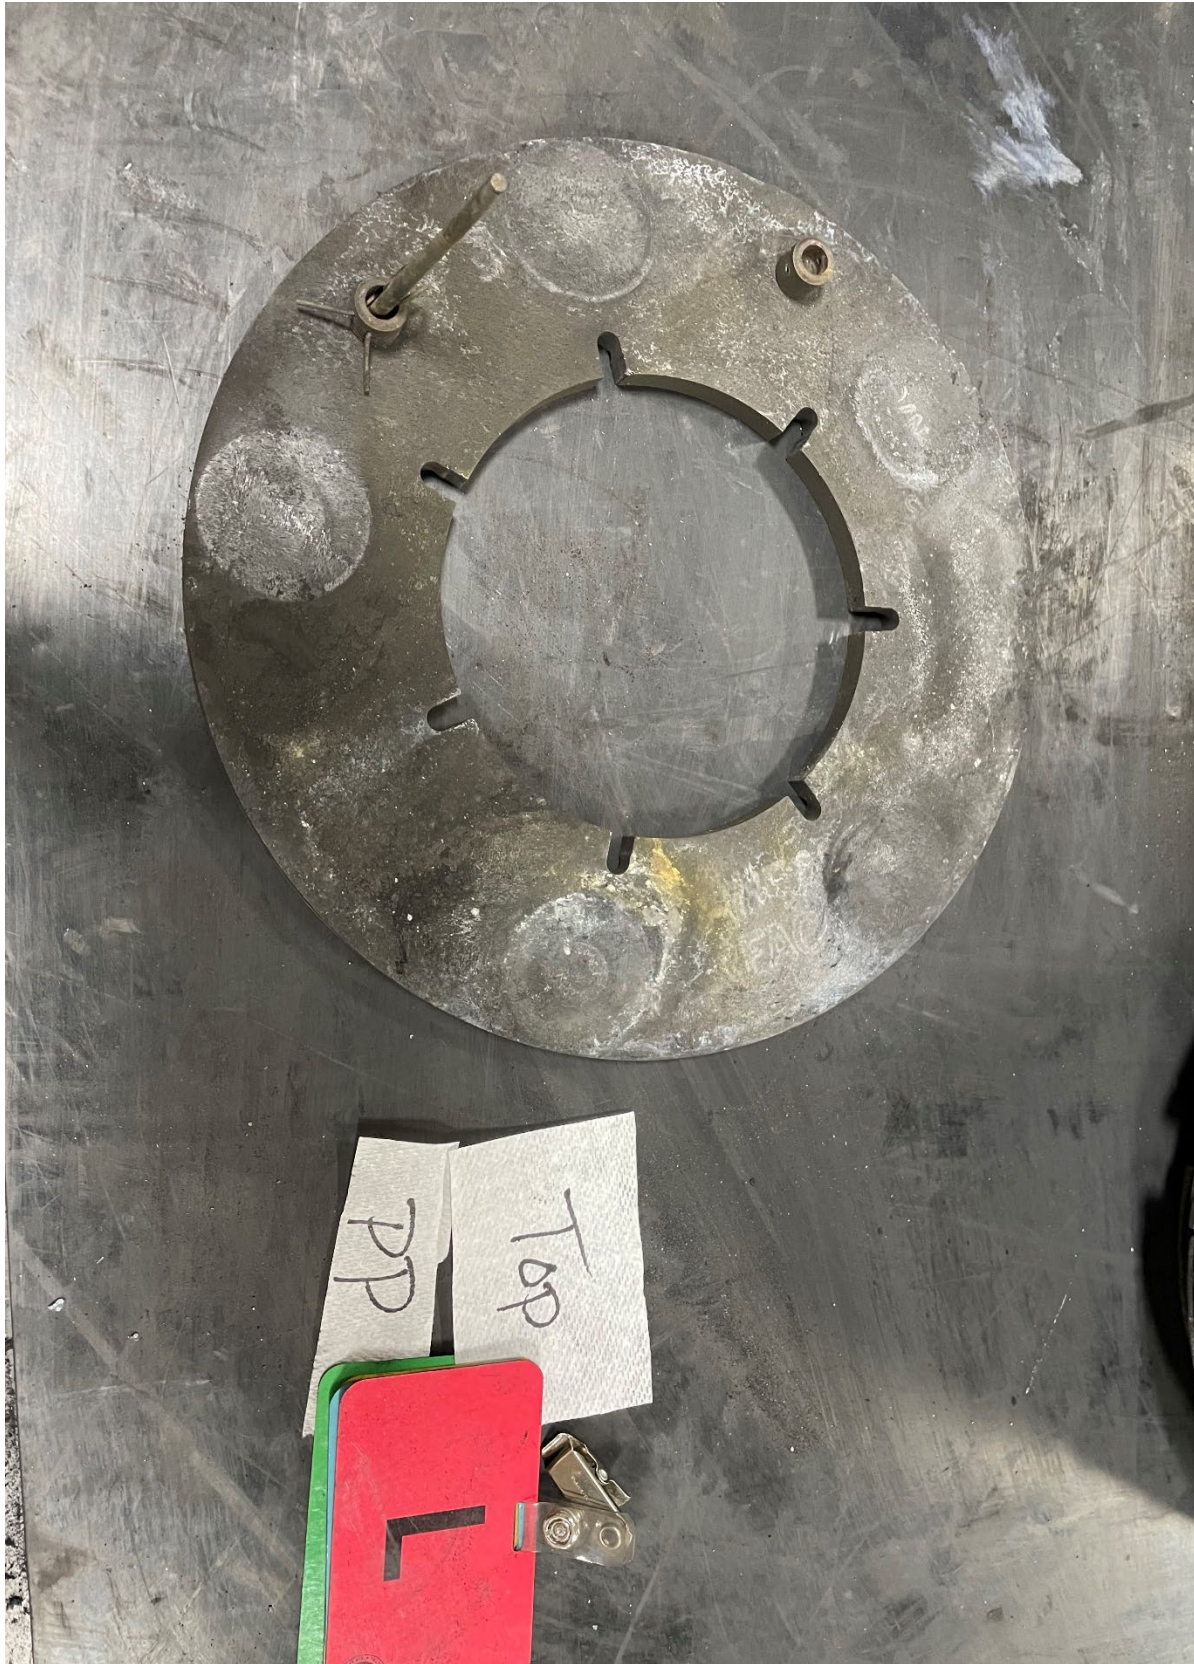
The brake stack was disassembled. The pressure plate showed normal wear. See Figure 17. The stators and rotors were examined. The observed wear was considered normal. The stators and rotors did not exhibit any sign of oxidation or deterioration.

**Figure 17.** The left brake assembly pressure plate, top side.

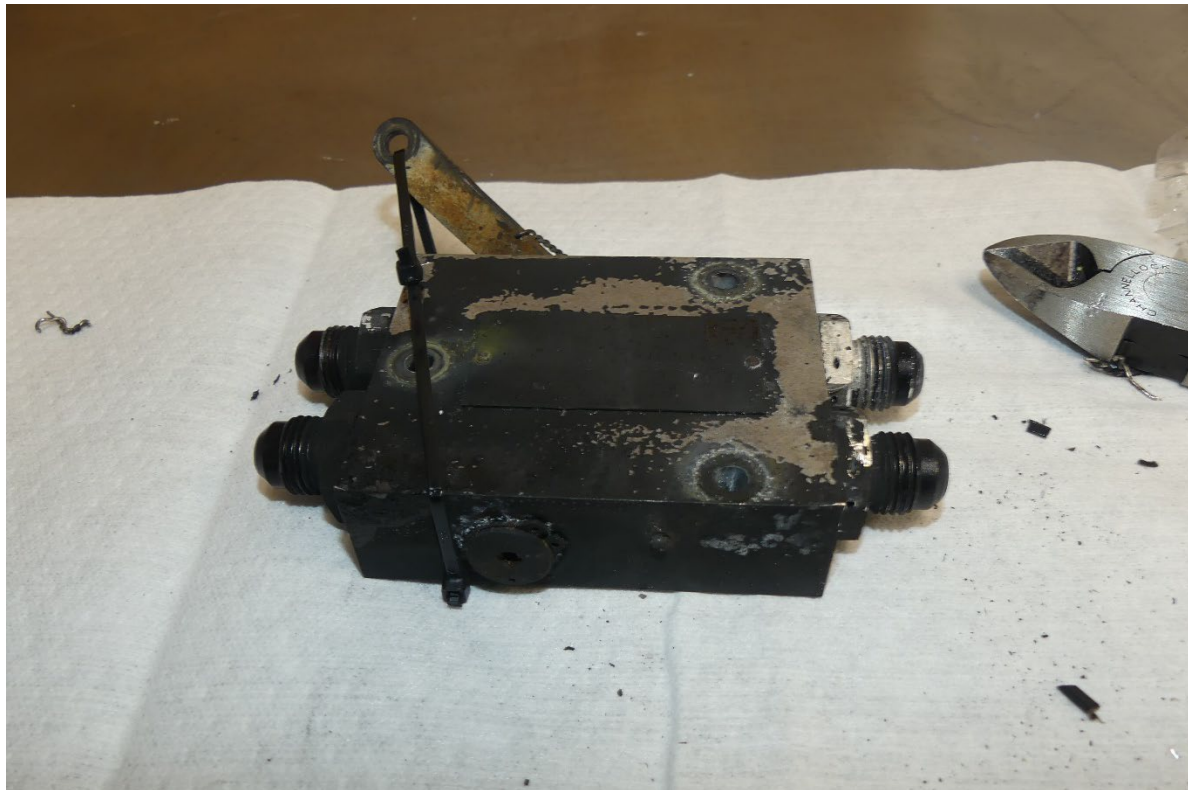
A visual examination of the valve determined the valve lever was in the closed position. When the plastic restraint holding the valve handle was removed, the valve lever could not be moved by hand. See Figure 18.

**Figure 18.** The parking brake valve, as received, prior to disassembly, with plastic restraint on valve handle.

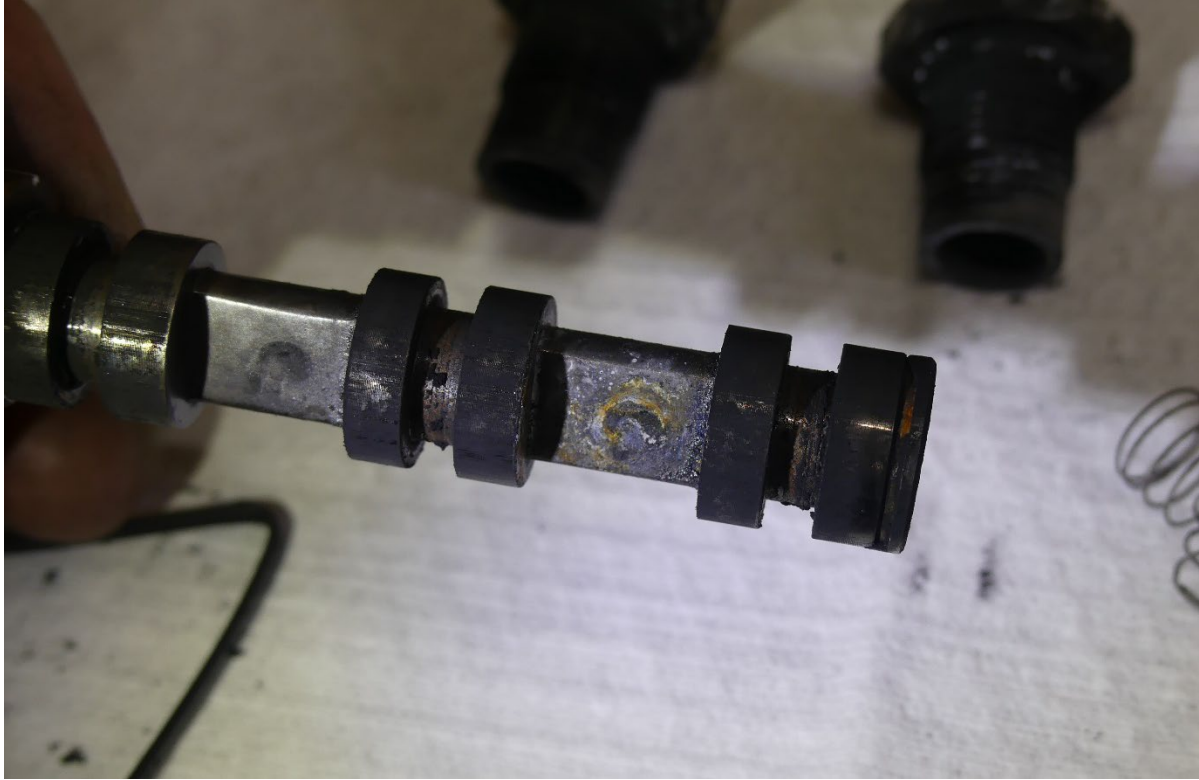
Circular witness marks were noted on the flat portion of the cam. GarKenyon personnel indicated that, based on the position of the valve, the marks may have been made by heat damage from the poppet valve touching the flat spots of the cam during the post-crash fire. See Figure 19.

**Figure 19.** The parking brake valve cam, with witness marks on the flat spots.

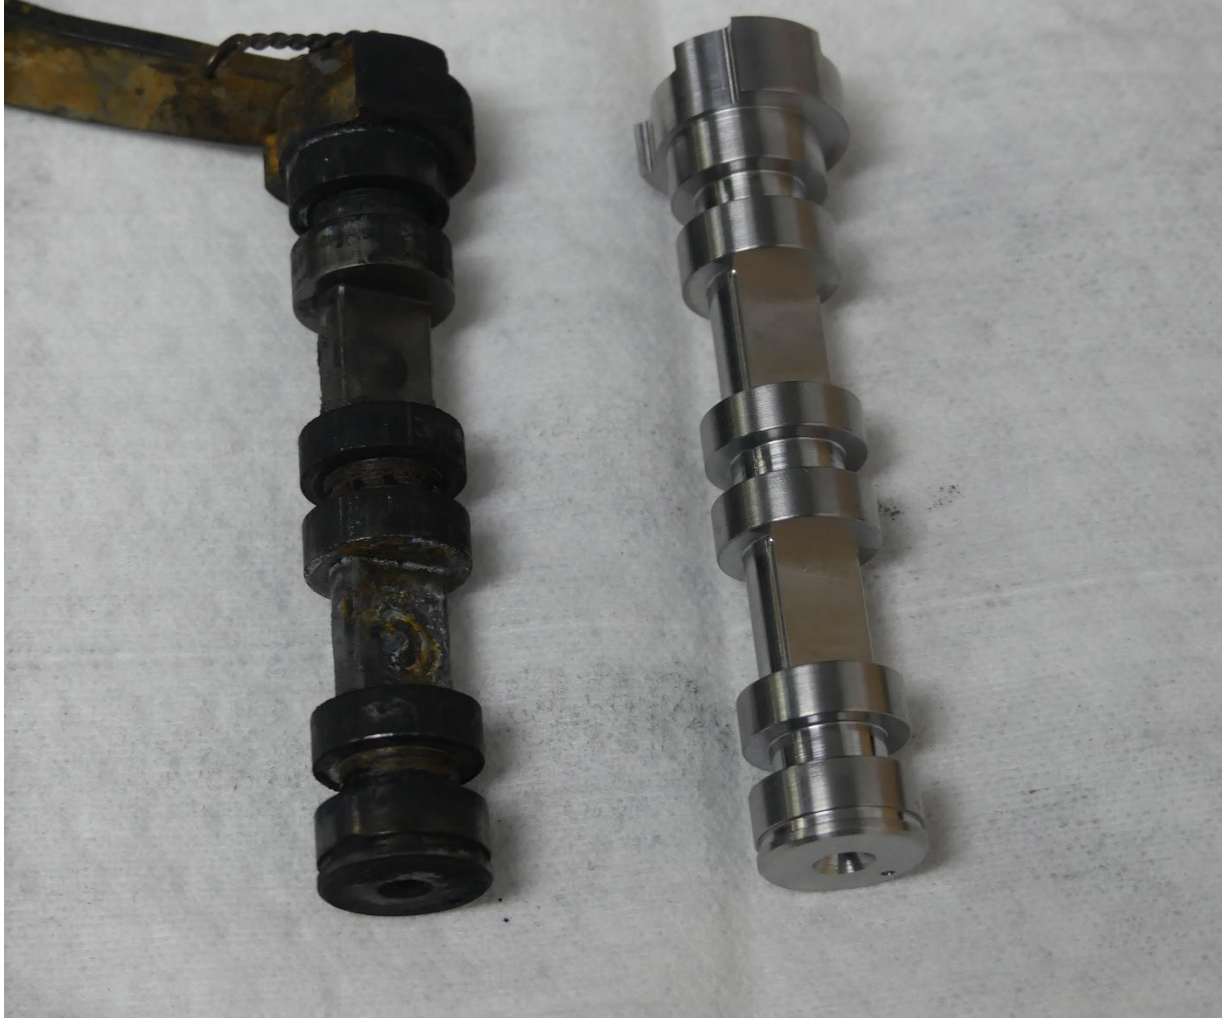
The cam (and attached lever) from the accident valve was compared to a newly manufactured cam. See Figure 20.

**Figure 20.** Side by side comparison of the accident parking brake valve's cam and lever (left) against a new cam (right).
