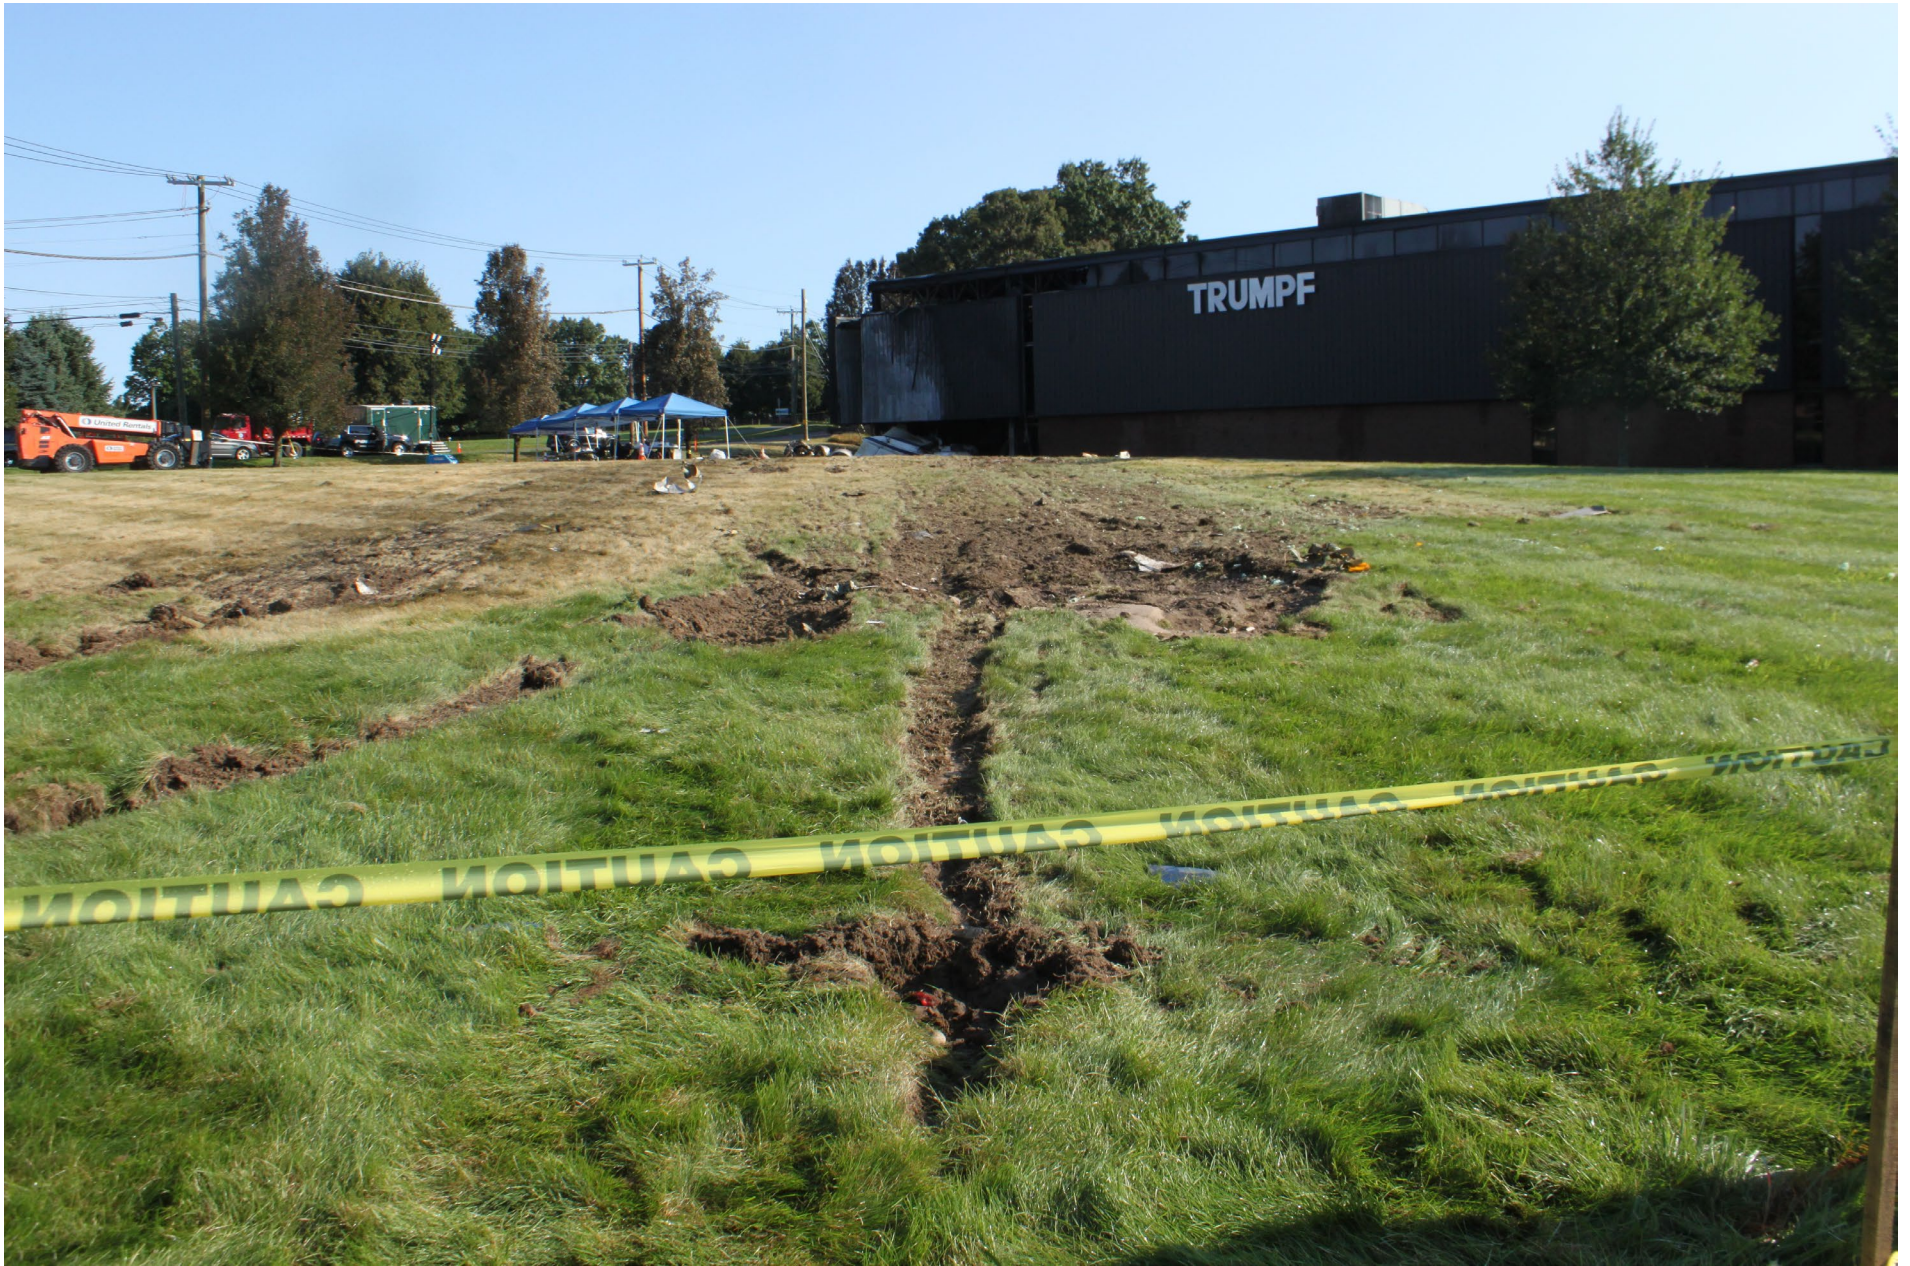
**Photo 1 – NTSB Digital Photograph. View Looking at the Initial Ground Impact Location with the Main Wreckage in the Background.**

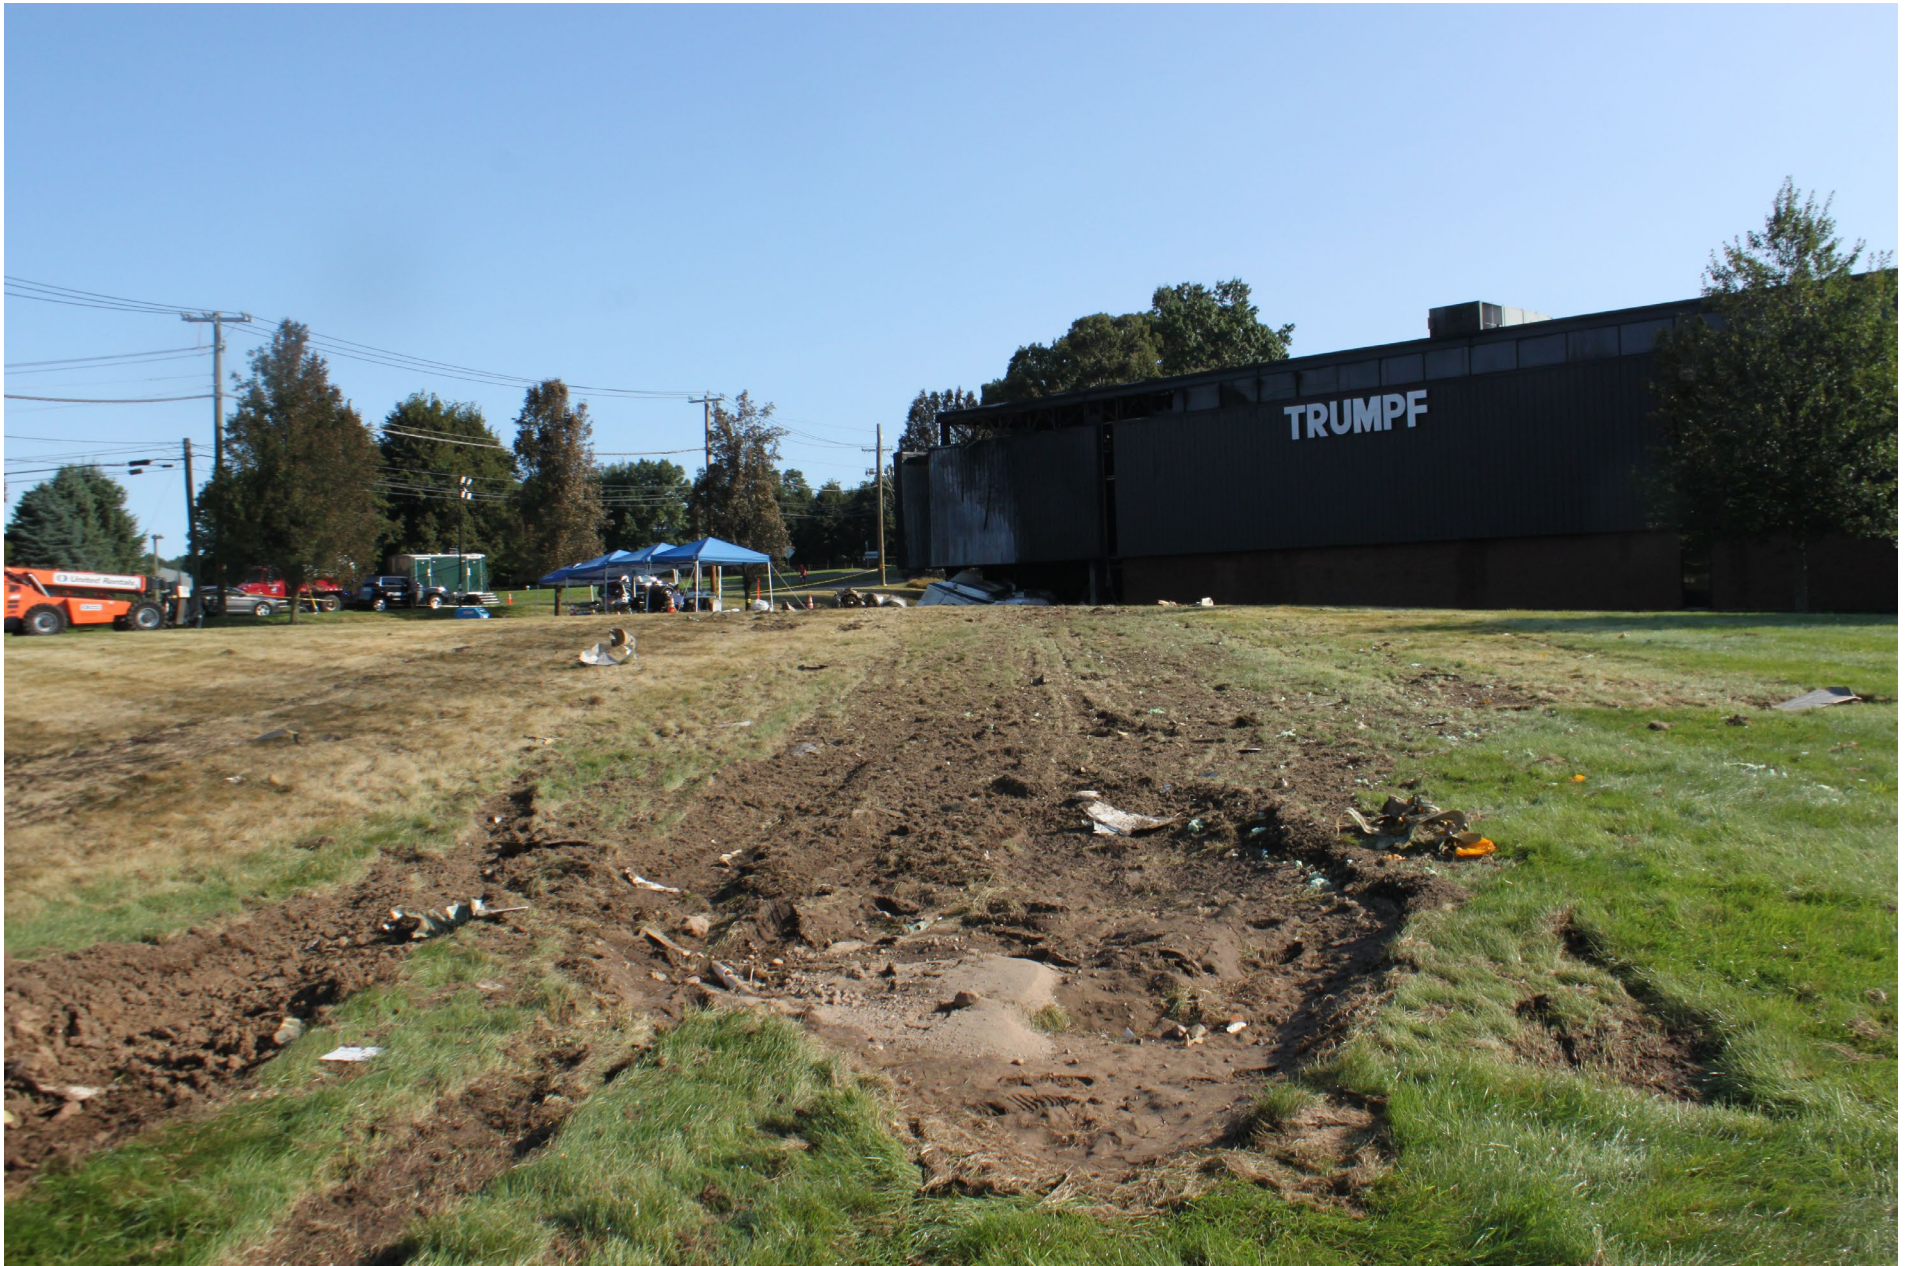
**Photo 2 - NTSB Digital Photograph. View Looking at the Ground Impact Location Consistent with the Top Portion of the Fuselage with the Main Wreckage in the Background.**

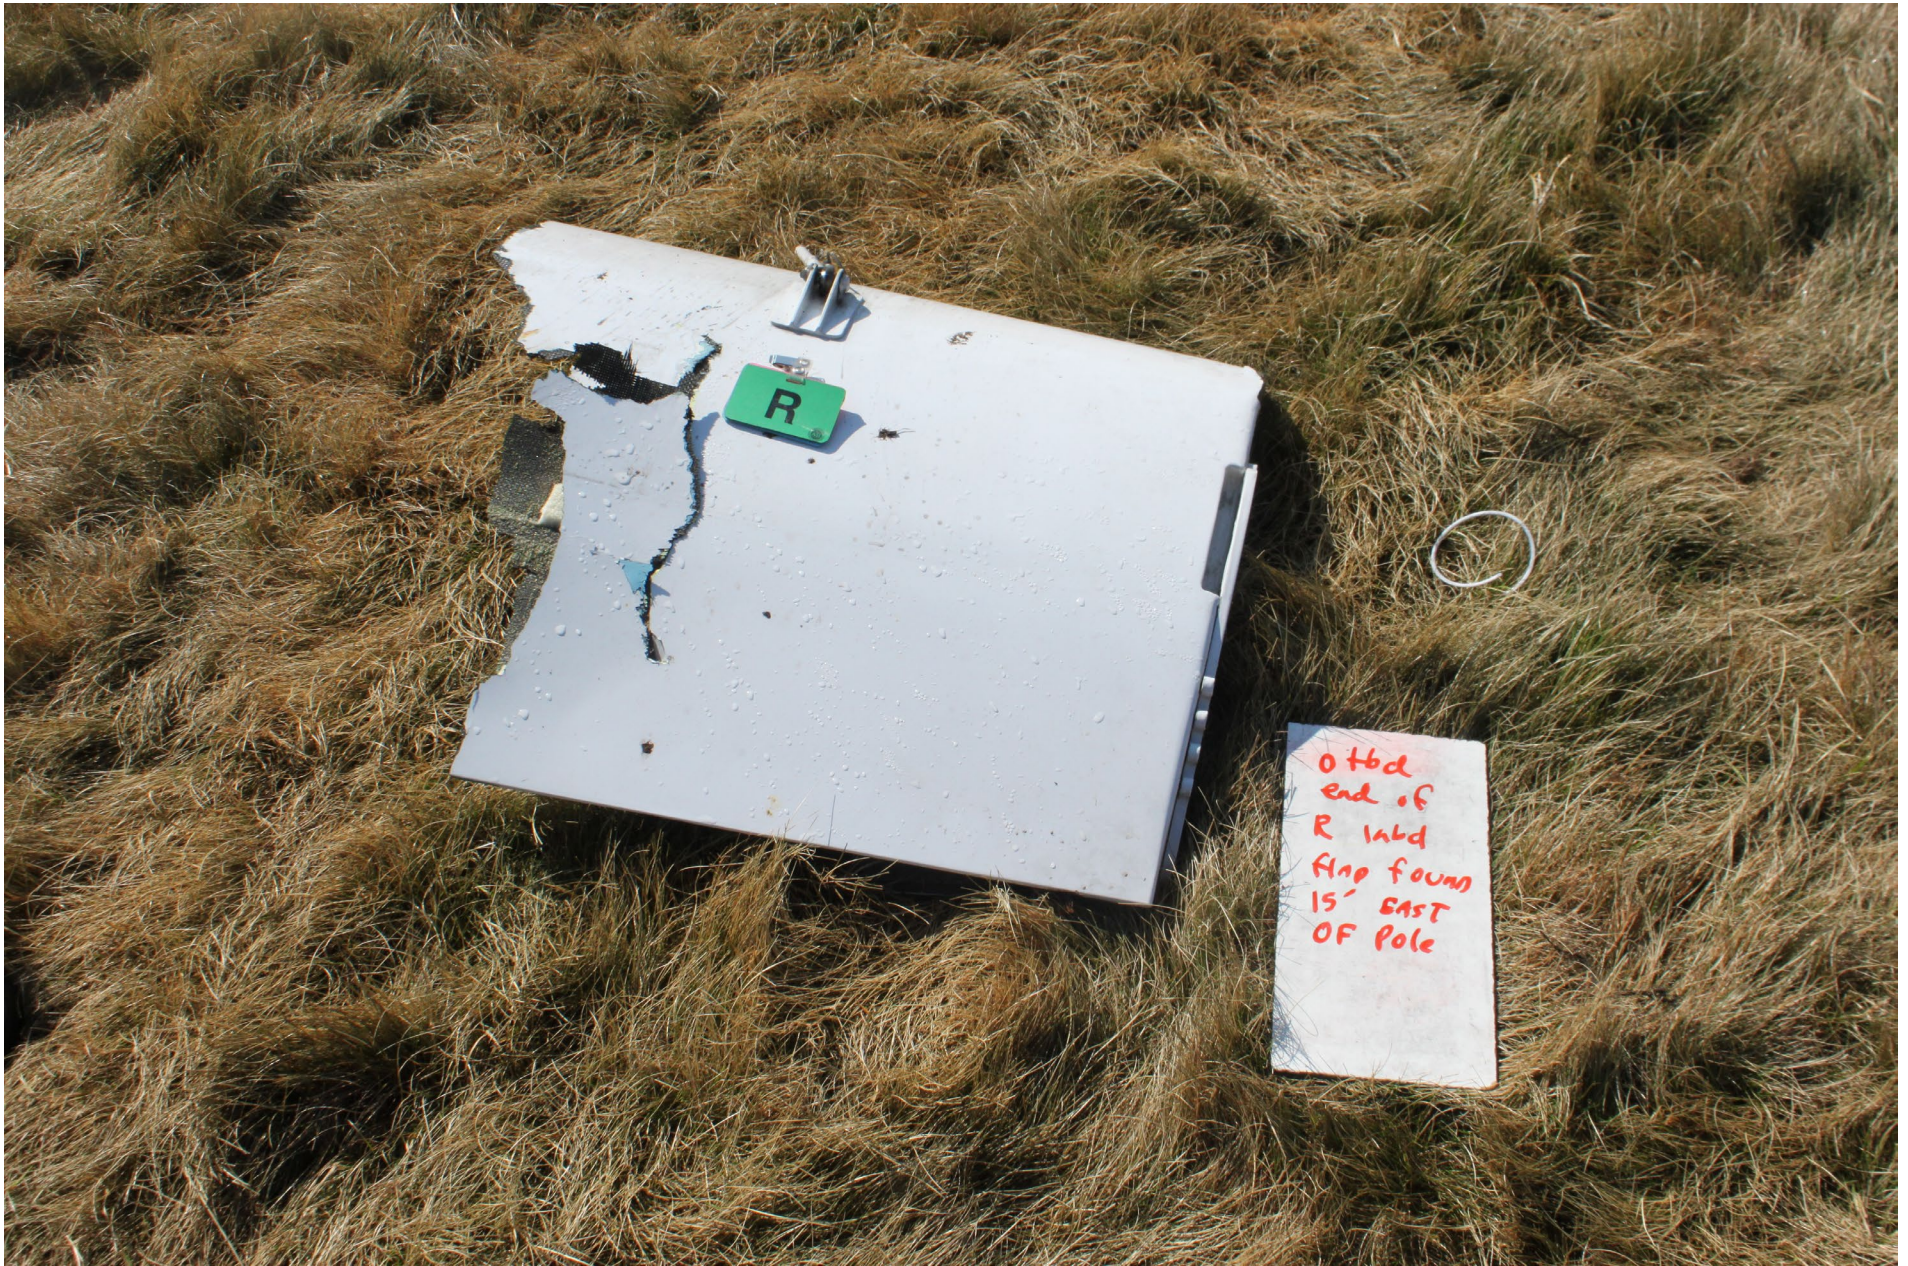
**Photo 3 - NTSB Digital Photograph. Outboard End of Right Inboard Flap Found 15 Ft East of Impacted Pole.**

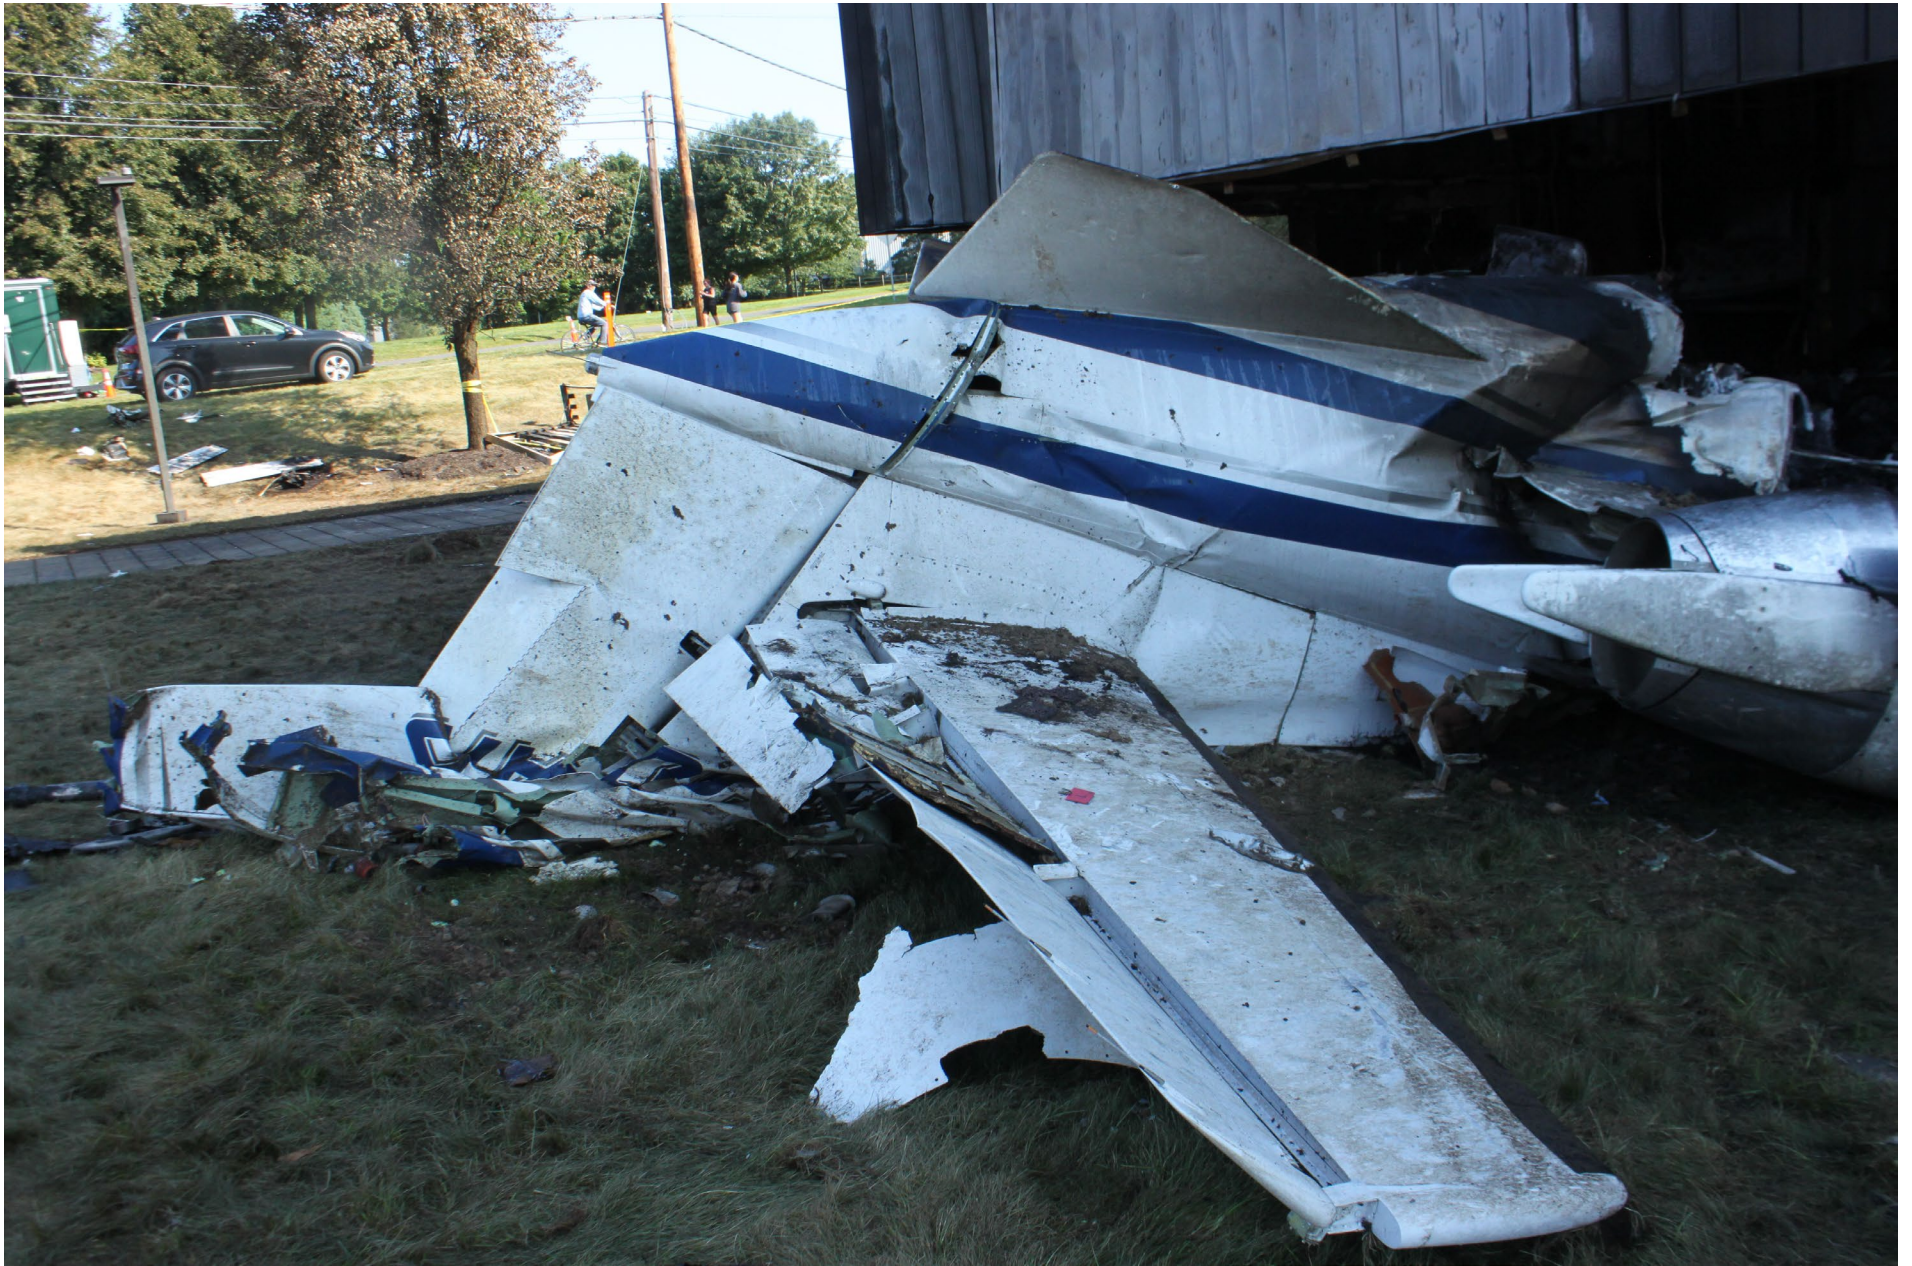
**Photo 4 - NTSB Digital Photograph. Left Side View of the Inverted Aft Empennage at the Accident Site.**

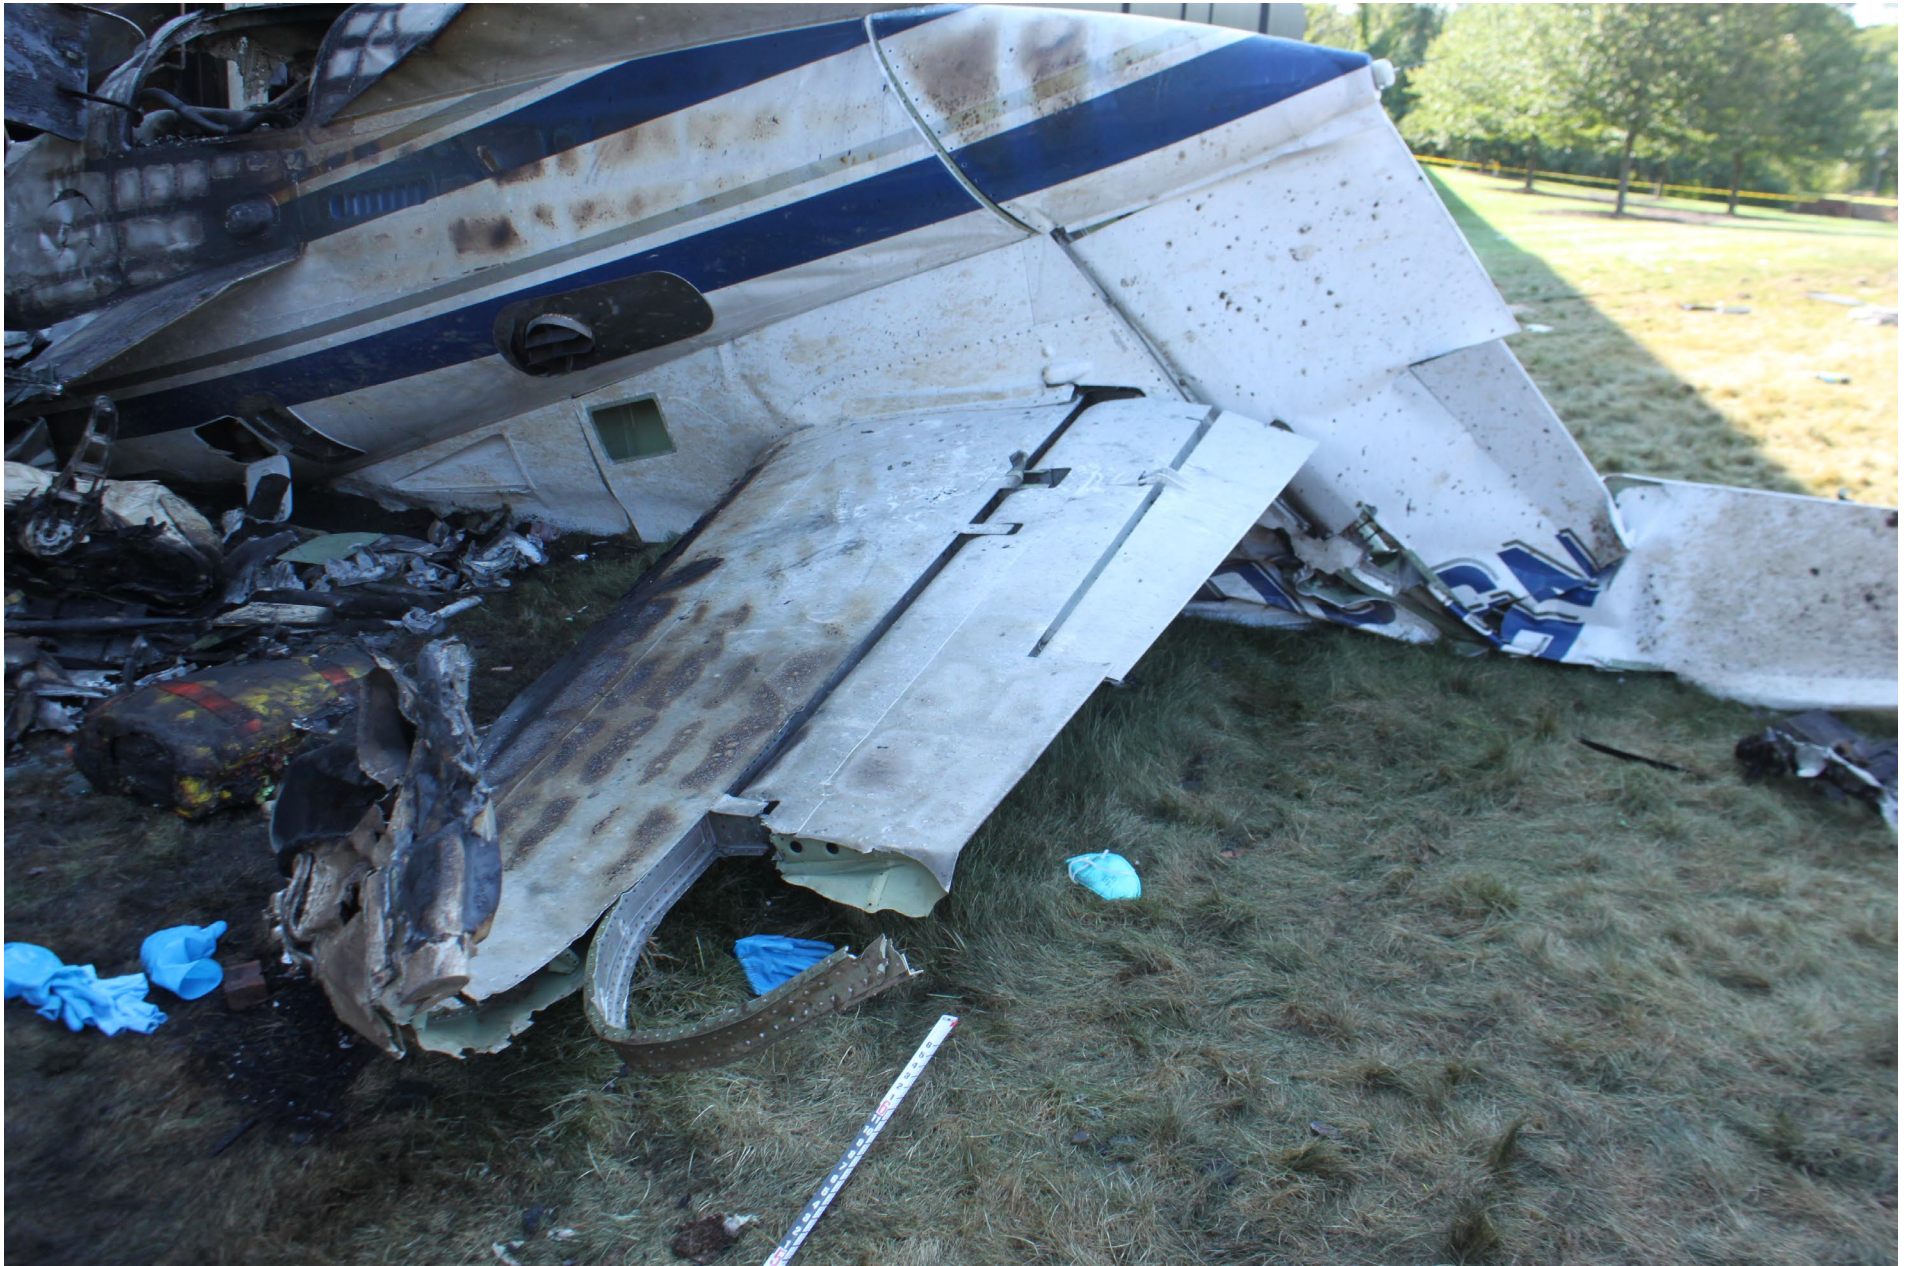
**Photo 5 - NTSB Digital Photograph. Right Side View of the Inverted Aft Empennage at the Accident Site.**

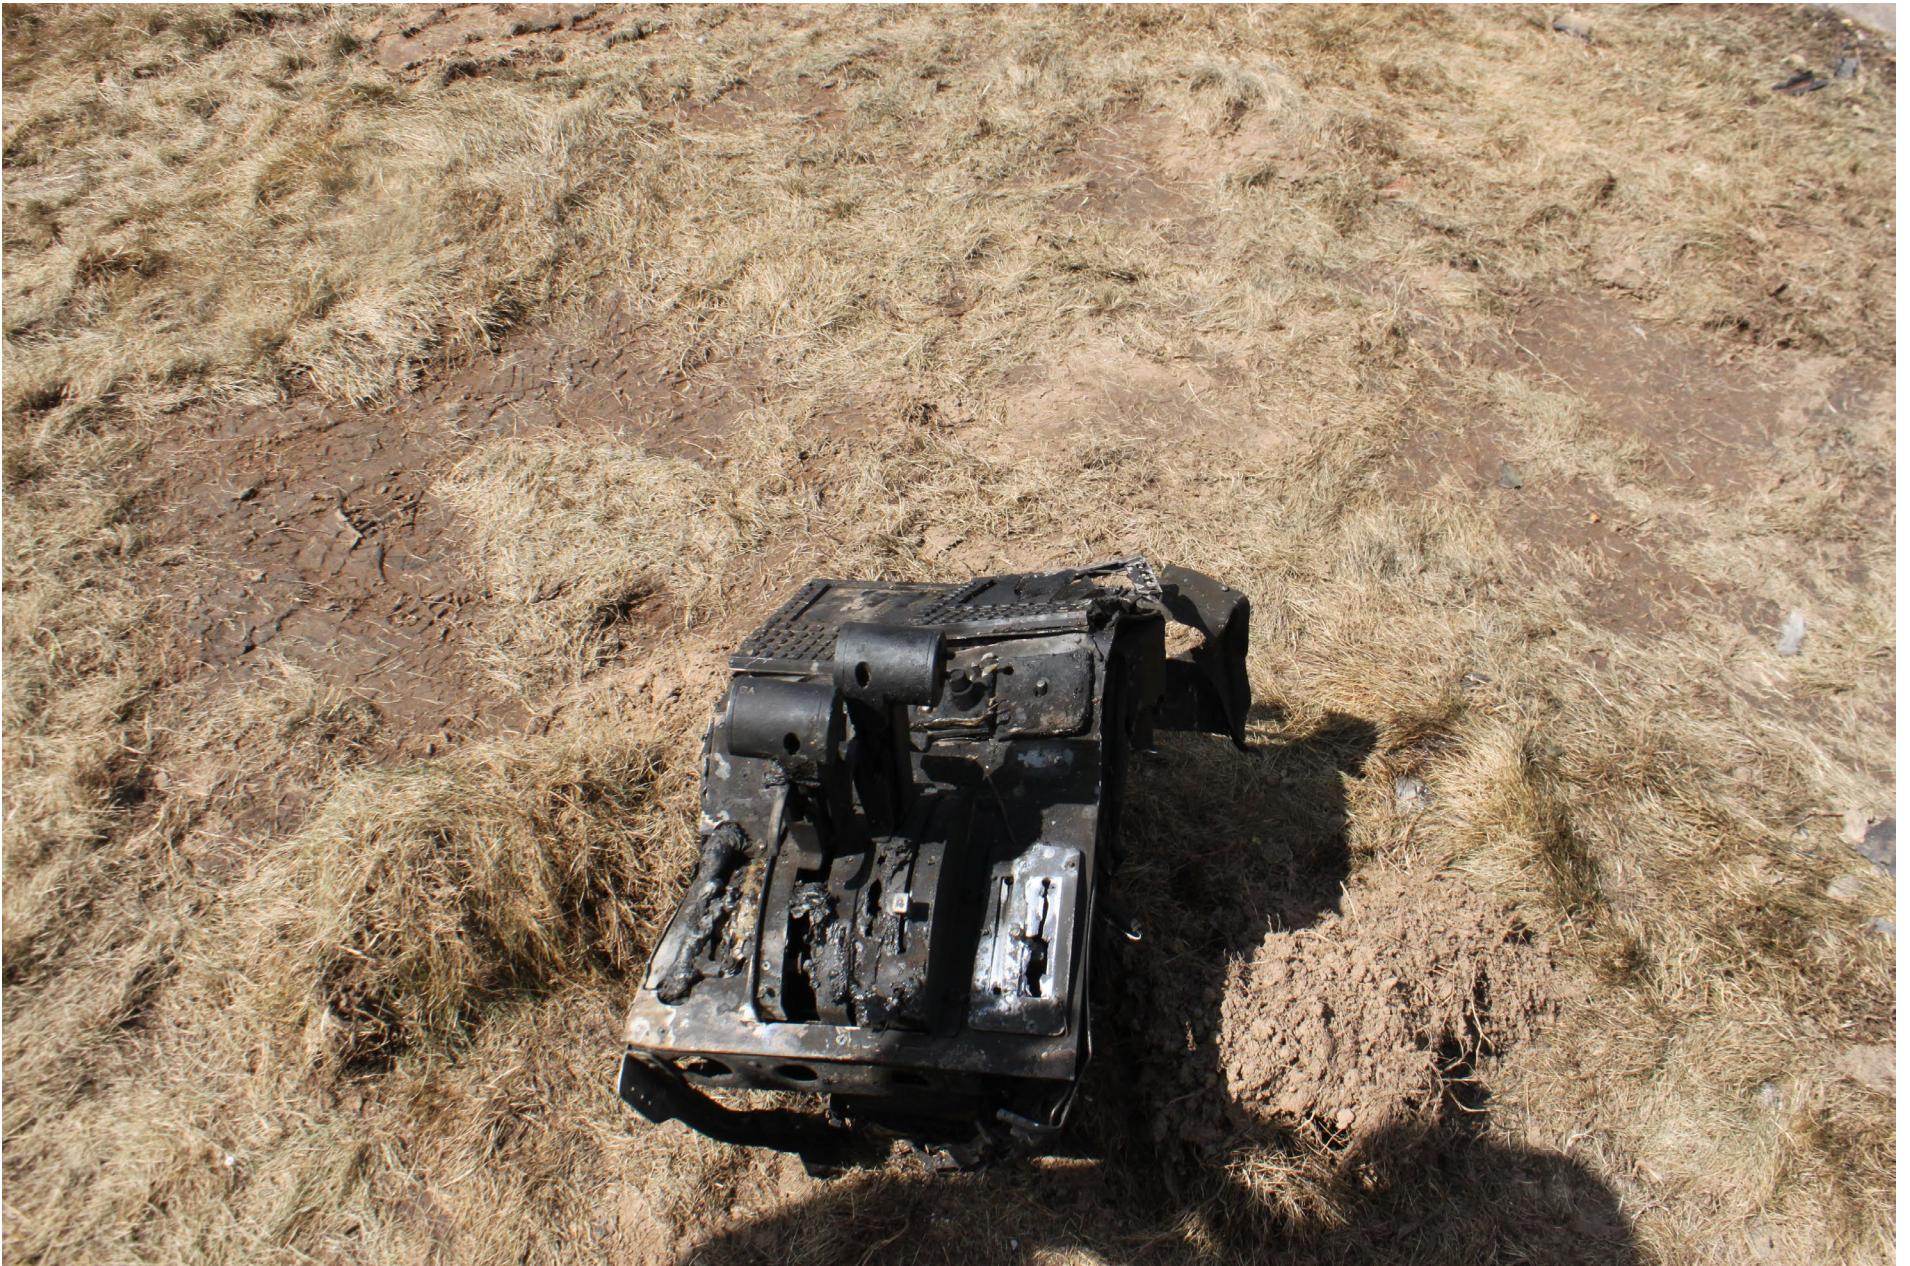
**Photo 6 - NTSB Digital Photograph. View of the Separated Throttle Quadrant.**

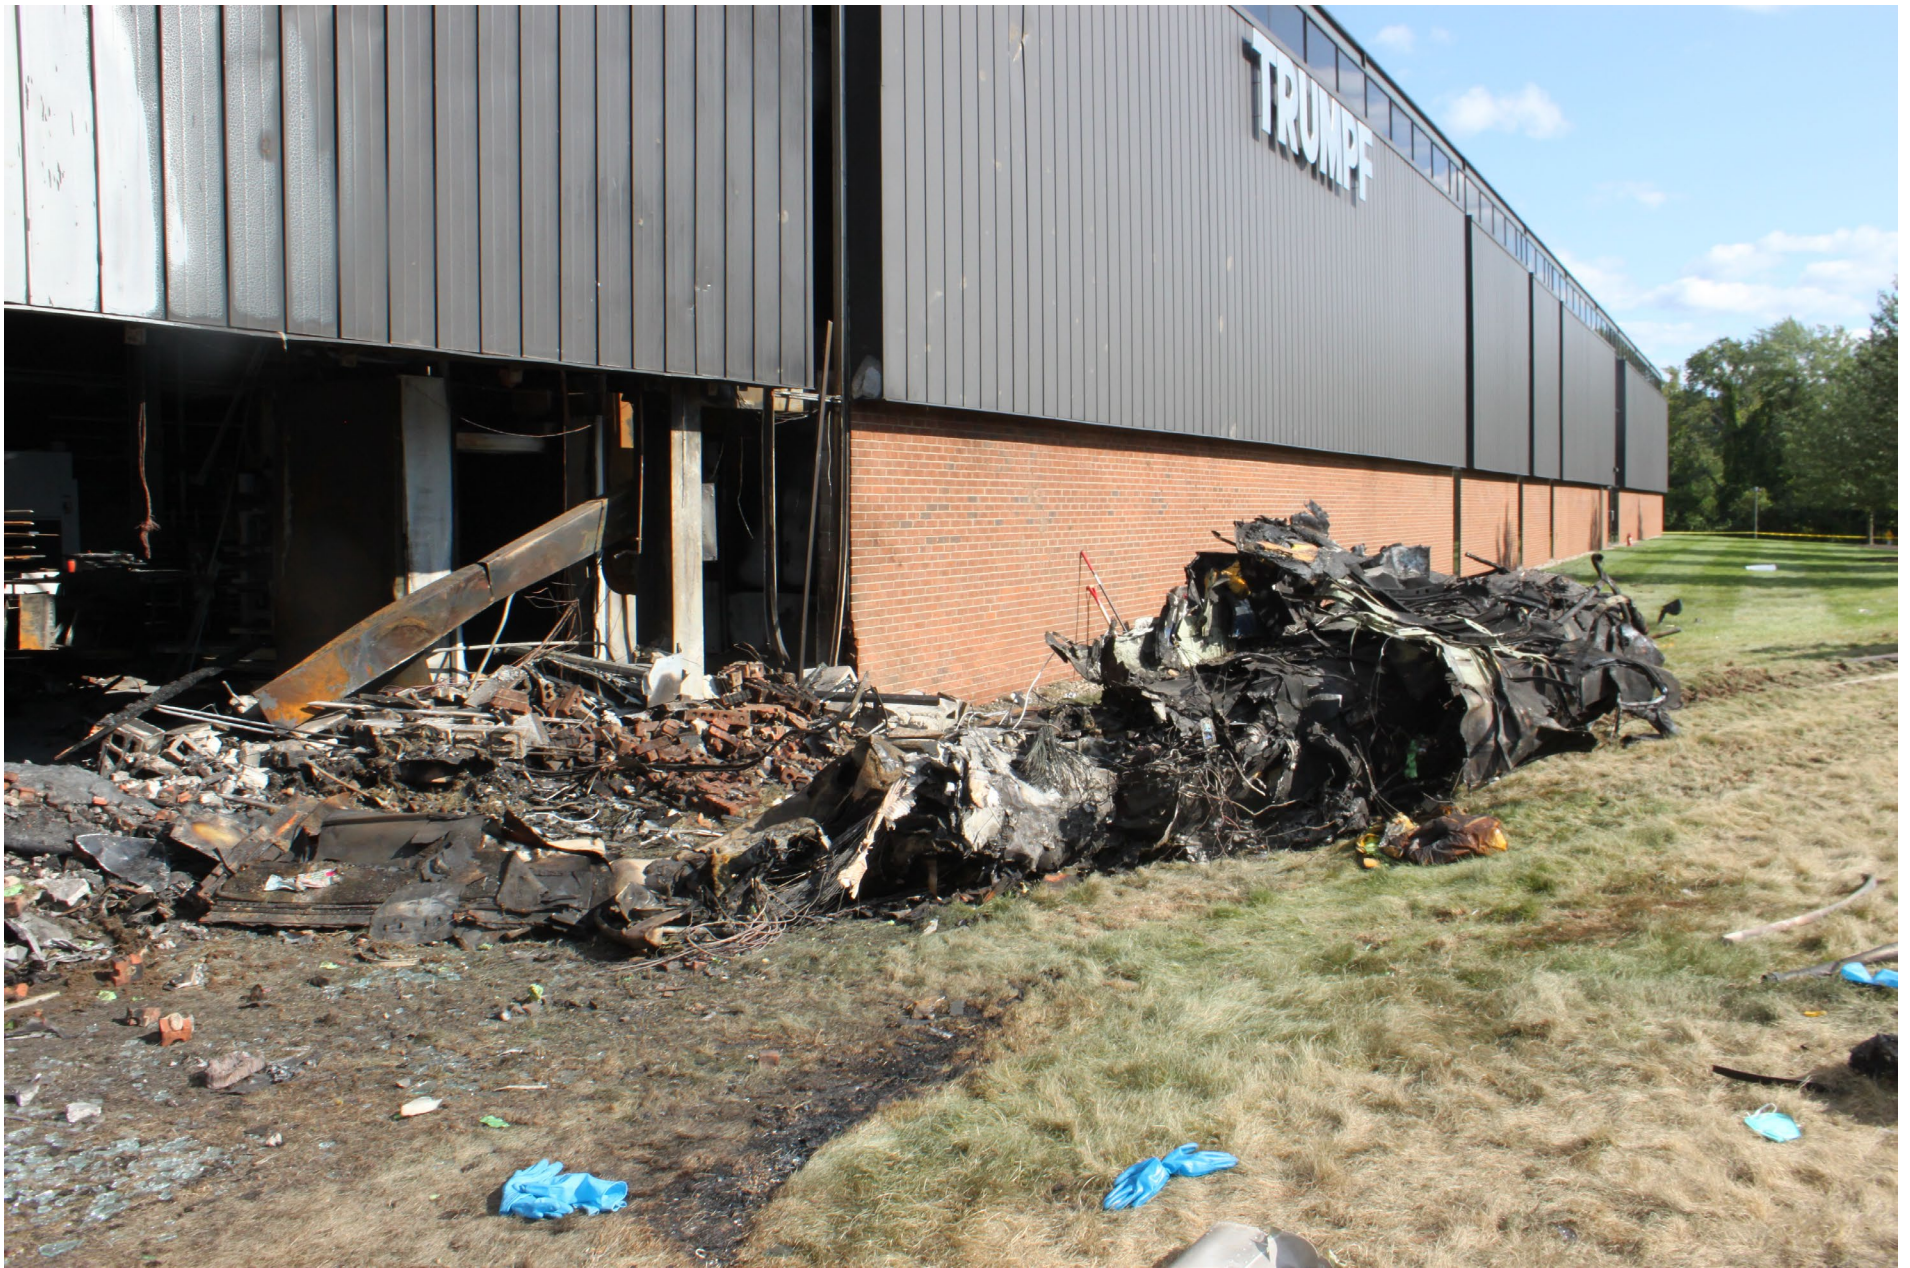
**Photo 7 - NTSB Digital Photograph. View of the Wreckage Following Removal from Inside and Just Outside the Impacted Building.**

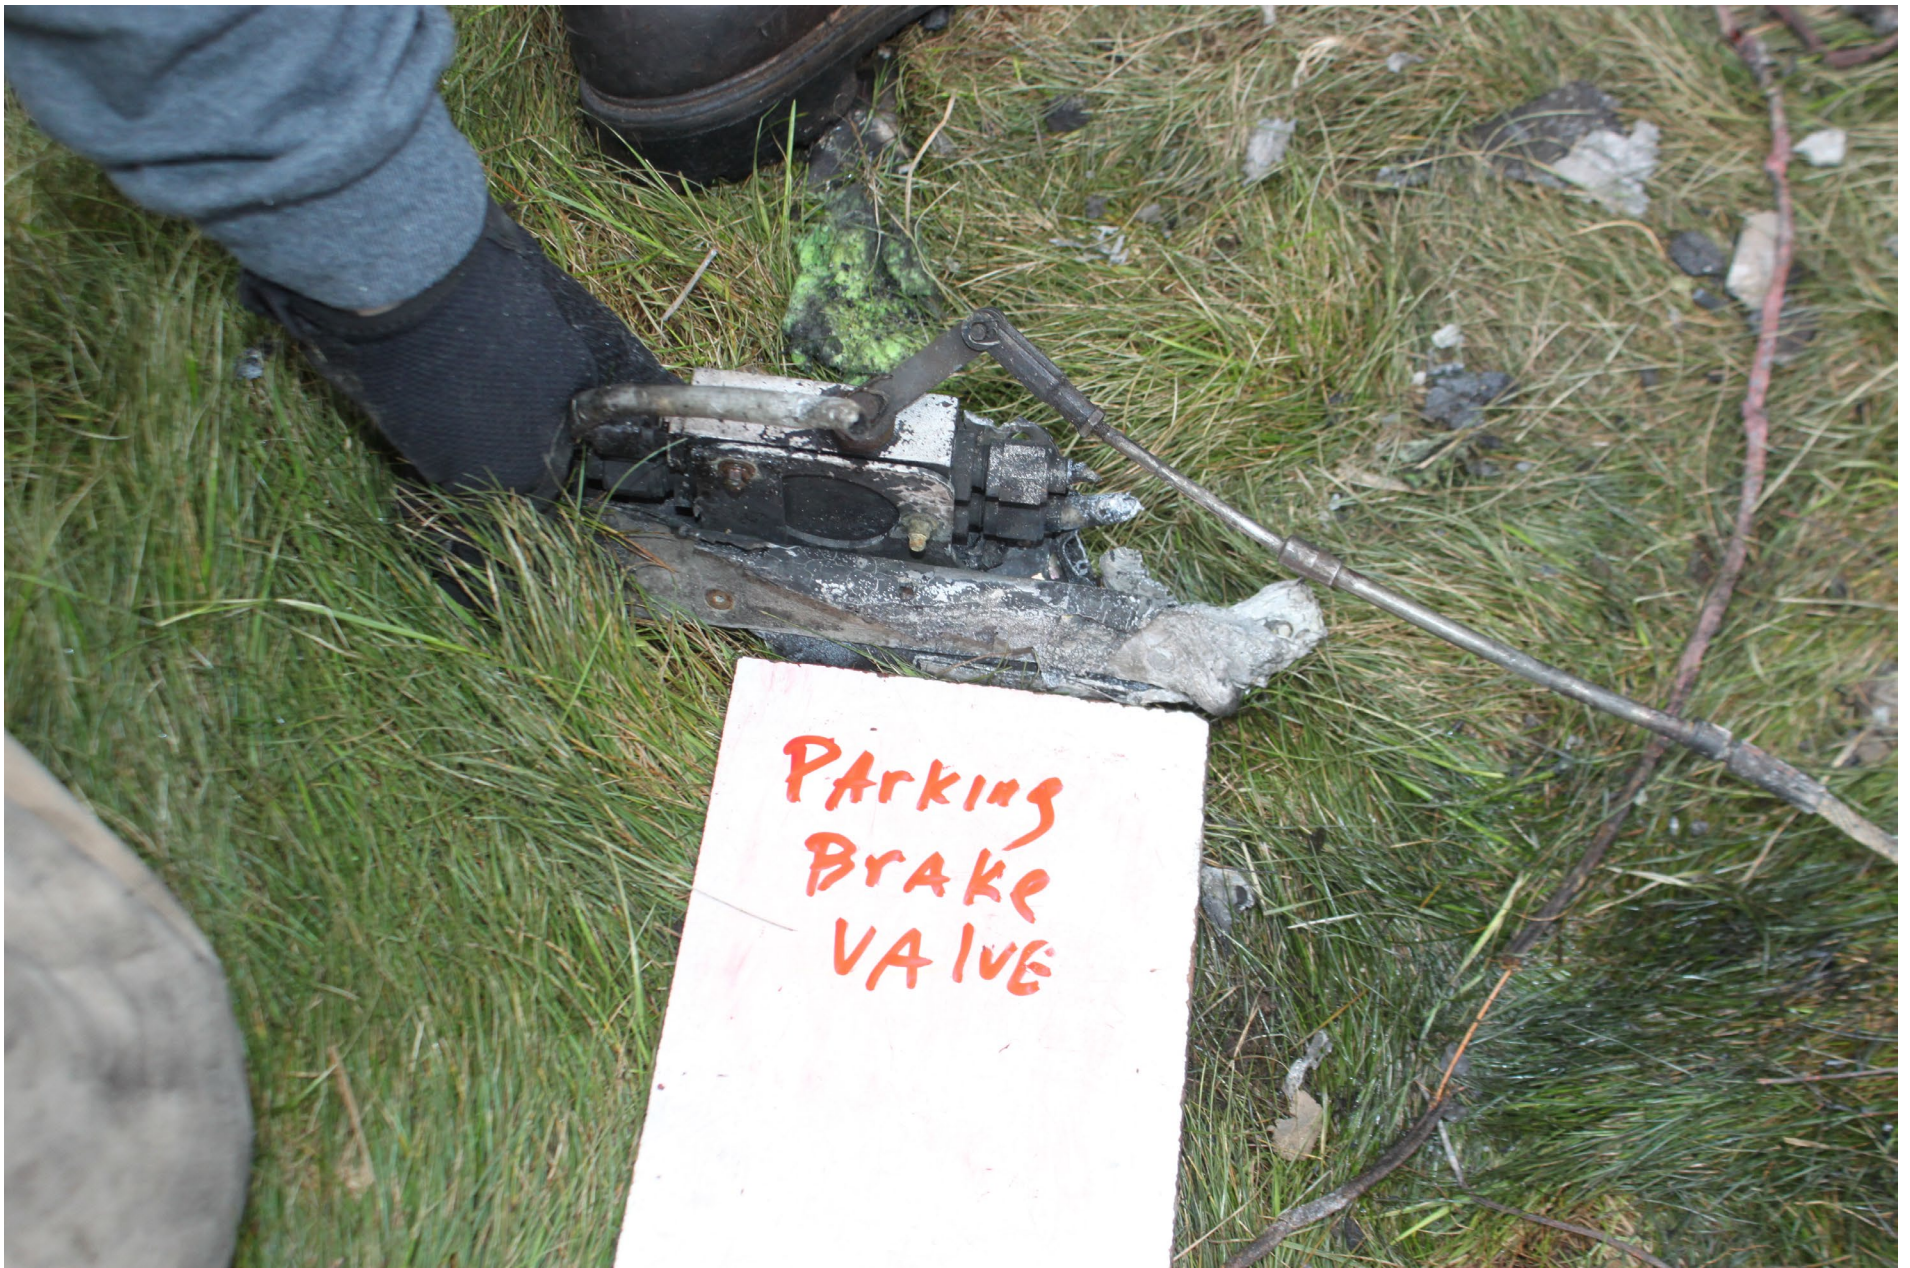
**Photo 8 - NTSB Digital Photograph. View of the Parking Brake Valve and Attached Cable after Recovery From the Wreckage.**

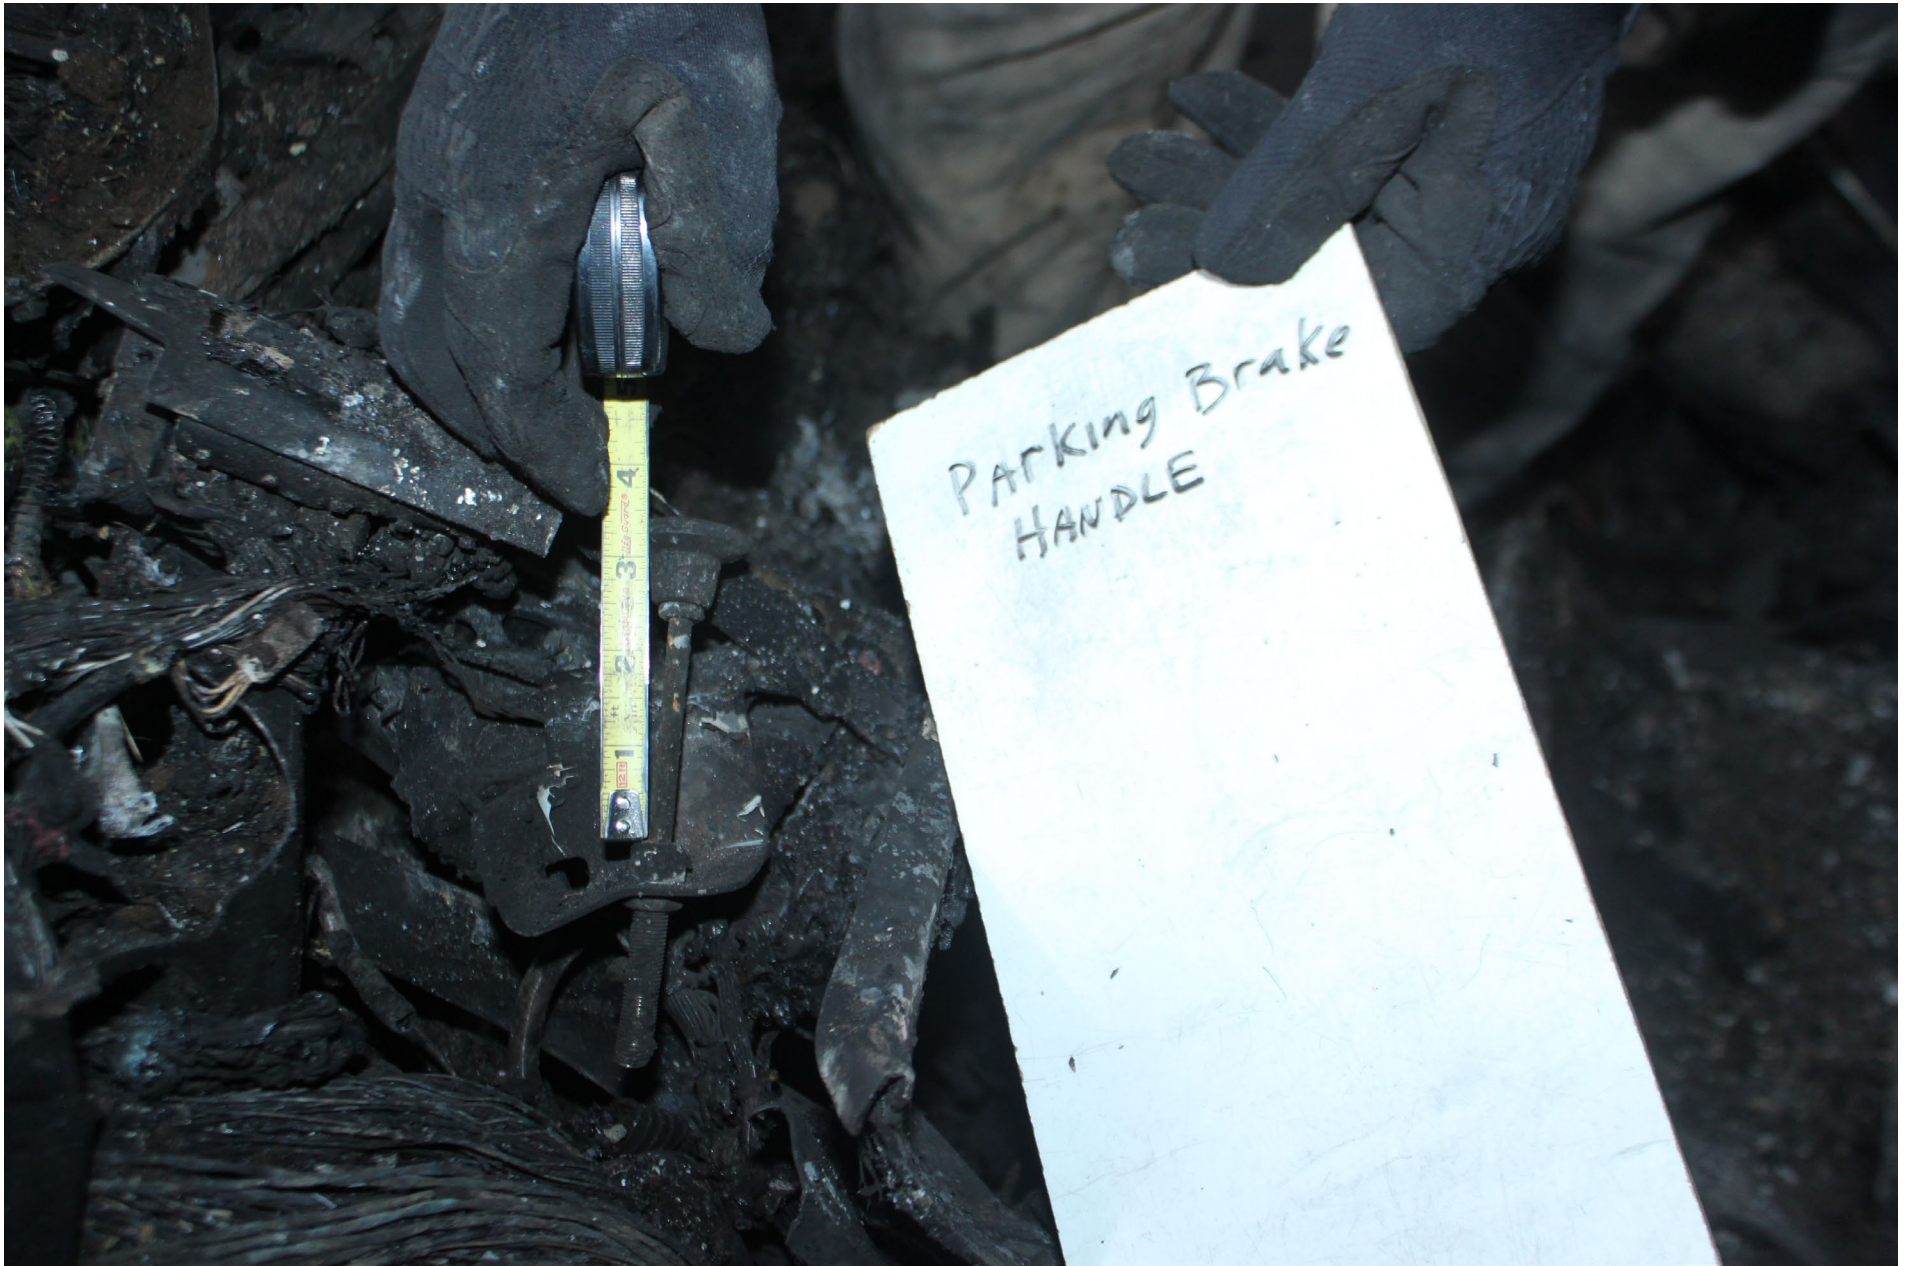
**Photo 9 - NTSB Digital Photograph. View of the Parking Brake Knob as First Found in the Wreckage. Note the Approximate Extension of 2.5 Inches.**
