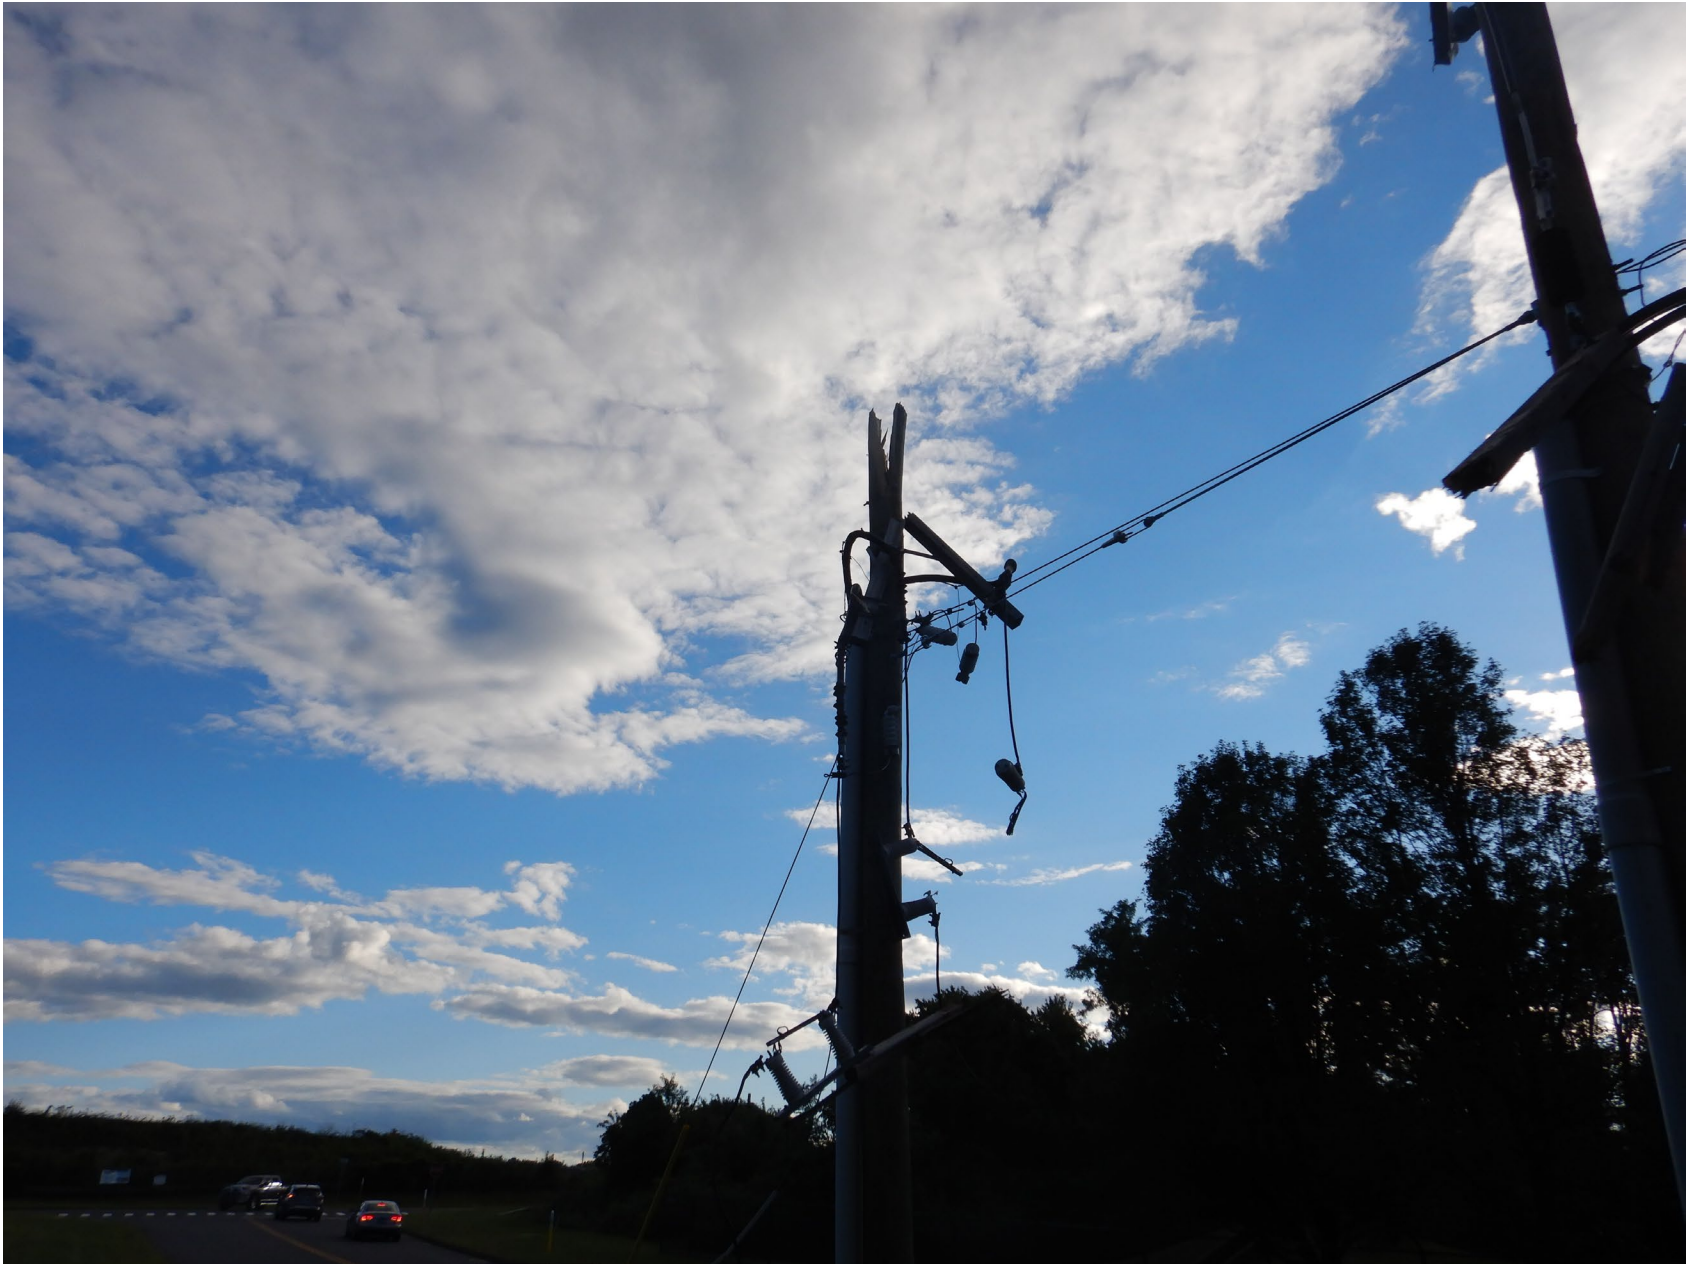
**Photo 10 – Textron Aviation Digital Photograph. View of the Broken Powerline/Telephone Pole.**

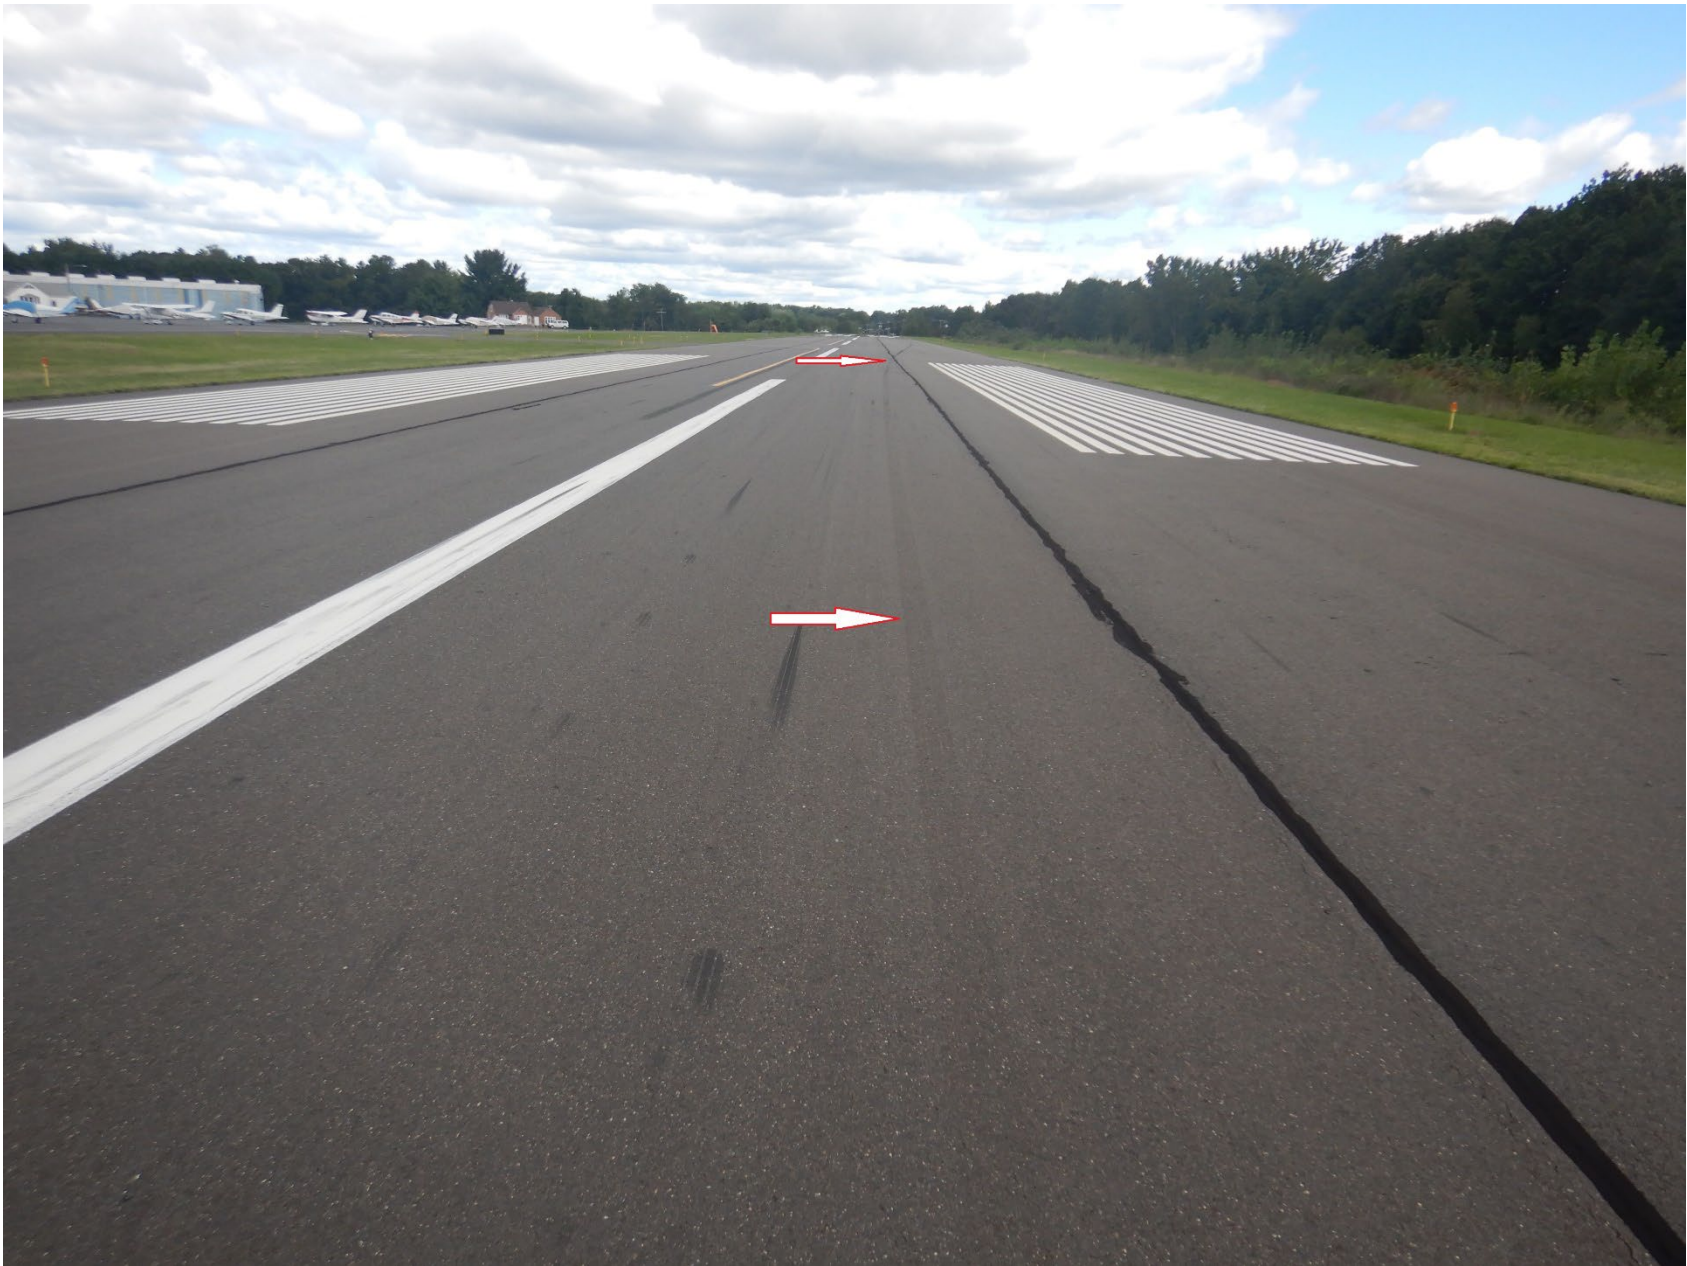
**Photo 11 – Textron Aviation Digital Photograph. Arrows Point to Right Main Landing Gear Tire Mark. Note the Deviation to the Right.**

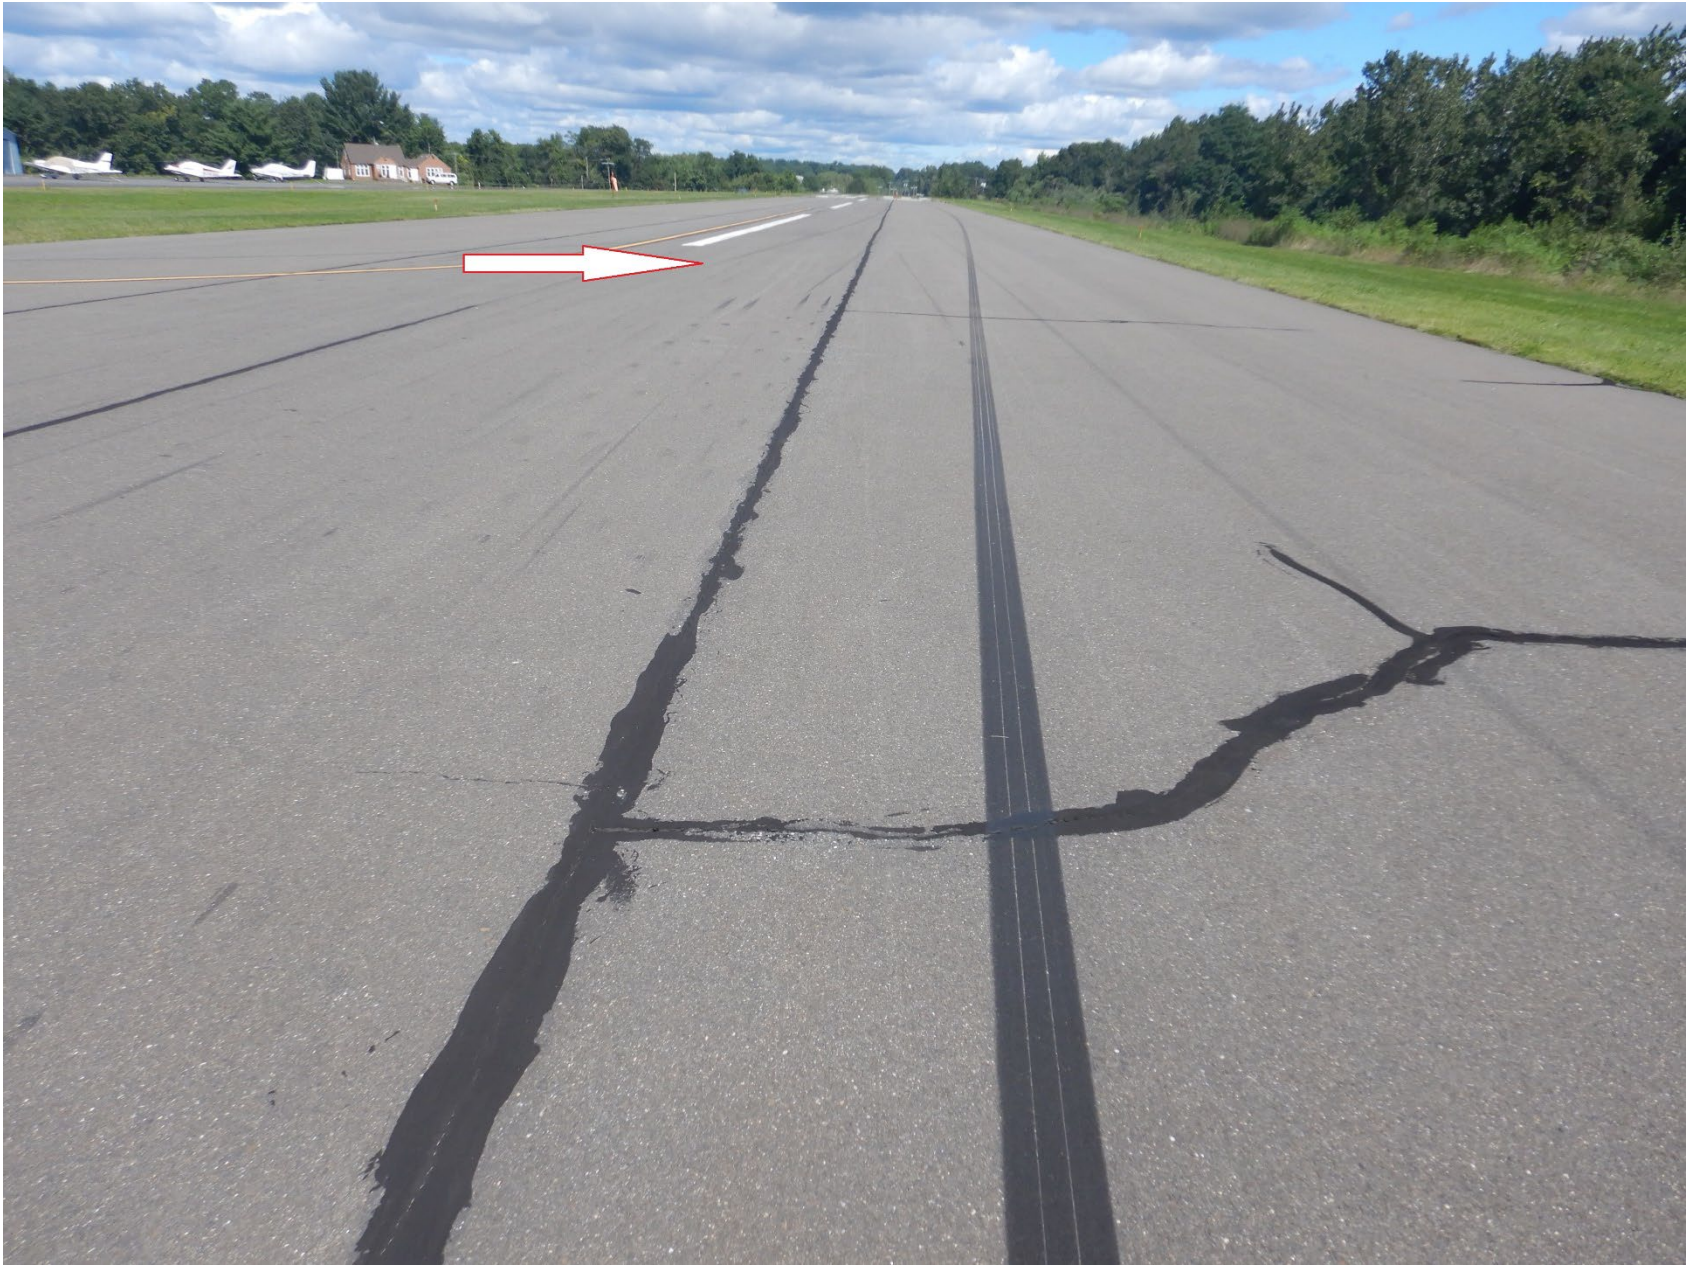
**Photo 12 - Textron Aviation Digital Photograph. Arrow Points to Left Main Landing Gear Tire Mark. Note the Very Dark Mark From Right Main Landing Gear Tire and The Drainage Grooves in The Tread.**

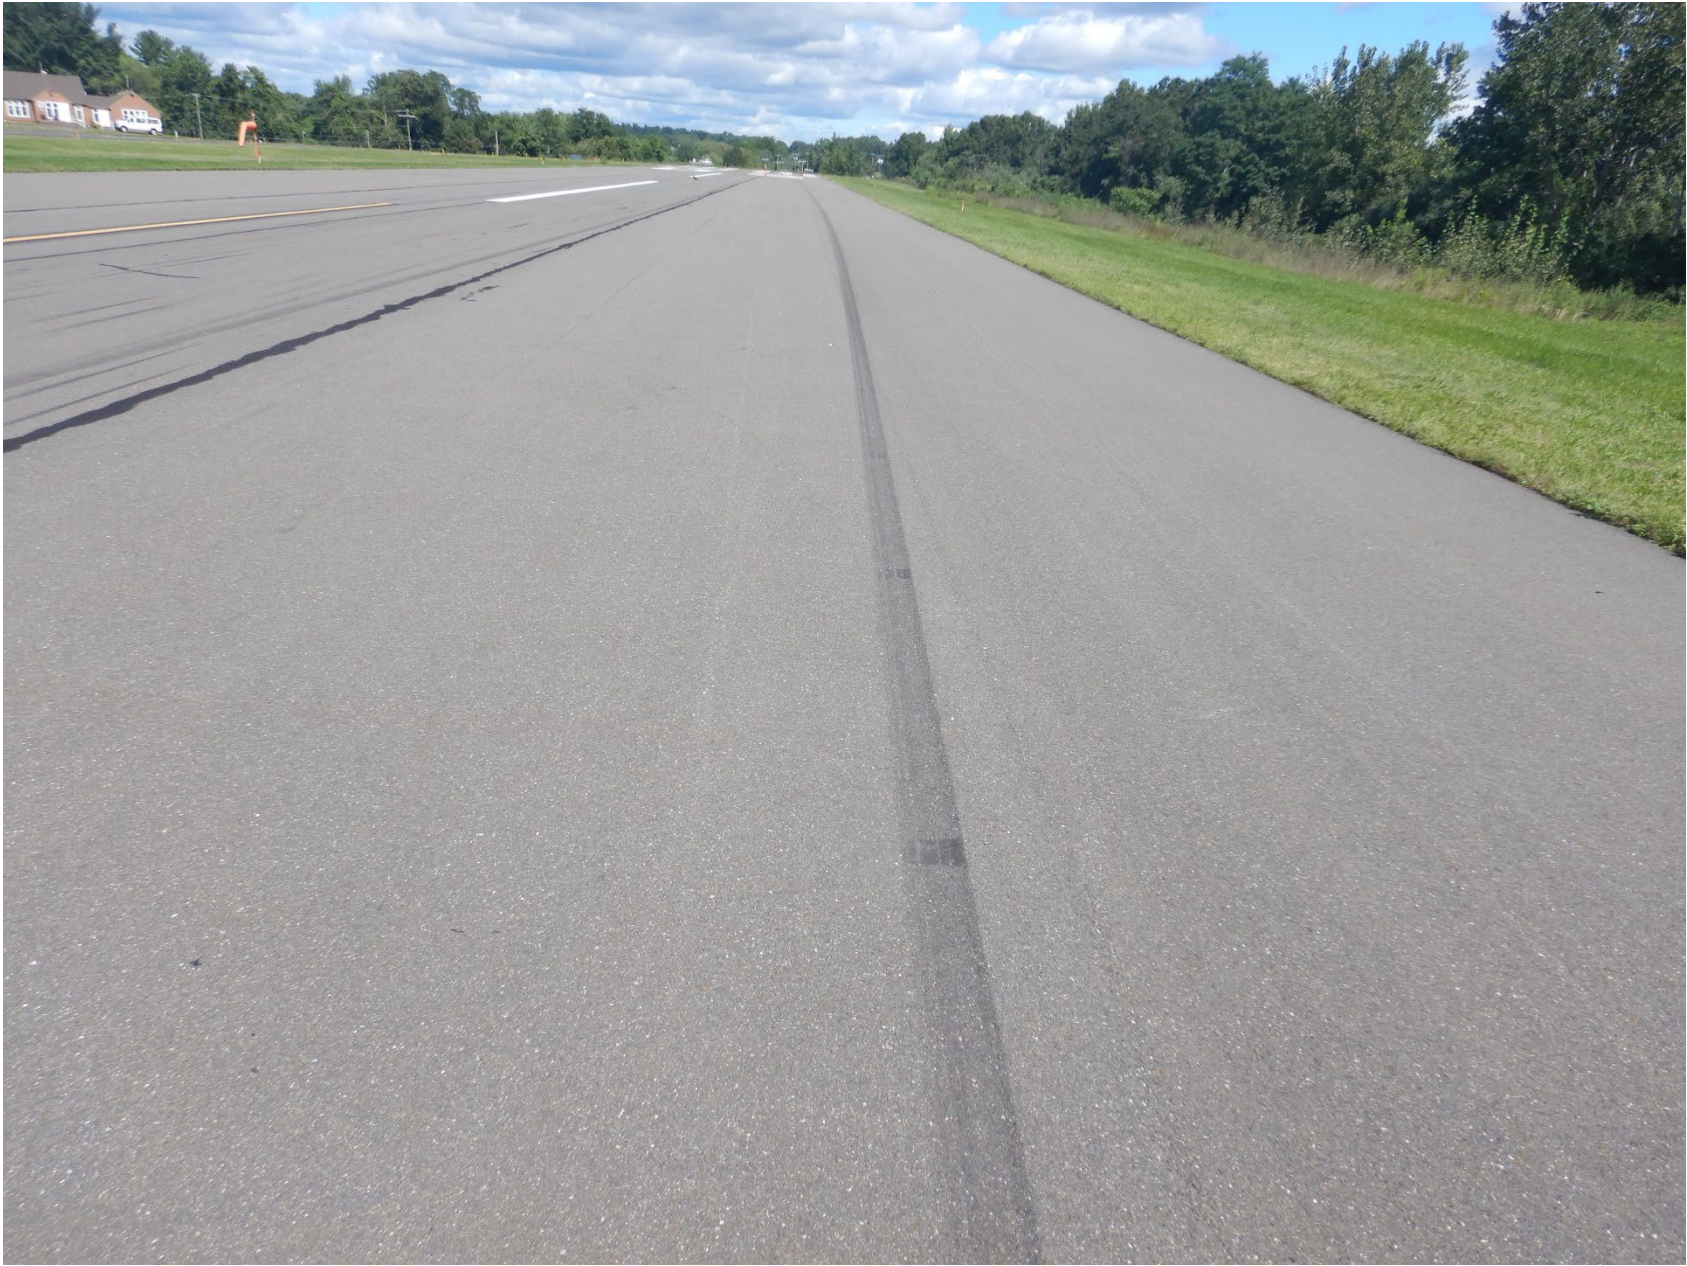
**Photo 13 - Textron Aviation Digital Photograph. View of Right Main Landing Gear Tire Track. Note the Alternating Light and Dark Locations Spaced 6 Ft 6 Inches Apart.**

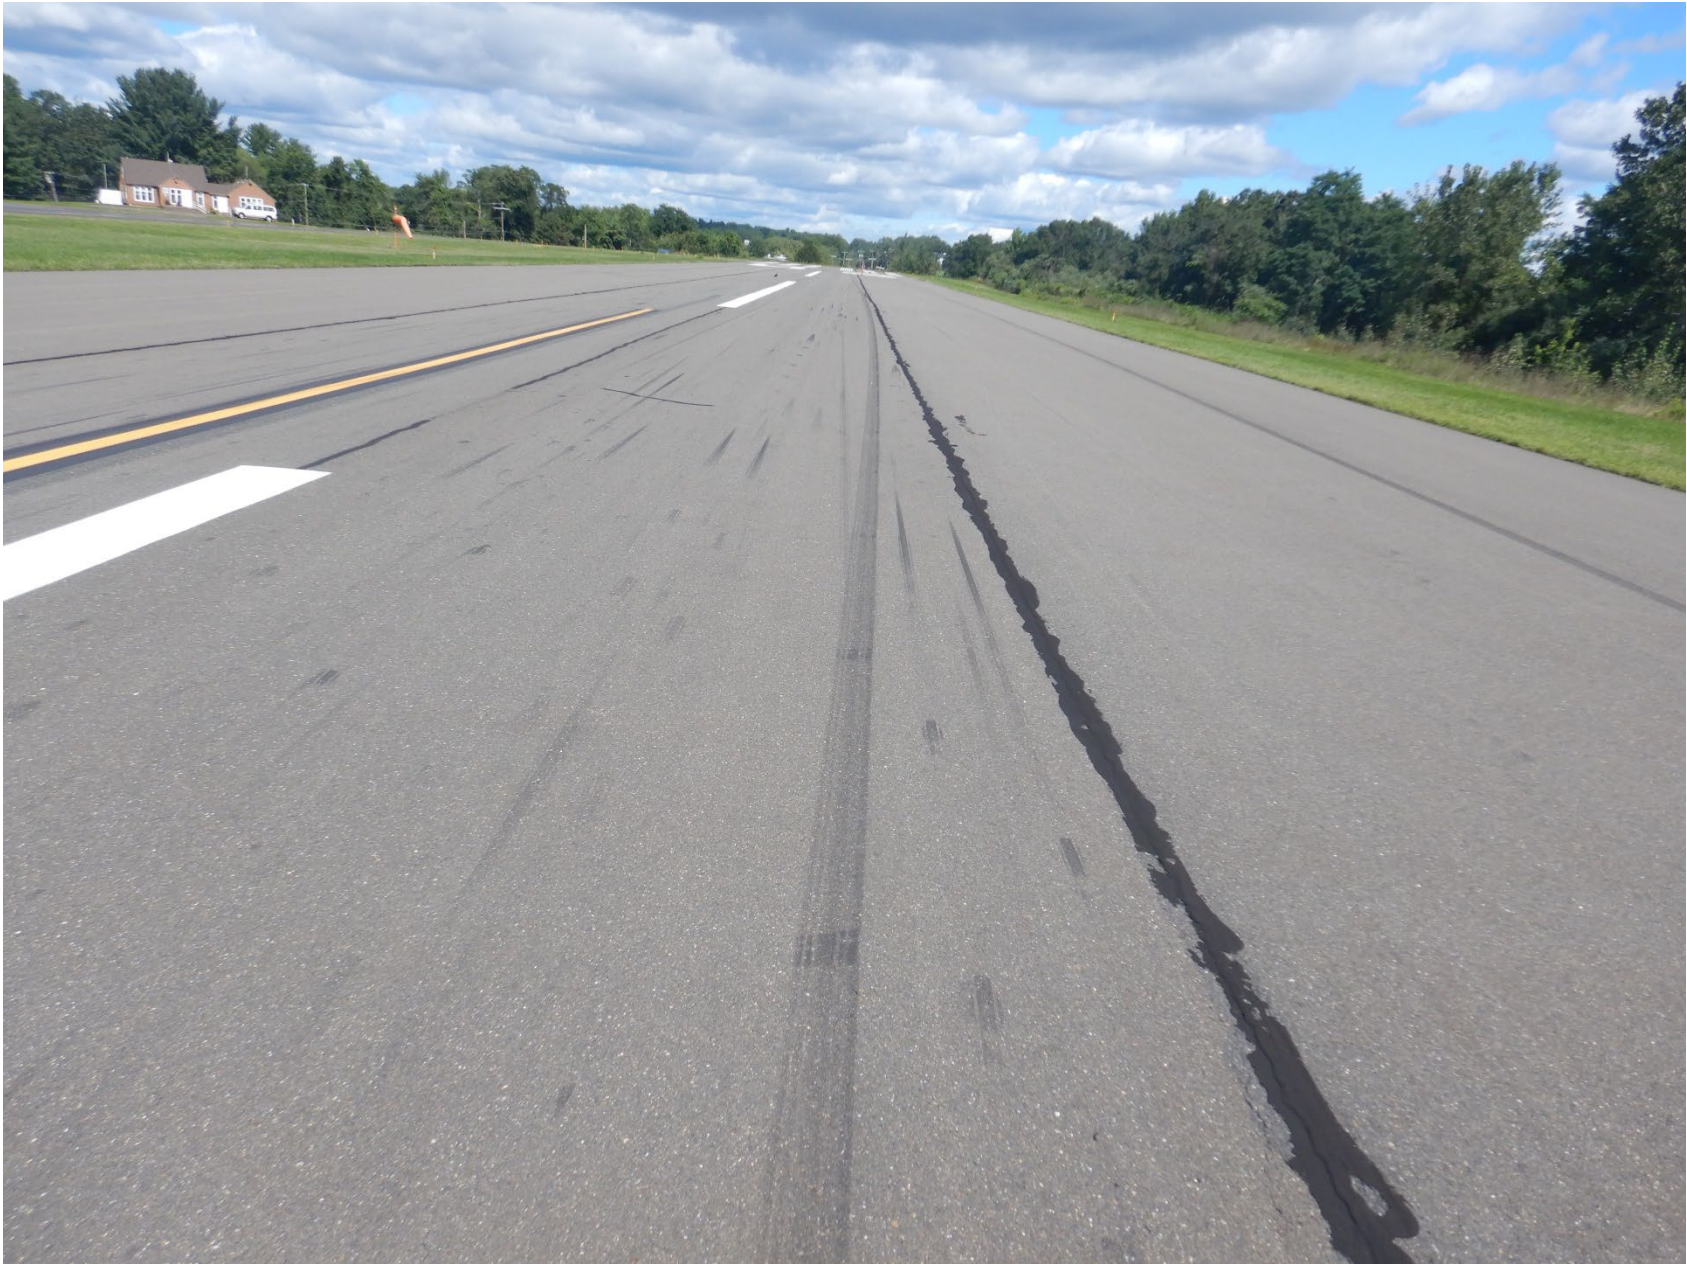
**Photo 14 - Textron Aviation Digital Photograph. View of Left Main Landing Gear Tire Track. Note the Alternating Light and Dark Locations Spaced 6 Ft 6 Inches Apart.**

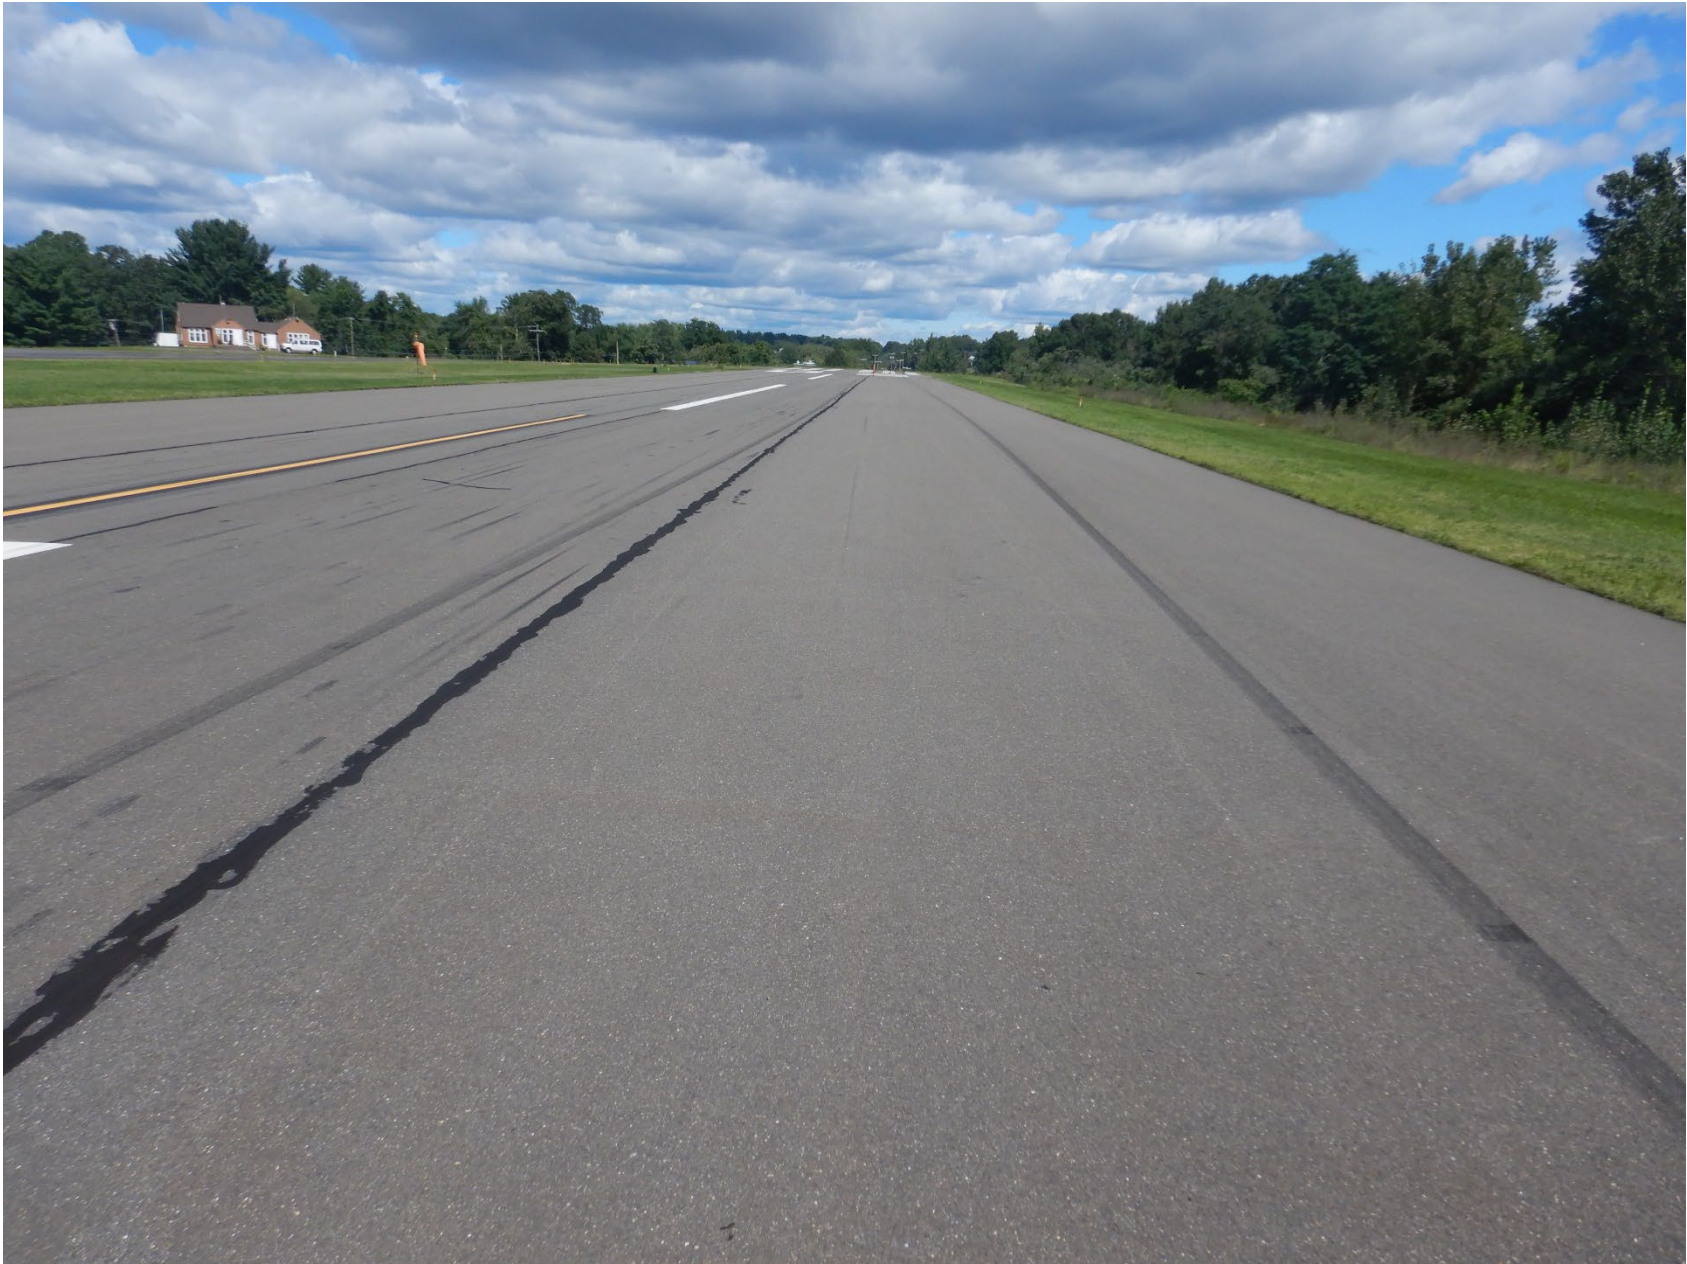
**Photo 15 - Textron Aviation Digital Photograph. View Showing the Left and Right Main Landing Gear Tire Skid Marks. Note the Alternating Light and Dark Spaced 6 Ft 6 Inches Apart for Both.**

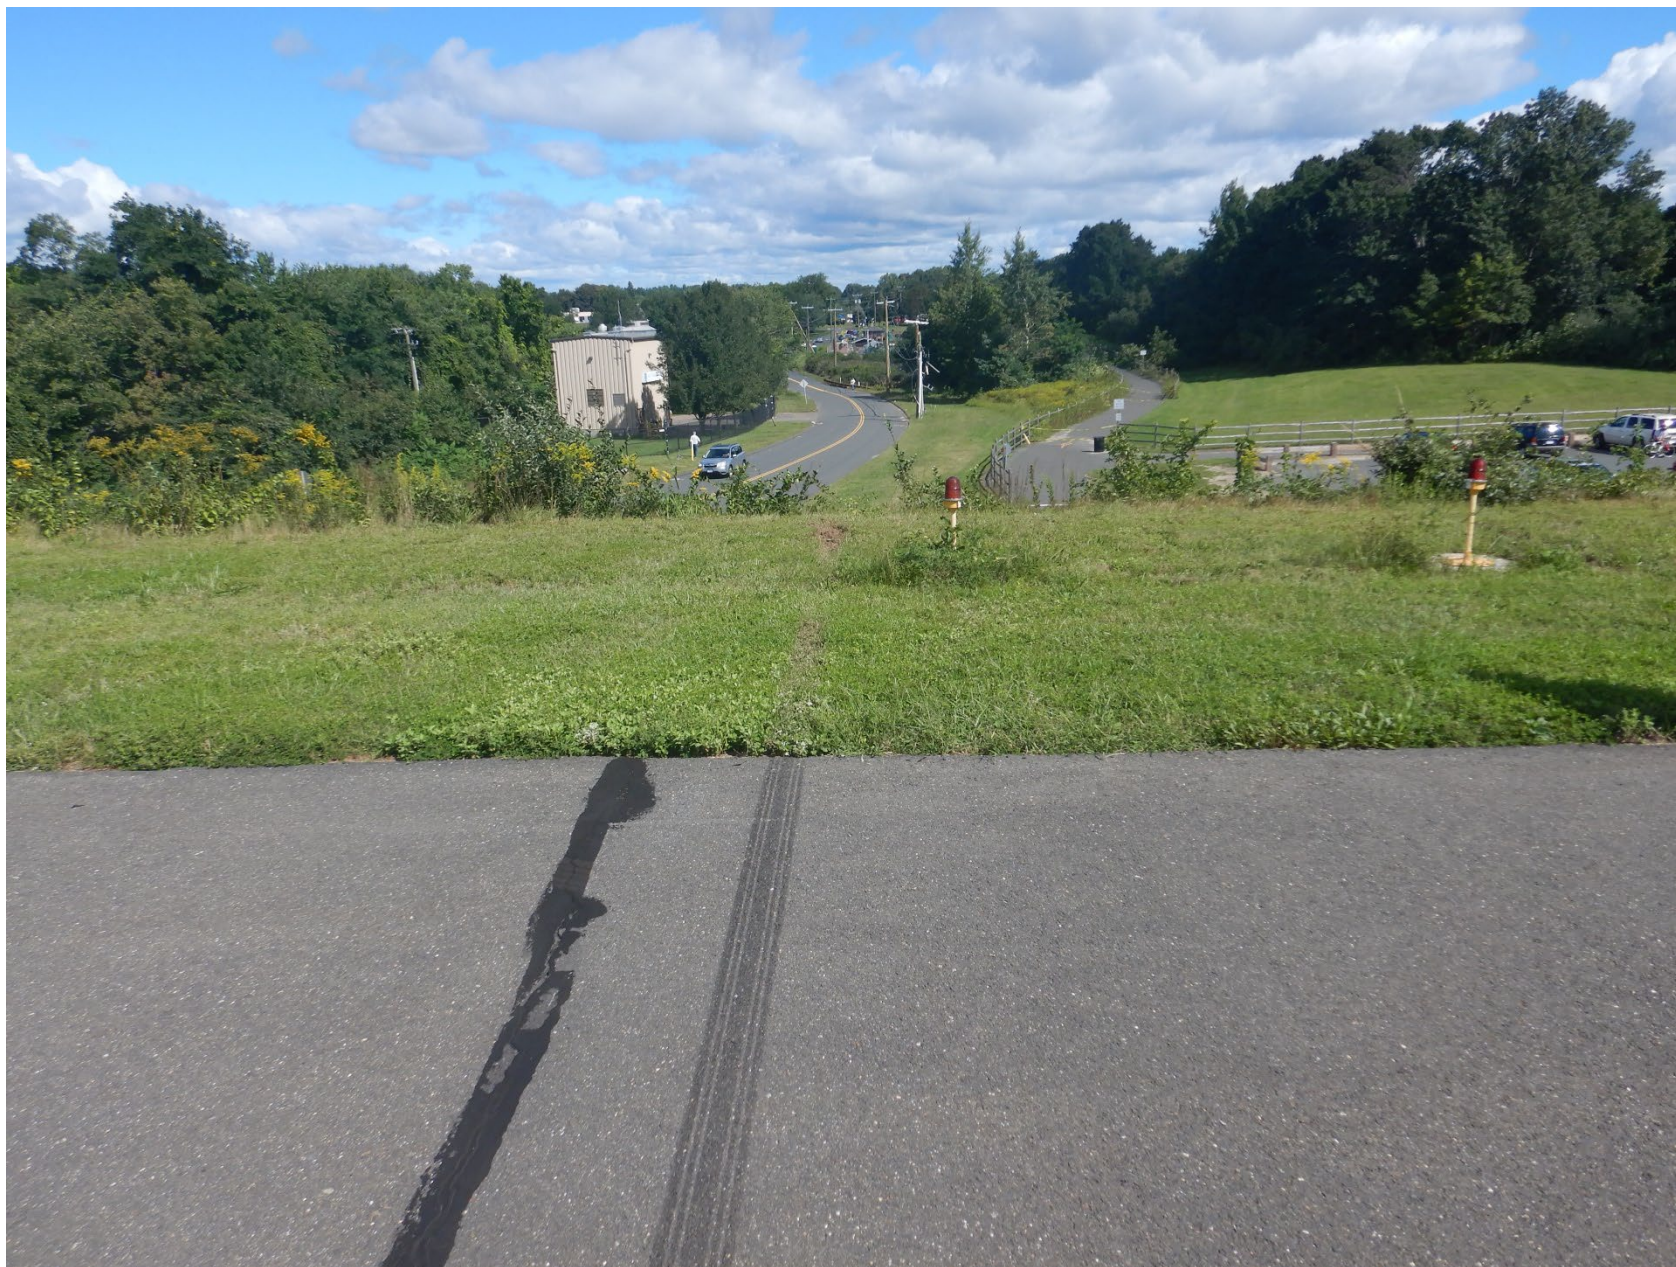
**Photo 16 - Textron Aviation Digital Photograph. View Taken Near the Departure End of the Runway Showing the Left Main Landing Gear Tire Mark. Note the Drainage Grooves in The Tread.**

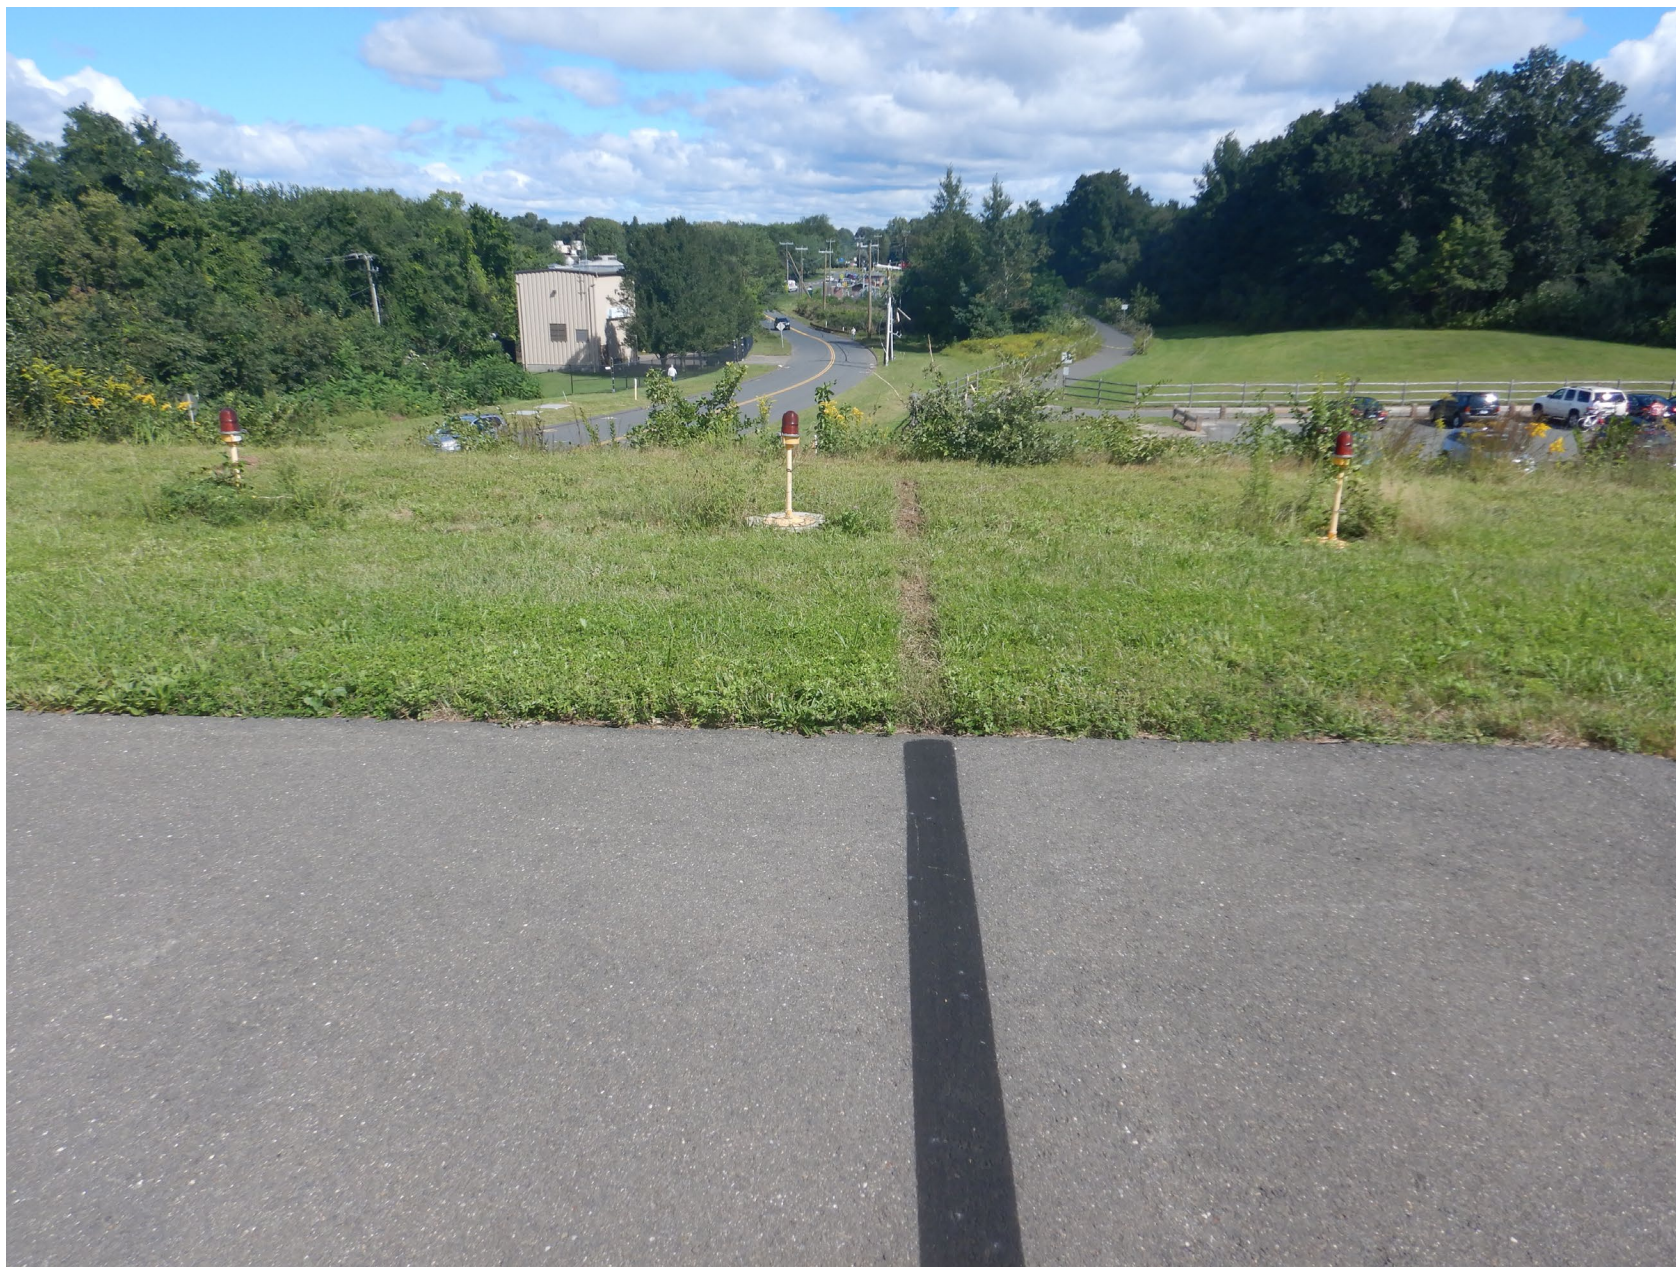
**Photo 17 - Textron Aviation Digital Photograph. View Taken Near the Departure End of the Runway Showing the Right Main Landing Gear Tire Mark. Note the Lack of Drainage Grooves in The Tread.**

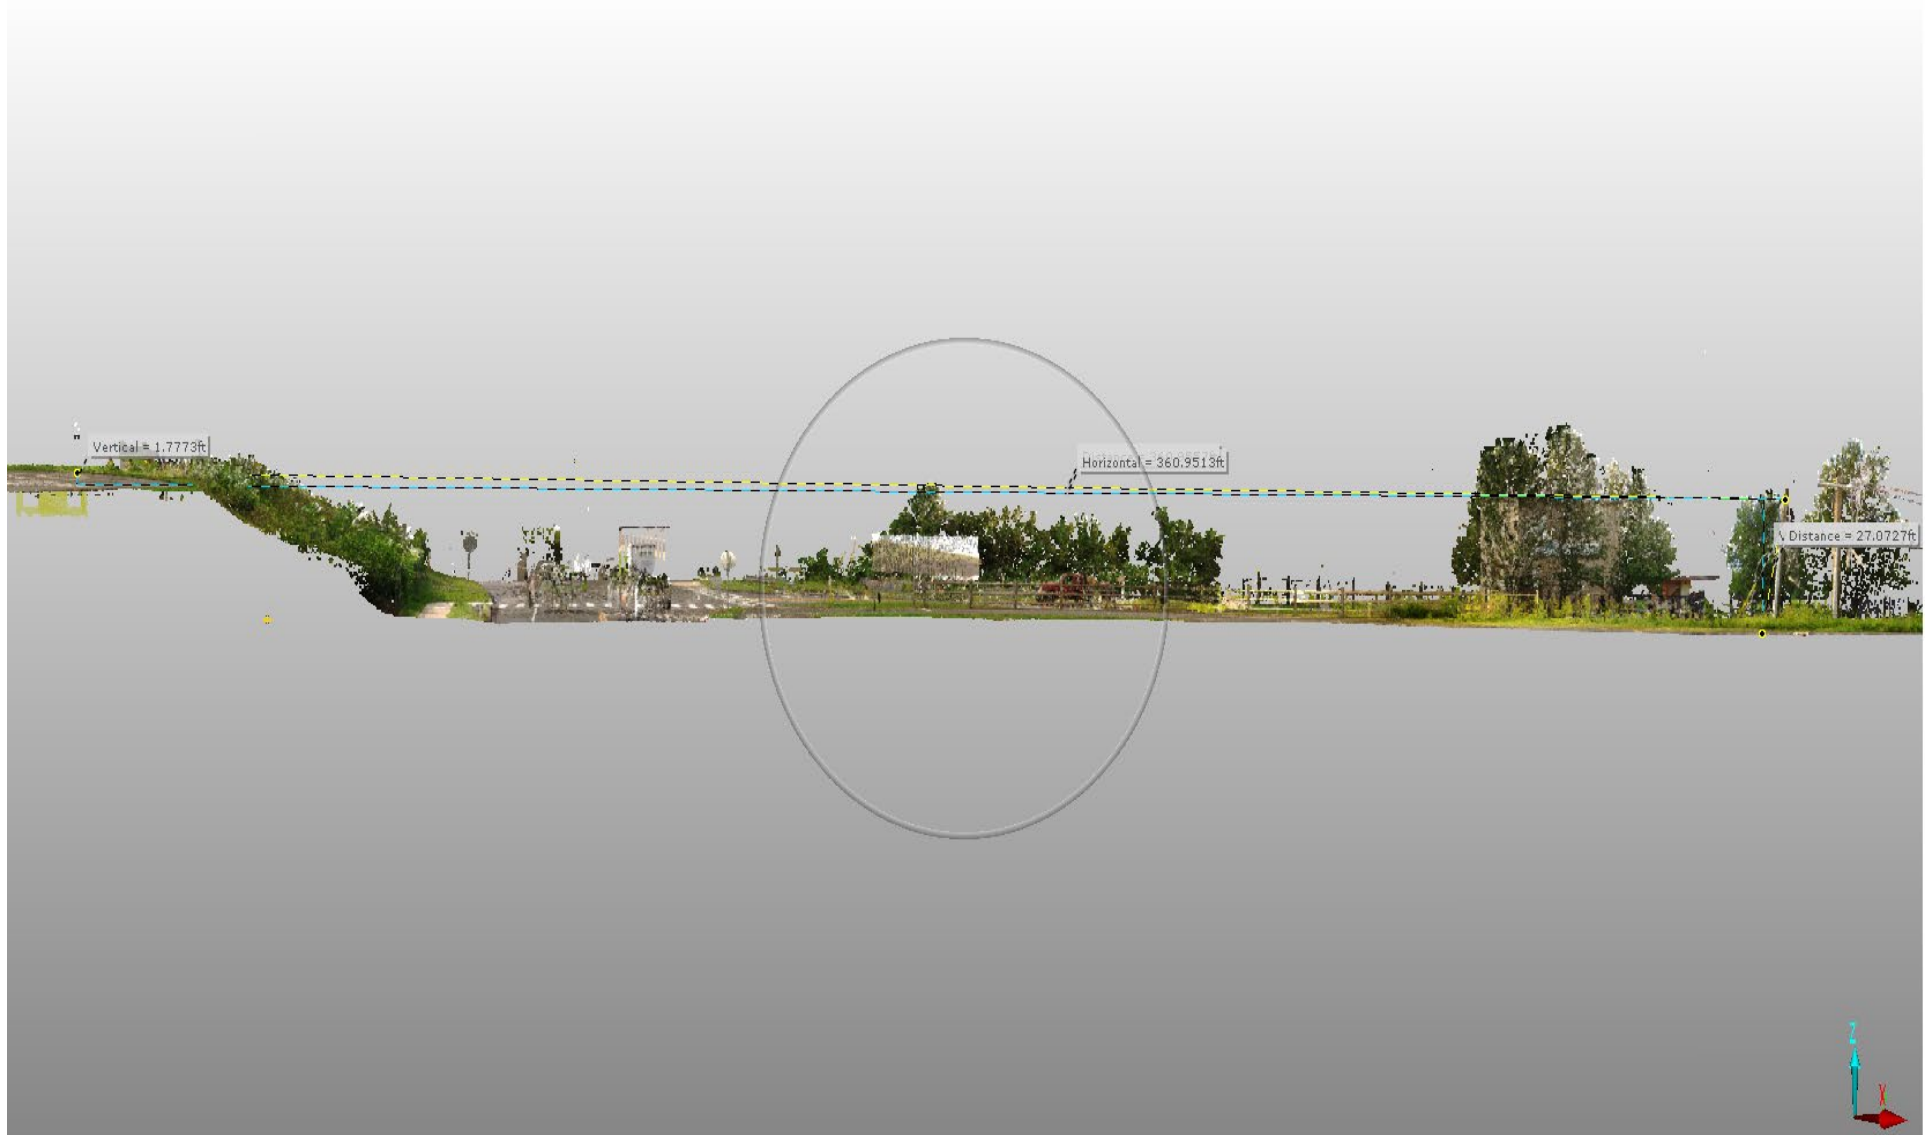
**Photo 18 – FARO Photograph. Side Scan View Showing the Terrain Elevation Difference, The Distance the Impacted Pole was From the Departure End of the Runway, and the Height of the Broken PowerLine Pole.**
