# AIRCRAFT ACCIDENT REPORT

NPF/2018/10/03/F

**Final Report on serious incident involving  
Cessna Citation 560 XLS+ aircraft with nationality  
and registration marks 5N-HAR operated by the  
Nigeria Police Airwing which occurred at Sir  
Abubakar Tafawa Balewa Airport Bauchi, Nigeria  
On 3rd October, 2018**

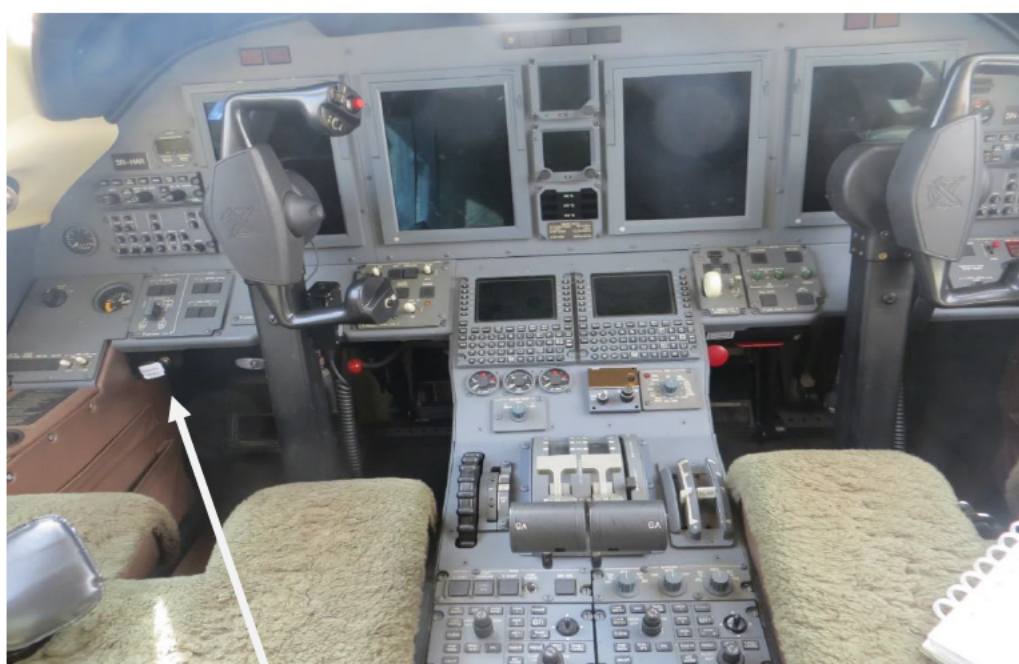
**Figure 2:** Parking brake position in the cockpit

It is possible for the parking brake to operate partially even when the parking brake knob is pushed forward if the pilot fails to fully depress the brake pedal when setting the parking brake. The PF stated that he maintained his toes on the brakes up to the

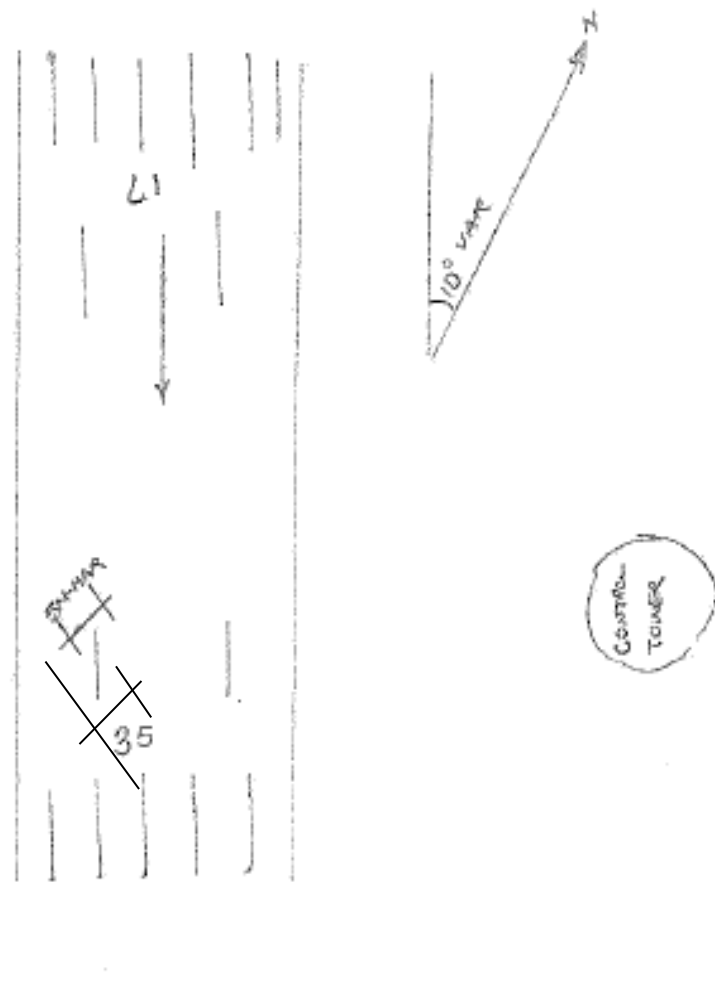
The aircraft came to a stop at about 45° to the right of centre line, 603 m (1,977 ft) before the end of RWY 17. The brake assembly of the two main landing gears were damaged including the hub cap, nut and screw from the main landing gear wheel. The main landing gear tyres were burnt and the left main landing gear up-lock bolt was also broken.

**Figure 3:** Sketch of the Accident site indicating the final position of the aircraft  
(Source: Nigeria Police)

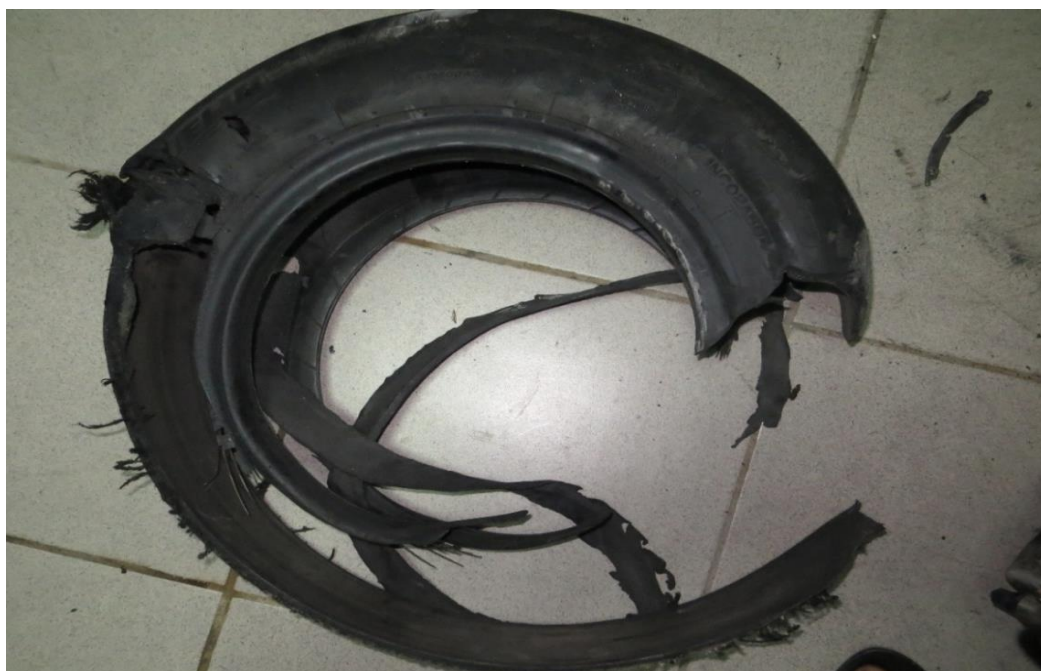
**Figure 4:** Burnt main landing gear tyre

The two main landing gear wheel assemblies were completely burnt.

When this occurs, the brake disks rub against the brake pads and causes heat to build-up which can be enough to start a wheel fire. This condition of partial operation of the parking brake during the taxi and take-off roll led to brake binding which resulted in wheel fire.

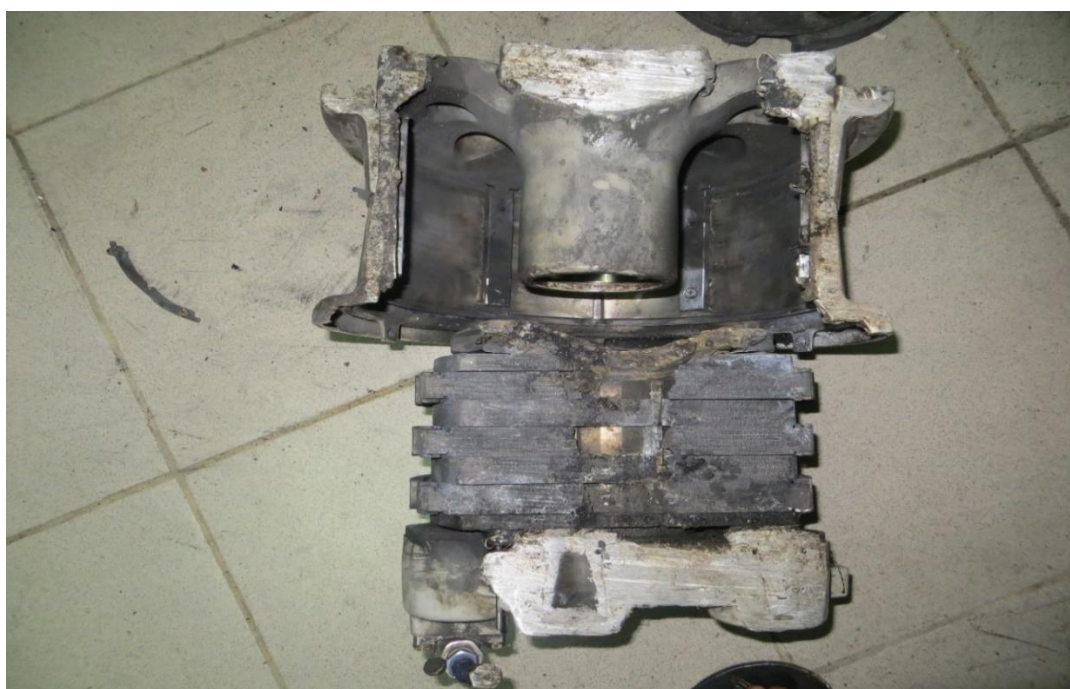
**Figure 5:** Damaged main landing gear brake assembly

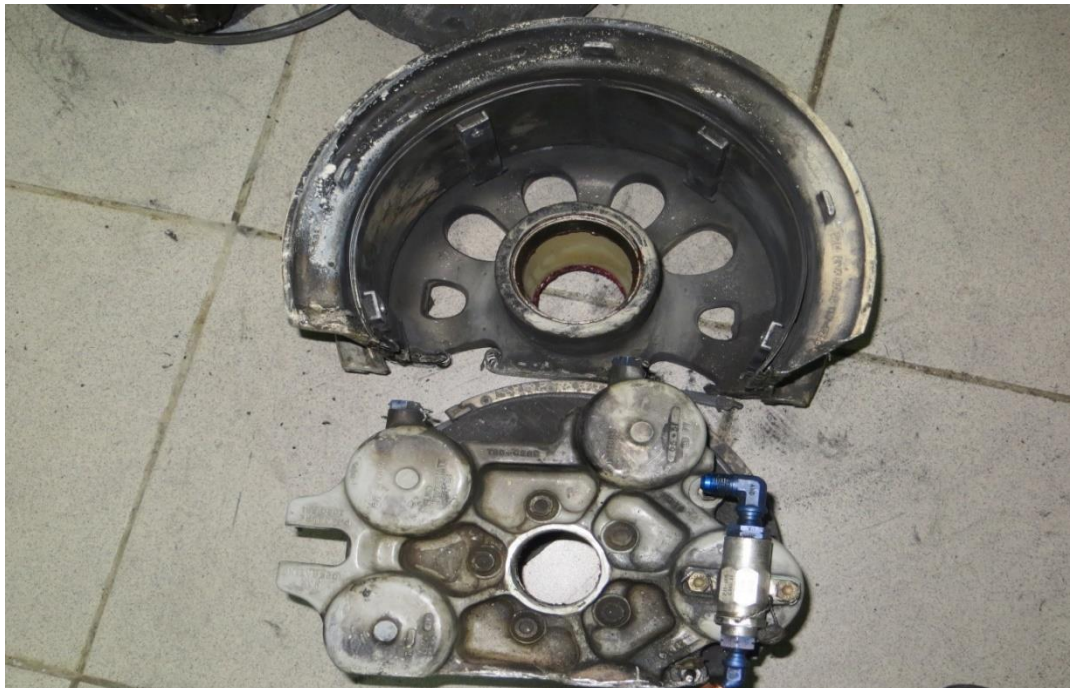
**Figure 6:** Damaged left main landing gear up-lock bolt

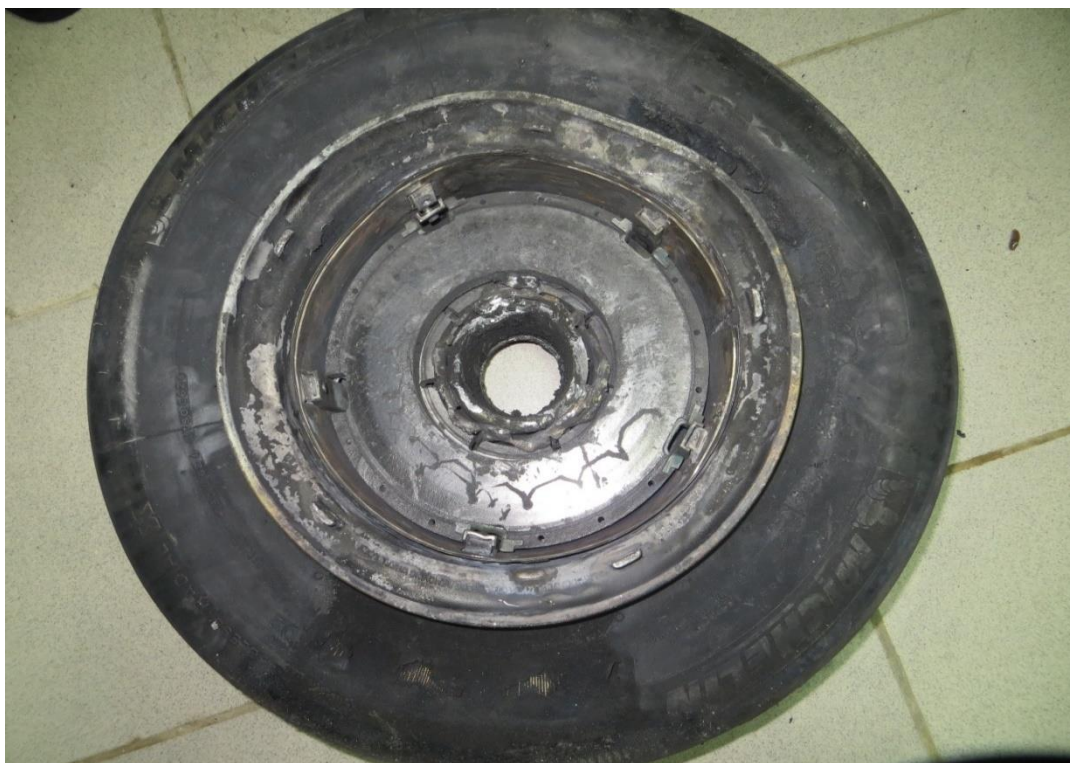
**Figure 7:** Damaged main landing gear wheel assembly
