## Memorandum For Record

**Date: 7/29/2023**  
**NTSB Accident Number: ERA21FA346**

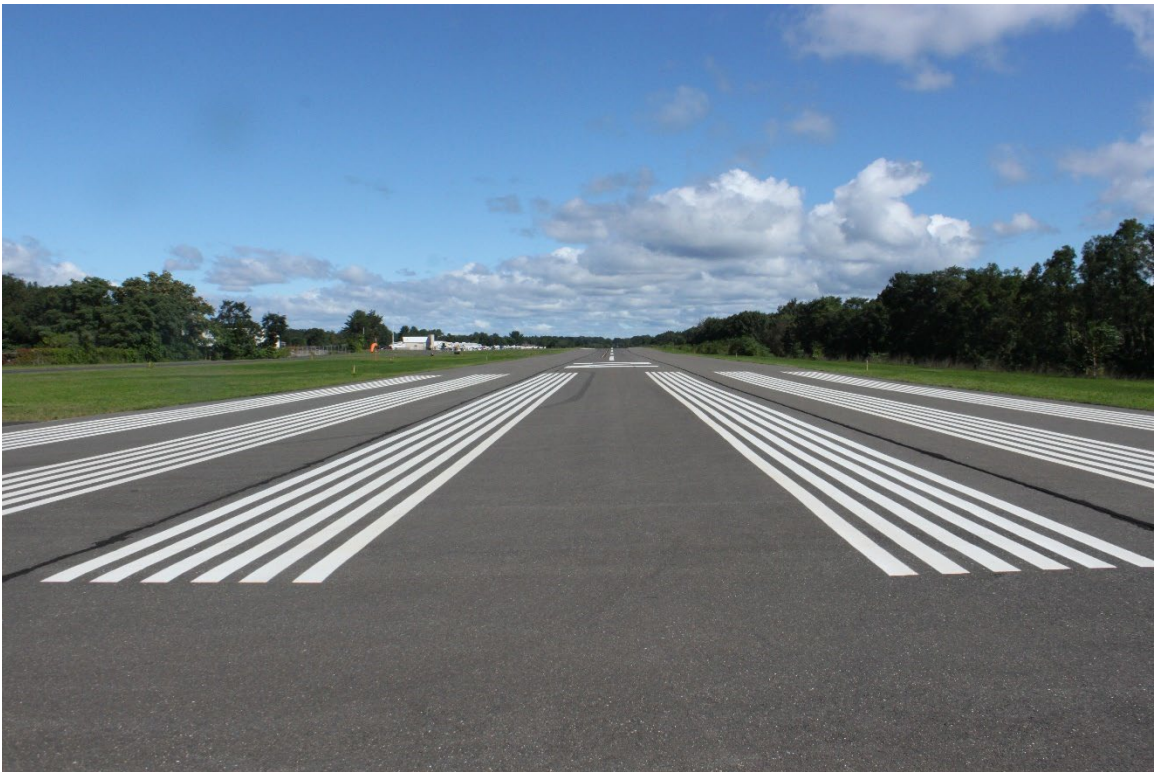
Examination of the taxiway leading onto the approach end of runway 2 and also the approach end of the runway revealed no discernable tire marks associated with the accident airplane (Figure 2). The first discernable mark associated with the right main landing gear tire was located about 9 ft right of runway centerline and about 2,361 ft from the approach end of the runway (Figures 3 and 4).

Figure 2: NTSB Digital Photograph. Ground View From Approach End of Runway 2.

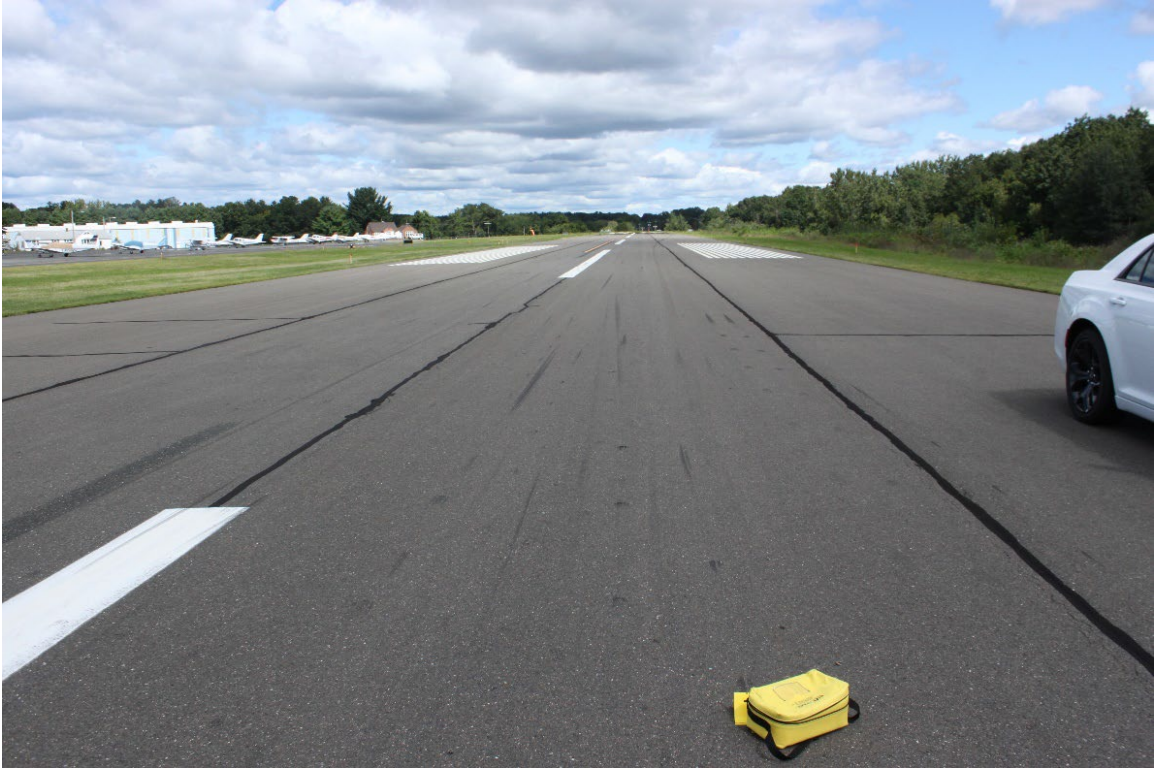
Figure 3: NTSB Digital Photograph. Yellow Bag Identifies Location of First Observed Tire Mark from Right Main Landing Gear Located 2,360.9 ft along and 9 ft right of runway centerline runway 2.

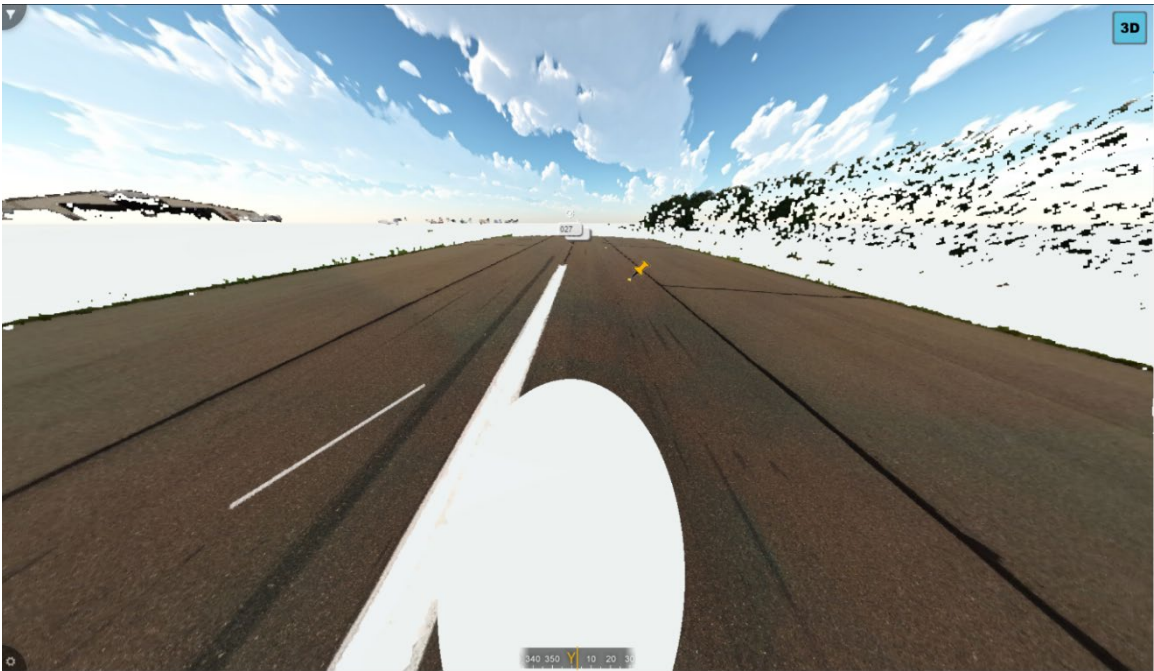
Figure 4: Faro Image From Scan Station 26 Located About 2,326 Ft From Approach End of Runway 2. Pin indicates 1<sup>st</sup> identified Location of the Tire Mark Made by the Right Main Landing Gear Tire 2,360.9 Ft and about 9 Ft Right of Runway Centerline.

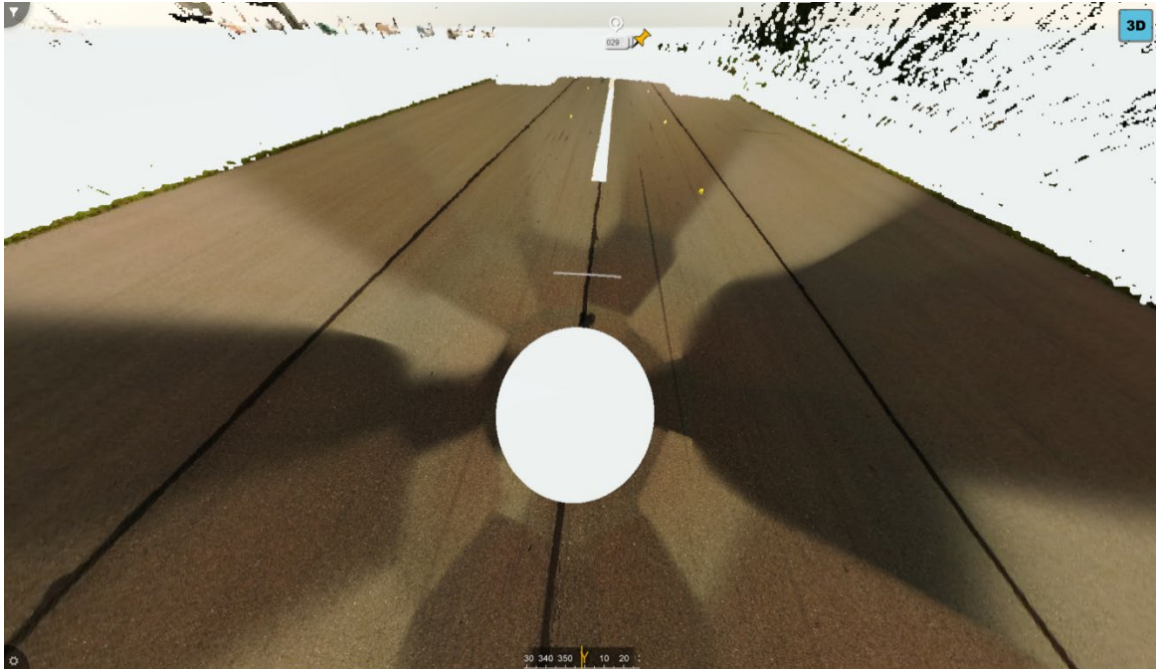
The first discernable mark from the left main landing gear tire was located about 6 ft left of runway centerline and 2,482 ft from the approach end of the runway (Figure 5 From Faro Scan 28). The distance between the center of the marks were about 15 ft, consistent with the published width between the left and right main landing gear tires.

Figure 5: Faro Image From Scan Station 28 Located About 2,443 Ft From Approach End of Runway 2. Yellow Marker in Foreground Left of Runway Centerline indicates 1<sup>st</sup> identified Location of the Tire Mark Made by the Left Main Landing Gear Tire 2,482 Ft and about 6 Ft Left of Runway Centerline. Markers right of Runway Centerline Indicates Tire Marks from Right Main Landing Gear Tire. Note the Marks Slight Veering to the Right.

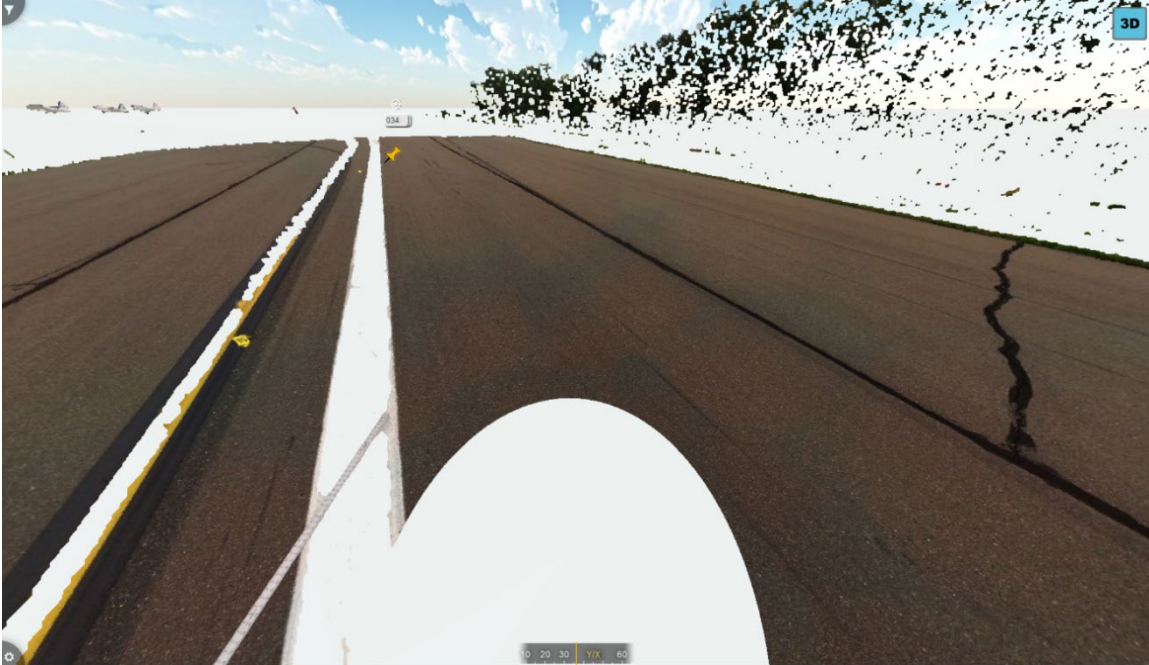
Figure 6: Faro Image From Scan Station 33 Located About 2,668 Ft From Approach End of Runway 2. Yellow Pin Marks Approximate Location of Spot 366, Which was About 2,720 Ft From the Approach End of Runway 2, And where the Left Main Landing Gear Crossed the Runway CenterLine. A Limitation of the Program Prevented Placement of the Pin on the Runway CenterLine. Note The Continued Deviation to the Right.

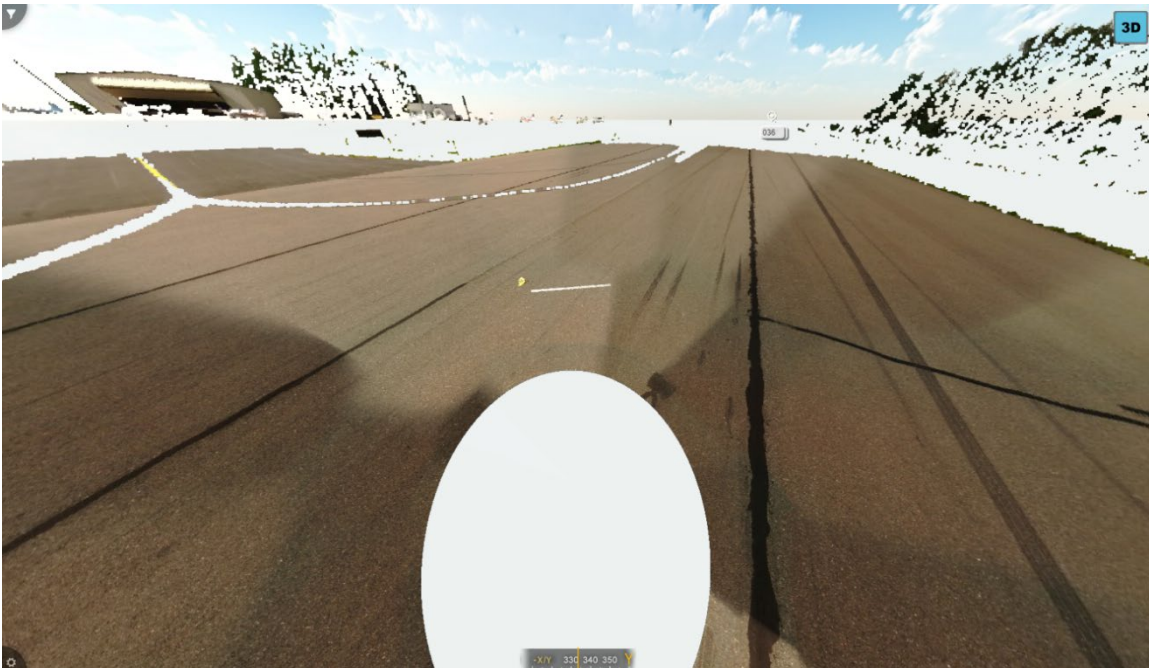
Figure 7: Faro Image From Scan Station 35 Located About 2,798 Ft From Approach End of Runway 2. Yellow Marker Depicts Mark From Left Main Landing Gear Tire. Note the Dark Mark From Right Main Landing Gear Tire and the Grooves Consistent with Tire Inflation. Note The Continued Slight Deviation to the Right.

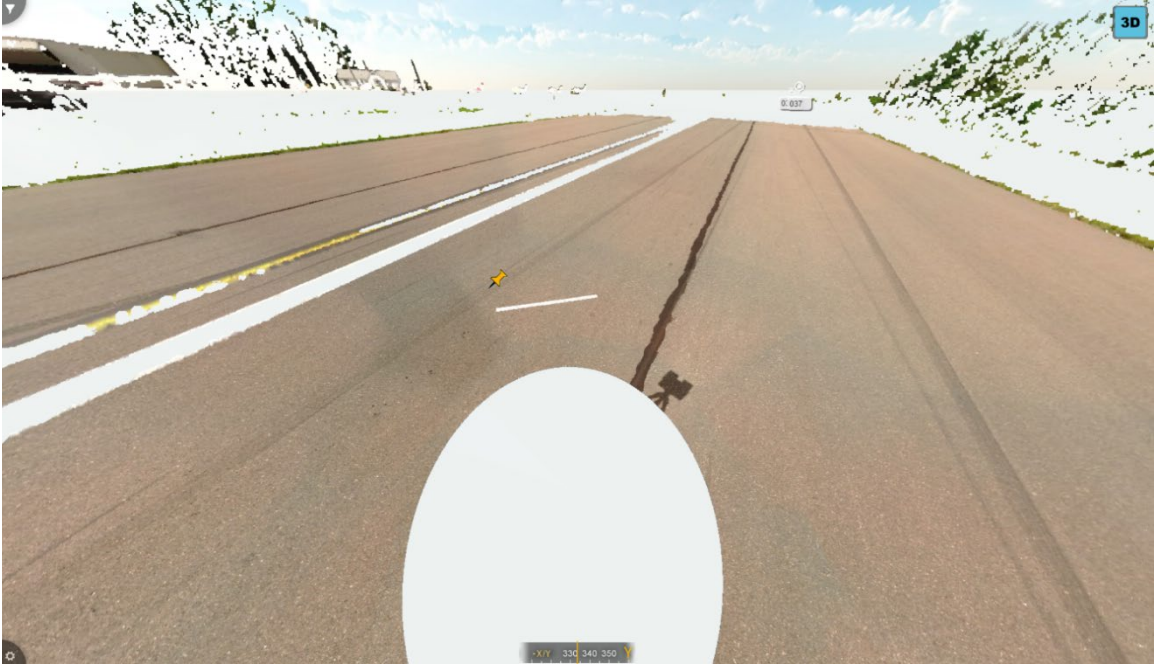
Figure 8: Faro Image From Scan Station 36 Located About 2,855 Ft From Approach End of Runway 2. Yellow Pin Marker Depicts Mark From Left Main Landing Gear Tire. Note the Dark Mark From Right Main Landing Gear Tire and the Grooves Consistent with Tire Inflation. Note The Continued Slight Deviation to the Right.

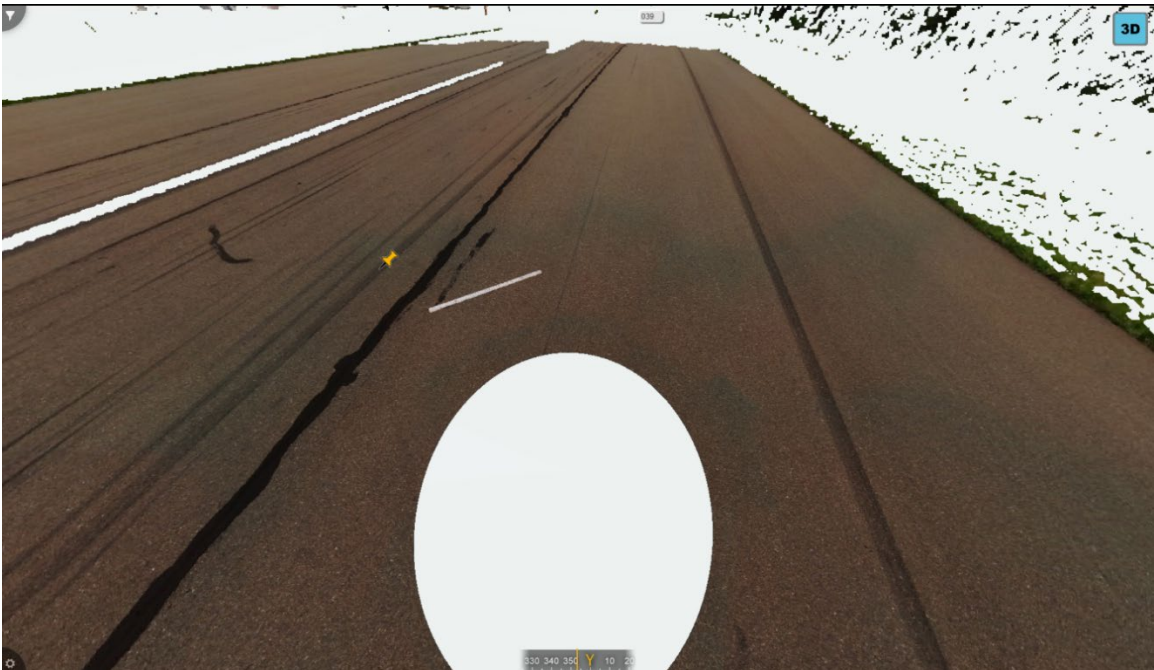
Figure 9: Faro Image From Scan Station 38 Located About 2,986 Ft From Approach End of Runway 2. Yellow Pin Marker Depicts Mark From Left Main Landing Gear Tire. Note the Dark Mark From Right Main Landing Gear Tire. Note The Continued Slight Deviation to the Right.

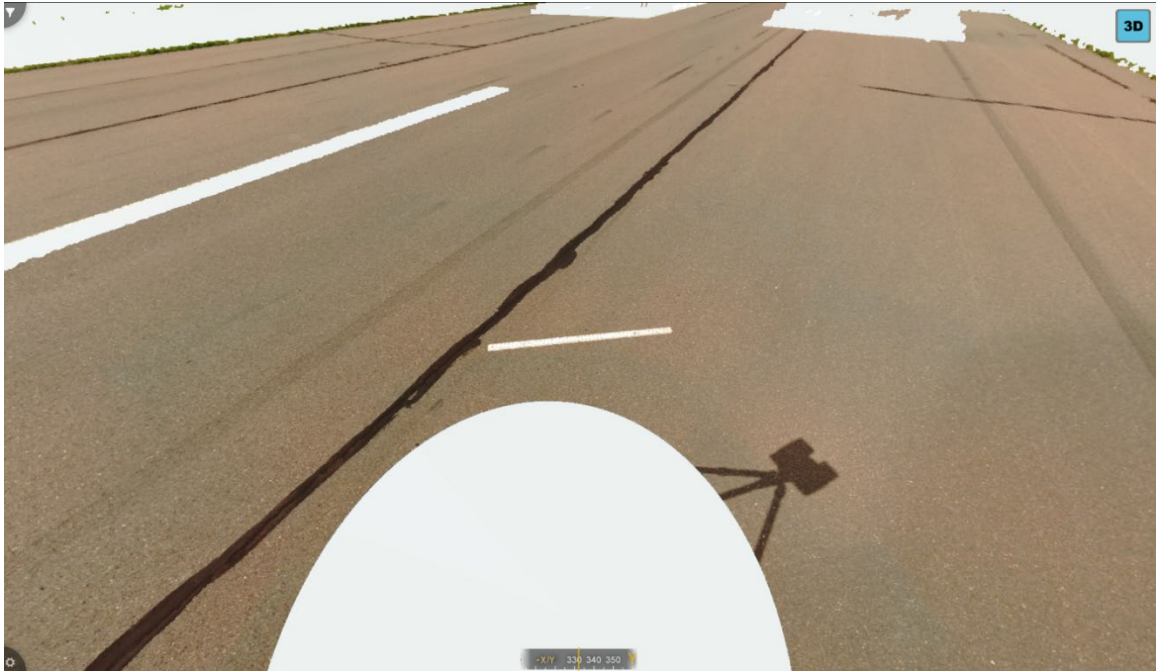
The marks from both main landing gear tires continue and about 3,337 ft from the approach end of the runway 2, or about 328 ft before the departure end of the runway the drainage grooves in the tread of the right tire were still visible while the mark was still dark (Figure 10). The marks from both main landing gear tires continue to the end and right side of the runway where the mark from the left tire was lighter in color and still displayed drainage grooves in the tread while the mark from the right tire was solid black and no drainage grooves were visible (Figure 14). The marks from both tires continued off the runway onto a short width of grass, where the mark from the left main landing gear tire ends about 18 ft past the runway end, and the mark from the right main landing gear tire ends about 15 ft past the runway end (Figure 15).

Figure 10: Faro Image From Scan Station 43 Located About 3,337 Ft From Approach End of Runway 2. Marks from Left and Right Main Landing Gear Tires with Grooves of both Noted.

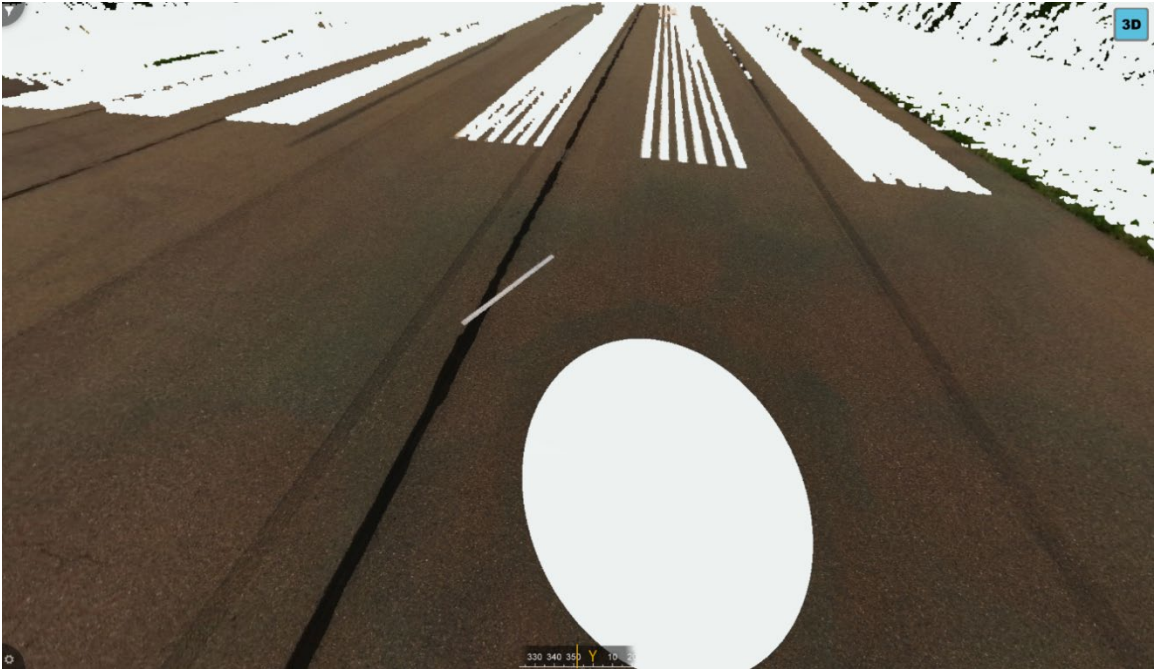
Figure 11: Faro Image From Scan Station 45 Located About 3,491 Ft From Approach End of Runway 2. Marks from Left and Right Main Landing Gear Tires Are Observed.

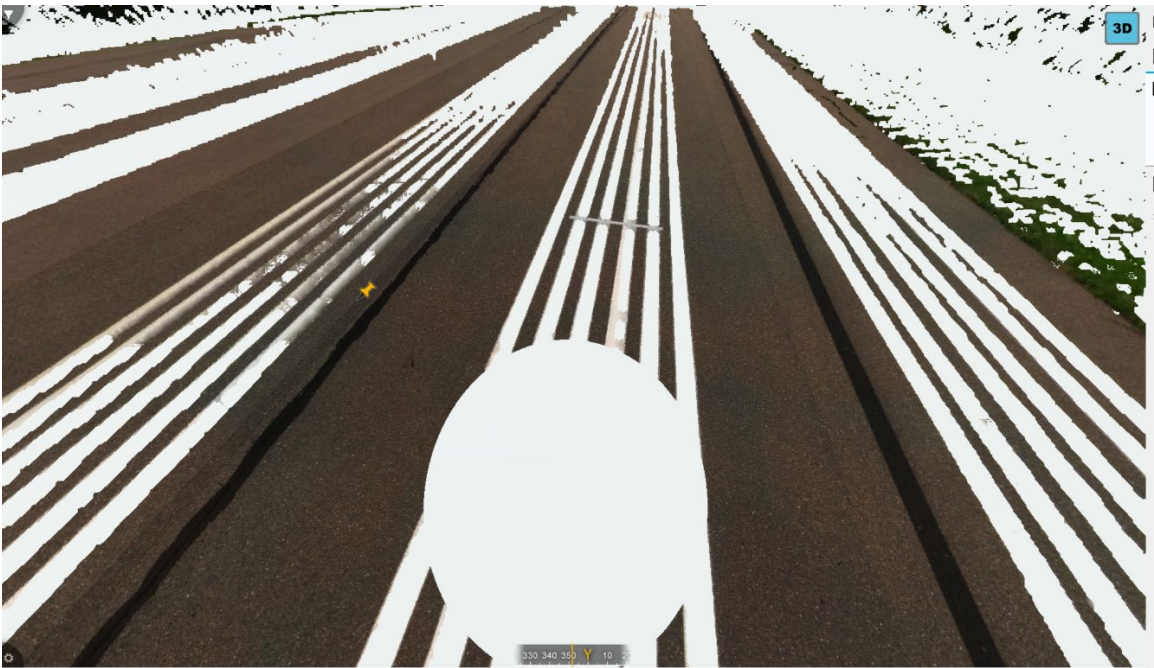
Figure 12: Faro Image From Scan Station 46 Located About 3,564 Ft From Approach End of Runway 2. Pin Marks Left Tire Mark, While Very Dark Mark From Right Tire is Noted Near Runway Striping.

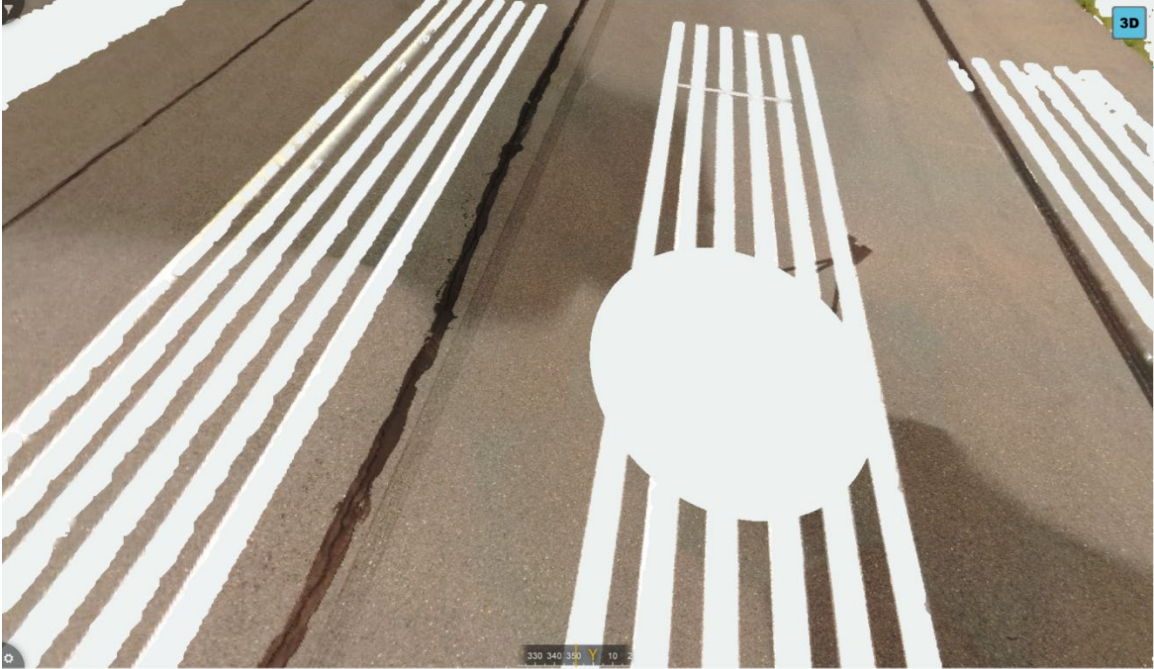
Figure 13: Faro Image From Scan Station 47 Located About 3,639 Ft From Approach End of Runway 2. Tire Mark From Both Main Landing Gear Tires with Grooves Noted for Both Consistent with Tire Inflation.

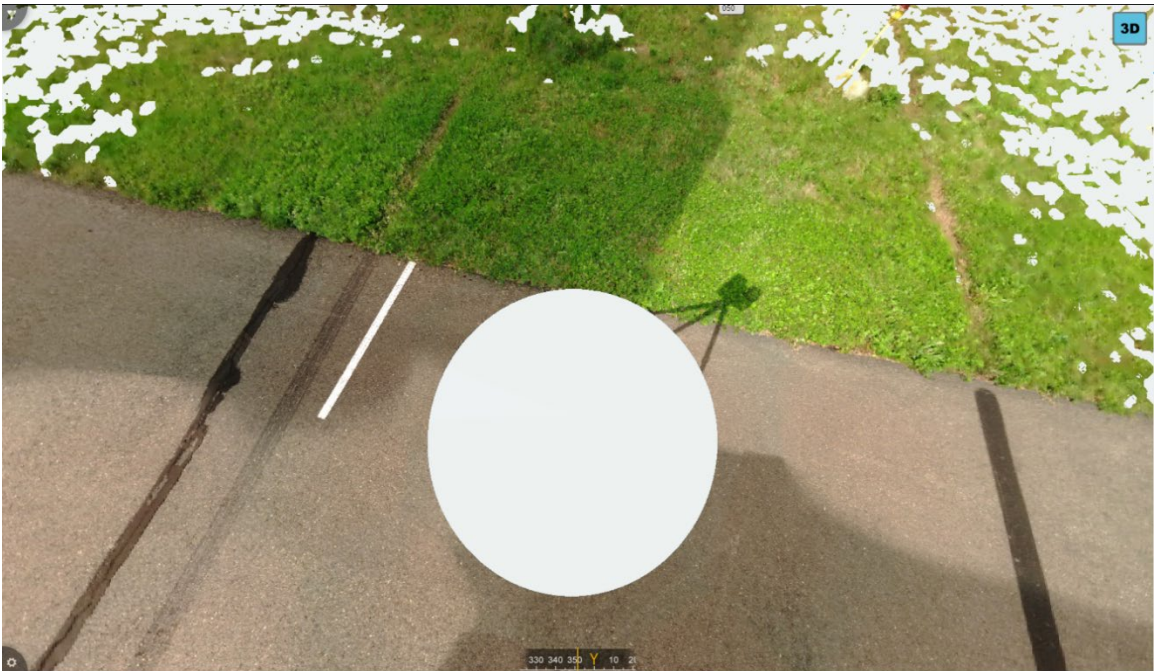
Figure 14: Faro Image From Scan Station 48 Located At Departure End of Runway 2. Note Light Tire Mark From Left Main Landing Gear While Very Dark Mark From the Right Main Landing Gear.

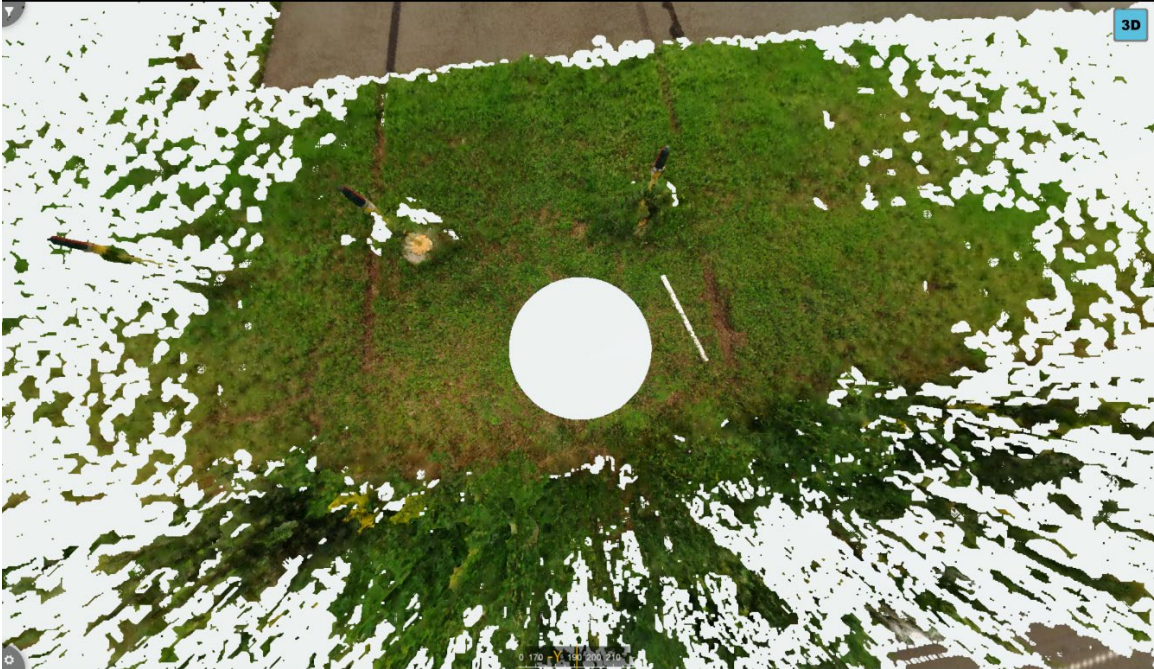
Figure 15: Faro Image From Scan Station 49 Located At Edge Of Airport Terrain Before Terrain Drop. Note marks from Both Main Landing Gear Tires in Grass.

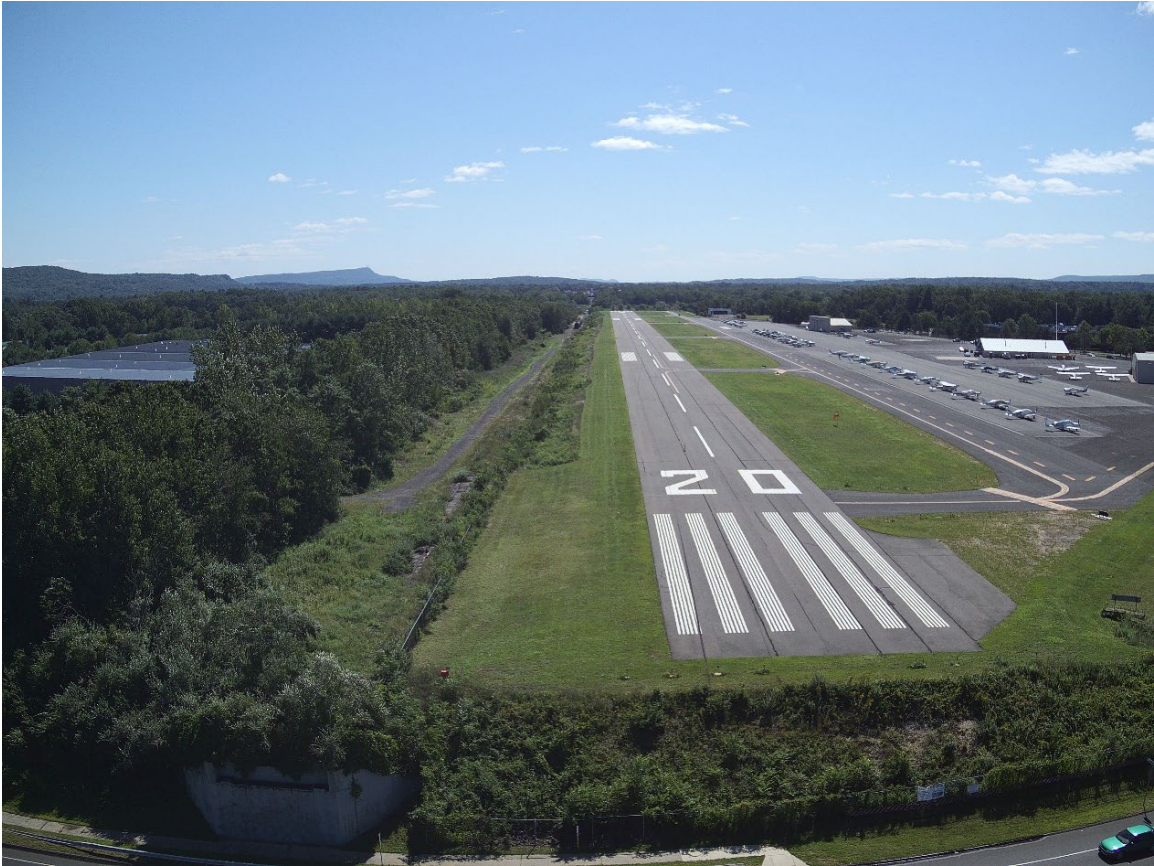
Figure 16: Still Image From UAS. View Taken Past Departure End of Runway 2 Looking Towards the Approach End of Runway 2. Note the Elevation Change Past the Departure End of the Runway.

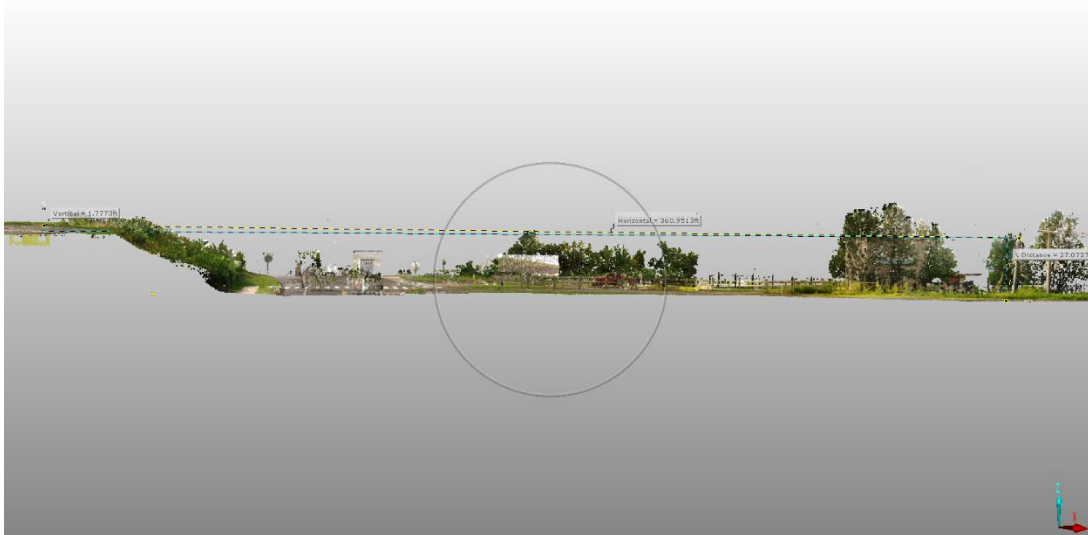
Using the Faro Scan, the terrain elevation at the base of the road just past the departure end of the runway was determined to be between 20 and 25 ft lower than the elevation at the departure end of runway 2. Additionally, Faro Scan past the departure end of the runway revealed the impacted pole was located about 361 ft from the departure end of runway 2, the pole was broken about 27 ft above ground level, and the height of the broken pole was about 1.8 ft lower than the elevation at the departure end of runway 2 (Figure 17).

Figure 17: Faro Scan Image Documenting Terrain Elevation Drop, Distance from the End of the Runway to the Impacted Pole, and Elevation Difference From the Runway and Where the Pole Broke.
