# Runway excursion involving Cessna 550, VH-FGK

Lismore Airport, New South Wales | 25 September 2015

**ATSB Transport Safety Report**  
Aviation Occurrence Investigation  
AO-2015-114  
Final – 25 July 2016

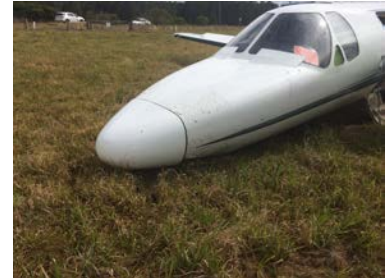
## Accident site

The captain rejected the take-off, applied full braking and reverse thrust, but the aircraft overran the runway. The nose landing gear detached from the aircraft about 50 m beyond the end of the sealed runway, and the aircraft came to rest in long grass and mud. The aircraft sustained substantial damage, and the captain and copilot were uninjured.

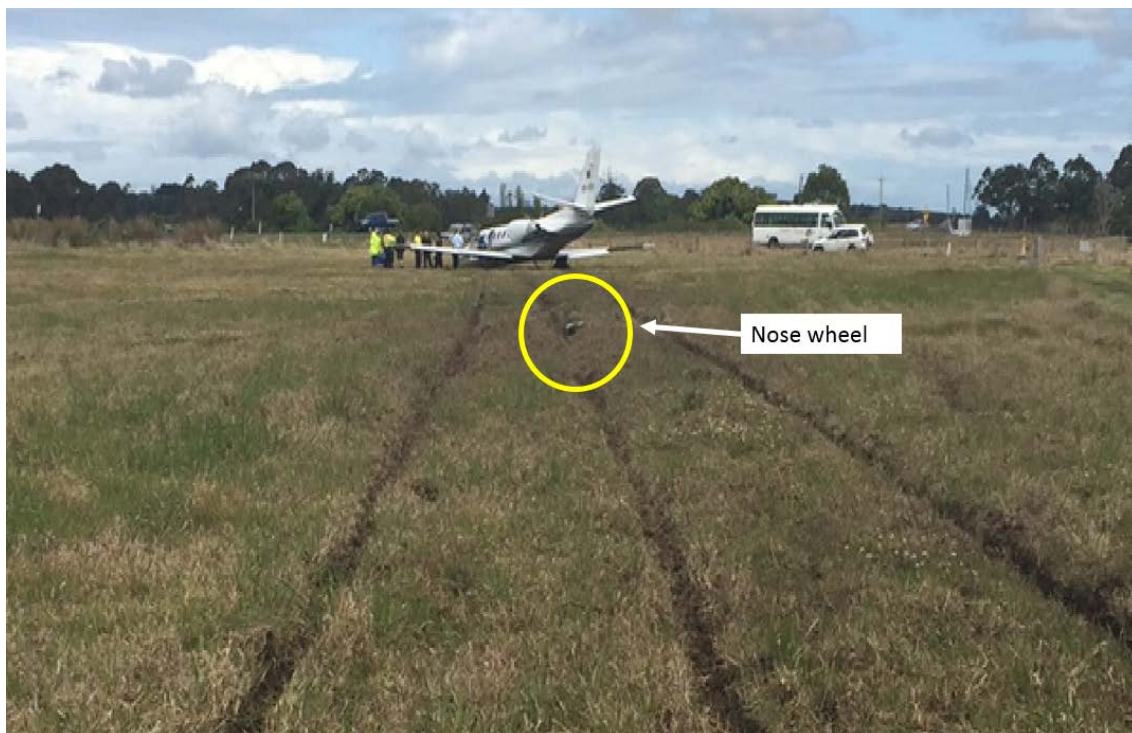
**Figure 2: Accident site**

The aircraft continued to the end of the sealed runway and onto the grass in the runway end safety area (RESA), coming to rest slightly left of the extended centreline, about 100 m beyond the end of the runway (Figure 2).

Similarly, using measurements from Google Earth based on photos of the accident site, the aircraft came to rest about 150 m beyond the sealed runway and before the airport boundary fence. The RESA at Lismore may have assisted in decelerating the aircraft after the rejected take-off and reduced risk of injury and damage to the aircraft.

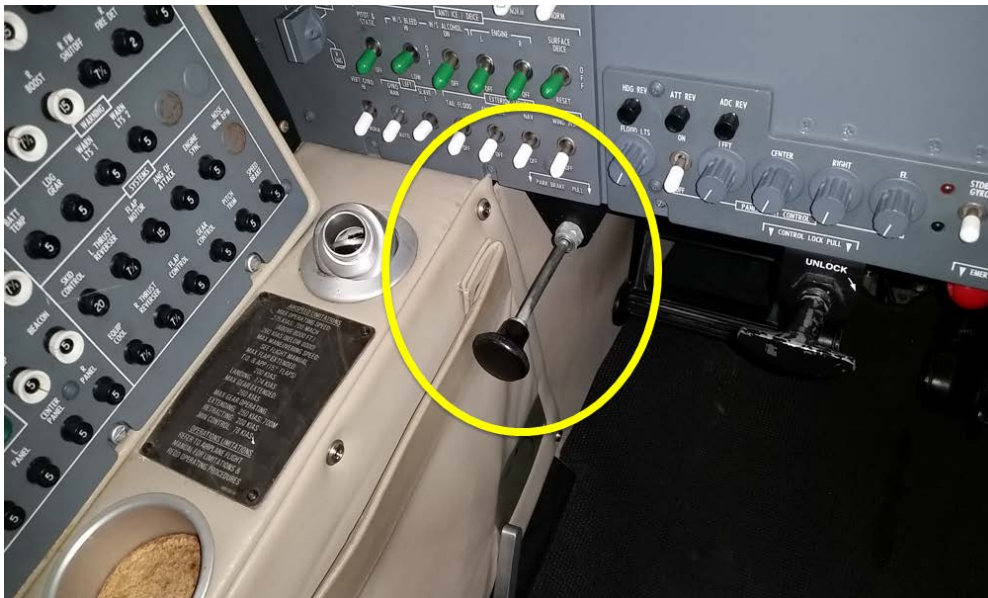
**Figure 4: Parking brake lever in the ON position**

The parking brake was set by either pilot applying and holding footbrake pressure and the pilot in the left (captain's) seat pulling out the parking brake lever underneath the left instrument panel (Figure 4). The lever could be selected OFF or fully ON. There was no partial release position of the lever. When the lever was pushed forward from the ON position, pressure in the lever would continue to release the lever until it was in the OFF position. The position of the parking brake lever was not visible to the pilot in the right seat. There was no cockpit annunciation that the parking brake lever was in the ON position.

With the parking brake on, the applied pressure in the brake lines is trapped, and when the footbrake is released, the pressure at the brakes remains. If the parking brake handle is pulled with no footbrake pressure applied, no pressure will be present in the brakes. However, any subsequent footbrake pressure will be trapped and maintained, until the parking brake lever is returned to the OFF position. The park brake is certified to ensure that with full pressure applied, the wheels will remain locked even if full thrust is applied on both engines.

The parking brake was found engaged following the accident. However, the captain reported engaging it after the aircraft came to rest in the grass. The captain also reported that evacuation training always included setting the park brake as one of the first actions. The captain could not recall selecting the parking brake ON while at the holding point, where the aircraft was stationary for over 4 minutes.

The parking brake was found engaged following the accident. The captain reported they engaged it after the aircraft came to rest in the grass. However, it is possible that having observed the parking brake engaged on returning to the aircraft after exiting following the accident, and expectations based on evacuation training, the captain may have assumed they engaged it during the shutdown process, influencing their subsequent memory. The flight crew reported being quite shocked and in a hurry to exit the aircraft in case of fire following the accident, and the CVR showed that the copilot needed to remind the captain to complete another pre-evacuation action (shutting down the engines). The copilot was unable to see the parking brake lever from their position.

The Australian Transport Safety Bureau recommends that Textron Aviation (Cessna) take safety action to address the fact that Citation aircraft do not have an annunciator light to show that the parking brake is engaged and the Cessna 'before take-off' checklist does not include a check to ensure the parking brake is disengaged.

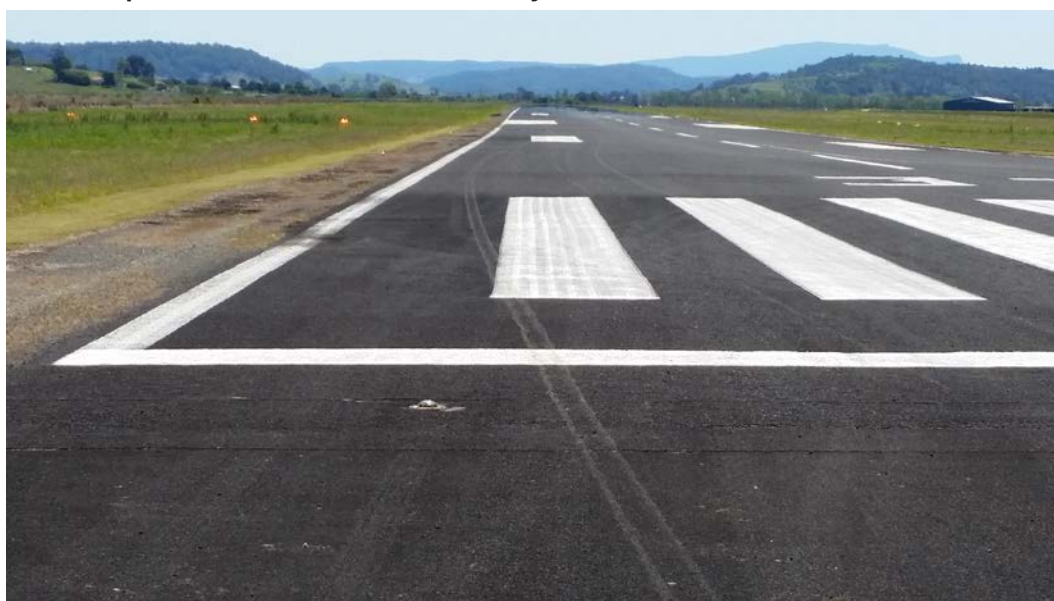
**Figure 5: Southeast end of the runway showing right wheel contact marks on the runway and their position in relation to the runway centre line**

Distinctive marks on the end of runway 15 indicated that the right wheel tyre had deflated after the captain rejected the take-off and the wheel's rim was making contact with the runway. The position of the tyre witness marks on the runway showed that the aircraft remained just to the right of the centreline but moving towards the left as it exited the runway (Figure 5).

Neither crew member detected any tendency for the aircraft to yaw. Additionally, the position of the tyre witness marks on the runway showed that the aircraft remained on the runway centreline until after the captain rejected the take-off. This is indicative of equal resistance from both main wheels and not a failure of one wheel, brake or tyre.

Given that only one tyre was damaged (and that witness marks indicate it was damaged after the rejected take-off), it is therefore probable that the rolling resistance experienced by the aircraft was a result of partial brake pressure in both wheels. This affected both the slow acceleration rate and inability to rotate the aircraft at  $V_R$ .

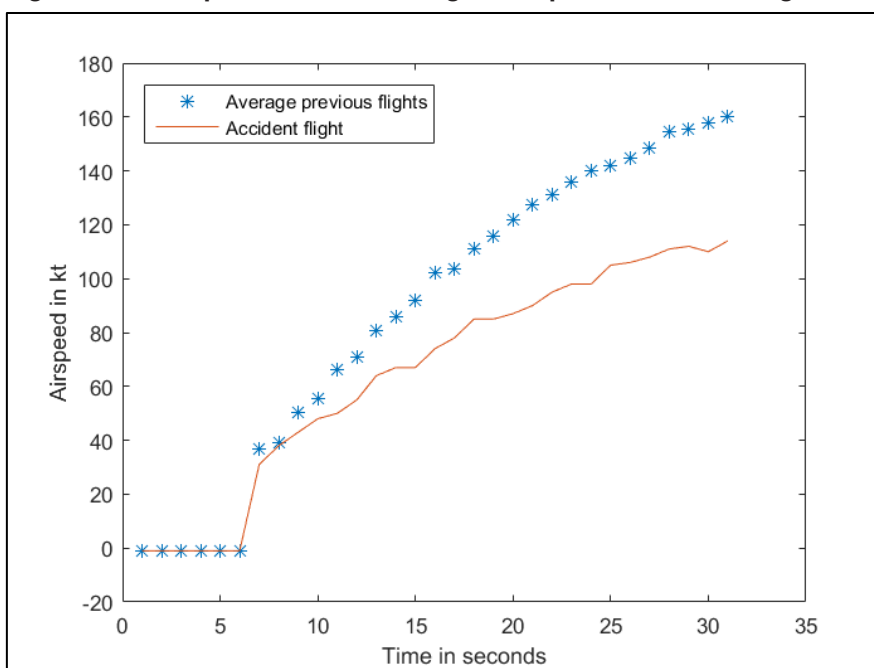
**Figure A-1: Airspeed of accident flight compared to the average of four previous flights**

The accident flight take-off data shows a reduced acceleration compared with the previous four flights, but a similar engine RPM. Figure A-1 shows the airspeed of the accident flight and the average of the four previous flights, which were not significantly different from each other.

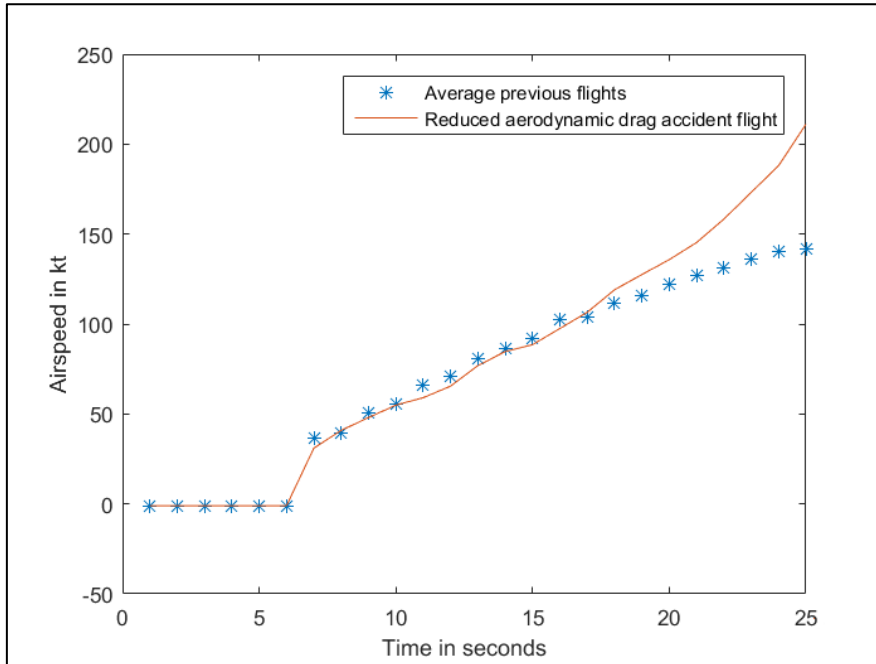
**Figure A-2: Airspeed of accident flight without an aerodynamic drag component, compared to the average of four previous flights**

The aerodynamic drag increases with the *square* of speed. If the increased drag was primarily aerodynamic, the effect on the airspeed curve would be an increase in the curvature (downwards) as speed increased, after being similar at lower airspeeds. Figure A-2 shows the airspeed from the accident flight with a component of aerodynamic drag removed, and compared to the average previous flights. As can be seen from the graph, this does not reflect a similar acceleration profile to the previous flights. The graph depicts the airspeed showing the commencement of the take-off run, to when the captain rejected the take-off in the accident flight.

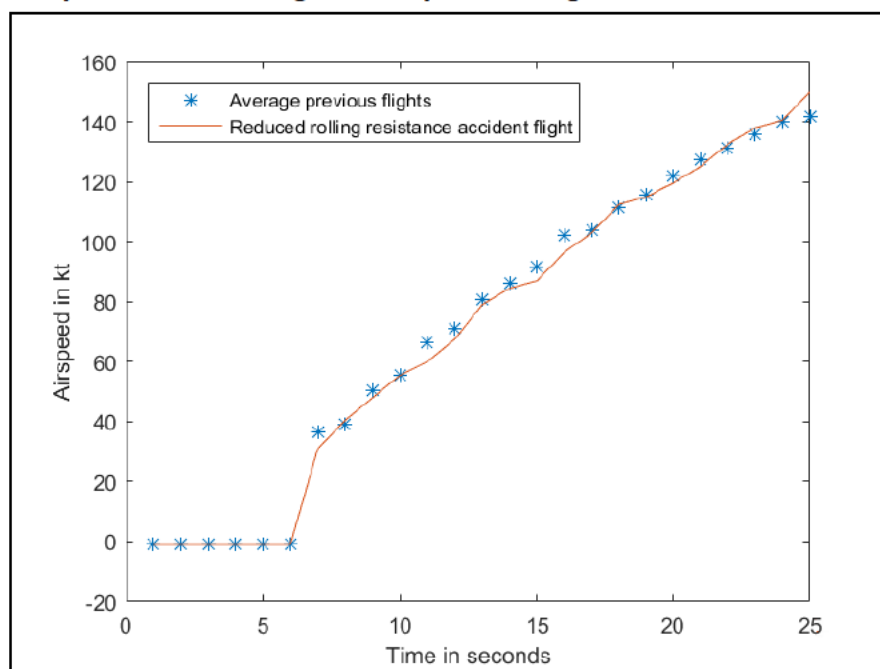
**Figure A-3: Airspeed of accident flight with a reduced rolling resistance component, compared to the average of four previous flights**

A correction of an acceleration of 2.5 kt/second as a constant applied to the accident flight is depicted in Figure A-3. As can be seen, the corrected line correlates closely with the average take-off acceleration from the previous four flights. Adding an acceleration component equates to a deceleration (or rolling resistance) component present in the accident flight data. A deceleration component of 2.5 kt/second is 0.13 g.

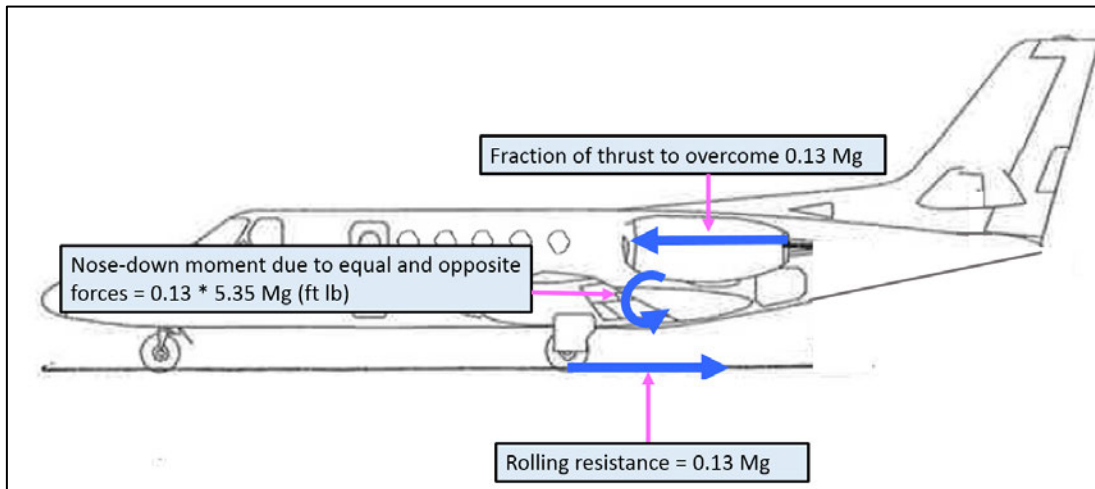
**Figure A-4: Representation of thrust, rolling resistance and nose-down moment**

The nose-down moment of the thrust force required to counteract the additional rolling resistance of 0.13 g, is  $0.13 \text{ Mg} \times 5.35 \text{ (ft lb)}$ .<sup>8</sup>

The nose-down moment due to the additional rolling resistance, depicted in Figure A-4, is equivalent to the nose-down moment due to the vertical force ( $Mg$ ) through a more forward centre of gravity position (Figure A-6). So that  $0.13 Mg * 5.35 \text{ (ft)} * 12 \text{ (inches per foot)} = Mg * x$ , where  $x$  is the effective forward movement of the CG. Therefore,  $x$  is 8.35 inches, which is 10.3% MAC.

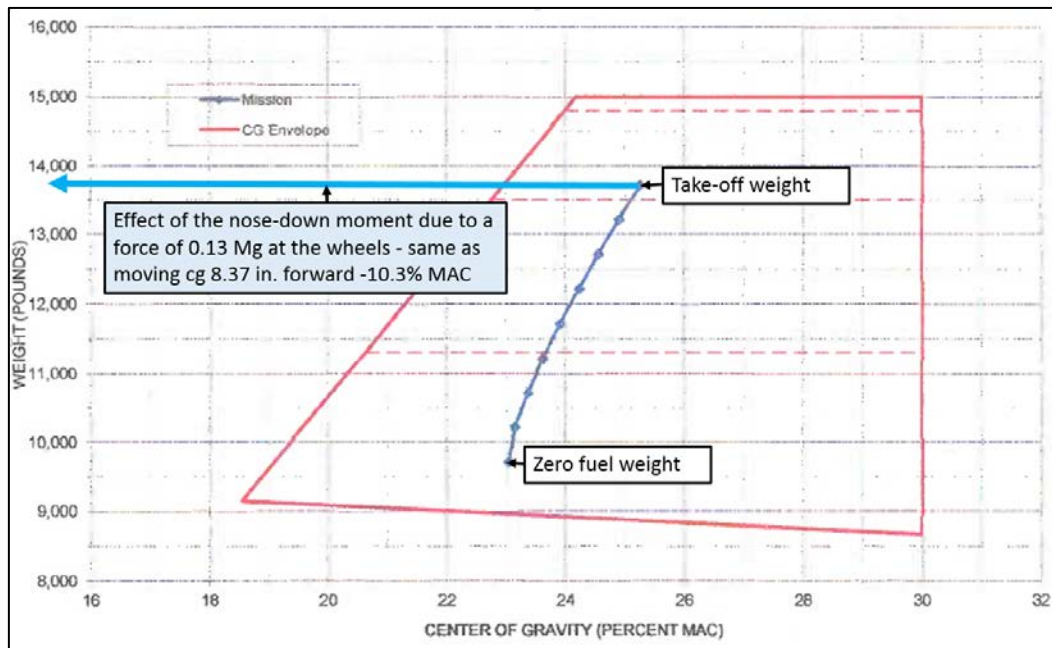
**Figure A-7: Load sheet for VH-FGK showing the accident flight computation of weight and balance from take-off to landing, and the effect of moving the centre of gravity 8.35 inches forward**

The aircraft's load sheet the flight crew prepared for the flight is depicted in Figure A-7. The computed CG was 25.1% MAC at take-off. The most forward allowable at that weight was 22% MAC. Moving the centre of gravity forwards 8.35 inches, or 10.3% MAC, would place the effective centre of gravity over 5 inches forward of the allowable range (and off the chart). In that condition it should be impossible to raise the nose of the aircraft – to rotate on take-off.
