**NATIONAL TRANSPORTATION SAFETY BOARD**  
Vehicle Recorder Division  
Washington, DC 20594

## **Onboard Image & Security Camera**

**Specialist's Factual Report**  
**By Sean Payne**

| NTSB Number: | ERA21FA354 |

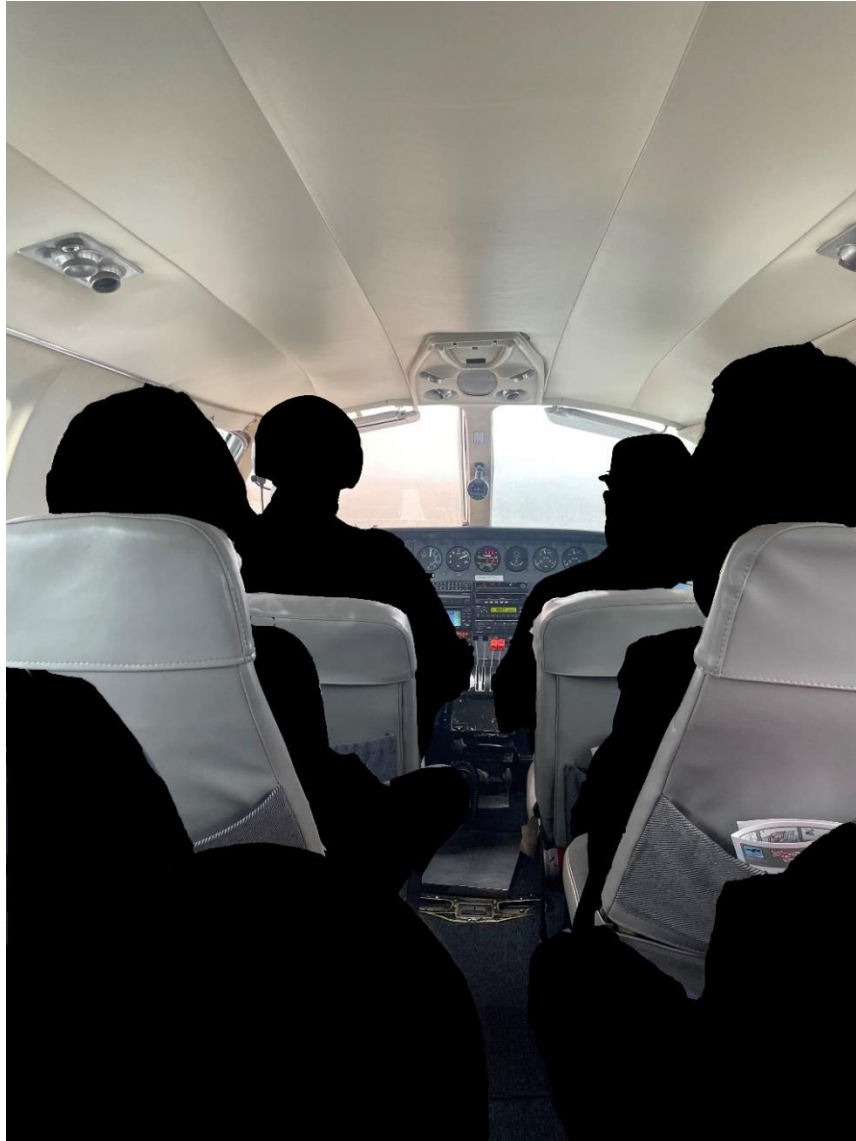
Figure 1 is the first image taken by the passenger. The occupants of the aircraft have been redacted. The manifold pressure for both engines is shown around 17 inches Mercury (inHg), the RPM for both propellers is shown as around 2,400 RPM. Visible engine instruments appear to have nominal values. Control levers for throttle and propeller are observed as shown in the image. The resolution of the image did not provide enough clarity to resolve the settings on the Garmin GPS navigation device.

The Precision Approach Path Indicator (PAPI) is visible through the windscreen to the right of the runway. The PAPI shows four white lights, indicating the aircraft was above glidepath for runway 7 at KPVC. The altitude and airspeed indicators are not visible and thus a determination of the aircraft's energy state at this time was not possible.

**Figure 1.** The first photo provided by the passenger.

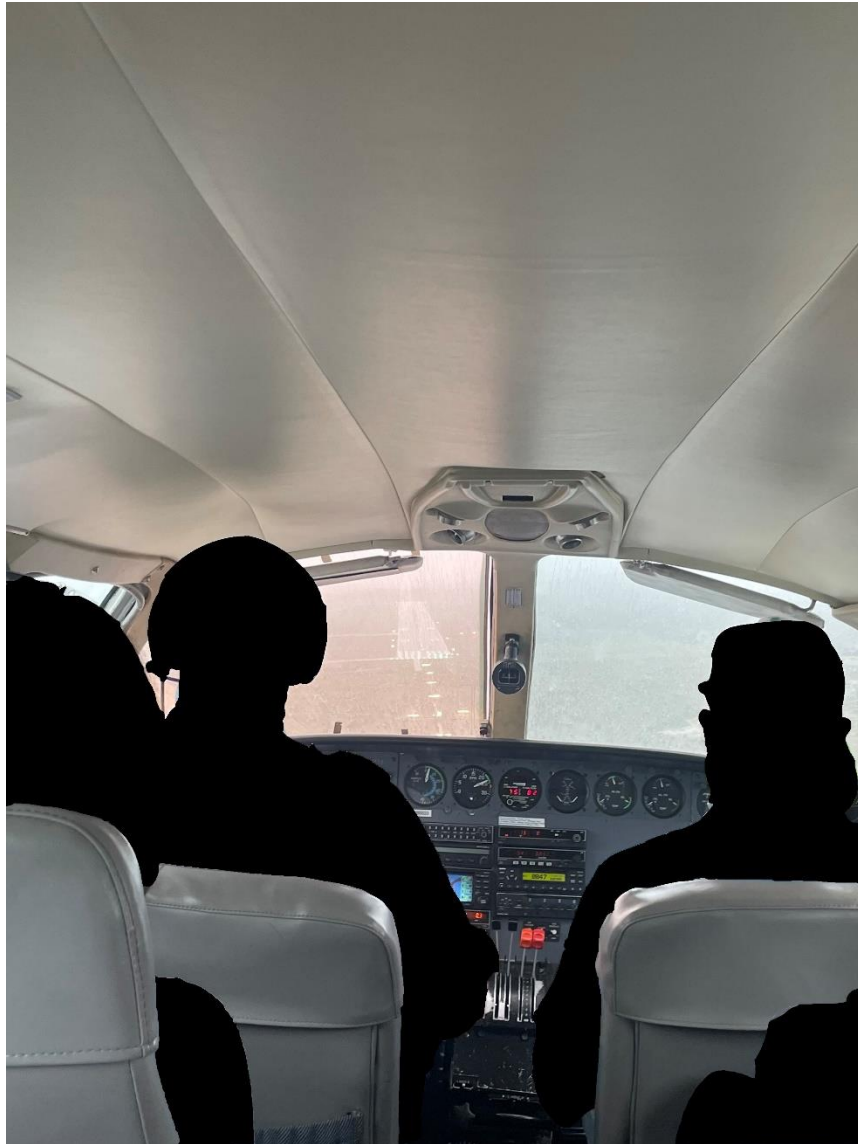
Figure 2 is the second image taken by the passenger. The occupants of the aircraft have been redacted. The manifold pressure for both engines indicated around 17 inHg, the RPM for both propellers indicated around 2,400 RPM. Visible engine instruments appear to have nominal values. Control levers for throttle and propeller are observed as shown in the image. The resolution of the image did not provide enough clarity to resolve the settings on the Garmin GPS navigation device.

The Precision Approach Path Indicator (PAPI) is visible through the windscreen. The PAPI shows two white lights, the other two lights of the PAPI are obscured by the center

post of the windscreen. The PAPI indicates the aircraft is either at or above glidepath for runway 7 at KPVC. The altitude and airspeed indicators are not visible and thus a determination of the aircraft's energy state at this time was not possible.

**Figure 2.** The second photo provided by the passenger.

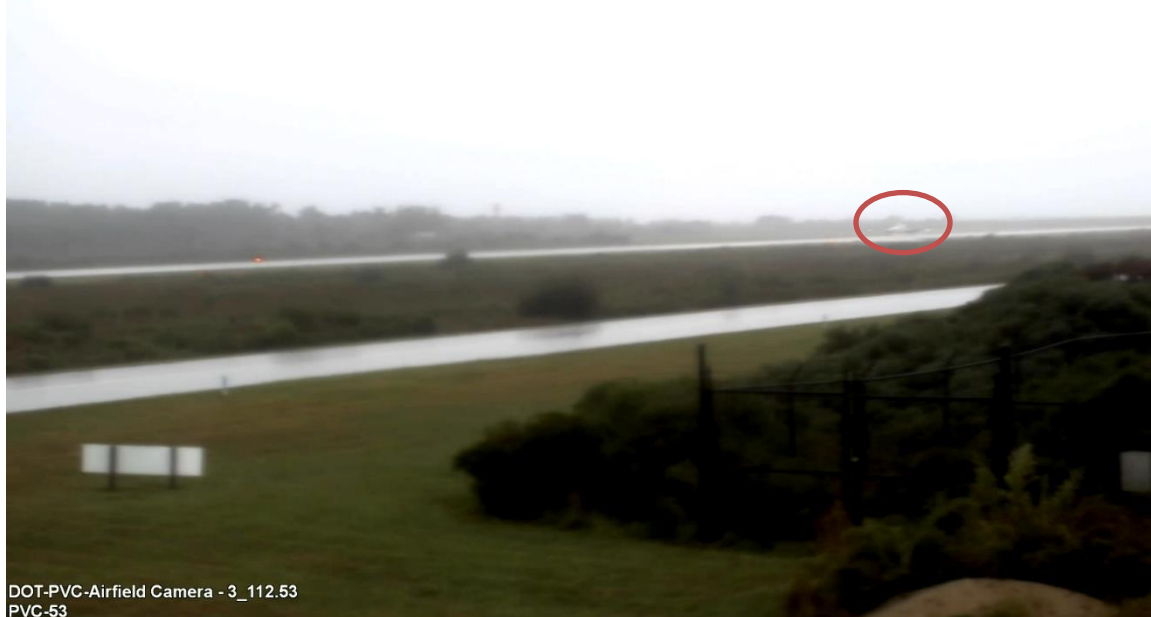
Security footage was reviewed from the camera pointed toward the arrival end of runway 7. The point at which the aircraft touched down was approximated. Figure 3 is a screen capture of the aircraft touching down on runway 7 at KPVC from the recording. Post-accident, a measurement was taken from the beginning edge of the threshold from the

arrival end of runway 7. The measurement was taken by driving a vehicle into a location that matched the accident aircraft's touchdown point on the security recording. The measurement from touchdown point to the beginning of the edge of the threshold was approximately 650 feet. Figure 4 approximates this position on Google Earth.

**Figure 3.** The aircraft's approximate touchdown point as shown in the screen capture from the security camera. A red reticle highlights the accident aircraft.

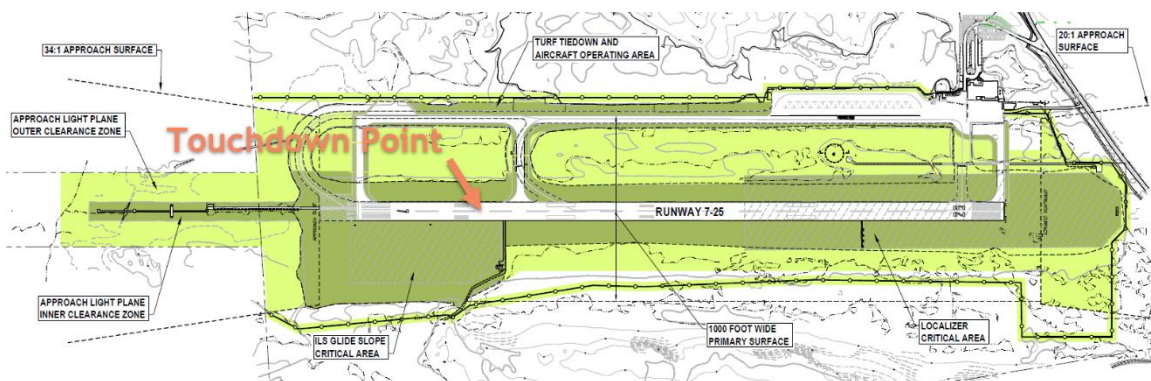
**Figure 4.** The approximated touch down position using Google Earth.
