## **NATIONAL TRANSPORTATION SAFETY BOARD**

# **SURVIVAL FACTORS**

ERA21FA354

Location: Provincetown, MA  
Date: September 9, 2021  
Time: 1527 Eastern daylight time (EDT)  
1927 Coordinated universal time (UTC)  
Airplane: Cessna 402C, N88833, Cape Air

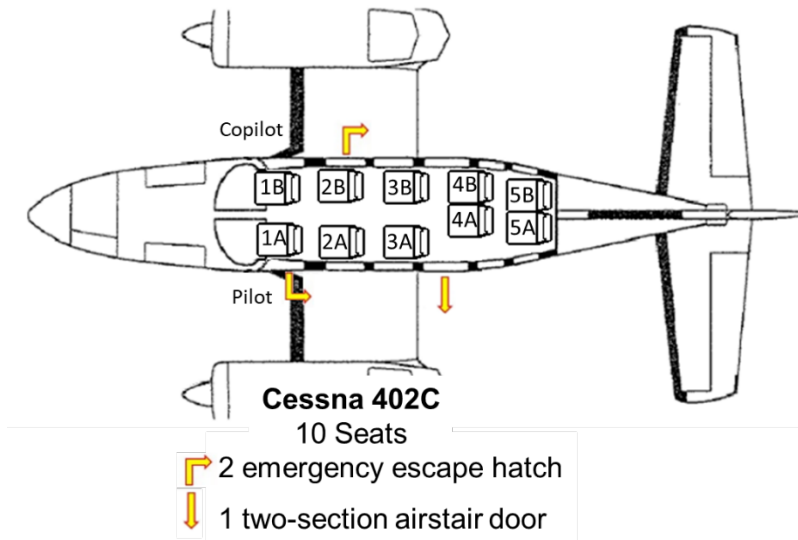
The airplane was a Cessna 402c non-pressurized twin engine piston airplane. It was configured with a pilot seat (1A), a copilot seat (1B), and eight passenger seats (see figure 1). The airplane was equipped with an escape hatch adjacent to the pilot seat (1A); an emergency escape hatch adjacent to seats 2B; and a two-section clamshell-style outward opening airstair door (main cabin door) adjacent to seats 4A, the lower portion of which was equipped with stairs. The pilot and copilot seats were equipped with lift latch lap belts and single-strap shoulder harnesses, and the passenger seats were equipped with lift latch lap belts. Seven occupants were on board the flight, the pilot and six passengers. Passengers were seated in seats 1B, 2A, 2B, 3A, 3B and 4A.

**Figure 1.** Cabin configuration of N88833 with occupant and exit locations.

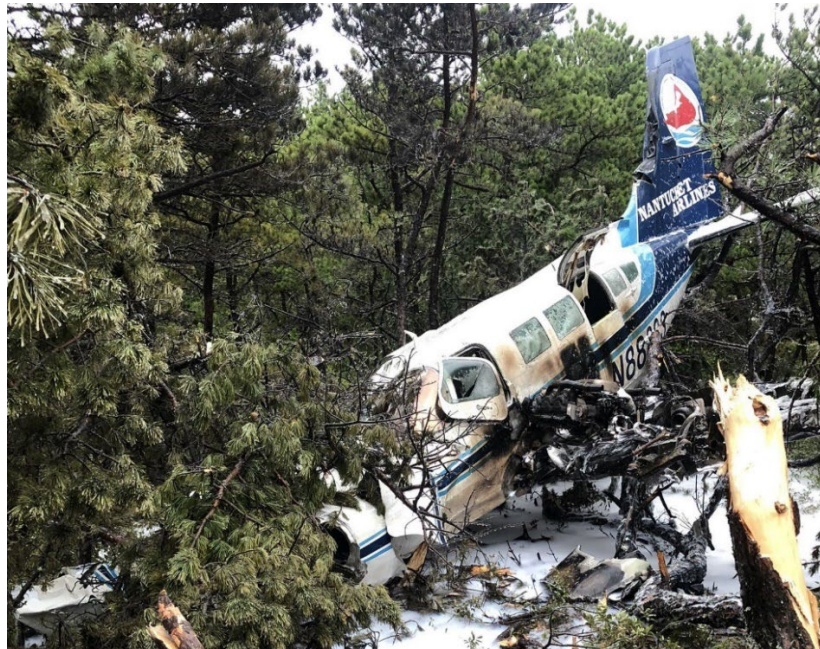
The airplane had a post-crash fire with charring noted along the exterior left side from just aft of the nose section to the main cabin door, as well as on the right side just in front of the wing. There was crumpling from the nose aft to just in front of the wing on both sides of the airplane (see figure 2).

**Figure 2.** N88833 post-crash after the fire was extinguished.

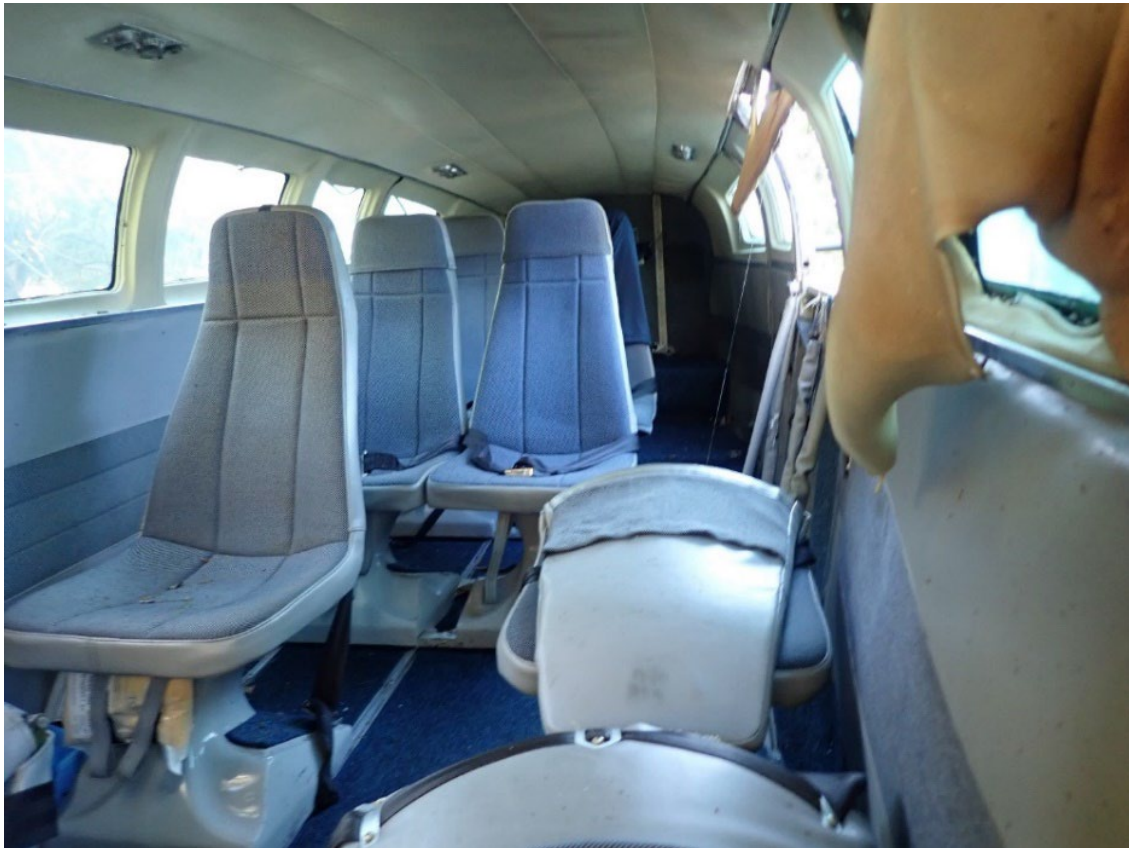
The cabin was mostly intact (see figure 3) with downward overhead cabin deformation noted to the front right structure around copilot seat (1B) near an area where a tree found inside of the windshield (see figure 4). There was fire damage to the interior of the cabin on the left side just aft of the pilot seat (see figure 5).

**Figure 3.** Aft-facing photograph taken from the pilot escape hatch.

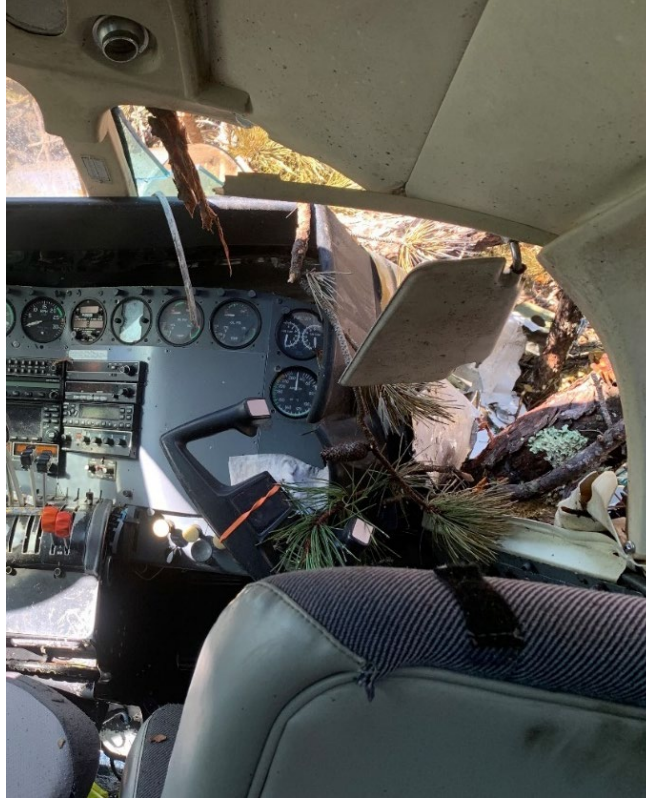
**Figure 4.** Photograph of structure around copilot seat (1B).

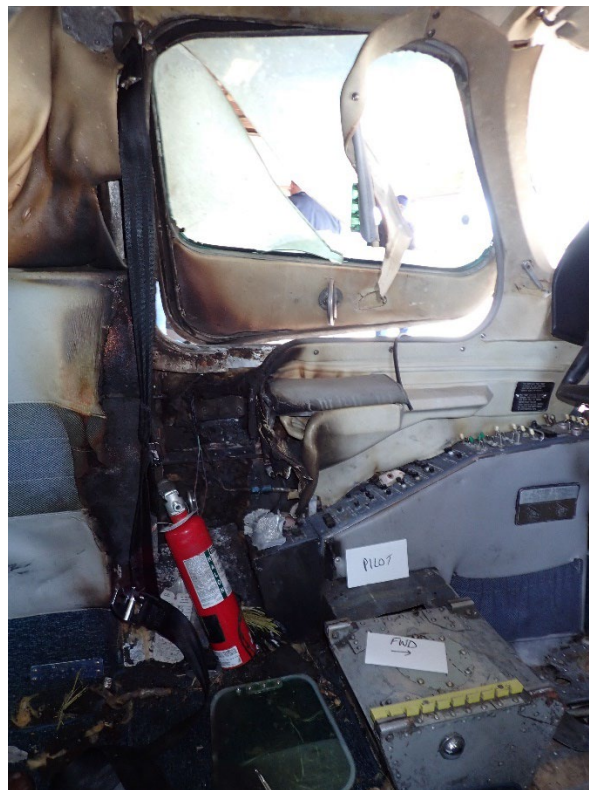
**Figure 5.** Photograph of charring aft of the pilot seat after the pilot seat was removed.

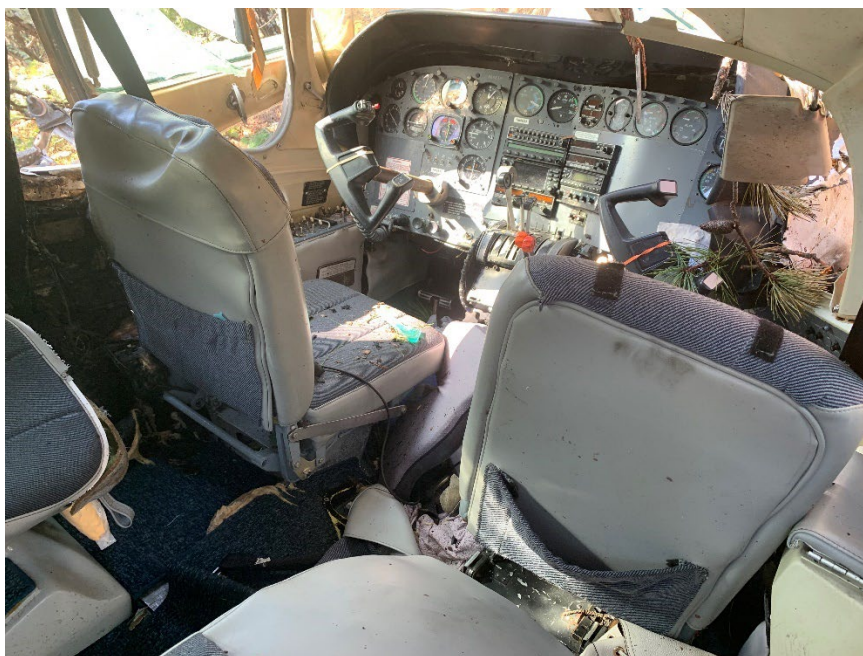
The pilot and copilot seats (1A and 1B) were composed of a metallic frame with an adjustable seatback. They were able to be adjusted forward or aft on the seat rails to accommodate the occupant (see figure 6). Both seats remained attached to the seat rails which were fastened to a boxed structure which then attached to the floor. The seats were found with the seatback in an upright position with no damage noted to the seat cushions or structure. There was no seat manufacturer information or data plate located on the seats.

The seats were equipped with a 3-point restraint with a lift latch buckle manufactured by AmSafe. The lap belt was anchored on the floor, with the upper torso restraint anchored slightly aft and above the occupant on the sidewall. The seat belts did not become detached from their anchor points and were unbuckled when investigators arrived. The buckle could be latched and released normally. The webbing for the upper torso section and right lap belt were in good condition but the left, outboard lap belt was melted.

**Figure 6.** Pilot and copilot seat as found in airplane when investigators arrived on scene at the accident site.

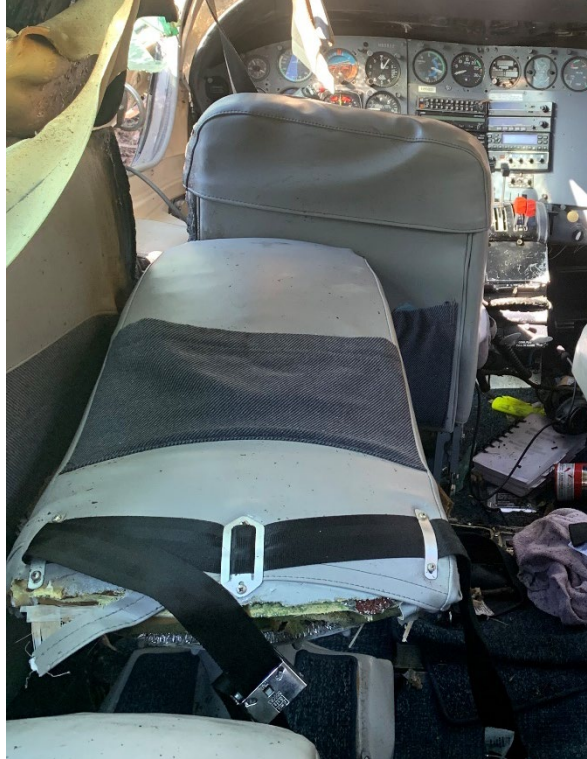
Seat 2A was found with the seatback rotated forward and had visible damage along the back seatpan/seatback junction (see figure 10). There were no data labels found on the seat or pedestal. The seat rail locking plunger functioned properly, and there was no damage noted to the attachment points or the seat rails.

**Figure 10.** Seat 2A as found in the airplane.

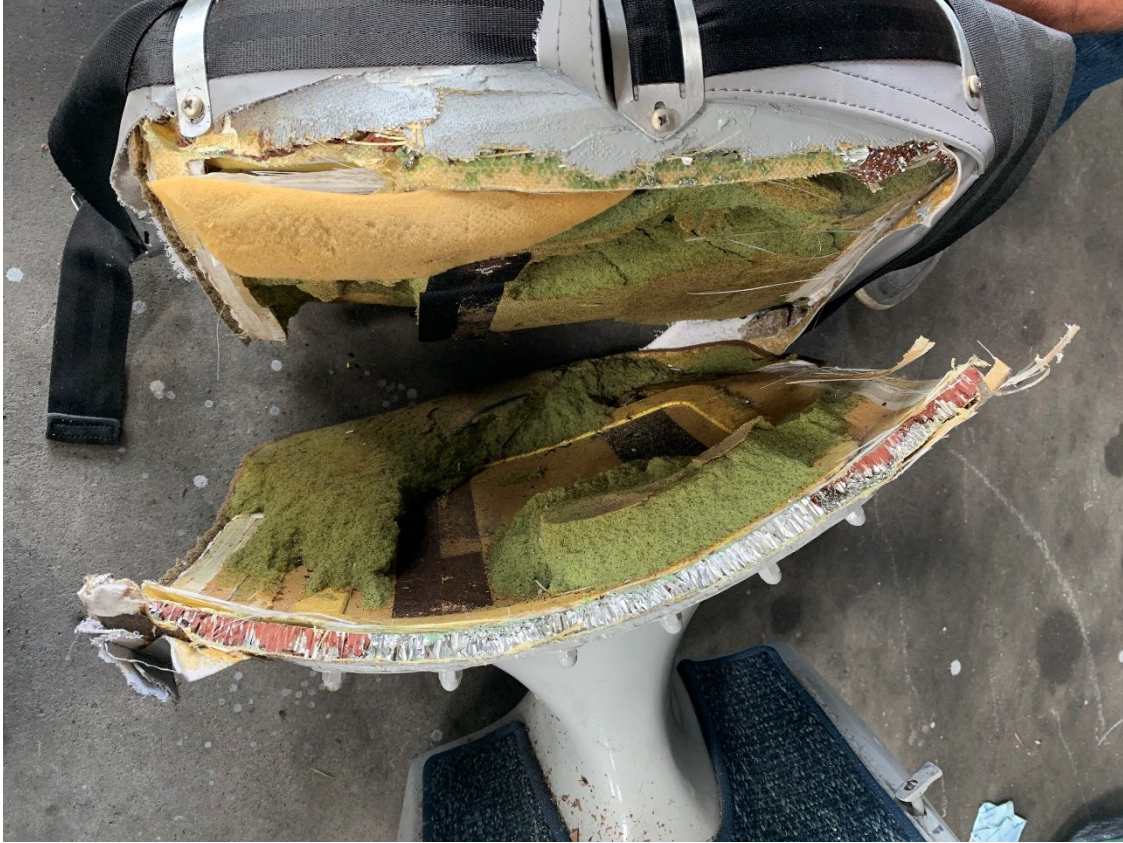
The seat covering was a single sewn piece that went over the seat and was glued to the bottom of the pedestal. When the broken seat back was lifted, the cover for the seat bottom was no longer attached and there was tearing of the foam along the seat bottom (see figure 11). A small amount of fire damage was noted on the front right portion of the exposed foam.

**Figure 11.** Seat 2A viewed from the rear with broken section lifted away revealing damage to the seat bottom cushion.

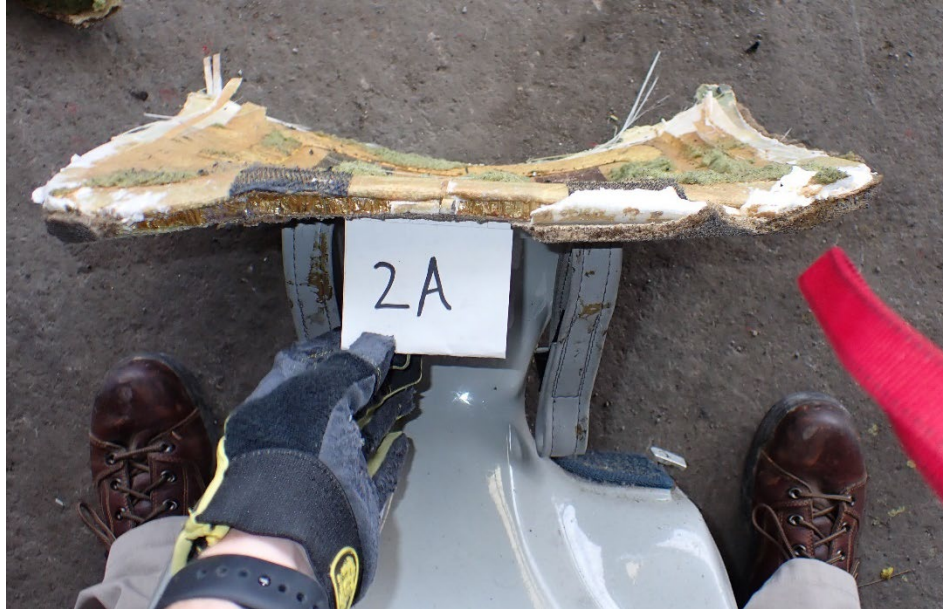
After removing the seatback portion, the remaining cushion material was removed to examine the seat bottom. Damage along the rear right side of the seat pan was found, as well as downward deformation along the forward right edge of the seat (see figure 12). There were also loose fibers along the sides of the seat pan from where the cushion material was pulled away from the pan.

**Figure 12.** View of seat pan from the front showing damage to the forward right portion of the pan.

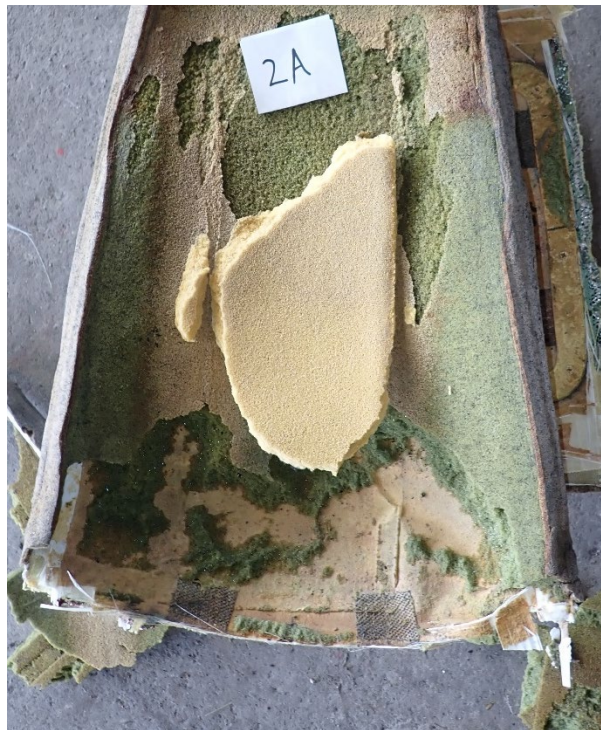
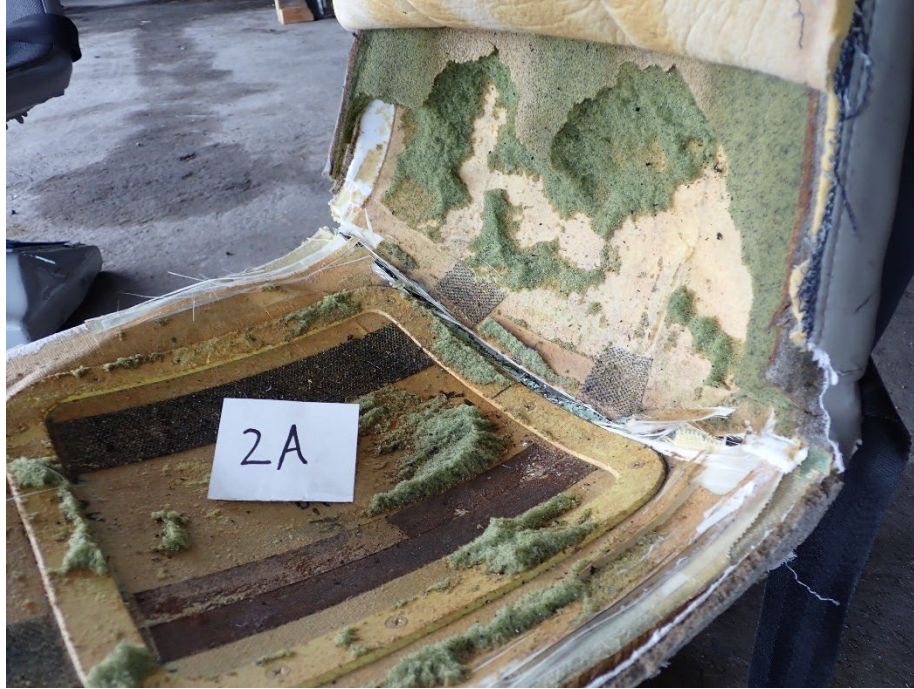
After the seatpan was documented, the seatback foam was removed to expose the structure beneath. Crumpling was found on the left side of the seatback structure (see figure 13 and 14).

**Figure 13.** Seat 2A seatback with covering and foam removed to show crumpling on the bottom left section of the structure.

**Figure 14.** Seat 2A with covering and foam removed from seatpan and the lower portion of the seatback.

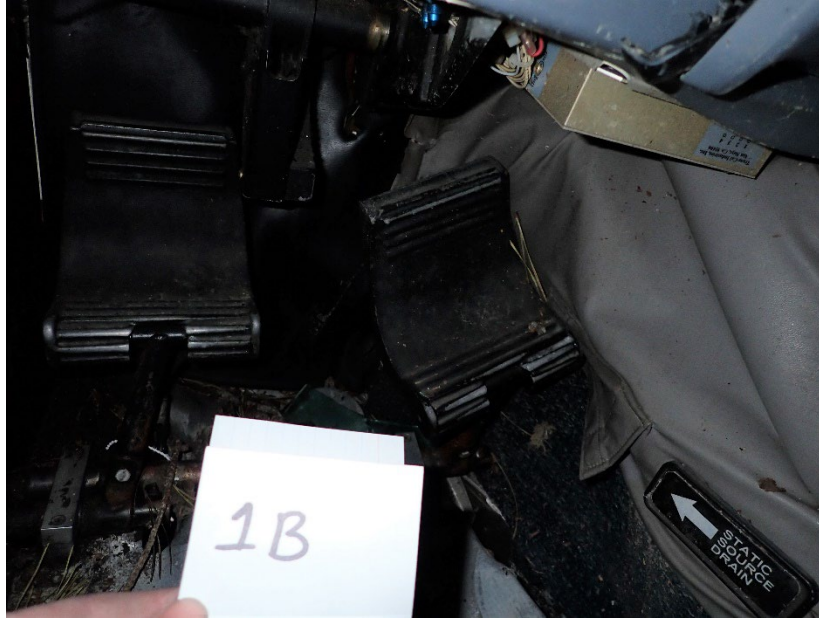
The rudder pedals were examined, and the captain's rudder pedals appeared undamaged. The area around the captain seat was free of any damage or debris. The area around copilot seat (1B) had some deformation to the surrounding structure (see figure 15) with damage to the right rudder pedal.

**Figure 15.** Copilot seat (1B) rudder pedal area.

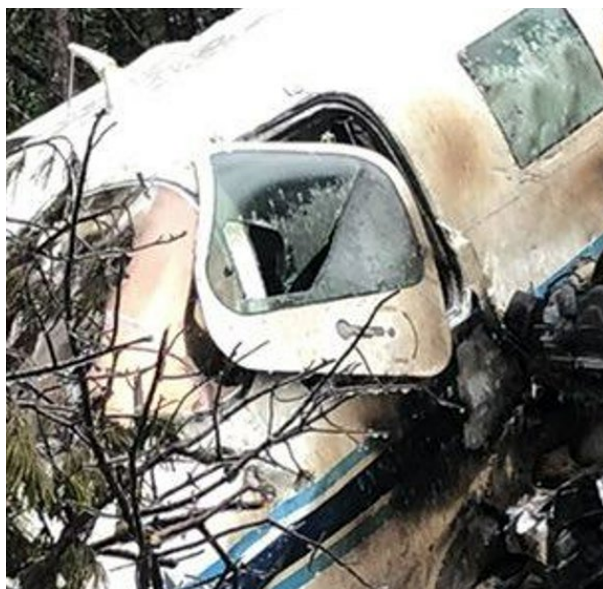
The left window escape hatch was located adjacent to the pilot and found partially attached to the airplane; however, it was no longer secured and had damage to the window (see figure 16). The opening measured 18 inches wide at the top and 27 inches wide at the bottom, with a height of 21 inches (see Figure 17).

**Figure 16.** Left escape hatch located adjacent to the pilot, as found after the fire was extinguished.

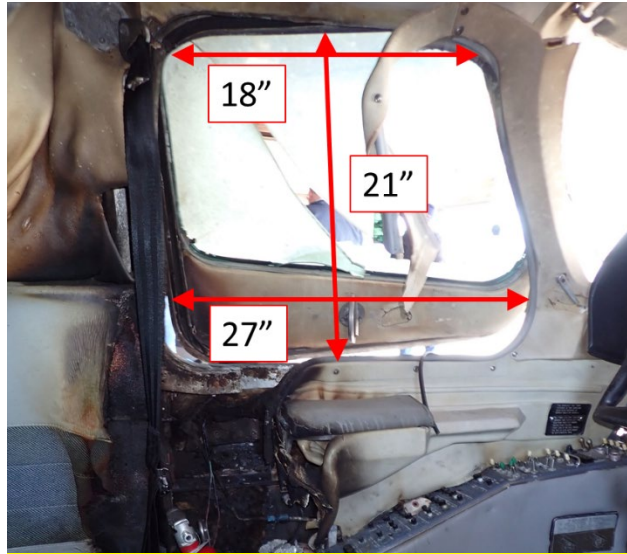
**Figure 17.** Left escape hatch by pilot with measurements, looking from the interior of the airplane outward.

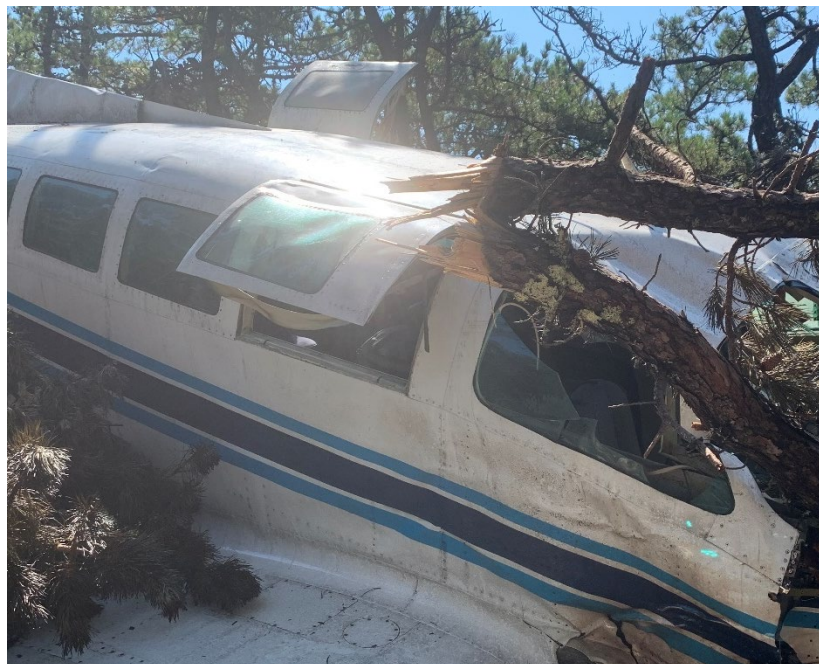
The right escape hatch was located by seat 2B and was found open (see figure 18). According to passenger statements it was opened by the female passenger in 2B following the directions on the safety briefing card located in the seatback pocket. It measured 25.5 inches wide with a height of 16 inches (see figure 19). The handle functioned when turned and the hatch opened without impingement.

**Figure 18.** Right escape hatch located adjacent to seat 2B, as found after the fire was extinguished.

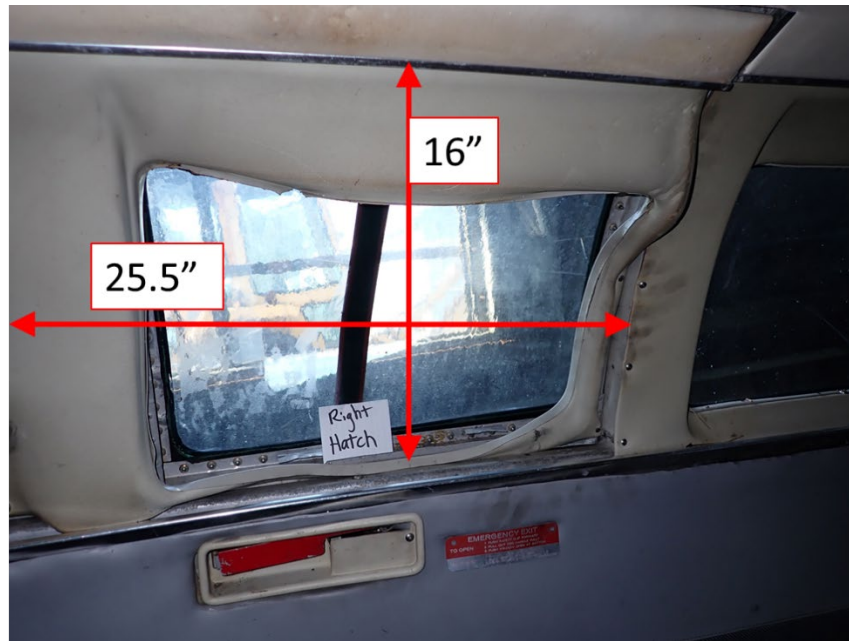
**Figure 19.** Right escape hatch with measurements, as viewed from the interior.

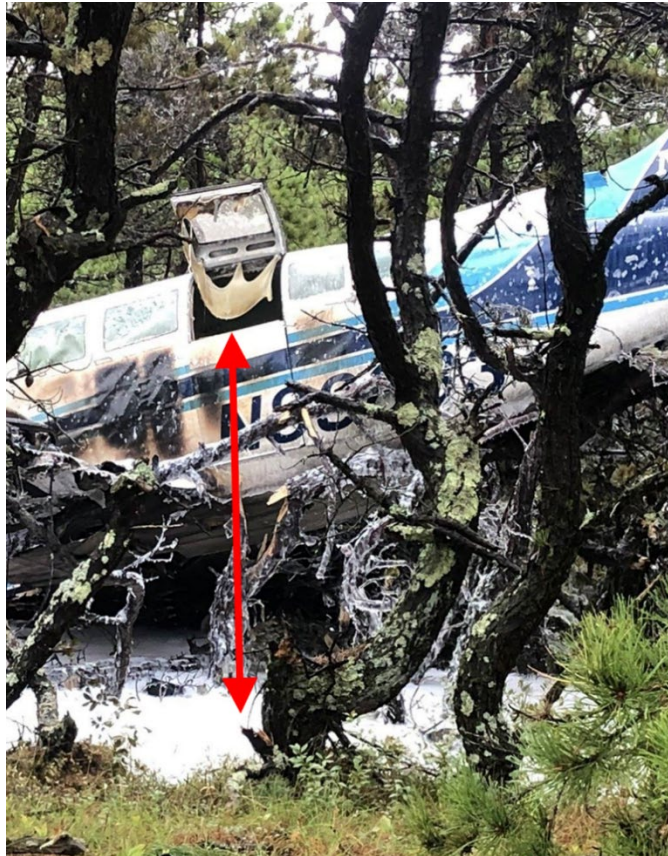
The door was found partially open at the scene. The top portion of the two-piece clamshell type door was open however the bottom section was still closed and secured (see figure 21). According to interviews passenger 4A stated he was unable to open the main cabin door and turned in his seat and started kicking it. He kicked the upper window latch and the top portion of the door opened. All passengers described evacuating out the top half of the door and jumping or falling to the ground below. This height was estimated from photos of the airplane at the accident

**Figure 21.** Main cabin door adjacent to seat 4A, as found after the fire was extinguished.

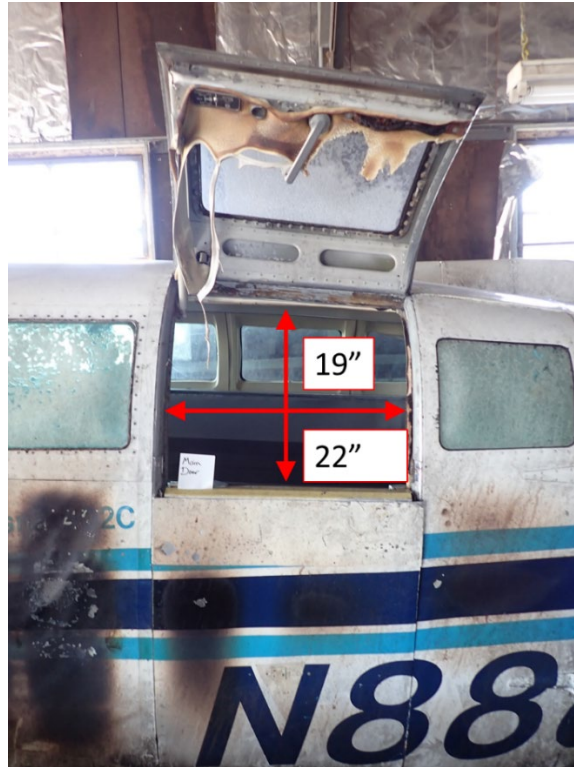
scene as about 9.5 feet. The opening measured 22 inches wide and 19 inches high (see figure 22). The lever for the top portion and latch for the bottom both functioned normally.

**Figure 22.** Main cabin door opening as the passengers exited with measurements.

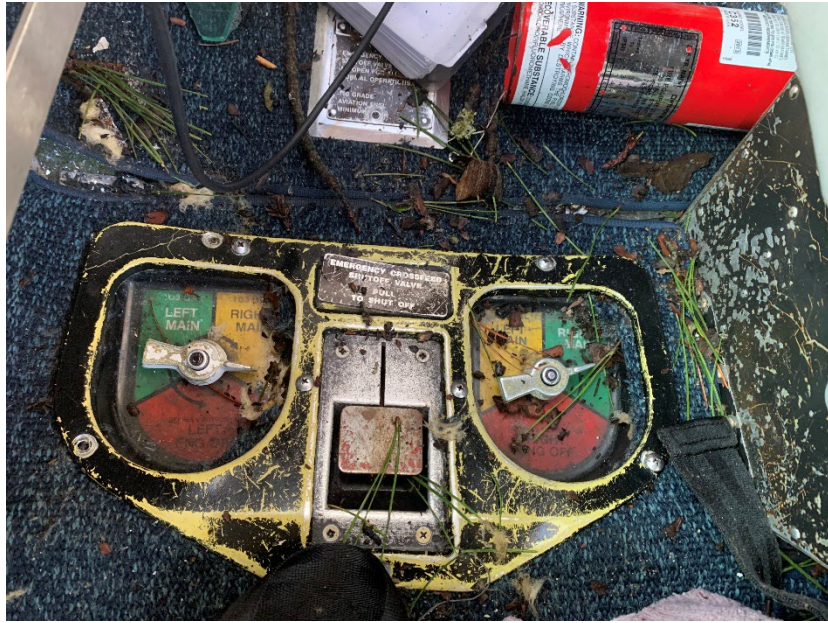
A single halon fire extinguisher was found lying on the floor just forward of the copilot seat (see figure 23). It is normally secured to the front of the copilot seat.

**Figure 23.** Figure extinguisher as found by investigators in the airplane.
