# National Transportation Safety Board

ERA21FA354

## AIRCRAFT PERFORMANCE STUDY

November 23, 2022

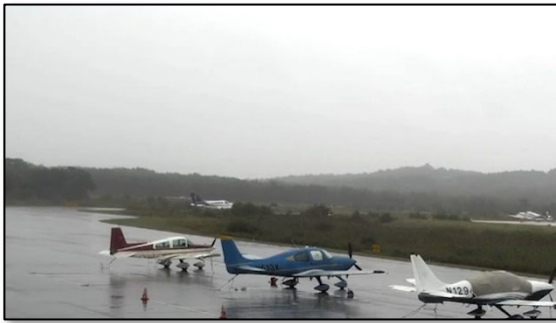
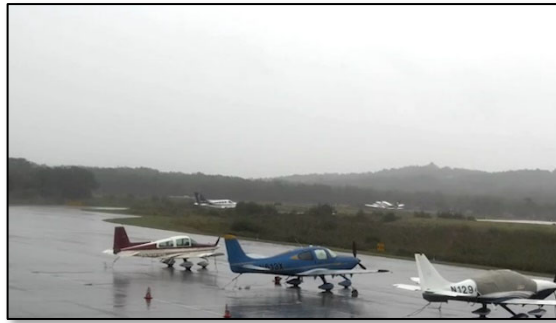
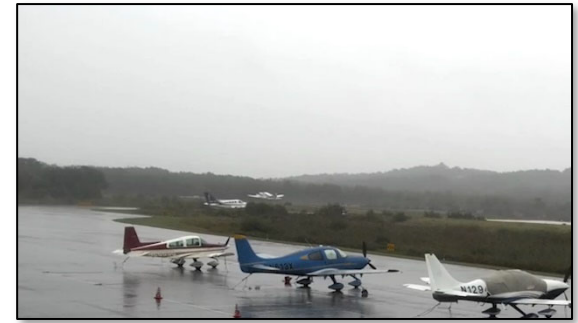
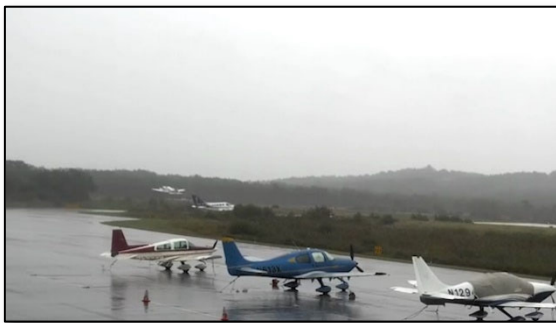
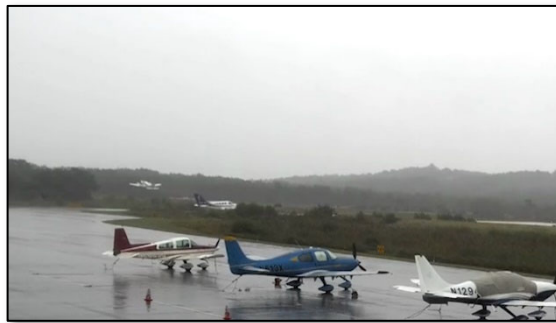
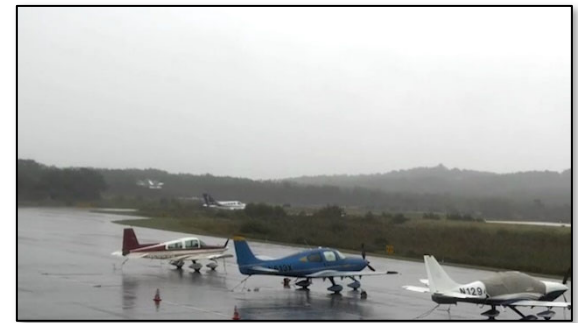
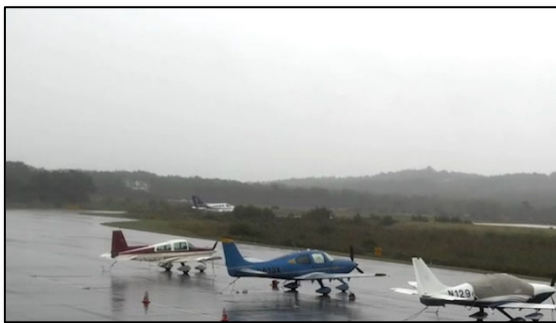
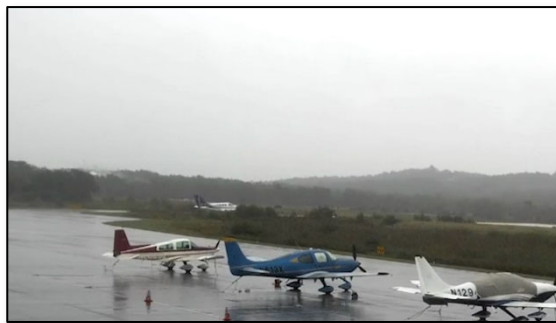
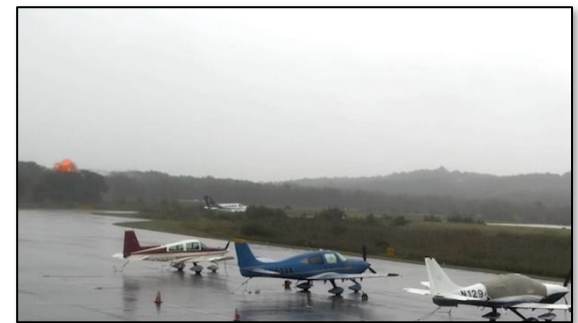
**Figure 3.** Selected frames from security camera video depicting departure from runway 7 and impact with trees. Note that the time intervals between the selected frames are not uniform.

A review of airport surveillance video revealed it was raining heavily at the time the accident airplane landed. As the airplane touched down on the runway, a splash of water was observed. During the landing rollout, as the airplane passed the airport's windsock, the windsock's movement was consistent with the airplane landing with a tailwind. The airplane then began to climb as it neared the end of the runway. The airplane entered a shallow climb and collided with trees. The video showed that the airplane disappeared into the trees and that a large fireball erupted shortly after.

As noted above, the airplane came to rest upright approximately 200 ft. from its initial contact with the trees. A series of frames from the surveillance video showing the airplane's impact with the trees is shown in Figure 3. Photos of the accident site, along with a *Google Earth* image of the departure end of the runway, tree line, and road near the accident site, are shown in Figure 4. The *Google Earth* image was taken on 10/23/2021 (45 days after the accident). As shown in the image, the wreckage location area was apparently cleared of trees to facilitate the removal of the wreckage.

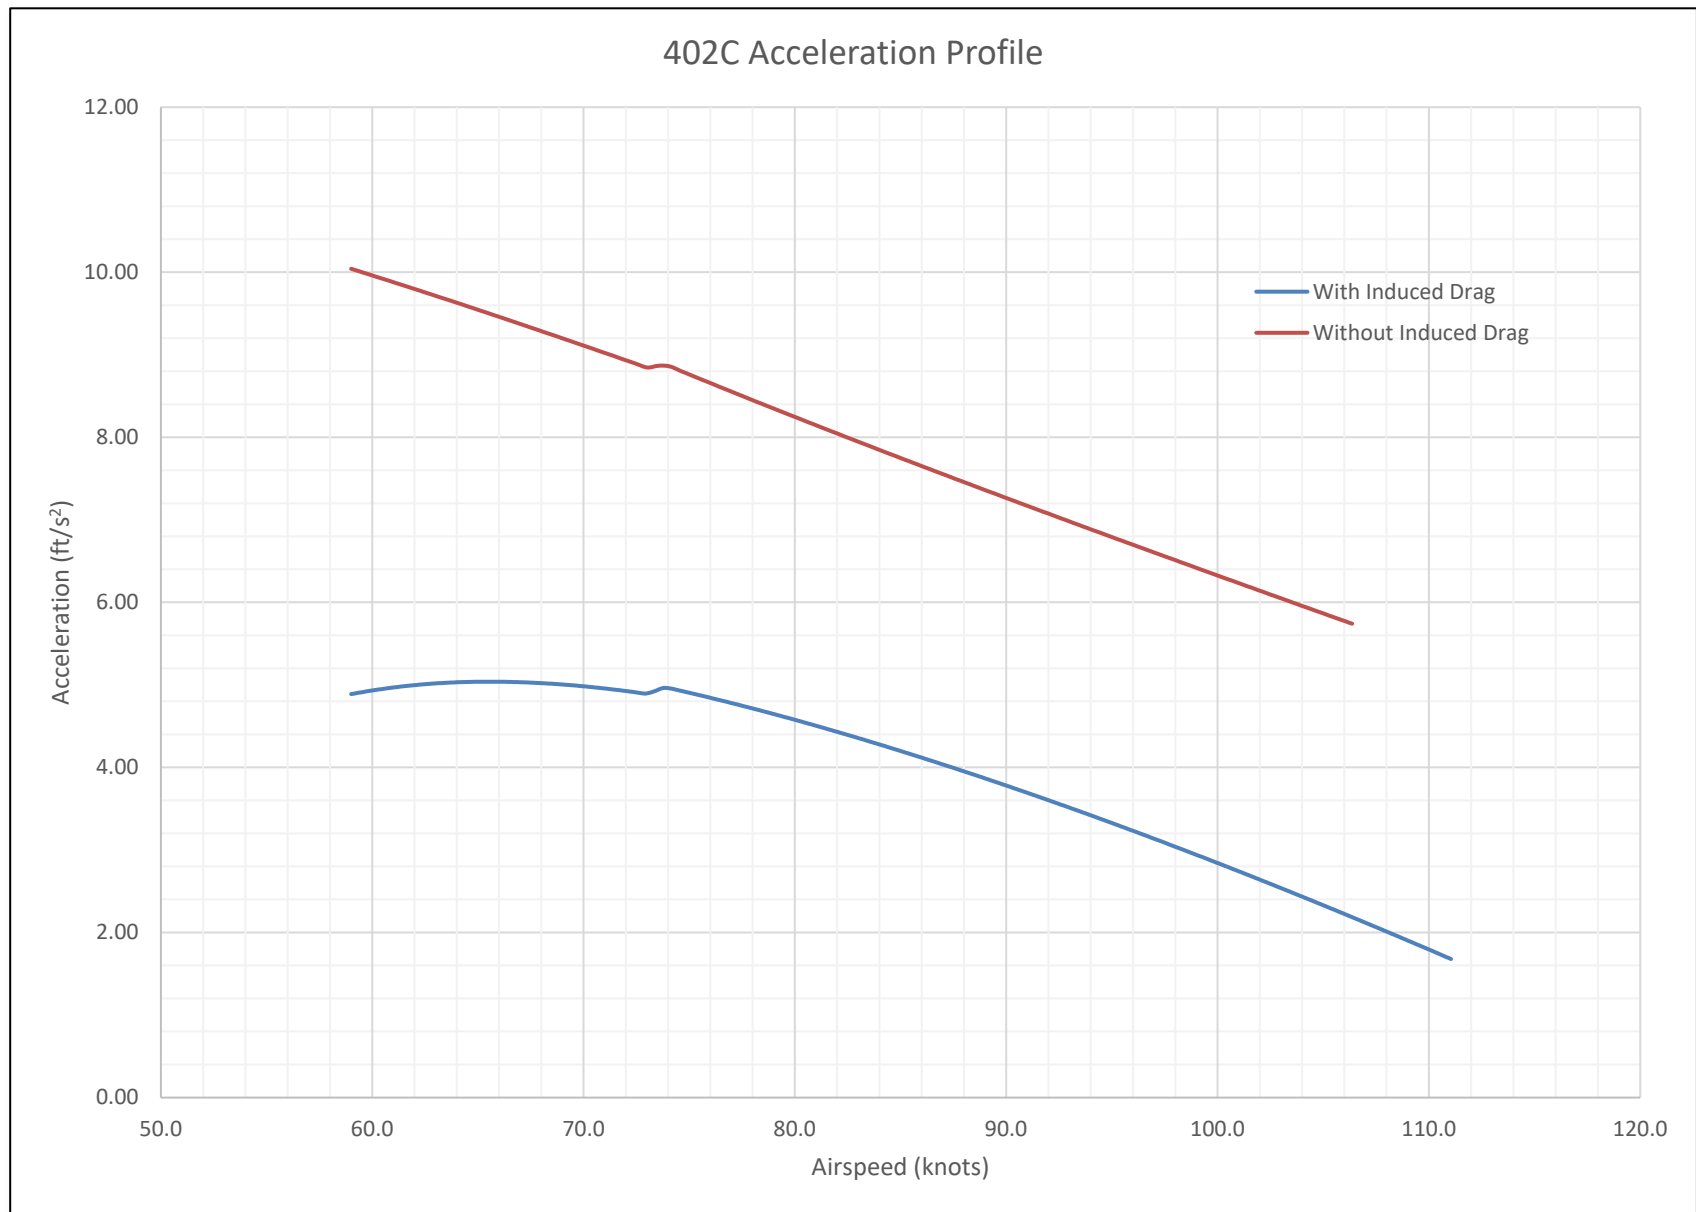
**Figure 7.** Cessna 402C level-flight acceleration capability at 6,215 lb. with flaps up and gear down (provided by Textron).

In response to an inquiry from the NTSB concerning the acceleration N88833 could have achieved during the attempted takeoff from runway 7, Textron provided the information presented in Figure 7. This figure plots the maximum-power acceleration of the Cessna 402C in level flight, with the flaps up and the gear down (the configuration found in the wreckage of N88833). Textron's document transmitting this data states

Figures 7, 10a, and 10b indicate that both ground effect and achieved acceleration have a significant effect on the airplane's climb performance. As Textron noted when communicating the data in Figure 7 to the NTSB, "the documented POH takeoff distance calculations were performed using only parasitic drag ( $C_D$ ) and ignored induced drag as a means to account for ground effect."

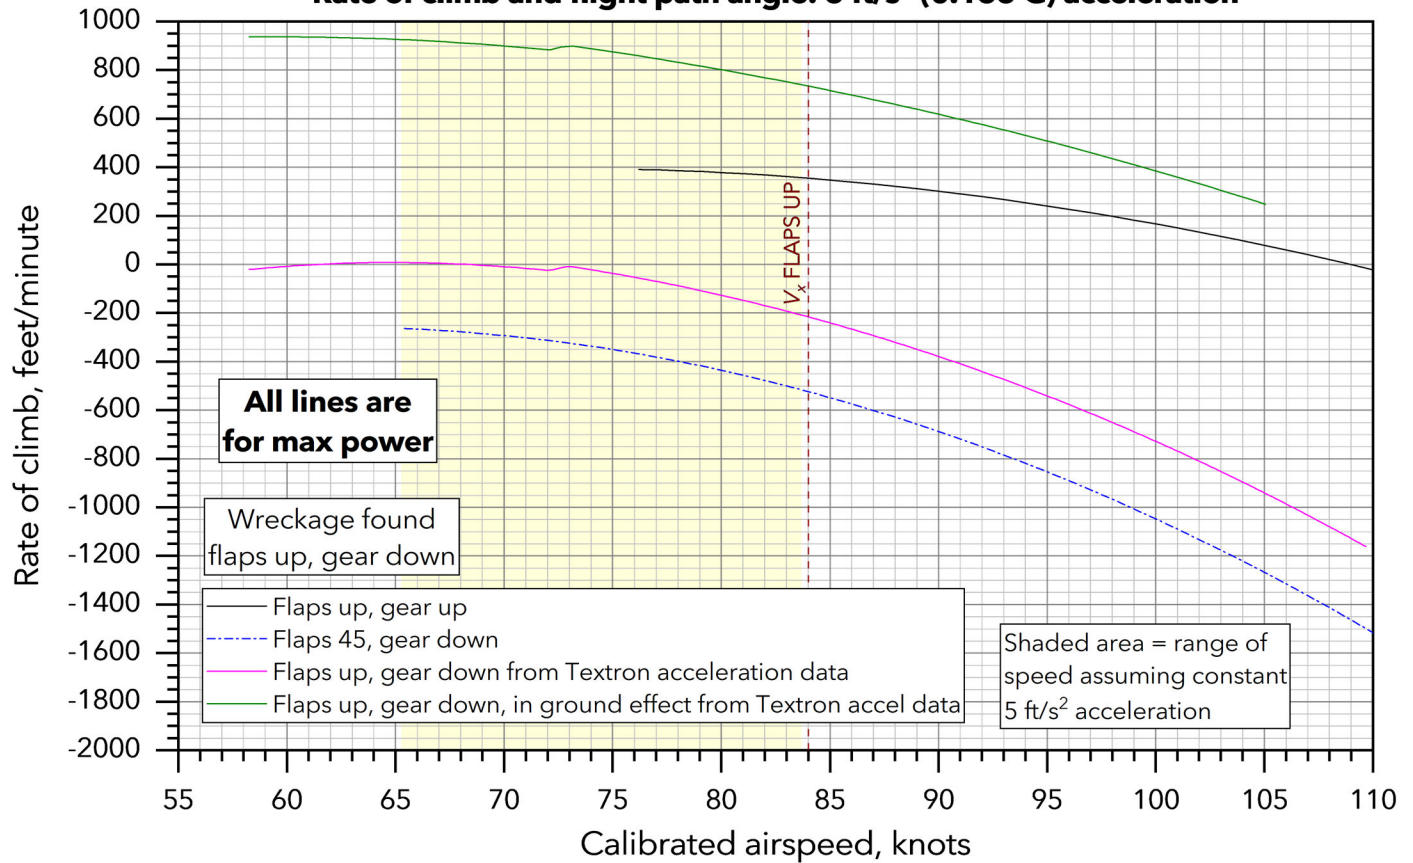
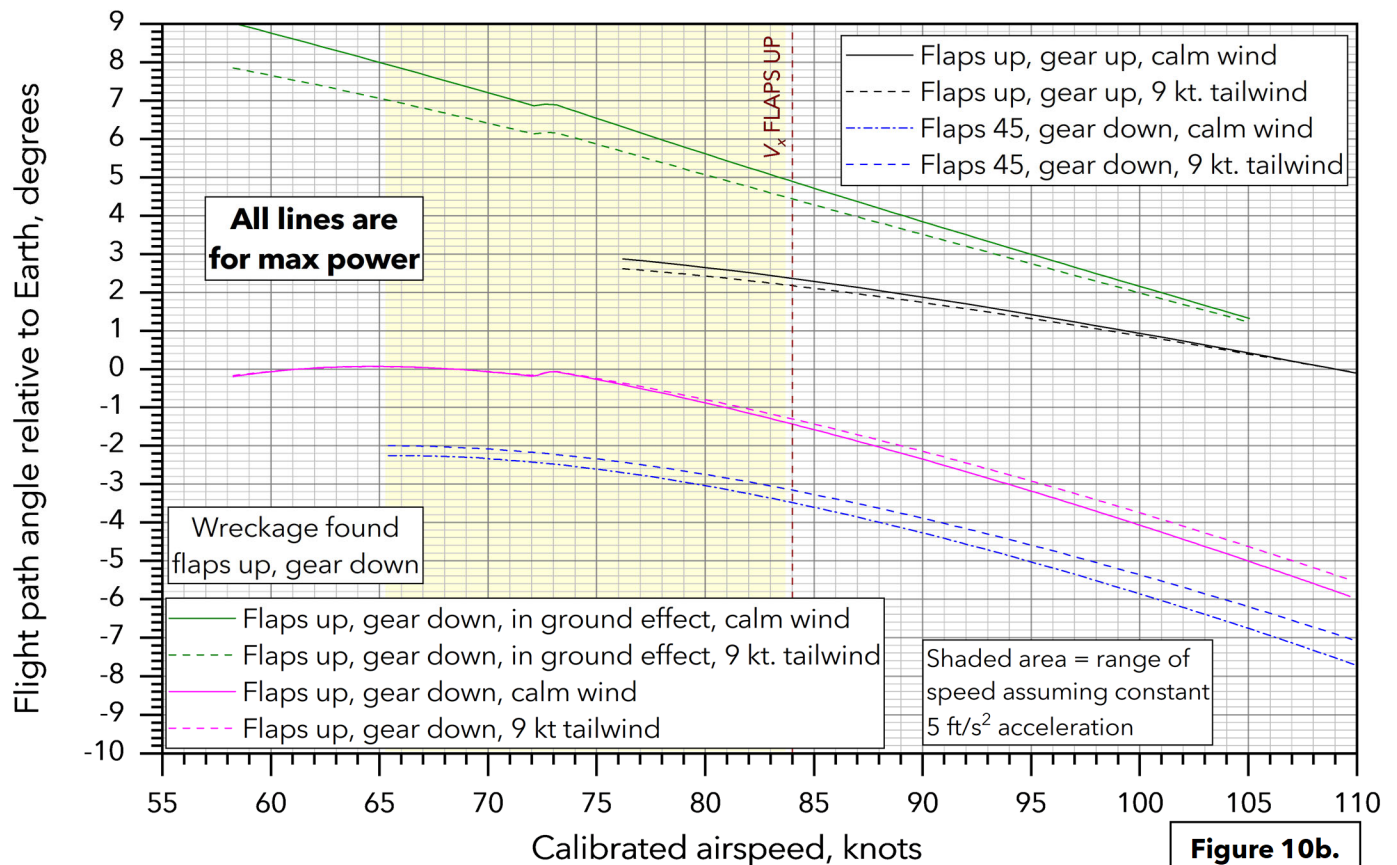
Figure 10b.

Figure 10b indicates that while accelerating at  $5 \text{ ft/s}^2$  (0.155 G) with the flaps up and the gear down, some ground effect is required to lift off; in free air (out of ground effect) all the engine power is required to overcome drag and accelerate the airplane. In the wreckage of N88833, the flaps were found up and the gear down. It is not known when the flaps were retracted, but it was likely on the ground soon after the pilot decided to abort the landing and attempt to take off again. This timing would be consistent with the procedures for a "touch-and-go," and the negative climb rate depicted in Figure 10b indicates that it is unlikely that the airplane could have accelerated and taken off with flaps  $45^\circ$ .

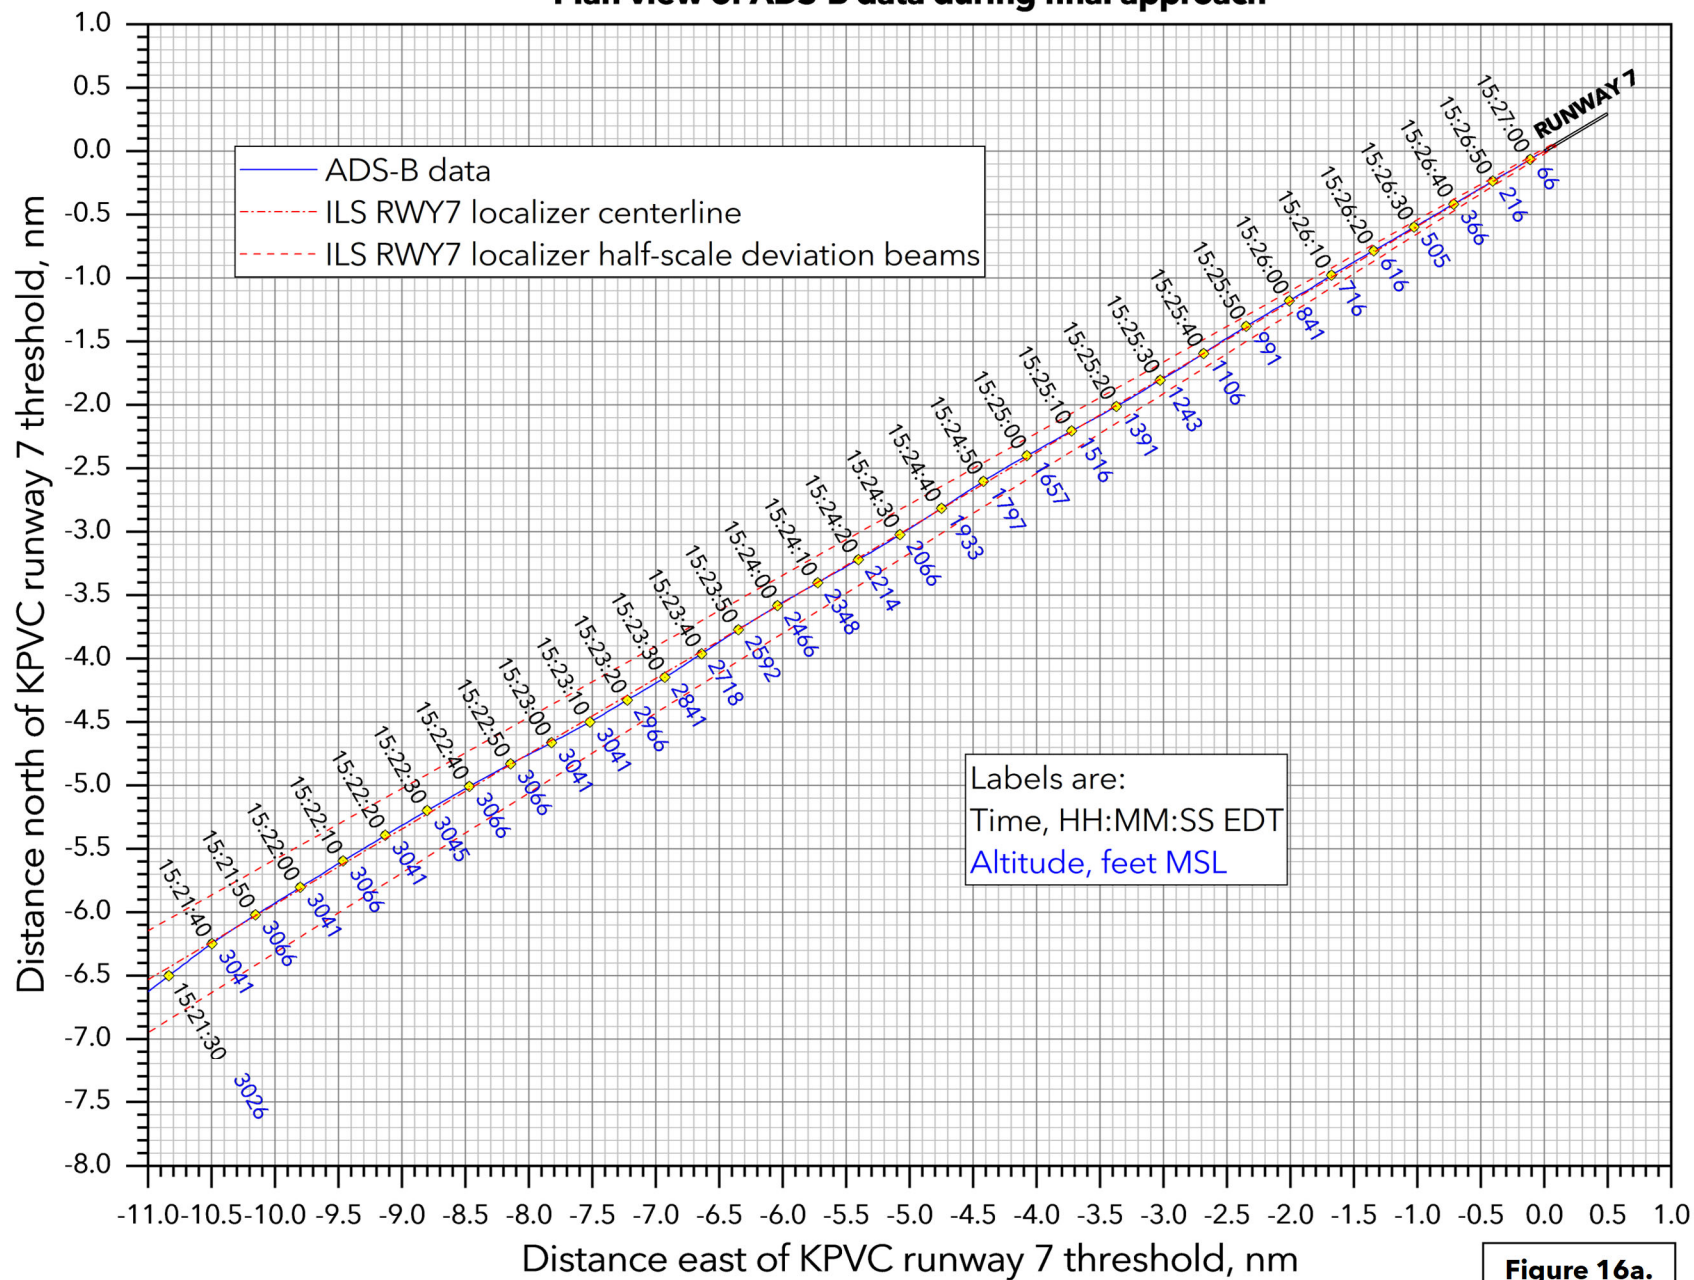
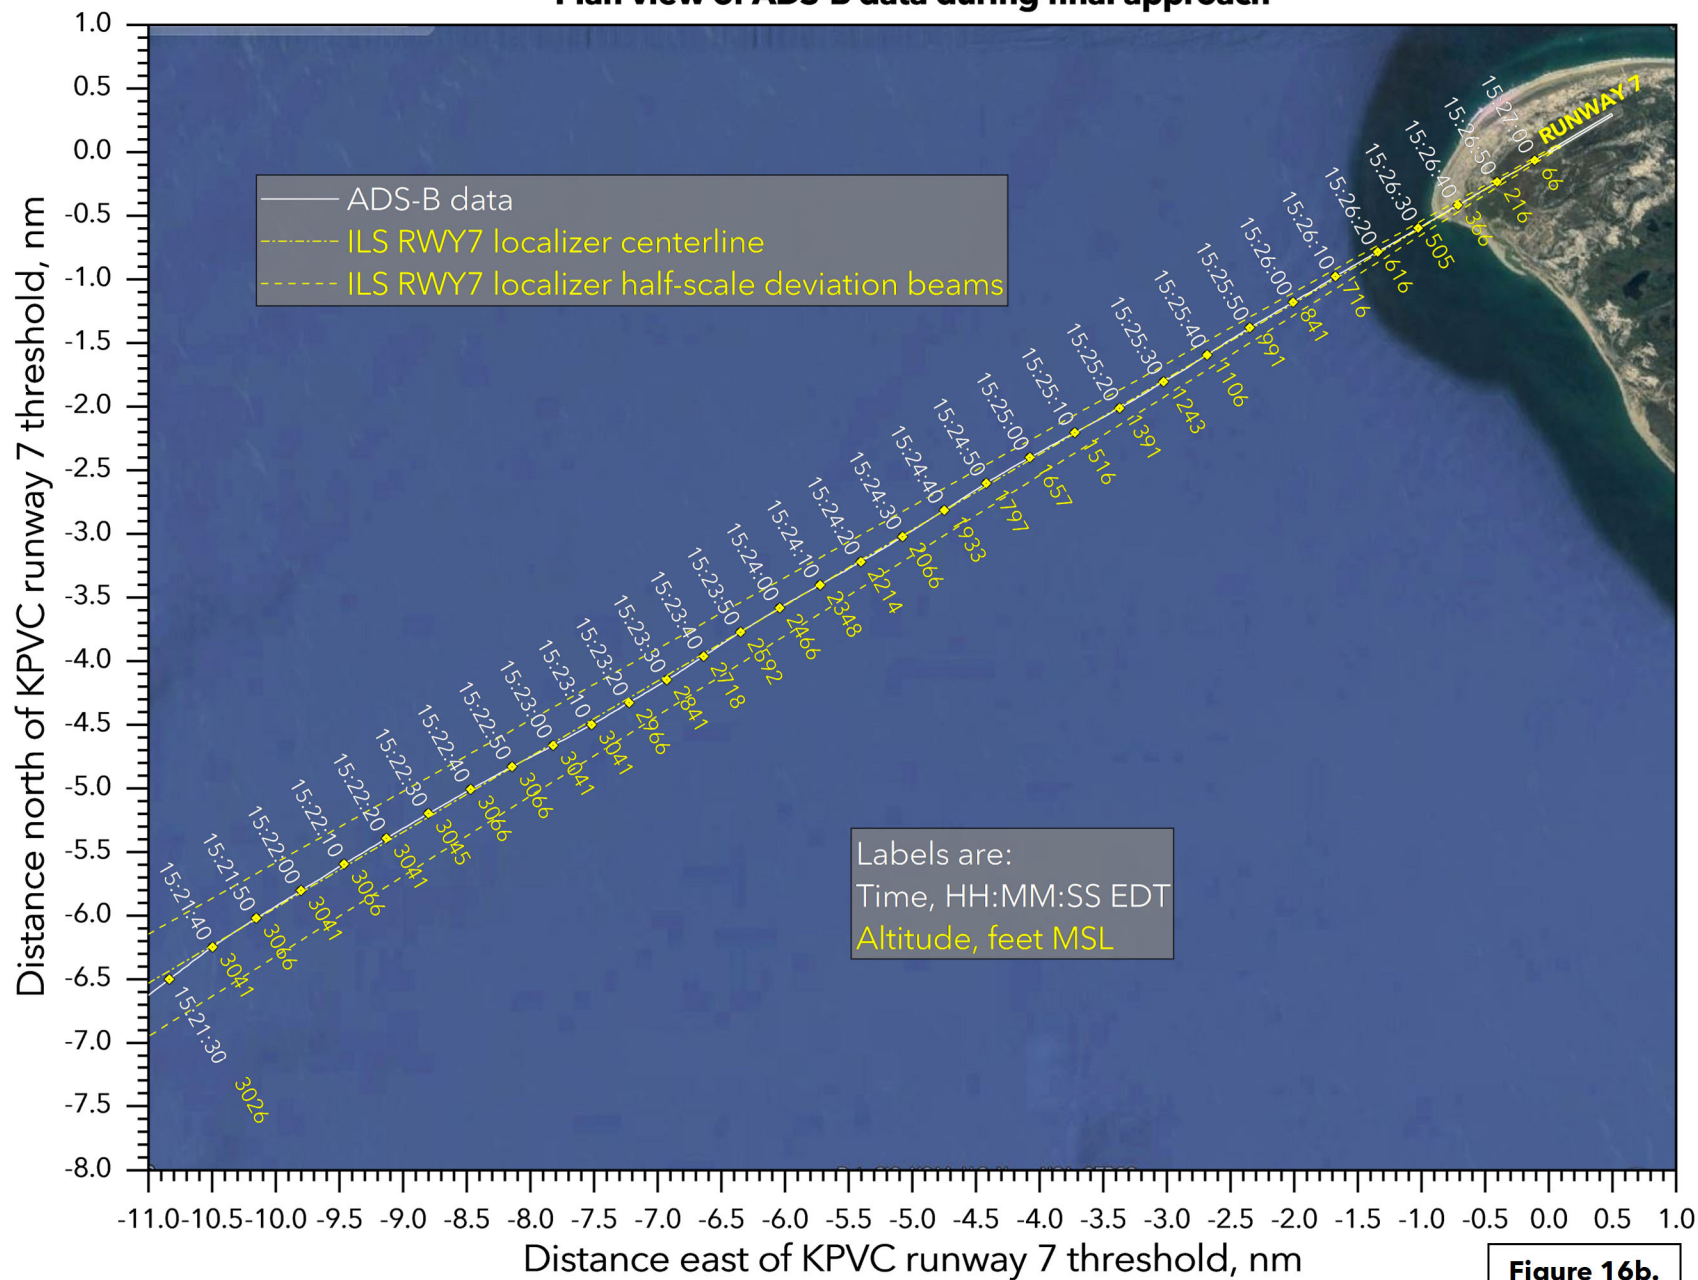
At 15:25:40, N88833 descended through 1,100 ft. MSL centered on the localizer for the ILS approach to KPVC runway 7 (see Figures 16 and 17). The airplane was slightly above the ILS glideslope centerline, at an airspeed of 129 KCAS and descending at about 760 ft./min. (see Figures 18 and 21). The airspeed was slowly decaying, at about 1 knot every 10 seconds. Since the airplane was not equipped with (or required to be equipped with) an FDR, it is not known when the flaps or gear were extended.

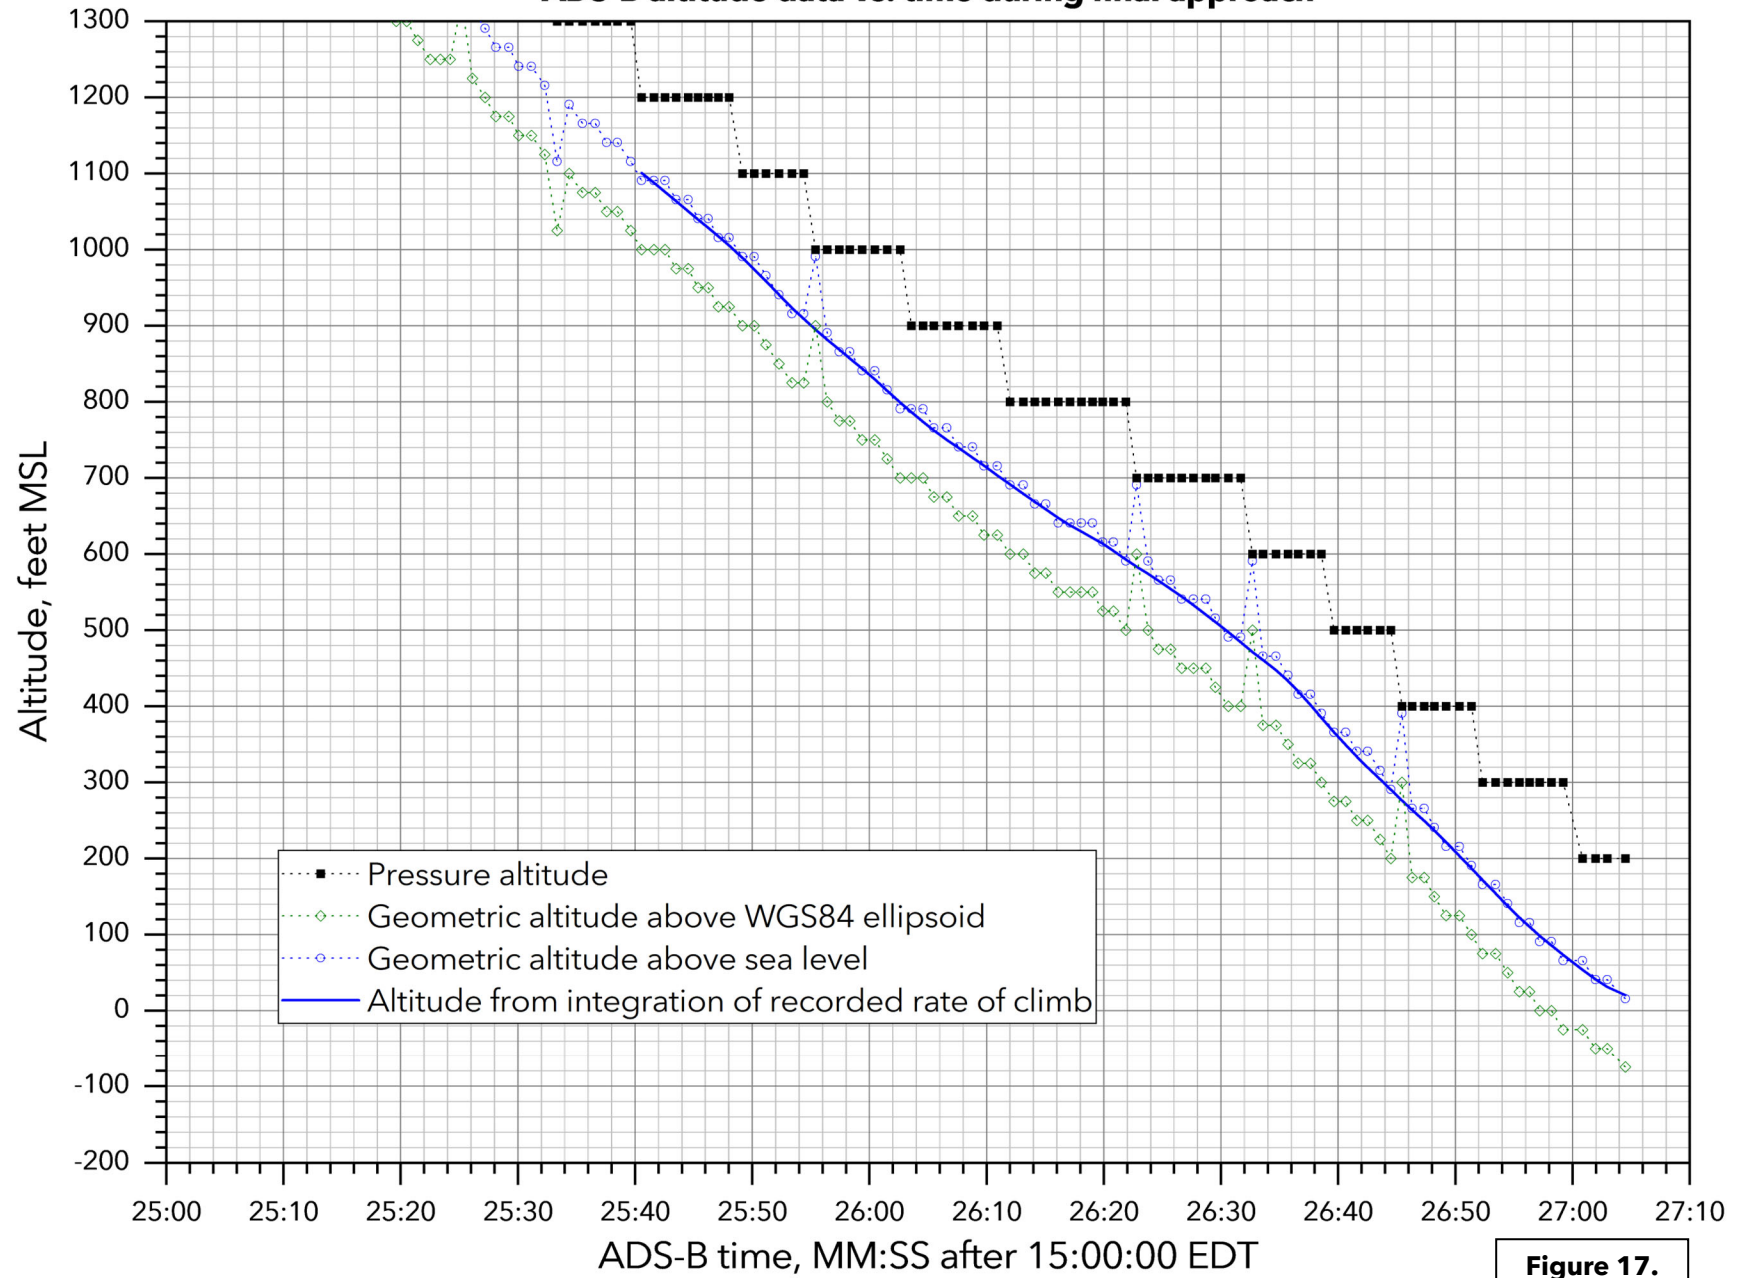
Figure 17.

Figure 17 indicates that N88833 was at 58 ft. MSL (50 ft. above the runway) at about 15:27:00; at that time, the airspeed was 107 KCAS (and 110 KIAS at flaps 45°, per the airspeed calibration table in the POH/AFM). Consequently, the airplane was 15 KIAS above the 95 KIAS target at 50 ft. AGL recommended by the POH/AFM and the NPH. Considering that at the accident weight (6,215 lb.) the target speed at 50 ft. is 89 KCAS / 90 KIAS, at 110 KIAS the airplane was 20 KIAS faster than this target.
