Re: Party Submission – NTSB Accident Investigation (ERA21FA354)

## **Hyannis Air Service, Inc. Safety Improvements**

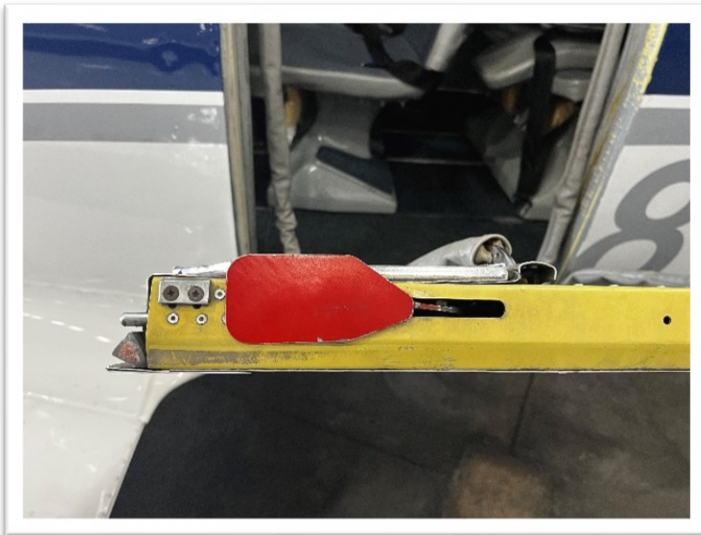
#### **Door Handle Painted Red**

Overview – The company has painted all Cessna 402C aircraft lower airstair door handles red in an effort to make the handle more easily visible in case of an emergency evacuation. Post accident, the lower airstair door was found in the upright/closed position and able to function normally. Additionally, passengers did not indicate that they attempted to open the lower airstair door. This enhancement improves the ability for passengers to see and operate the door during egress.
