**NATIONAL TRANSPORTATION SAFETY BOARD**  
Vehicle Recorder Division  
Washington, DC 20594

## Video Study

| Aircraft: | Cessna 414, N8132Q |
| NTSB Number: | ERA21LA011 |

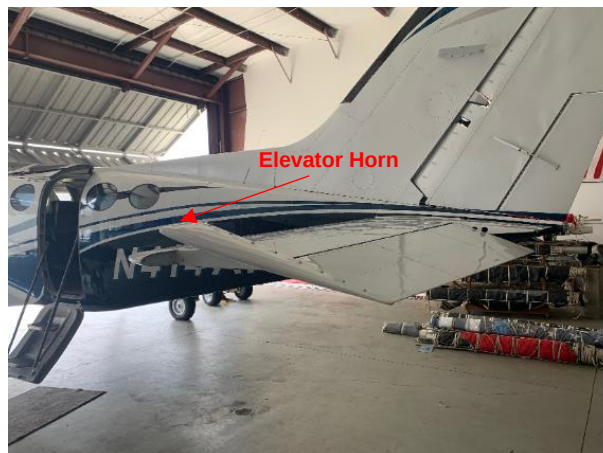
Extracted frames from videos IMG\_3210.mov and IMG\_1405.mov were captured, enhanced and compared to an exemplar image of a Cessna 414 with an elevator control lock installed. The condition of the exemplar Cessna 414 with the elevator control lock installed is shown in figure 4. Figure 4 shows the elevator in a trailing edge down position. Elevator "horns" which are visible on the outer edges of the elevator are shown being above the horizontal stabilizer surface. This is annotated in figure 4.

Figure 4. A exemplar photo of a Cessna 414 with an elevator control lock installed. The elevator is fixed in a trailing edge down position. Elevator horns are seen on the edge of the horizontal stab and above the horizontal stab.

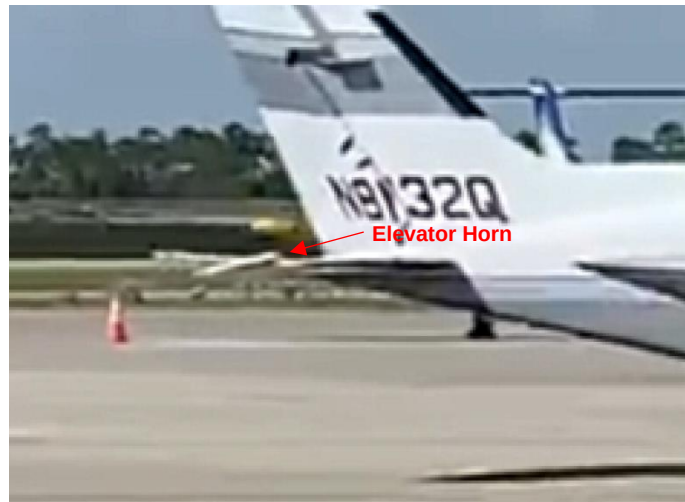
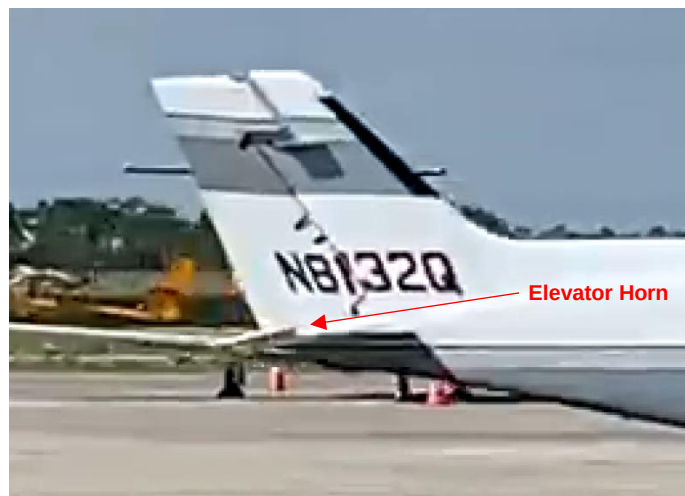
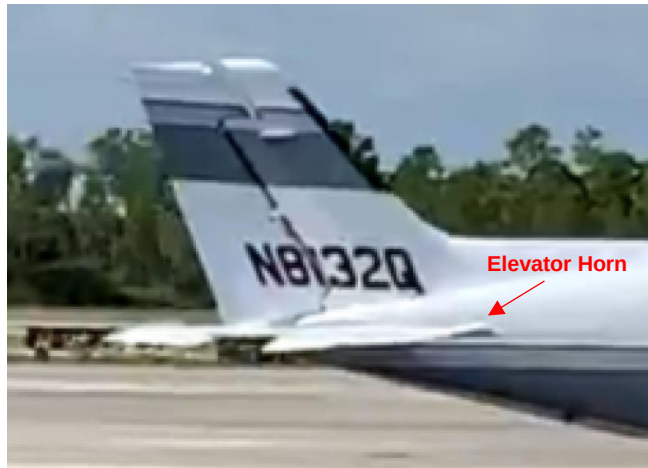
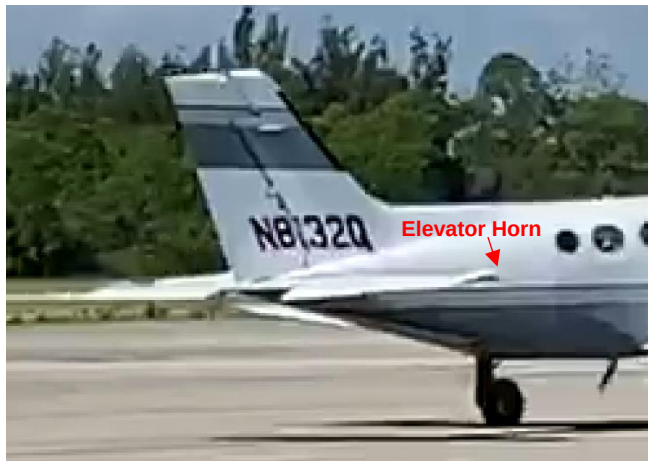
Figures 5, 6, 7 and 8 are extracted frames from IMG\_3210.mov. The frames were zoomed, cropped, and filtered with a series of sharpness and blur effects in an attempt to clarify the image. The elevator is in a trailing edge down position shown on the figures. The exact position of the elevator in relation to the horizontal stab was not quantified.

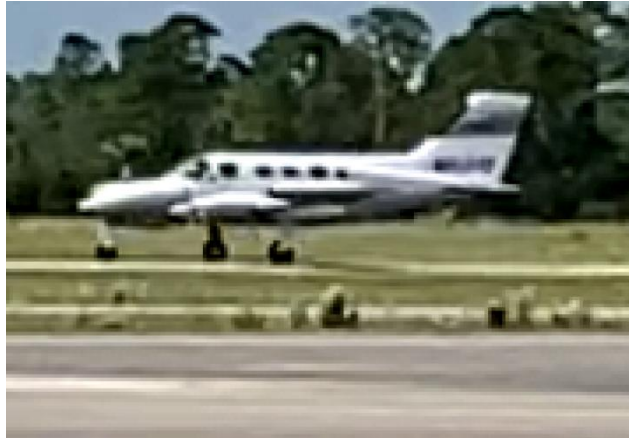
Figure 9. An extracted frame from IMG\_1405.mov.

Figure 9 is an extracted frame from IMG\_1405.mov. The figure shows the accident aircraft was on a takeoff roll approximately 1,900 feet from the runway 14 threshold. The frame has been zoomed, cropped, and filtered with a series of sharpness and blur effects in an attempt to clarify the image. The elevator position was unable to be determined from this image. As the aircraft passed the observer and traveled down the runway, the tail of the aircraft was visible, however, at the resolution provided, a determination of elevator position was unable to be made.

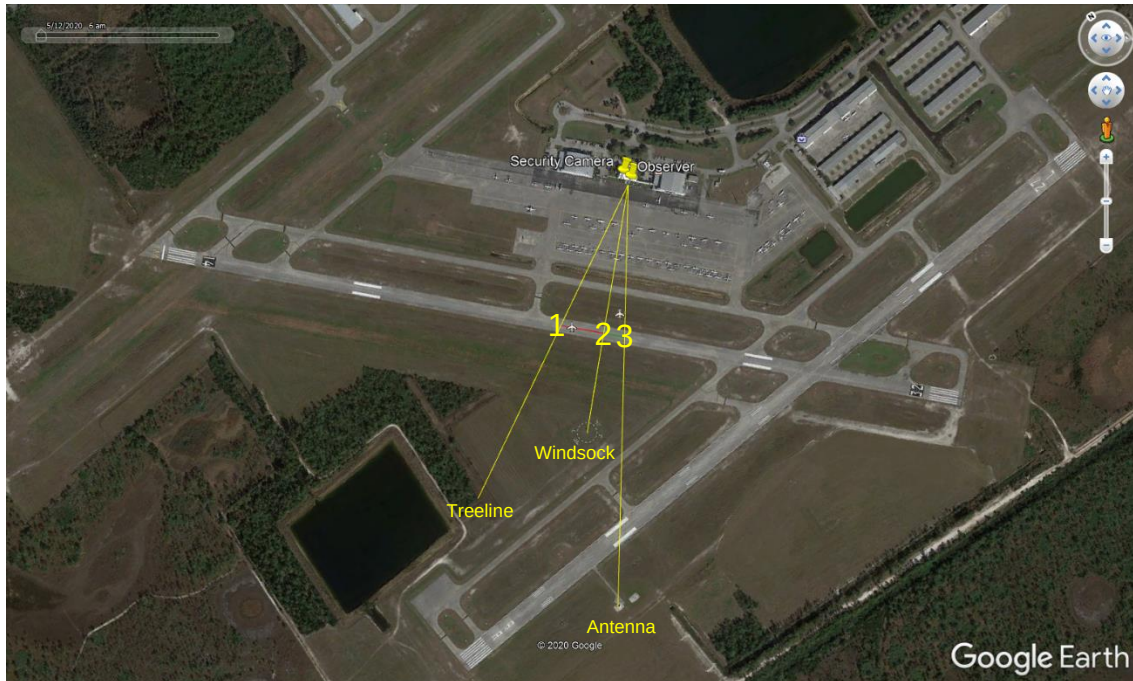
Using the information from IMG\_1405.mov, three lines of sight were identified from the observer's perspective, and they were translated to a geographical map (Google Earth). Figure 11 shows these three lines of sight, path 1, path 2 and path 3. Path 1 translates from the observer's position, across the runway and to the leading edge of a bank of trees. Path 2 translates from the observer's position, across the runway and to the airport's windsock. Path 3 translates from the

observer's position, across the runway and to an antenna structure adjacent to runway 9R. Three virtual points were created on the runway where path 1, path 2 and path 3 cross the runway's centerline. These points are now referred to as point 1, point 2 and point 3. When measured on Google Earth, the distance between these points 1 and 2 is approximately 231 feet, and between points 2 and 3 is 113 feet. The red line indicates the distance between points 1 and 2 and the green line indicates the distance between points 2 and 3.

**Figure 11. Lines of sight identified on airport property that translate to the observer's position in IMG\_1405.mov.**

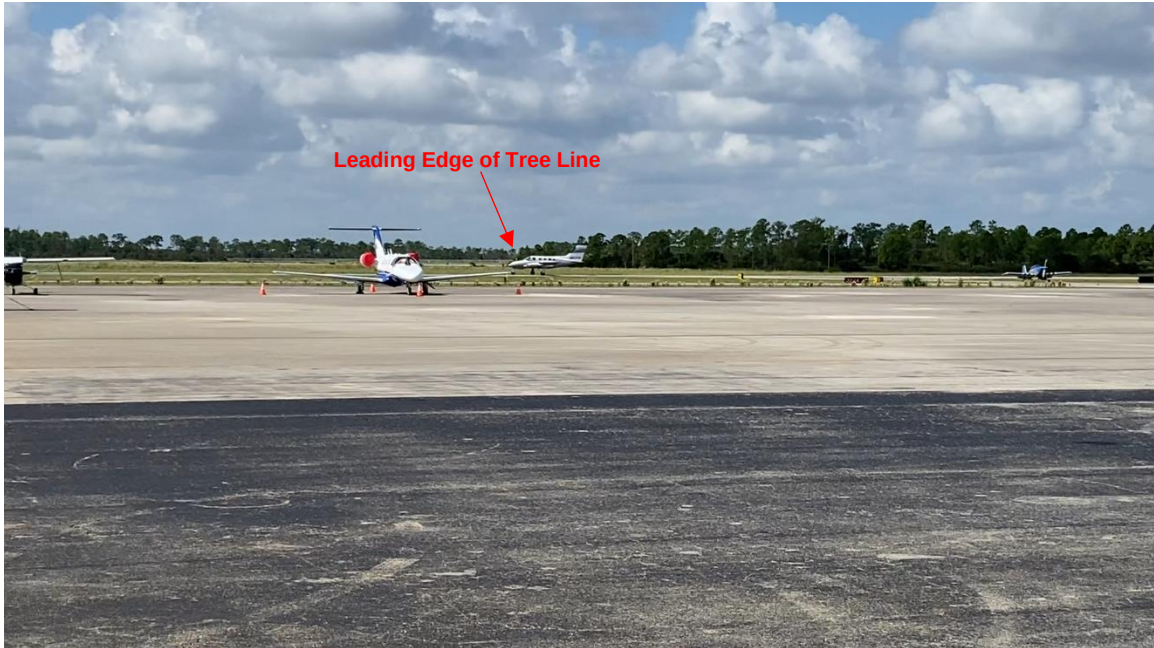
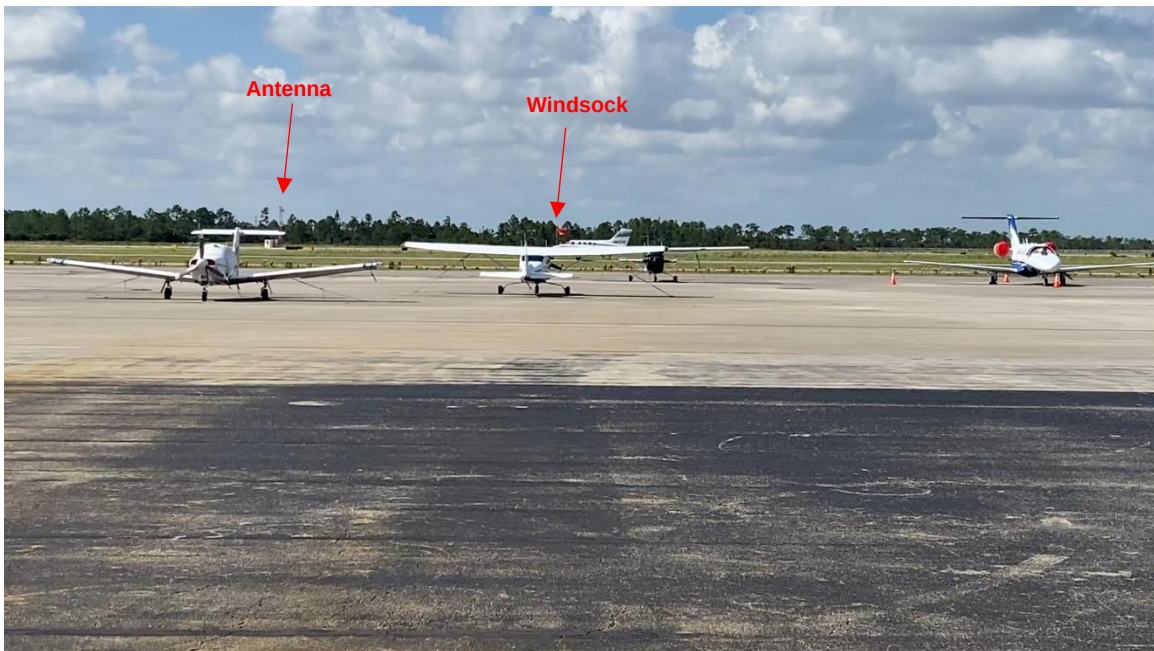
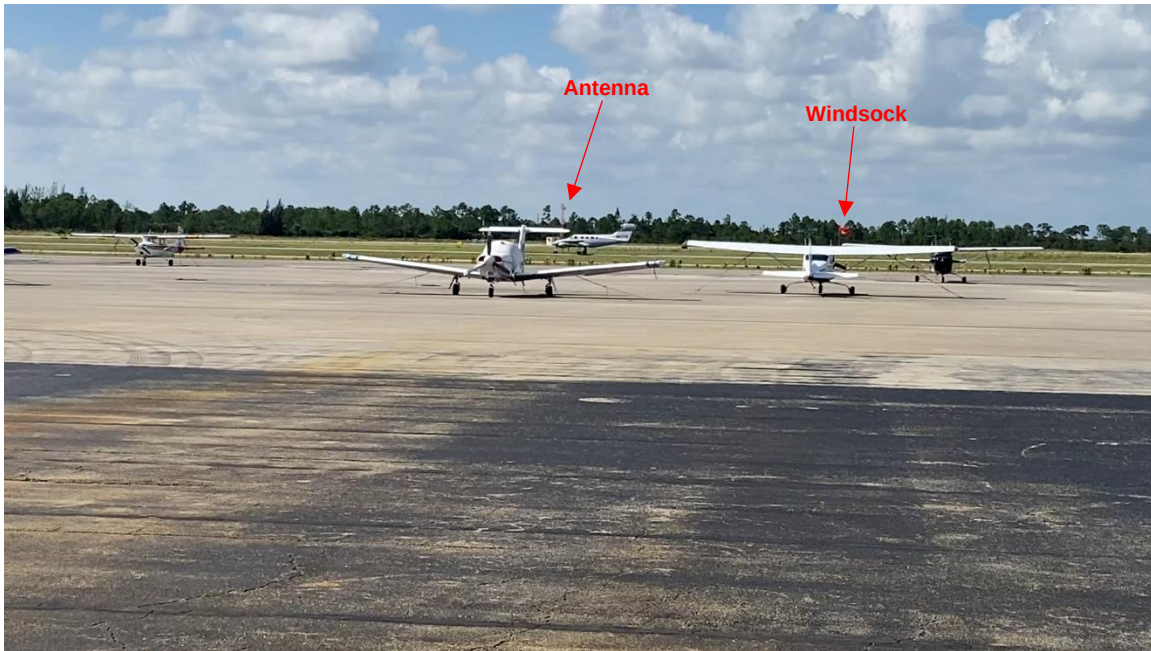
Next, three frames were extracted from IMG\_1405.mov that show the aircraft's nose intersecting these two positions. Figure 12 shows the aircraft at point 1. Figure 13 shows the aircraft at point 2. Figure 14 shows the aircraft at point 3. For the aircraft to travel between points 1 and 2, 44 frames had elapsed, or approximately 1.467 seconds had passed based on the camera's frame rate of 30 frames per second. For the aircraft to travel between points 2 and 3, 20 frames had elapsed, or approximately 0.667 seconds had passed based on the camera's frame rate of 30 frames per second.

Assuming the aircraft was on the runway's centerline, the distance (D) traveled between points 1 and 2 was 231 feet. The aircraft accomplished this in 44 frames, or 1.467 seconds (t). Using the formula of calculating average speed ( $v = \frac{\text{distance } (D)}{\text{time } (t)}$ ), yields the average ground speed of the accident aircraft between point 1 and point 2 was 157 feet per second, or 93 knots.

Using the same equation, a distance of 113 feet and 20 frames (0.667 seconds) between points 2 and 3 yields the average ground speed of the accident aircraft between point 2 and point 3 was 169 feet per second, or 100 knots.

The aircraft's average groundspeed between segments 1 and 2 suggested the aircraft was accelerating at this time.
