## Robinson Helicopter Company Accident Report

| AIRCRAFT MODEL: | <u>R22 Beta II</u> |
| REGISTRATION: | <u>N566BC</u> |
| NTSB IDENTIFICATION: | <u>ERA21LA024</u> |

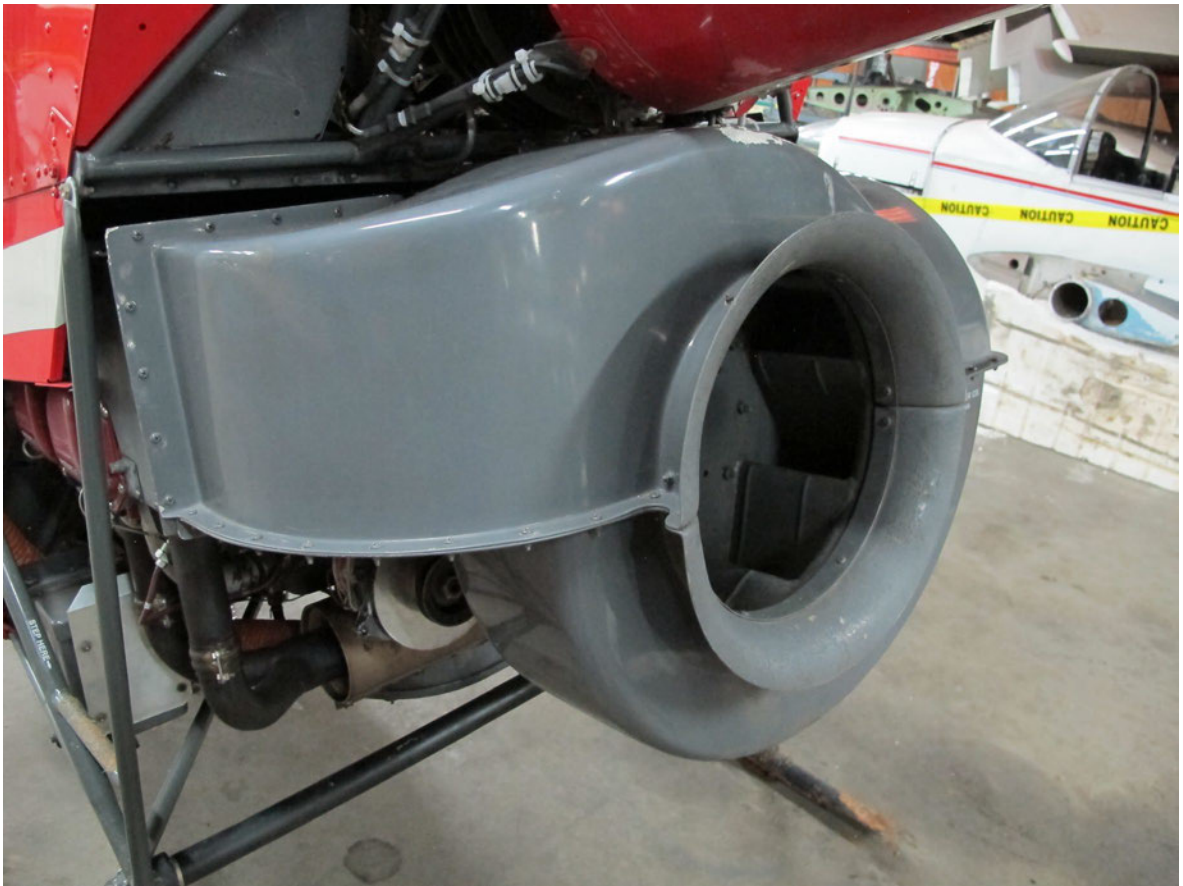
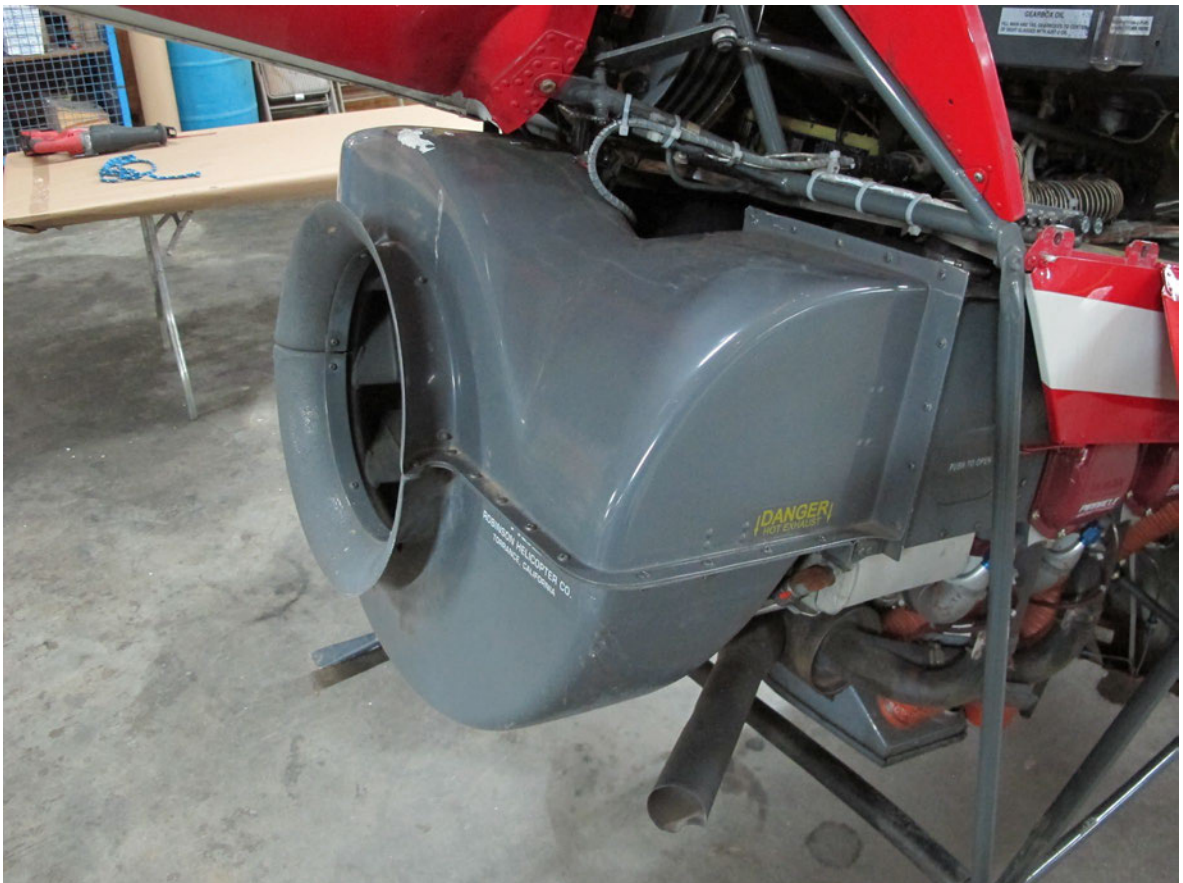
Above and below: Cooling scroll and fan.

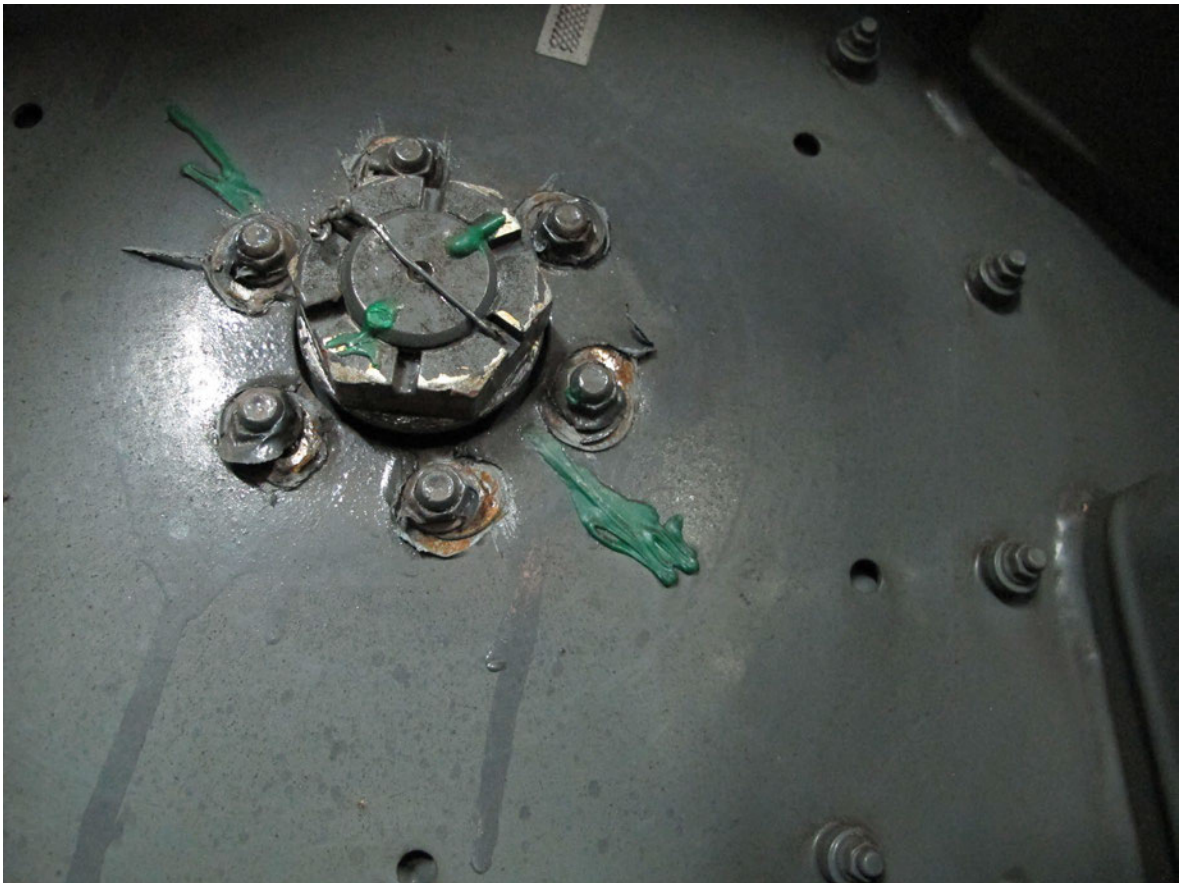
The alignment marks (torque stripe) on the cooling fanwheel were not aligned with the marks on the nut by about 90° and misaligned with the roll pin by about 10°.

The paint around the fanwheel to hub hardware was displaced and there was surface corrosion on the exposed metal around the hardware. The threads of the bolts extended more than two threads beyond the nuts but the bolts could be easily rotated with a wrench. The fanwheel could not be removed using the appropriate tooling. Heat was applied to the hub but still would not separate. The fanwheel was disassembled, exposing the damage (oval shape) to the fanwheel to hub mounting holes in both the fanwheel and backing plate.

Fanwheel to hub attachment hardware and hub nut. Note misaligned torque stripe.

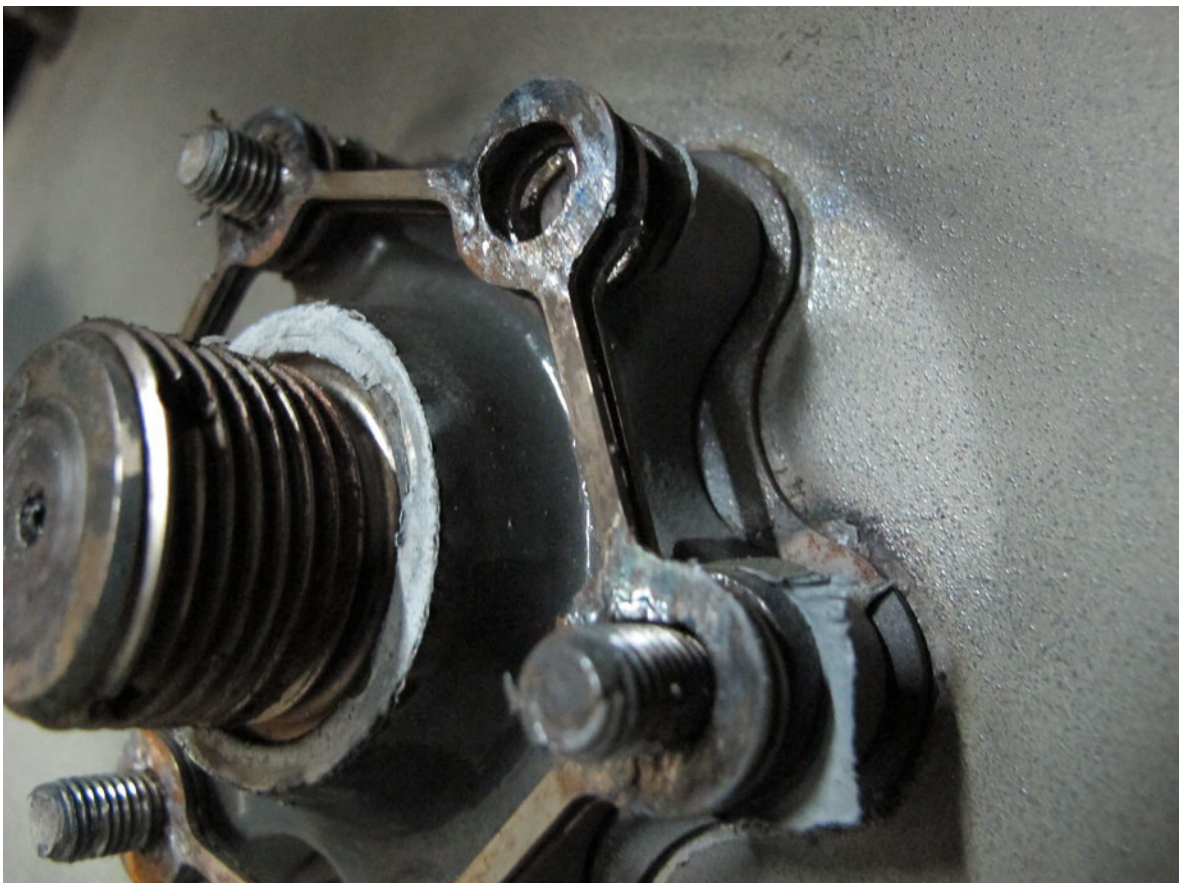
Fanwheel hub and spacer with fanwheel removed.

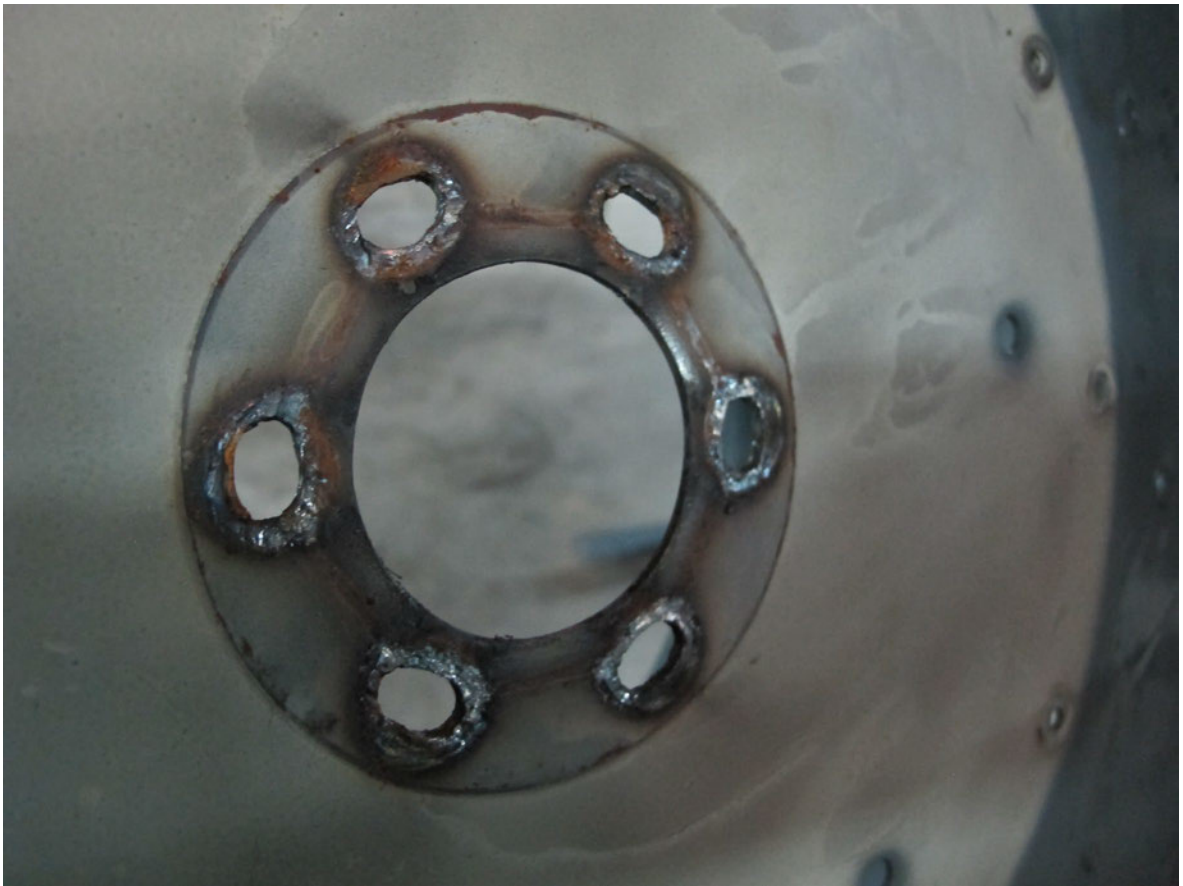
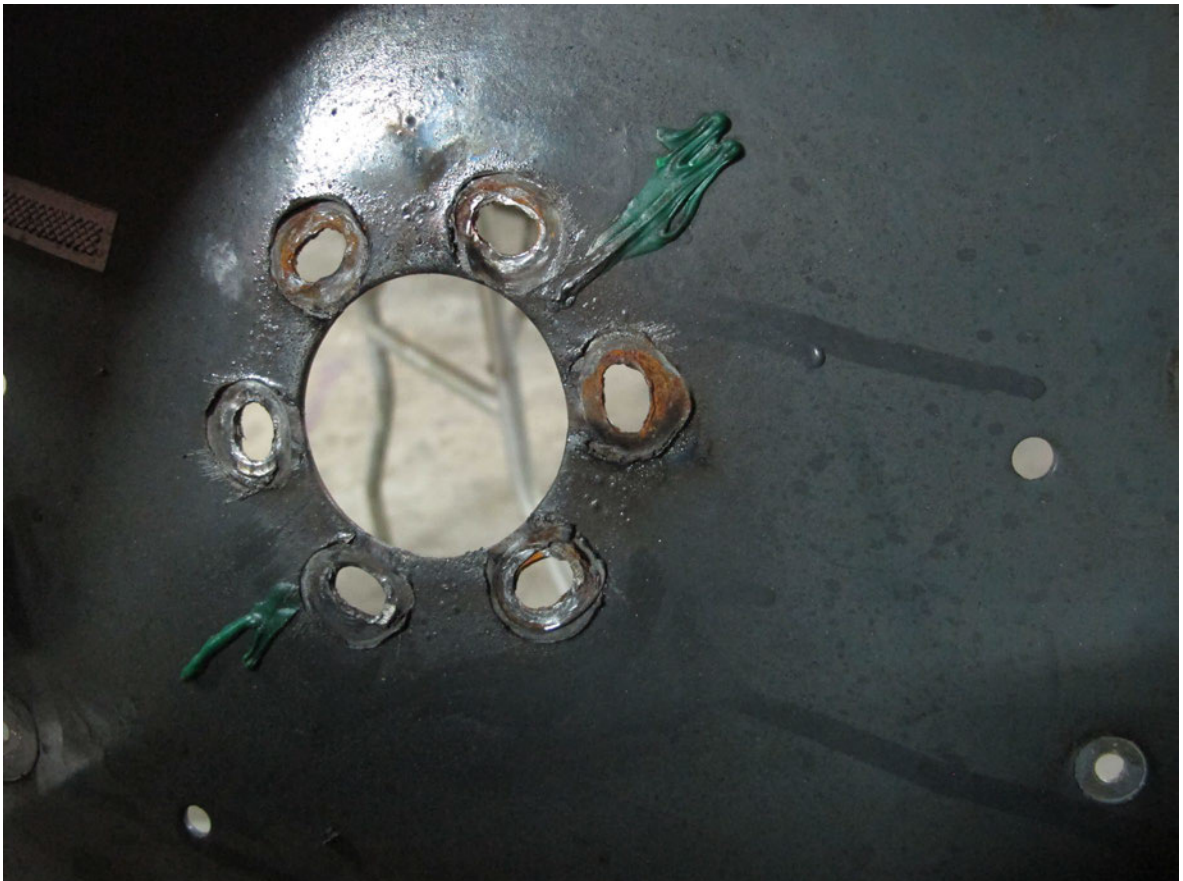
Above and below: Fanwheel to hub mounting holes.  
Note: The black soot is from applying heat to the hub while attempting to remove it.

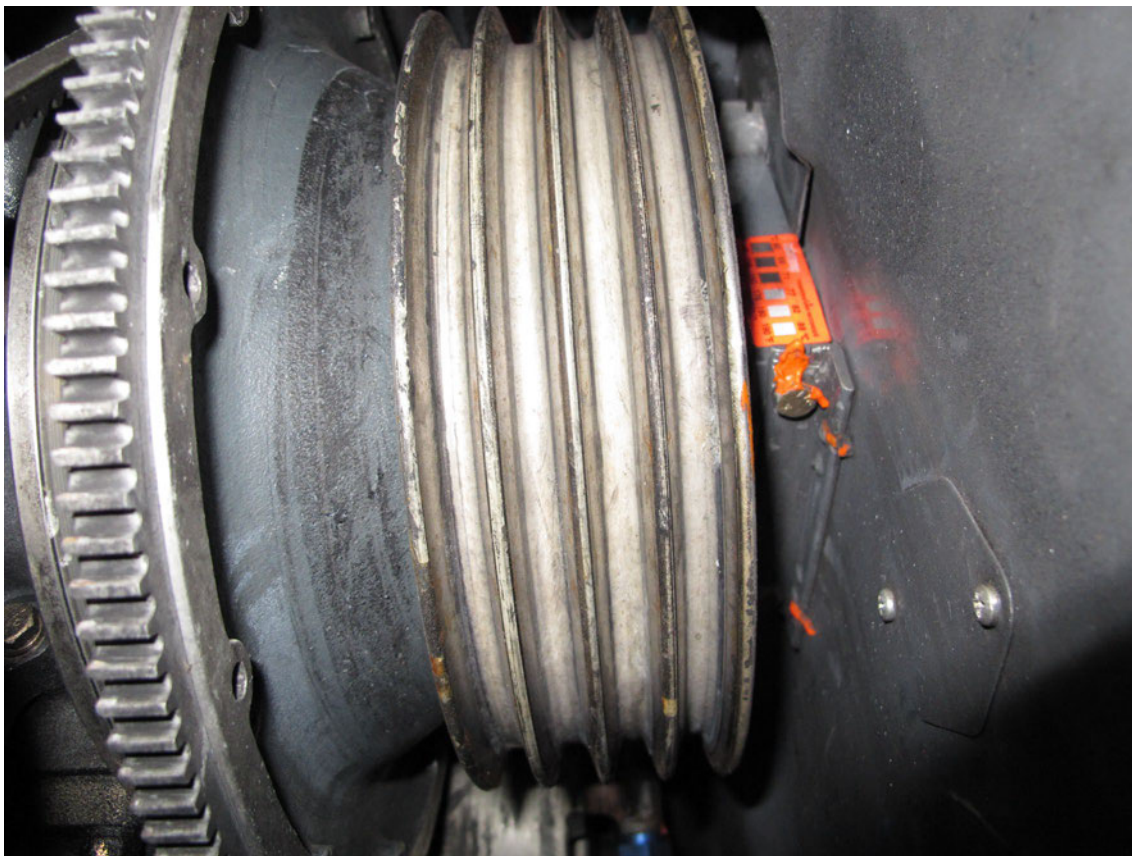
The lower and upper sheave grooves were unremarkable. Most of the V-belts were not recovered. A 2' section of one vee was recovered. The backing was not present. One end had a jagged surface, the other end was frayed. The friction surfaces were smooth with no glazing or thermal damage.

The lower sheave grooves.

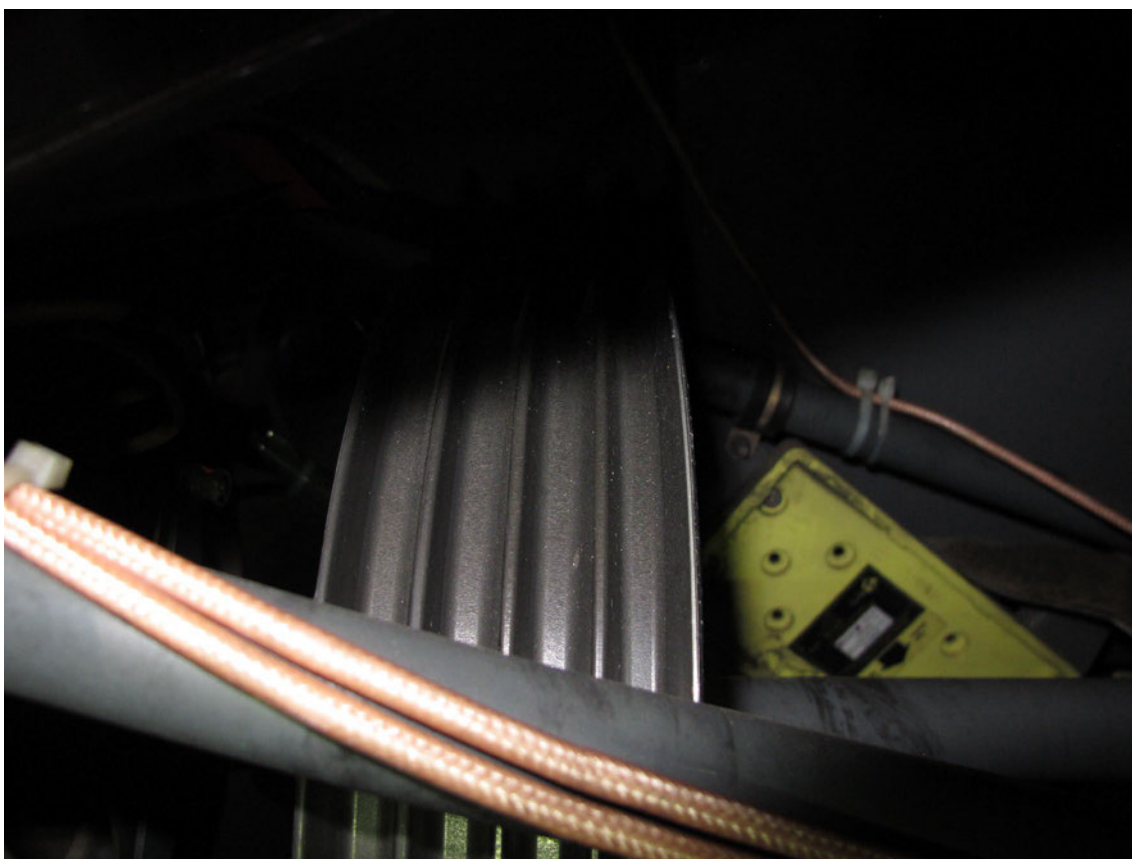
The upper sheave grooves.

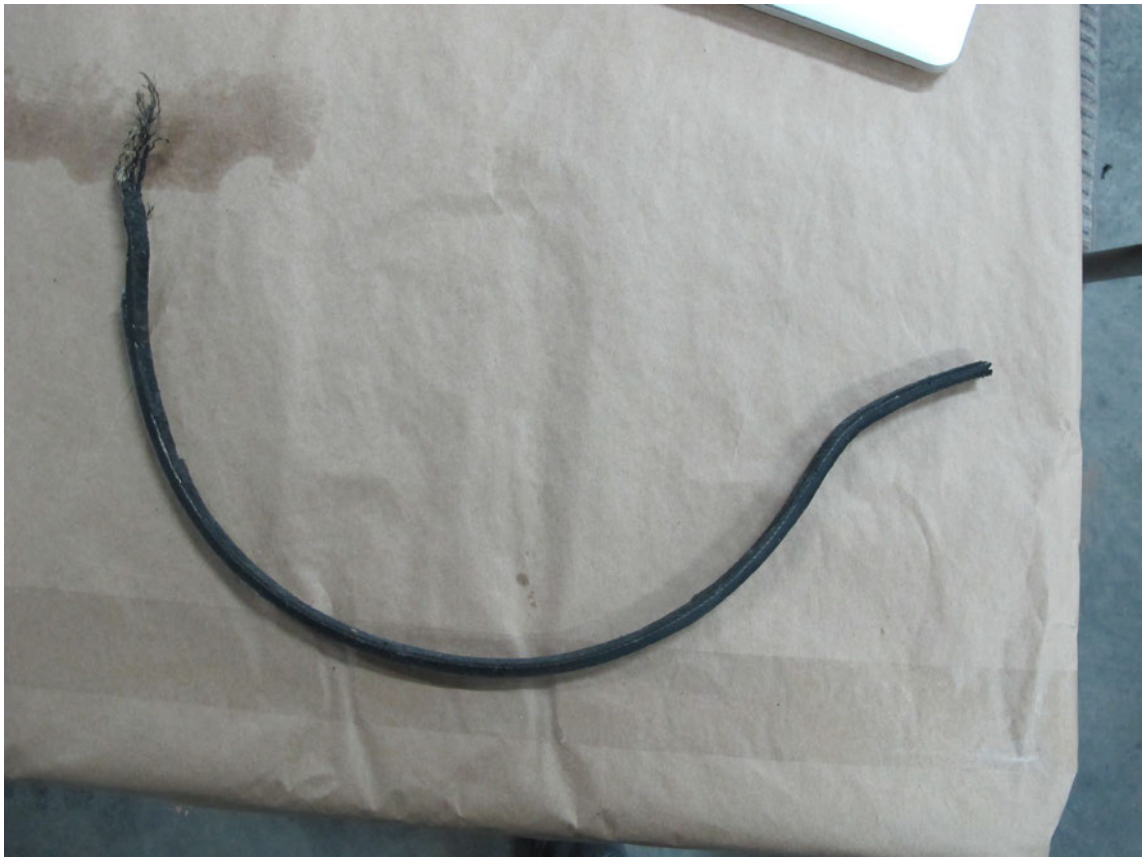
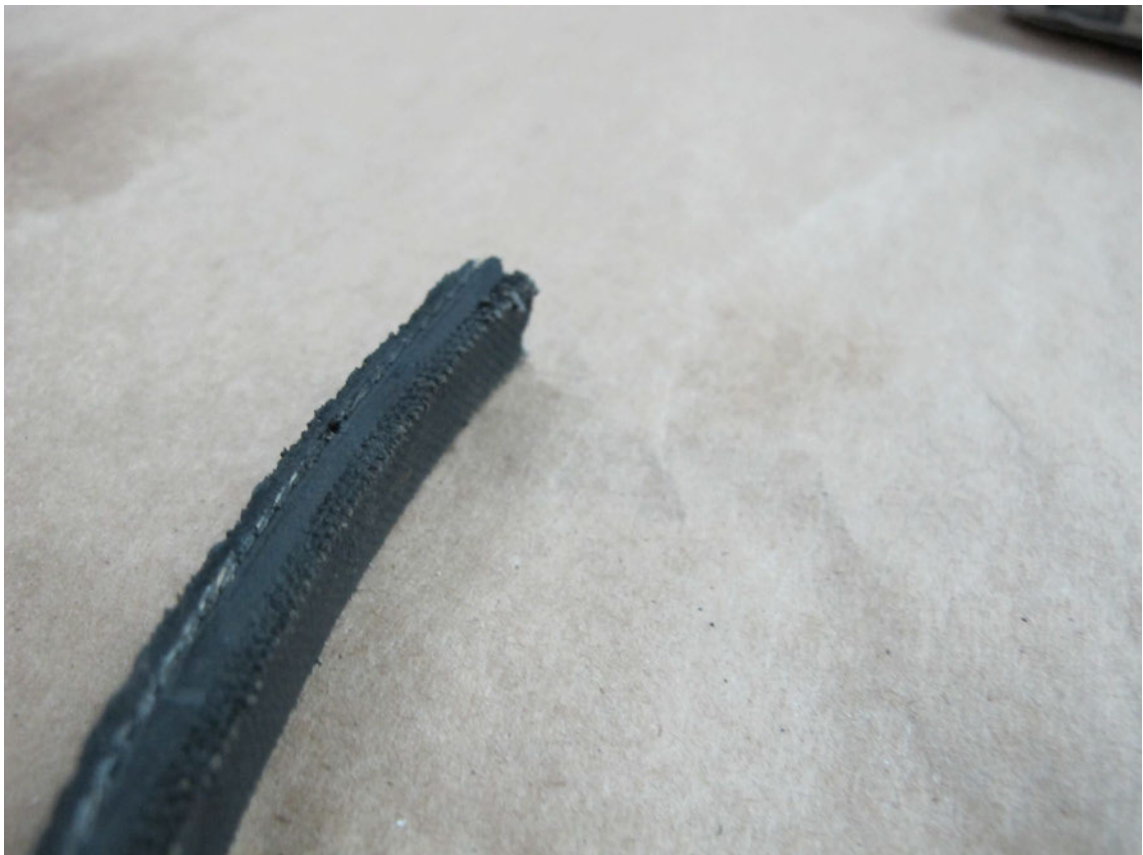
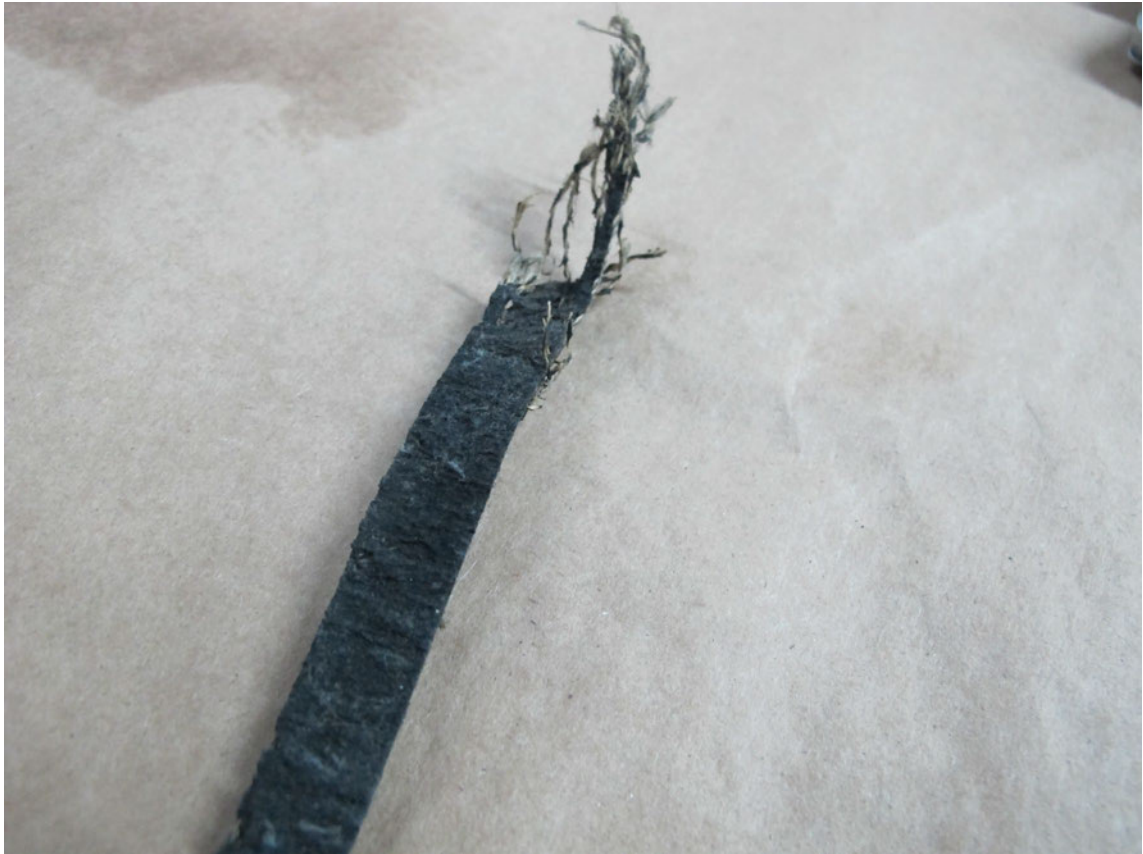
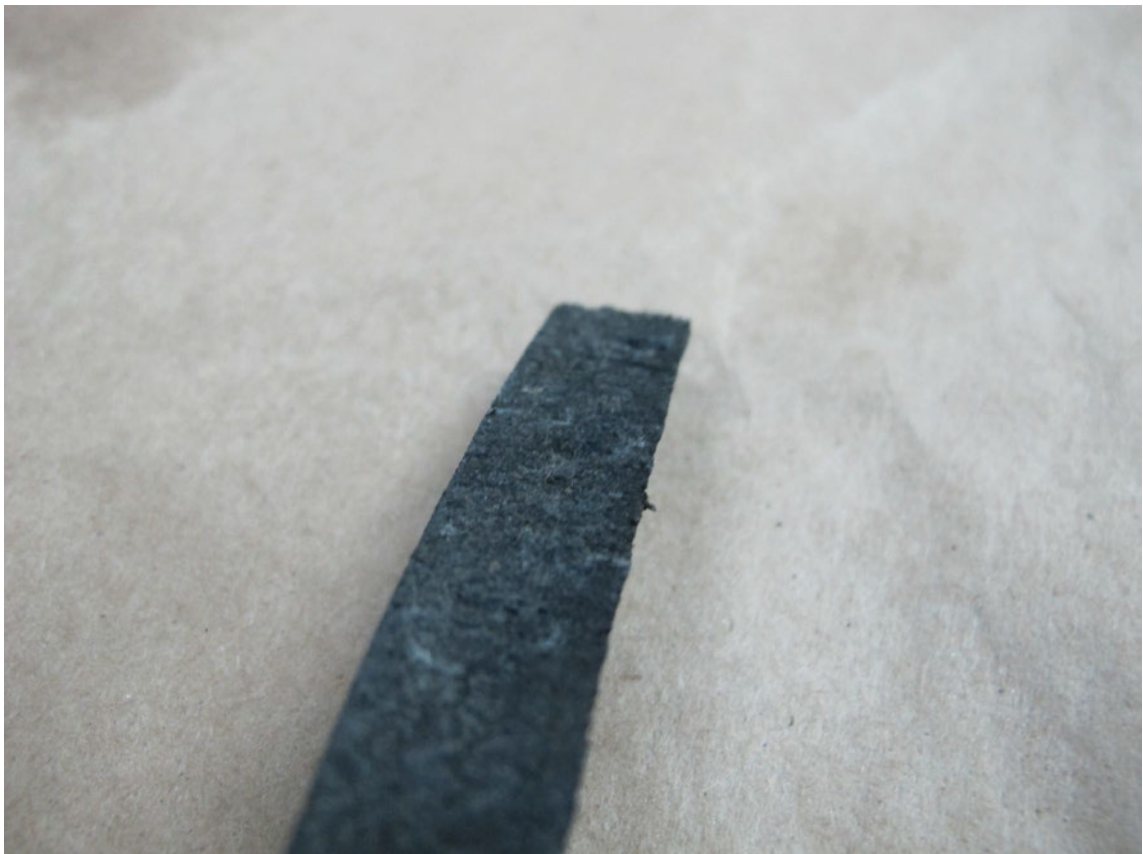
Above and below: The remaining portion of V-belt.

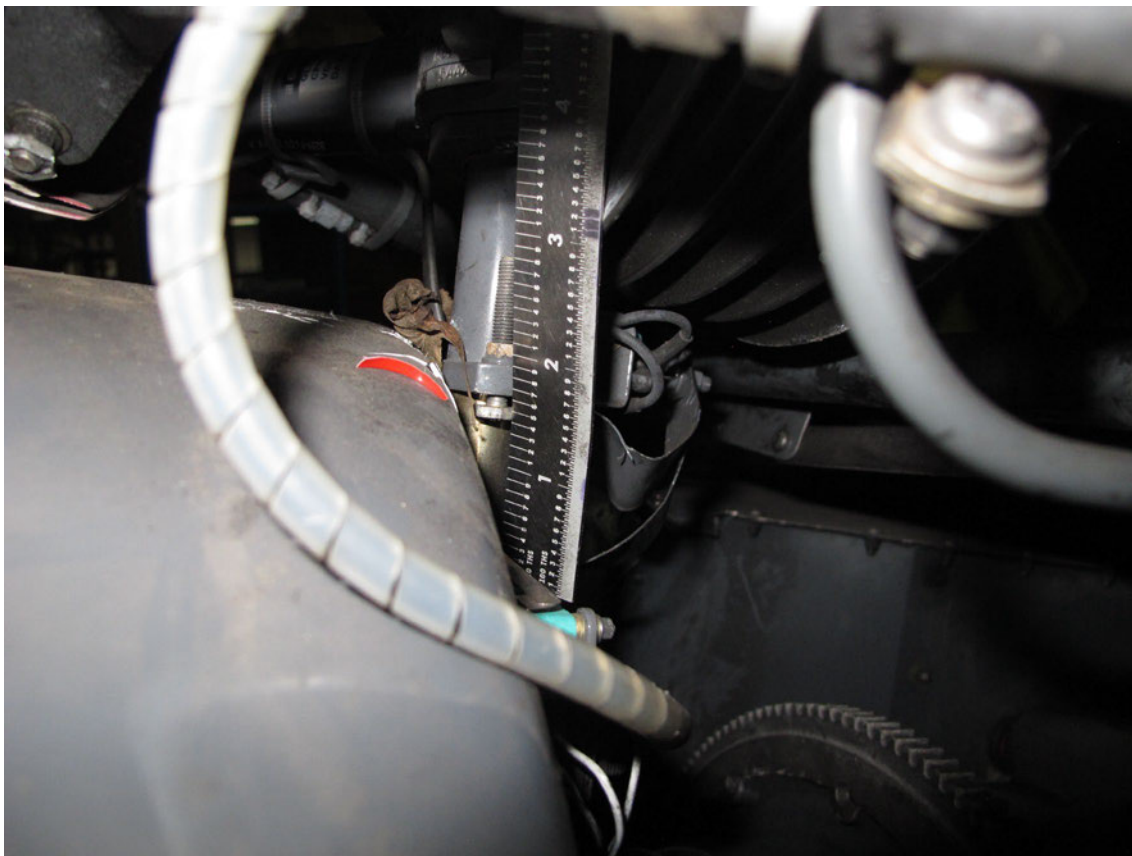
The belt tension actuator was extended 1.65" measured between the scissor mounts. The scissors were deformed and the overtravel switch was damaged. The upper and lower actuator support bearings rotated smoothly. The actuator was removed and functionally tested at Robinson Helicopter Company. The "Load Tension" and the "Amperage Draw" were slightly above production specifications. The fuse installed in the actuator circuit protection fuse holder was a 2-amp fuse. Specifications require a 1.5-amp fuse. The spare fuse holder contained a 1.5-amp fuse. An actuator time delay assembly was not installed as required with Service Bulletin SB-113A.

Actuator extension distance.

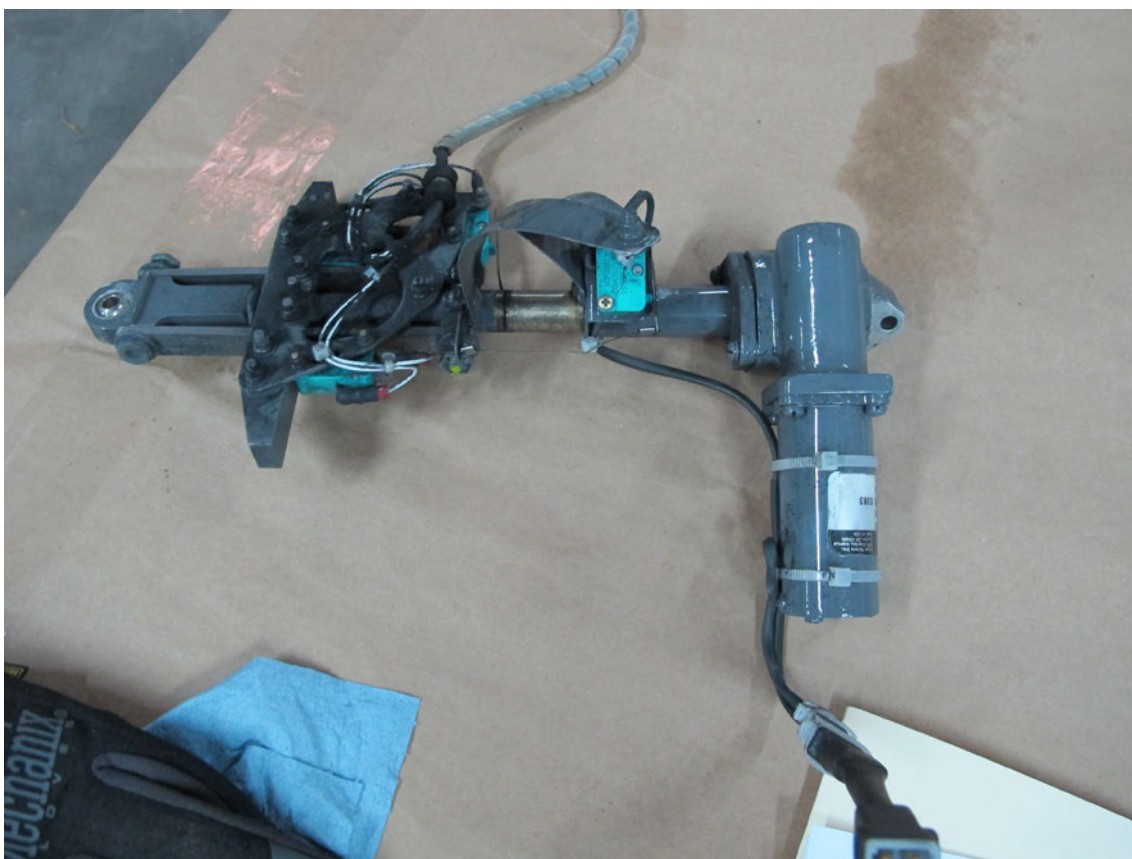
Actuator.

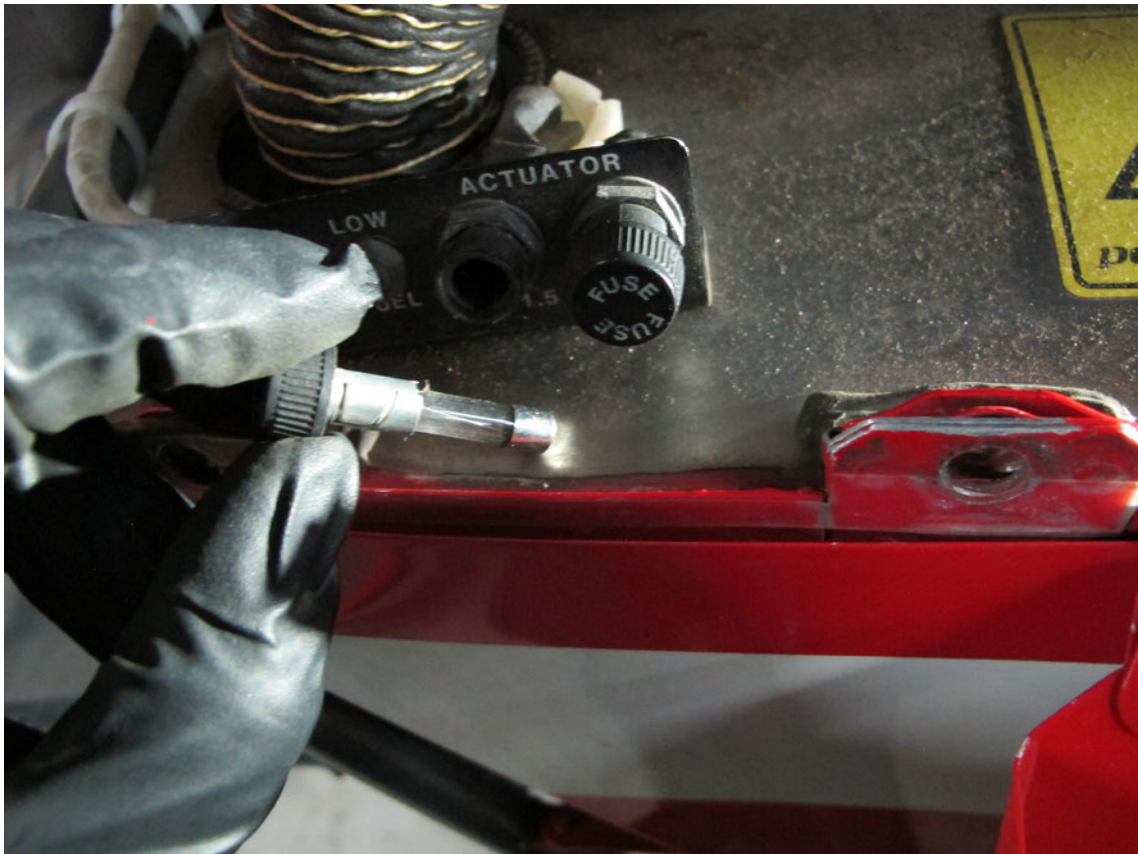
2 amp fuse.

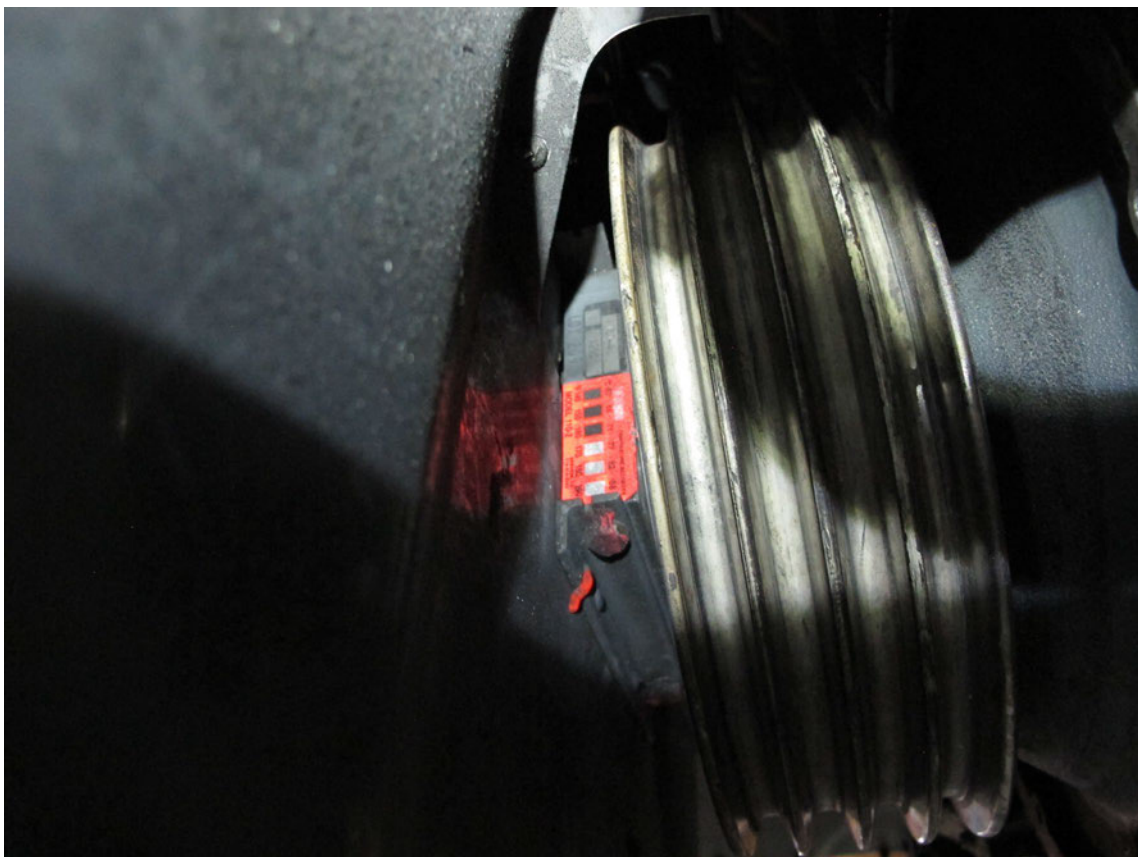
Lower actuator support bearing.

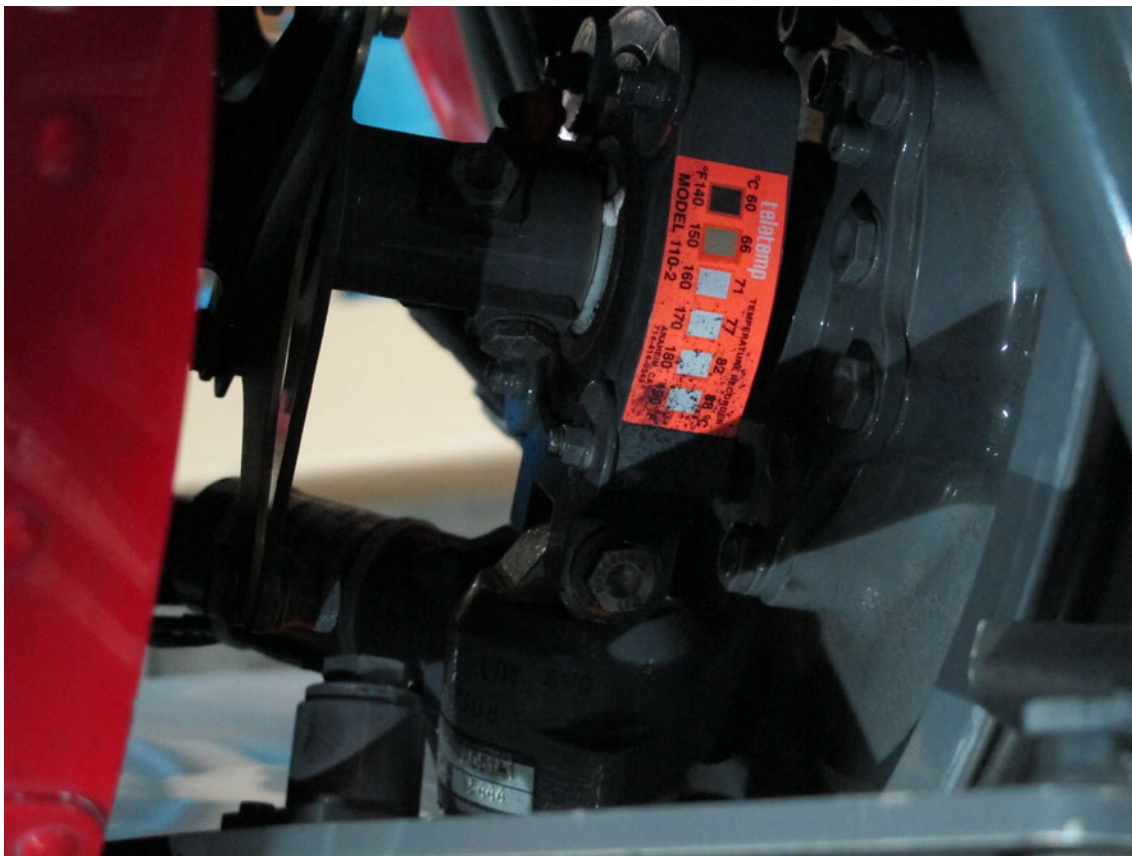
Upper actuator support bearing.

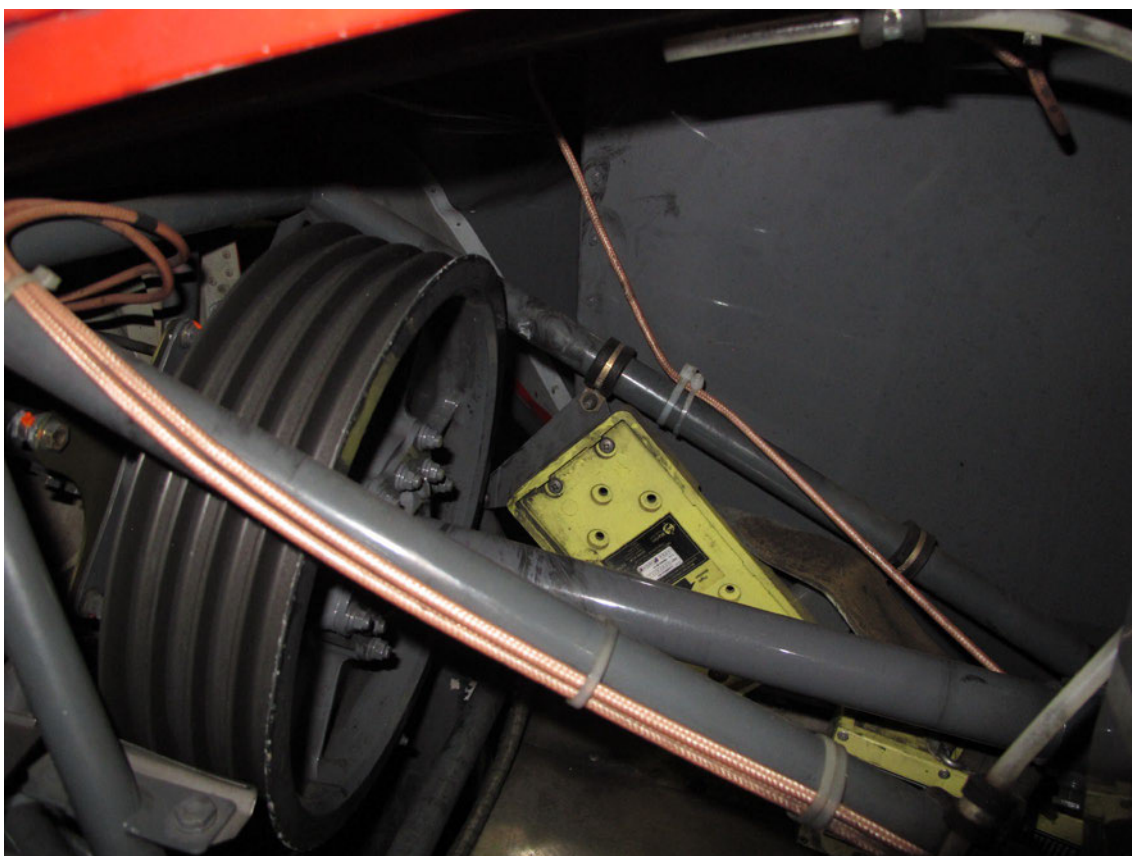
The upper sheave rotated freely and smoothly on the clutch shaft when moved in a clockwise direction (looking forward) and locked on the shaft when moved in a counterclockwise direction.

Upper sheave and clutch shaft.
