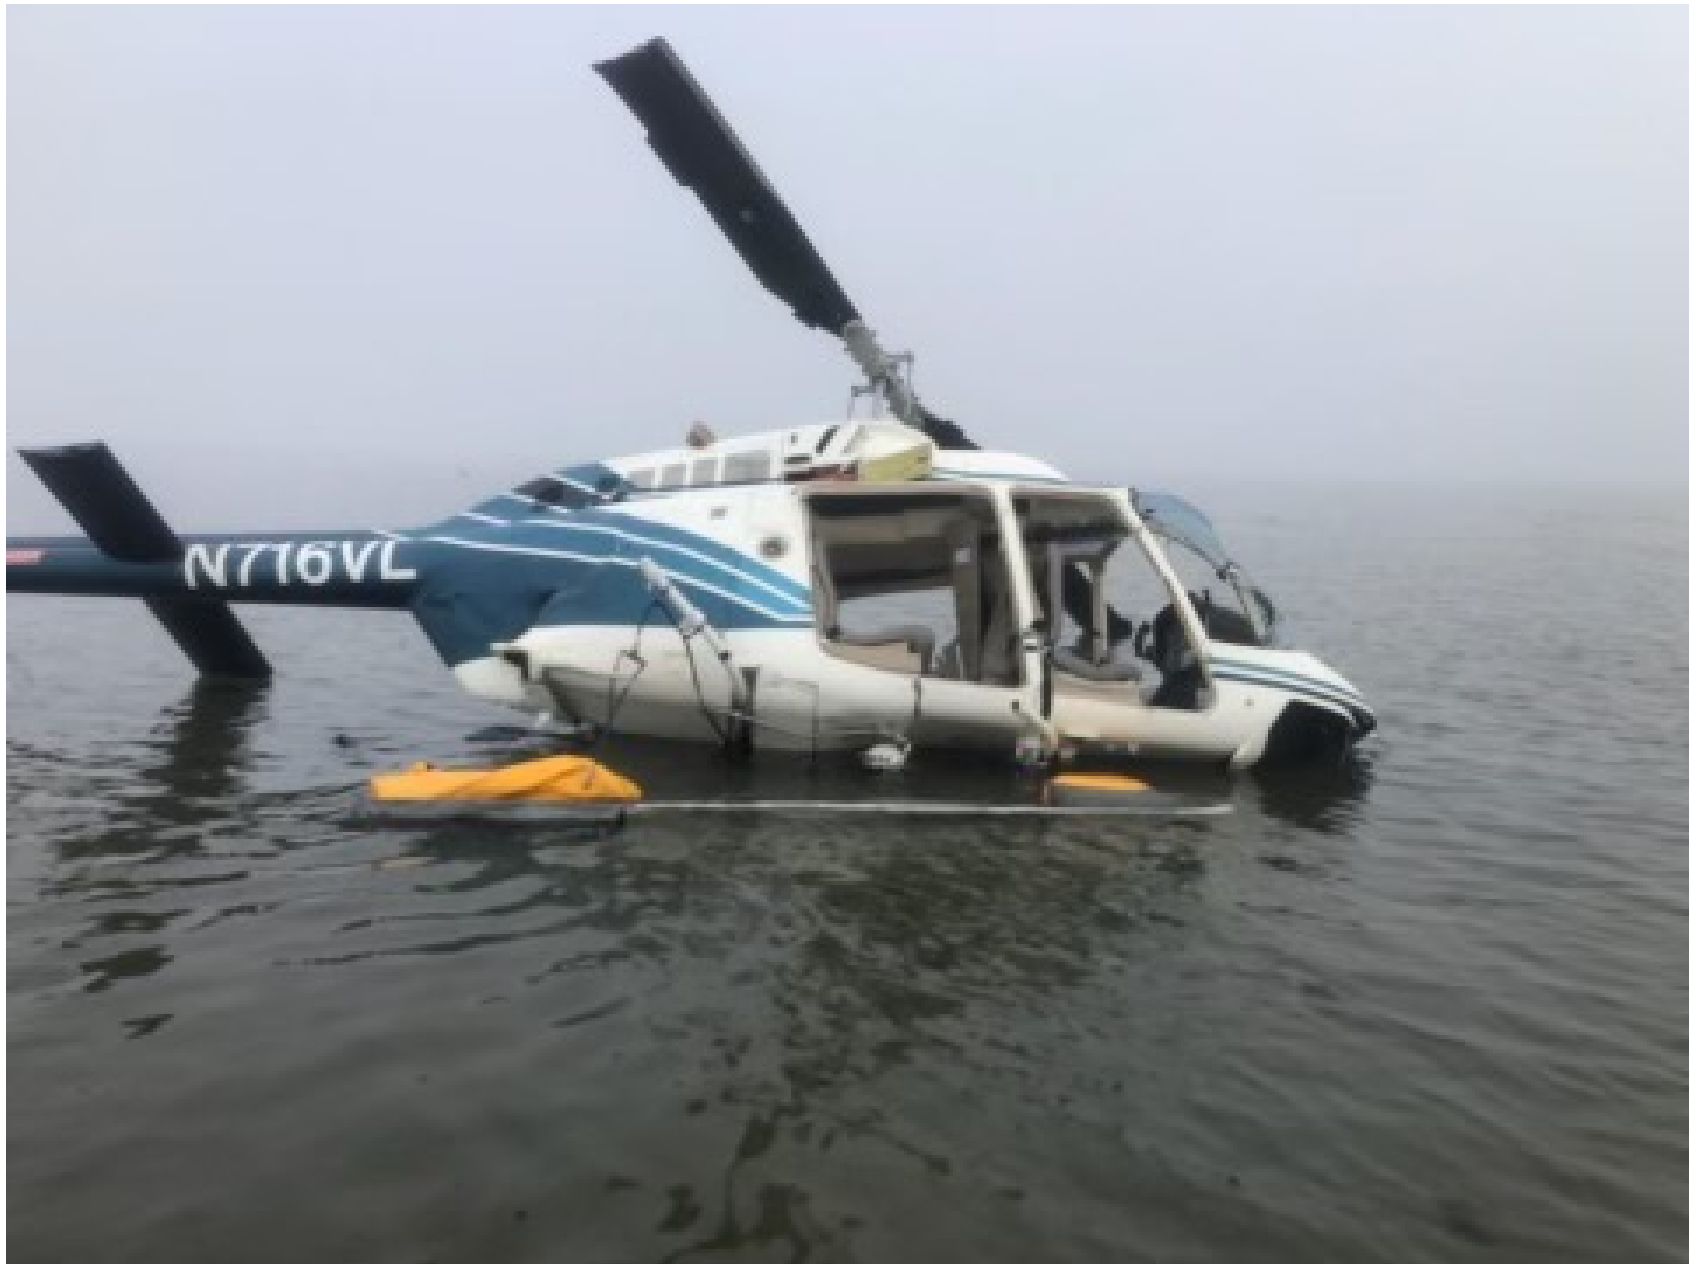
Photo 1 – Digital Photograph From Nassau County Police Department Aviation Unit. Right Side View of the Helicopter. Note the Separated Doors and Displaced Crosstubes.

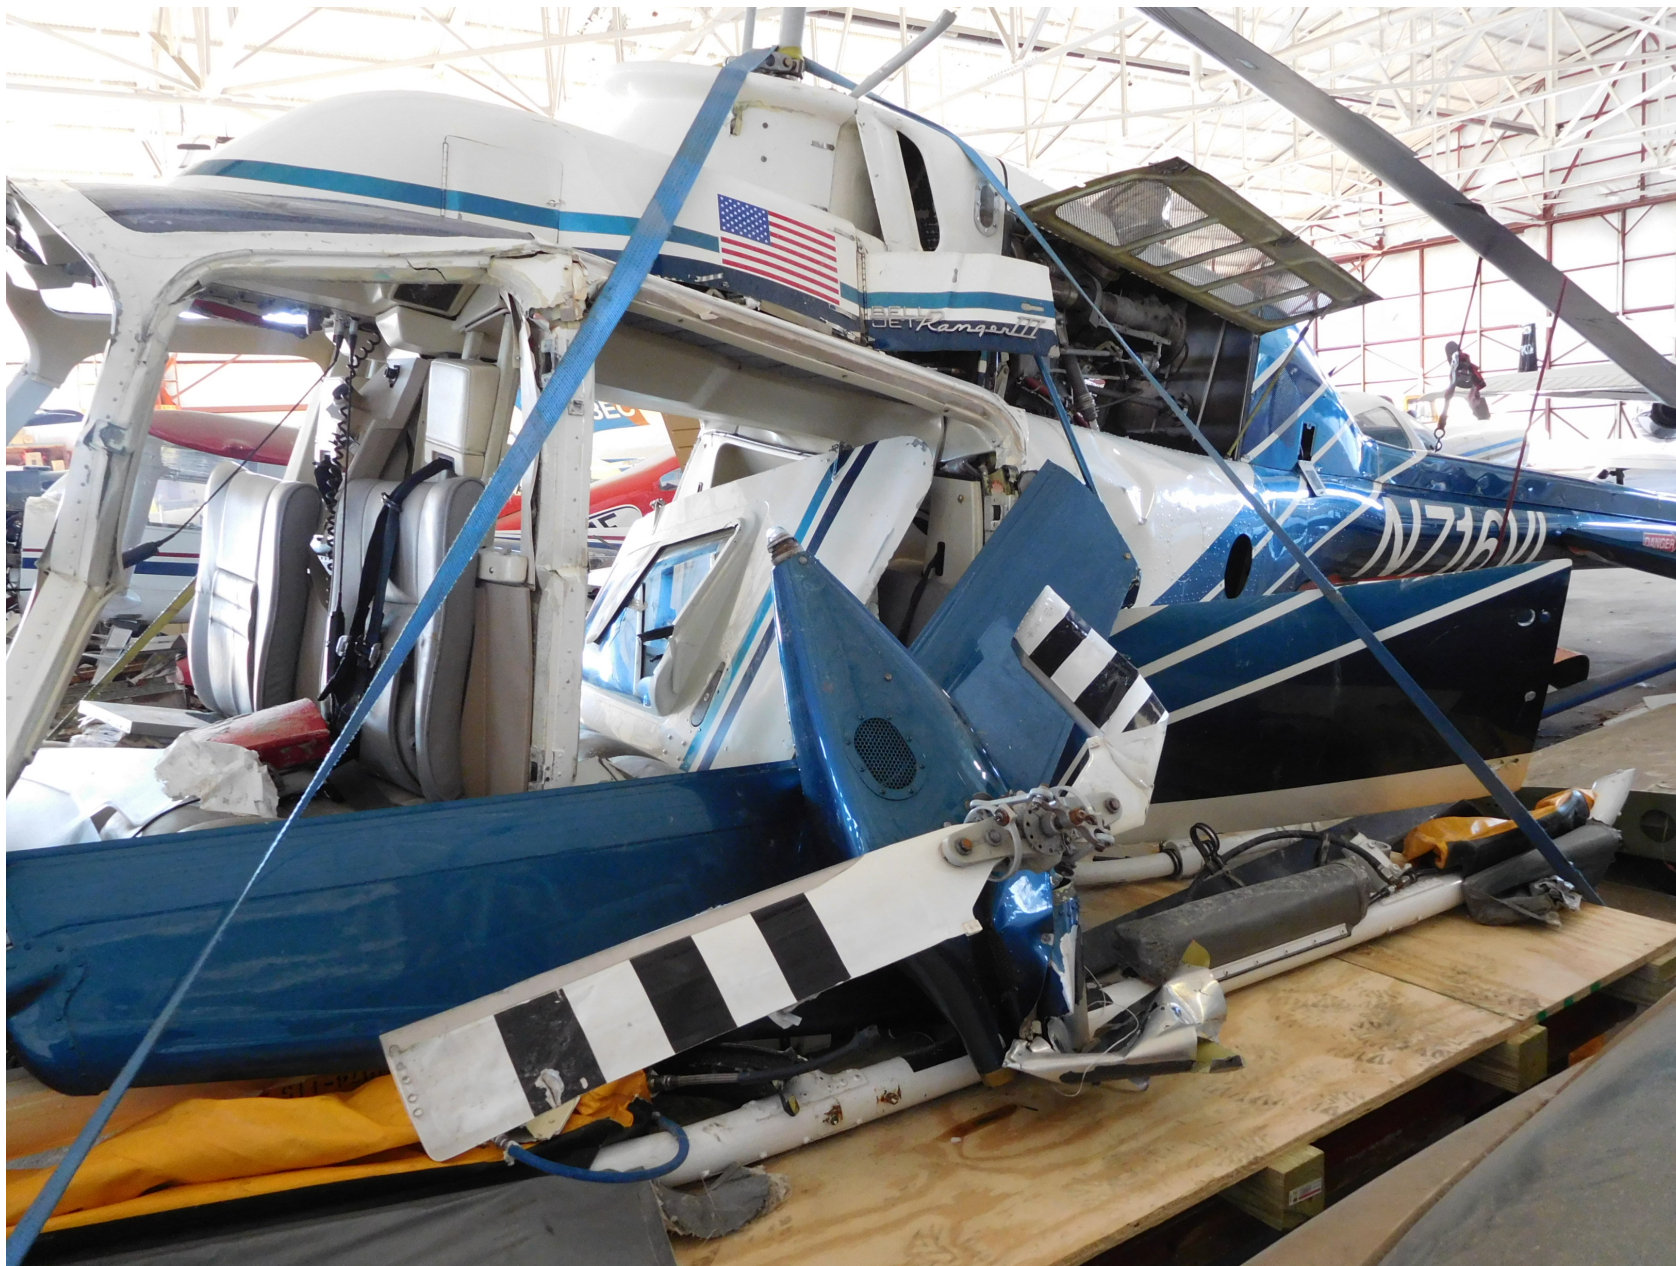
**Photo 2 – Digital Photograph From Insurance Adjuster. Left side View of the Helicopter Following Recovery, also Depicting Recovered Tail Rotor Assembly.**

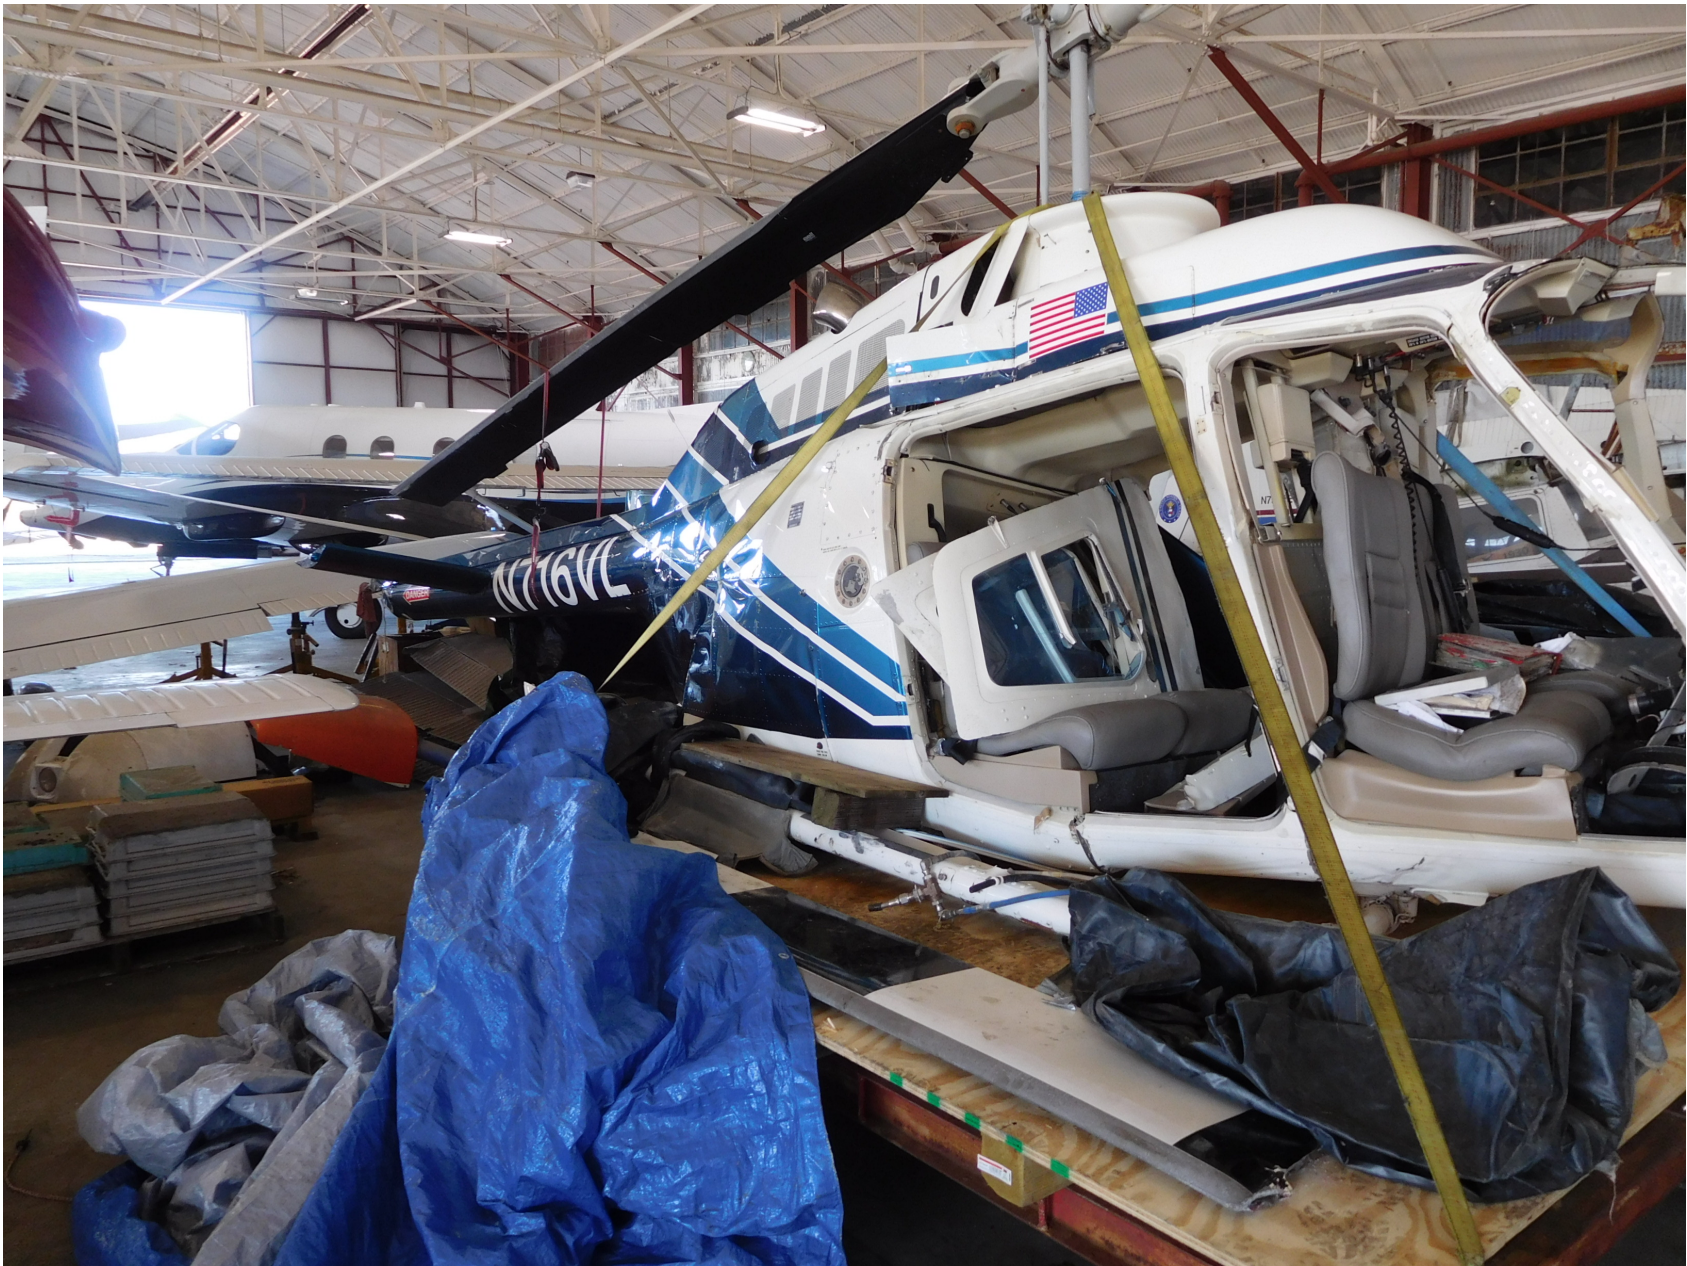
**Photo 3 - Digital Photograph From Insurance Adjuster. Right side View of the Helicopter Following Recovery.**

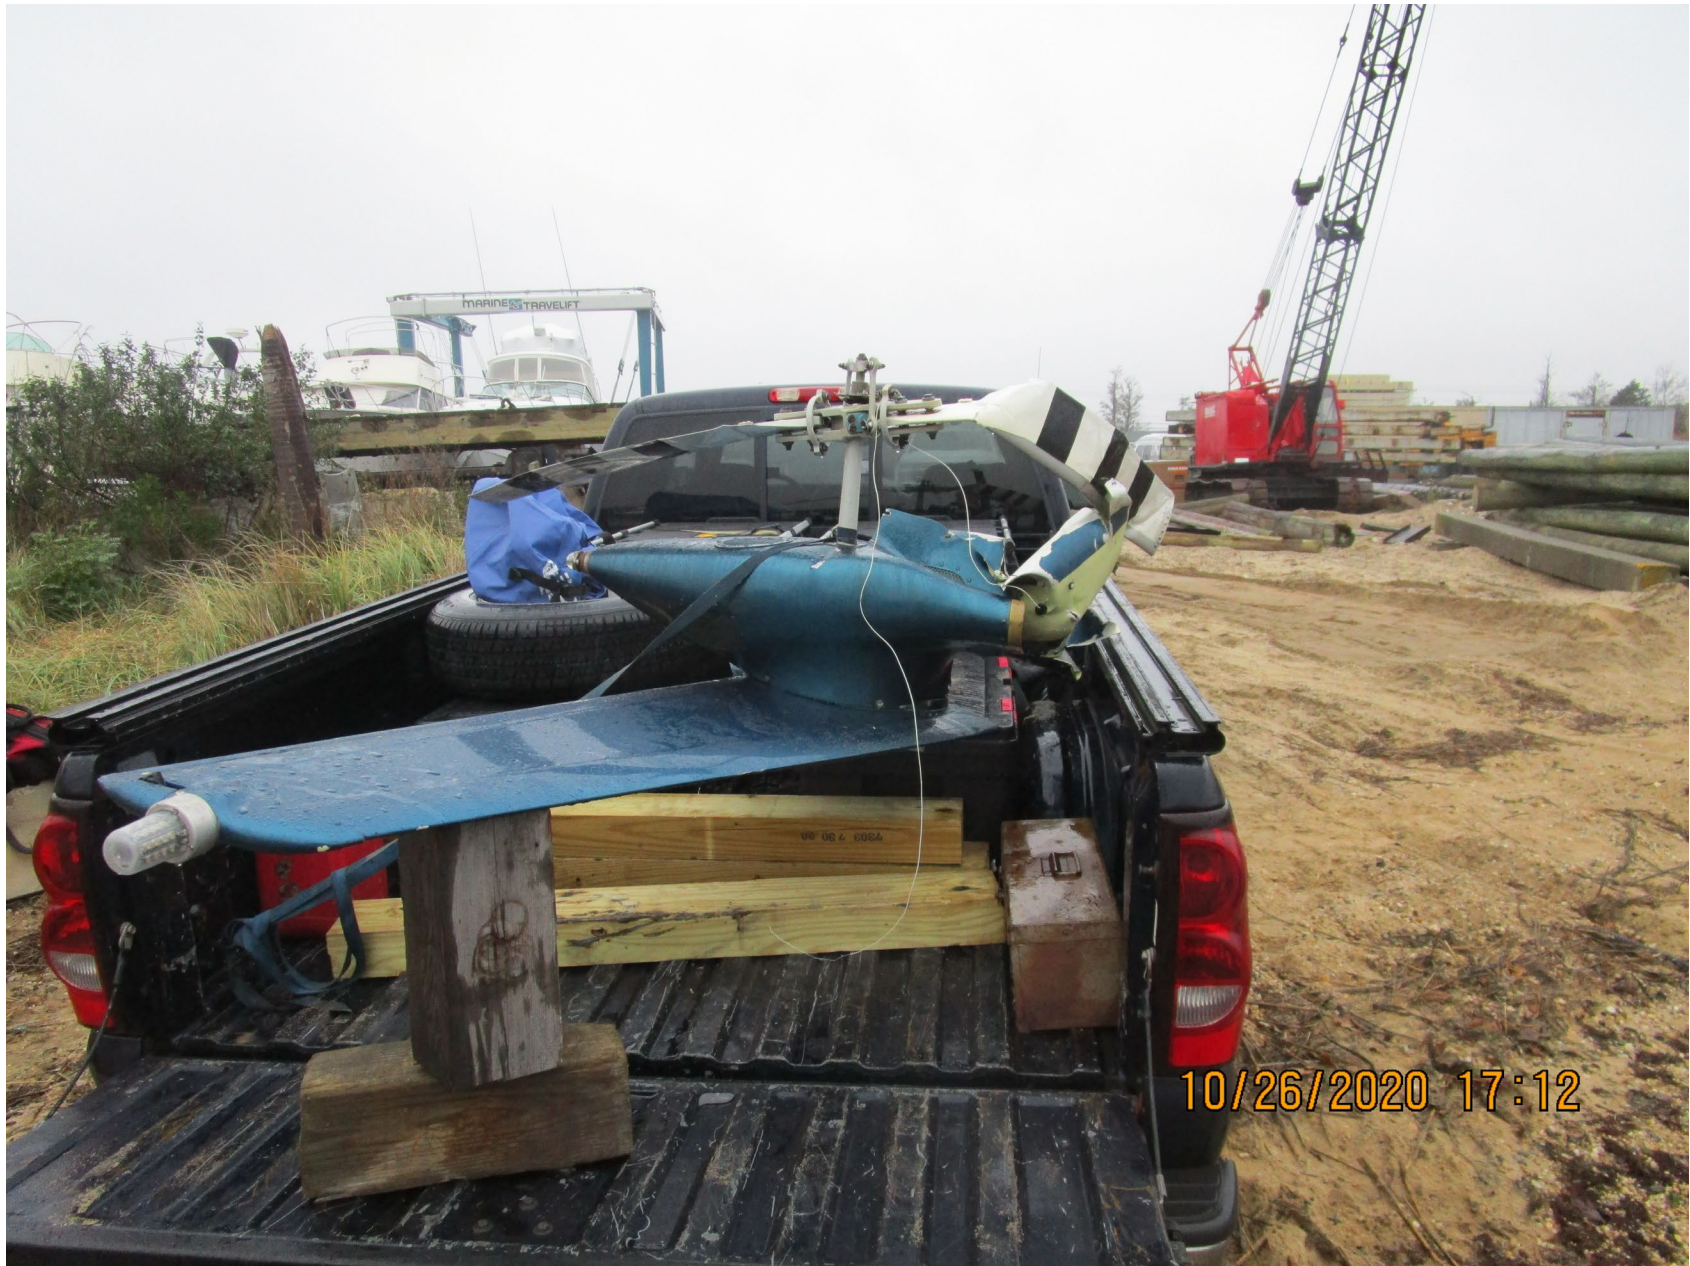
**Photo 4 - Digital Photograph From Federal Aviation Administration. View of the Tail Rotor Assembly Following Recovery.**

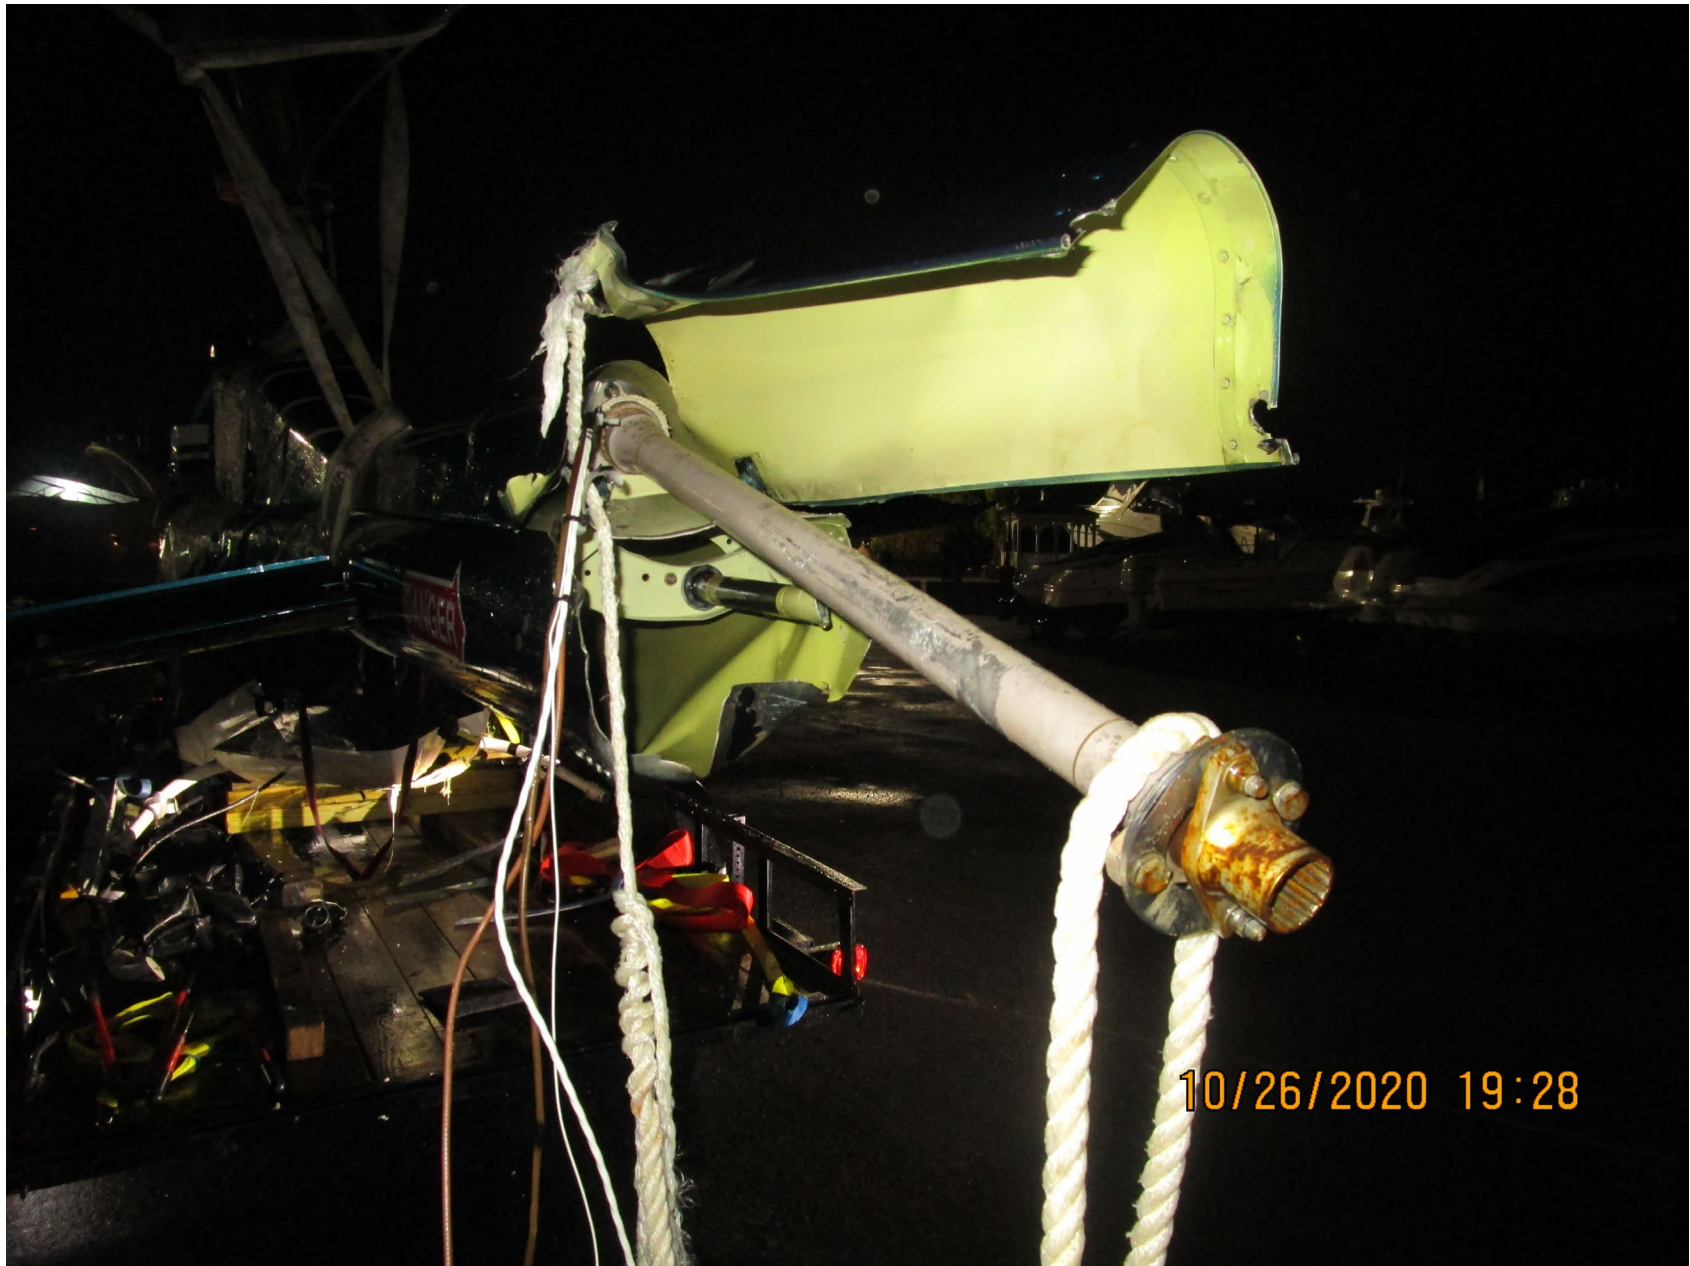
**Photo 5 - Digital Photograph From Federal Aviation Administration. View of the Tail Rotor Drive Shaft and Fractured Tail Rotor Control Fixed Tube Assembly.**
