## Investigative Photographs

Peter Wentz  
Air Safety Investigator  
Eastern Region Aviation

ERA21LA048

November 25, 2020

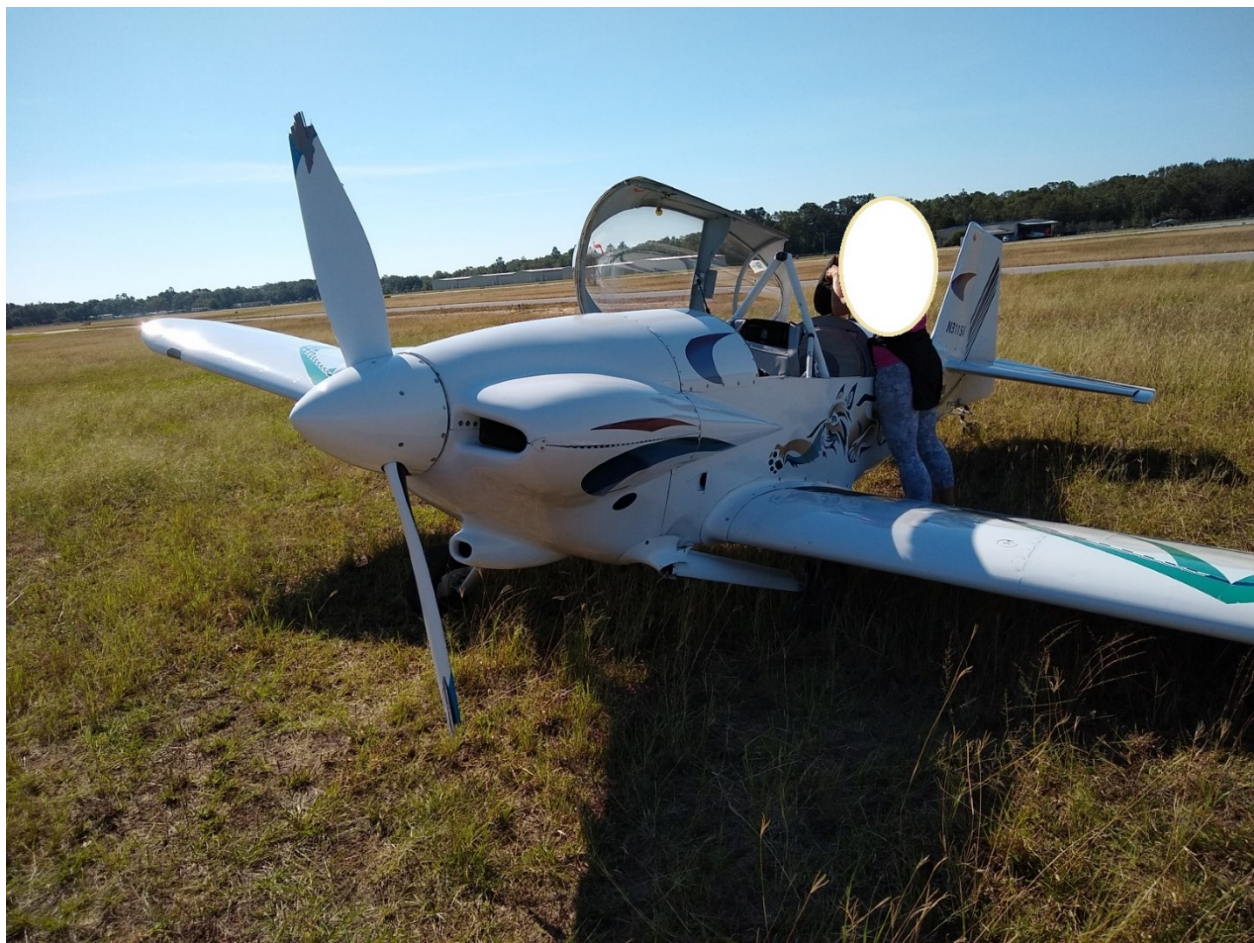
**Photograph 1<sup>1</sup> – Accident airplane – left front view.**

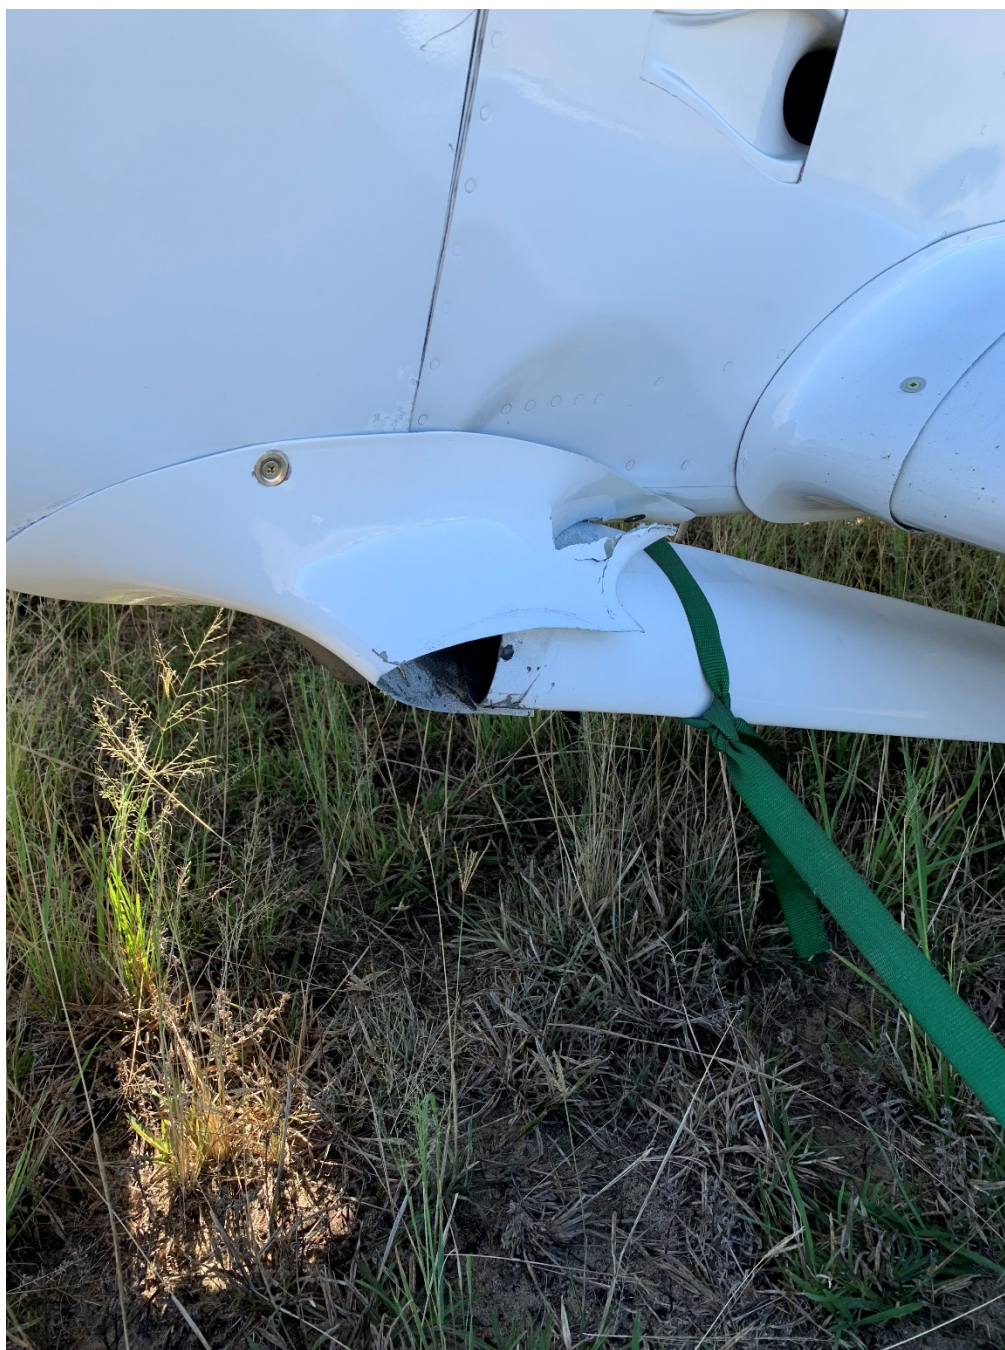
**Photograph 2<sup>2</sup> – Left main gear strut.**

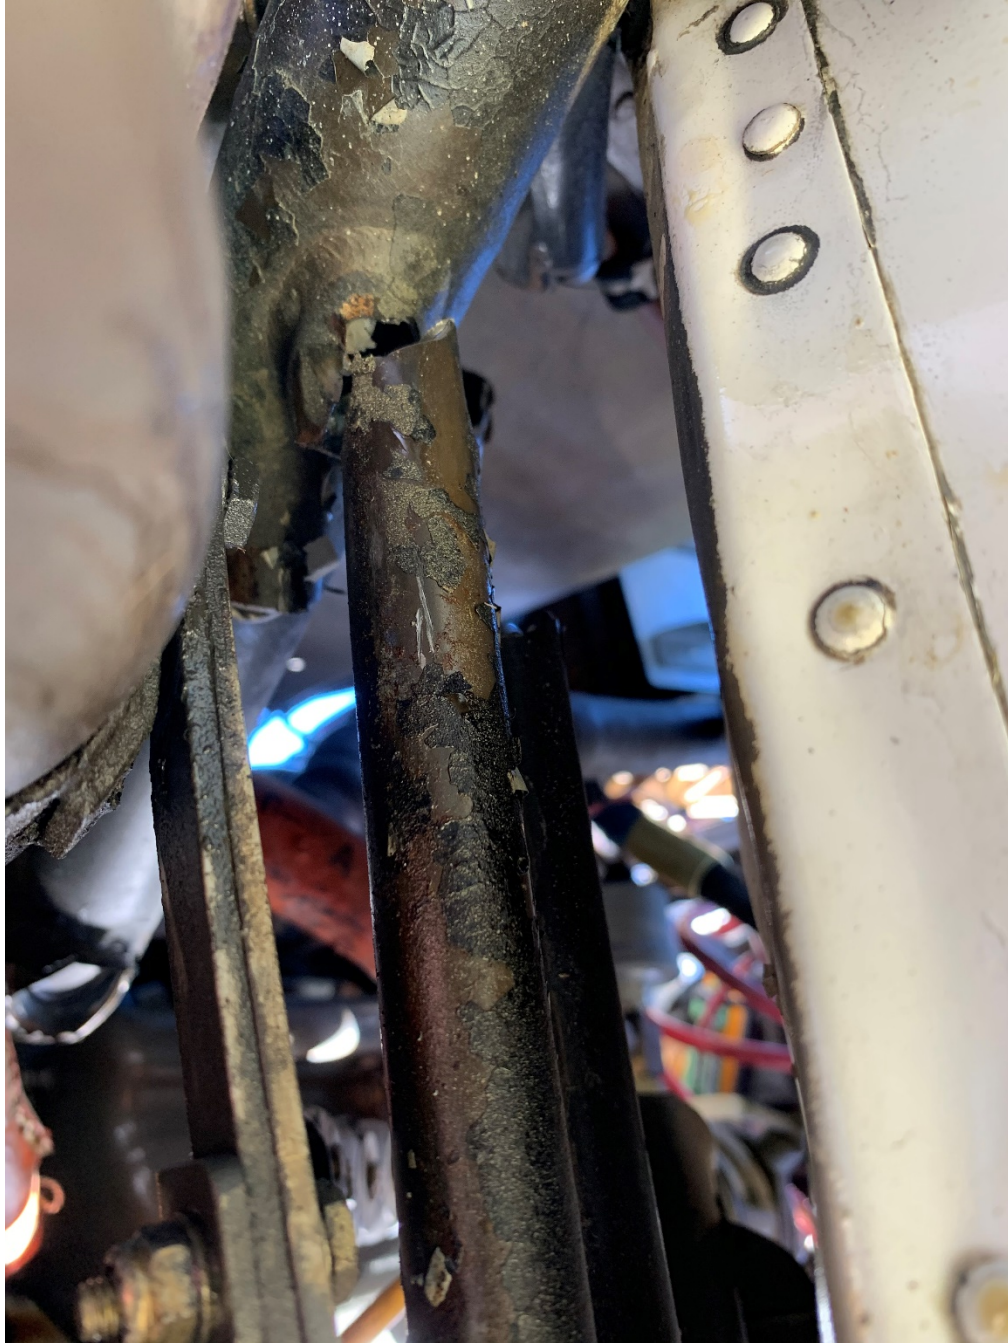
**Photograph 3<sup>3</sup> – Accident airplane motor mount.**
