# Wreckage Examination Notes

Accident Investigation: 11-24-20 1966 V35 D-8069 N35AW Deltaville VA 1F

On 06-01-21, Brian Rayner, NTSB, and Peter Basile, Textron Aviation, examined the aircraft wreckage at Anglin Aircraft Recovery Service in Clayton, DE.

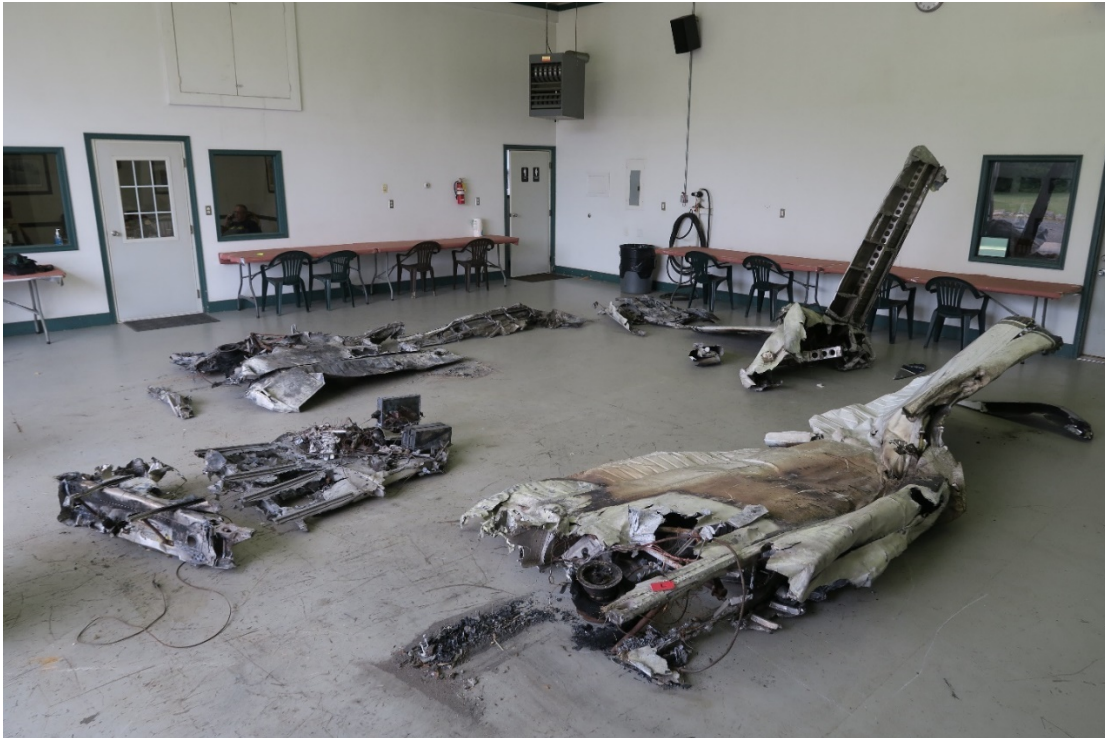
Exam, ASI-20-CS-008

The aircraft was observed separated into multiple sections which consisted of the left wing, right wing, V-tail, fuselage floor assembly, and engine. The aircraft structure was laid out in the storage building to resemble a properly oriented aircraft. Several small bags contained additional wreckage of fire damaged structure and molten aluminum. Several pieces in the bags were examined for possible bird strike damage and residue; none was observed.

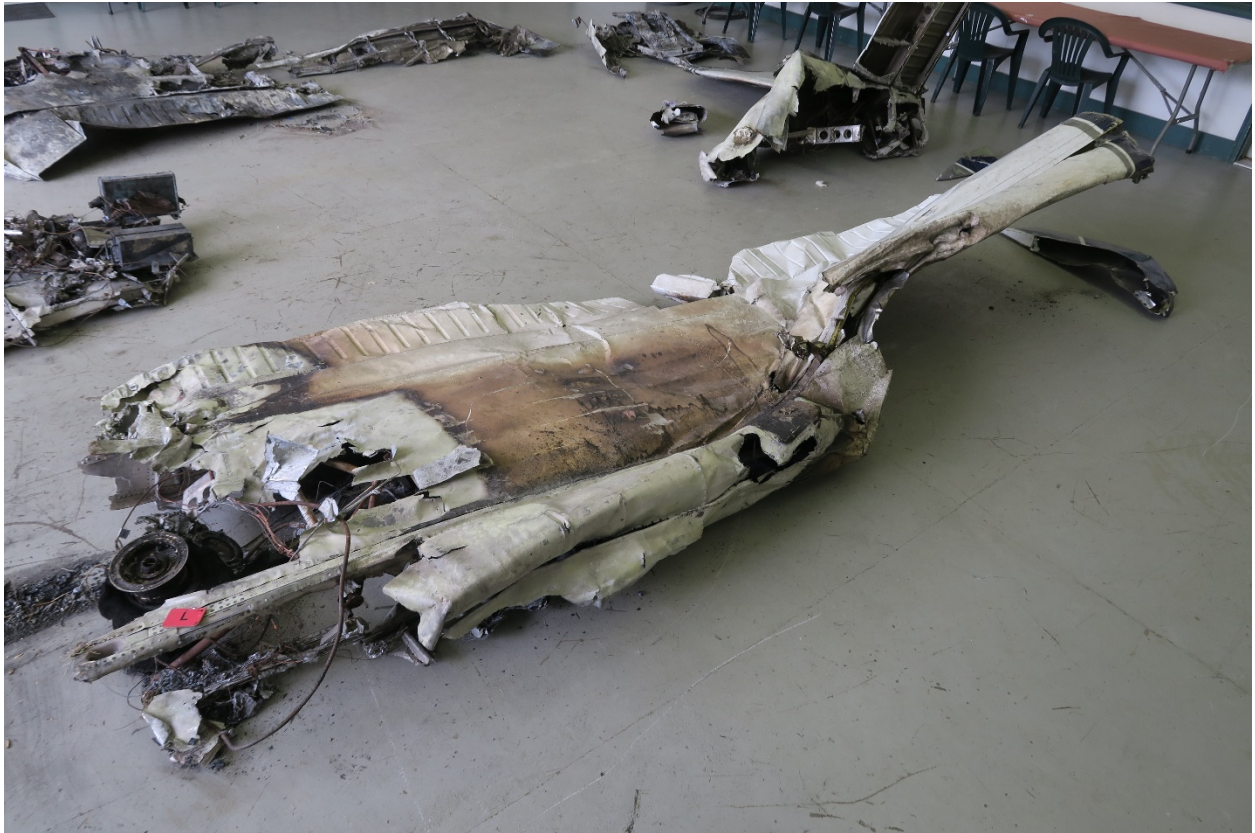
Exam, ASI-20-CS-009

The left wing remained in one large piece and sustained leading edge impact damage near the flap/aileron intersection. The flap and aileron remained attached to the wing. The left wing tip was separated; it exhibited score marks on the lower surface. The left main landing gear sustained post-impact fire damage and remained in the UP position. The aileron control cables were not examined. The leading edge of the left wing was examined for possible bird strike damage and residue; none was observed.

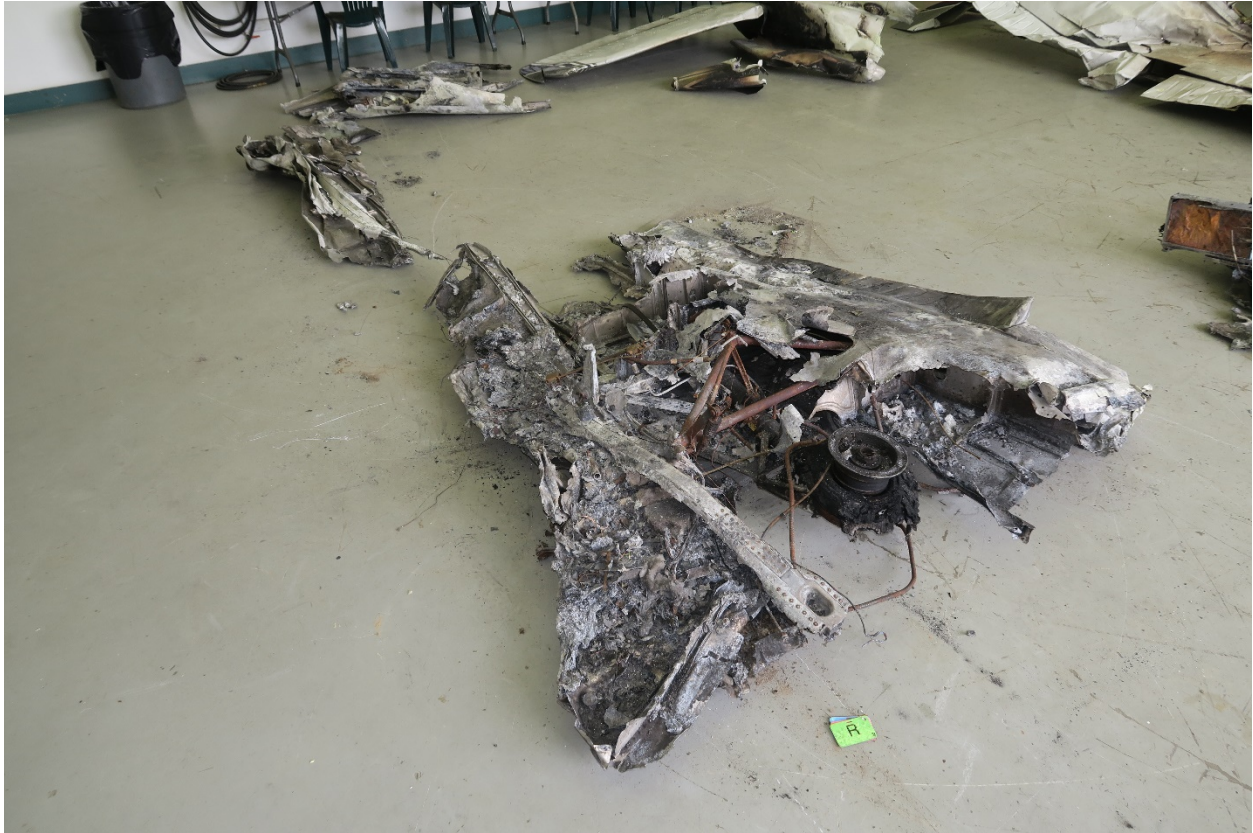
Exam, ASI-20-CS-029

The right wing sustained significant post impact fire damage. The outboard right wing structure and right aileron were consumed by fire. The right flap remained attached to the wing. The right main landing gear sustained post-impact fire damage and was observed in the UP position. The aileron control cables were not examined. The leading edge of the right wing was examined for possible bird strike damage and residue; none was observed.

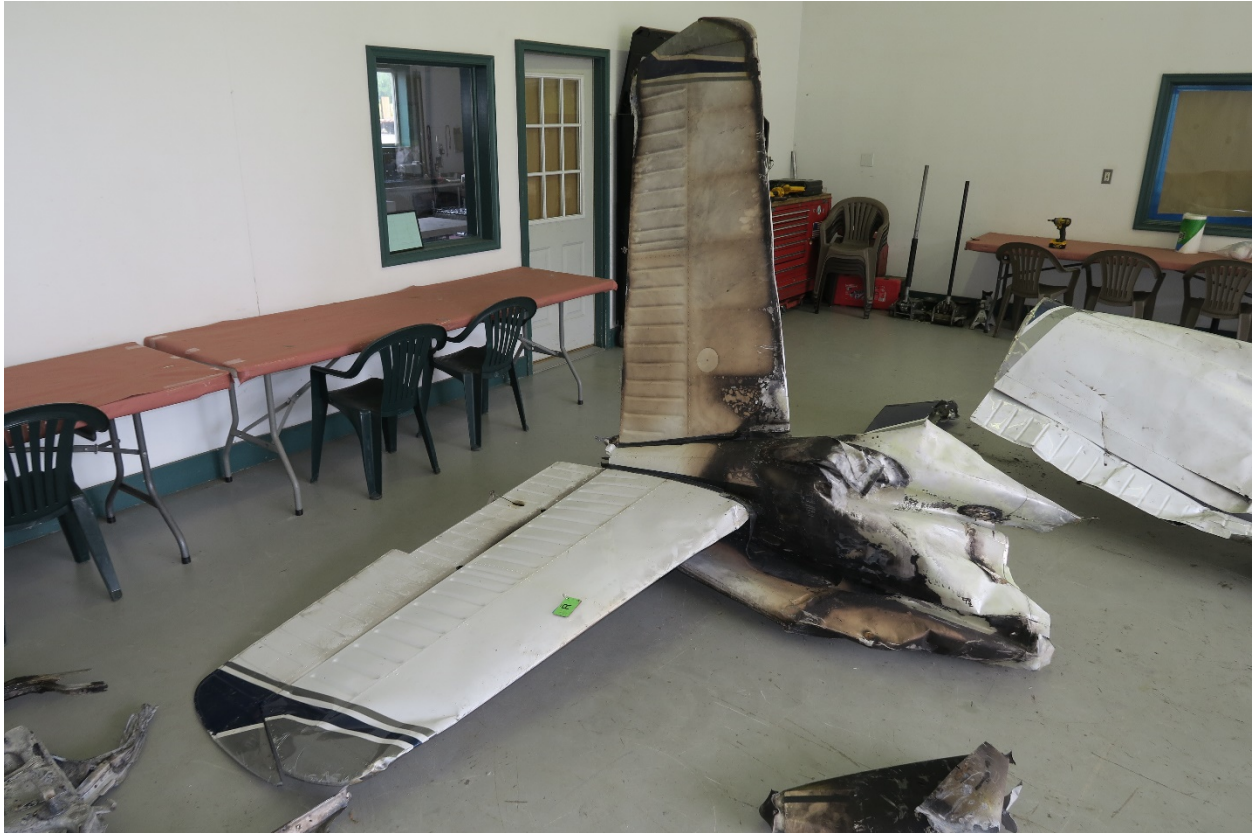
Exam, ASI-20-CS-038

The V-tail remained principally intact. The lower skin of the left stabilizer sustained fire damage and was melted. The left ruddervator was not observed; it was presumed melted in the post-impact fire. The leading edge of the left and right stabilizer were examined for possible bird strike damage and residue. No definitive evidence of a bird strike was observed. The leading edge of the right stabilizer exhibited an impact near the tail cone attachment; the source of the dent was undetermined.

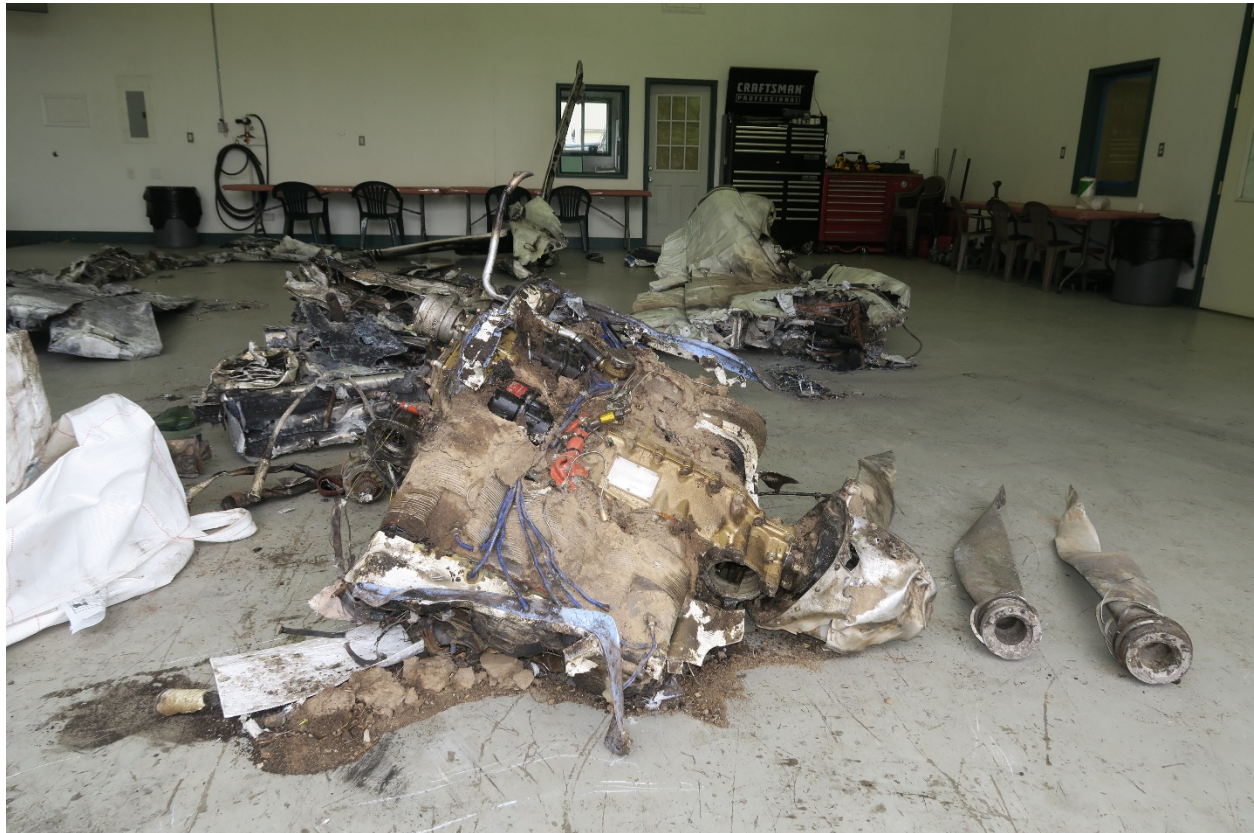
Exam, ASI-20-CS-068

The engine sustained ground impact damage and post-impact fire damage. The engine was not examined. The propeller hub remained attached to the engine. One propeller blade remained loose in the hub. The other two propeller blades were found in the bags of wreckage. The blades were twisted and exhibited leading edge gouges and chordwise scoring.
