## RECORD OF CONVERSATION

**Date: December 3, 2020**  
**Person Contacted: John “Jack” E. Demyan**  
**NTSB Accident Number: ERA21LA058**

**Date: December 4, 2020**  
**Person Contacted: Robert W. Cook**  
**NTSB Accident Number: ERA21LA058**

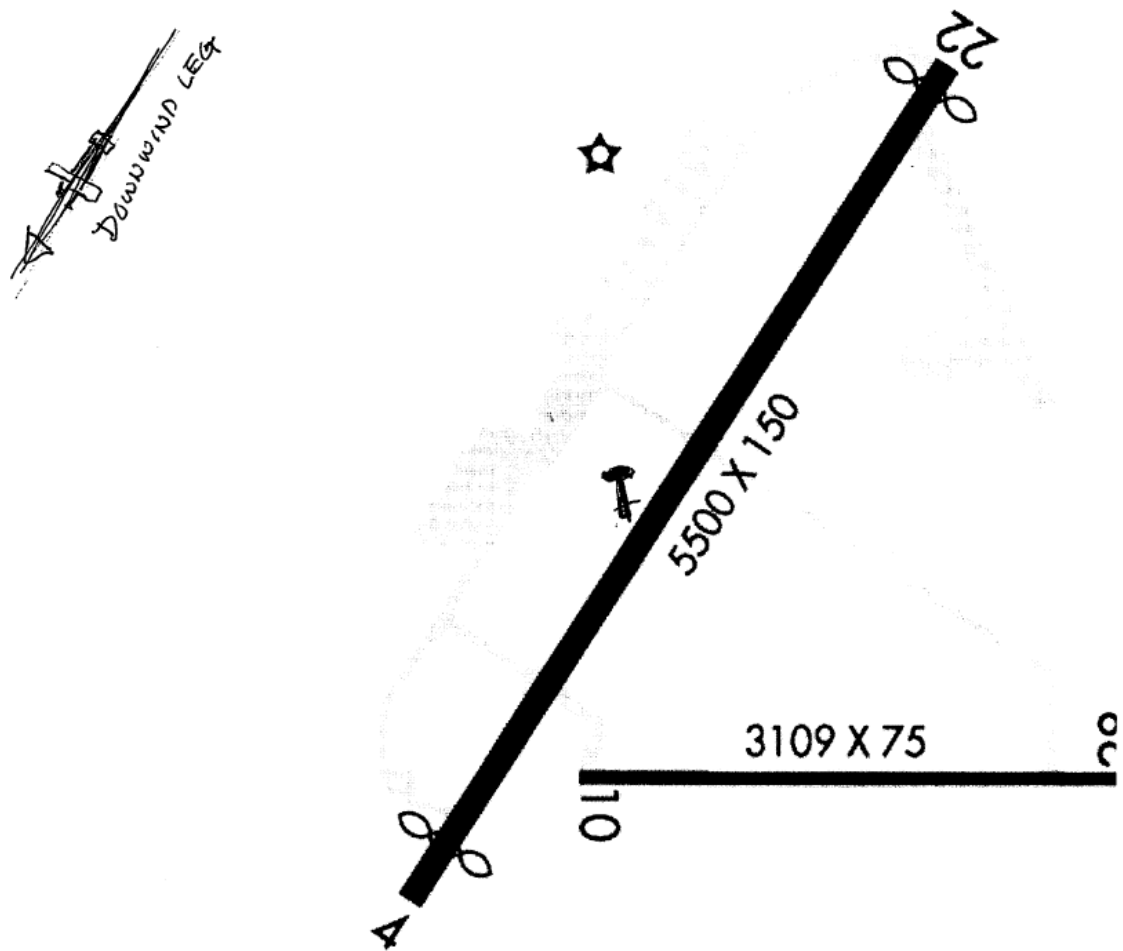
<sup>3</sup> In an e-mail on December 3, 2020, he provided a diagram depicting how he perceived the wind “T” to be pointing when he observed it in flight during the downwind leg. It is attached to this document.

Because the wind was reported to be variable, that told him that the wind direction was not a constant, would likely vary and that the best available indication of wind direction was the wind T. As indicated on the sketch, the wind appeared to indicate runway 4 as the best choice (as it appeared to him on the downwind leg). He added that the last definitive report was from 340° and the last aircraft (although faster and heavier) used runway 4, which was 150 ft wide. With that width he could take advantage of it, land near the downwind edge and could use the width to his advantage. He planned to touch down on the edge and aim for the opposite corner. Thirty to forty minutes after the accident he noted people were landing on runway 22.

Figure 1: Annotated Airport Diagram titled, "Pilot's View of Wind-T from downwind leg.pdf" Provided by Pilot by E-mail December 3, 2020.
