**NATIONAL TRANSPORTATION SAFETY BOARD**  
Office of Aviation Safety

**AIRWORTHINESS GROUP CHAIRMAN'S FACTUAL REPORT**

**ERA21LA065**

Operator: Private  
Location: Leesburg, Virginia  
Date: December 6, 2020  
Time: 1420 Eastern Standard Time (EST)  
Aircraft: Piper PA-46-600TP (M600), SN 4698111  
Registration: N282ST

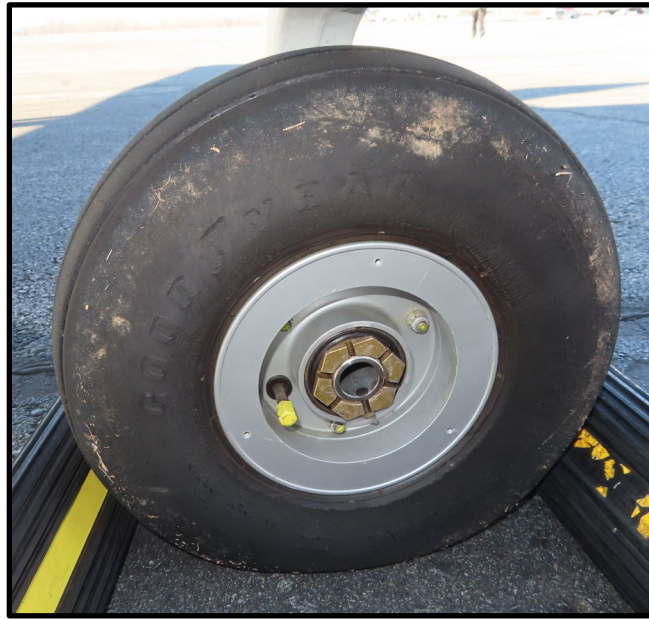
The NLG strut and tire were intact, and the tire pressure measured 33 psi. The manufacturer specified a NLG tire pressure of 92-97 psi at the time of the incident. The NLG lower fork was deformed to the left such that the wheel was offset about 10° from vertical. The raised 'Goodyear' lettering on the right sidewall was partially abraded away and there was crosswise scuffing of the tread, Figure 8. The steering horn remained installed on the top of the NLG strut and had some areas of chipped and cracked paint. There was chipped paint, but no mechanical damage noted to the right turn and left mechanical stops on the trunnion and strut. There was a small impact mark noted on the aft face of the left side of the steering arm that serves as the left turn mechanical stop. The left and right rudder pedal pushrod forward rod ends had several threads exposed forward of the jam nut. There was white grease protruding out of the forward end of the steering bungee.

*Figure 8-NLG tire with abrasion and crosswise scuffing.*

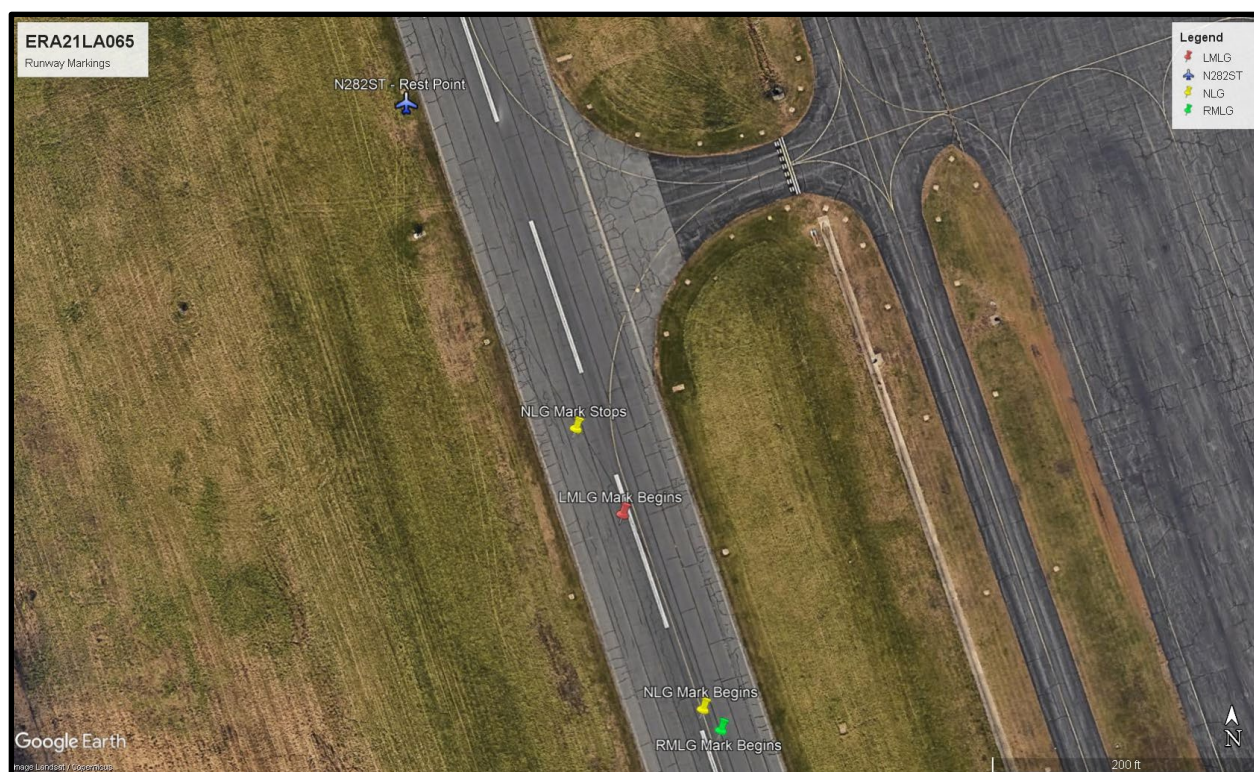
The airplane came to rest in the grass about 12 feet from the left edge of the runway 35 paved surface and about 2,370 feet from the approach end of the runway, Figure 9. There were three distinct ground scars in the grass coincident with the locations of the RMLG, LMLG, and NLG between the edge of the runway and the airplane resting point. The LMLG departed the left side of the paved surface about 2,170 feet from the approach end, the NLG departed about 2,212 feet from the approach end, and the RMLG departed about 2,243 feet from the approach end. At the runway departure point the NLG ground scar was 4 feet from the RMLG ground scar and 8.8 feet from the LMLG ground scar measured perpendicular to the scars. There were distinct rubber transfer marks on the paved surface of Runway 35 that matched the locations of the ground scars. The rubber transfer marks were traced back to their beginning points on the runway surface. The LMLG rubber transfer mark showed four parallel lines with spaces between consistent with the tire tread pattern and the tires rolling with brakes applied. The LMLG mark began about 1,996 feet from the approach end of the runway and 9.5 feet left of the centerline, arced to the left, and continued to the LMLG departure point. The marks were lighter in appearance for the first 85 feet then became much darker consistent with heavier braking action. The RMLG rubber transfer mark began about 1,820 feet from the approach end of the runway and about 9 feet right of the centerline, arced to the left, and showed four parallel lines with spaces between for the first 7 feet then transitioned to a darker and wider line with no tread pattern consistent with a skidding tire. The dark, wide RMLG skid mark continued until about 60 feet from the departure point where it transitioned to a very light mark. The NLG rubber transfer mark began about 1,840 feet from the approach end of the runway and 1 foot right of the centerline and continued until about 2,068 feet from the approach end and 22 feet left of the centerline. The NLG rubber transfer mark was a wider line of varying intensity with no tread pattern consistent with a skidding tire.

Figure 9-Rubber transfer marks on Runway 35.

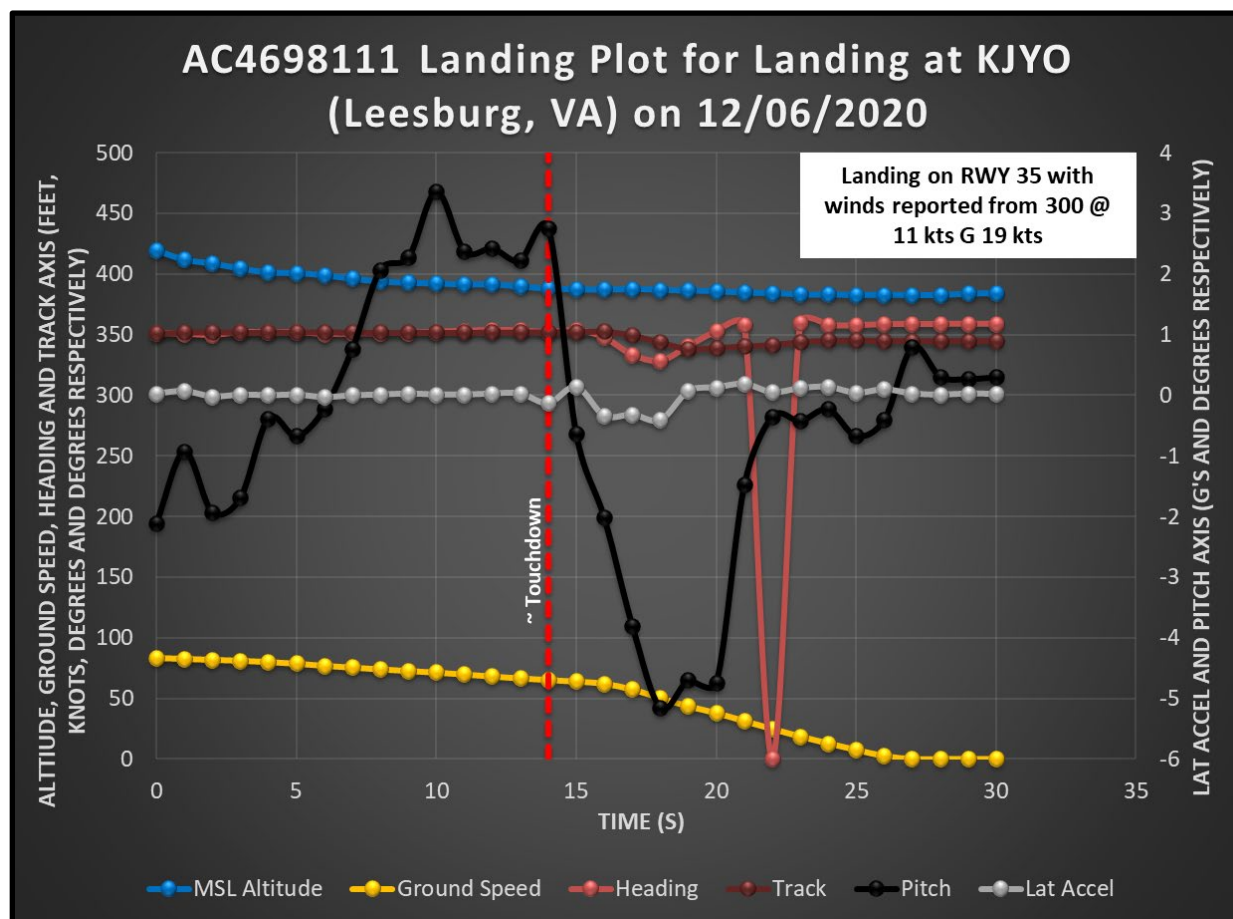
Piper plotted the altitude, groundspeed, heading, track, pitch and lateral acceleration data for the incident landing from the SD card at the request of the NTSB, Figure 11. The touchdown point was estimated based on the altitude and pitch parameters. The runway departure timing was estimated based on the airplane position information. The NLG touchdown can be estimated based on the pitch parameter. Immediately after touchdown, there was a right lateral acceleration that was immediately followed by a lateral acceleration to the left that continued for the next three seconds. As the left lateral acceleration increased, the heading and track began to diverge indicating the airplane was in a skid with the track exceeding the heading. The touchdown ground speed was about 65 kts. About 3 seconds after touchdown the groundspeed showed an increase in the negative slope and the pitch decreased indicating application of brakes. Starting about 5

seconds after touchdown, the lateral acceleration transitioned to the right and the track decreased below the heading. The airplane departed the runway between 6 and 7 seconds after the touchdown at a ground speed about 38 kts. The airplane came to rest about 12 seconds after touchdown on a heading of 359°.

Figure 11-Plot of data from N282ST incident landing.

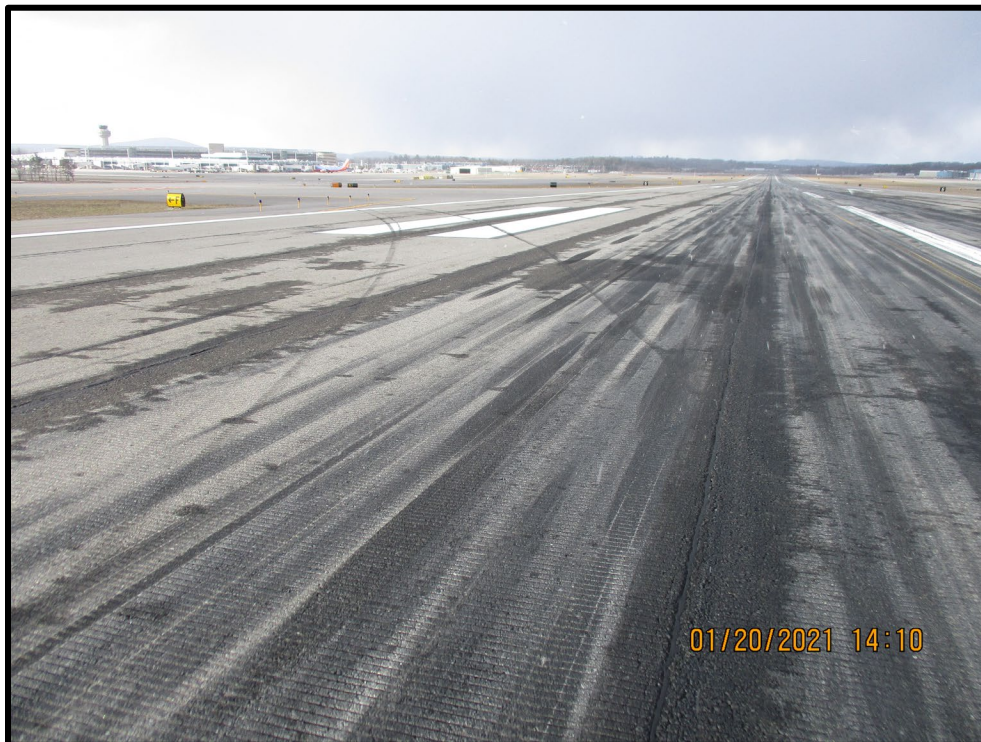
The airplane came to rest in the grass and dirt adjacent to the runway and taxiway F intersection about 1,660 feet from the displaced threshold of runway 35. There were two distinct ground scars in the grass and dirt coincident with the locations of the LMLG and NLG. The RMLG remained on the paved surface. There were distinct rubber transfer marks on the paved surface of Runway 35 that matched the locations of the two ground scars and the RMLG. The rubber transfer marks were traced back to a point about 330 feet from the airplane resting location where they became indiscernible from all the other rubber transfer on the runway. All three transfer marks were dark, wide lines with no visible tread pattern consistent with skidding tires. The three marks arced to the left throughout their length. The NLG mark was initially to the right of the LMLG mark and crossed over the LMLG mark about halfway along the length to end up on the left side of the LMLG mark, figure 12.

Figure 12-Tire skid marks on runway 35 from N641WA.

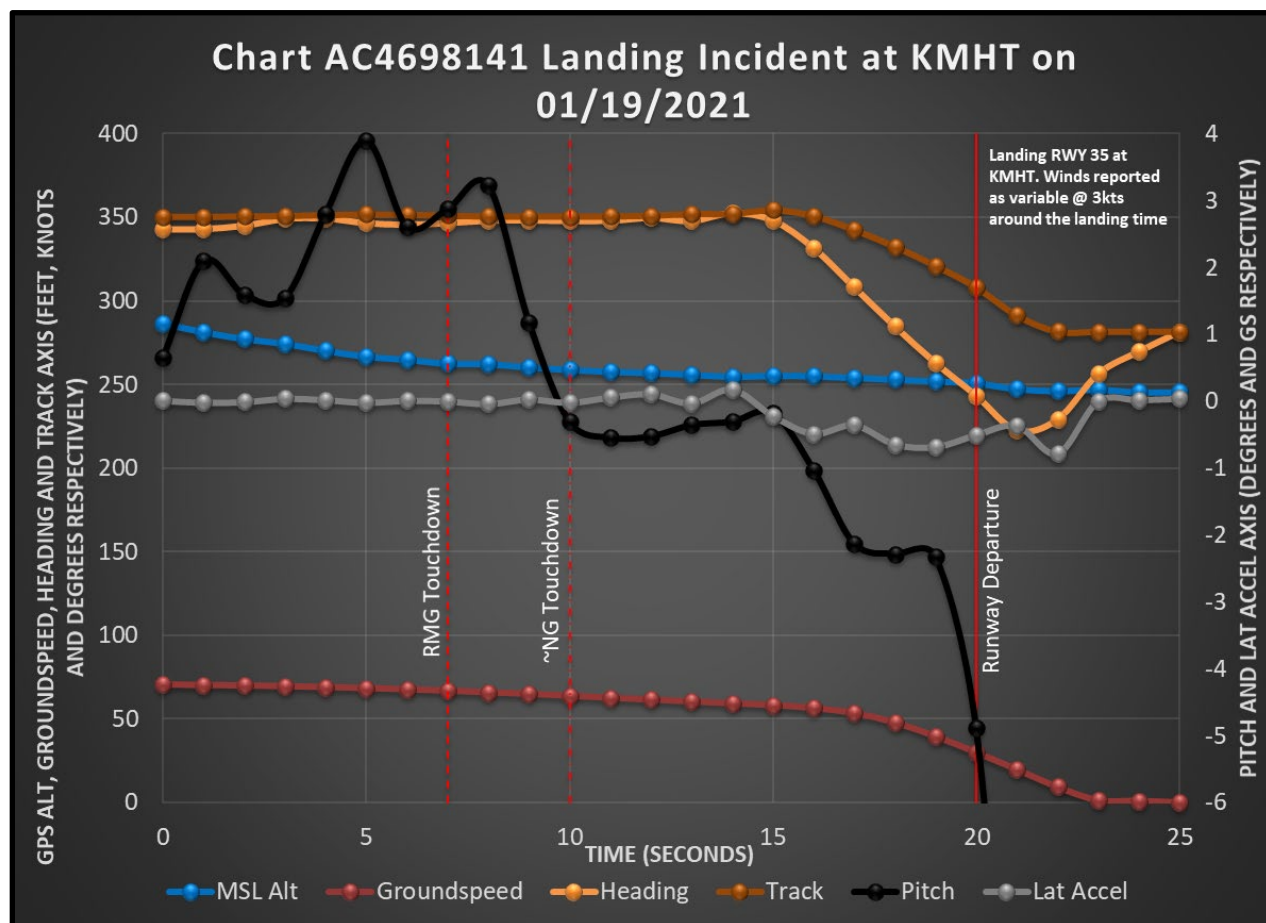
Piper plotted the altitude, groundspeed, heading, track, pitch and lateral acceleration data for the incident landing from the SD card at the request of the NTSB, Figure 13. The RMLG touchdown points was established with the wheel speed information contained in the internal CMC data. The runway departure timing was estimated based on the airplane position information. The NLG touchdown was estimated based on the pitch parameter. The landing appeared nominal with the heading and track aligned and the RMLG touched down at a ground speed about 67 knots. The NLG touched down about 3 seconds after the RMLG at a recorded ground speed about 64 knots. About 2 seconds later there was a noticeable oscillation in the lateral acceleration followed by a significant left lateral acceleration that reached about 0.7 g about 5 seconds after NLG touchdown. During this time the airplane heading and track started to diverge and the heading decreased more than 90° left of the runway heading. The airplane heading and track deviated more than 60° at their maximum point. The airplane departed the runway about 13 seconds after RMLG touchdown and the NLG collapsed causing the pitch to decrease sharply. The airplane departed

the runway at a ground speed about 30 kts and came to rest about 18 seconds after RMLG touchdown on a heading about 280°.

Figure 13-Plot of data from N641WA incident landing.

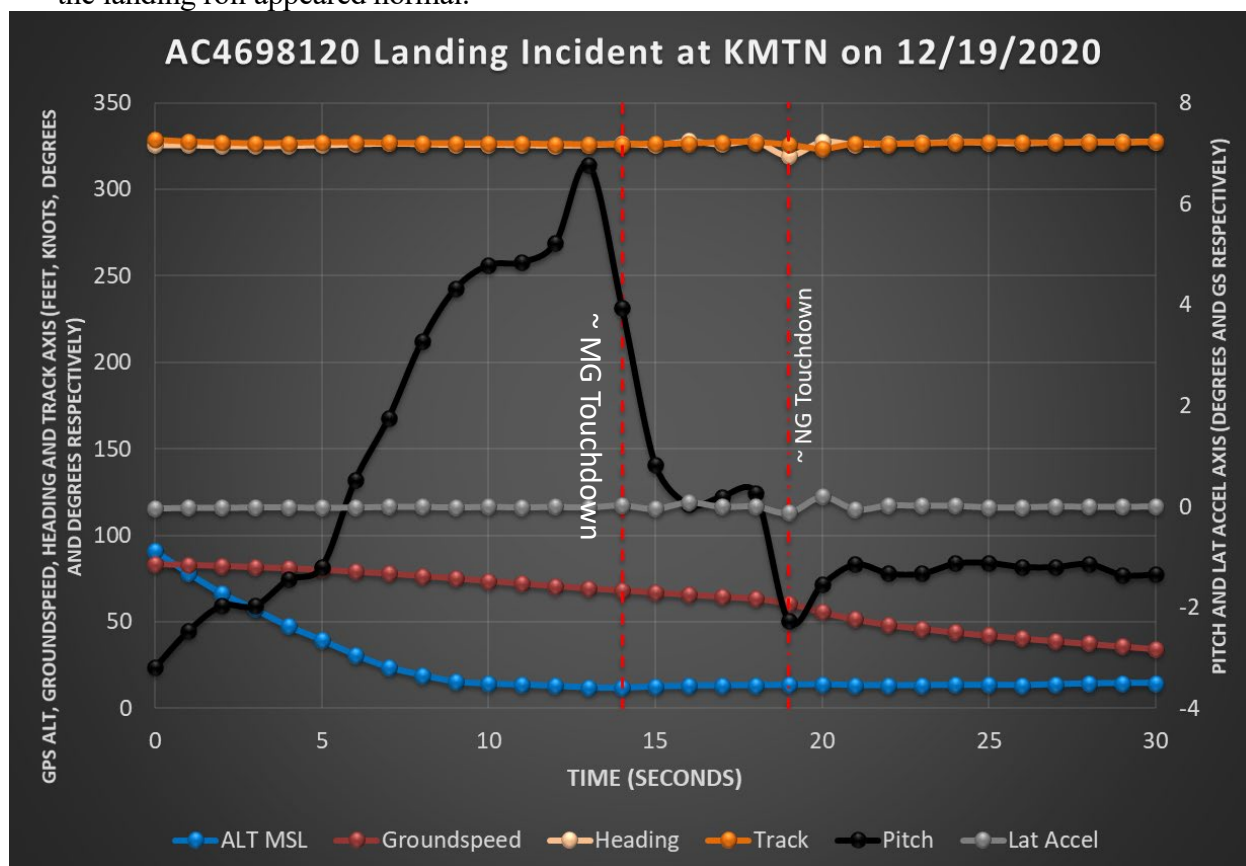
Piper plotted the altitude, groundspeed, heading, track, pitch and lateral acceleration data for the incident landing from the SD card at the request of the NTSB, Figure 14. The MLG touchdown point was estimated based on the altitude and pitch parameters. The NLG touchdown was estimated based on the pitch parameter. The landing appears nominal with the heading and track aligned and the MLG touches down at a ground speed about 68 knots. The NLG touches down about 5 seconds after the MLG at a recorded ground speed about 61 knots. There was some slight oscillation in the lateral acceleration between MLG and NLG touchdown. When the NLG touches down there is a left lateral acceleration about -0.12 g followed 1 second later by a right lateral acceleration about 0.20 g. The lateral acceleration oscillates slightly for the next 3 seconds before becoming stable. During this time the airplane heading deviated from the track. The remainder of the landing roll appeared normal.

Figure 14-Plot of data from N831PS incident landing.

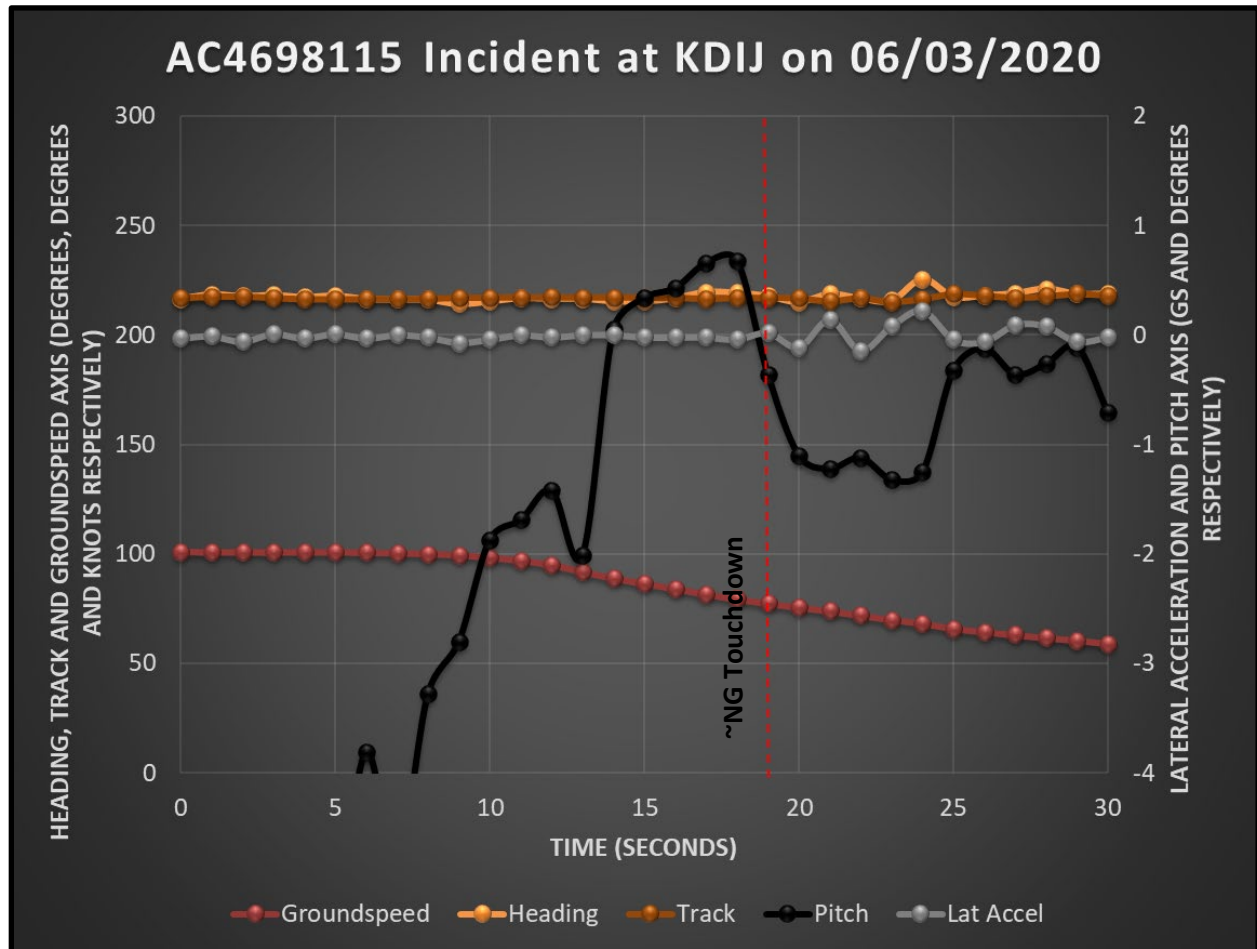
Piper plotted the groundspeed, heading, track, pitch and lateral acceleration data for the incident landing at DIJ from the SD card at the request of the NTSB, Figure 15. The NLG touchdown was estimated based on the pitch parameter. The landing appeared nominal with the heading and track aligned and the NLG touched down at a ground speed about 78 knots. Immediately after NLG touchdown there was a left lateral acceleration that was followed by lateral acceleration oscillations right and left for the next 5 seconds. About 5 seconds after NLG touchdown the heading and track reached their maximum difference with the heading about 9° right of the track. About 6 seconds after NLG touchdown there was a noticeable increase in pitch followed by a decrease in the lateral acceleration oscillation. The remainder of the landing then appeared

Figure 15-Plot of data from N115NX incident landing at DIJ.

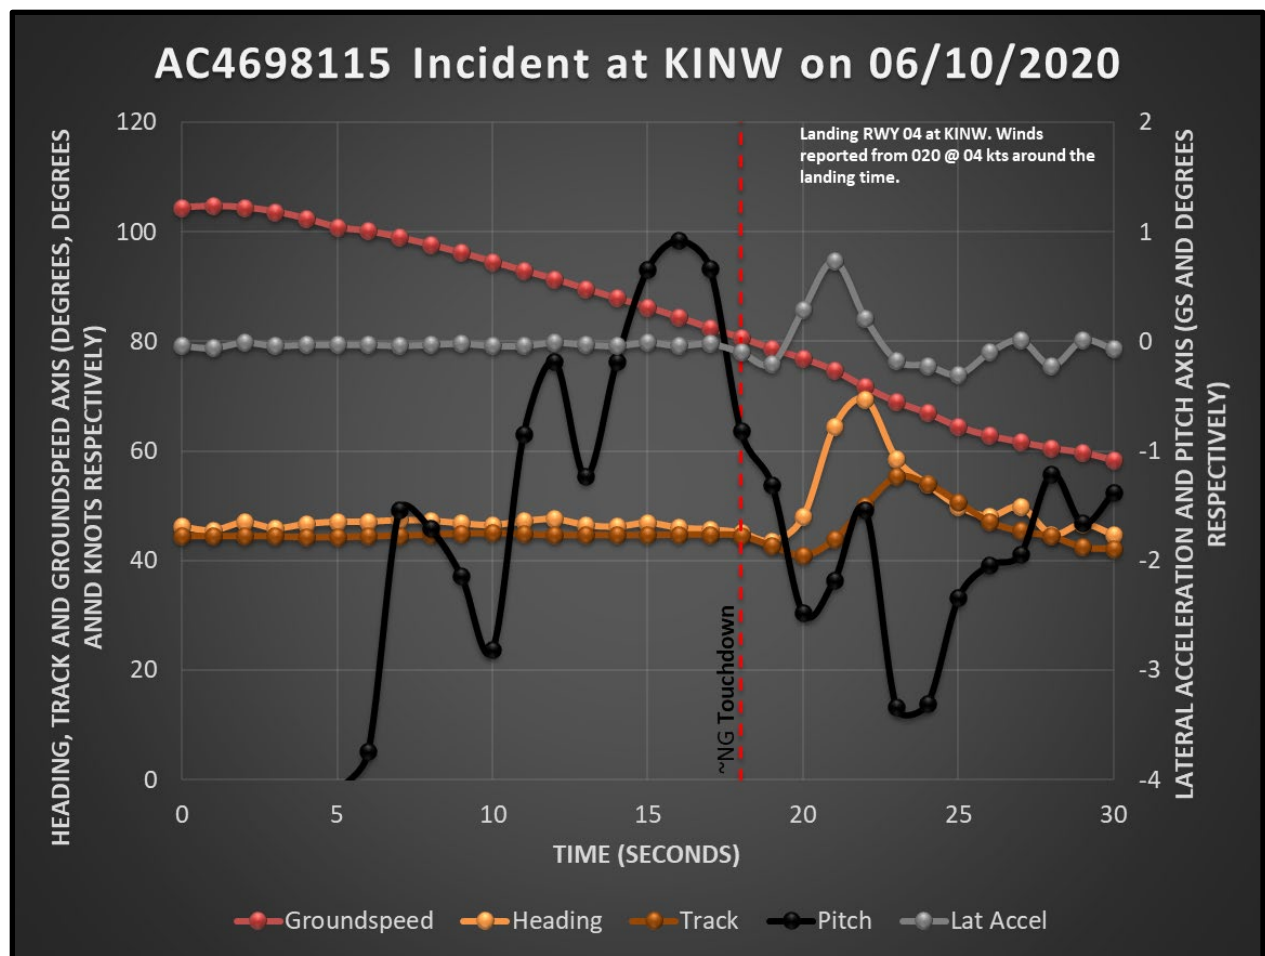
Piper plotted the groundspeed, heading, track, pitch, and lateral acceleration data for the incident landing at INW from the SD card at the request of the NTSB, Figure 16. The NLG touchdown was estimated based on the pitch parameter. The landing appeared nominal with the heading and track aligned and the NLG touched down at a ground speed about 81 knots. Prior to NLG touchdown there was a slight left lateral acceleration that continued as the NLG touched down. About 1 second after NLG touchdown there was a significant veer to the right with the right lateral acceleration reaching a maximum of about 0.73 g about 3 seconds after NLG touchdown. At this time, the deviation between heading and track was maximum with the heading about 20° right of the track. About 5 seconds after NLG touchdown the pitch began to increase, and the heading and track became aligned again. The remainder of the landing then appeared nominal with the heading and track mostly aligned.

Figure 16-Plot of data from N115NX incident landing at INW.
