**NATIONAL TRANSPORTATION SAFETY BOARD**  
Office of Aviation Safety

**LANDING GEAR EXAMINATION SUMMARY**

**A. ACCIDENT      ERA21NA065**

Location:        Leesburg, Virginia  
Date:             December 6, 2020  
Time:            1404 Eastern Standard Time (EST)  
Operator:        Private  
Aircraft:        Piper PA-46-600TP  
Registration:    N282ST

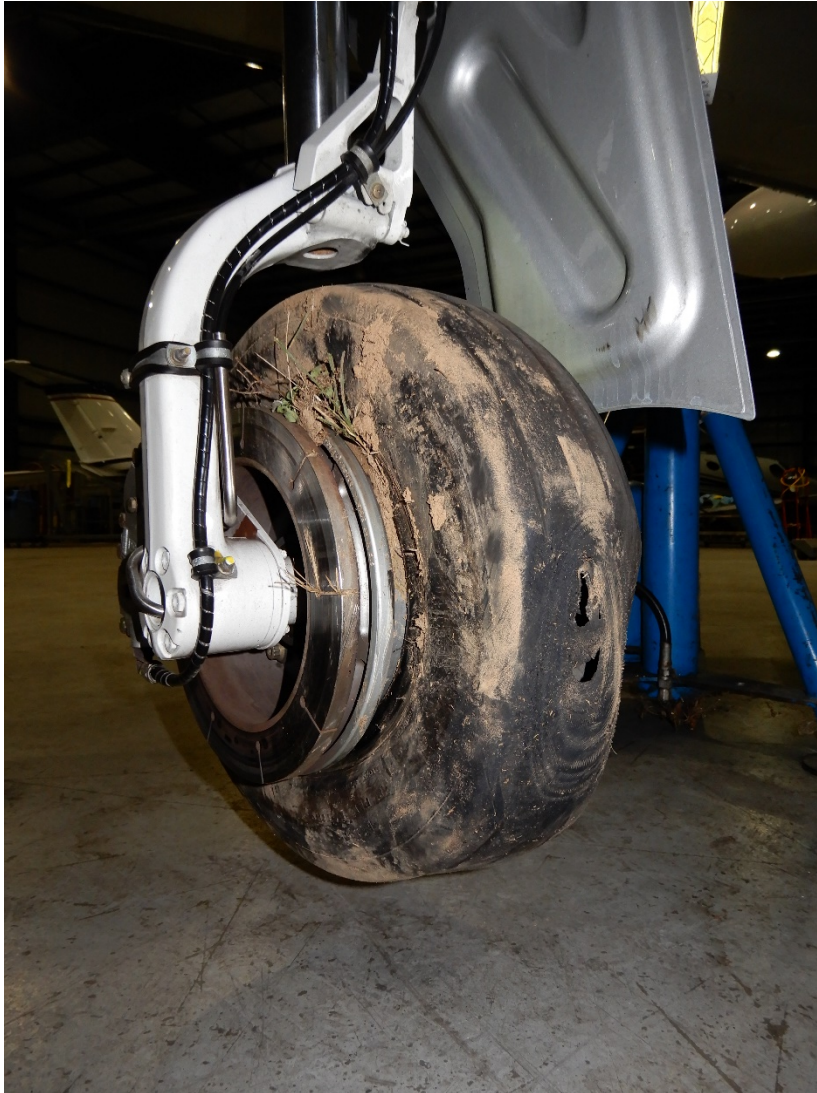
*Figure 1. Right main landing gear.*

The right main landing gear tire was blown. It exhibited 2 flat spots. One area at the 11 o'clock position on the tire and a large worn-down area at the 7 o'clock position that had worn through the tire tread. The preload bearings and brakes exhibited no anomalies when examined. The right main landing gear door was not damaged, but exhibited a small black mark/residue on it. The right main landing gear upper trunnion bushing had play in it.

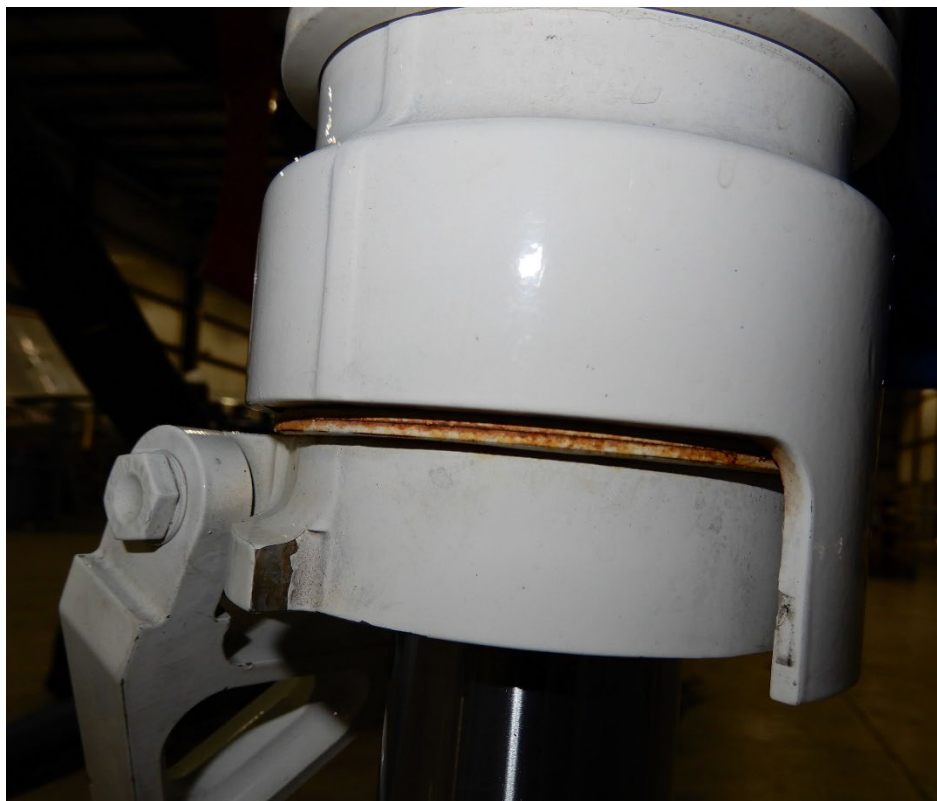
The trunnion mounted stops were damaged on both sides of the nose landing gear.

*Figure 2. Left side view of impact mark on nose landing gear.*

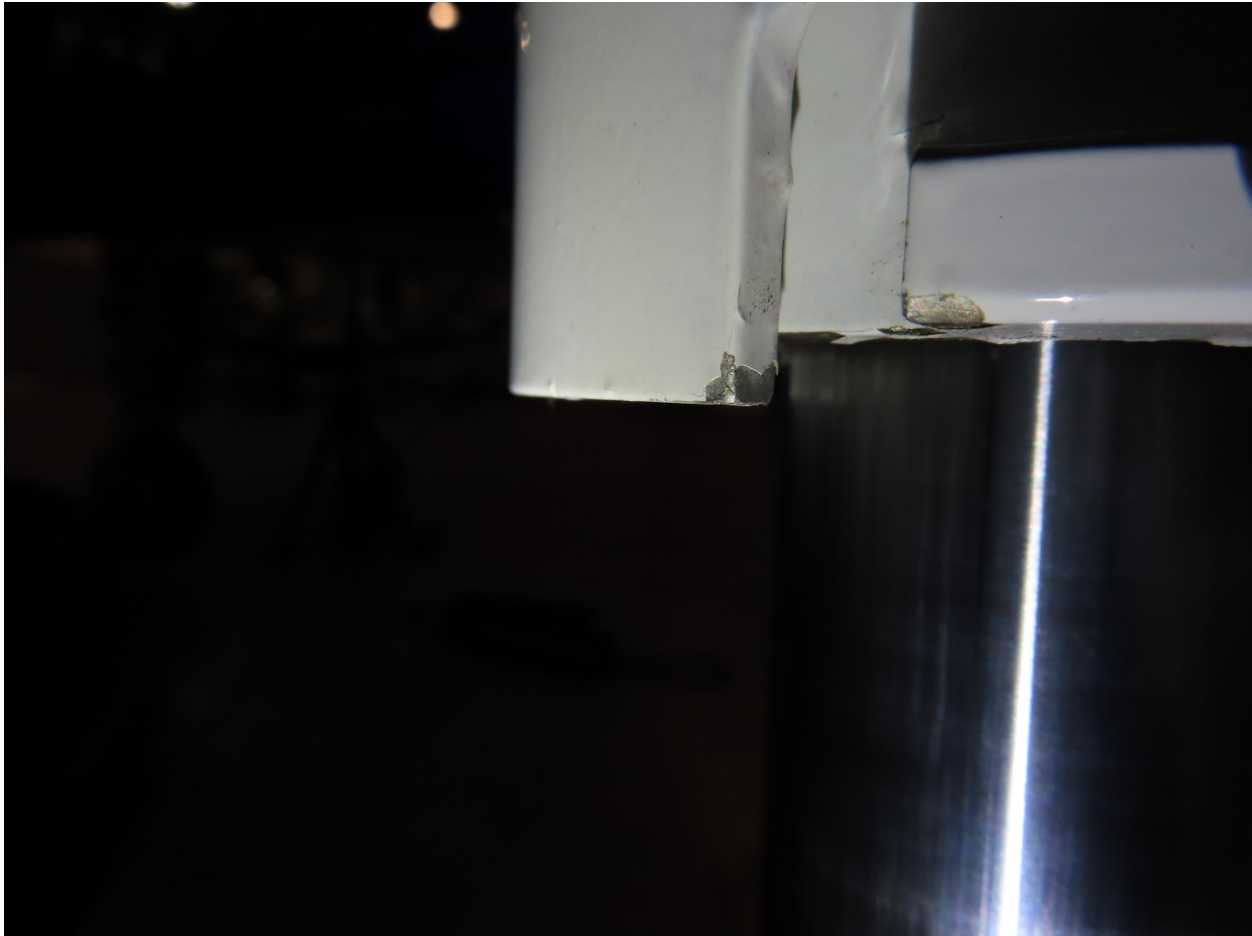
*Figure 3. Right side view of trunnion stop on nose landing gear.*

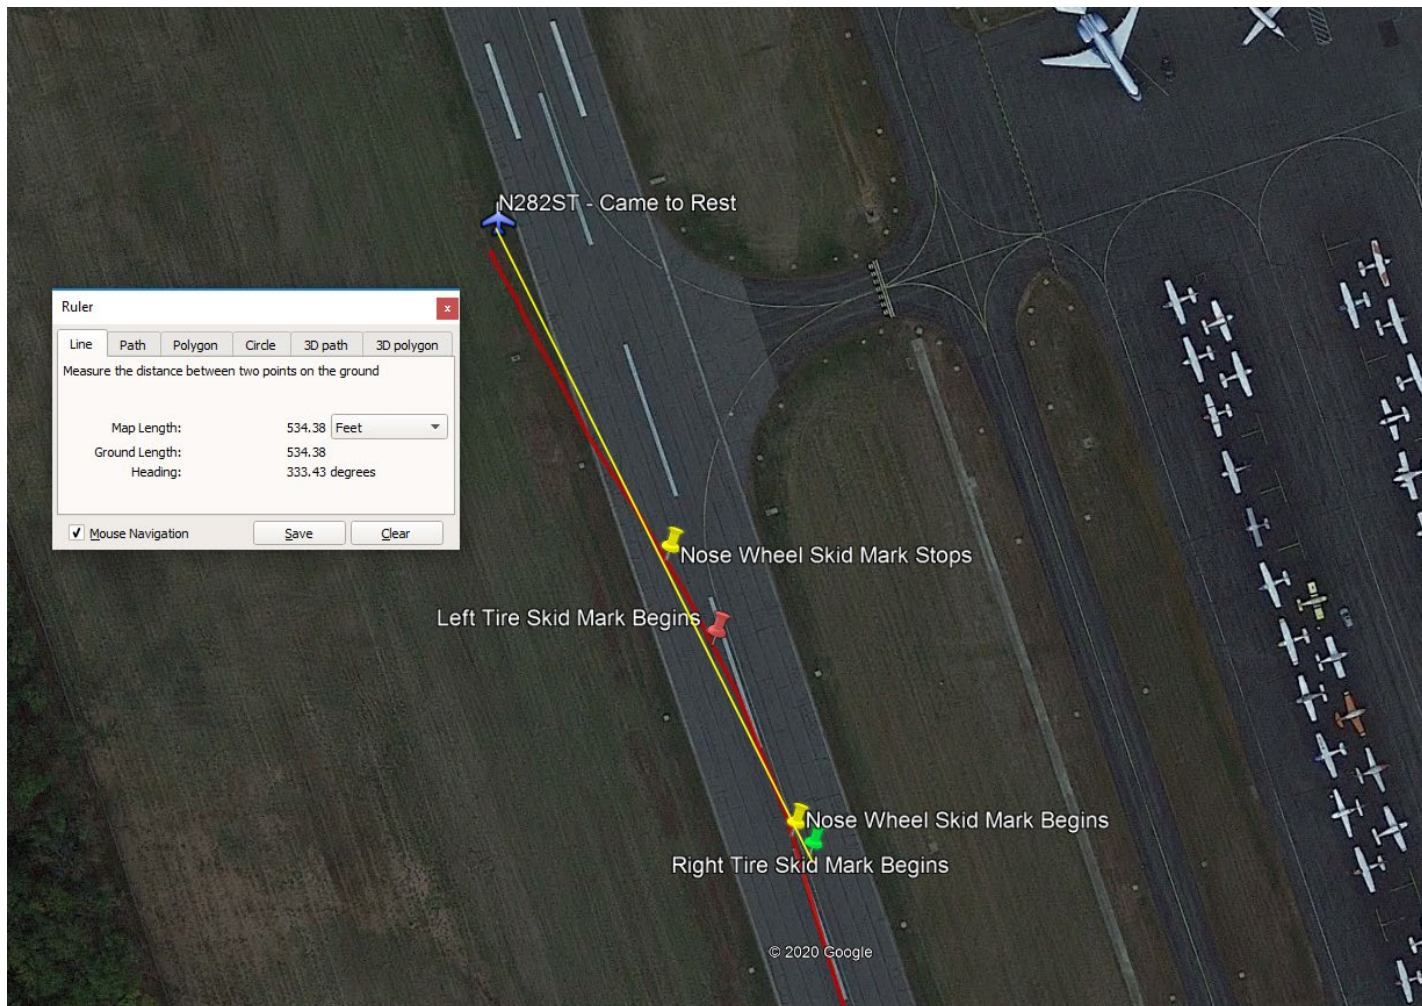
When the airplane departed the runway, the skid marks and tire marks in the dirt measured 4 ft from the nose landing gear to the right main landing gear and 8.8 ft from the left main landing gear to the nose main landing gear.

When the airplane was parallel with the runway sign, the tire marks in the grass measured 9 ft from the left main landing gear to the nose landing gear and 4.5 ft from the right main landing gear to the nose landing gear.

Figure 4. Google Earth view of skid mark locations and incident flight ground track.
