Piper Aircraft, Inc.  
2926 Piper Drive  
Vero Beach, FL, U.S.A. 32960

# SERVICE NO. 1350 BULLETIN

Date: December 17, 2020

**NOSE LANDING GEAR STEERING HORN AND ARM  
ASSEMBLIES INSPECTION**

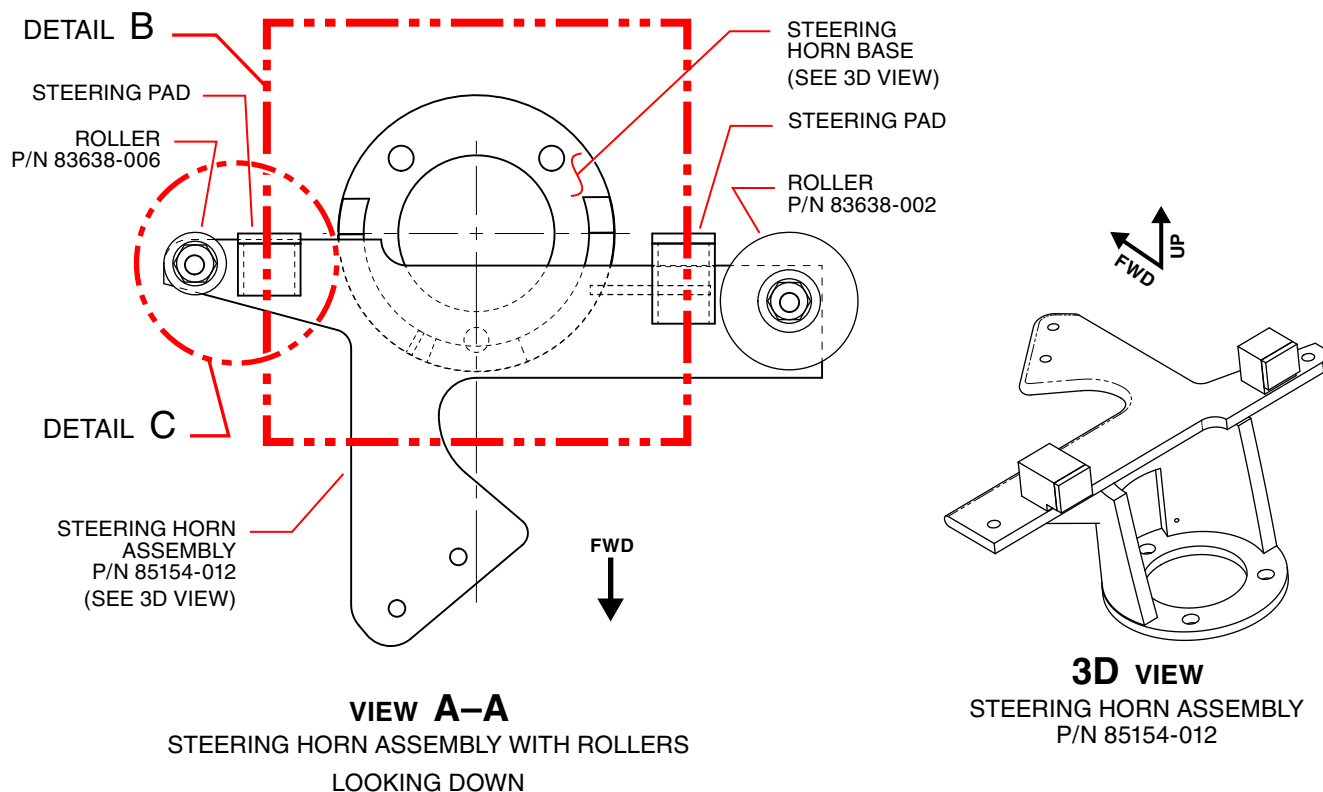
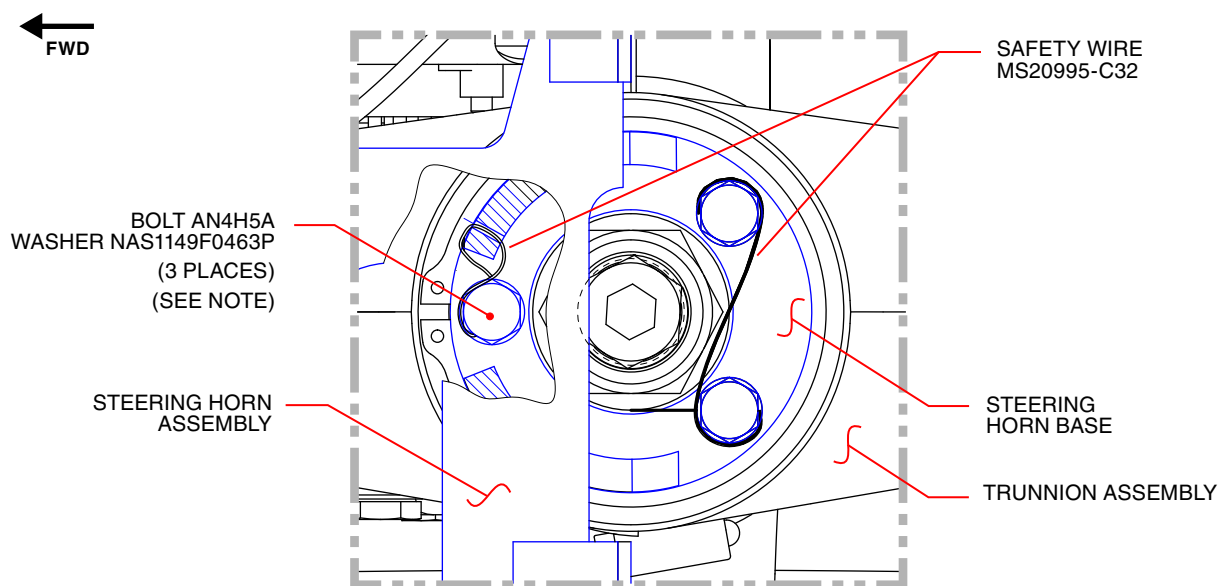
**DETAIL B**  
STEERING HORN BASE (TYPICAL)  
(VIEW ROTATED 90 DEGREES CW)

**NOTE:** Torque Bolts AN4H5A to 25–30 in-lb.

- 2) Install the hardware retained in Step 2, and torque the bolts per the note in Detail B. Safety wire the bolts with P/N 151-296 (MS20995-C32).
- c. Replace the steering arm assembly, if required.
