# NATIONAL TRANSPORTATION SAFETY BOARD

## MATERIALS LABORATORY FACTUAL REPORT

Report No. 21-072

Place : Attalla, Alabama  
Date : December 12, 2020  
Vehicle : Beech V35A, N5470U  
NTSB No. : ERA21LA068  
Investigator : Timothy Monville, AS-ERA

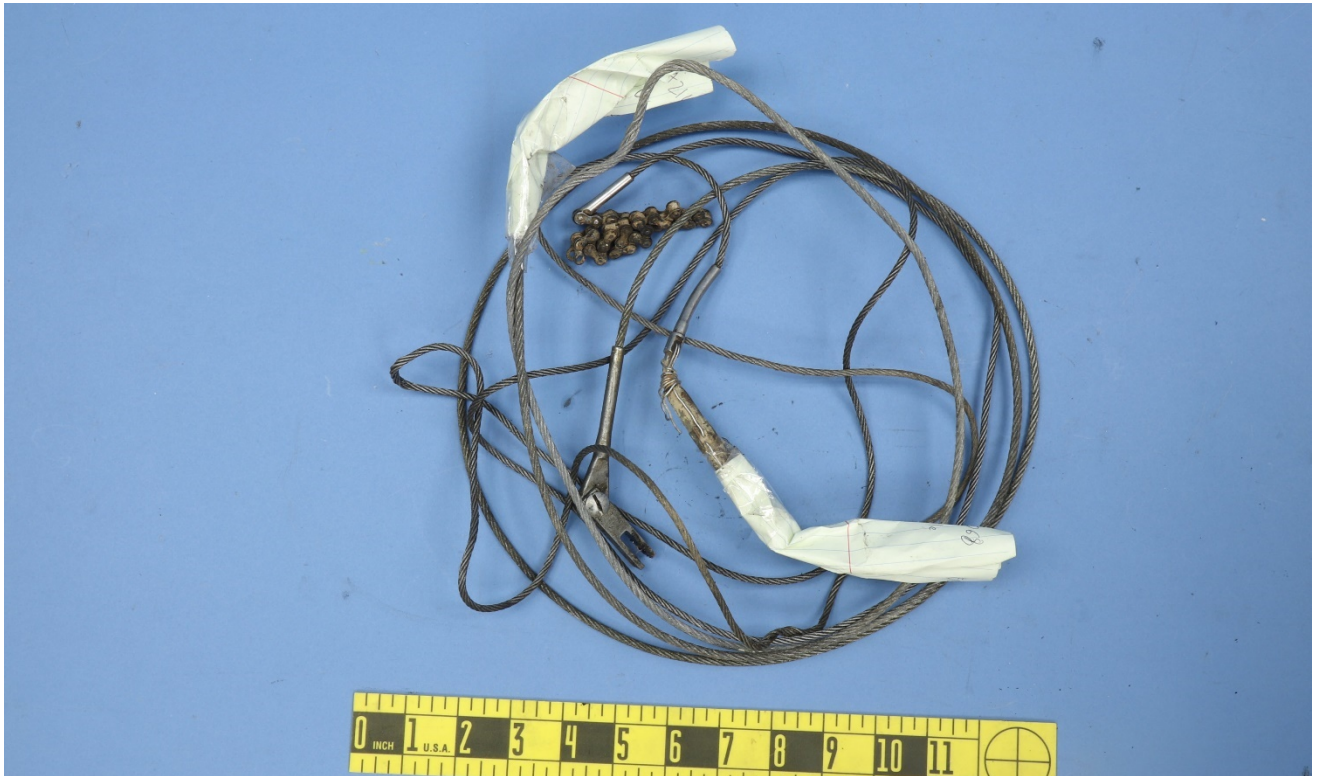
Figure 1 shows the right aileron direct cable (or wire rope) remnants, as received by the Materials Laboratory. The fractured ends of a turnbuckle fitting had been wrapped with notebook paper and taped prior to receipt. One of the sides was labeled "Cockpit End," and the other was labeled, "WMS" indicating the end towards the wing.

Figure 1 – View of the control wire rope remnants, as received.

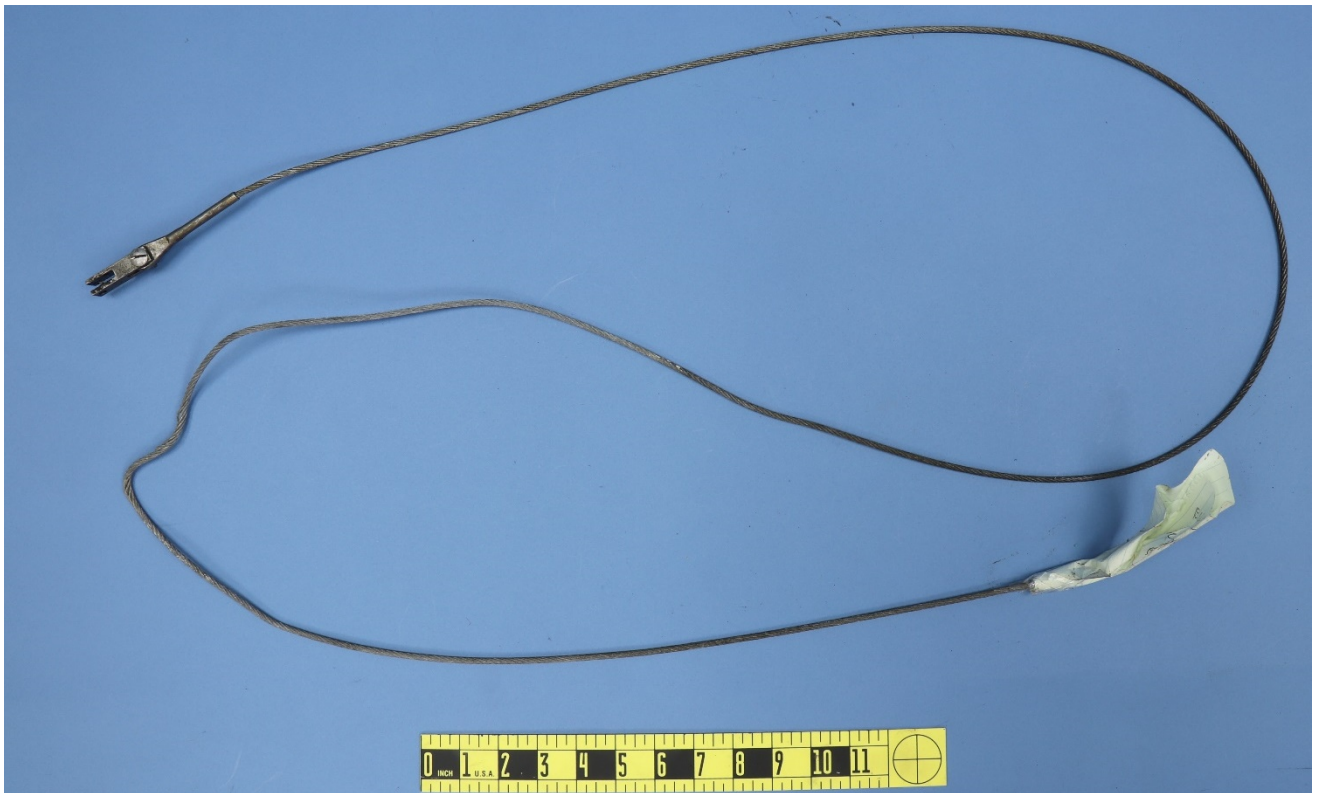
Figure 2 shows the WMS or wing side, as received. This section of the cable or wire rope measured 95.0 inches from the fitting to the outboard fixture (in the upper left of the figure) and 99.25 inches total length. Figure 3 shows the swaged portion of a wire rope turnbuckle terminal stud with a fracture that occurred at the terminus of the wire rope. This swaged portion of the terminal stud measured about 2.94 inches in length.

Figure 2 – View of the wire rope remnant side with the end labeled 'WMS End.'

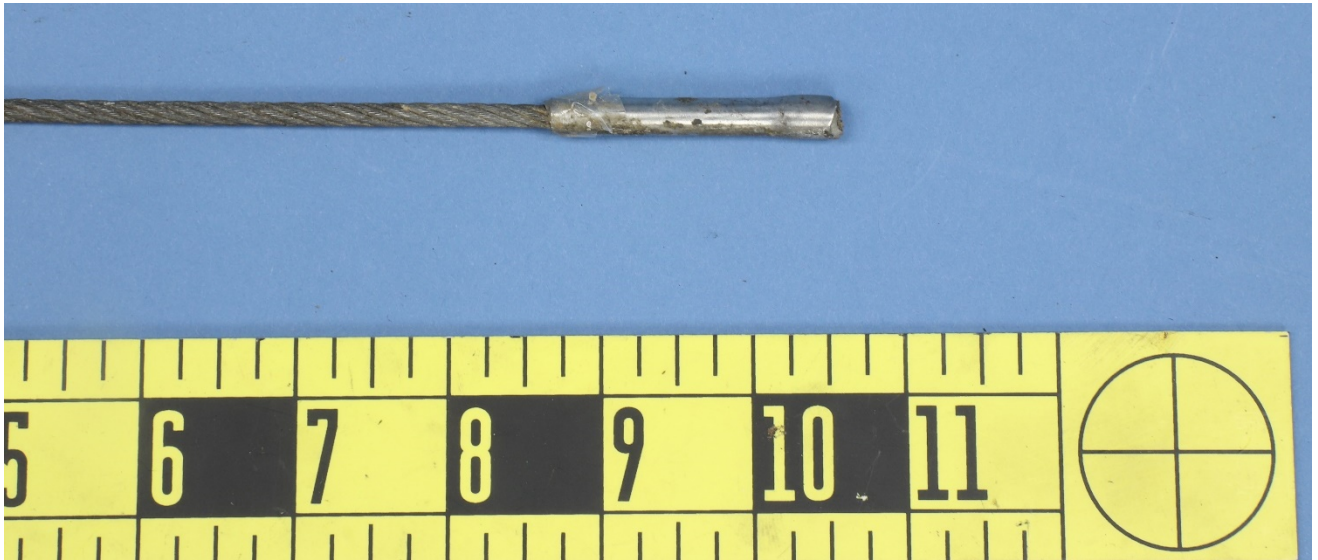
Figure 3 – View of the swaged end of the fractured terminal stud fitting end of the WMS end, viewed from the side.

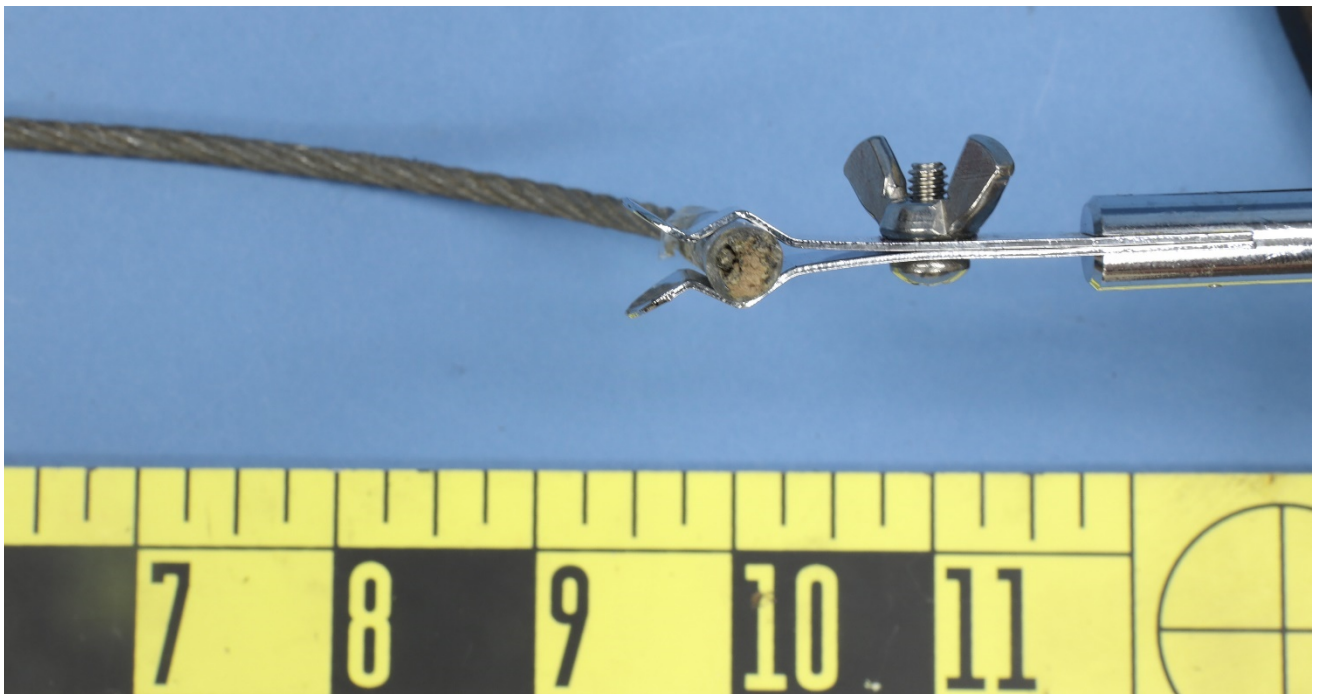
Figure 4 shows the as-received fracture surface of the swage portion of the terminal stud. This fracture surface contained enough caked dirt to obscure most of the strand ends.

Figure 4 – View of the swaged end of the terminal stud fracture surface from Figure 3, showing caked dirt and debris in the wire strands.

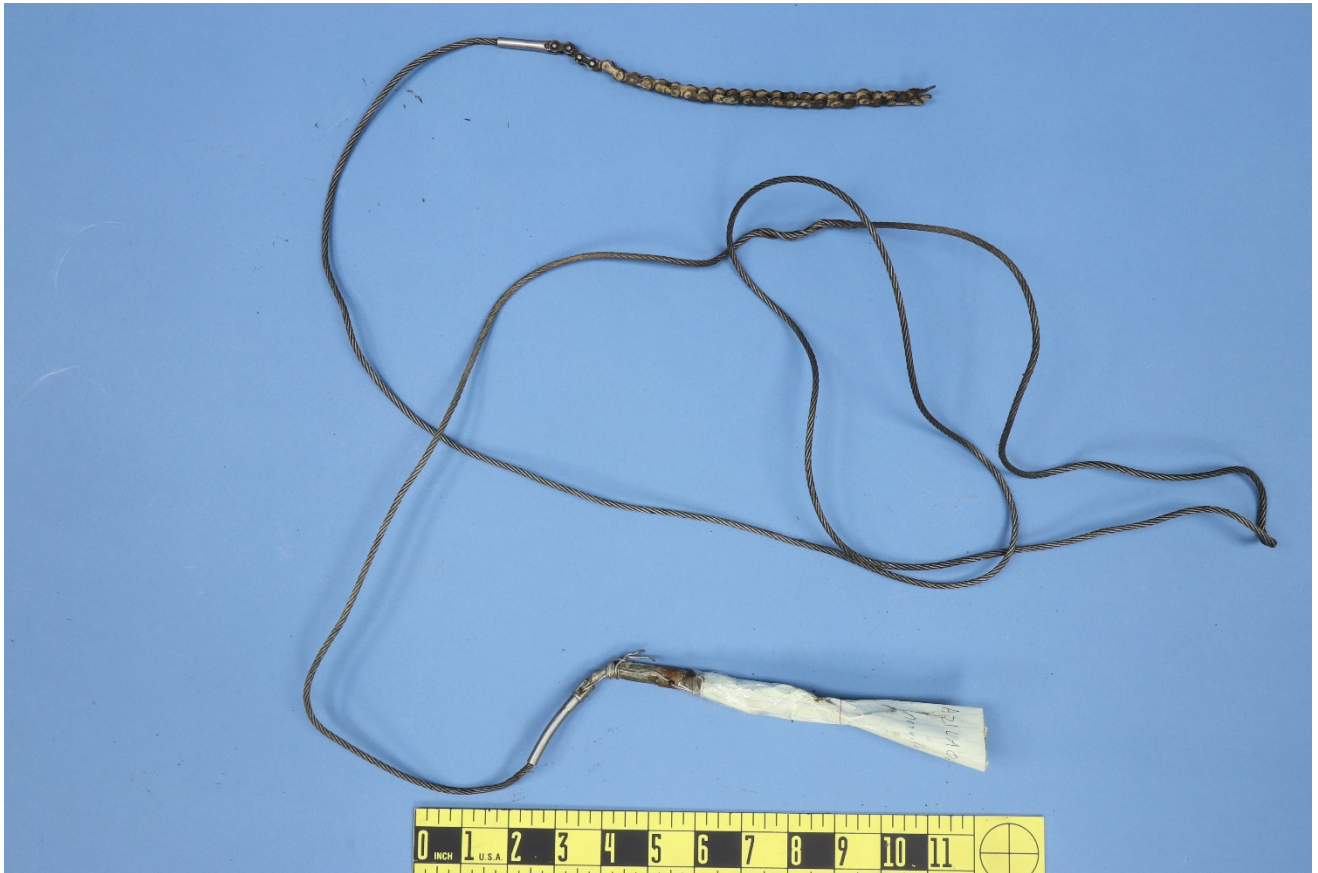
Figure 5 shows the section of the wire rope labeled “Cockpit End.” This section of wire rope was attached to a chain on the forward end, shown in the top of Figure 5. From the fractured fitting to the chain, the wire rope measured about 97.25 inches, with the entire remnant of the wire rope assembly measured about 107.5 inches total.

Figure 5 – View of the control wire rope remnant labeled 'Cockpit End', as received.

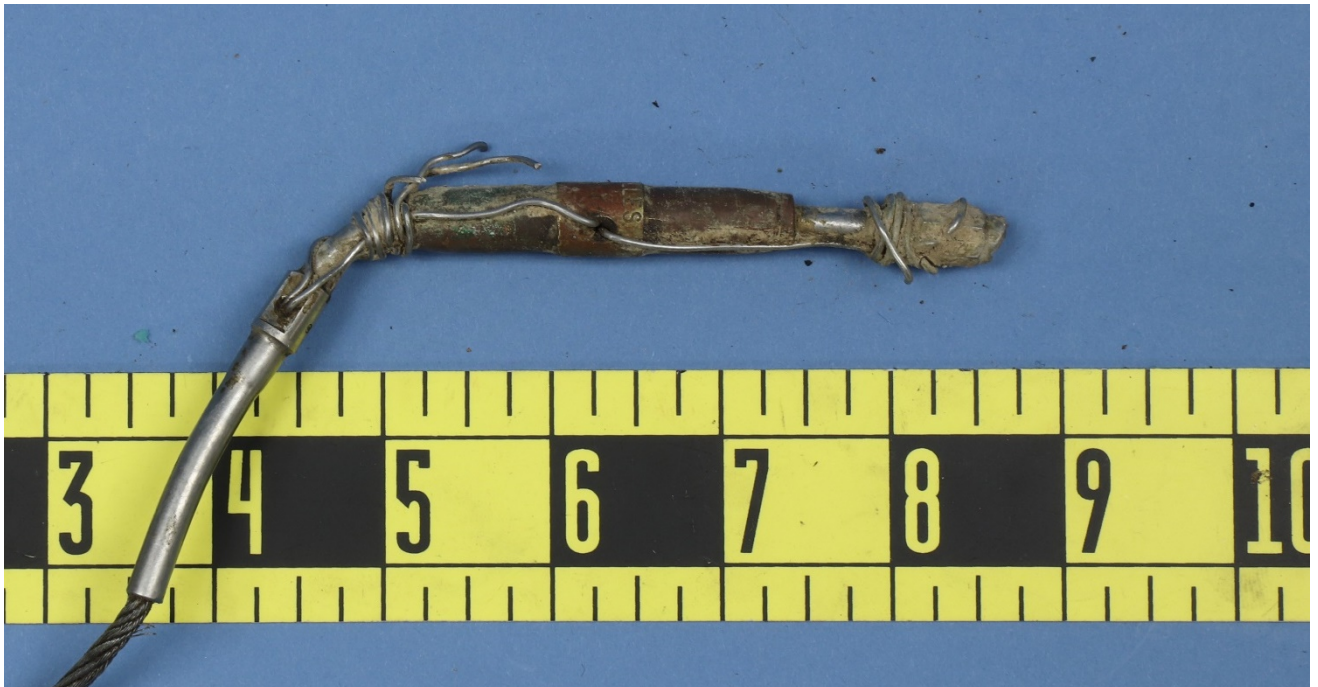
Figure 6 shows the “Cockpit End” of the fractured turnbuckle assembly, after removing the covering. The fractured turnbuckle assembly exhibited several strands of safety wire wrapped around the part and through the holes in three locations. As shown in the left of Figure 6, the intact turnbuckle terminal stud was bent about 45°. The fracture surface of the turnbuckle terminal stud is shown in Figure 7. This end exhibited a general cup-shape, and as such was filled with caked dirt, consistent with contact with the ground after fracture.

Figure 6 – View of the as-received turnbuckle fitting with a fractured portion of a terminal stud from the 'Cockpit End' wire rope remnant, viewed from the side.

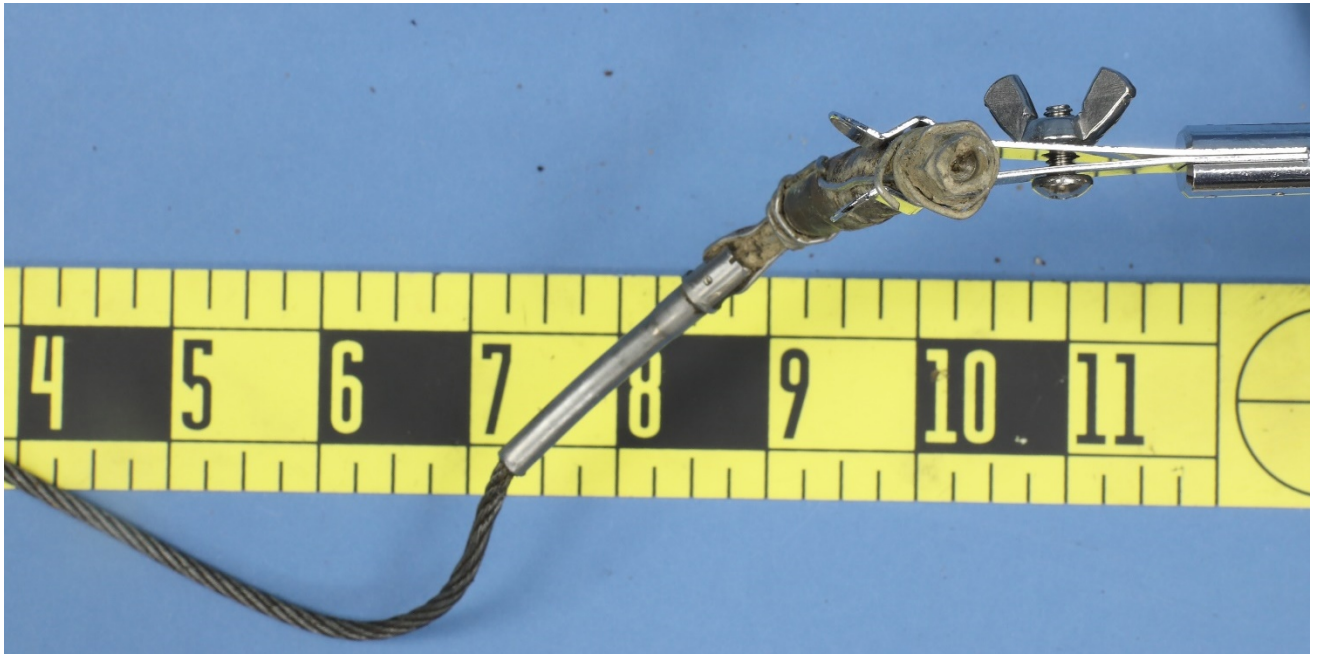
Figure 7 – View of the terminal stud fracture surface for the portion assembled to the turnbuckle fitting from cockpit end in Figure 6.

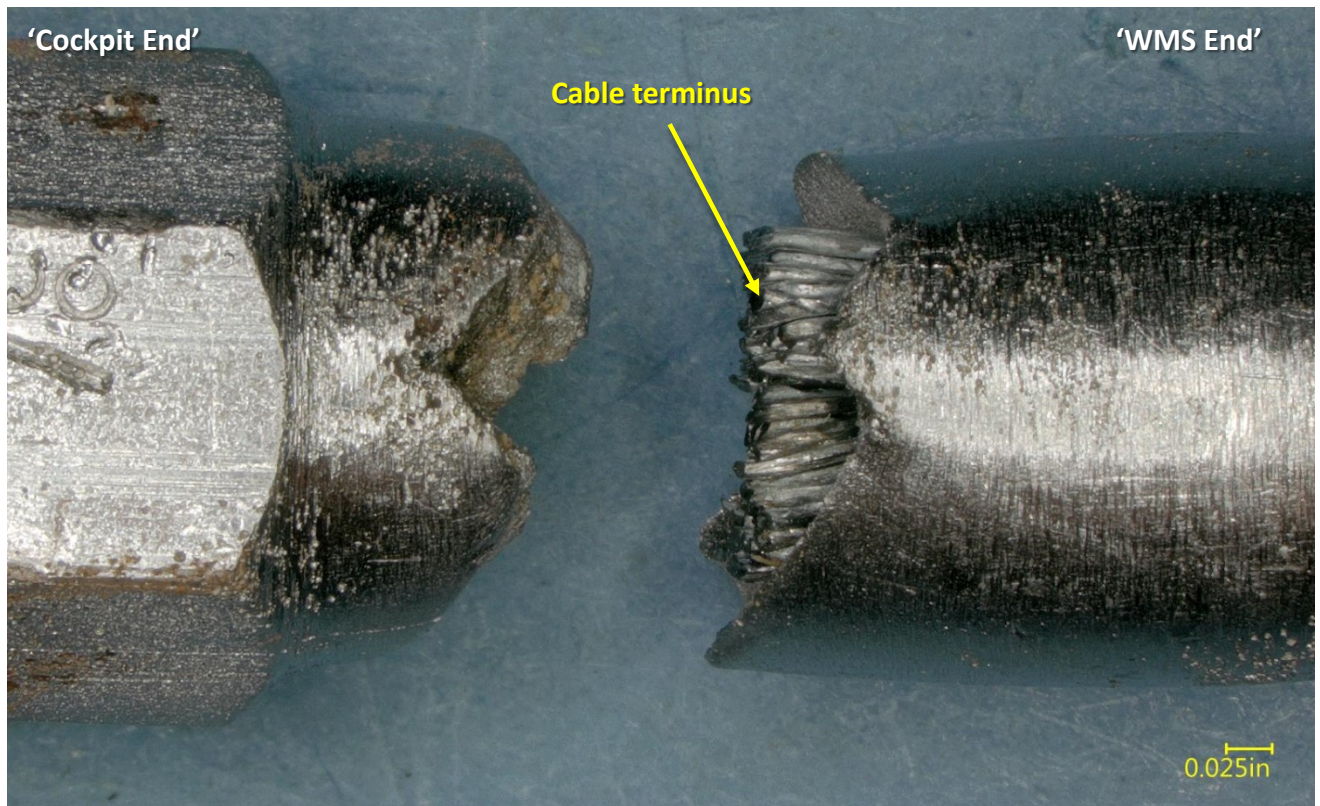
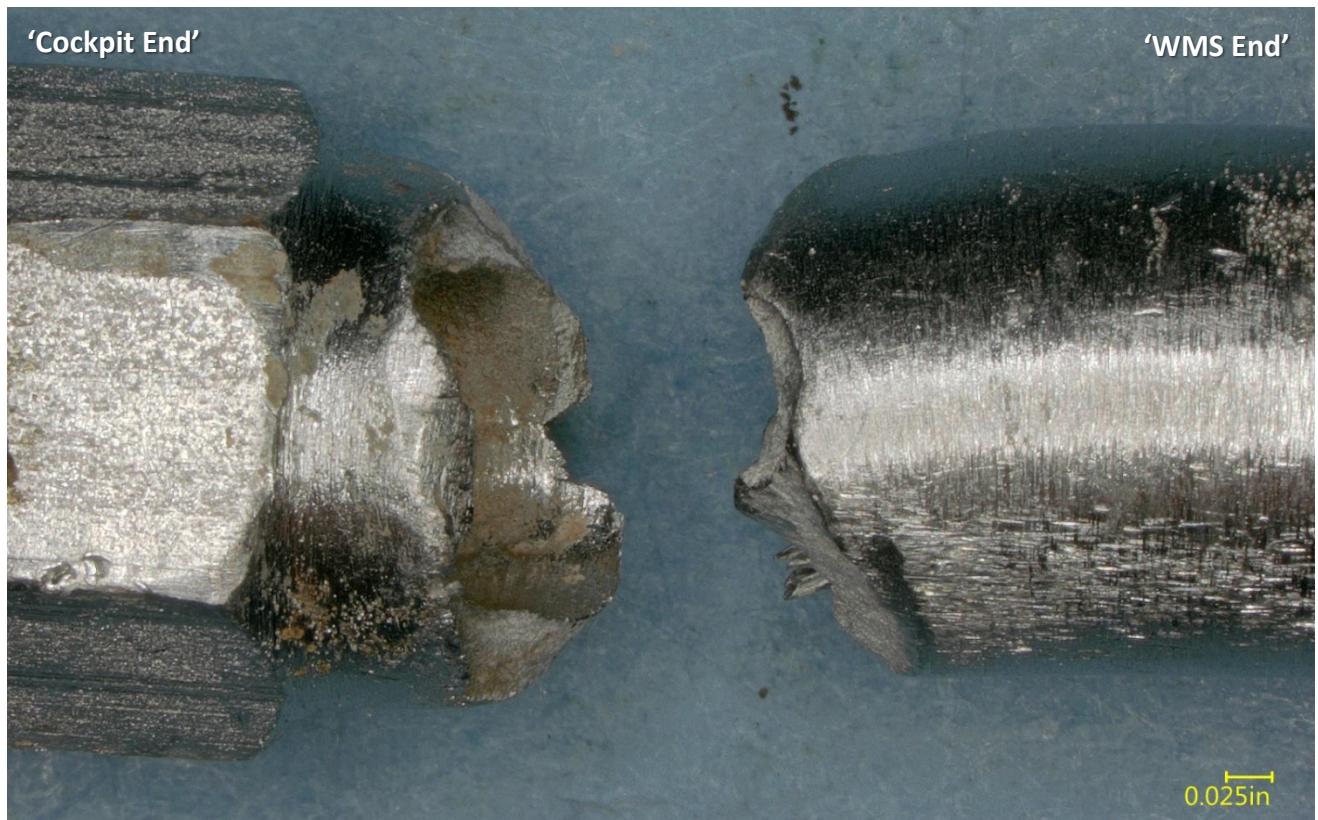
The fractured ends of the fitting were cleaned in an ultrasonic bath, first with acetone and then with an aqueous chelating cleaning solution.<sup>1</sup> Figures 8 and 9 show close view of the mating faces of the fracture facing each other, after cleaning. These figures illustrate the generally tortuous shape of the fracture surfaces, along with the rough surface texture. Particularly on the wing side, the terminal stud fracture exhibited localized deformation, consistent with necking, adjacent to the fracture surface. The wing side fracture surfaces in the terminal stud exhibited a cup-shape, with a general 45° slant.

Also of note, as illustrated in contrasting Figure 8 and Figure 9, were the wire strands being present on only the swaged or wing side of the fracture. This is demonstrated on the cockpit side of the fitting fracture, shown in Figure 10 after acetone cleaning, which was absent any wire rope strands. Rather, as shown in Figure 11, this fitting side consisted of a hollow bore which held the ends of the wires shown in Figure 8. The fracture surface of this part of the fitting exhibited a dull gray luster, with a rough tortuous surface. The fracture surface of the swaged end of the terminal stud fitting (wing end) is shown in Figure 12

Figure 8 – View of the mating ends of the terminal stud fracture surface, viewed from the side after cleaning twice.

Figure 9 – View of the terminal stud fracture surfaces viewed 180° from Figure 8.

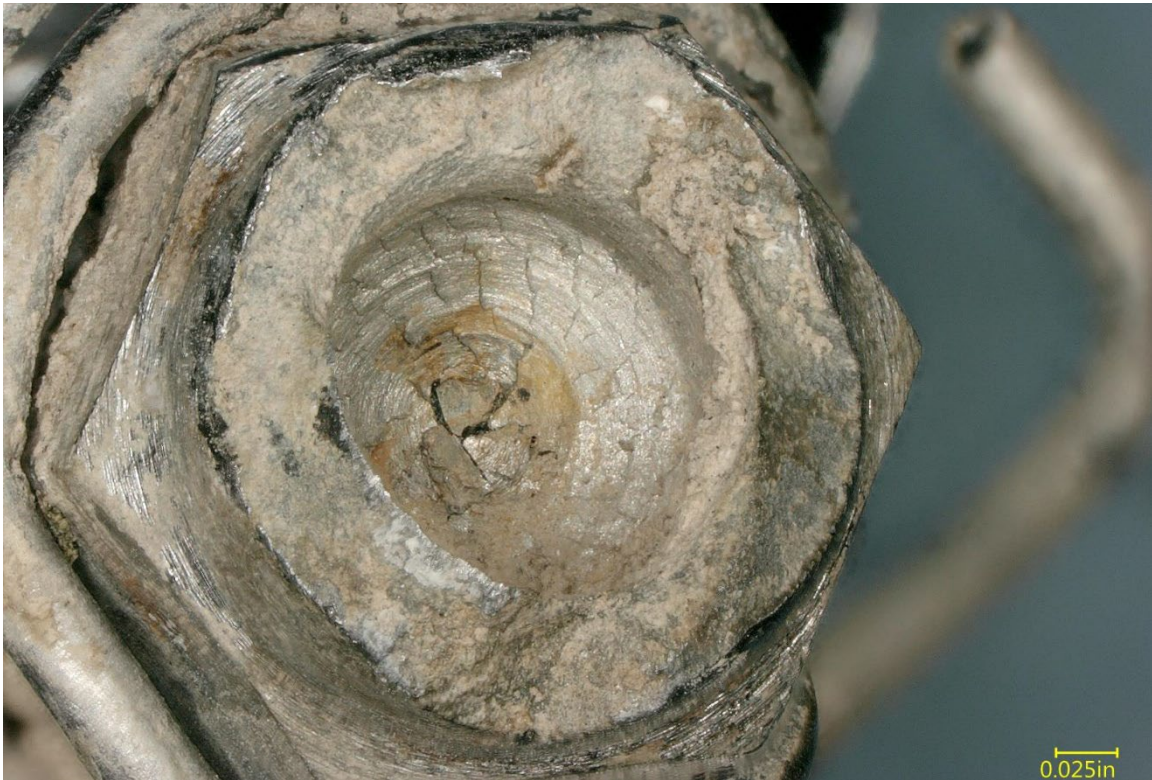
Figure 10 – View of the stud side (cockpit side) terminal stud fracture surface, post acetone cleaning.

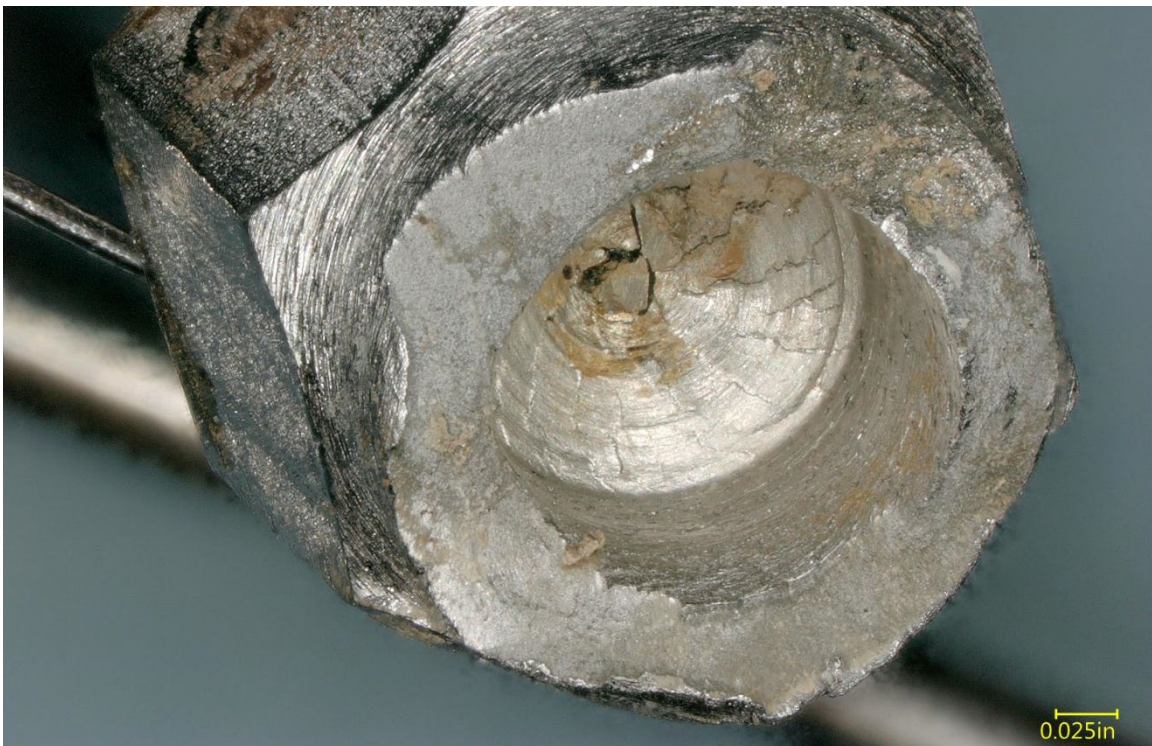
Figure 11 – View of the stud side (cockpit side) terminal stud fracture surface after second cleaning.

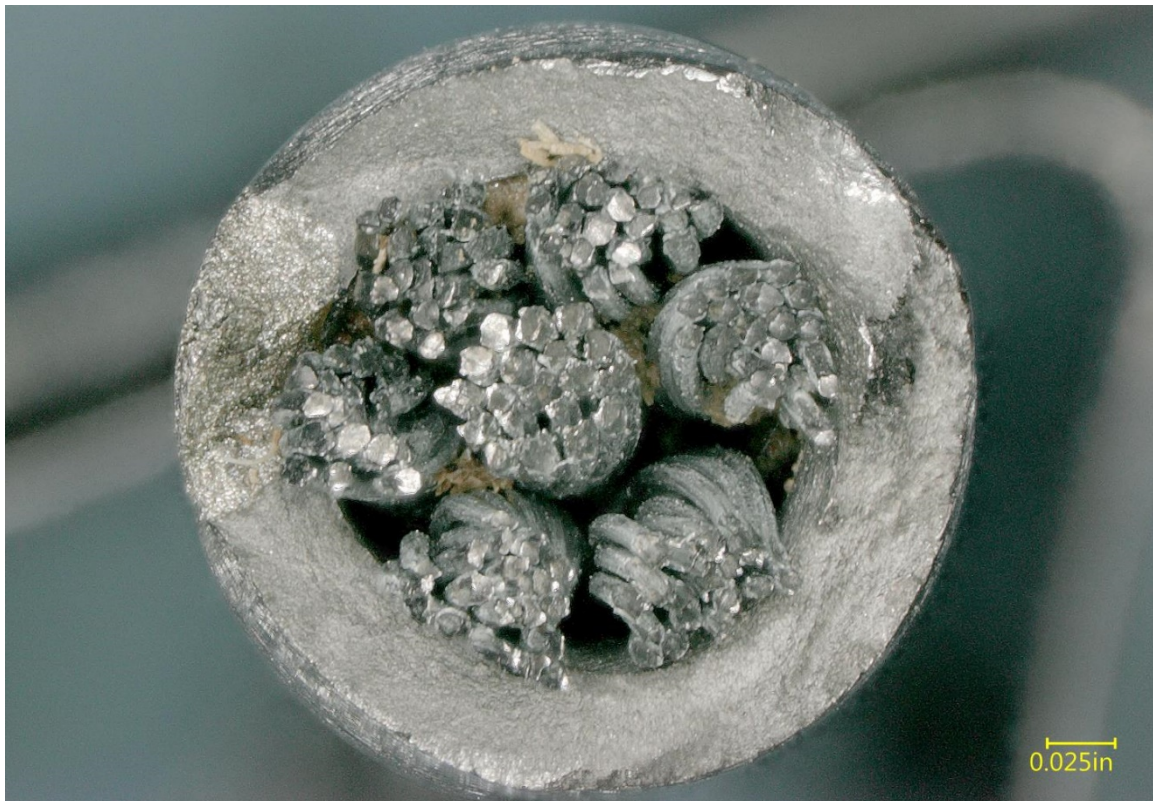
Figure 12 – View of the swaged end of the fractured terminal stud (WMS end) of the fitting, showing the wire-rope ends.

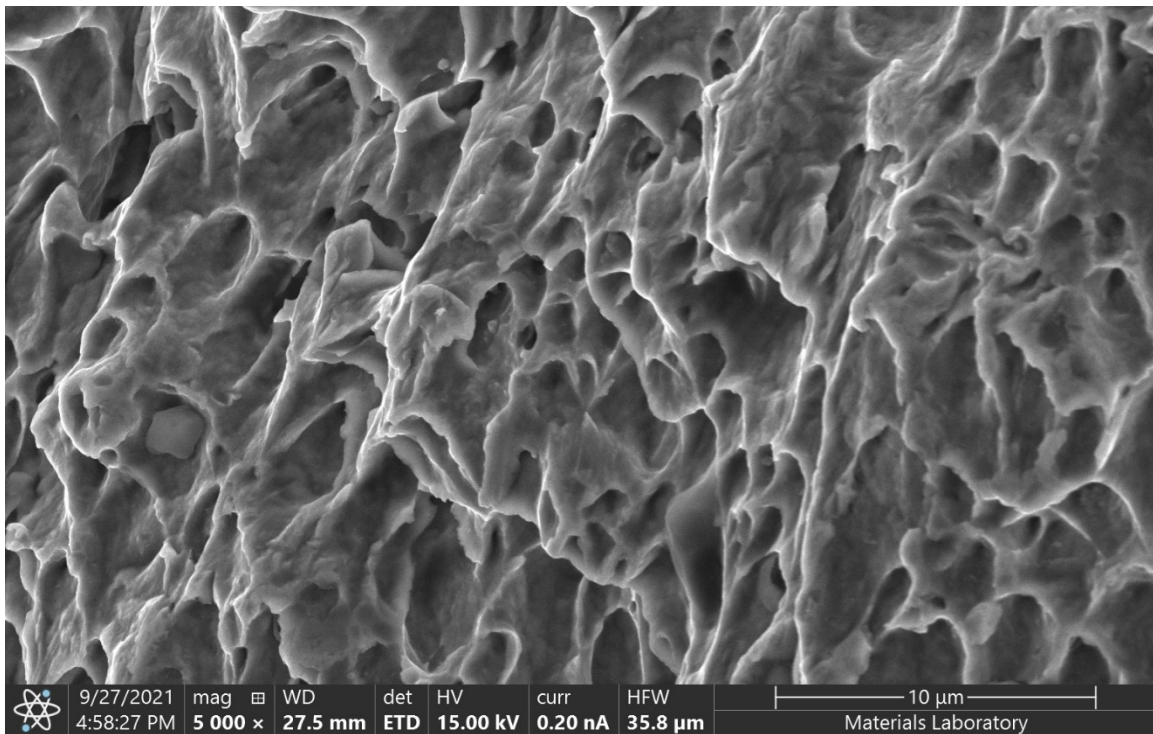
The fractured ends of the terminal stud were examined using a scanning electron microscope (SEM). The fracture surfaces exhibited consistent features, as typified in Figure 13—the fracture surface contained dimpled rupture, consistent with overstress fracture. There were some more visually reflective areas of the fracture surface, which were found to exhibit smearing, consistent with post-fracture damage to the surface. There were no indications of cracks, voids, or inclusions that would suggest pre-existing damage to the structure.

Figure 13 – Representative secondary electron (SE) micrograph of the terminal stud fracture surface, showing dimple rupture features.
