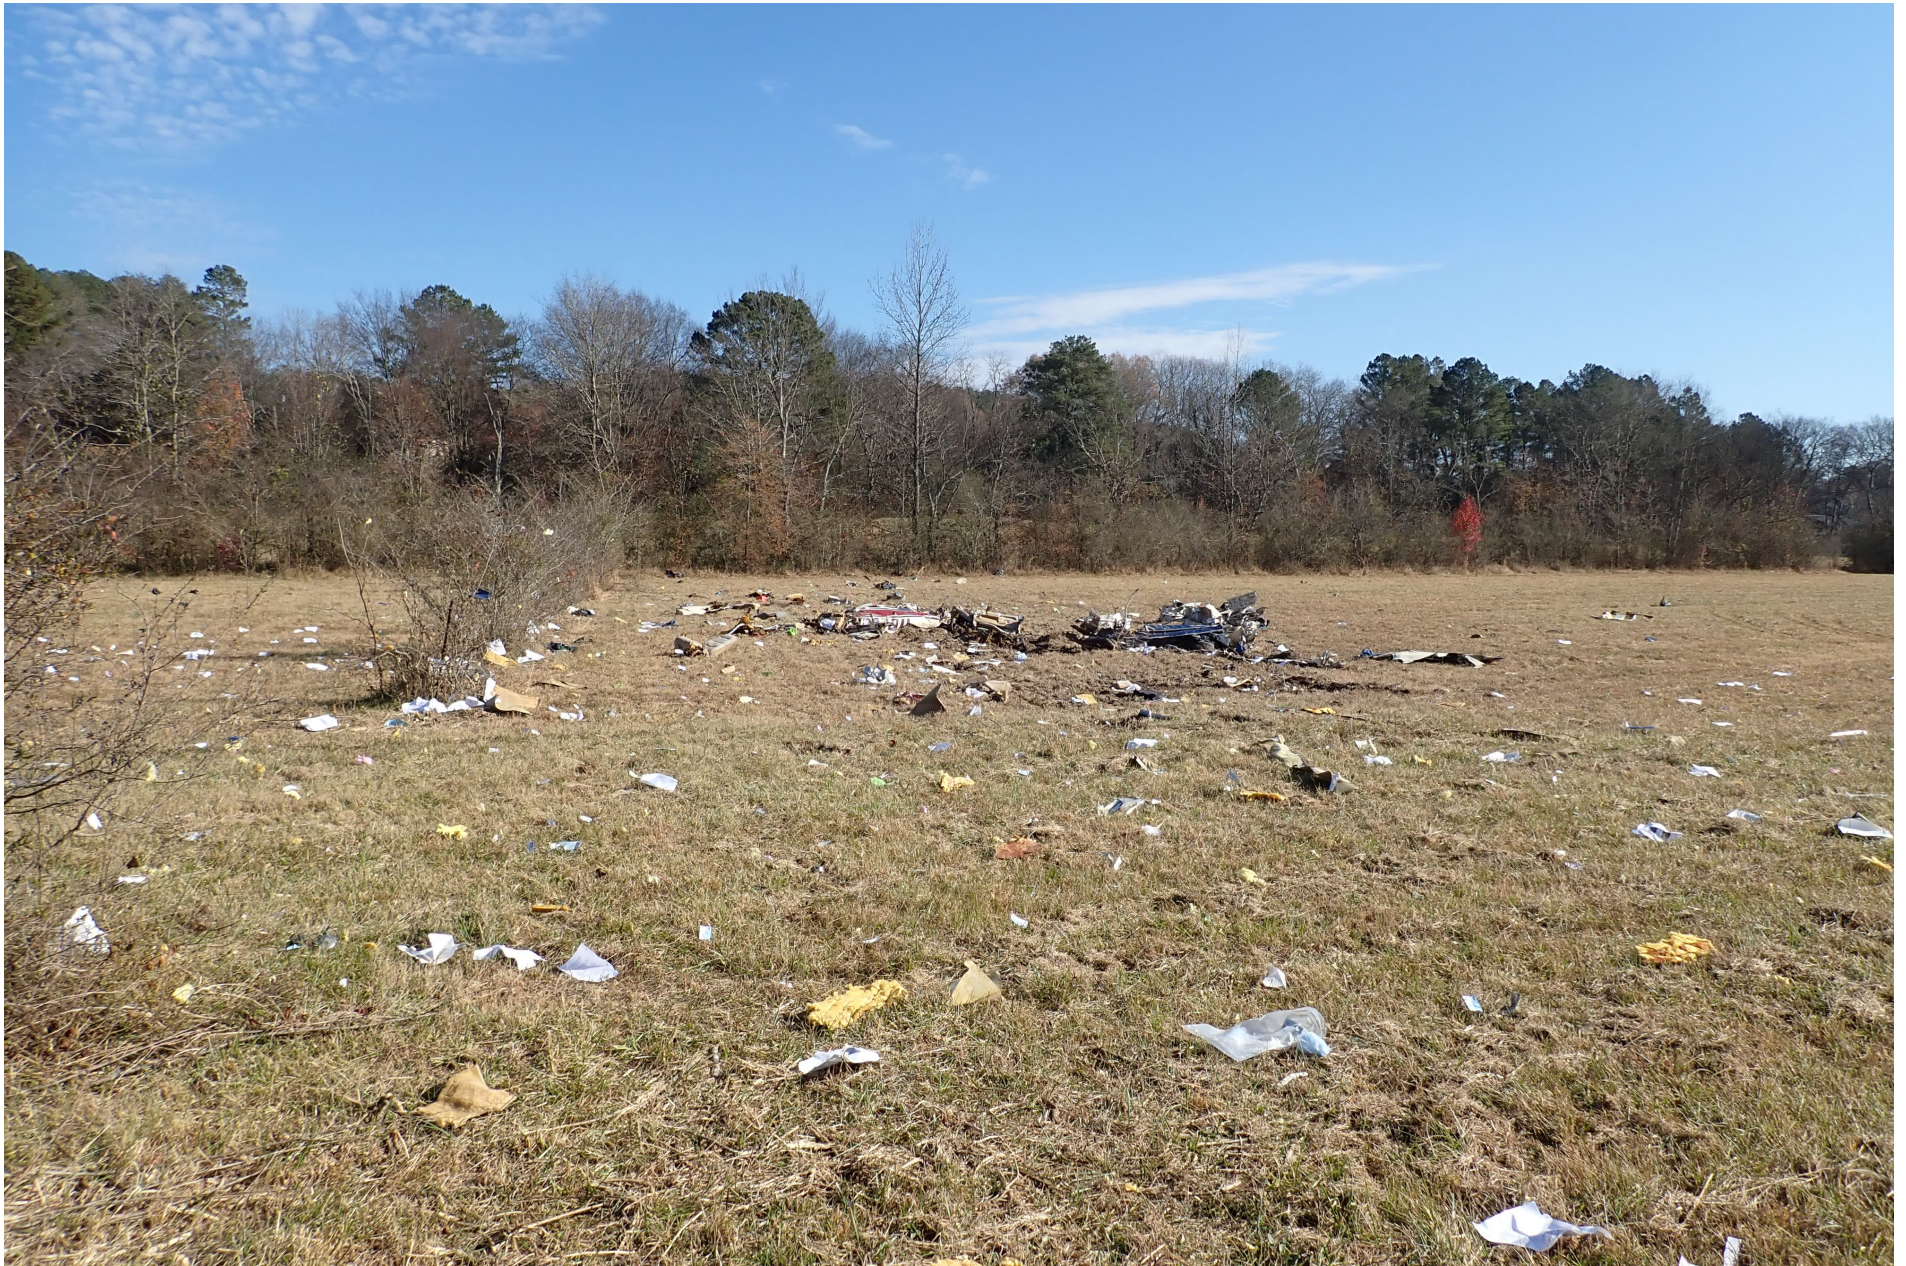
**Photo 1 – Digital Photograph From Textron Aviation. View of the Wreckage at the Accident Site. Note the Extensive Damage.**

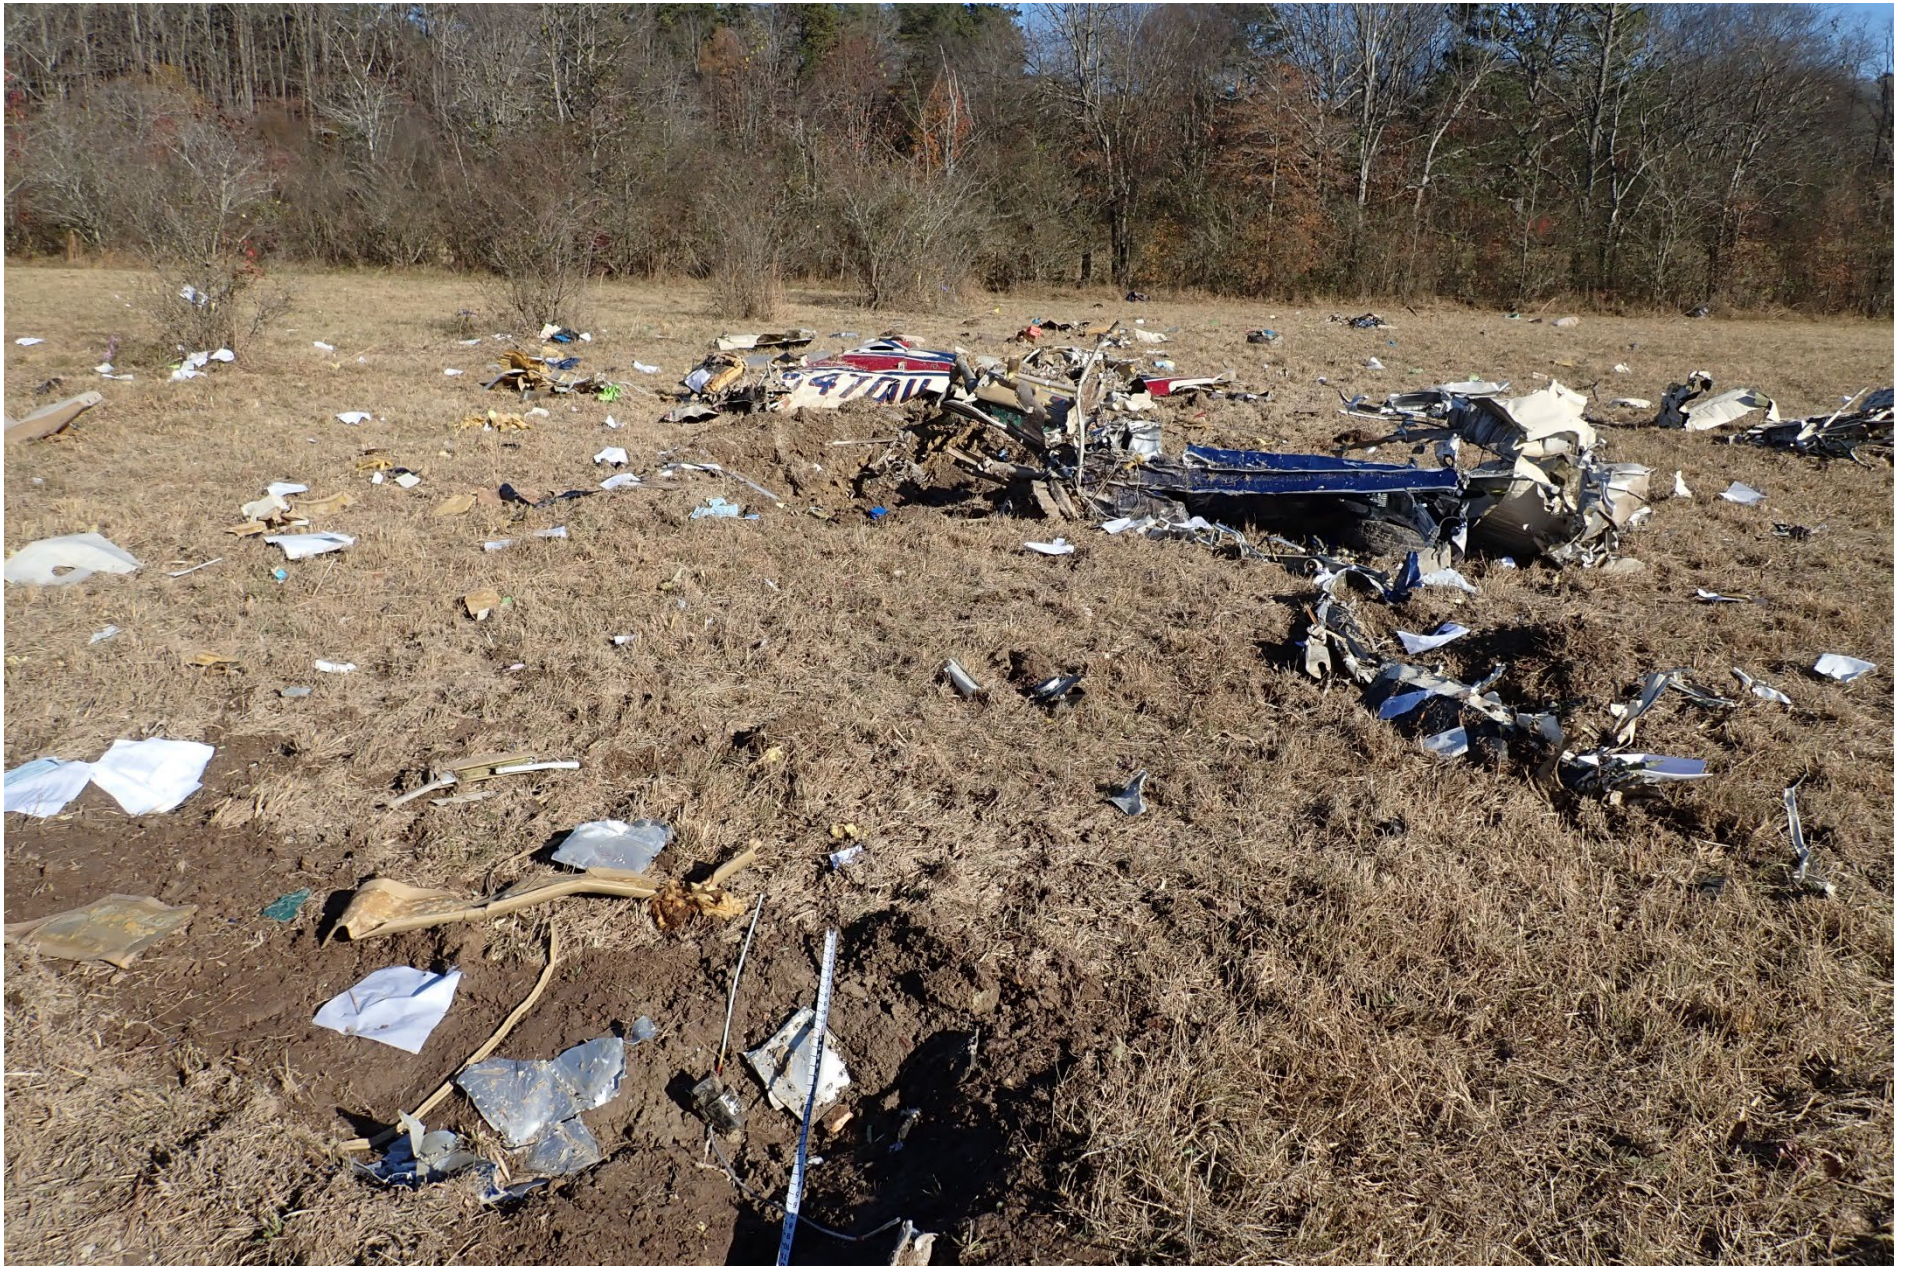
**Photo 2 - Digital Photograph From Textron Aviation. Another View of the Wreckage at the Accident Site. Note the Extensive Damage.**

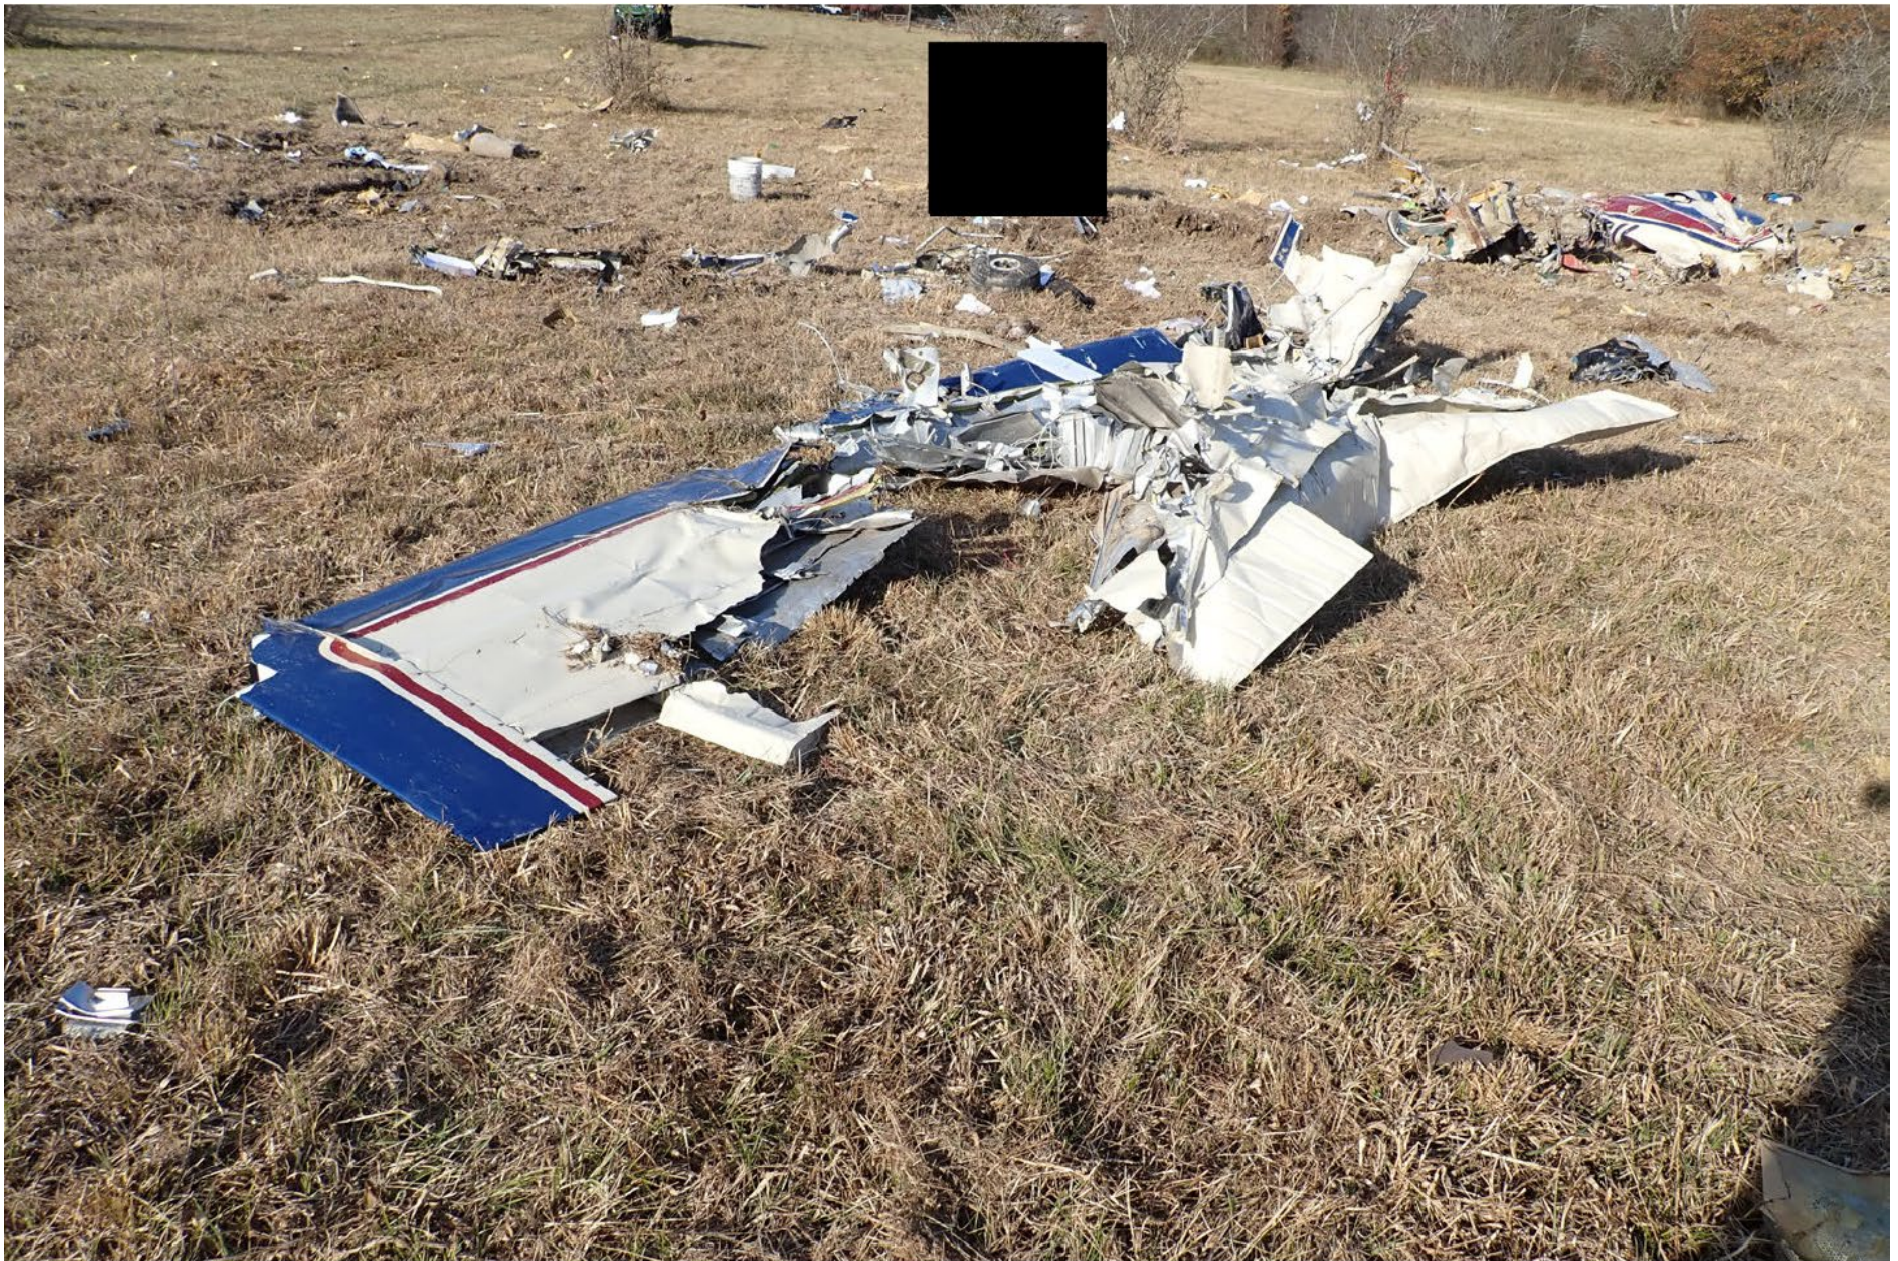
**Photo 3 - Digital Photograph From Textron Aviation. View of the Reconstruction of the Left Wing. Redaction is of Wreckage Recovery Crew Member.**

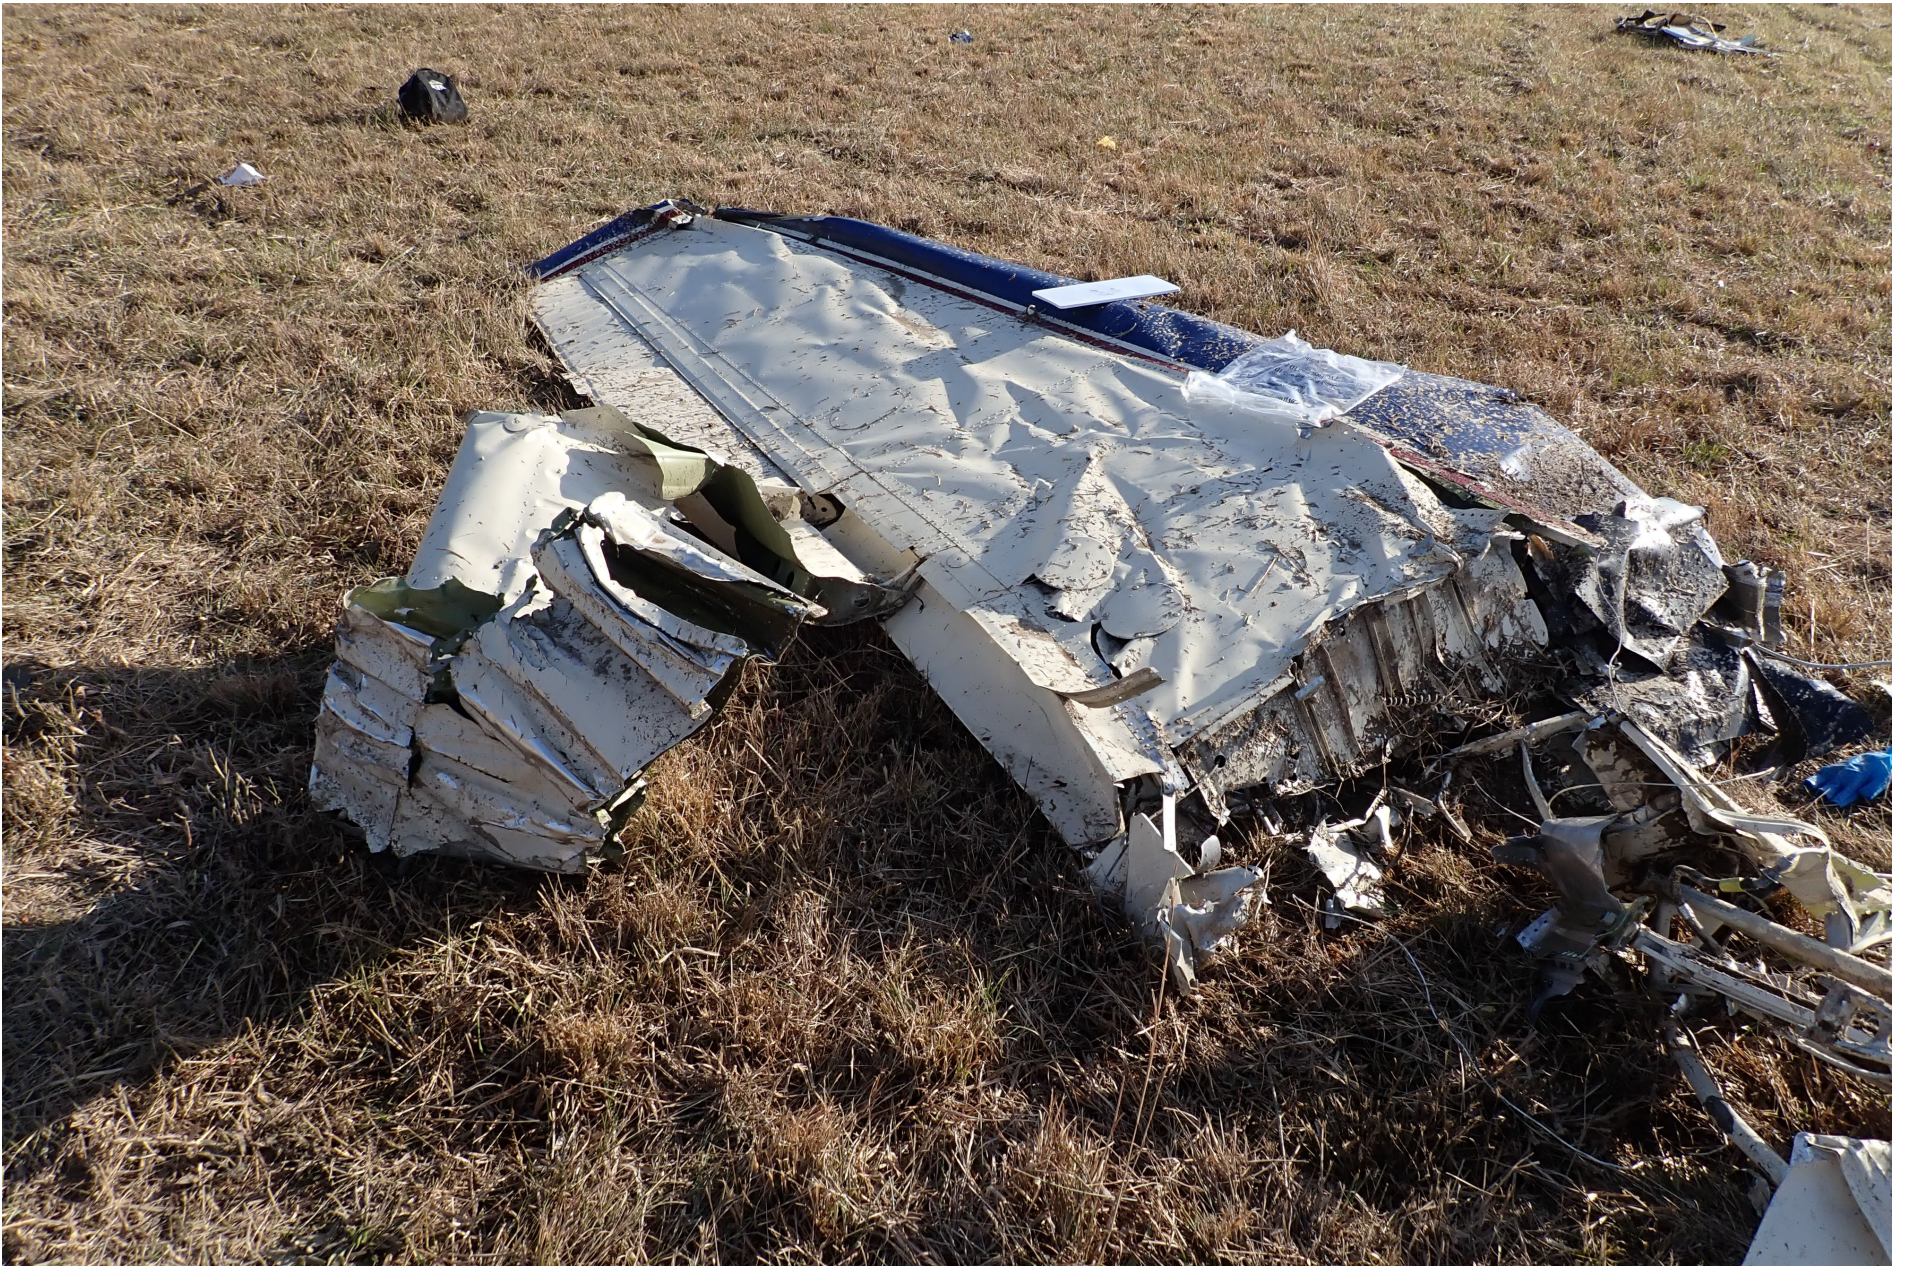
**Photo 4 - Digital Photograph From Textron Aviation. View of the Right Wing.**

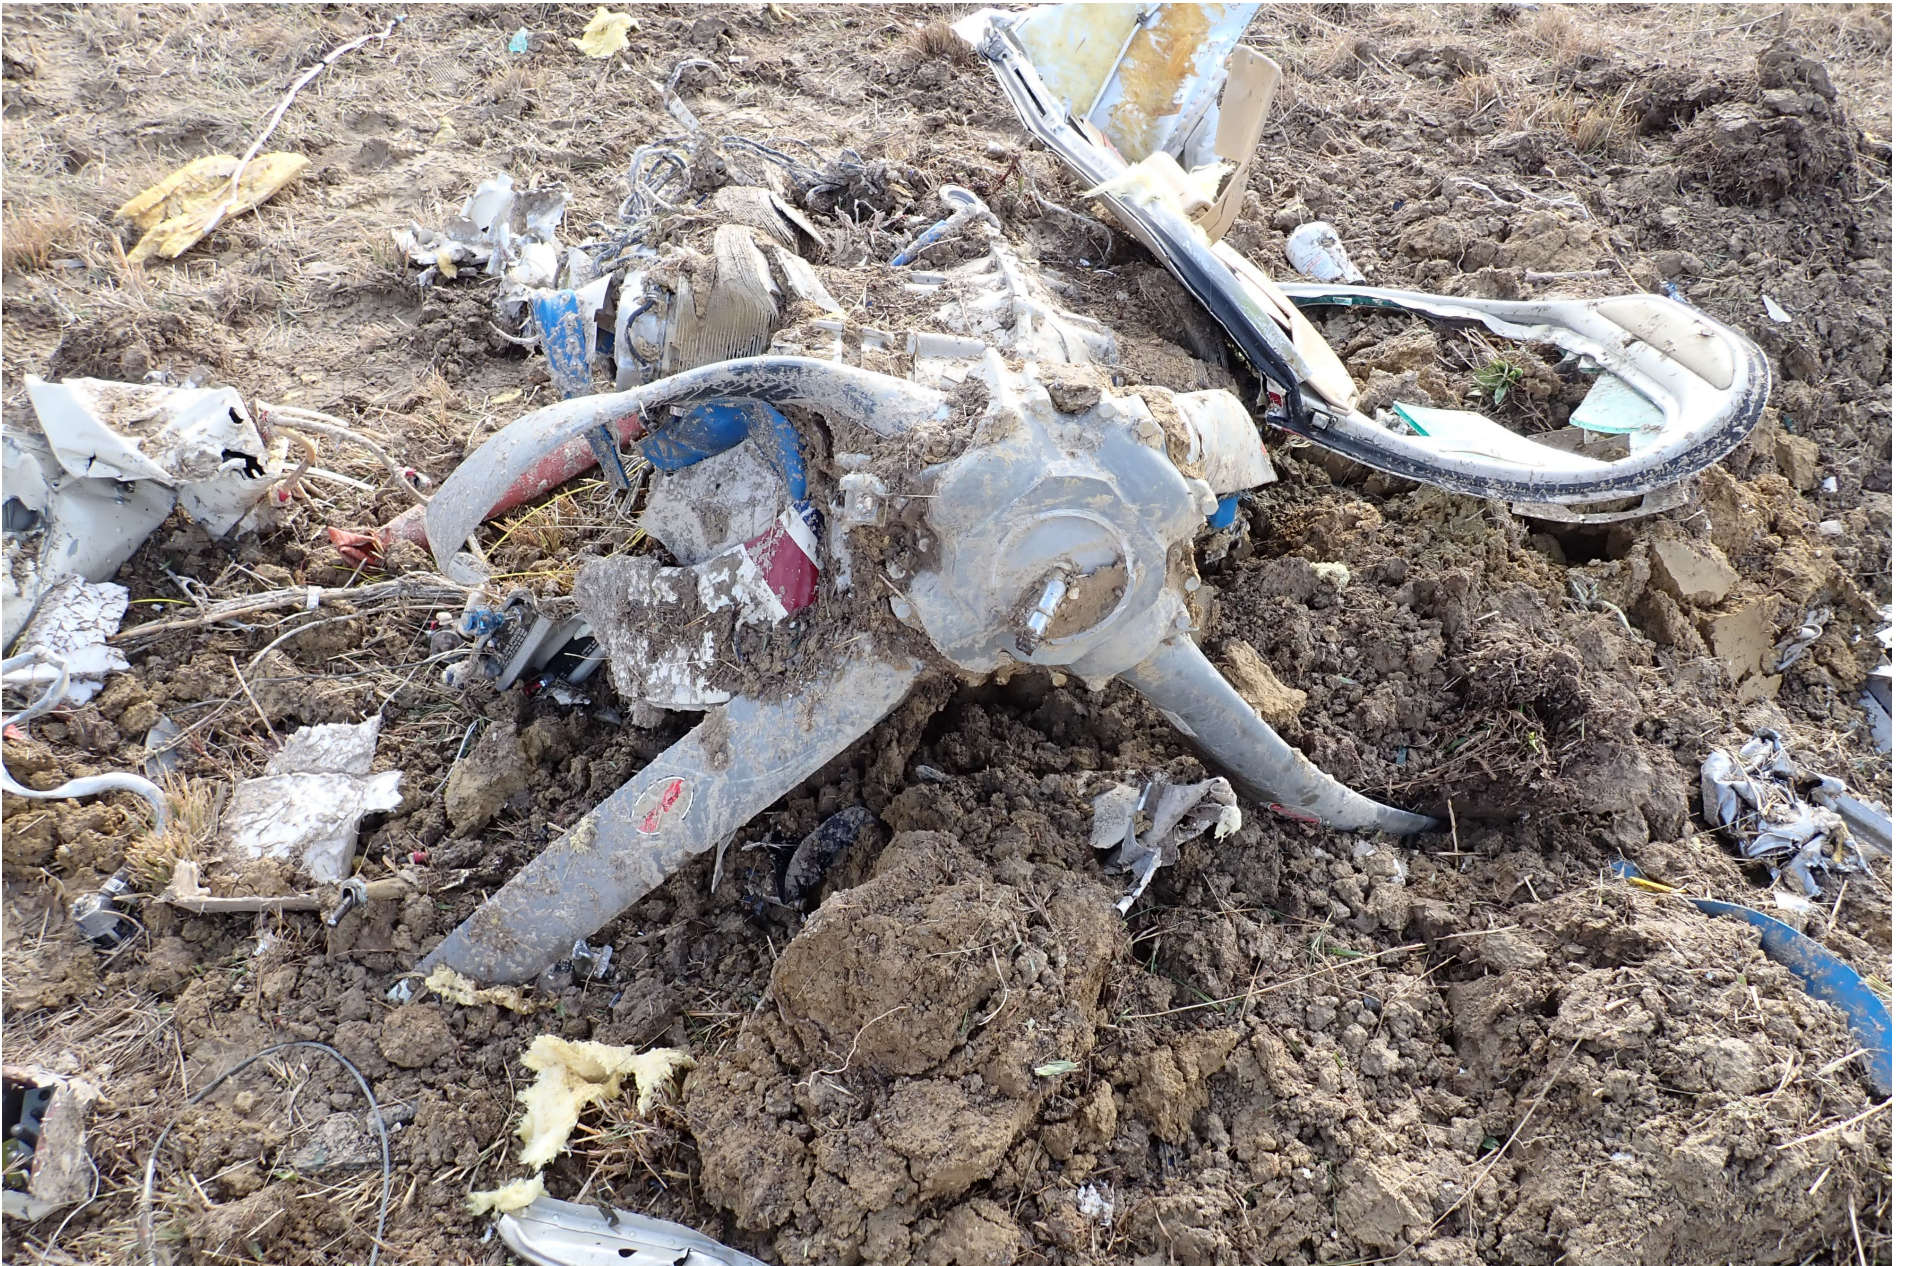
**Photo 5 - Digital Photograph From Textron Aviation. View of the Engine Assembly with Attached Propeller.**

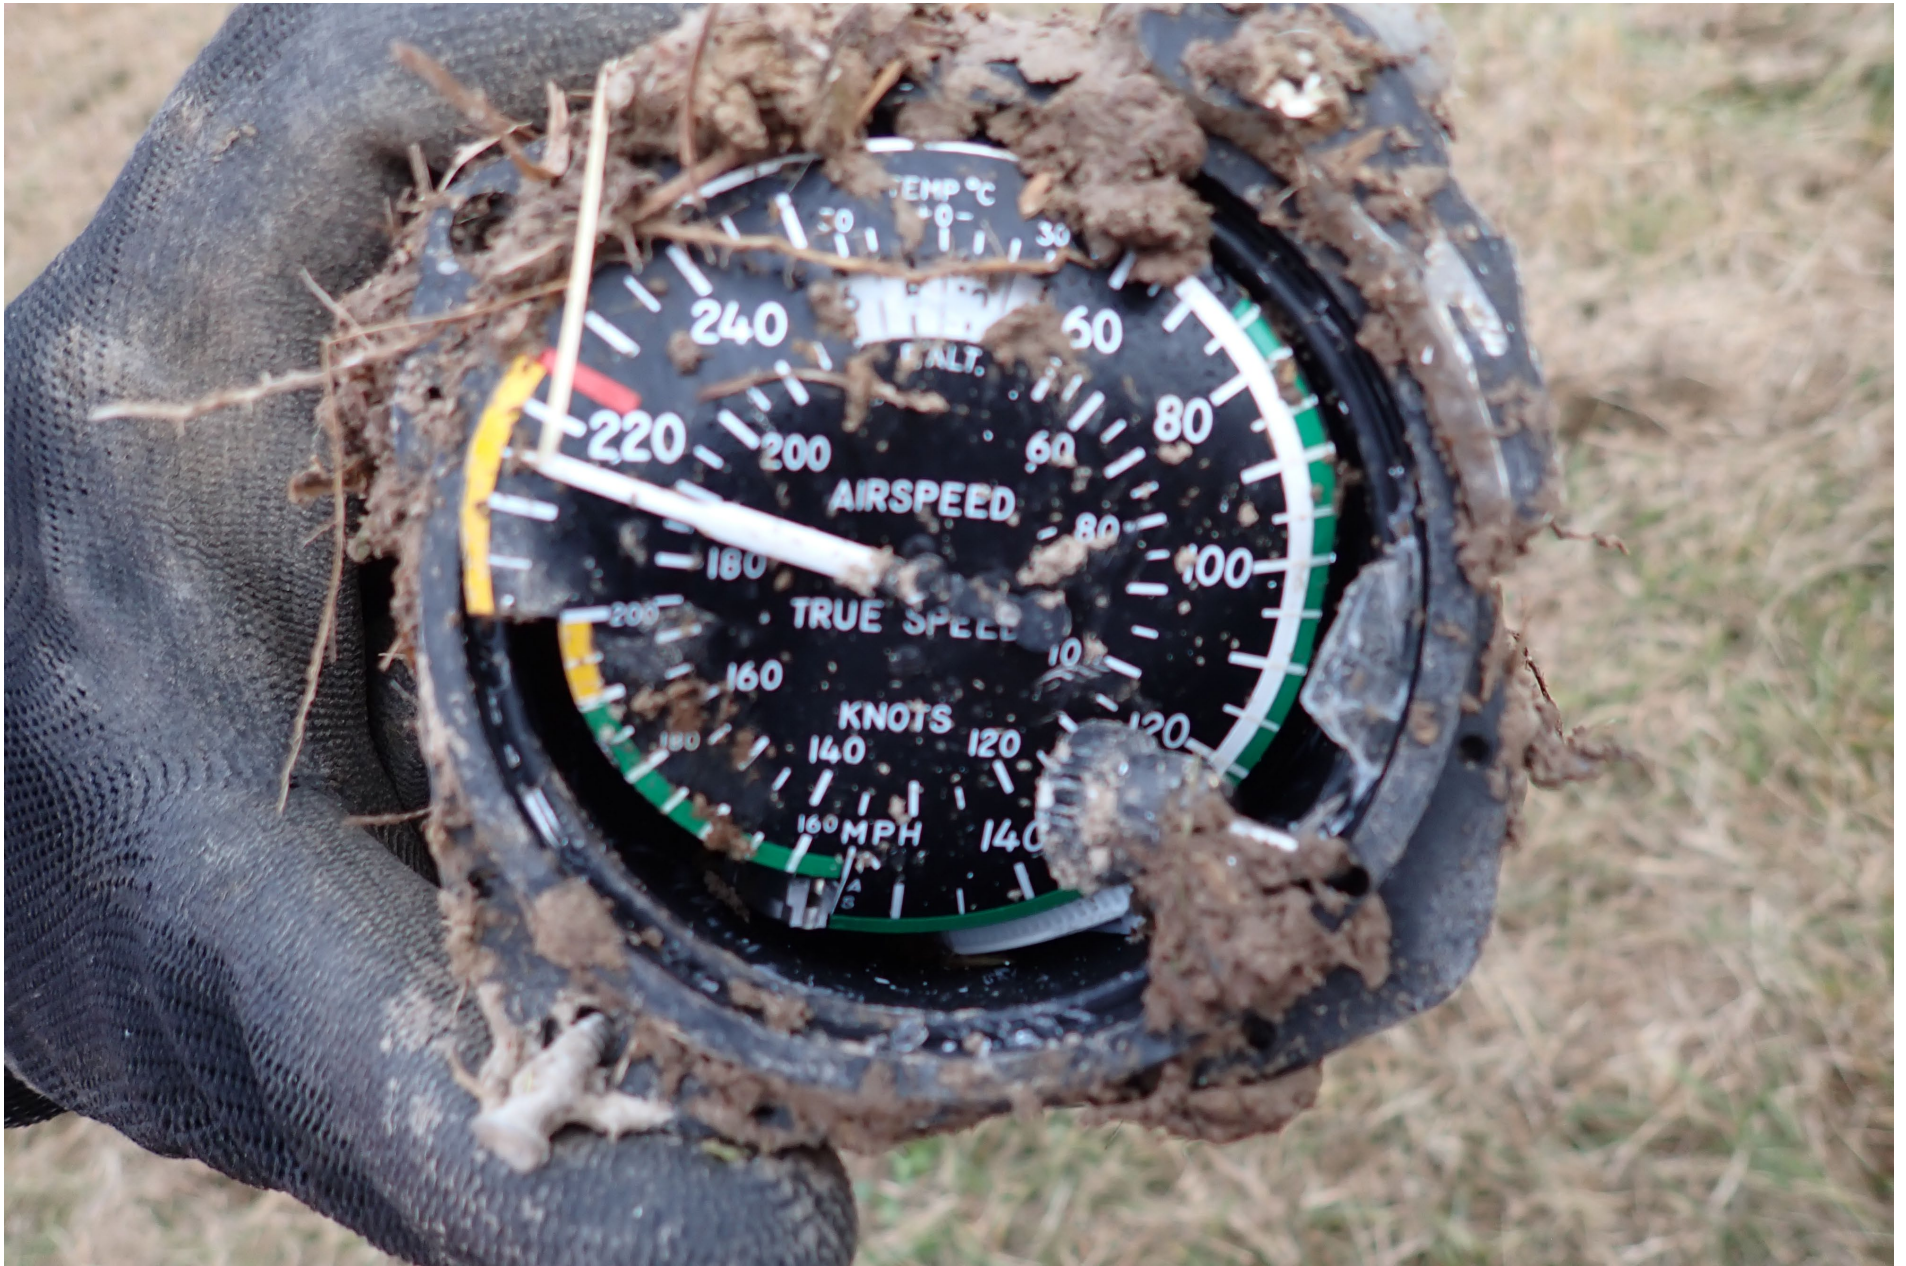
**Photo 6 - Digital Photograph From Textron Aviation. View of the Recovered Airspeed Indicator.**

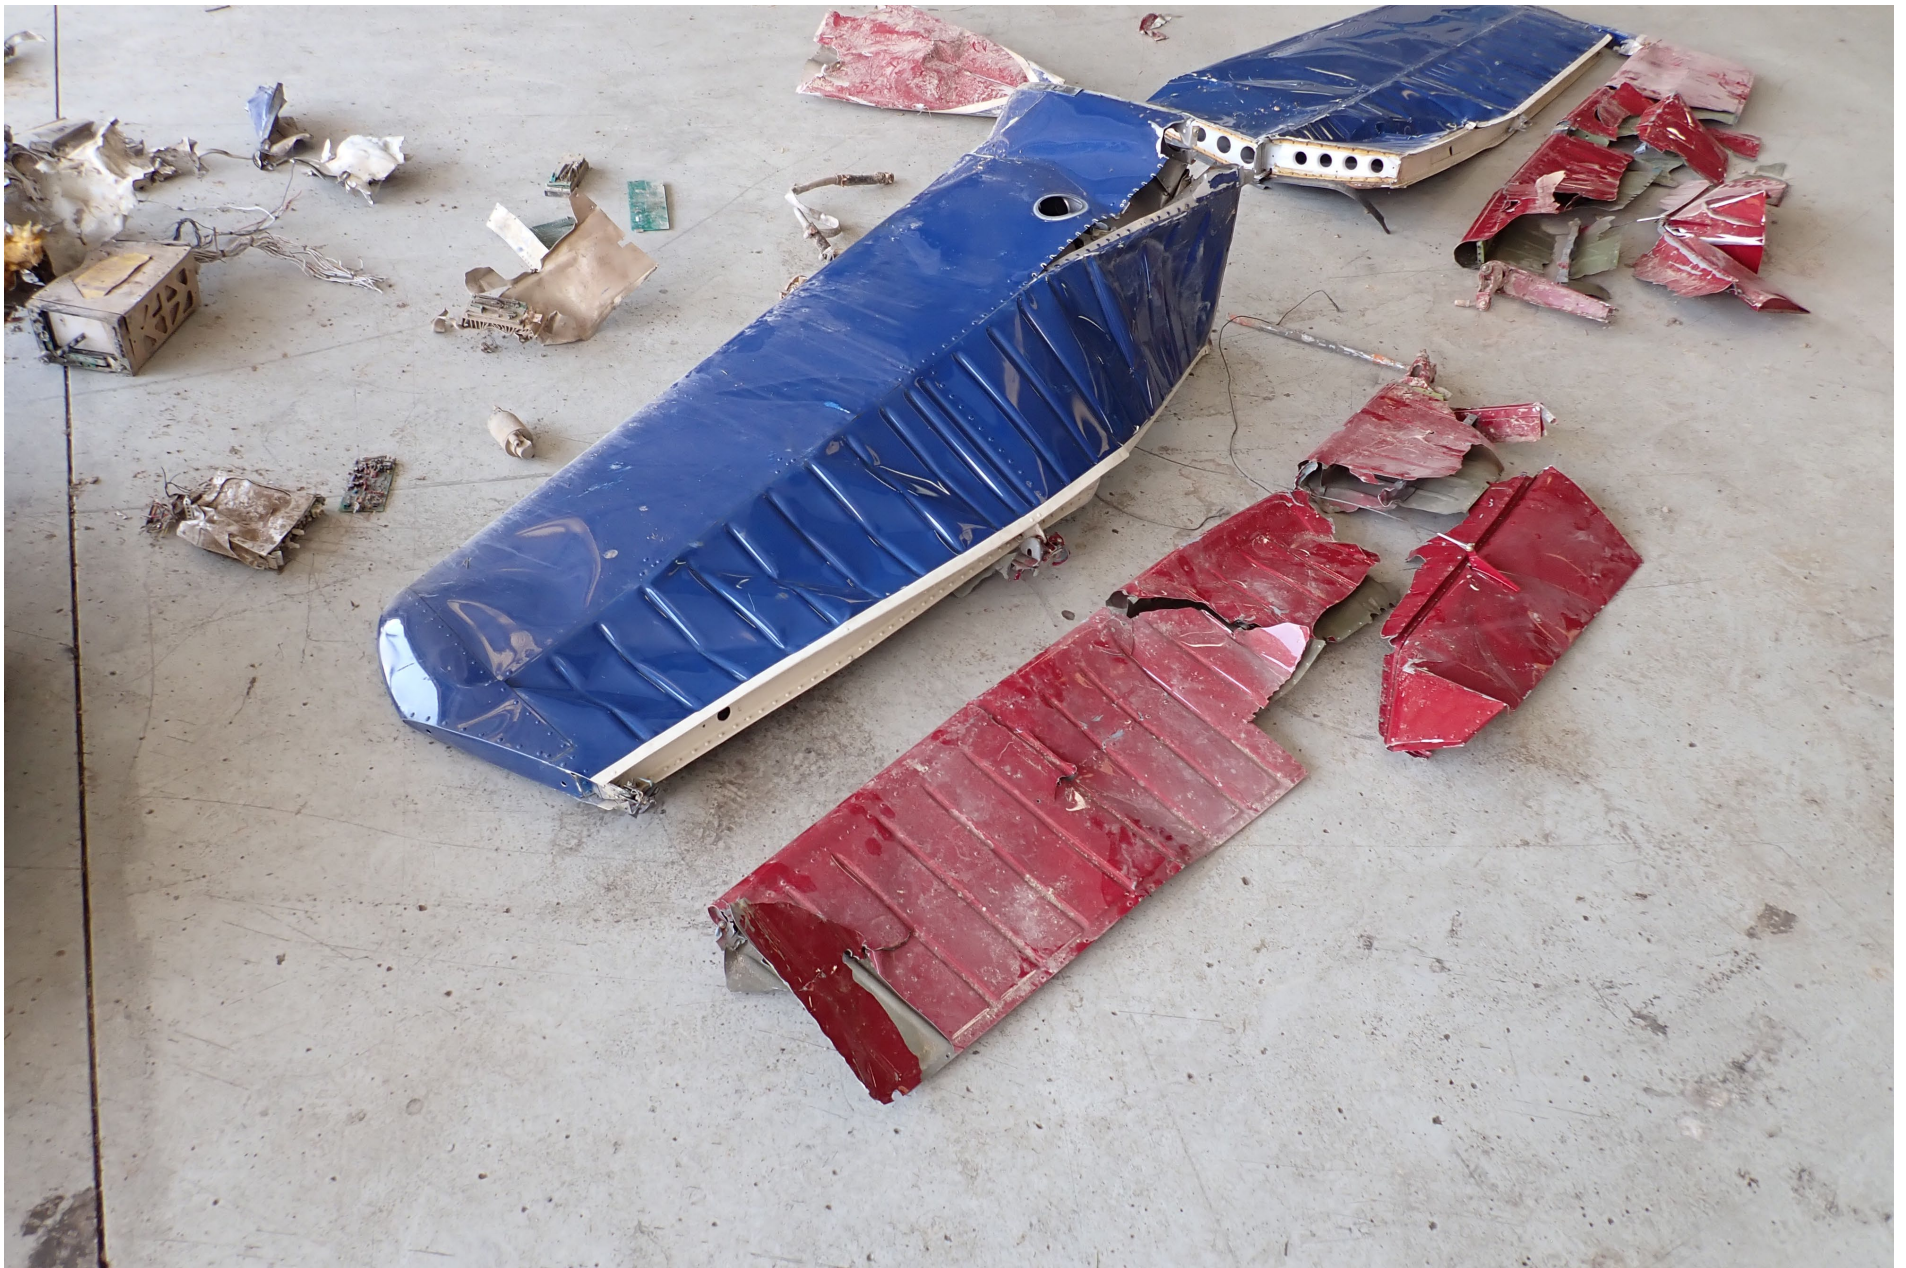
**Photo 7 - Digital Photograph From Textron Aviation. View of the Reconstruction of the Both Stabilizers and Elevators.**

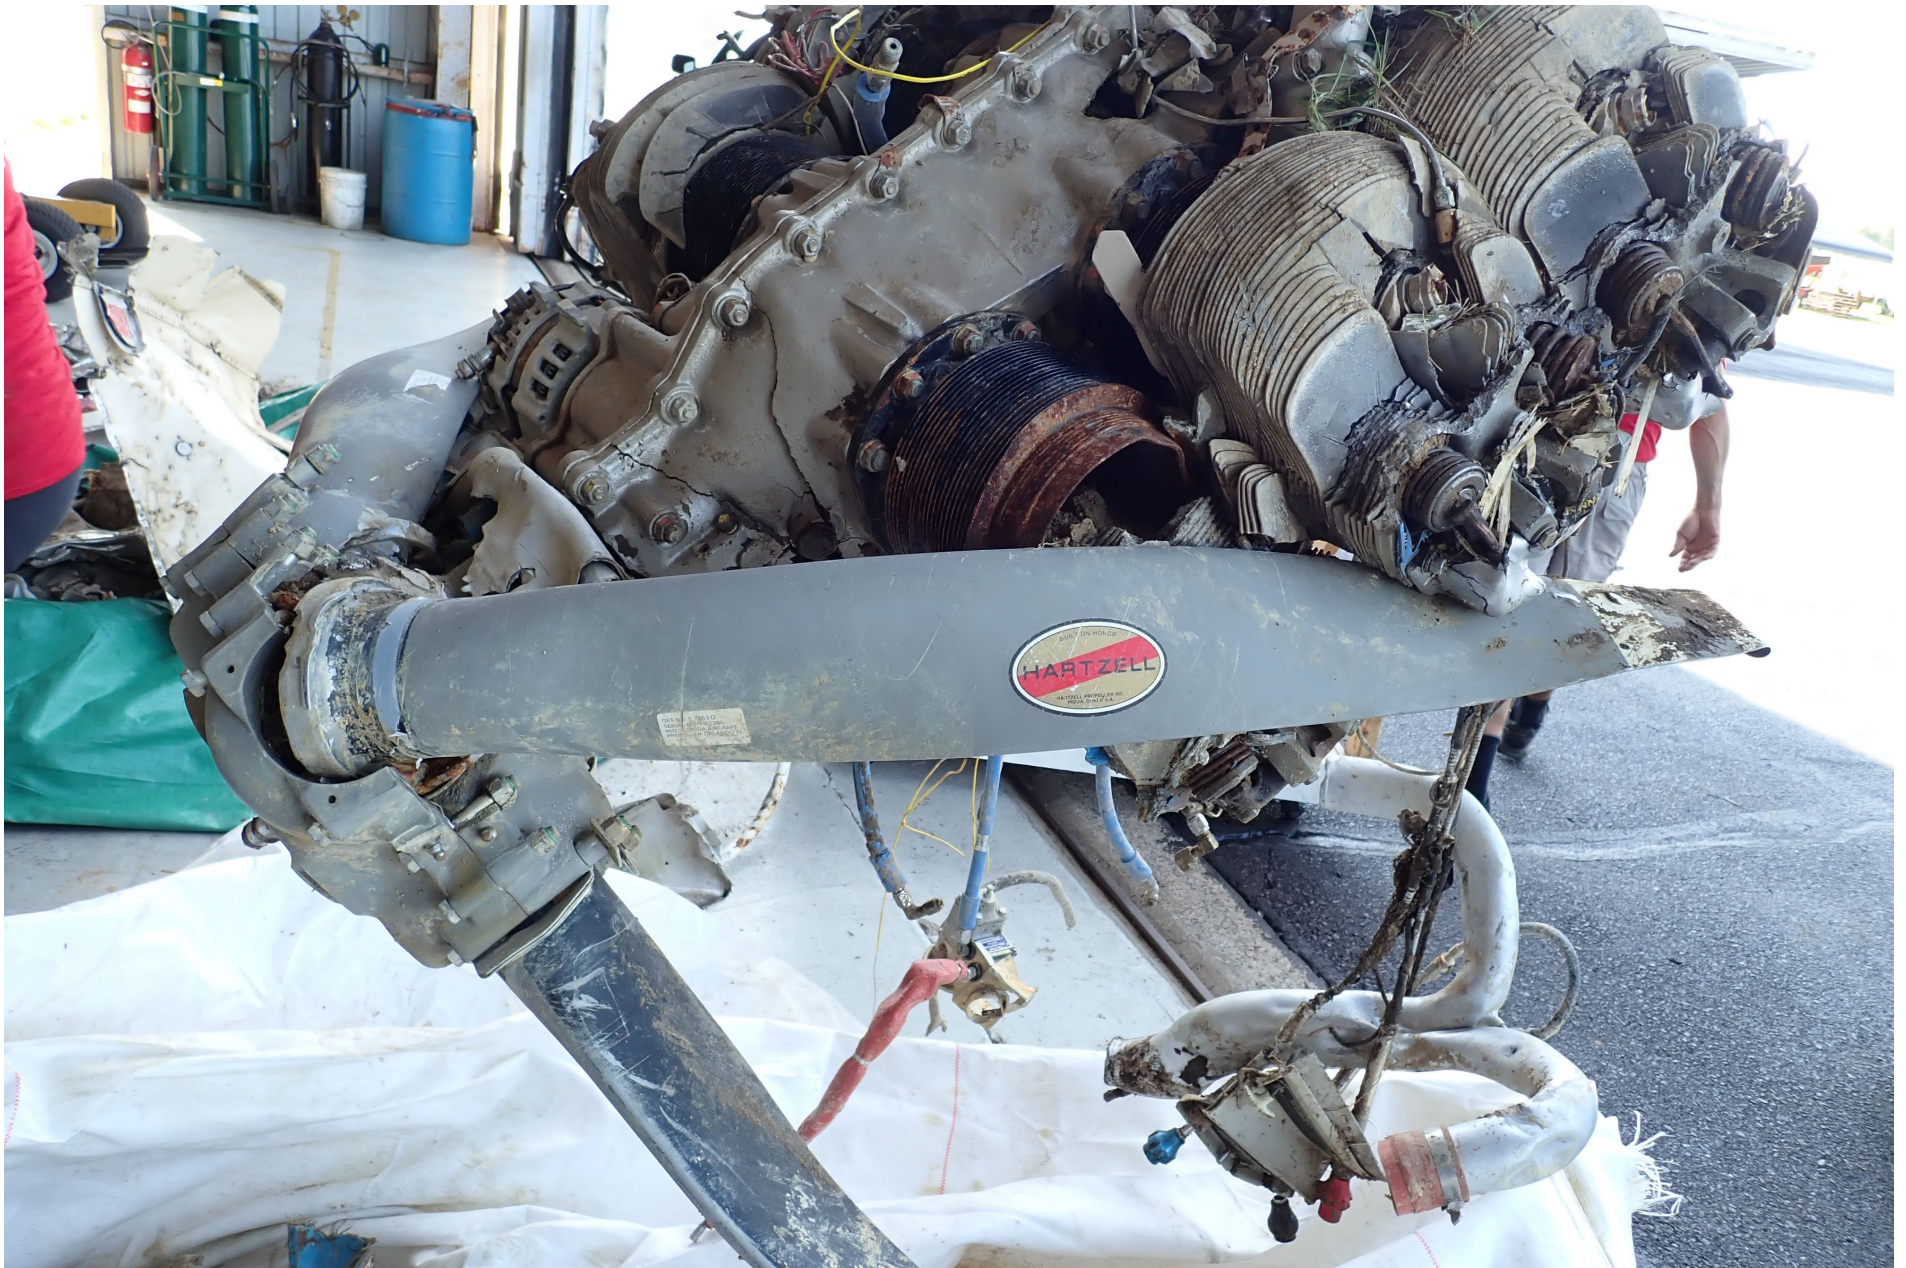
**Photo 8 - Digital Photograph From Textron Aviation. Left Side View of the Engine Assembly with Attached Propeller After Cleaning off the Mud.**

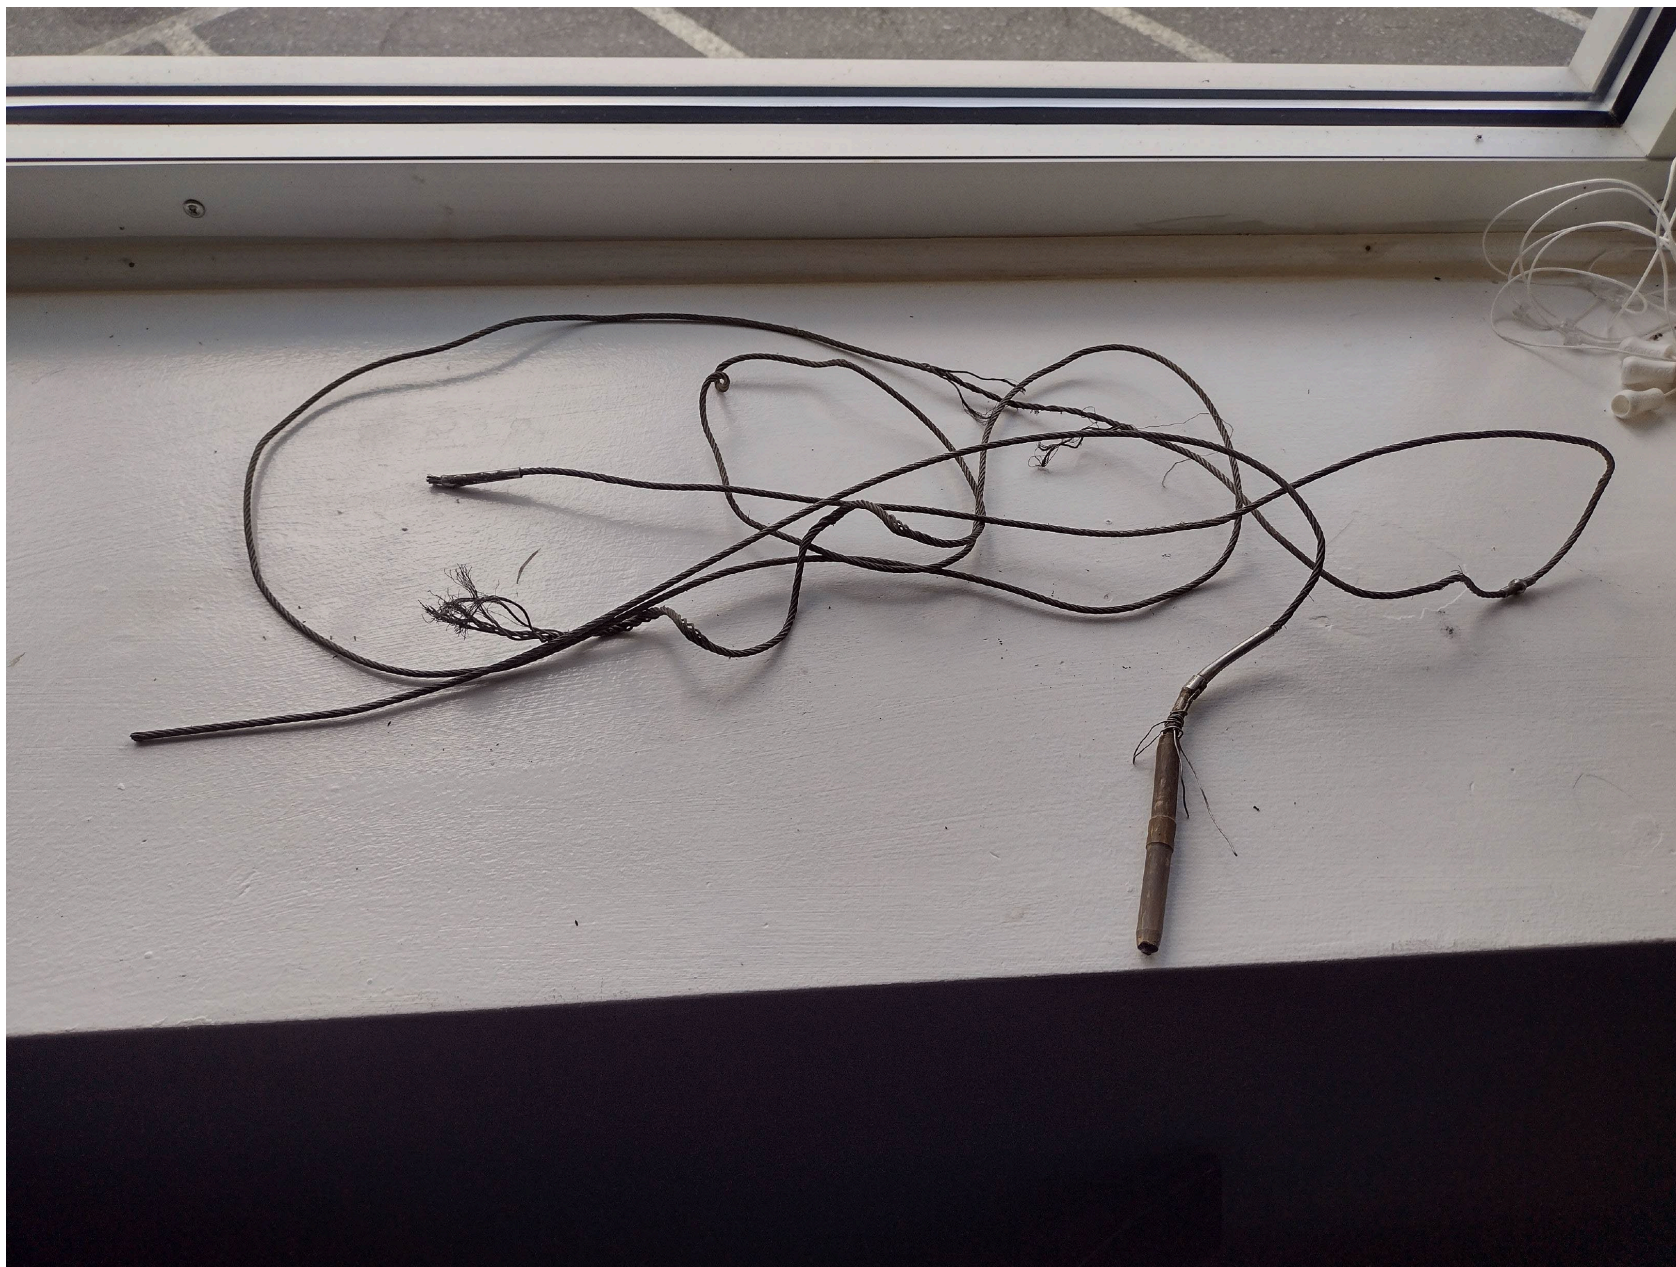
**Photo 9 - Digital Photograph From AMF Aviation. Loose Elevator Control Cable retained For NTSB Examination. Note the Fractured Turnbuckle Eye.**
