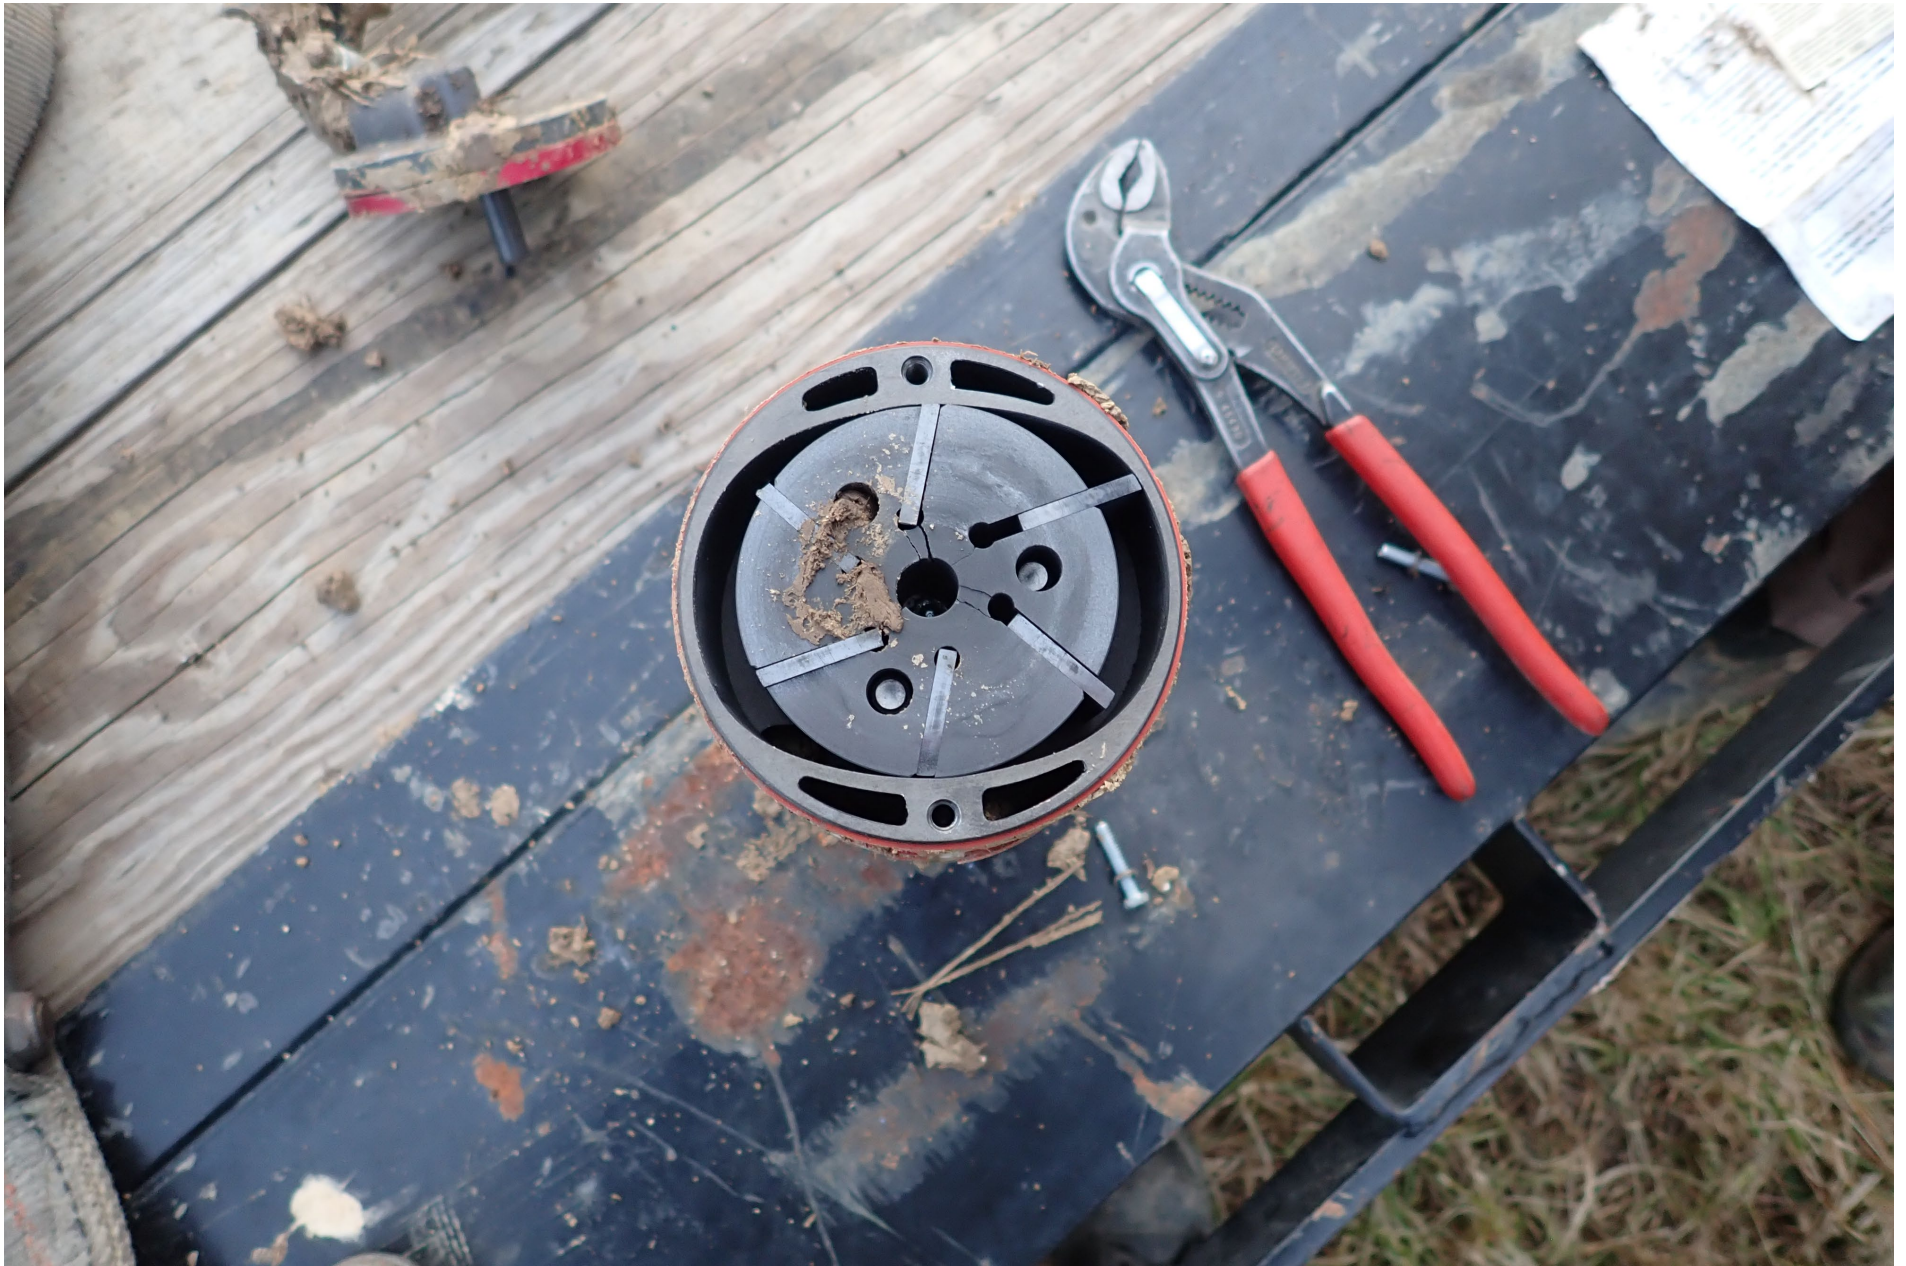
**Photo 10 - Digital Photograph From Textron Aviation. View of the Engine-Driven Vacuum Pump Following Removal of the Cover.**
