# NATIONAL TRANSPORTATION SAFETY BOARD

## MATERIALS LABORATORY ADDENDUM REPORT

Report No. 21-072B

Place : Attalla, Alabama  
Date : December 12, 2020  
Vehicle : Beech V35A, N5470U  
NTSB No. : ERA21LA068  
Investigator : Timothy Monville, AS-ERA

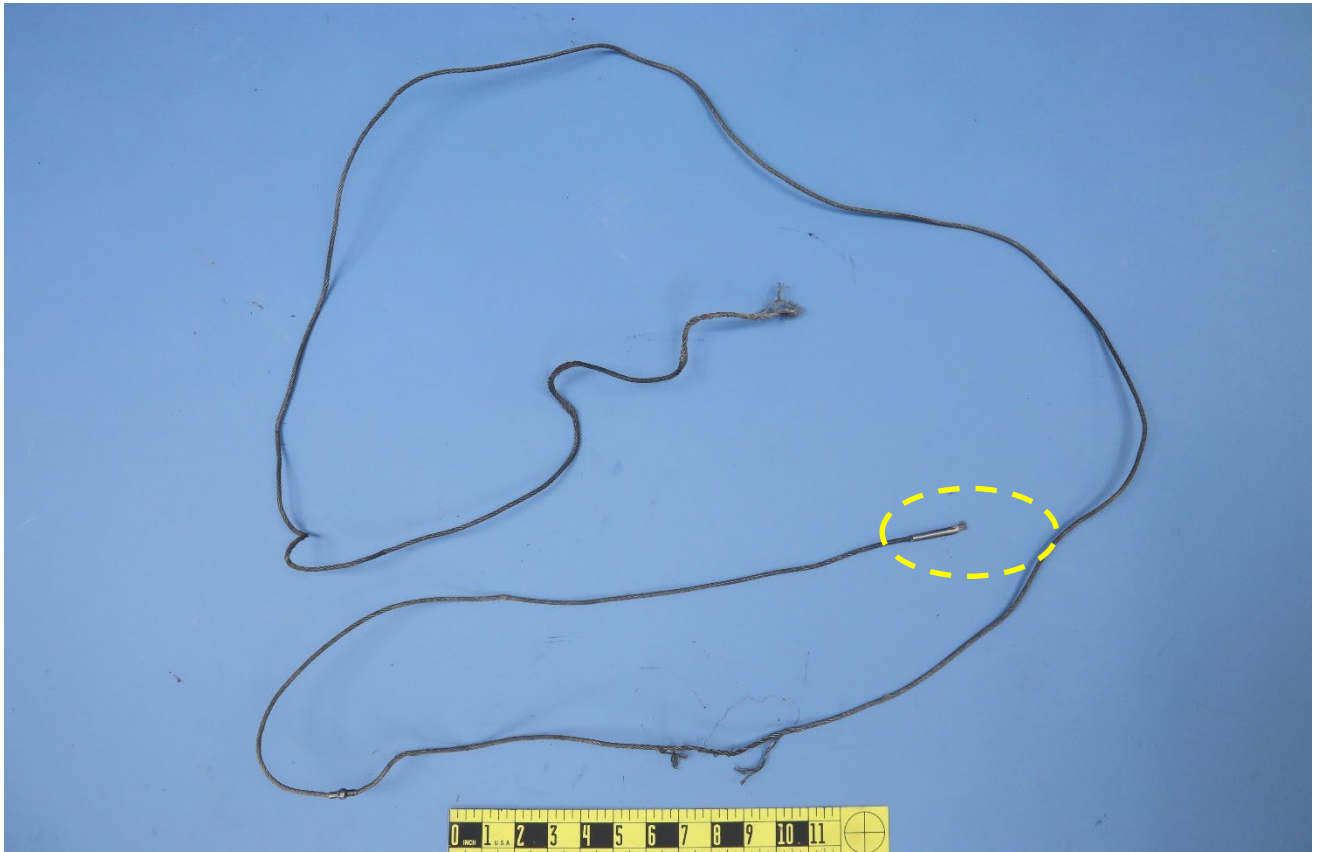
Figure 1 shows the longer of the two elevator primary control cable assemblies (also known as the elevator down cable, P/N 35-524651-7). This cable measured 94 inches long in total. One of the ends was consistent with a cut cable just outside the sleeve of a fork remnant (which was 2 inches long itself) (see Figure 2). This fracture surface is shown in Figure 3, which was stated to have adjacent to the bobweight—this portion was sectioned on scene after the accident. This section was 23 inches from the fork remnant to the swaged ball, and then 10 inches to an area of frayed and fractured wires.

Figure 1 – View of the longer elevator, or down, cable remnant, as received. The circled fractured end is highlighted in Figure 2.

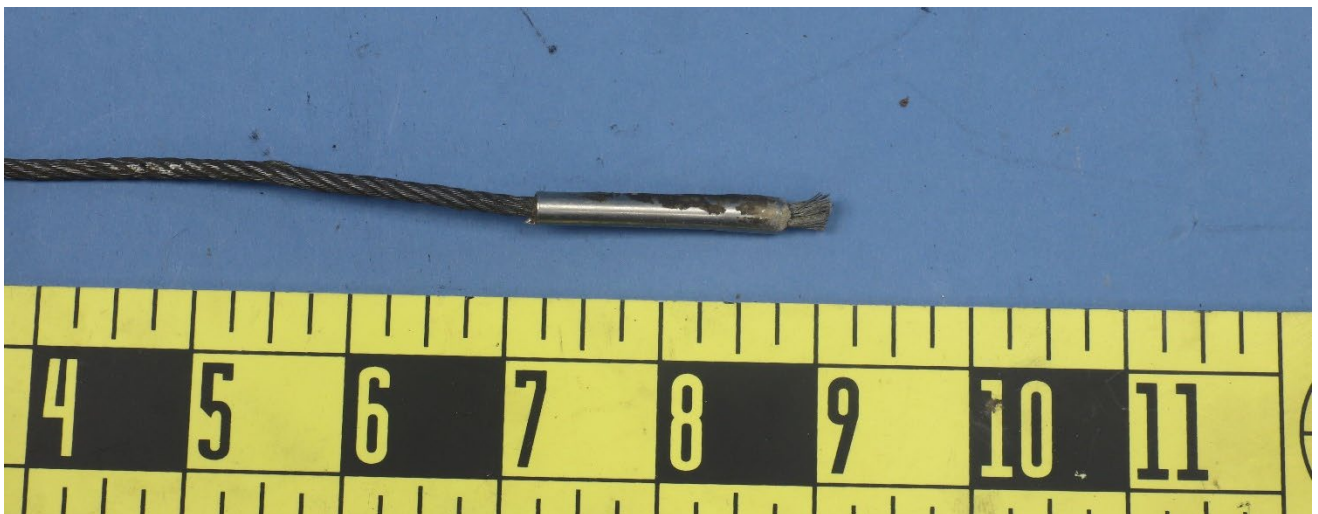
Figure 2 – View of the fractured fork with the cut wire strands, circled in Figure 1, showing the fractured end.

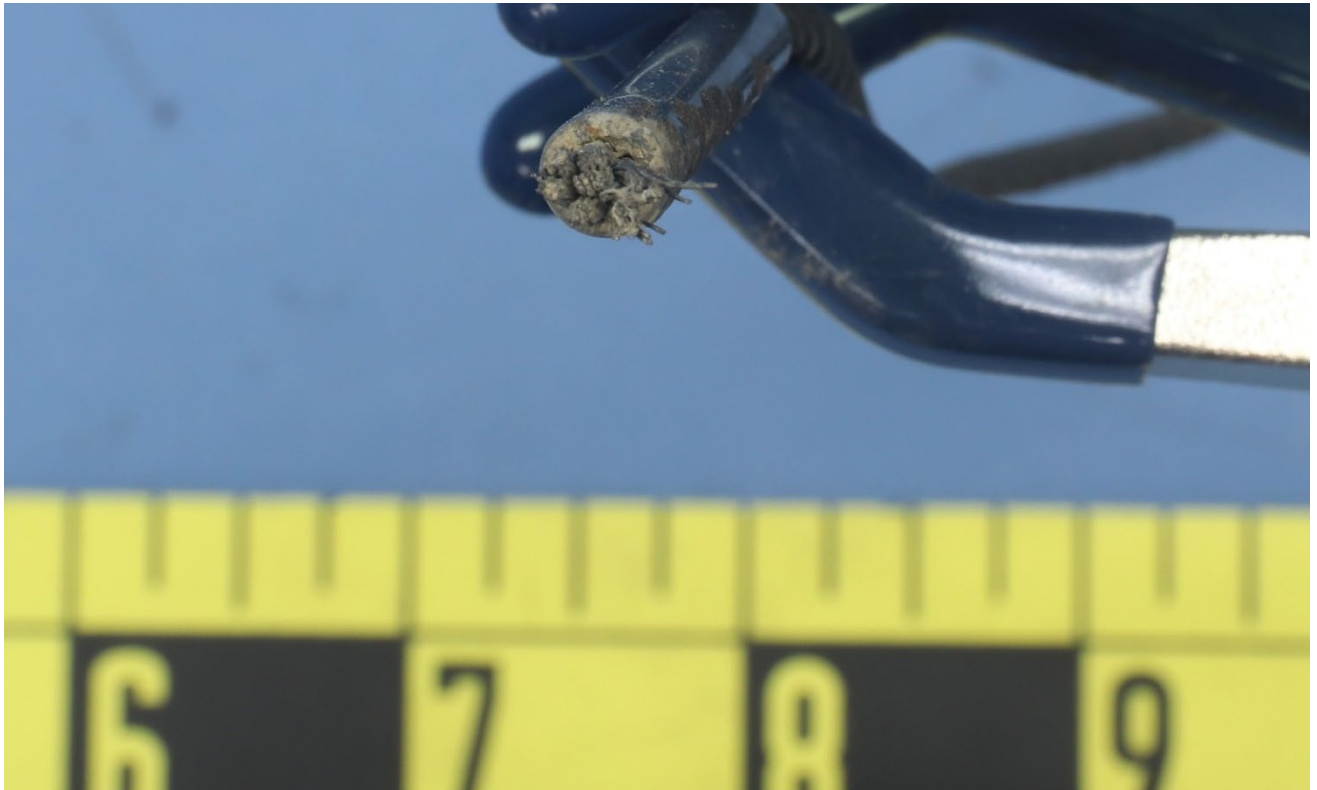
Figure 3 shows the cut ends of the wires just outside the fork remnant. As shown in this figure and Figure 4, the fork remnant exhibited indications of having fractured. Both the wire ends, and the fracture surface of the fork exhibited white and brown-colored compounds, consistent with post-fracture contamination. As shown in Figure 4, the fork material adjacent to the fracture surface exhibited elongation on the surface opposite that which experienced compressive buckling. These features were consistent with deformation from bending. Figure 5 demonstrates the dull rough surface texture of the fork fracture surface, which was oriented outward at an approximately 45° angle. The fracture

Figure 3 – View of the fracture surface of the wire strands and fork remnant in Figure 2.

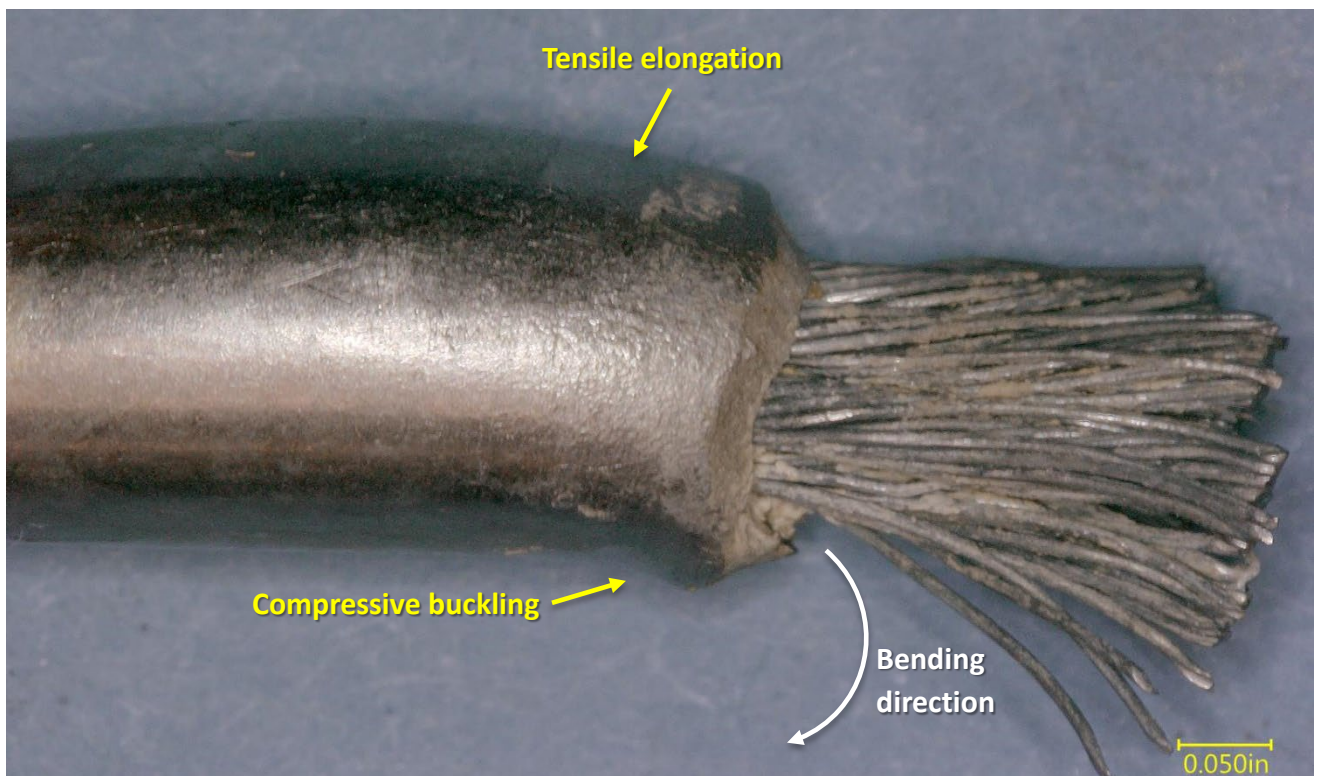
Figure 4 – View of the fractured fork remnant, from the side, annotated to show bending features.

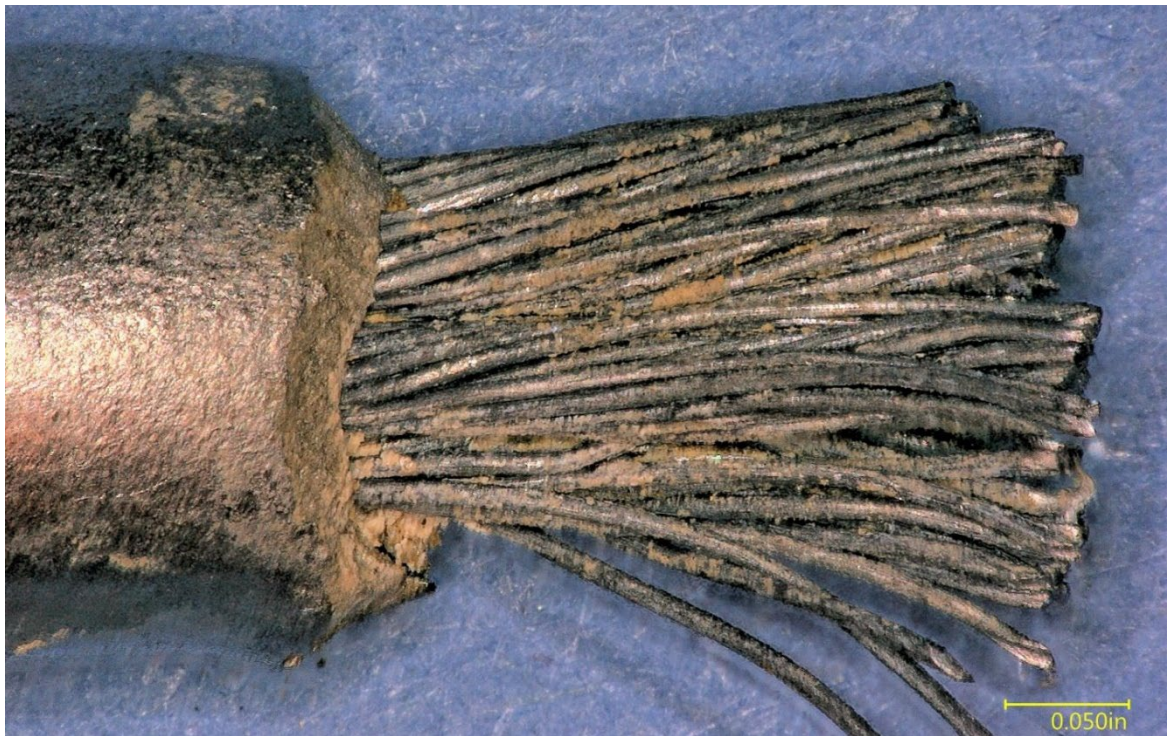
Figure 5 – Closer view of the fracture surface from the fork in Figure 4, rotated 90°.

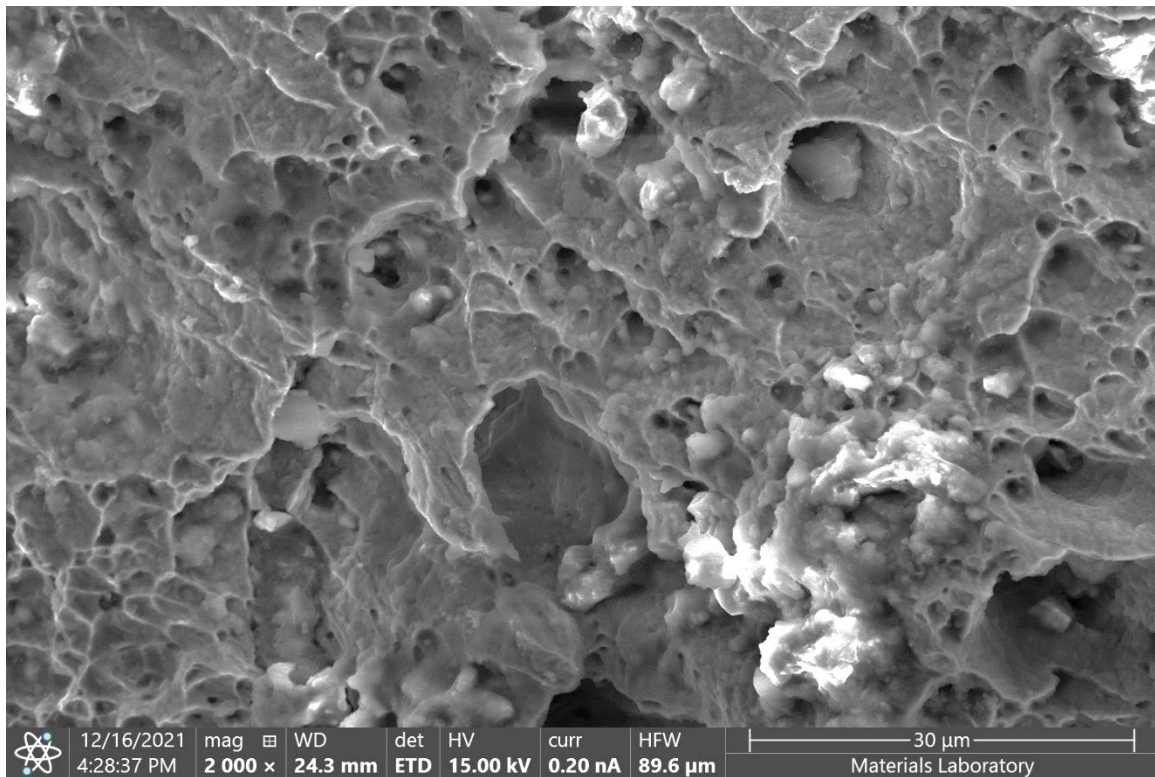
surface revealed dimpled rupture when examined using a scanning electron microscope (SEM), shown in Figure 6. No other fracture features were observed. These features were consistent with fracture from bending overstress. The chemical composition of the fork remnant was examined using energy dispersive x-ray spectroscopy (EDS) and was found to exhibit a composition consistent with austenitic stainless steel.

Figure 6 – Secondary electron (SE) micrograph of a typical area of dimpled rupture on the fork fracture surface.

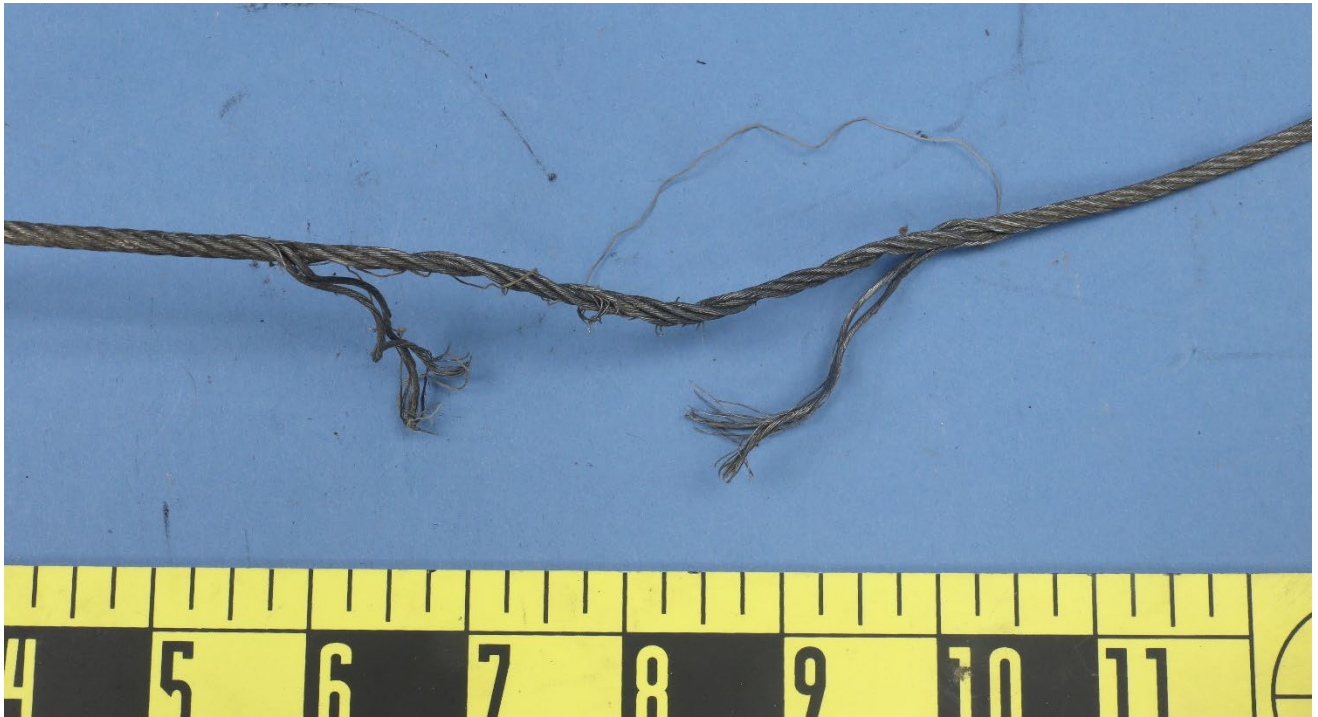
The opposite end of the down cable remnant consisted of a series of fractured cable wires that had frayed outward. In addition, as shown at the bottom of Figure 1, several of the wire strands had frayed outward and had fractured (see Figure 7).

Figure 7 – View of the frayed and fractured wire strands in the bottom of Figure 1.

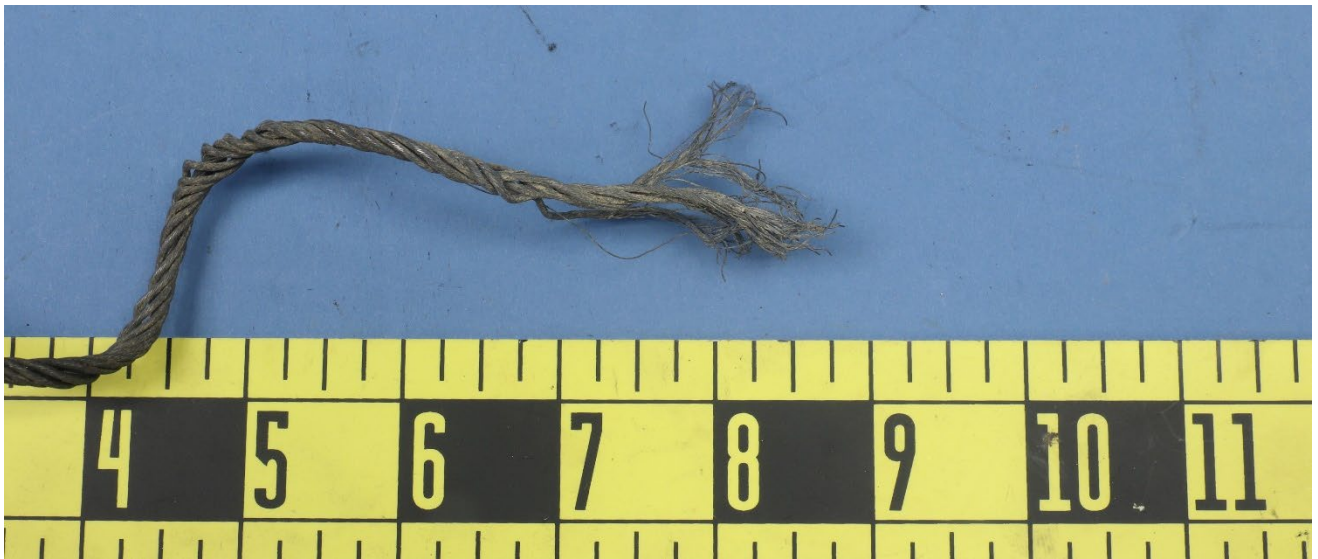
Figure 8 shows the side view of the frayed wire fracture end of the longer cable remnant. Half of the wires had been displaced in one direction, and the other half had been displaced in the other. The strand fractures were oriented in different directions, as illustrated in Figure 9 and Figure 10. The wire strand surfaces generally exhibited a dull, gritty texture, consistent with post-fracture contamination.

Figure 8 – View of the fractured wire strands from the opposite end, as received.

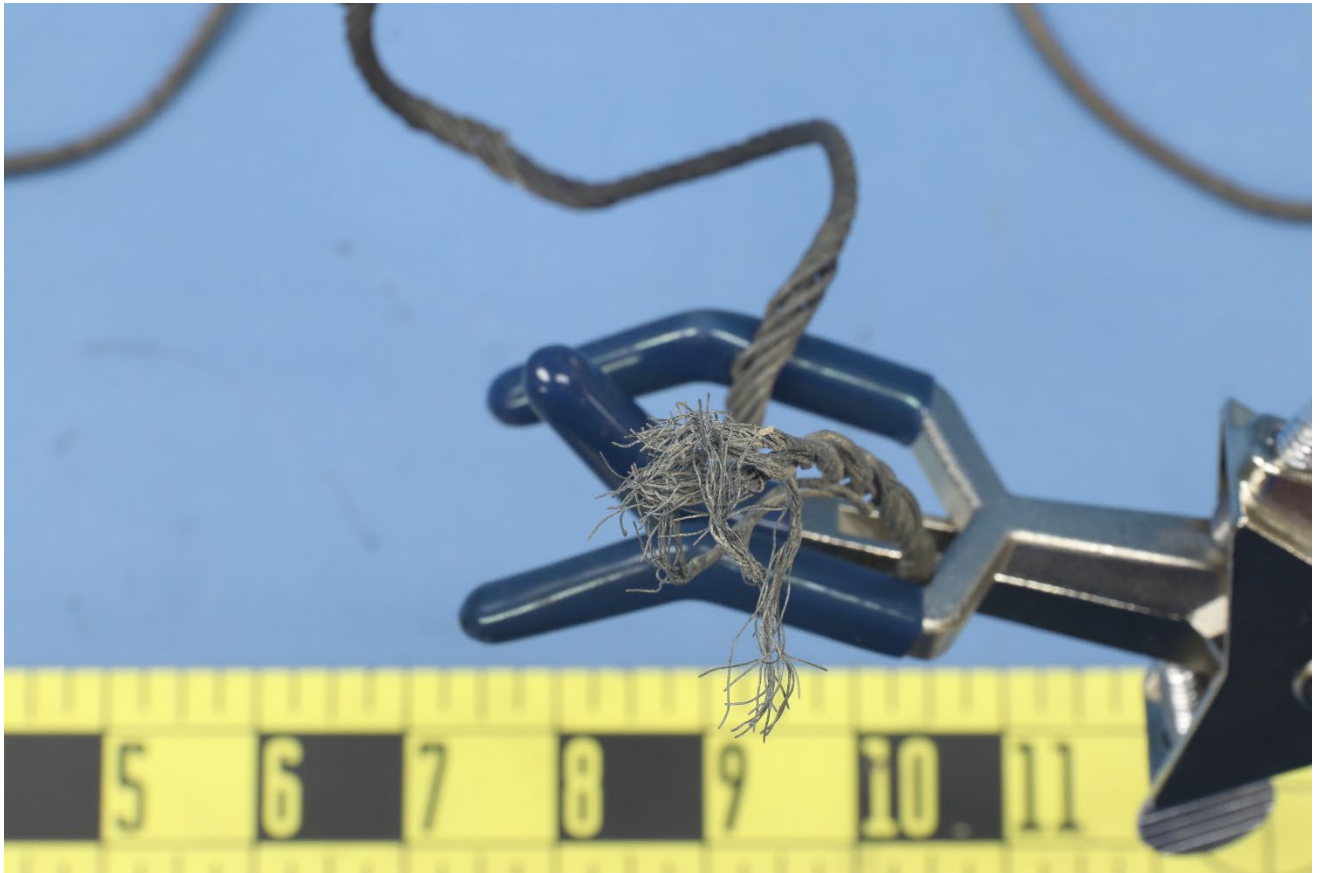
Figure 9 – View of the wire strand ends in Figure 8.

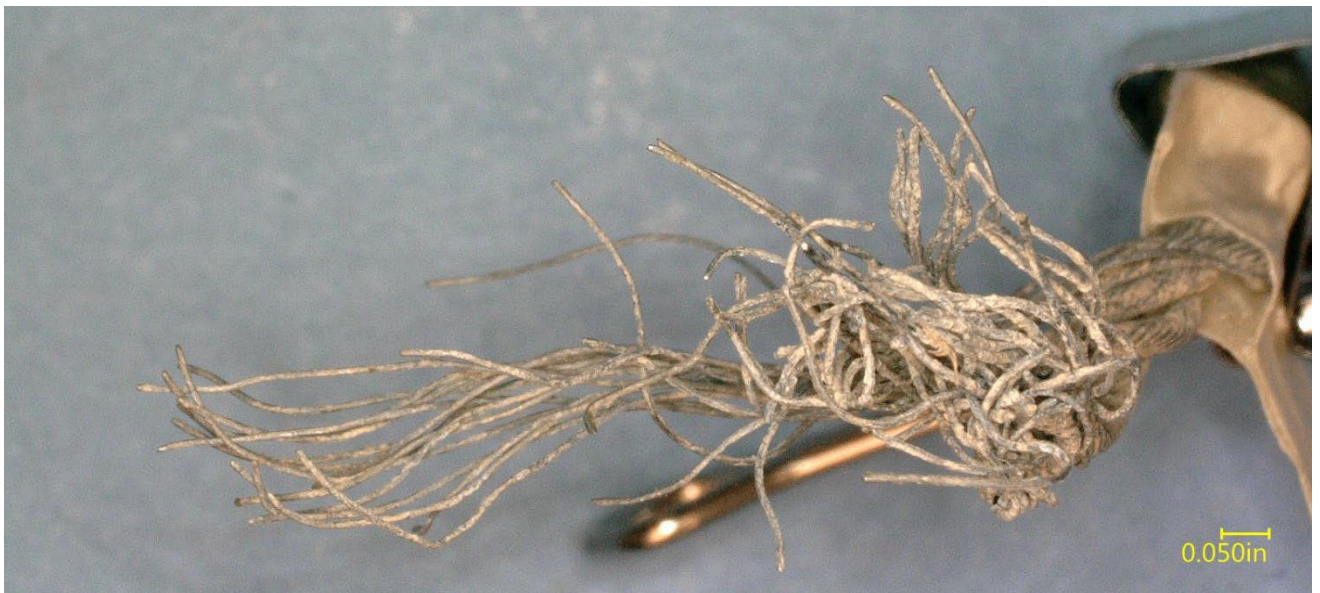
Figure 10 – View of some of the wire strands after sectioning.

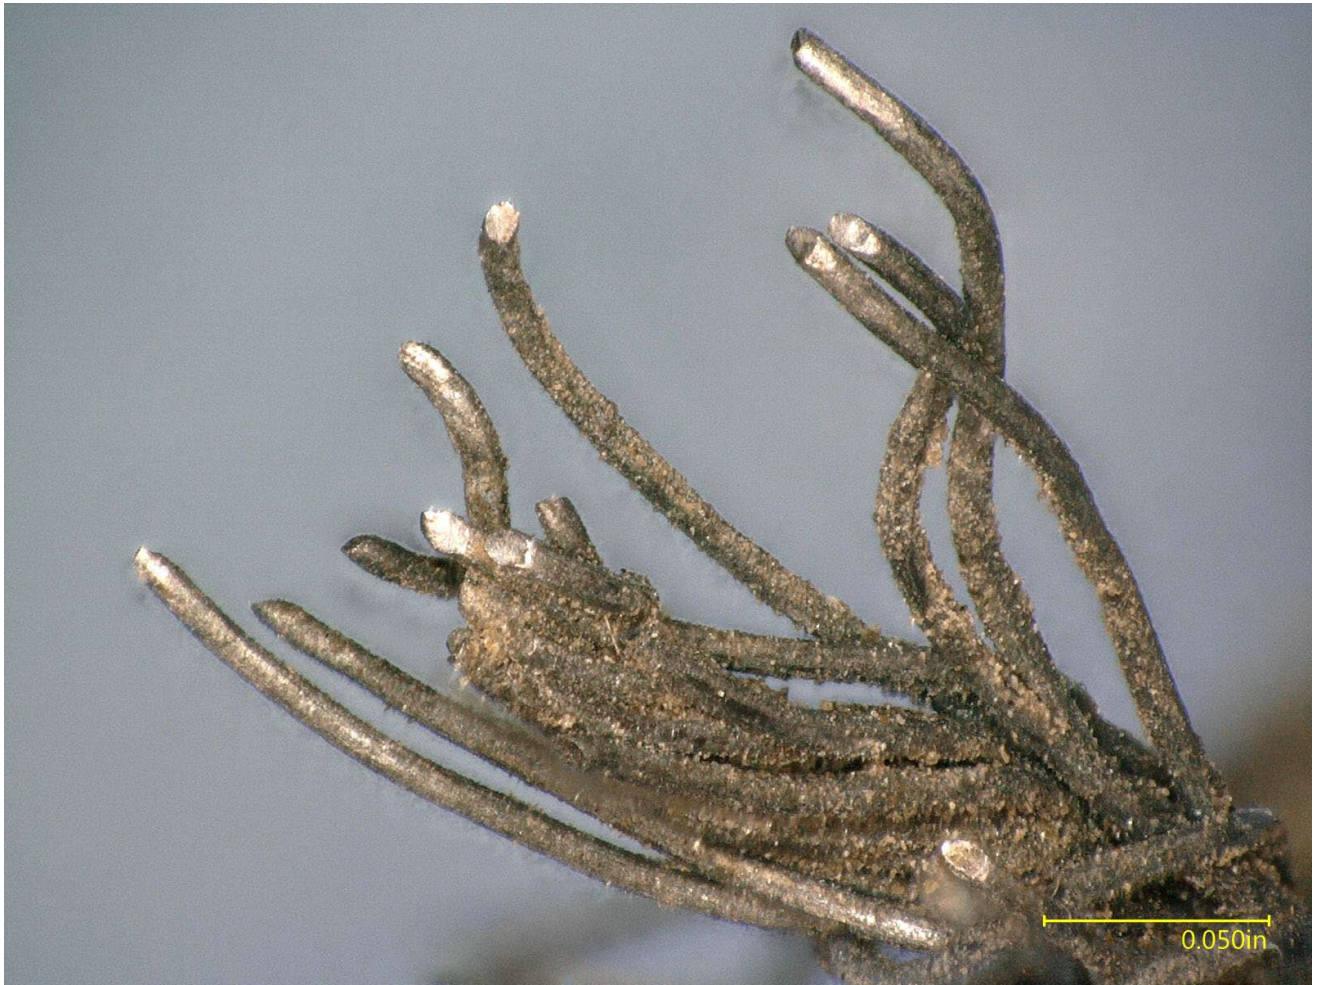
Figure 11 – Closer view of the wire strand ends from Figure 10.

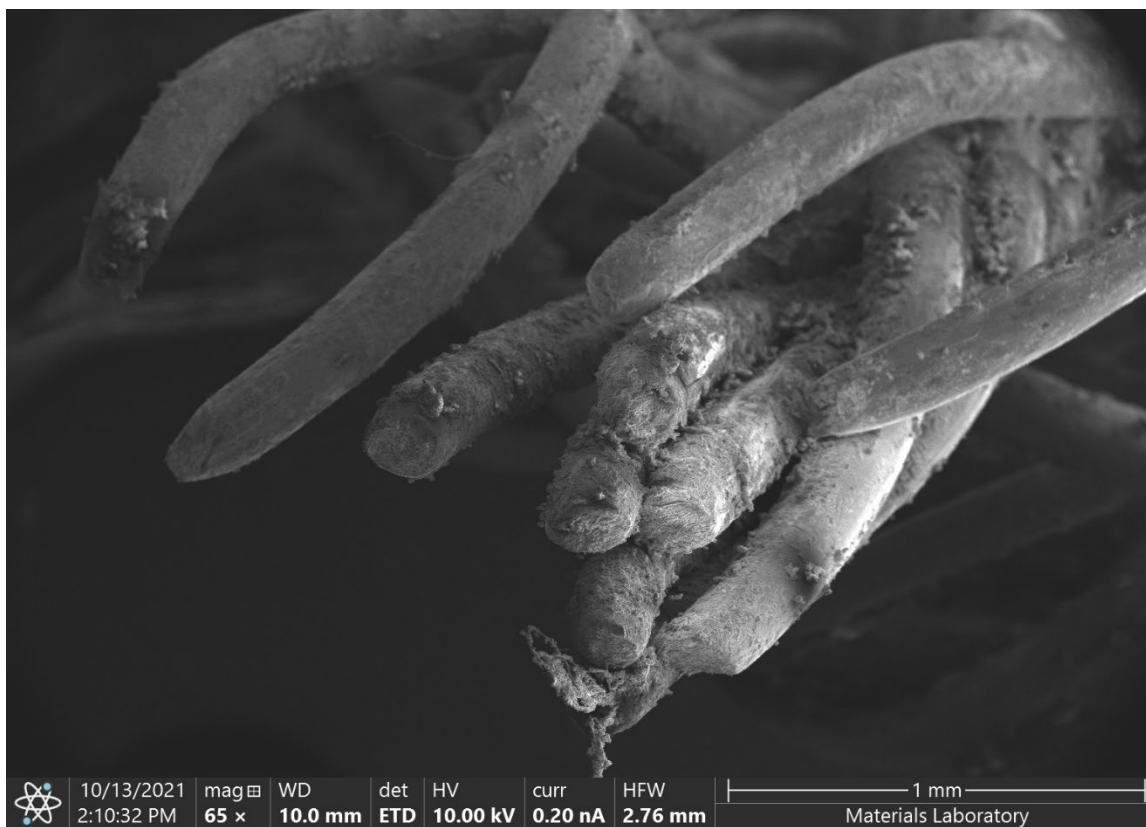
The wire strands from the long wire cable end fragment and the frayed ends were examined using an SEM. Several of the wire strand ends shown in Figure 11 are shown in Figure 12. All the strands exhibited contamination on the fracture and outer surfaces. This contamination was consistent with both post-fracture contamination and contamination (including material that had been applied) that was present prior to fracture.

Figure 12 – SE micrograph of a set of fractured wires in the frayed area of the cable.

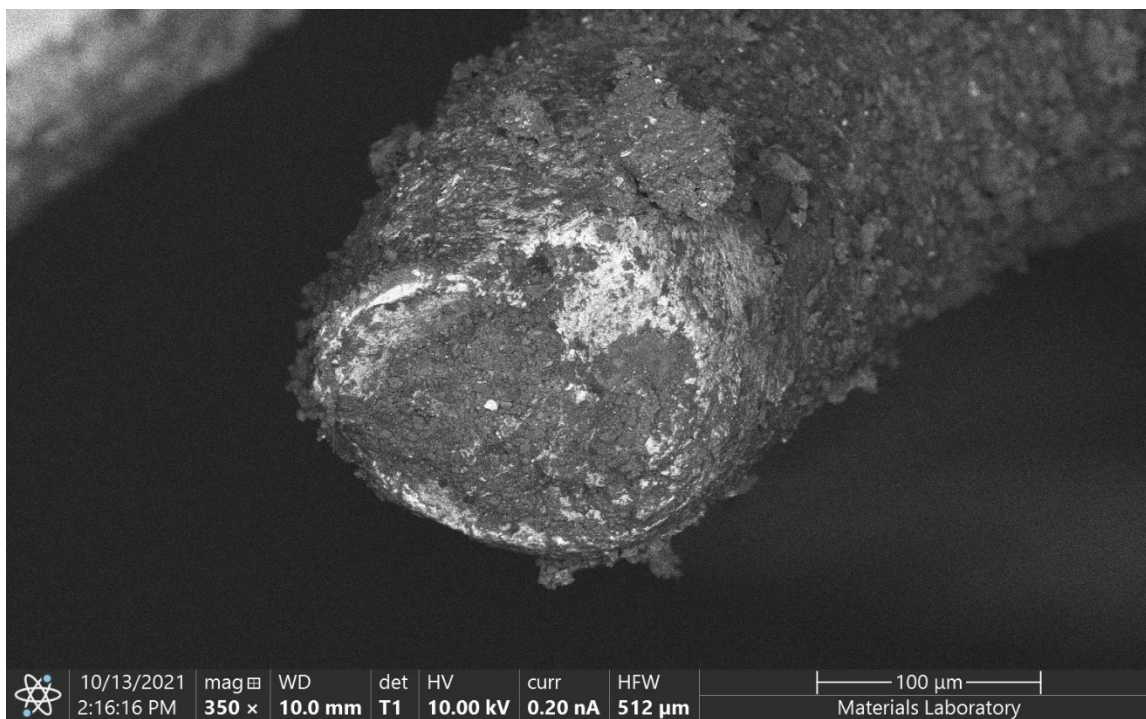
Figure 13 shows a typical fractured strand, exhibiting darker contrast material in backscattered mode, consistent with post-fracture nonmetallic compounds. One of the areas absent said contamination is illustrated in Figure 13. This area showed necking and dimpled rupture, along with a slanted direction to the fracture surface, as highlighted in Figure 14 and Figure 15. These features were consistent with fracture from tensile overstress along a plane of maximum shear stress.

Figure 13 – Backscattered electron (BE) micrograph of a fractured strand end from Figure 12.

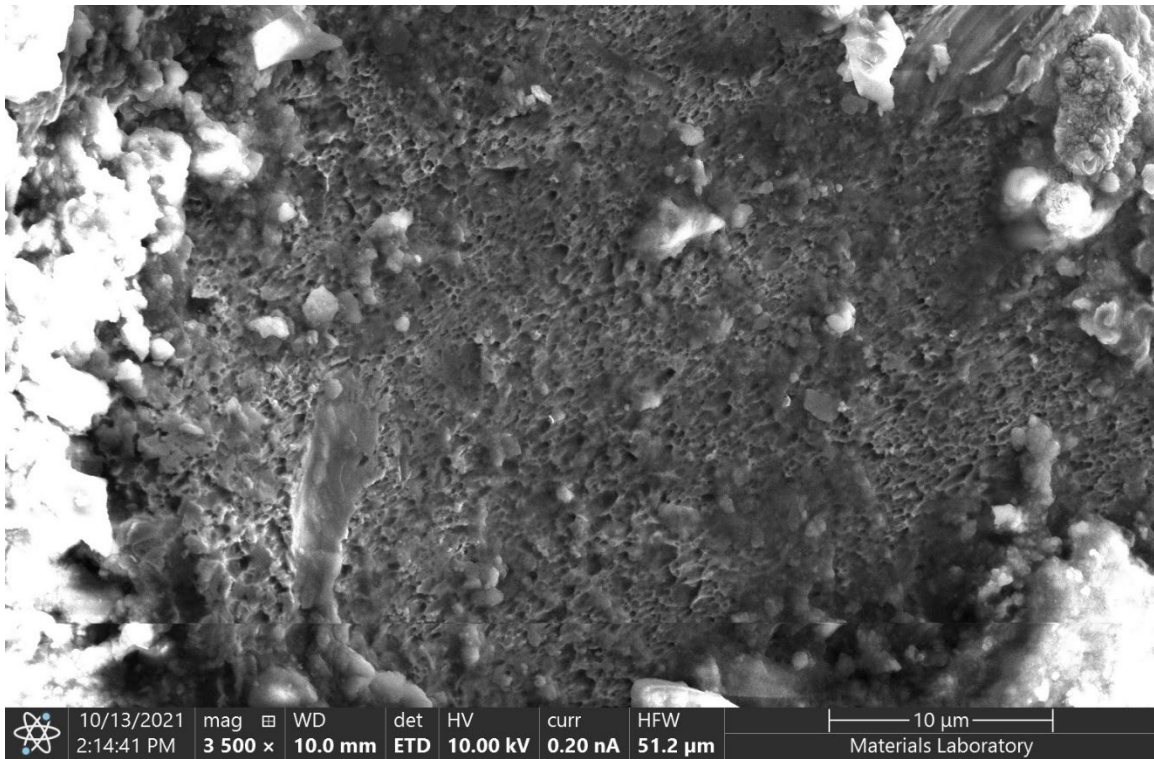
Figure 14 – SE micrograph of a closer area of the strand surface in Figure 13.

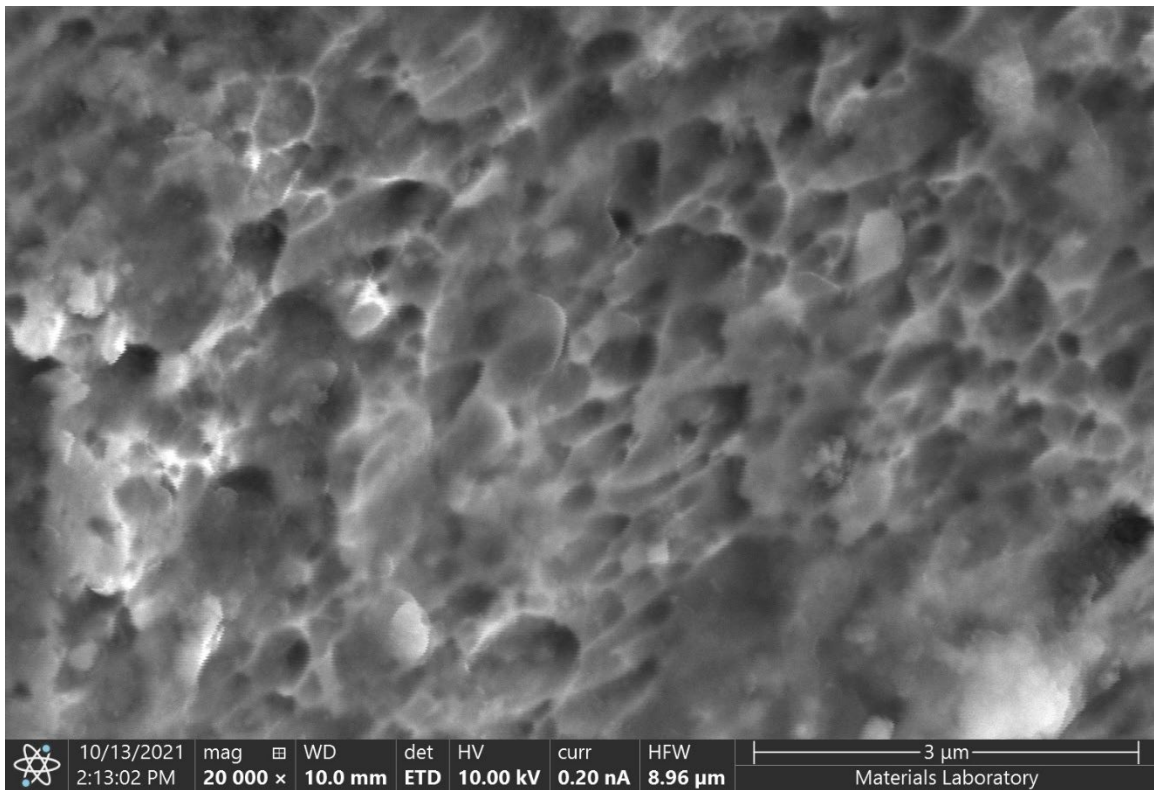
Figure 15 – SE micrograph of dimpled rupture features in Figure 14.

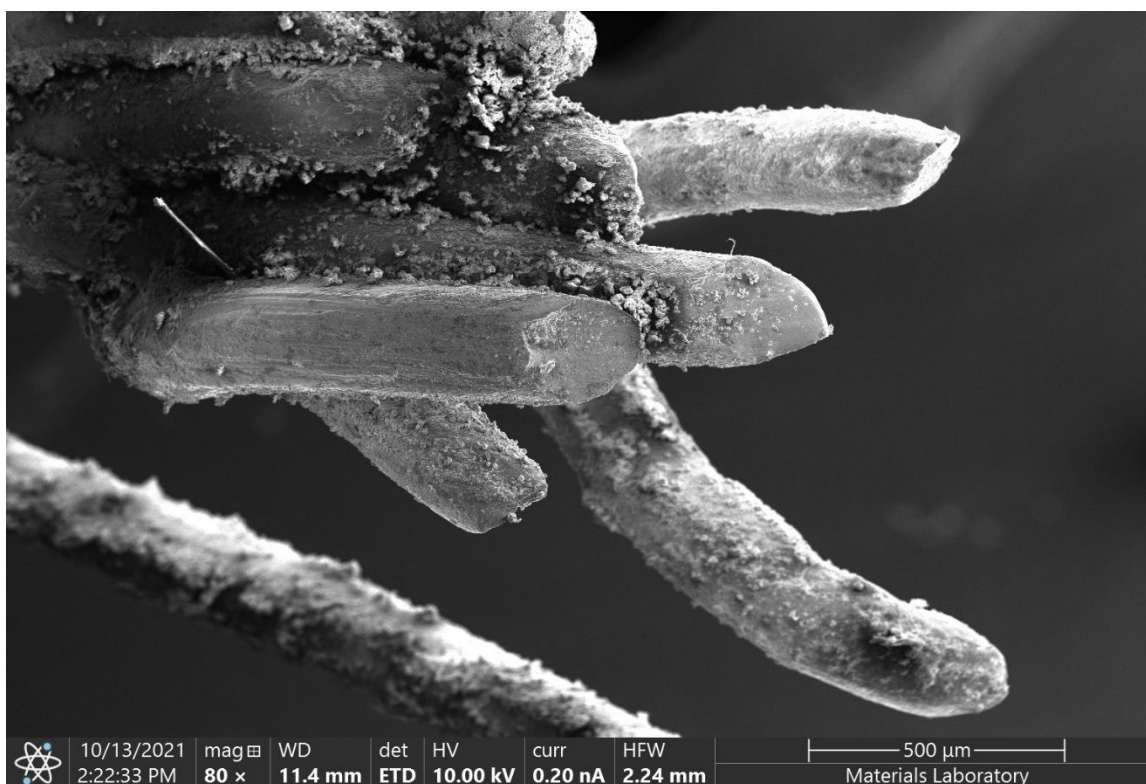
Figure 16 shows some of the frayed and fractured strands. A closer look at the fracture surface in the center of the figure is illustrated in Figure 17. Again, this surface exhibited dimpled rupture, consistent with fracture from overstress. None of the strands examined on any of the cable remnants showed any fracture features other than dimpled rupture or post-fracture damage.

Figure 16 – SE micrograph of a set of fractured strands along the frayed area.

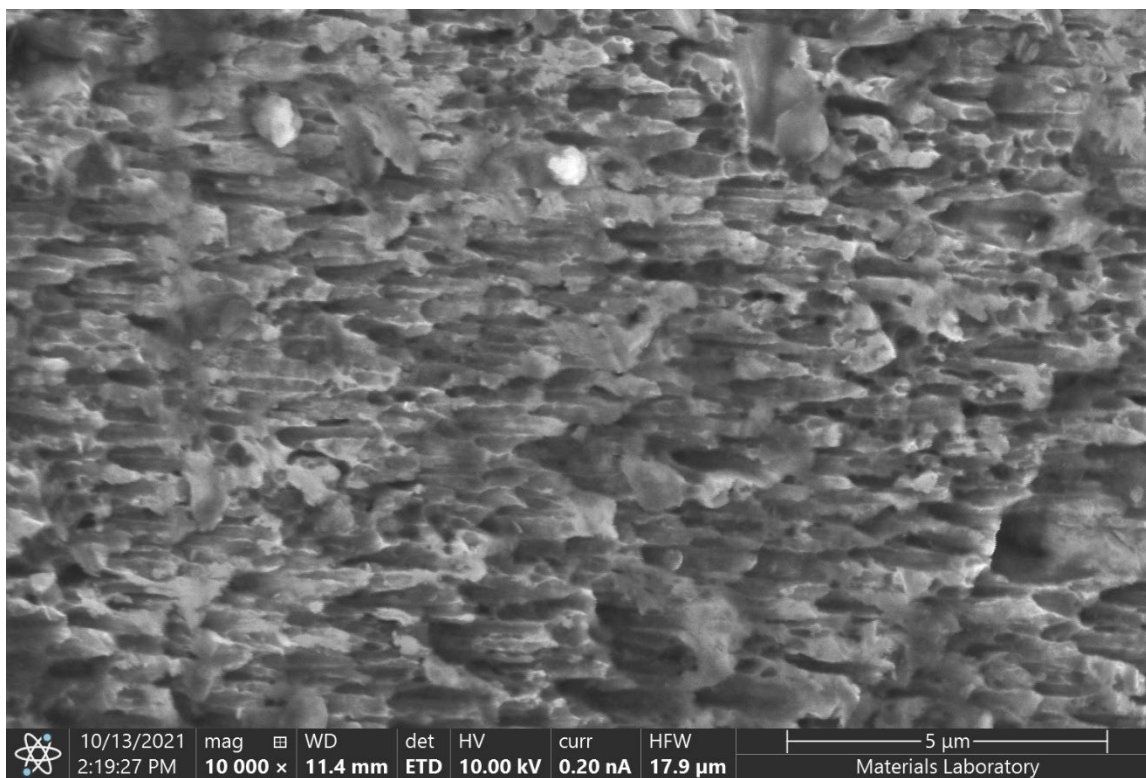
Figure 17 – SE micrograph of a closer area of the center strand fracture surface in Figure 16, showing dimpled rupture.

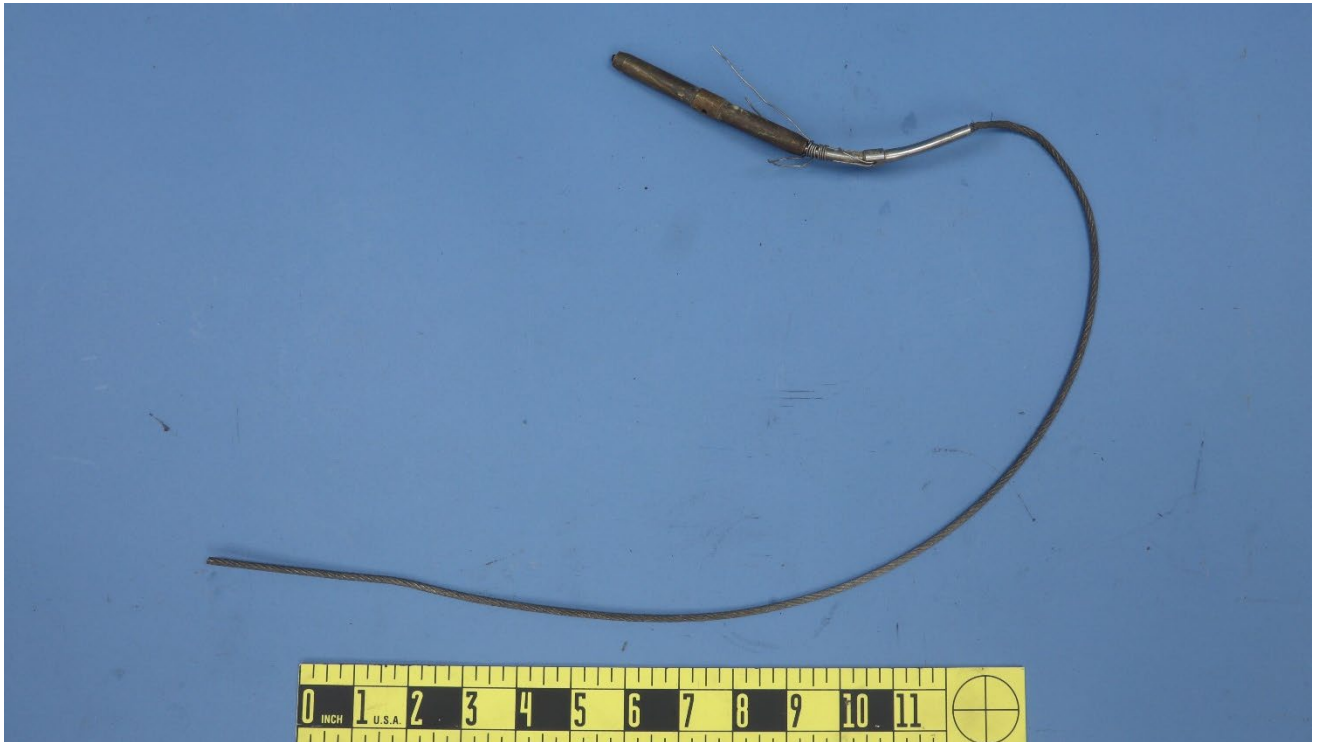
Figure 18 shows the shorter of the two elevator cable assembly remnants, also called the elevator up cable (P/N NAS304-35-2087). This section measured 23.5 inches in length, with the cable separated on one end and the turnbuckle and terminal end fractured on the other. The length of the fractured turnbuckle assembly was 6.25 inches.

Figure 18 – The shorter elevator cable remnant, or up cable, showing the fractured turnbuckle.

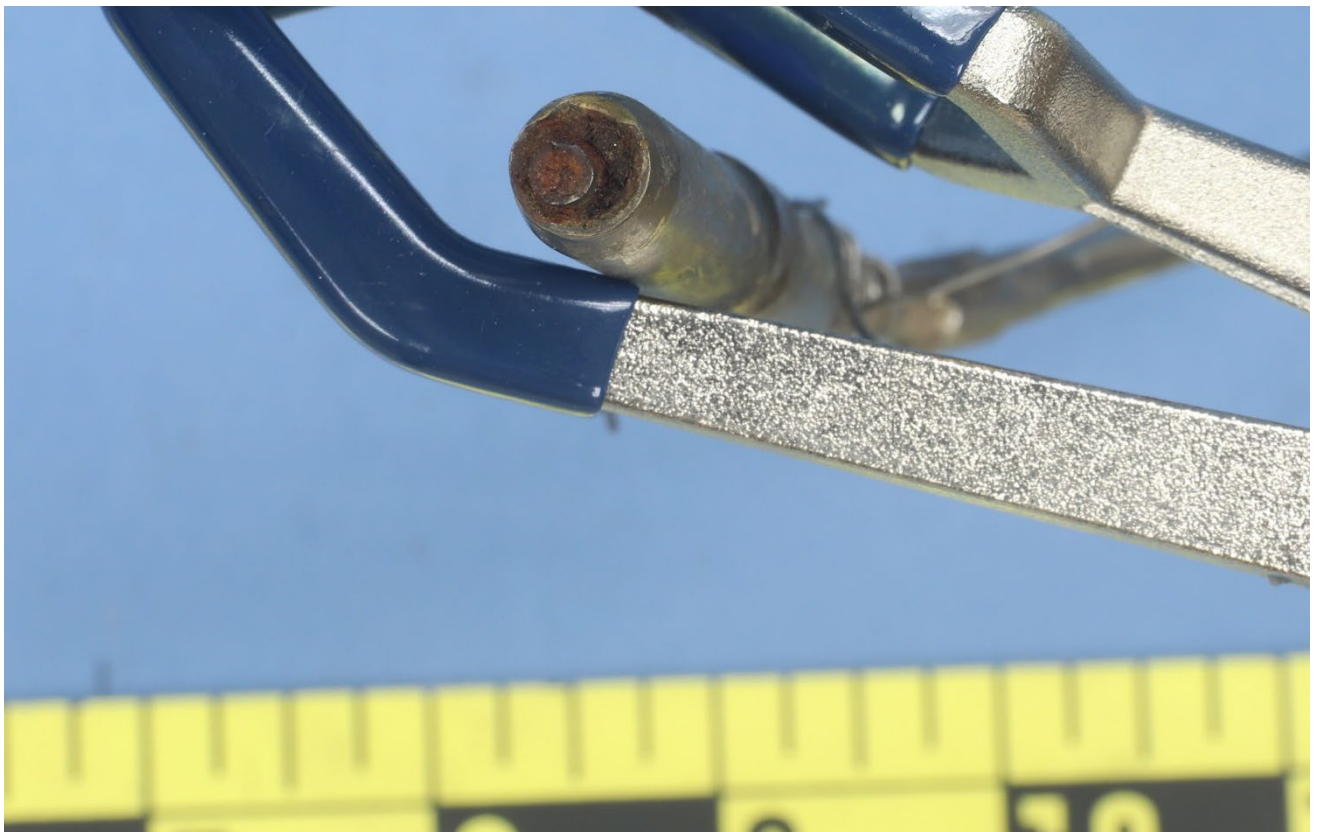
Figure 19 shows the fractured turnbuckle end, as received. This end consisted of a fractured terminal end inside of the brass eye turnbuckle (P/N AN165-22RL). The end exhibited oxidation in the form of iron oxide (rust) significant enough to obscure most of the features from being visible. In addition, this amount of rust had built up, concealing any gap between the end and turnbuckle control cable remnants when received by the Materials Laboratory. Figure 20 shows the cable end, where all the strands had fractured

Figure 19 – View of the turnbuckle with the fractured terminal end fracture surface, as received.

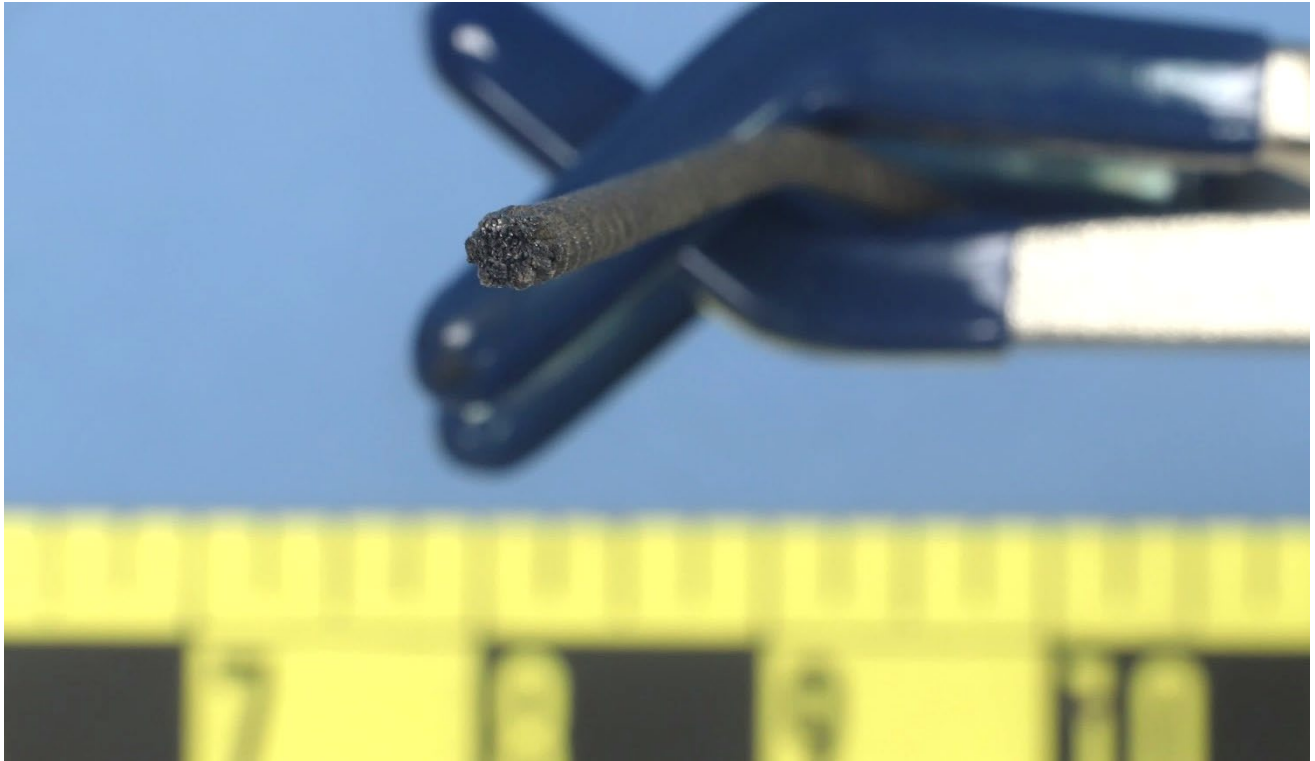
in the same location. In addition, the fracture was perpendicular to the cable direction, and none of the strands had frayed outward from the main assembly.

Figure 20 – View of the fracture surface of the strands from cable remnant in Figure 18.

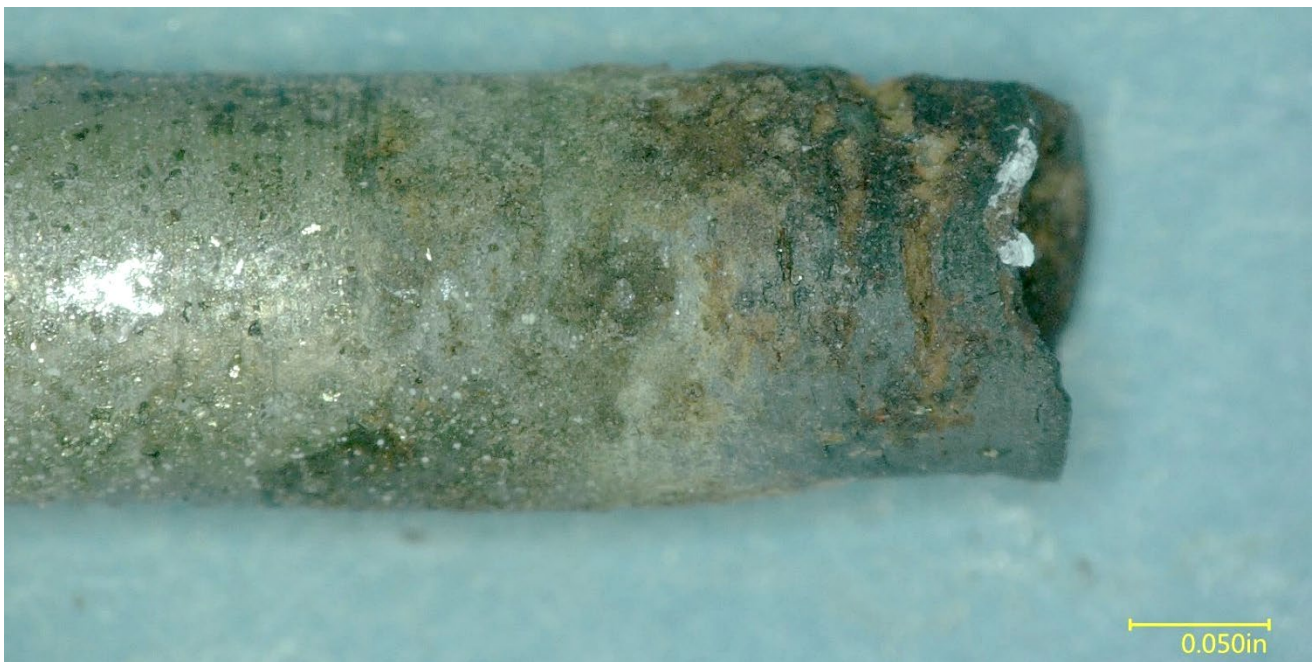
The outer surface of the turnbuckle exhibited a marking stating “ACHILLES.” Figure 21 shows the area towards the fracture surface of the terminal end after removal from the turnbuckle. The end tapered toward the fracture surface and was discolored relative to areas farther away (towards the left in the figure). These areas would have been inside the turnbuckle, whereas the discolored regions would be exposed to the environment outside the brass turnbuckle. The grayish-blue discoloration was consistent with corrosion compounds, which were thick enough to obscure the underlying surface features of the end.

Figure 21 – View of the fractured terminal end, after disassembly, but prior to cleaning.

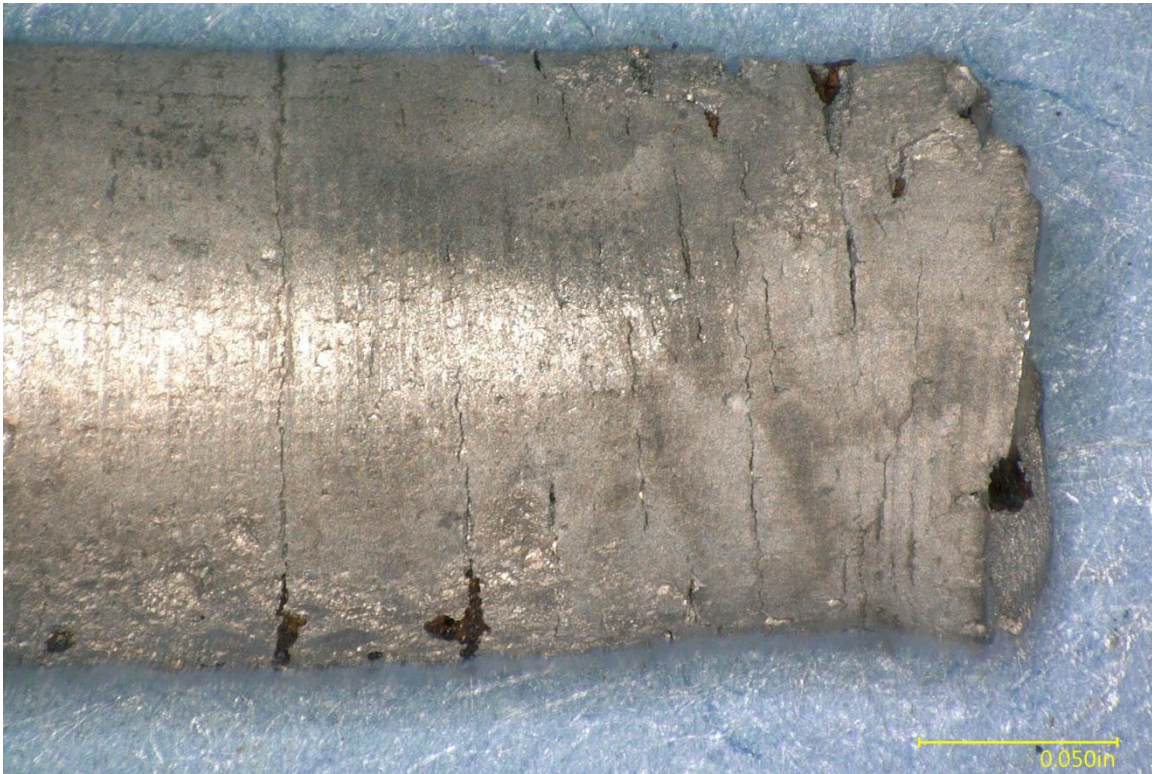
Figure 22 – Side view of the terminal end remnant near the fracture surface, showing a localized deformation near the surface, as well parallel surface cracks.
