# NATIONAL TRANSPORTATION SAFETY BOARD

## MATERIALS LABORATORY ADDENDUM REPORT

Report No. 21-072B

Place : Attalla, Alabama  
Date : December 12, 2020  
Vehicle : Beech V35A, N5470U  
NTSB No. : ERA21LA068  
Investigator : Timothy Monville, AS-ERA

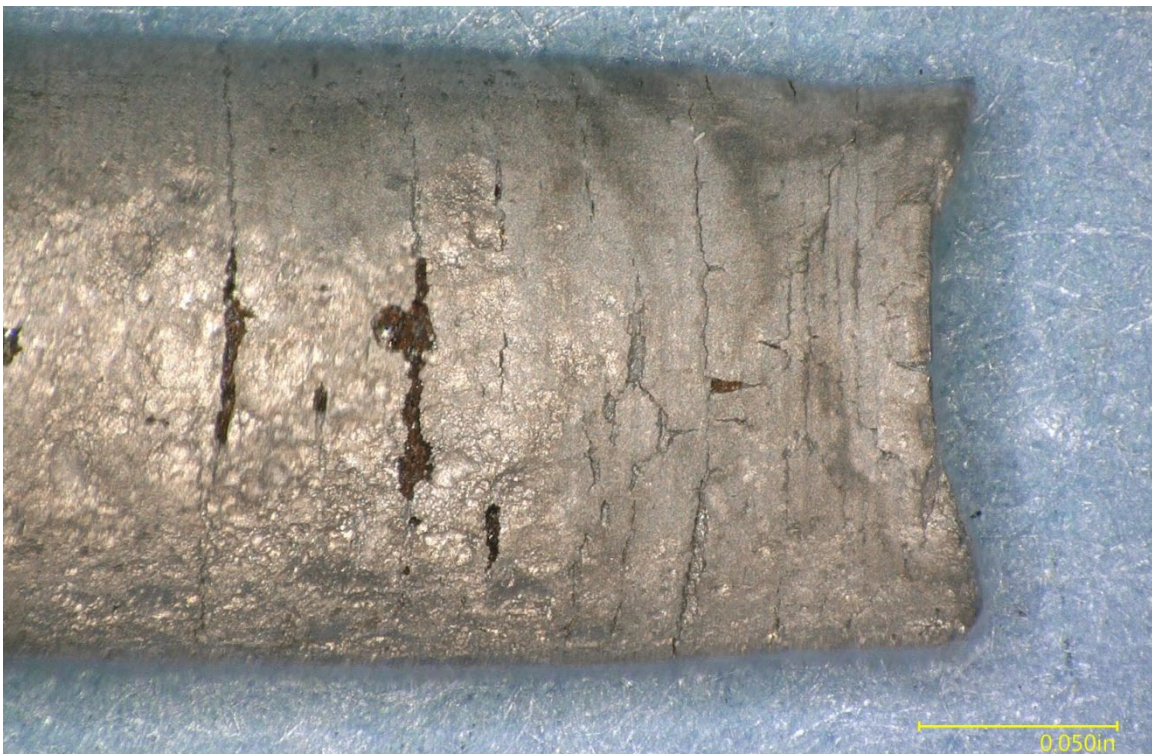
Figure 23 – The side of the end fracture, rotated 90° from Figure 22, showing a flattened area with some perpendicular secondary cracks.

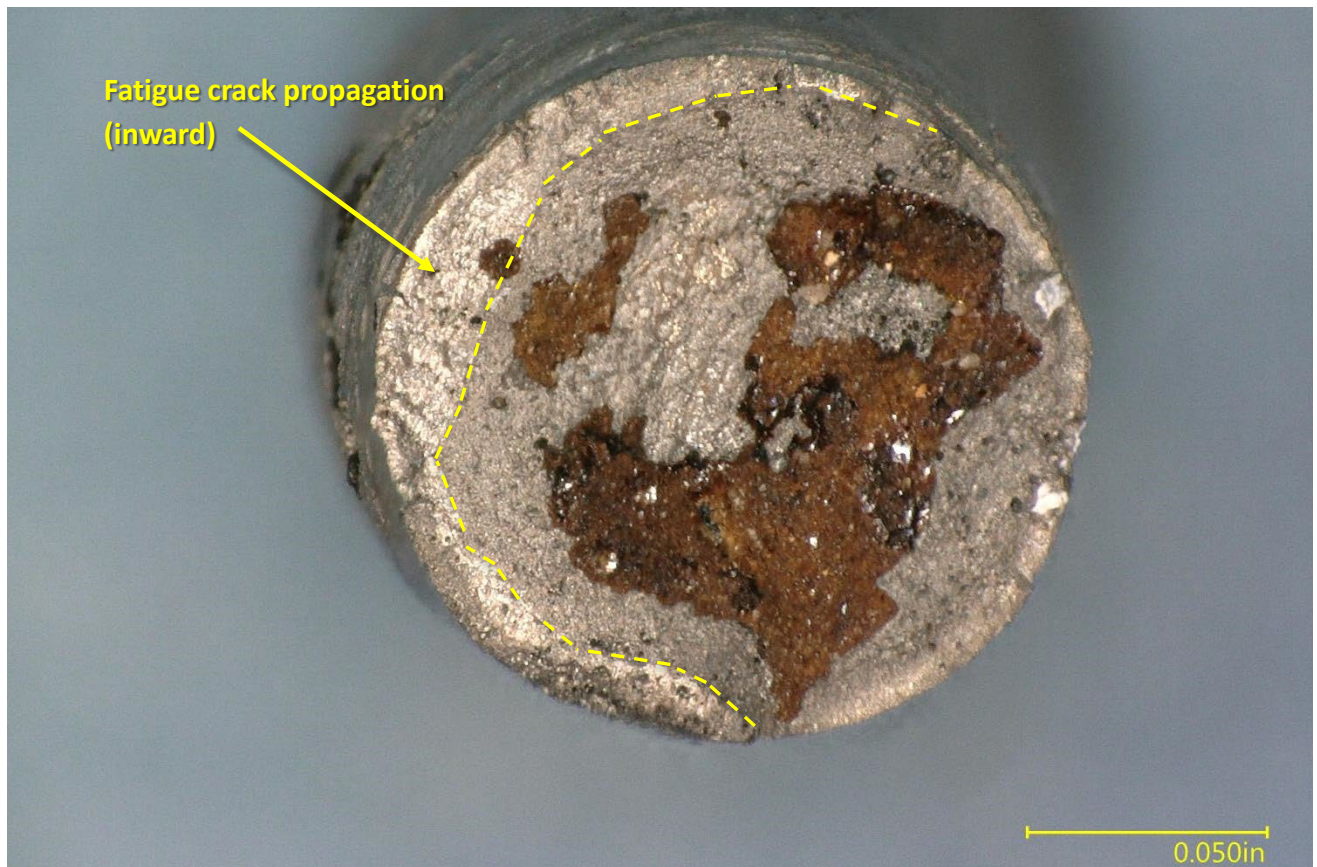
Figure 24 – View of the terminal end fracture surface after extensive cleaning (the brown areas were remnants of contamination/rust).

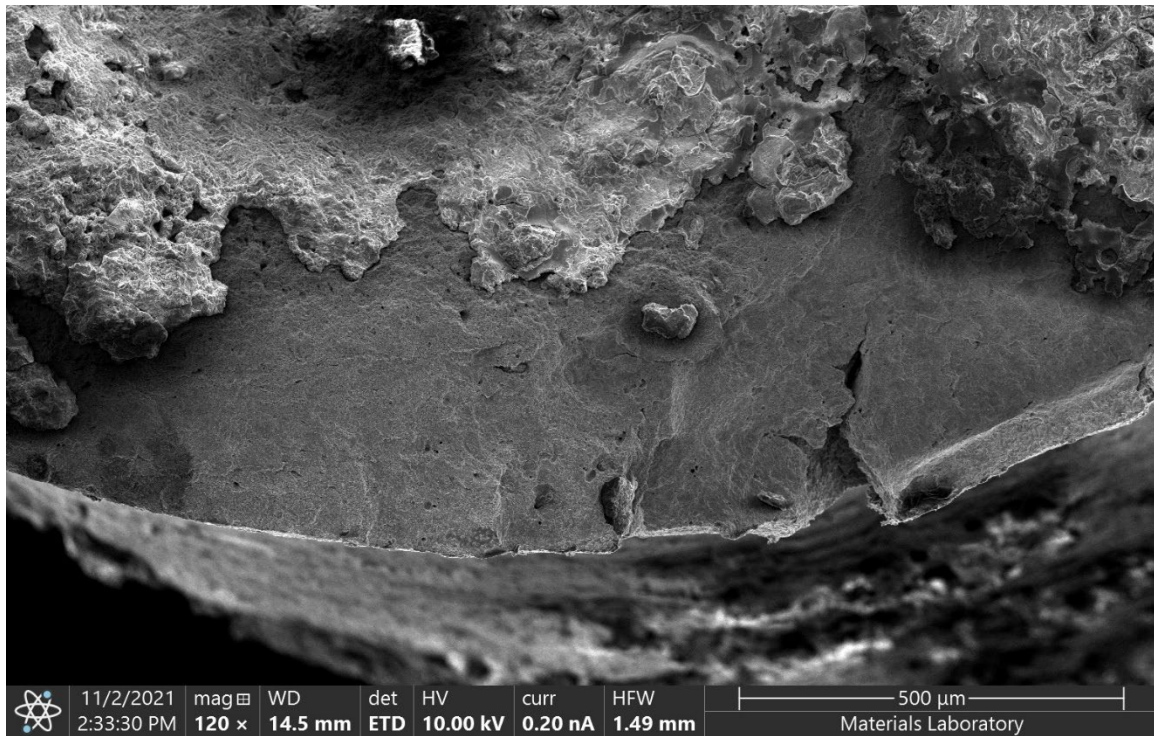
Figure 25 – SE micrograph of the edge of the end fracture surface, showing an area of ratchet marks and crack arrest marks.

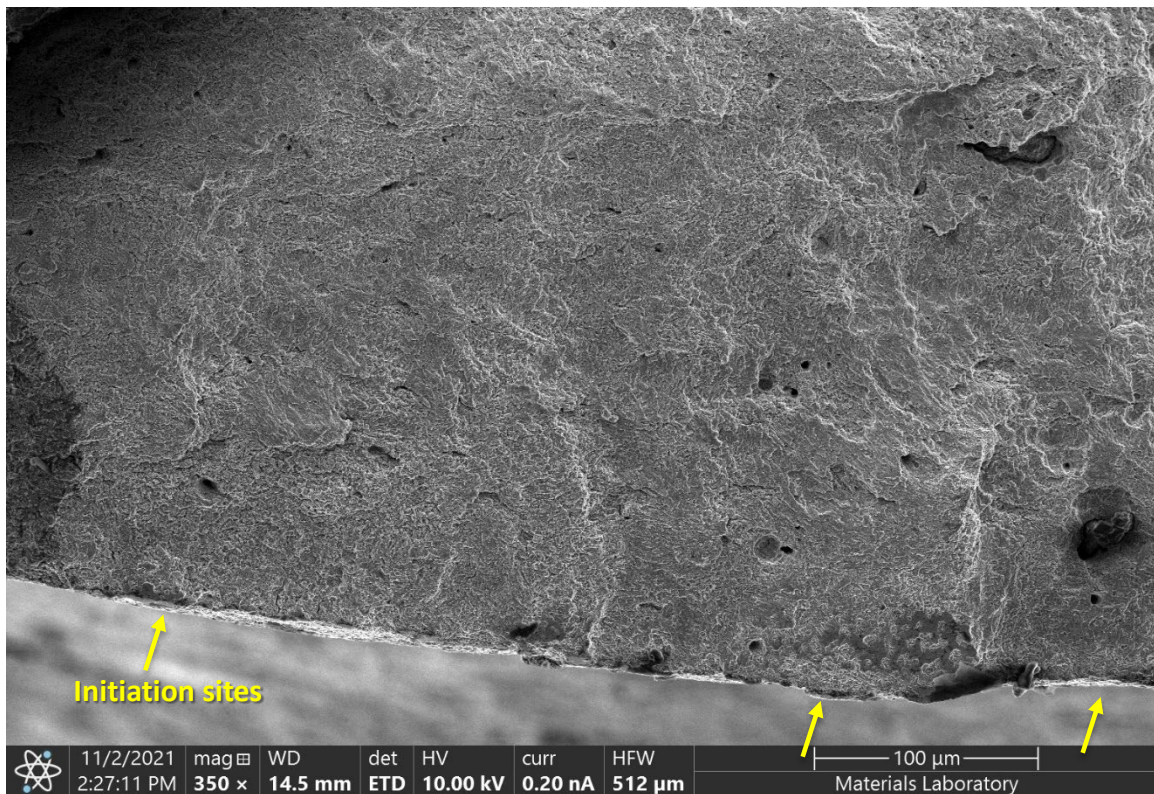
The fracture surface was examined using an SEM, and the edge with the progressive cracking features is shown in Figure 26. This area was approximately 0.25 circumferential inches long and 0.011 in (0.29 mm) deep. As shown in the figure, this region exhibited several ratchet marks oriented perpendicular to the edge. These features were consistent with multiple crack initiation sites (see Figure 27).

Figure 26 – SE micrograph showing a closer view of the depth of the fatigue region.

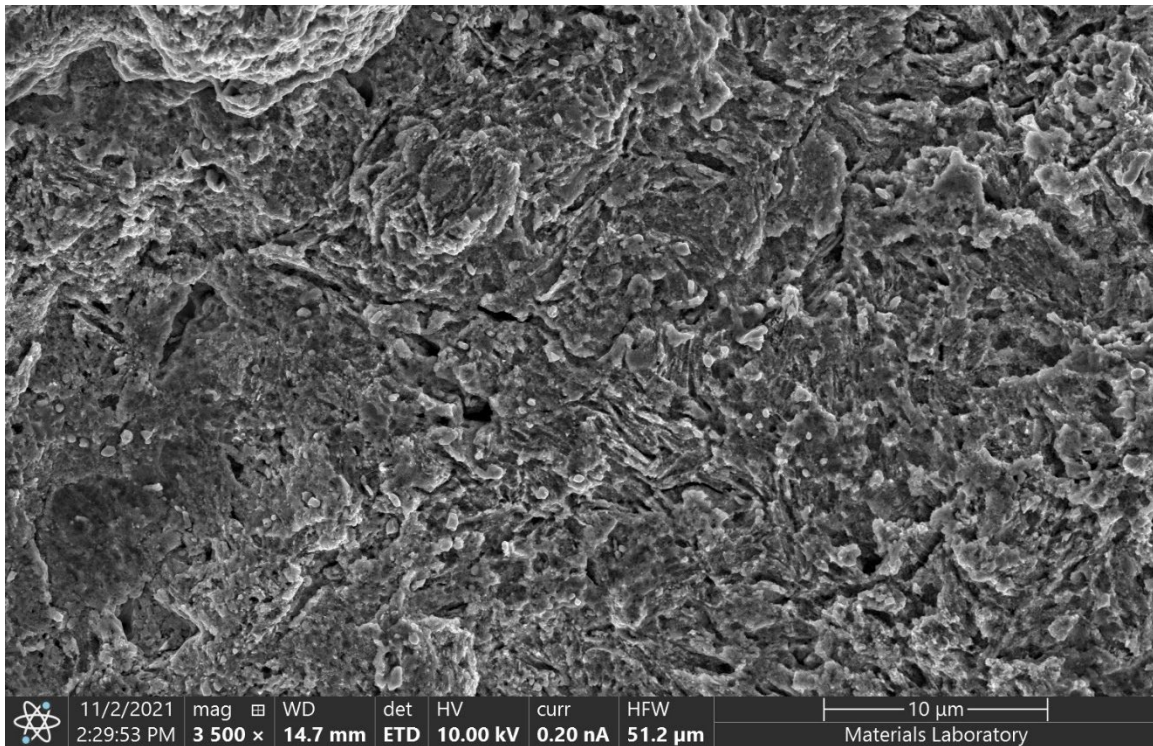
A closer view of this region revealed fatigue striations, consistent with fatigue crack propagation (Figure 27). These striations were oriented perpendicular to the longitudinal direction of the surface edge, consistent with inward crack growth. Removal of the surface oxides and contamination left much of the fracture surface altered, including exposing the underlying microstructure (consistent with the lamellar features of steels). These features were similar to, but were inconsistent with, fatigue striations.

Figure 27 – SE micrograph of a typical area in Figure 26, showing fatigue striations.

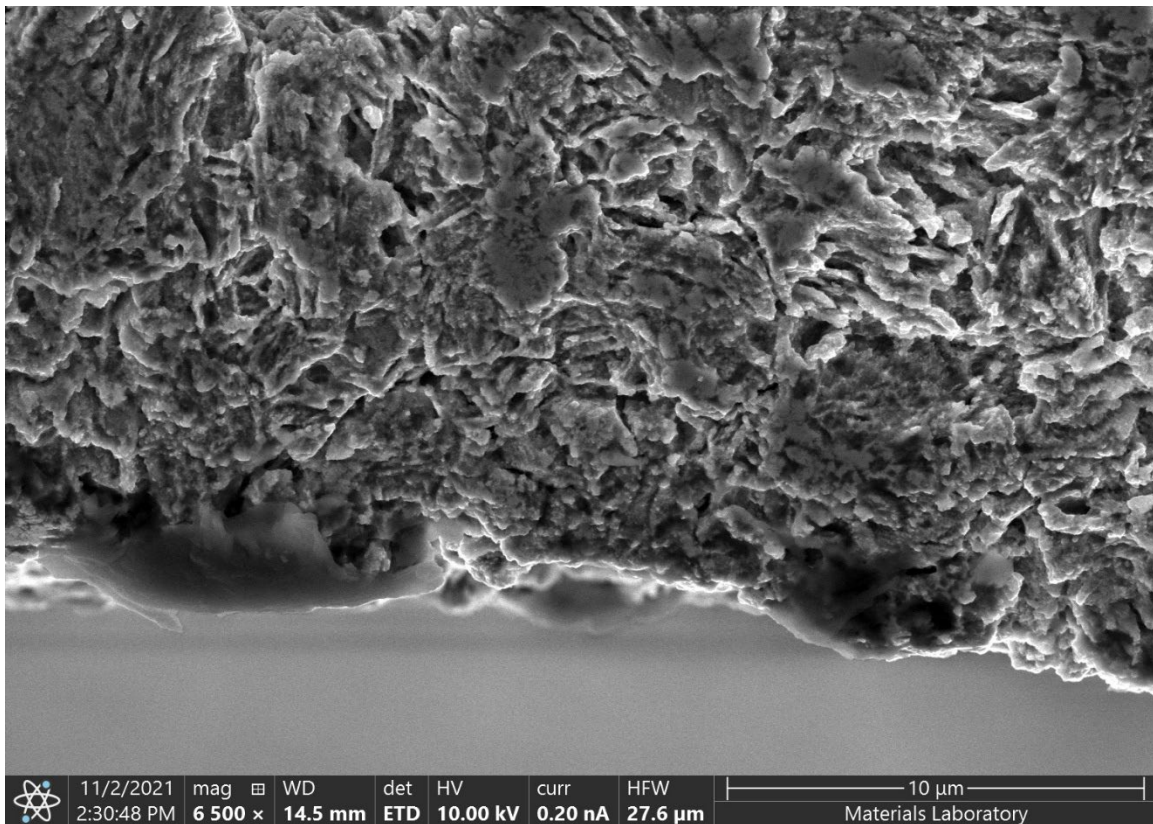
Removal of the surface oxide also created some damage to the fracture surface edge. Most of the crack initiation sites exhibited damage consistent with post-fracture damage, such as from excessive corrosion or impact with an adjacent object. Figure 28 shows a closer view of one of the lesser damaged fatigue crack initiation sites. The initiation sites did not exhibit any outstanding material features, such as an inclusion or

Figure 28 – SE micrograph of one of the fatigue crack initiation sites.

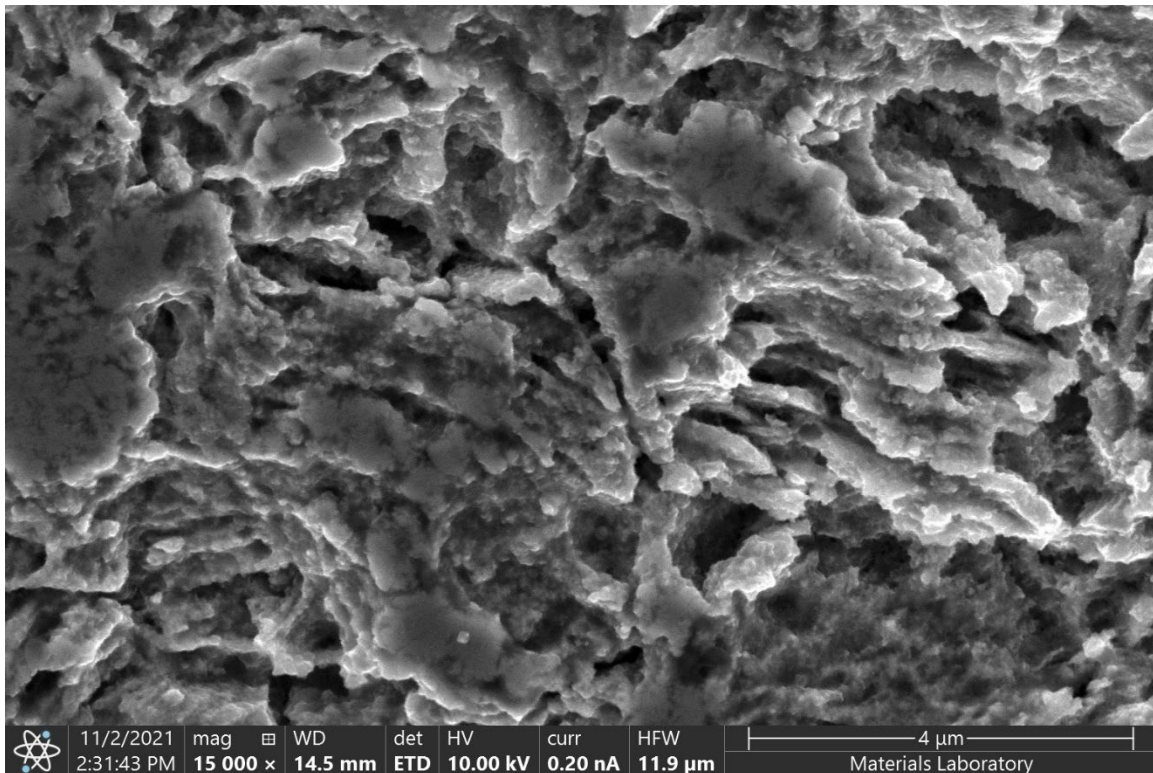
corrosion pit, but the edge was depressed inward at the initiation site. These features were consistent with those found along the parallel cracks along the shaft. Discernible fatigue striations were observed near this crack initiation site (Figure 29).

Figure 29 – SE micrograph of a closer view of striations emanating from the fatigue crack initiation site in Figure 28.

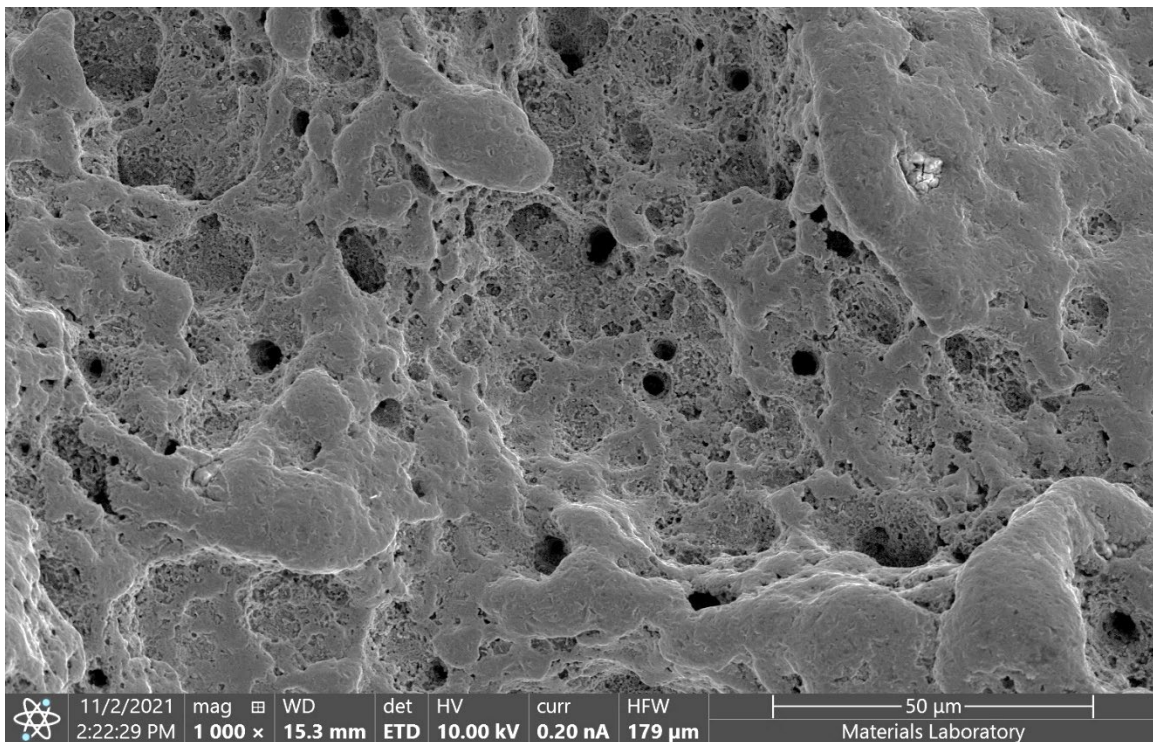
Further inward on the terminal end fracture surface, the surface exhibited dimpled rupture, consistent with subsequent overstress fracture (Figure 30). No other fracture features consistent with different failure modes were observed.

Figure 30 – SE micrograph of the inner overstress area of the terminal end, after cleaning, showing corroded remnants of dimpled rupture.

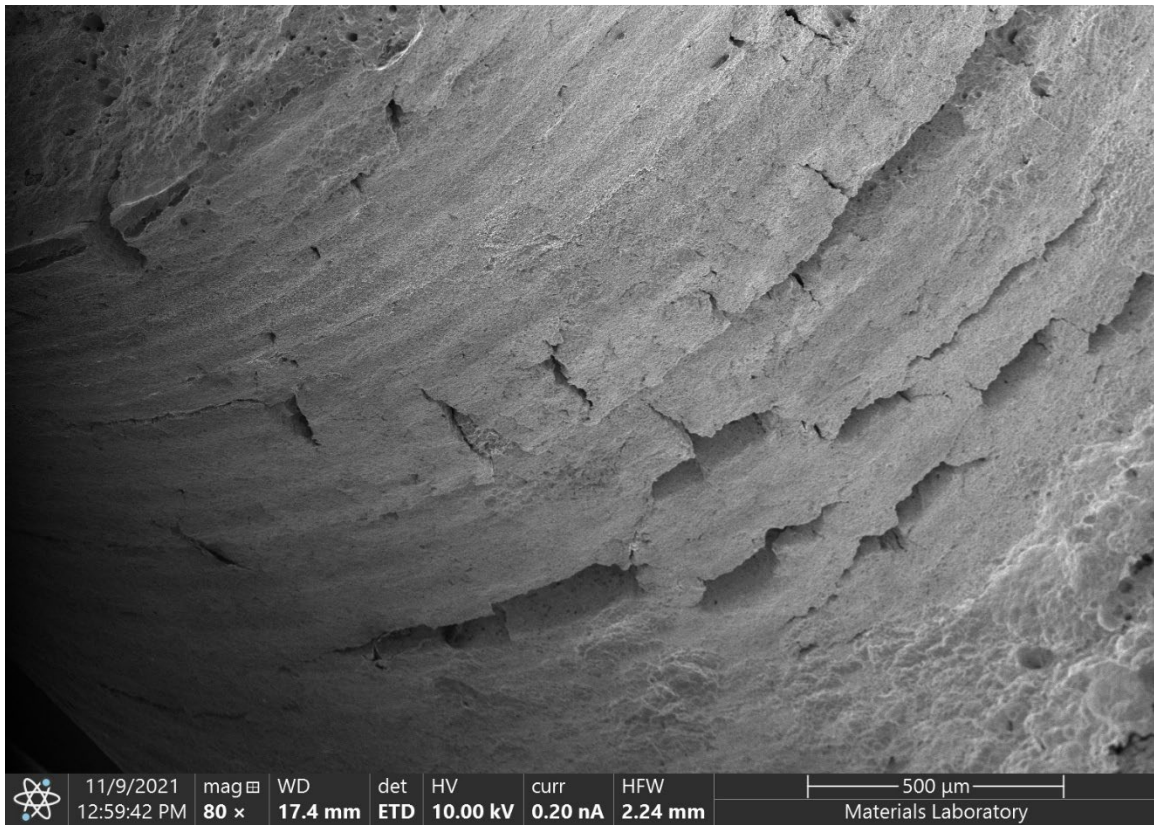
The parallel cracks outside the terminal end cylindrical surface (Figure 22 and Figure 23) were also examined using an SEM, as shown in Figure 31 and Figure 32. The other cracks exhibited similar features to the fracture surface, consistent with having undergone a post-cracking corrosive attack. With much of the surface compounds having been removed after cleaning, much of the compounds within the cracks had been removed as well.

Figure 31 – SE micrograph of the outer surface of the terminal end below the fracture (upper left) showing multiple parallel cracks.

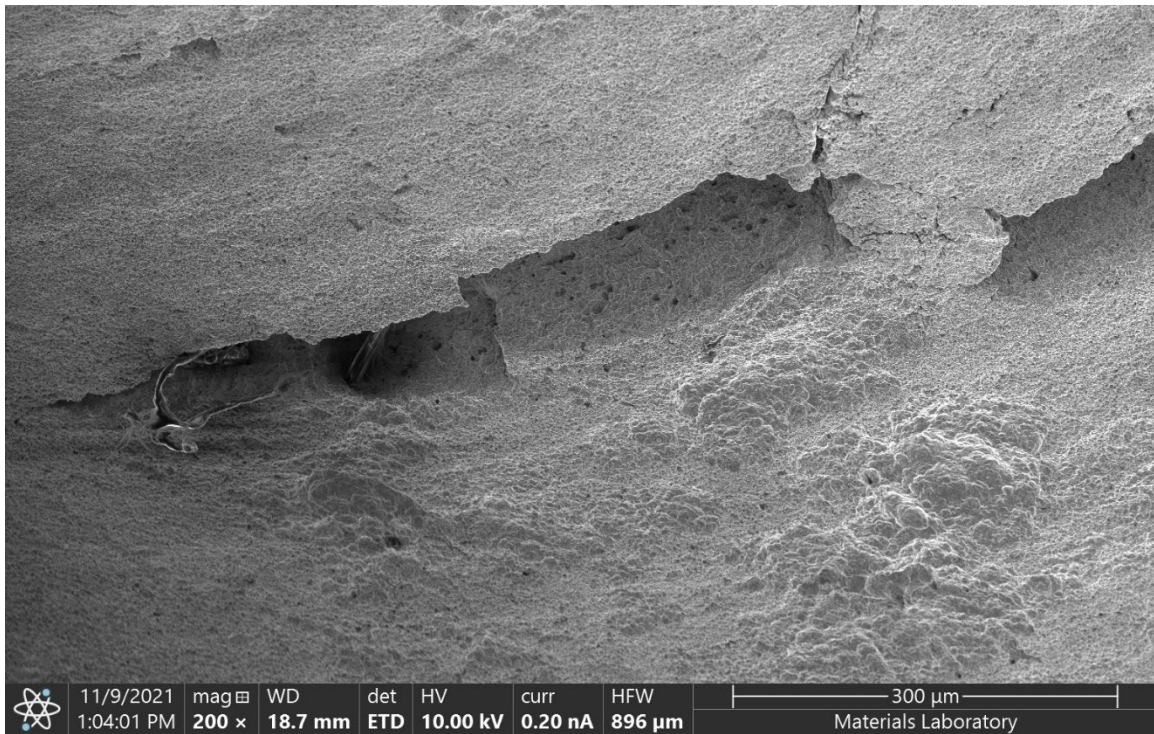
Figure 32 – SE micrograph of one of the parallel cracks in Figure 31.

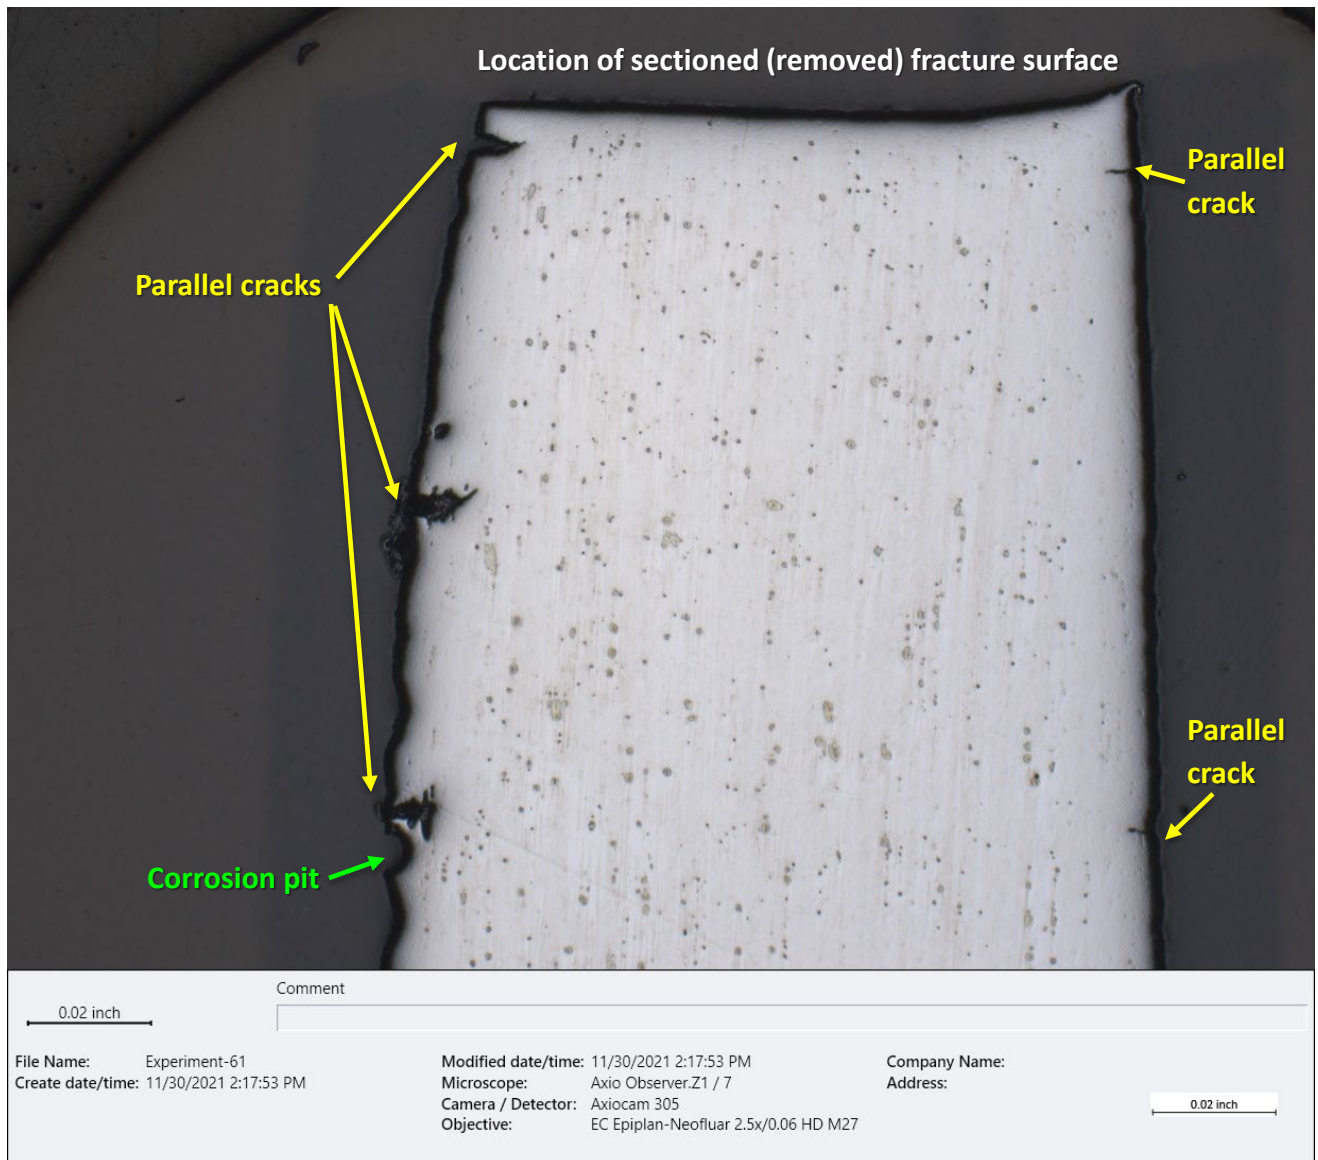
The fracture surface was excised from the terminal end, and the remainder of the terminal end was vacuum cold-epoxy mounted, ground, and polished. This preparation provided a cross section of much of the terminal end, as illustrated in Figure 33. Multiple cracks were identified in this cross section, along with an undulating outer surface consistent with some corrosion pitting. The cracks had penetrated up to 0.01 in (0.25 mm) into the outer surface. This cross section also showed that the terminal end exhibited a grain flow direction parallel to the longitudinal direction, consistent with the forging direction.

Figure 33 – Bright-field (BF) optical micrograph of a cross section of the terminal end, after sectioning of the fracture surface end (~25X, etched from tap water).

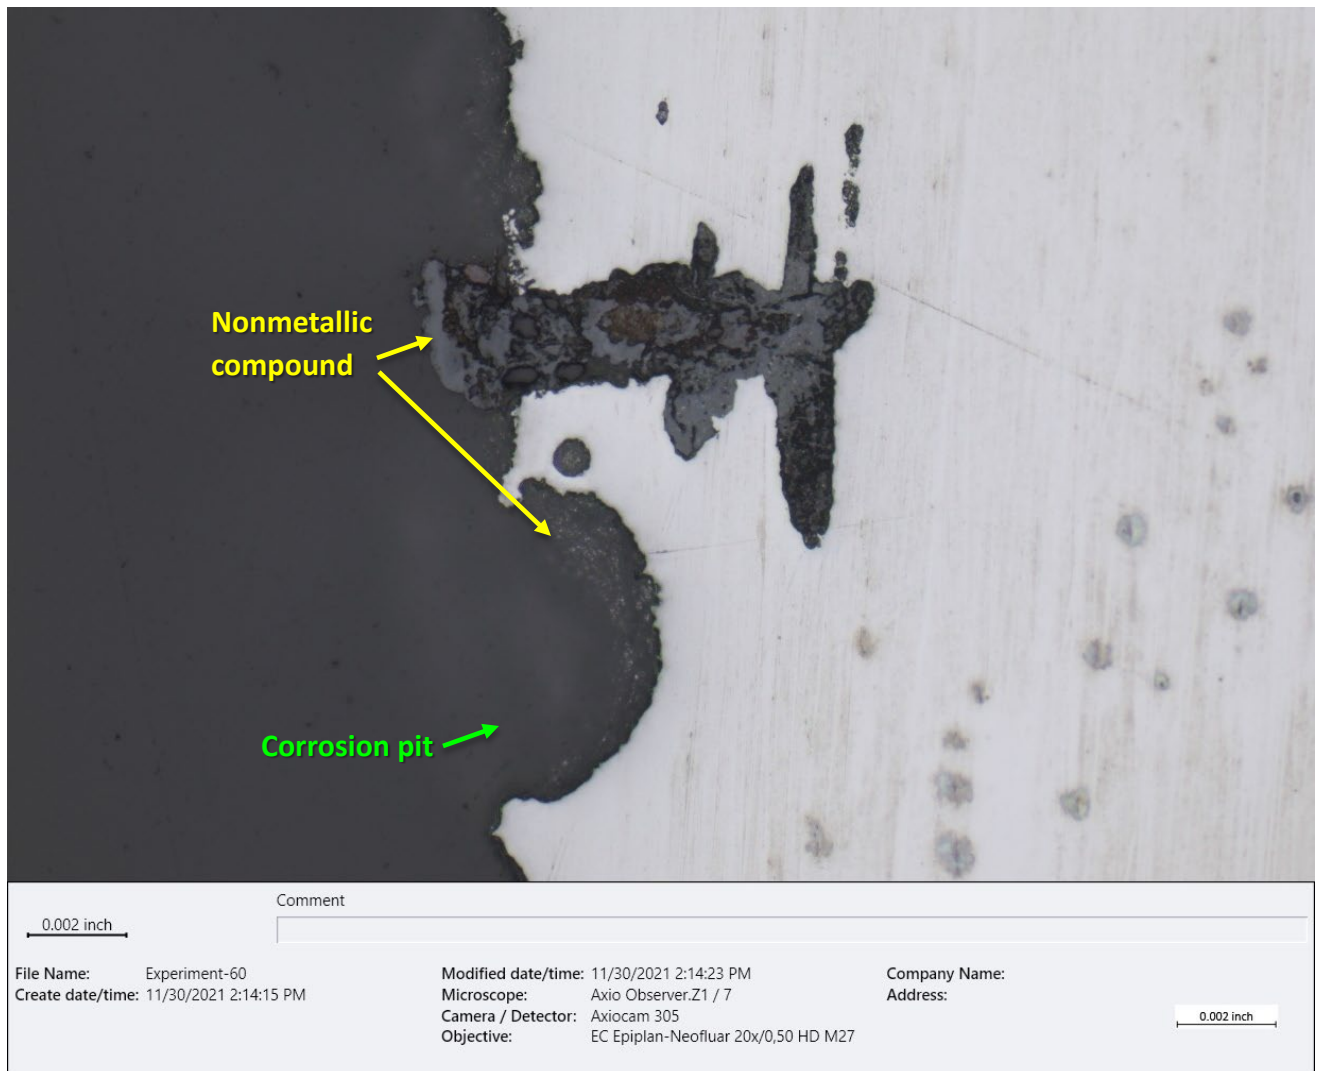
Figure 34 shows a closer view of one of the cracks. The crack was adjacent to a corrosion pit, shown below in the figure. Both features contained nonmetallic compounds, as evidenced by their lack of reflectivity in the micrograph. Figure 35 shows a crack closer to the fracture surface. This crack exhibited a wider opening and was absent much of the nonmetallic compounds seen in the other cracks. These features were consistent with deformation under the tensile stresses that caused the fracture of the terminal end at the fatigue crack on the fracture surface.

Figure 34 – BF optical micrograph of a corrosion pit adjacent to a crack with internal compounds (~200X, etched from tap water).

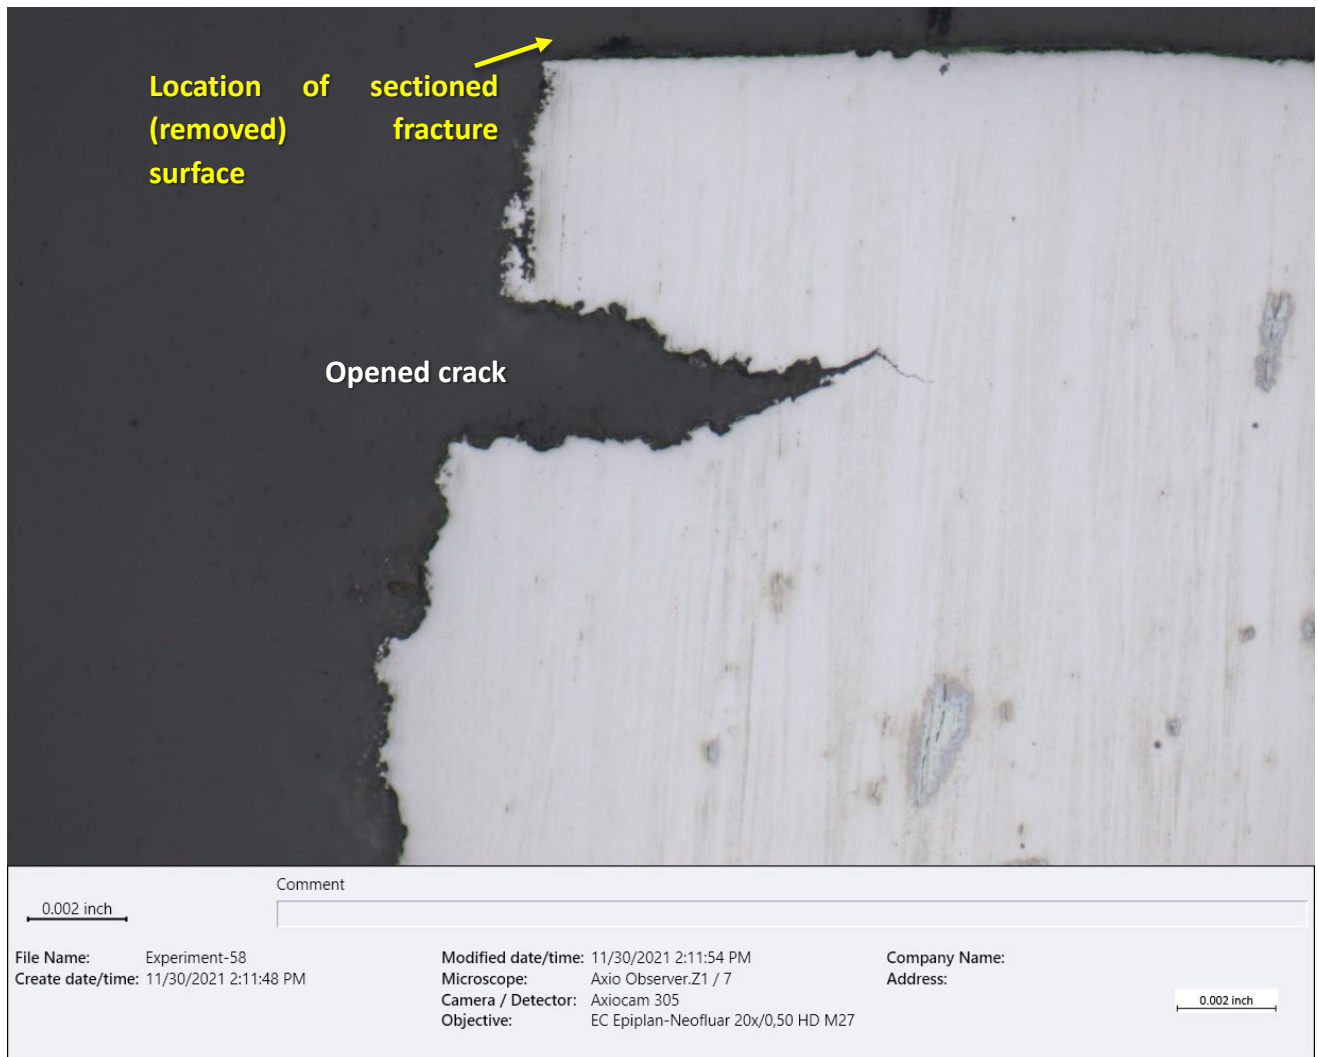
Figure 35 – BF optical micrograph of a opened crack near the fracture surface section (~200X, etched from tap water).

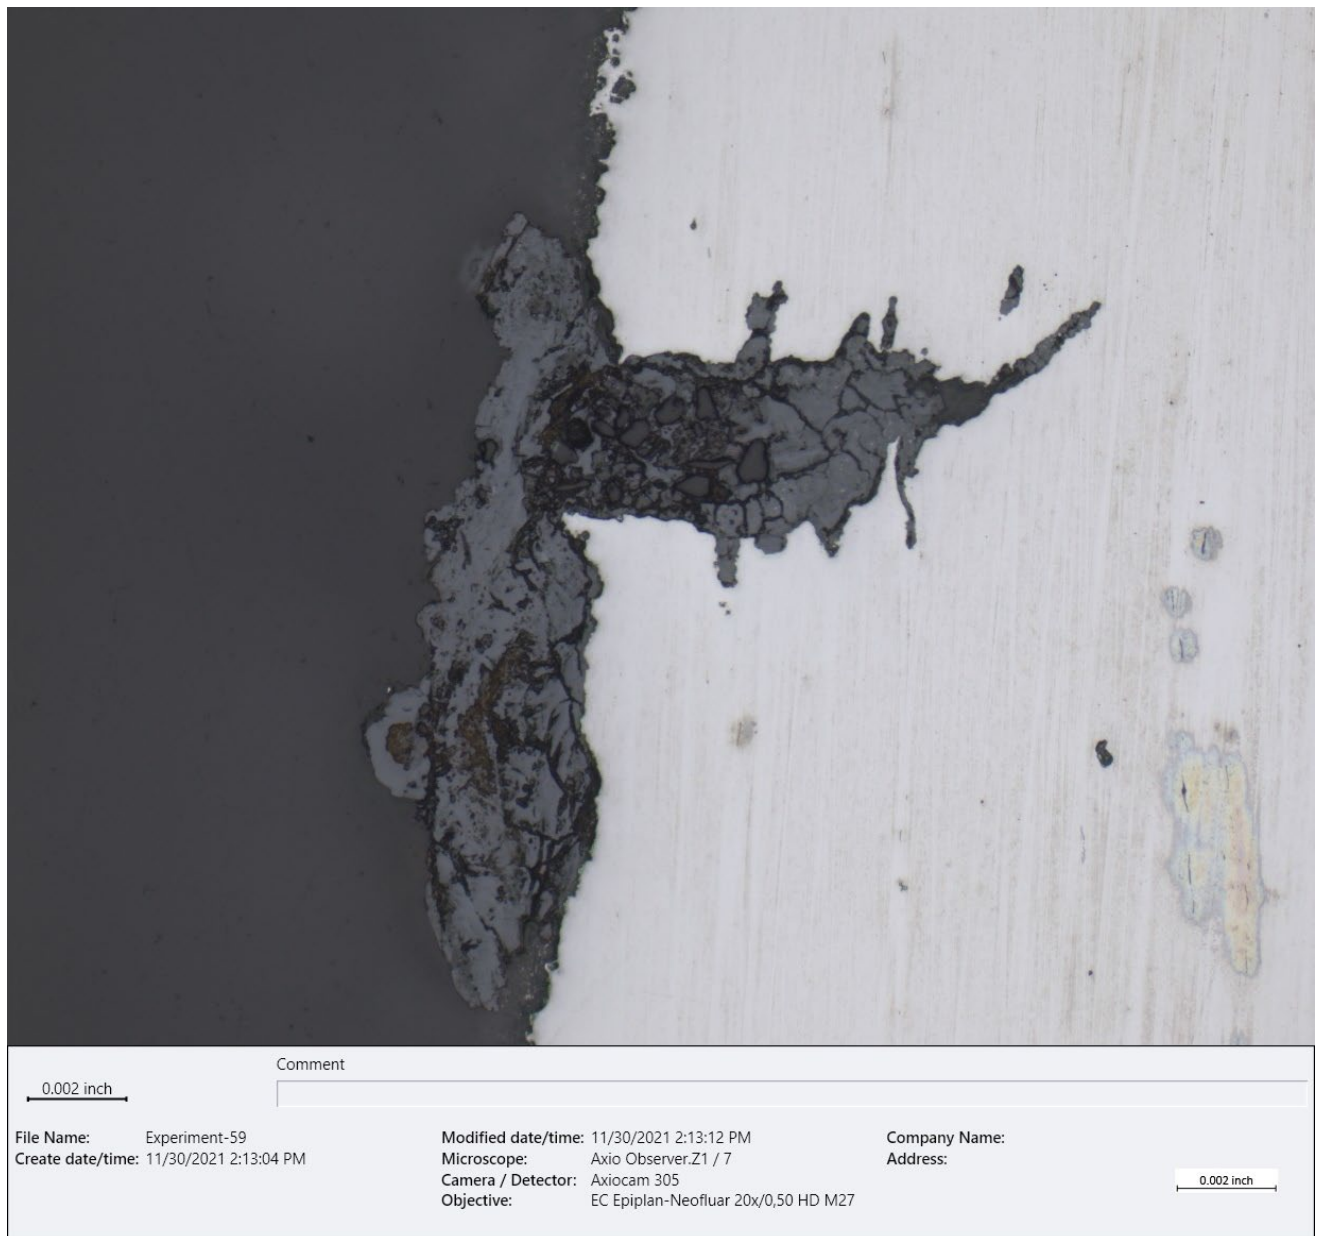
Figure 36 shows another surface crack with nonmetallic compounds in its interior. This crack exhibited perpendicular branched cracking along the direction of the material grain flow. These secondary branched cracks also contained the nonmetallic compounds present in the main cracks and along the surface above the cracks and pits.

Figure 36 – BF optical micrograph of a crack from the sectioned terminal end, showing nonmetallic compounds along crack front and secondary cracks (~200X, etched from tap water).

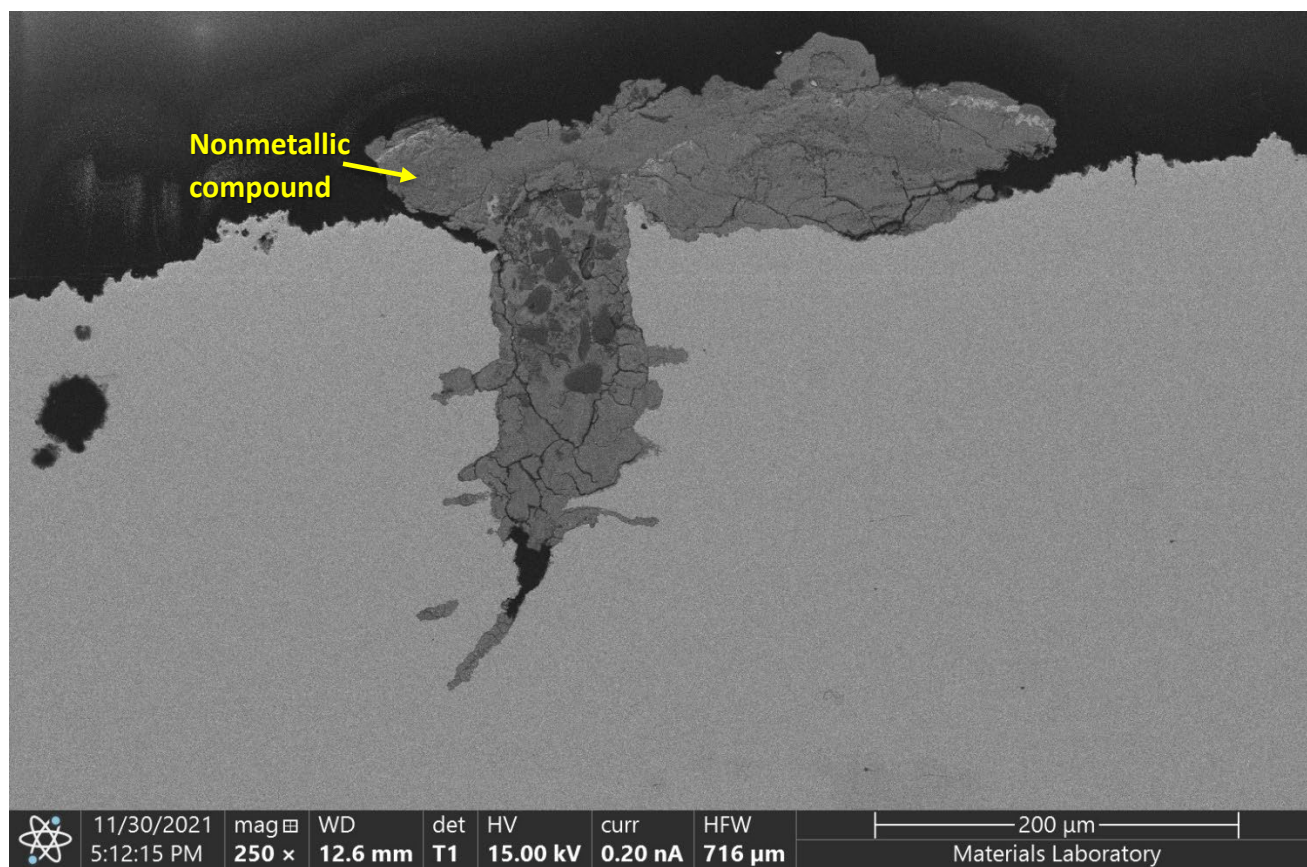
The metallographic cross section of the terminal end was examined using an SEM, and the crack in Figure 36 is shown in Figure 37 in a backscattered electron (BE) micrograph.<sup>3</sup> From examination using EDS, as exemplified using the x-ray maps in Figure 38, the compounds in the crack were primarily consistent with iron oxide and some silicon

Figure 37 – BE micrograph of the crack and oxides shown in Figure 36, rotated 90°.

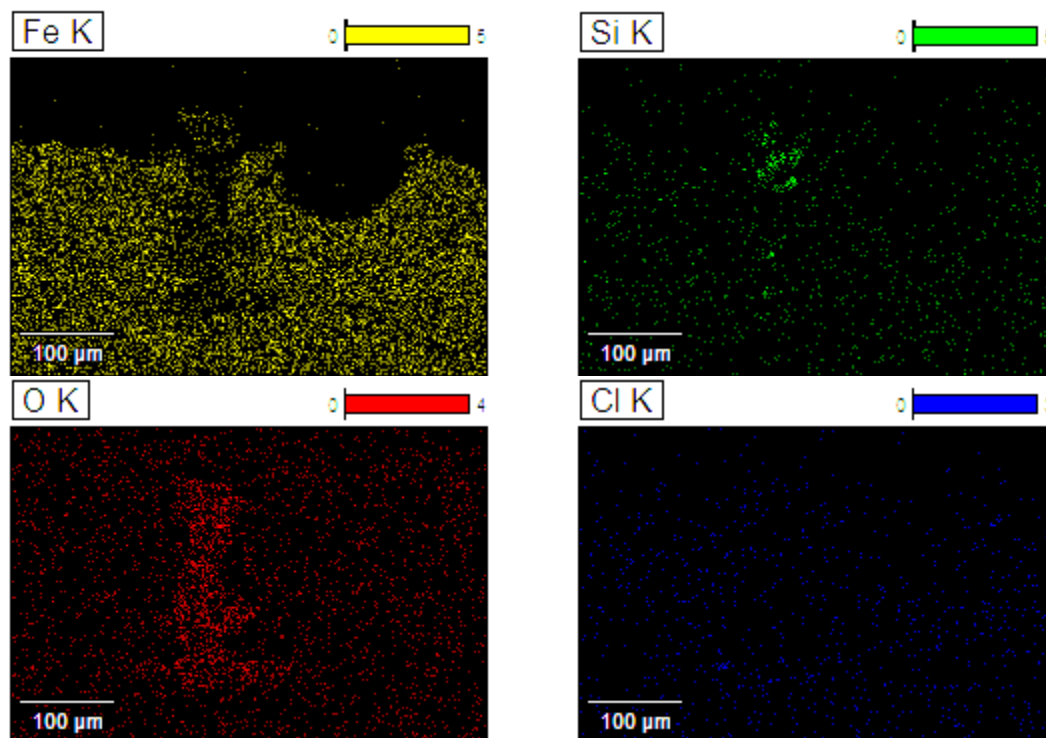
Figure 38 – X-ray maps of the area in Figure 37, showing relative intensities (concentrations) of Fe, Si, O, and Cl, respectively.

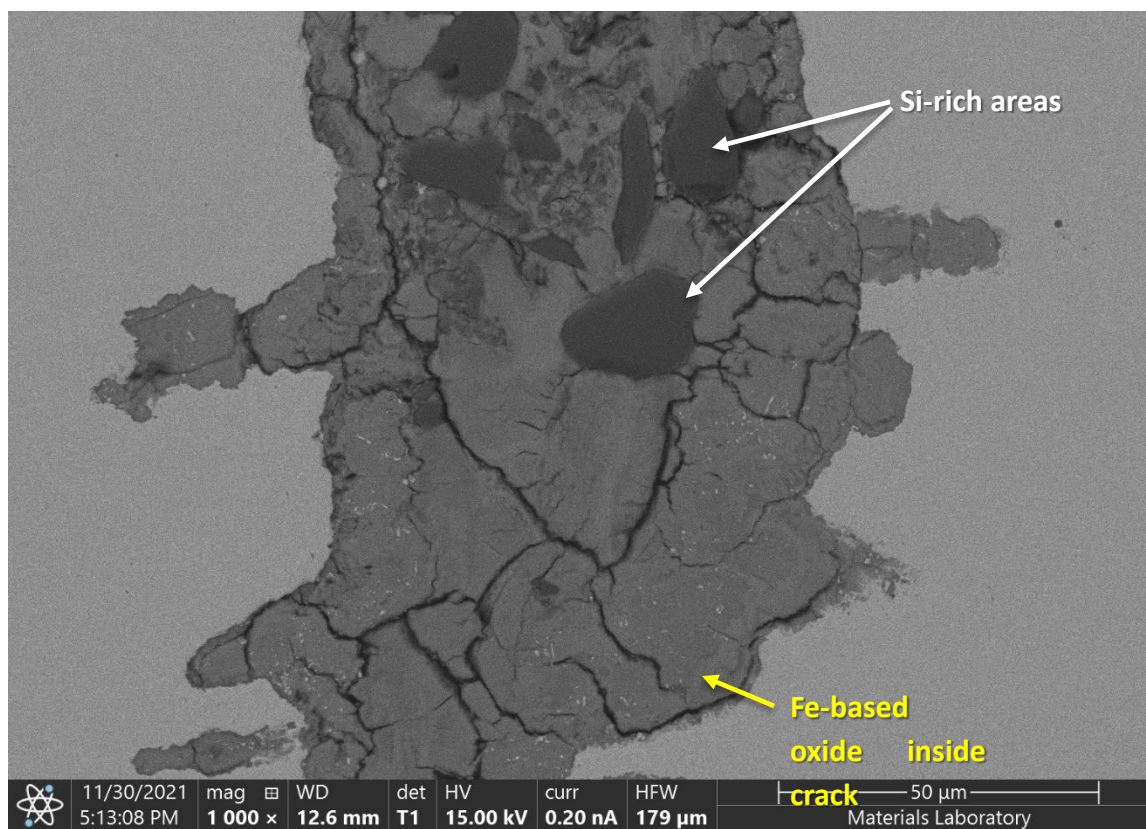
oxides. The silicon dioxides were found to be embedded in the iron oxides, as shown in Figure 39, when compared with the x-ray maps.

Figure 39 – BE micrograph of a closer view of the iron (dark gray) and silicon oxides (dark) in the crack in Figure 37.

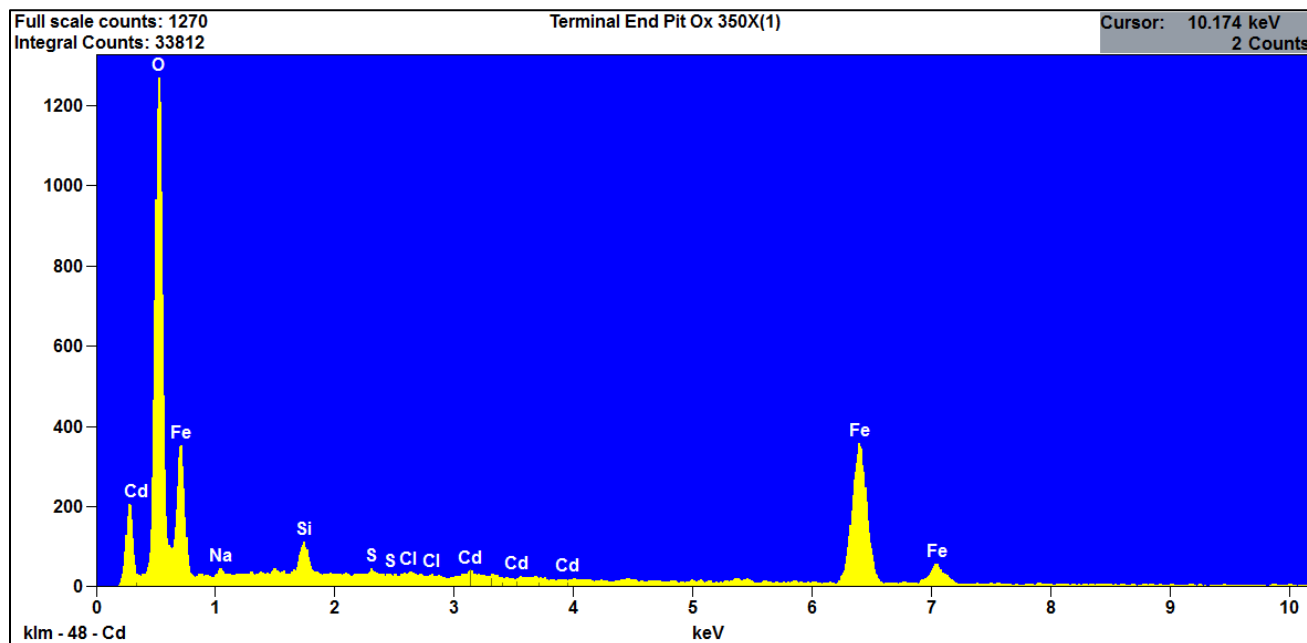
The chemical composition of the terminal end was inspected using EDS and was found to be consistent with carbon steel. As typified by the EDS spectrum in Figure 40, the oxide in the crack in Figure 39 exhibited chemical compositions consistent with corrosion products expected of carbon steel, primarily iron oxides. There were also elevated amounts of sodium, chlorine, and sulfur, consistent with constituents in salts corrosive to steel. In addition, some cadmium was present in the oxide, consistent with the end having been coated with cadmium.

Figure 40 – EDS spectrum of a typical area in the gray oxide in Figure 39, showing minor amounts of Na, Cl, S, and Cd.

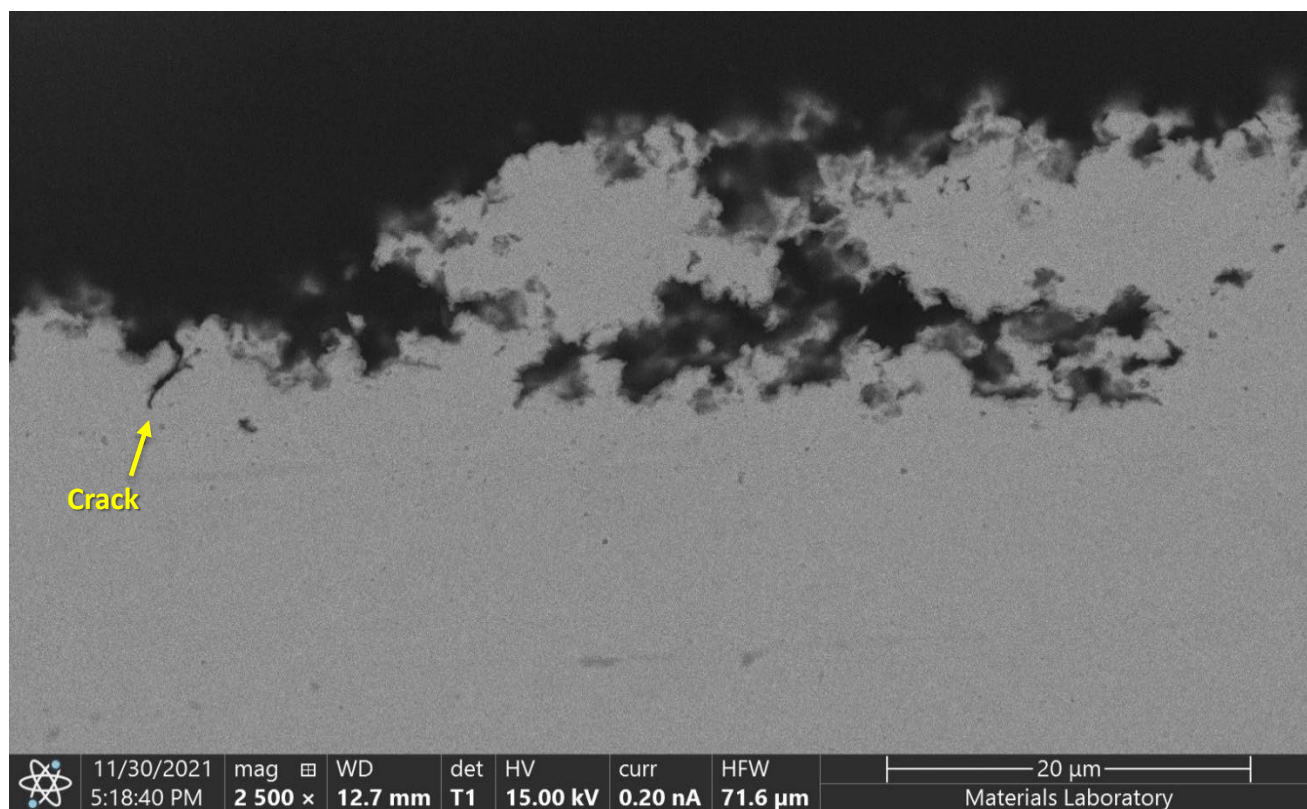
Figure 41 and Figure 42 show representative cross sections of the cylindrical surface of the terminal end. These areas were rough and uneven, consistent with exposure to corrosive attack. As shown in these figures, cracks were found emanating from the sharper points of the roughened surface.

These observed features were consistent with the terminal end of the turnbuckle having fractured from fatigue that initiated at multiple locations due to surface corrosion and pitting. Once the fatigue crack had propagated inward to its terminal depth, the rest of the assembly fractured from overstress.

Figure 41 – BE micrograph of a typical area of the terminal end surface, showing a small crack.

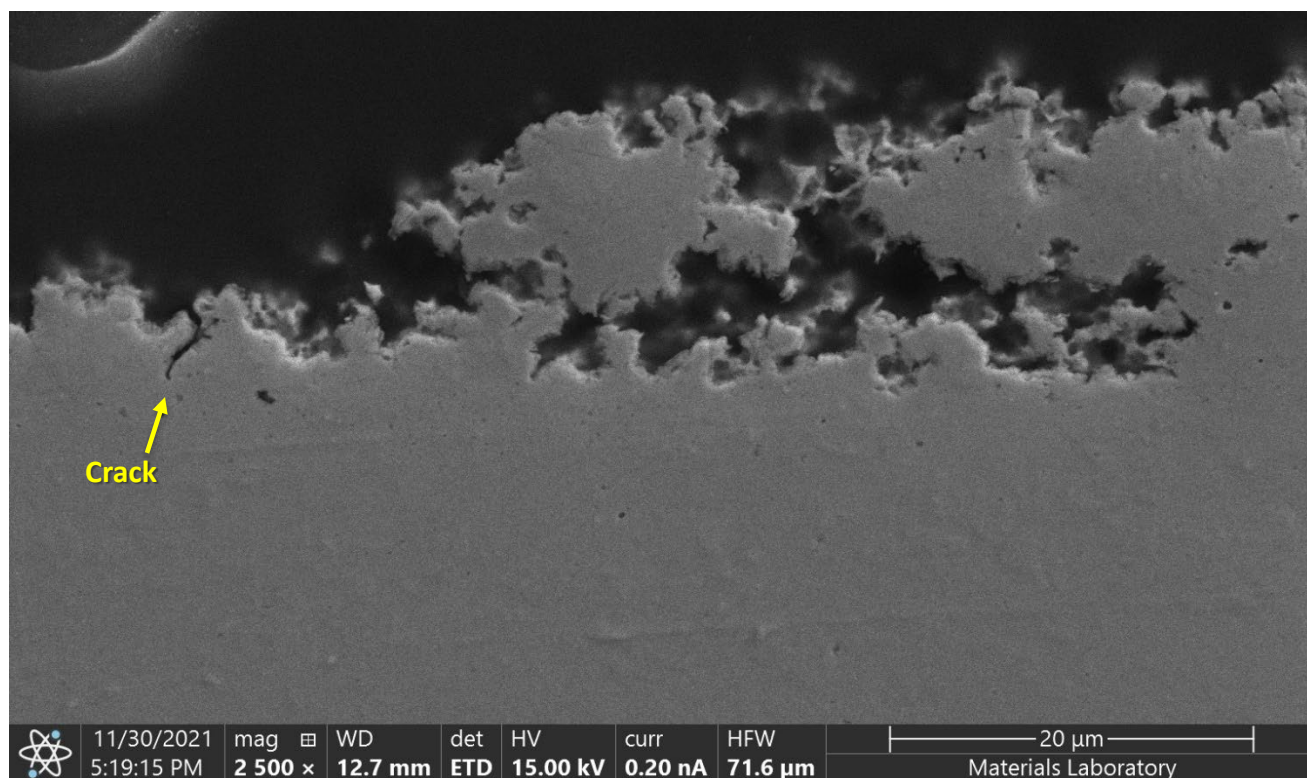
Figure 42 – SE micrograph of the same terminal end cross section location as Figure 41.
