# Safety Communique

January, 2012

**SUBJECT:** FLIGHT CONTROL CABLE SYSTEM INSPECTIONS

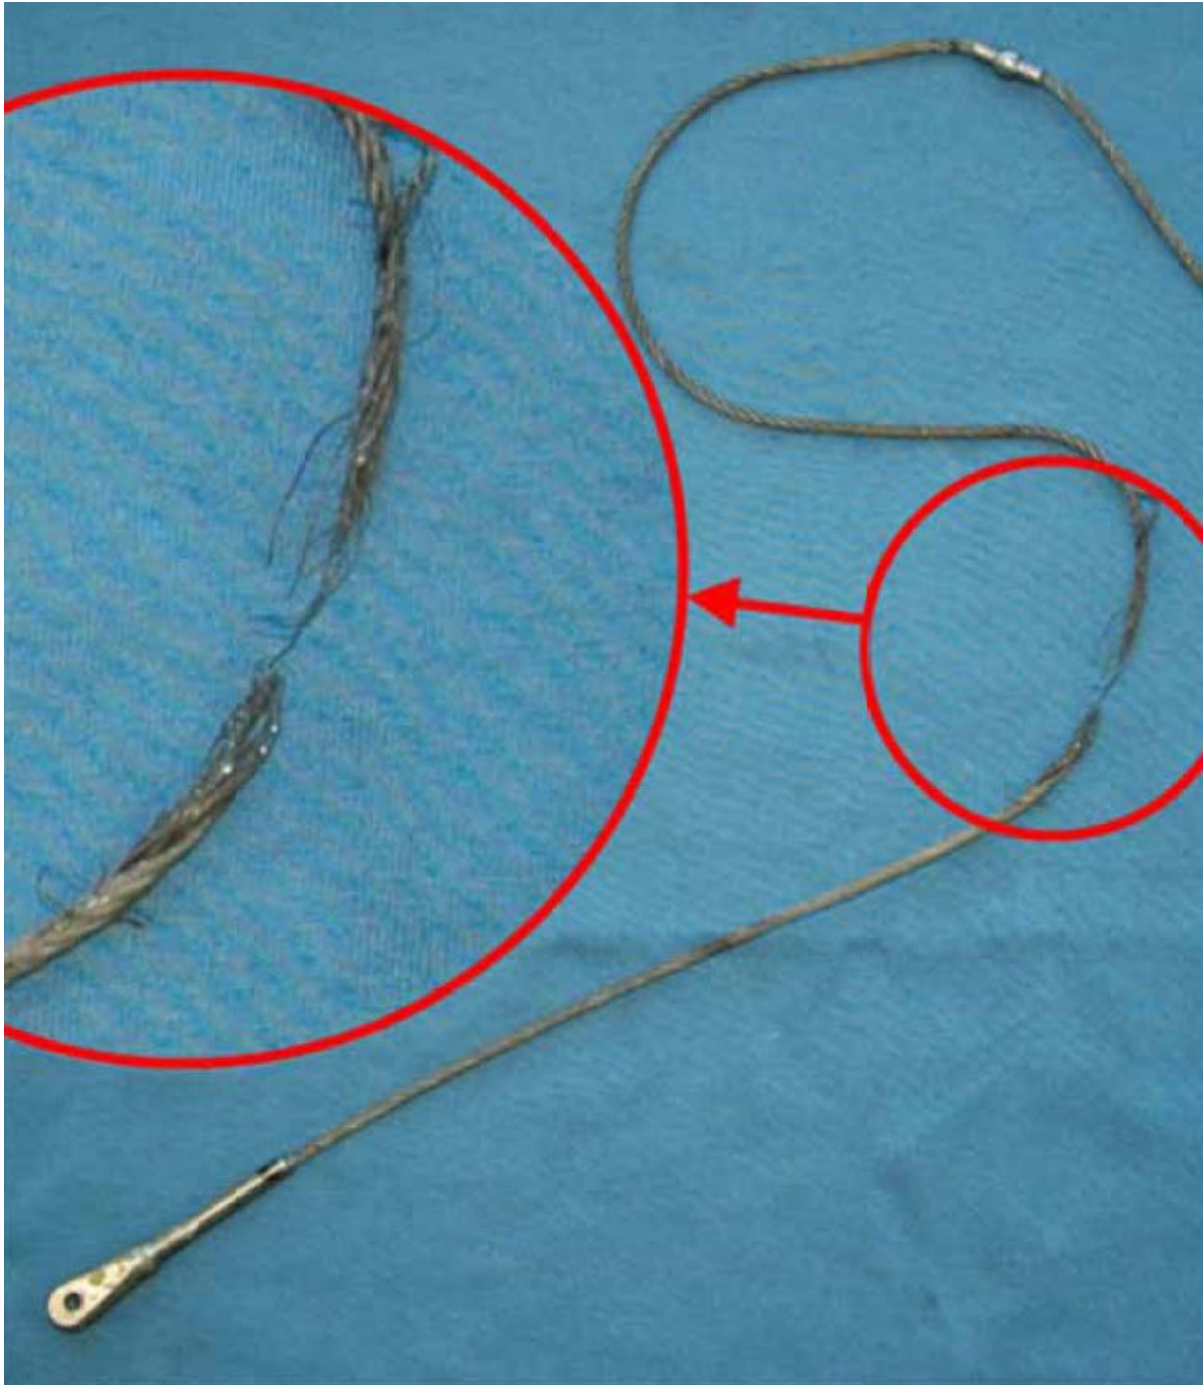
On December 4, 2011, HBC received a field condition report (FCR) from the owner/operator of a 1968 Bonanza Model E33 airplane with 4610 flight hours. A part number (P/N) 33-524000-63 forward elevator cable assembly was reported to have frayed to the point that only a few strands of cable remained intact. This discovery occurred just prior to takeoff. Figure 1 shows the frayed cable that was removed.

Frayed Elevator Control Cable  
Figure 1

The CASA ADs provide instructions to inspect the forward elevator control cable assembly for wear, broken wires and corrosion. The ADs also mandate that any cable be removed and replaced if it had been in service for more than 15 years. The ADs were applicable to all “single pole” design control systems. The definition noted on the ADs reads as follows; “single pole” refers to the arrangement whereby the pilot’s control yokes are supported by a single shaft moving in and out of the instrument panel for elevator (pitch) control.

HBC recommends, when inspections are performed on flight control cable systems as instructed in the applicable airplane Shop or Maintenance Manual, that flight controls are operated through their full range so that cables move away from pulleys and all portions of the cables are exposed for inspection. Full control travel motion may require two persons, one to cycle controls and another to inspect cables during movement. Although the CASA ADs only affect the elevator control cable system, current HBC inspection guidelines apply to all flight control cables. Anywhere a cable is not visible, the flight controls should be manipulated so 100% of all cables can be inspected. During the inspection process, the inspecting individual shall also examine the cable runs for incorrect routing, fraying, twisting, or wear at fairleads, pulleys, anti-abrasion strips and guards. Inspecting individuals shall ensure there is no interference with adjacent structure, equipment, wiring, plumbing, and other controls. Cable systems shall not exhibit binding through full travel, and proper tension of cables shall be maintained.
