# NTSB Investigation: ERA21LA070

Photo Array

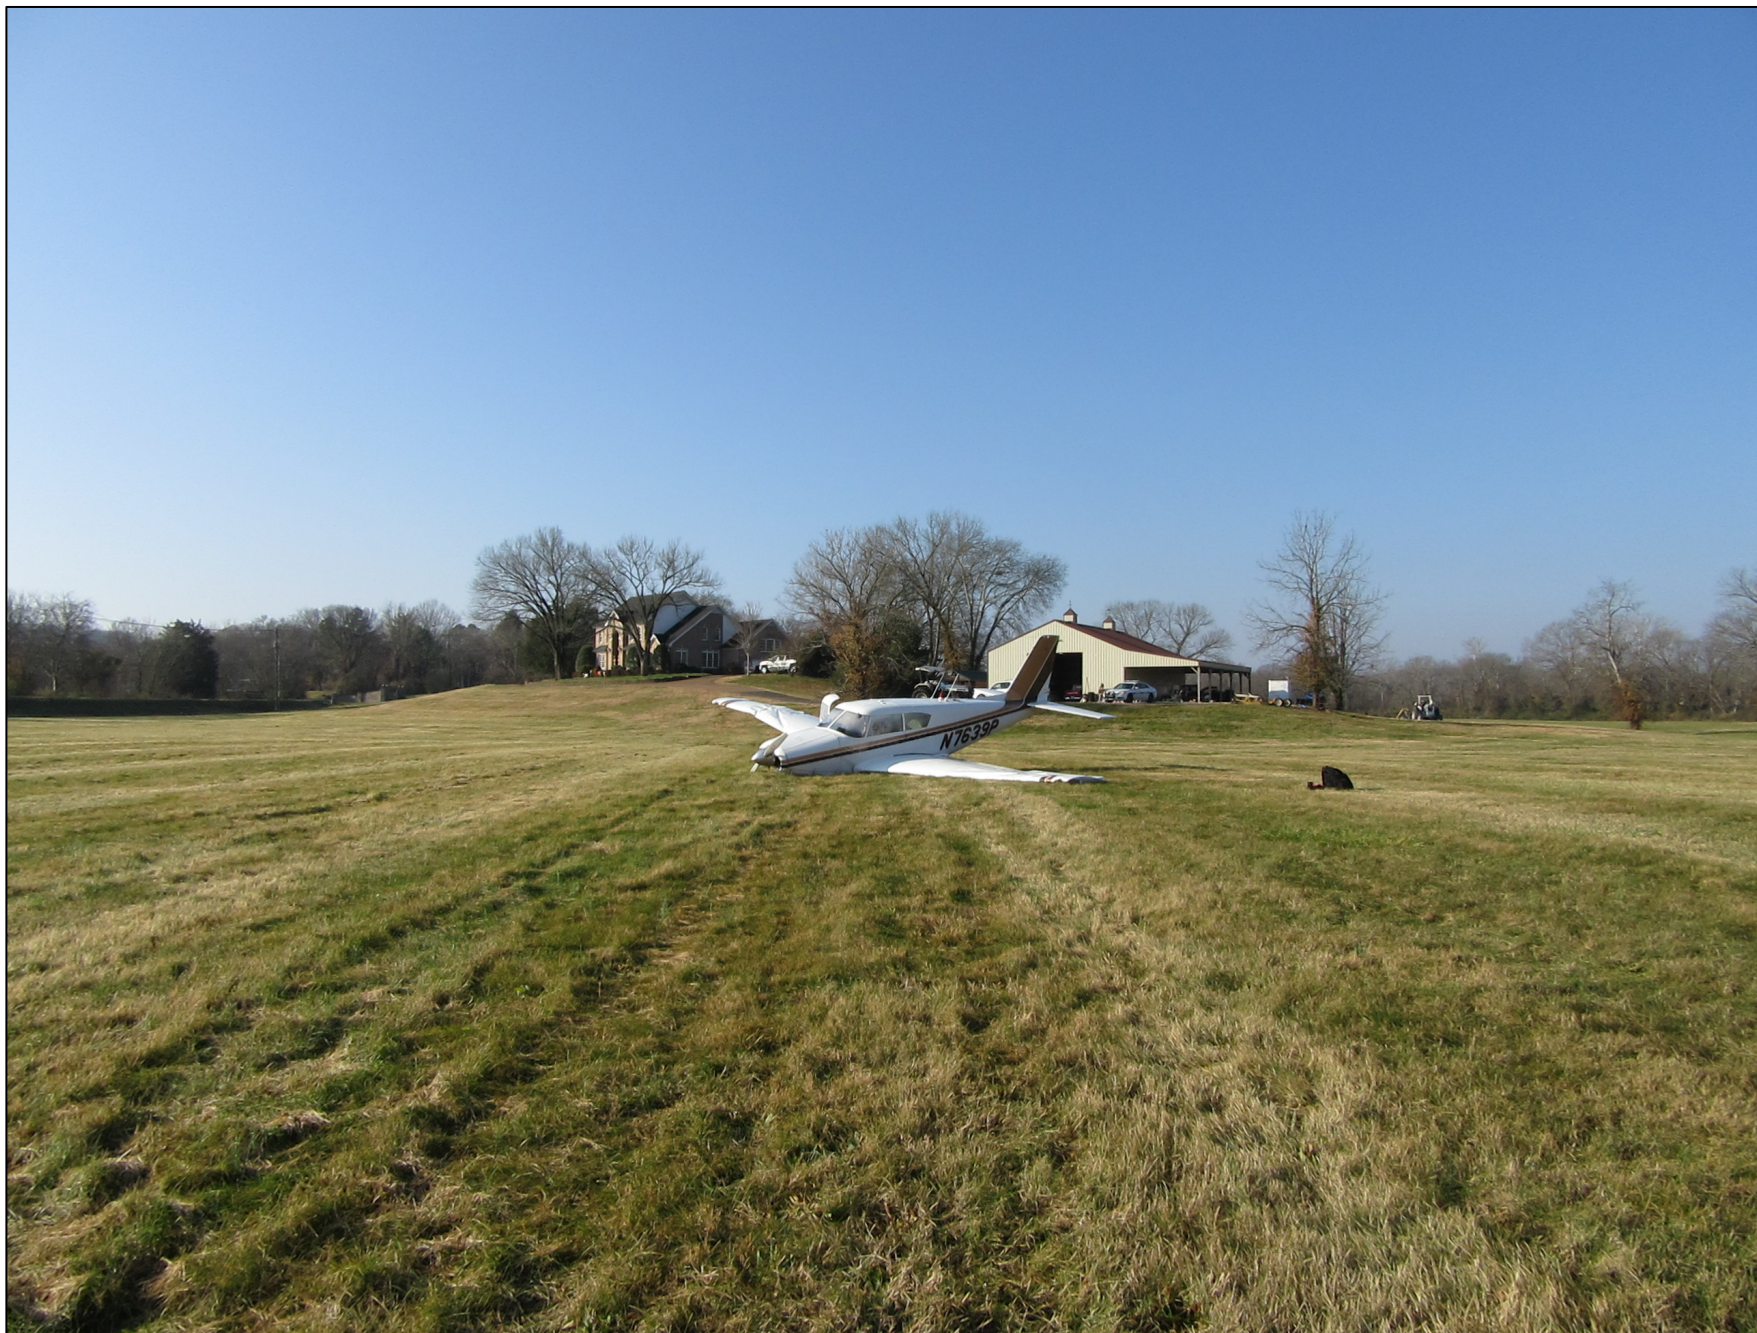
Photo 1 – View of the airplane at the accident site (Photo Courtesy of FAA)

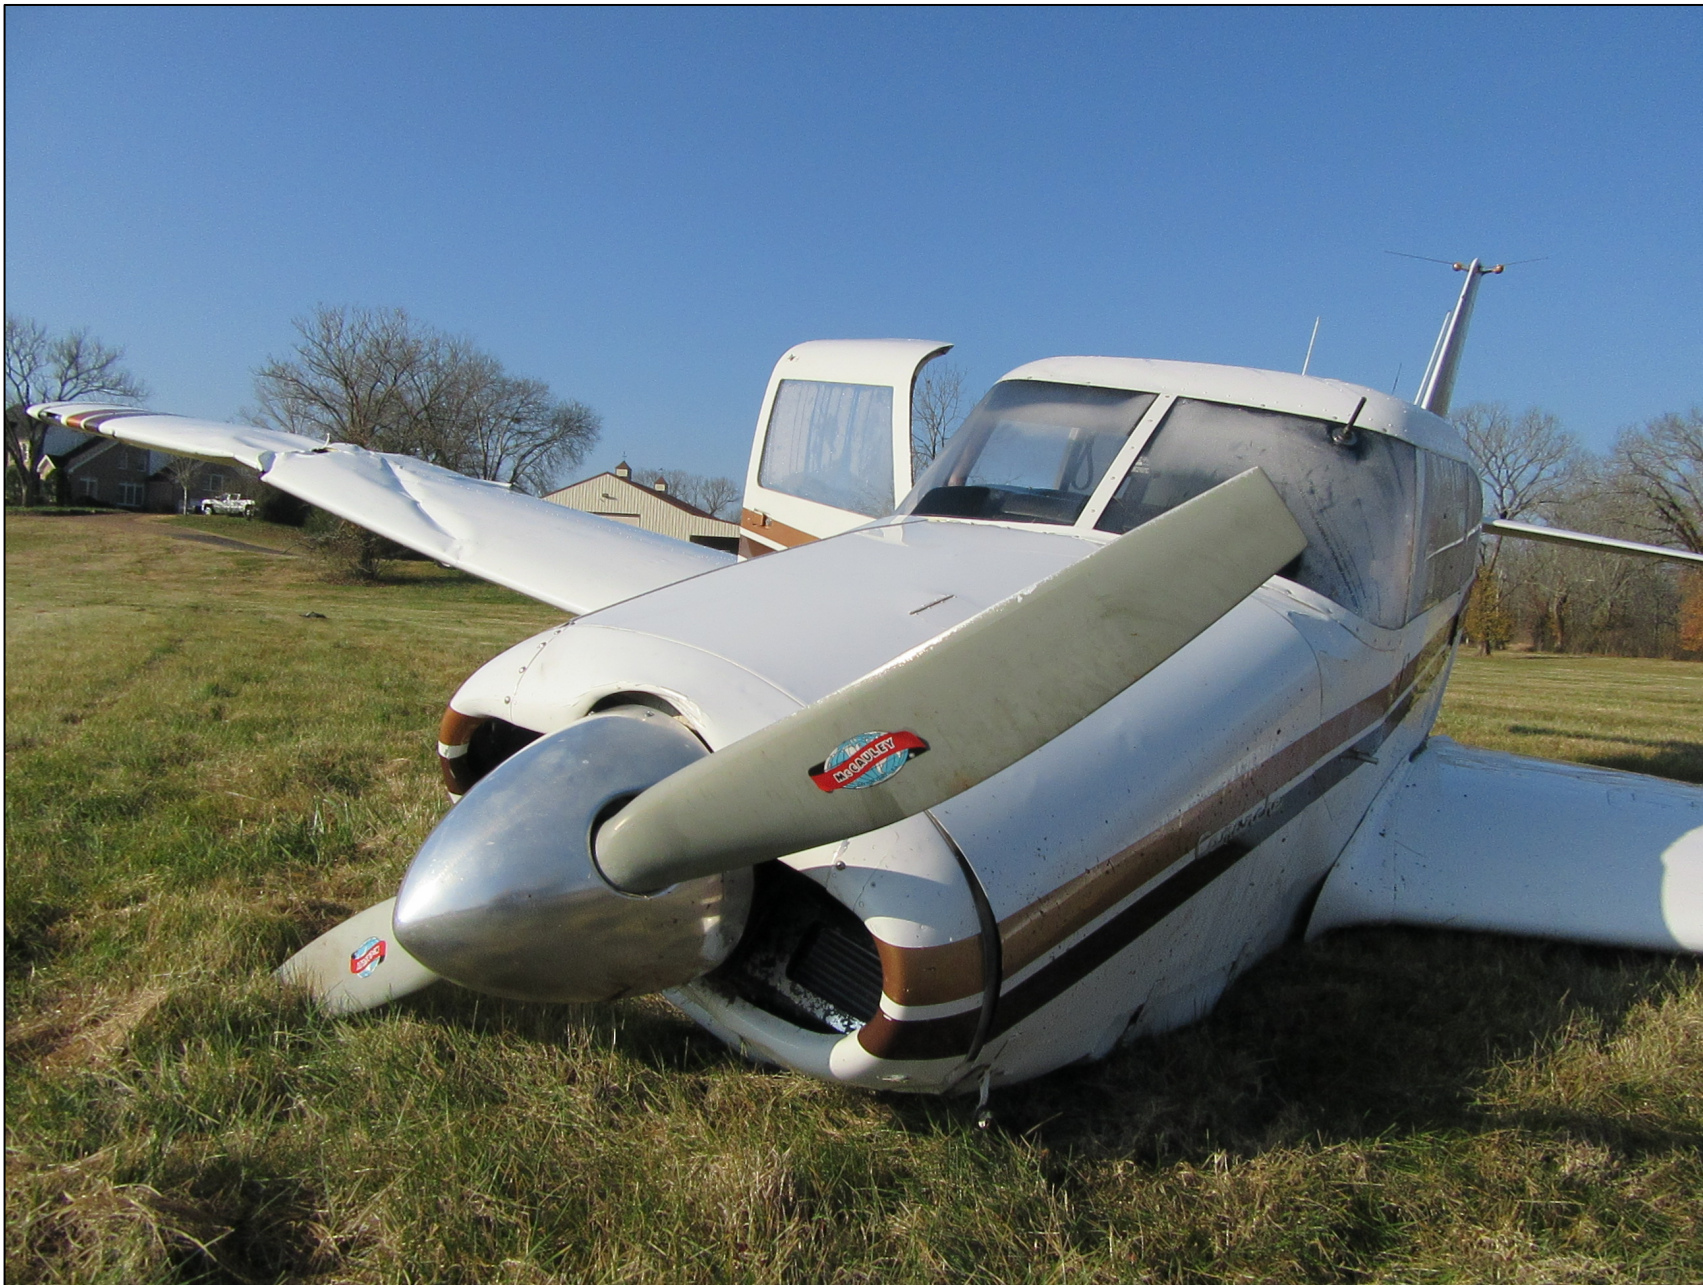
Photo 2 – Additional view of the airplane showing substantial damage to the right wing (Photo Courtesy of FAA)

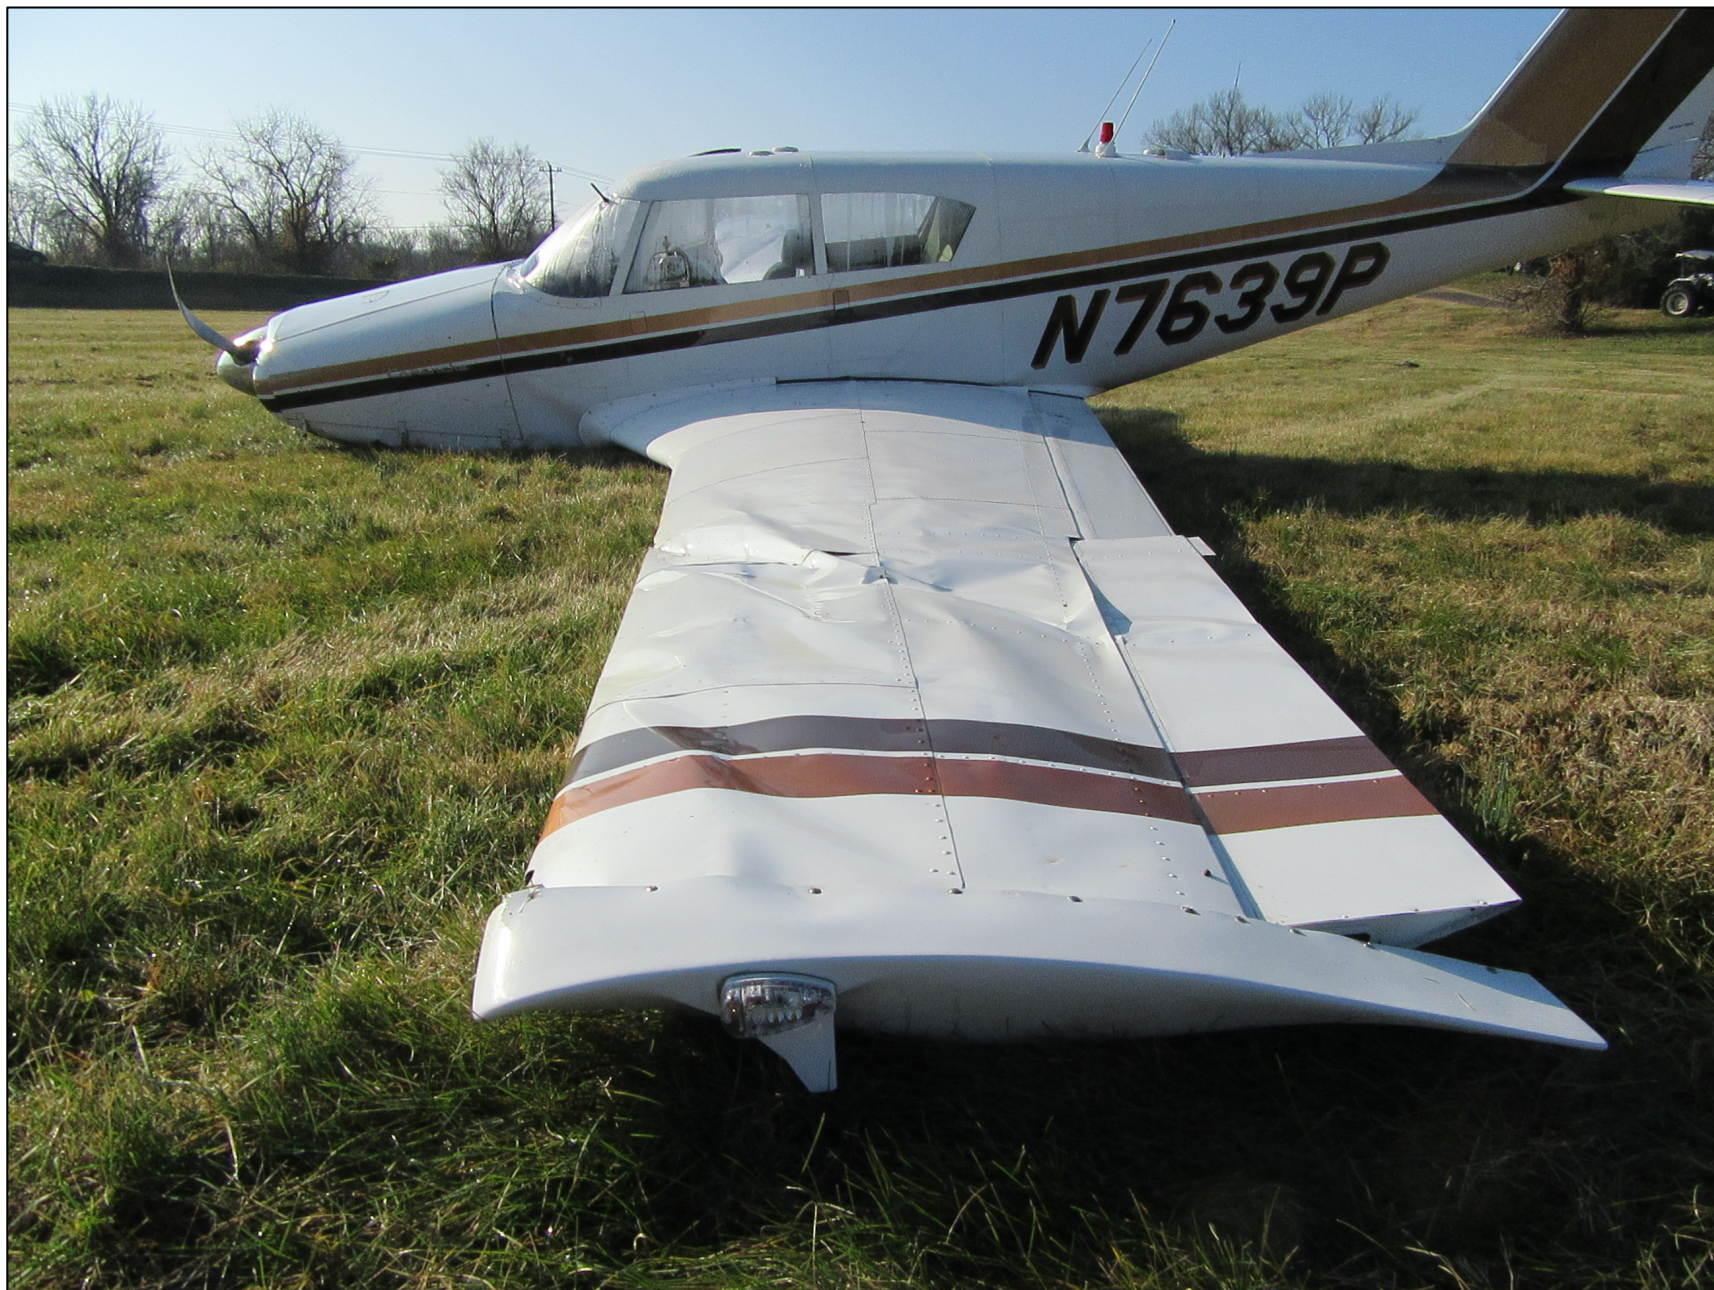
Photo 3 – Additional view of the airplane showing substantial damage to the left wing (Photo Courtesy of FAA)

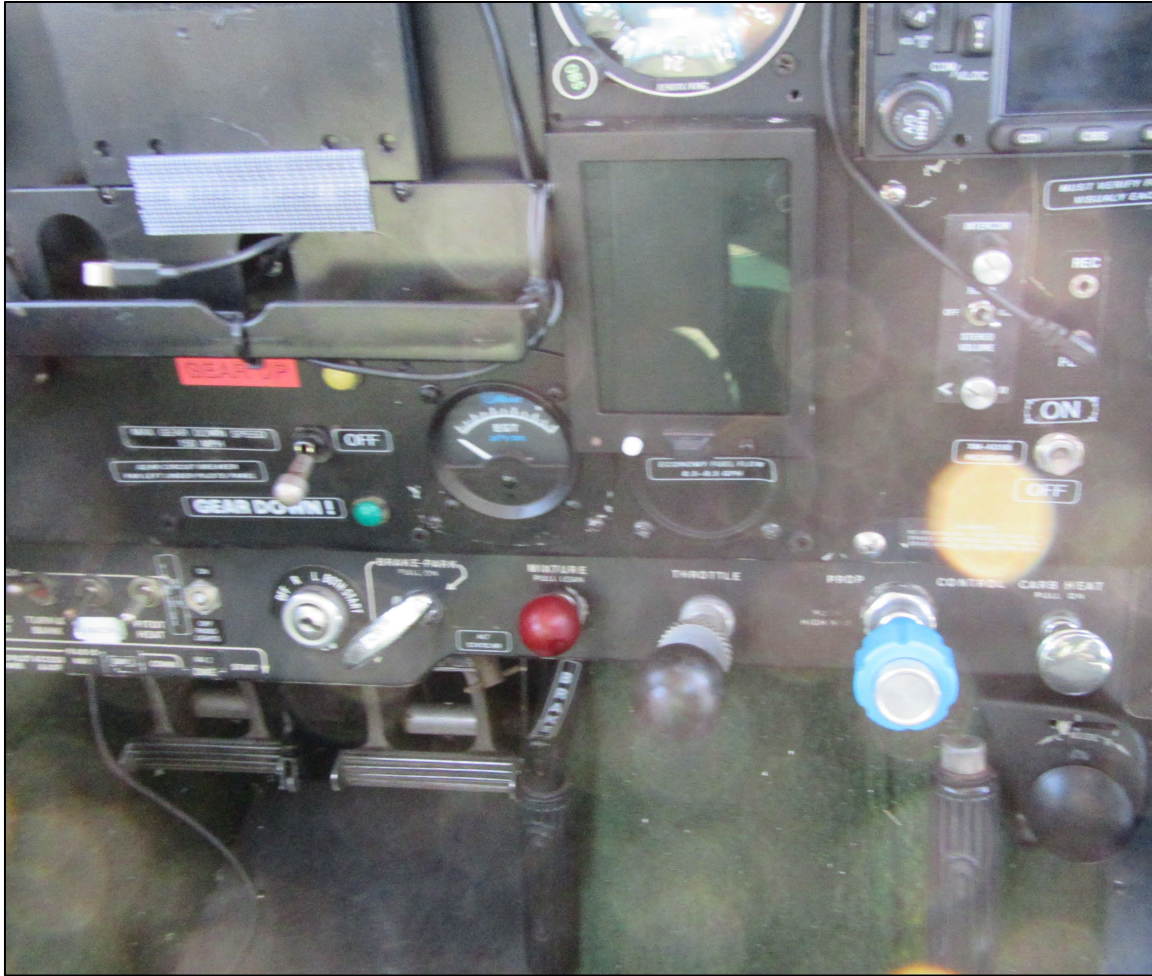
Photo 4 – View of the engine controls. The position of the carburetor heat lever was off (Photo Courtesy of FAA)

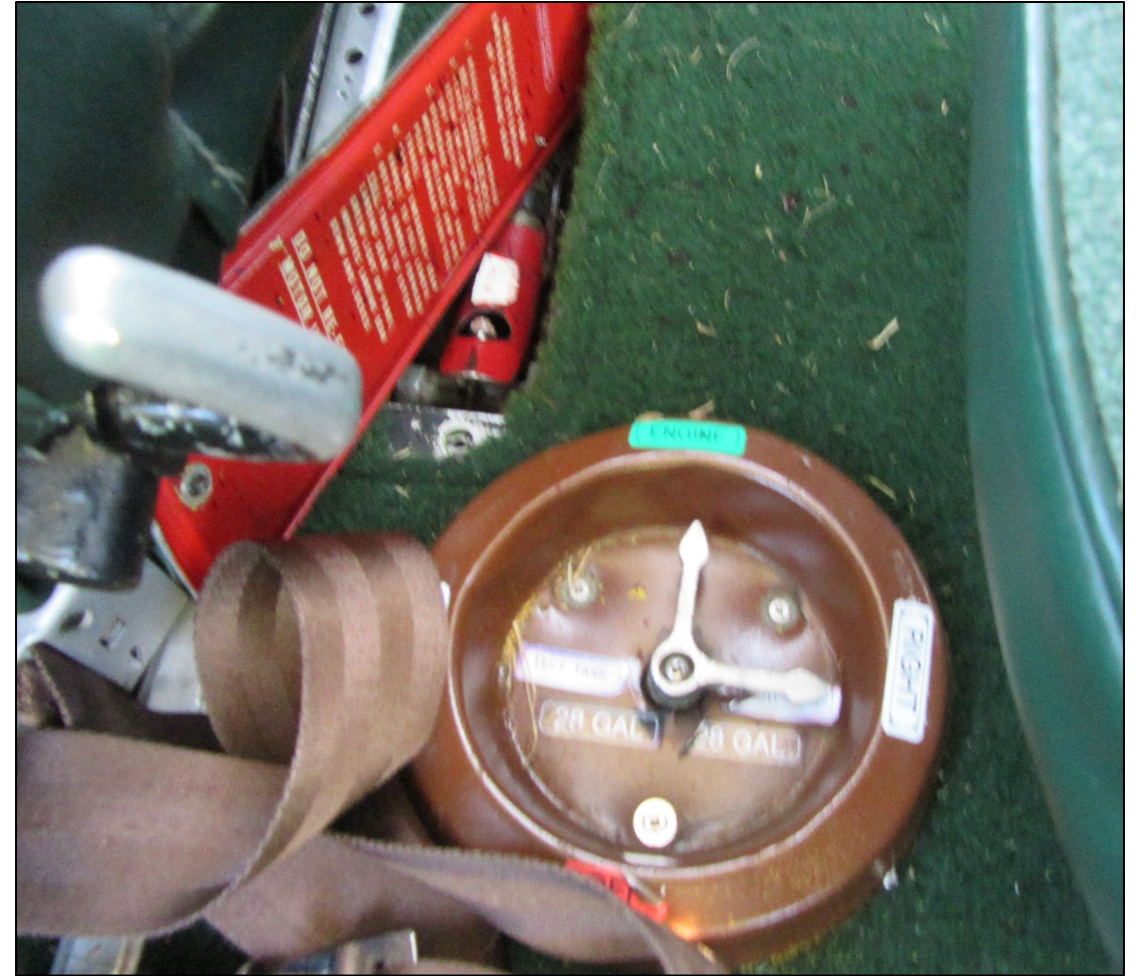
Photo 5 – View of the fuel selector selected to the right fuel tank. (Photo Courtesy of FAA)

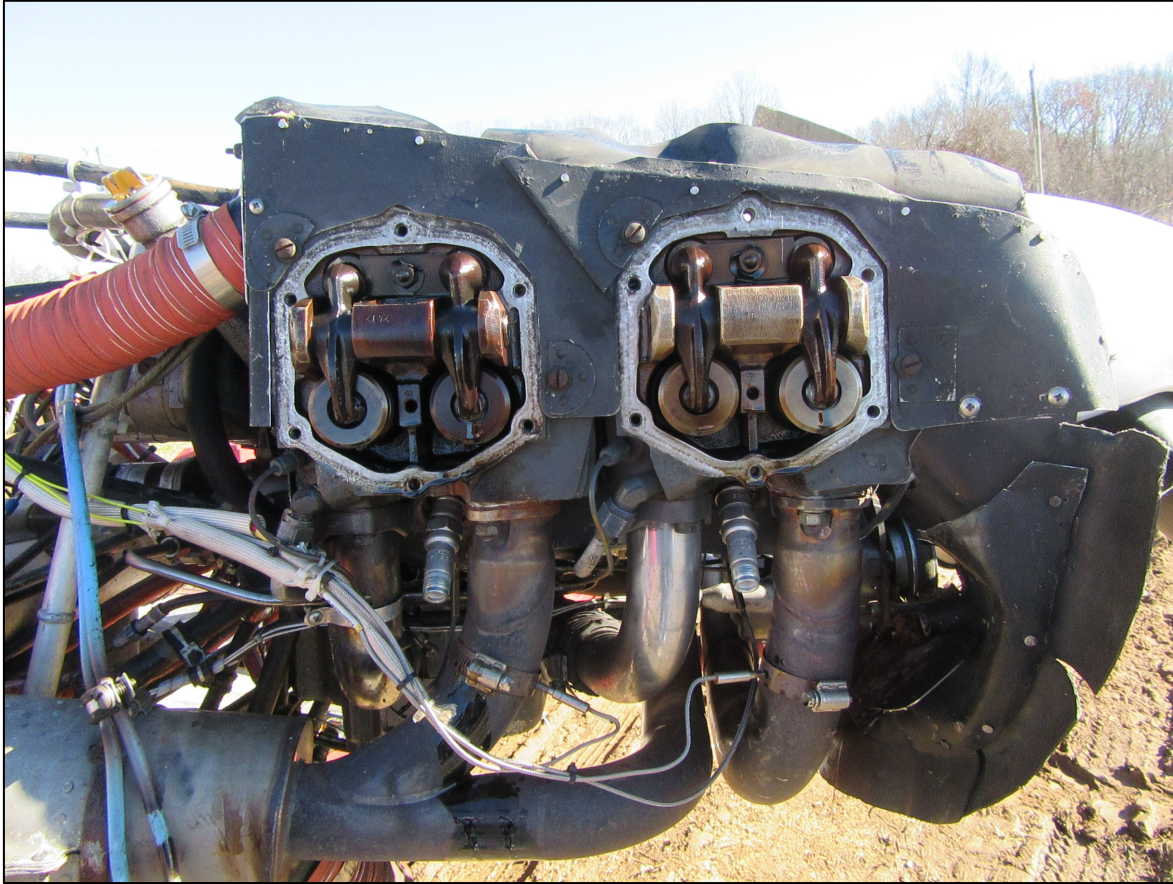
Photo 6 – View of the engine cylinders during engine examination.  
(Photo Courtesy of FAA)

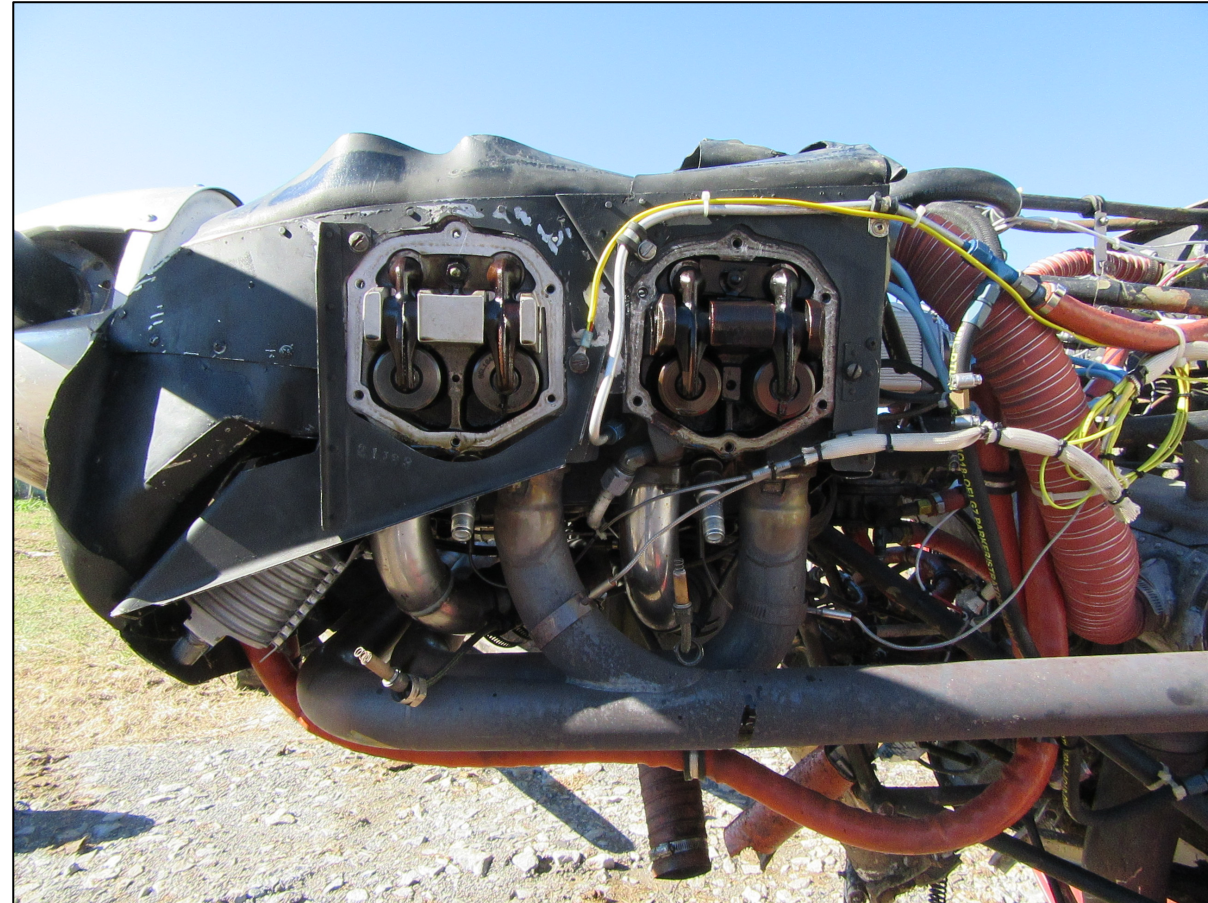
Photo 7 – View of the engine cylinders during engine examination.  
(Photo Courtesy of FAA)

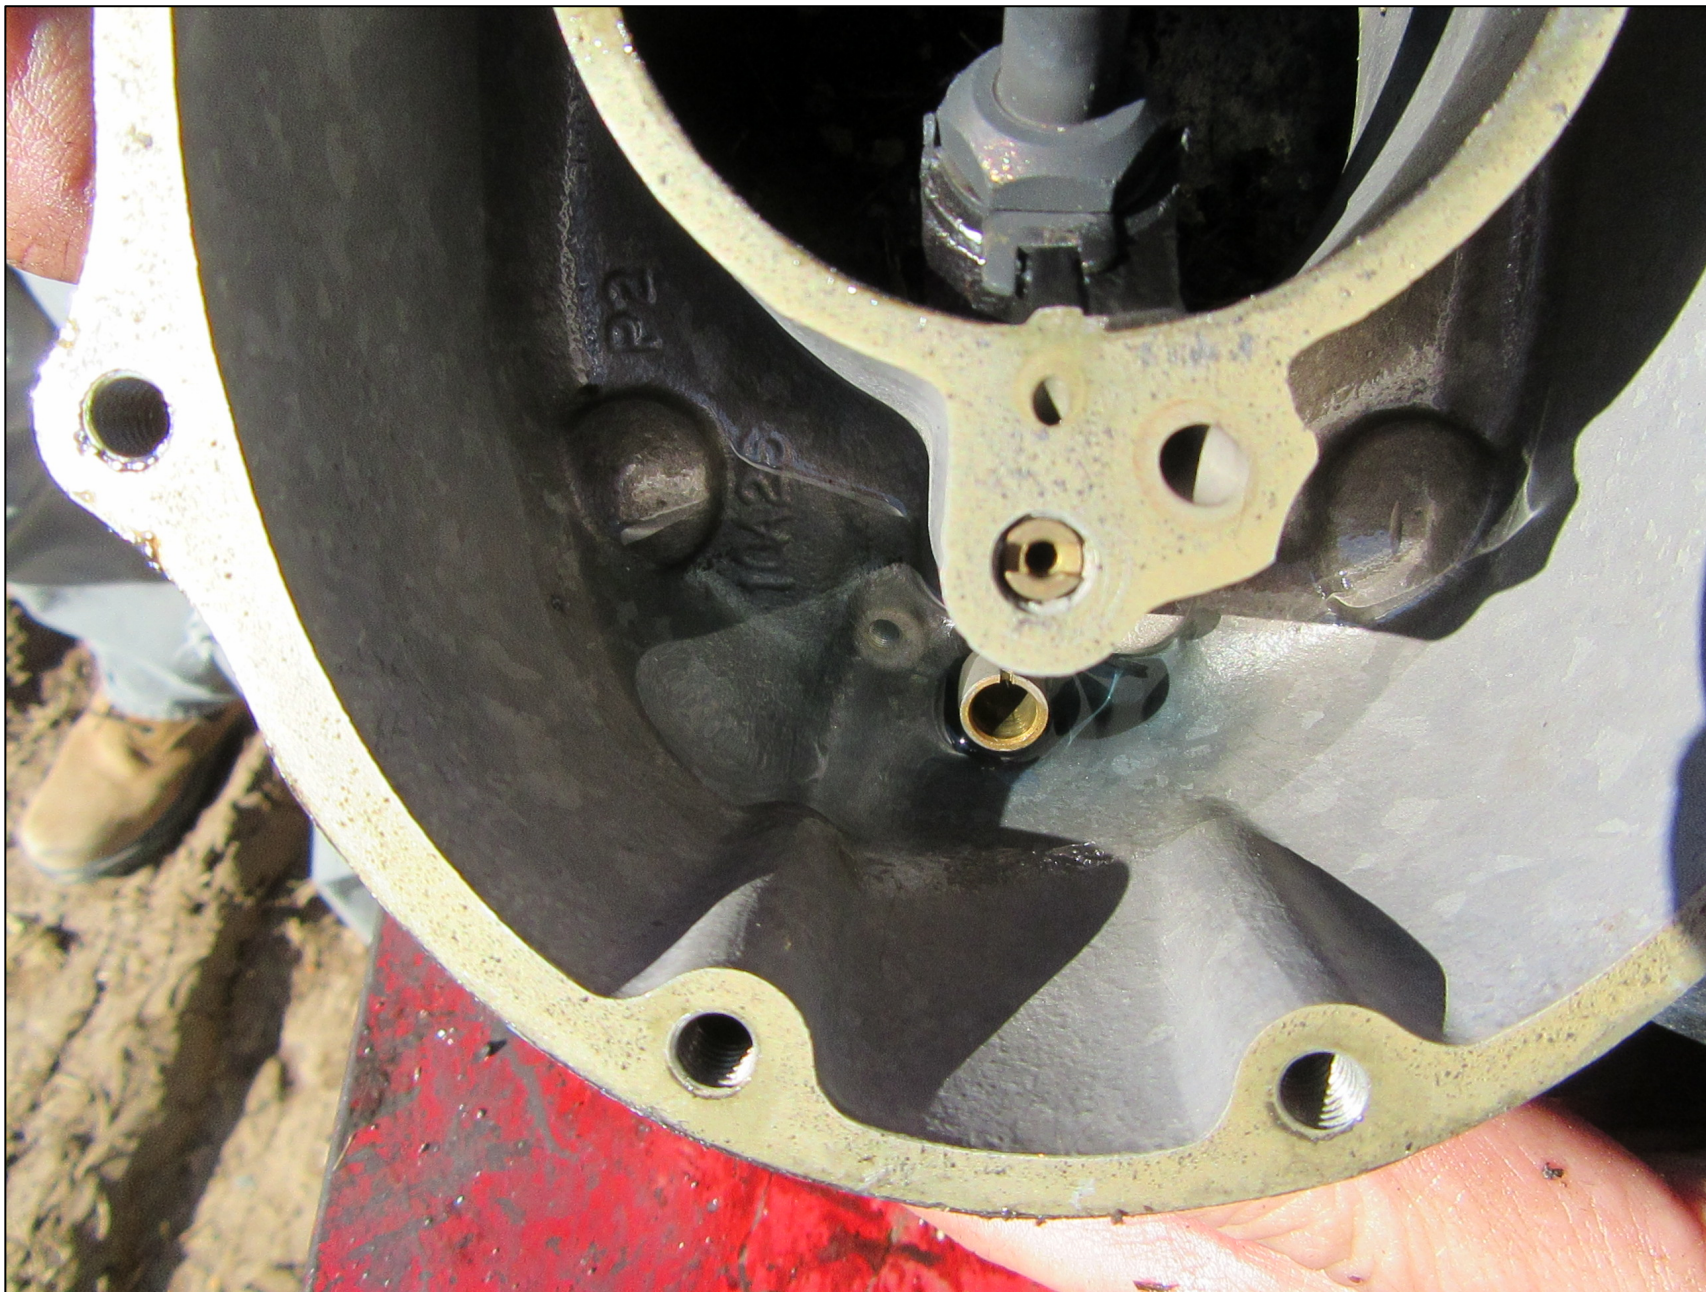
Photo 8 – View of the carburetor bowl disassembled during engine examination (Photo Courtesy of FAA)
