## **ERA21LA071 Examination Summary**

**Date of accident:** December 12, 2020  
**Location of accident:** San Mateo, FL  
**Aircraft registration:** N11TG  
**Aircraft type and S/N:** Silverlight AR1, S/N 0041  
**Engine type and S/N:** Rotax 914UL, S/N 9577246  
**NTSB number:** ERA21LA071  
**Date of Report:** February 24<sup>th</sup> 2021

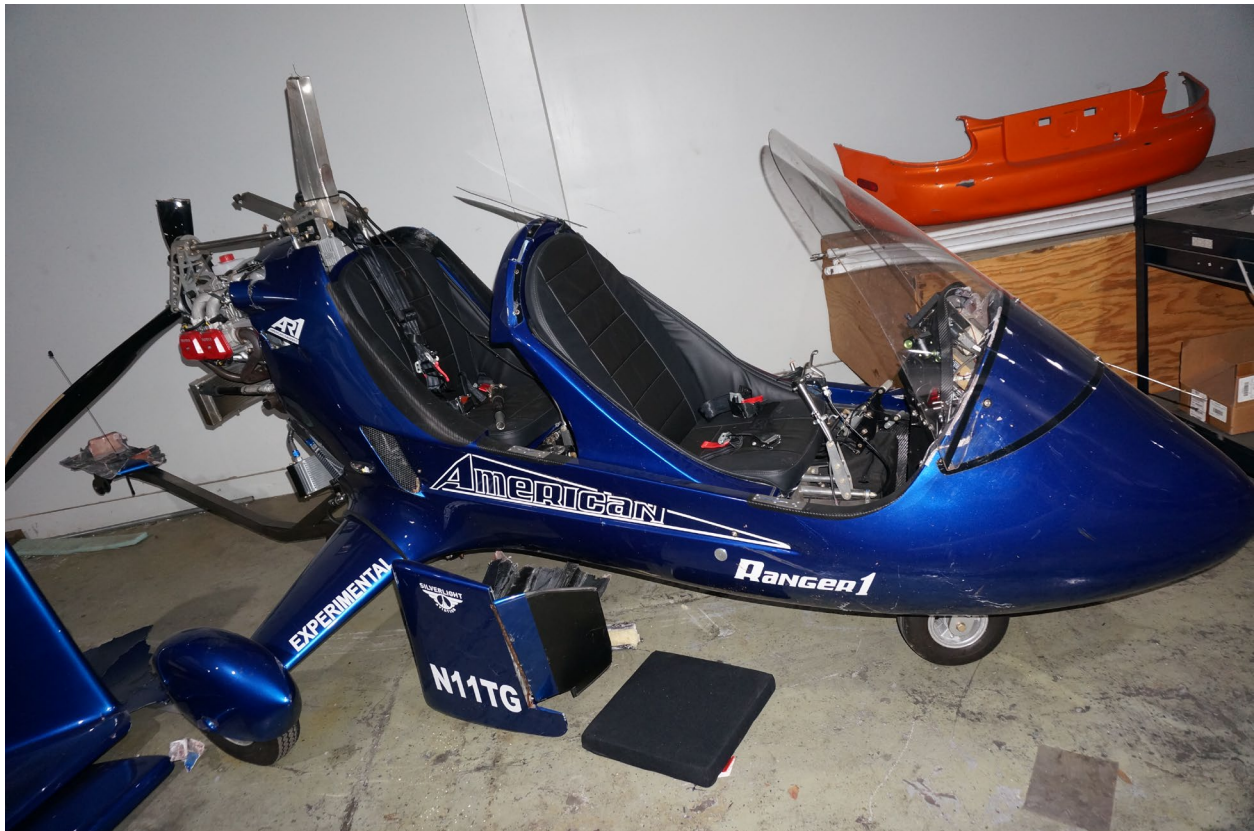
Figure 1. Gyroplane at recovery facility.

- The airframe consisted of two parts, a welded steel frame and a fiberglass fairing. The steel frame displayed minimal damage. The fiberglass streamlined fairing, displayed

several cracks, crush and compression damage in several areas, and the windshield had partially separated from its mounting location.

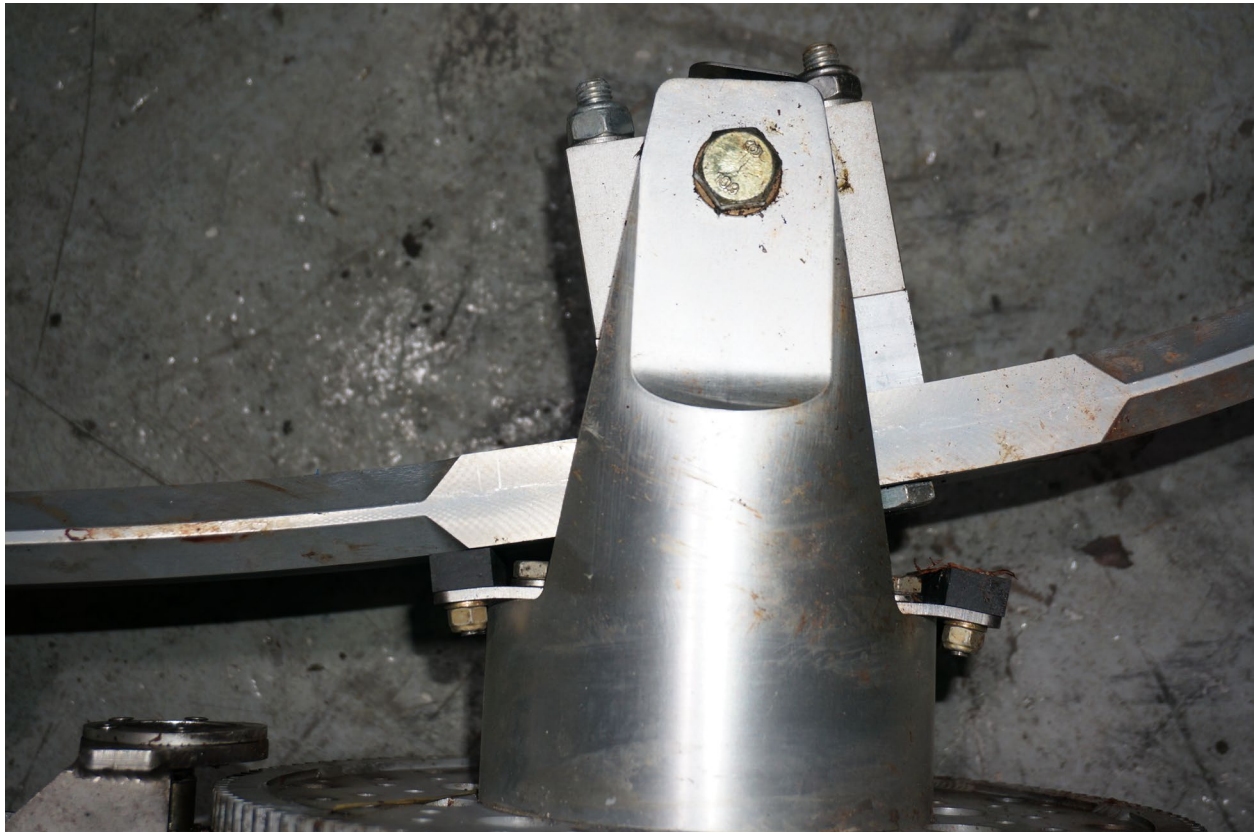
- Both droop stops were bent in a downward direction.

**Figure 2. View of the droop stops for the main rotor blades.**

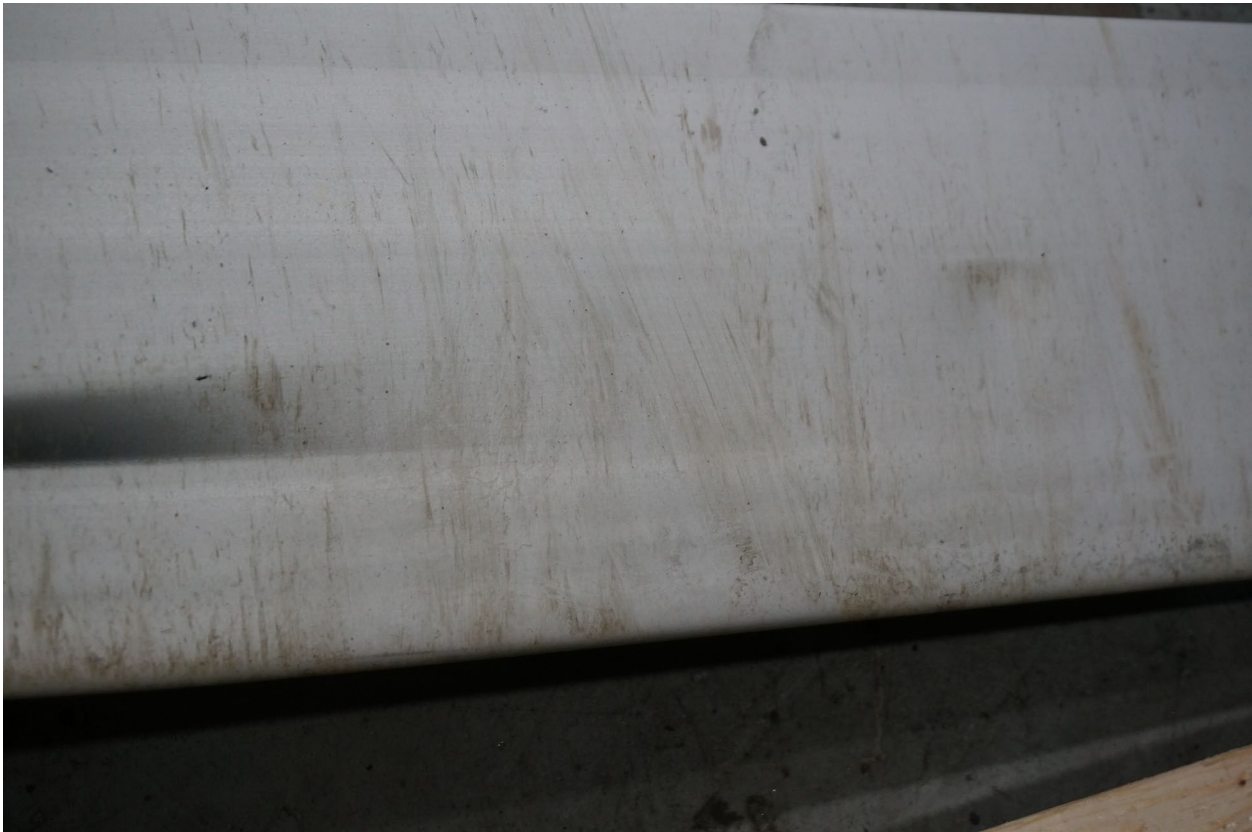
- The rotor blades displayed evidence of chordwise scratching.

**Figure 3. View of chordwise scratching on main rotor blade.**

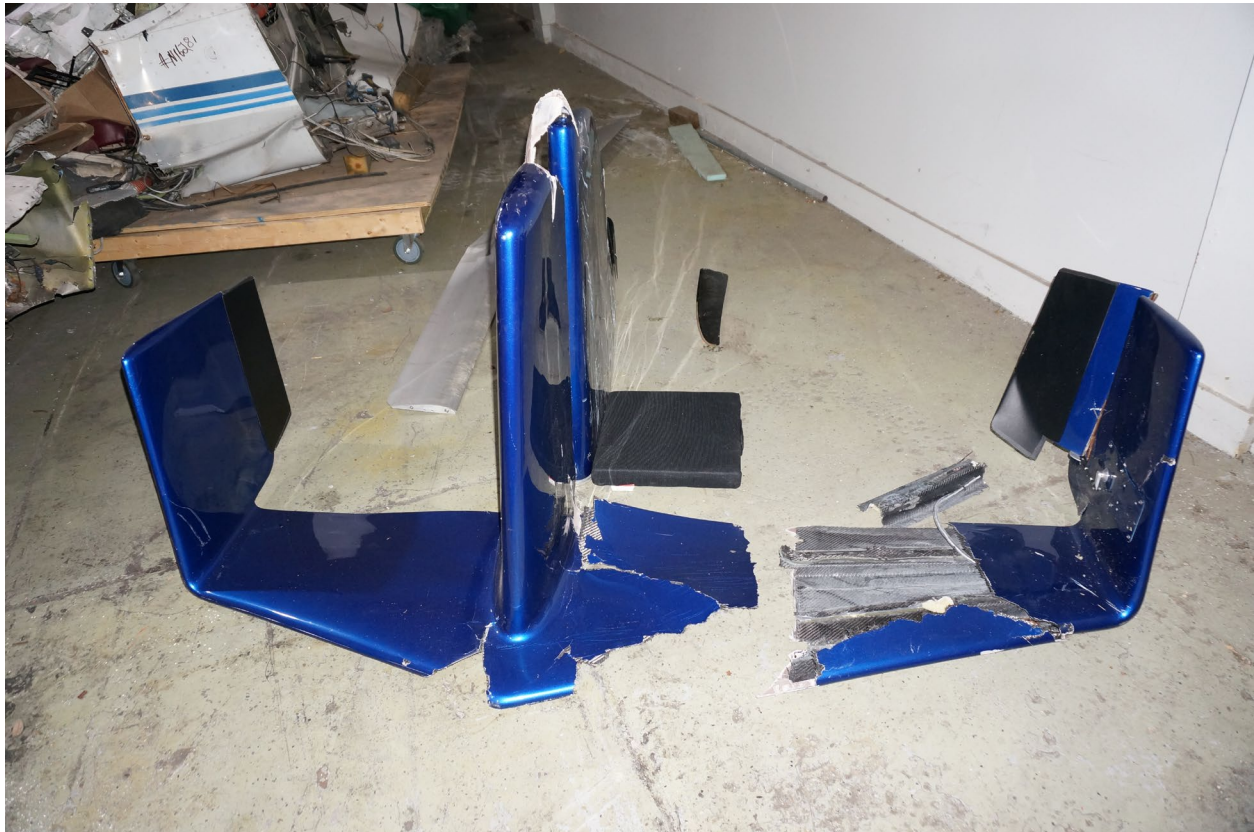
- The tail surfaces were found separated from the tail boom. Examination of the system indicated that the rudder control continuity was confirmed. The rudder was movable and control continuity was confirmed from the rudder pedals to the breaks in the system, and from the breaks in the system to the rudder panel.

**Figure 4. View of gyroplane empennage.**

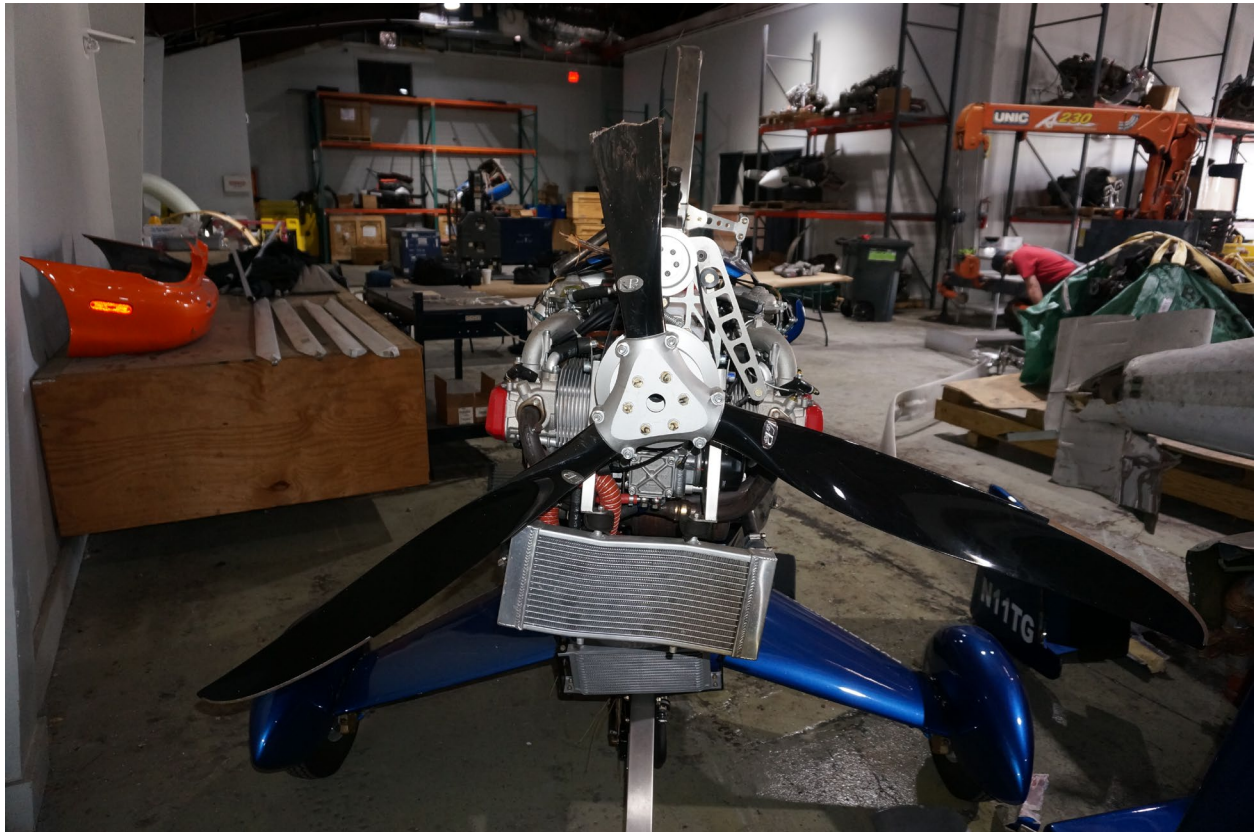
- Engine in good physical condition.
- One of the 3 propeller blades was broken about 11” outboard of the blade root.
- The other two propeller blades remained attached to the hub and undamaged.

**Figure 5. View of propeller.**

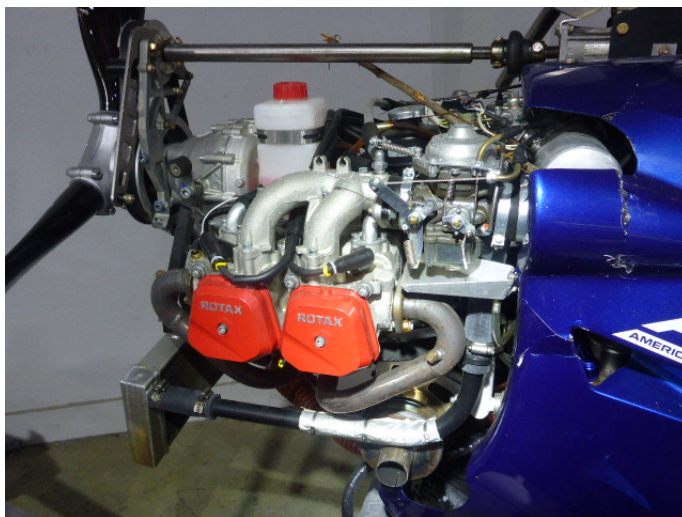
- 1/3 Carburetor float bowl appeared wet with fuel (externally).
- Removed the TCU for further testing (S/N 1842070028) (P/N 966 741).

**Figure 6. Right side of engine.**

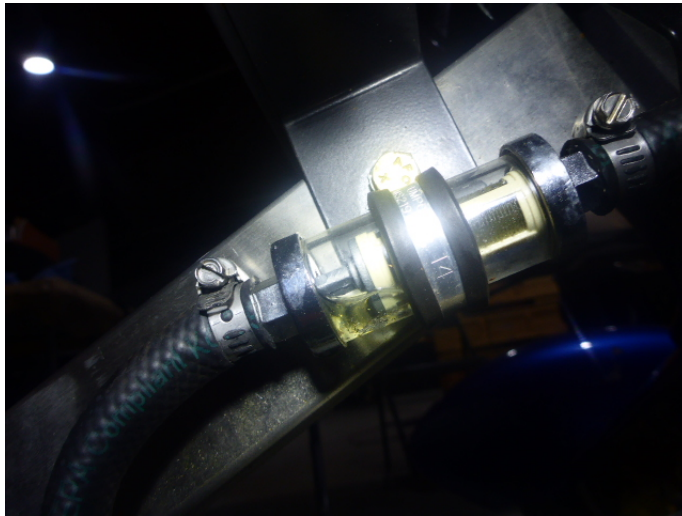
- Electric fuel pumps were turned on and operational.
- Fuel filter had aluminum shavings contained within.

**Figure 8. View of metal shavings in fuel filter.**

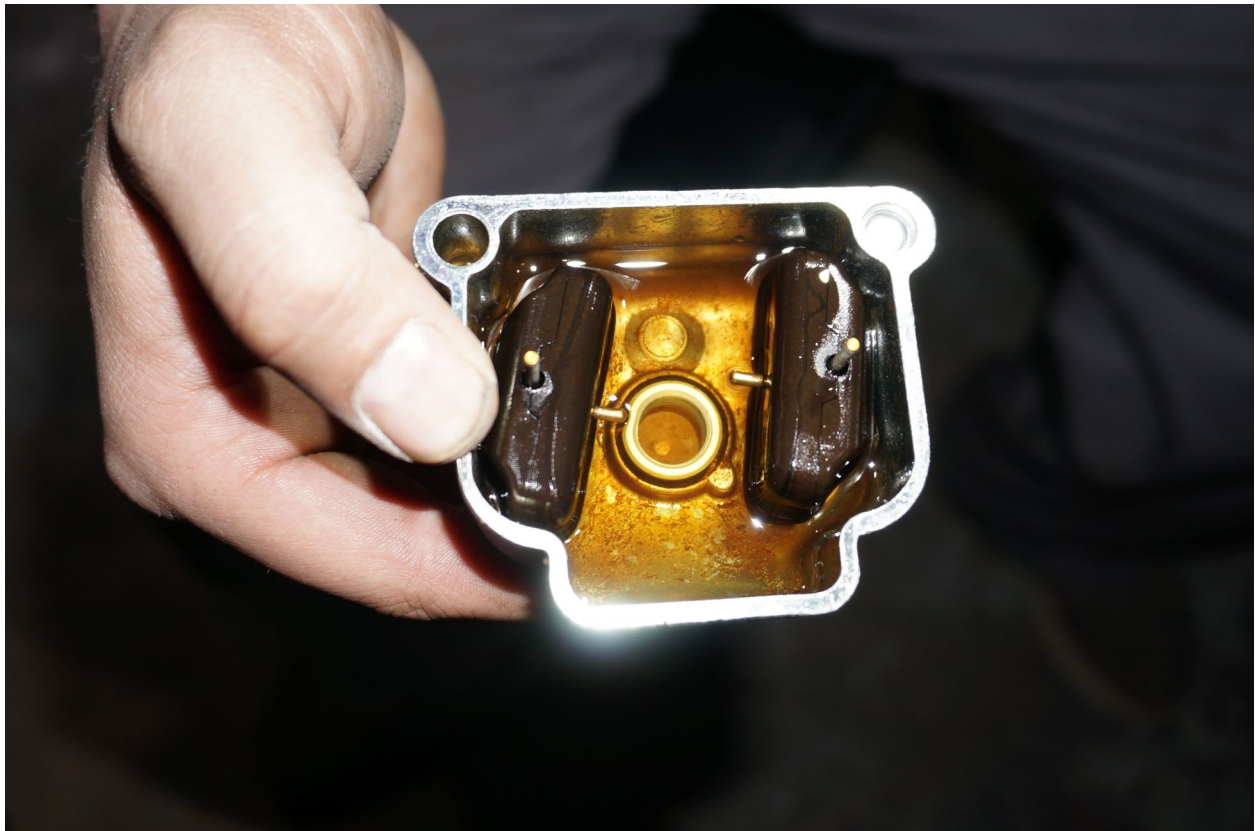
- Right (2/4) Carburetor float bowl had a brown, crusty substance on the bottom and the fuel contained evidence of water when tested with water finding paste – Floats weighed 6.4 Grams

**Figure 9. View of yellow fuel and crusty substance in the fuel.**
