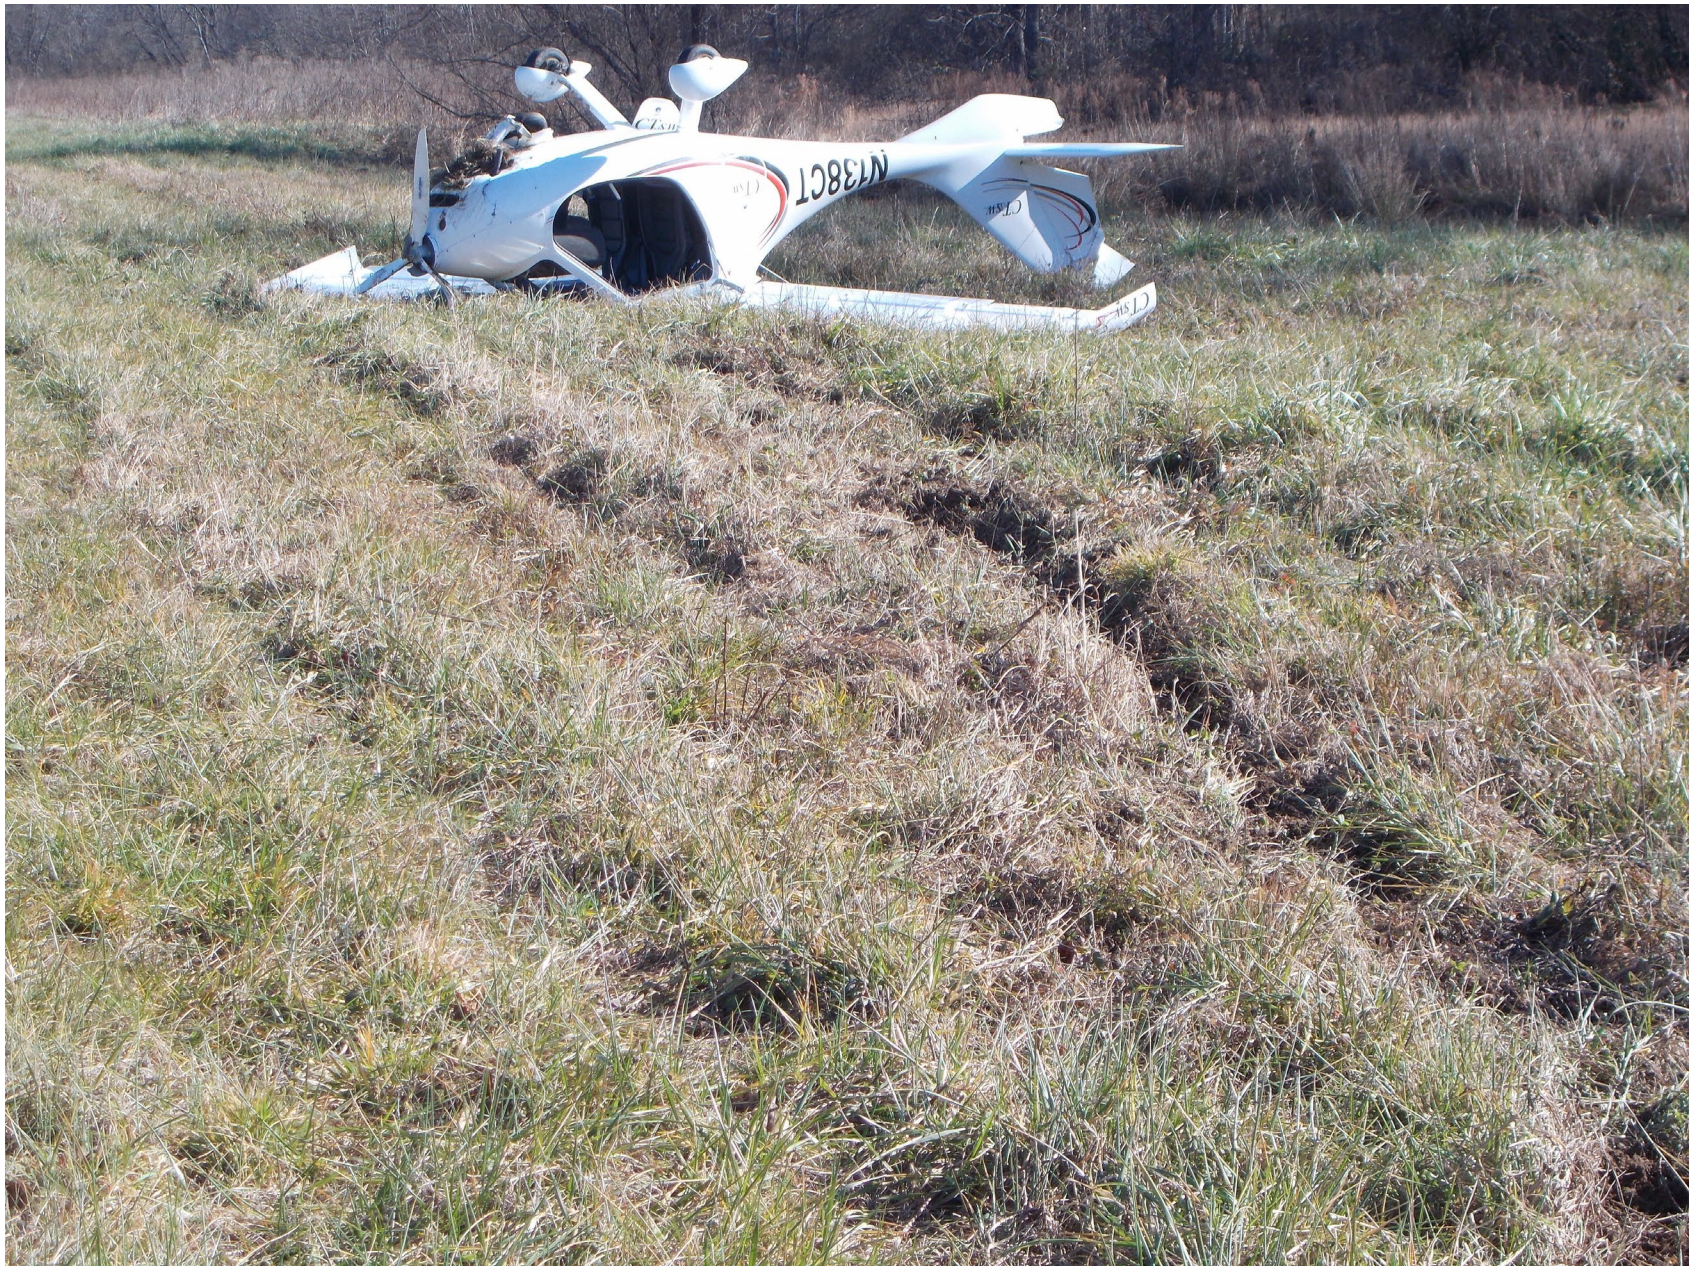
**Photo 1 – Main Wreckage (FAA Photo)**

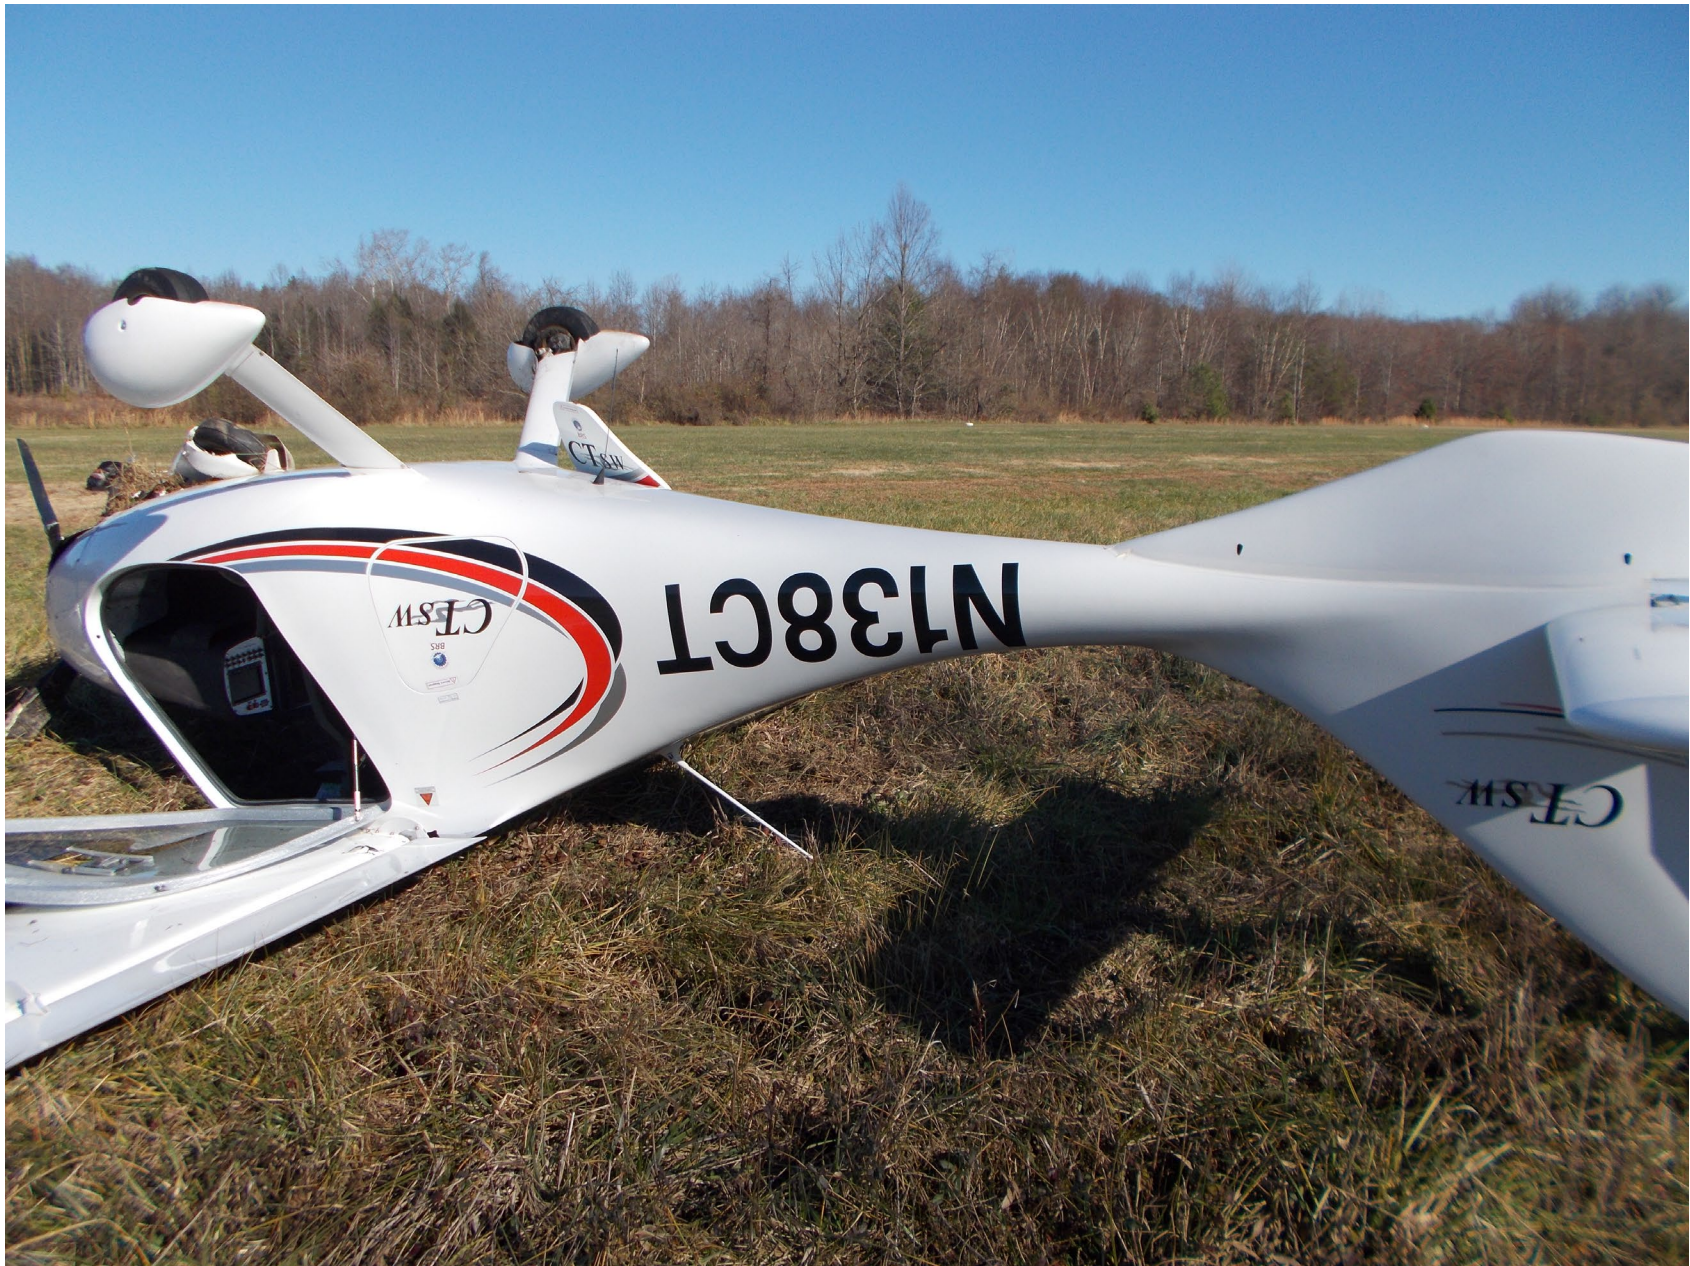
**Photo 2 - Main Wreckage (FAA Photo)**

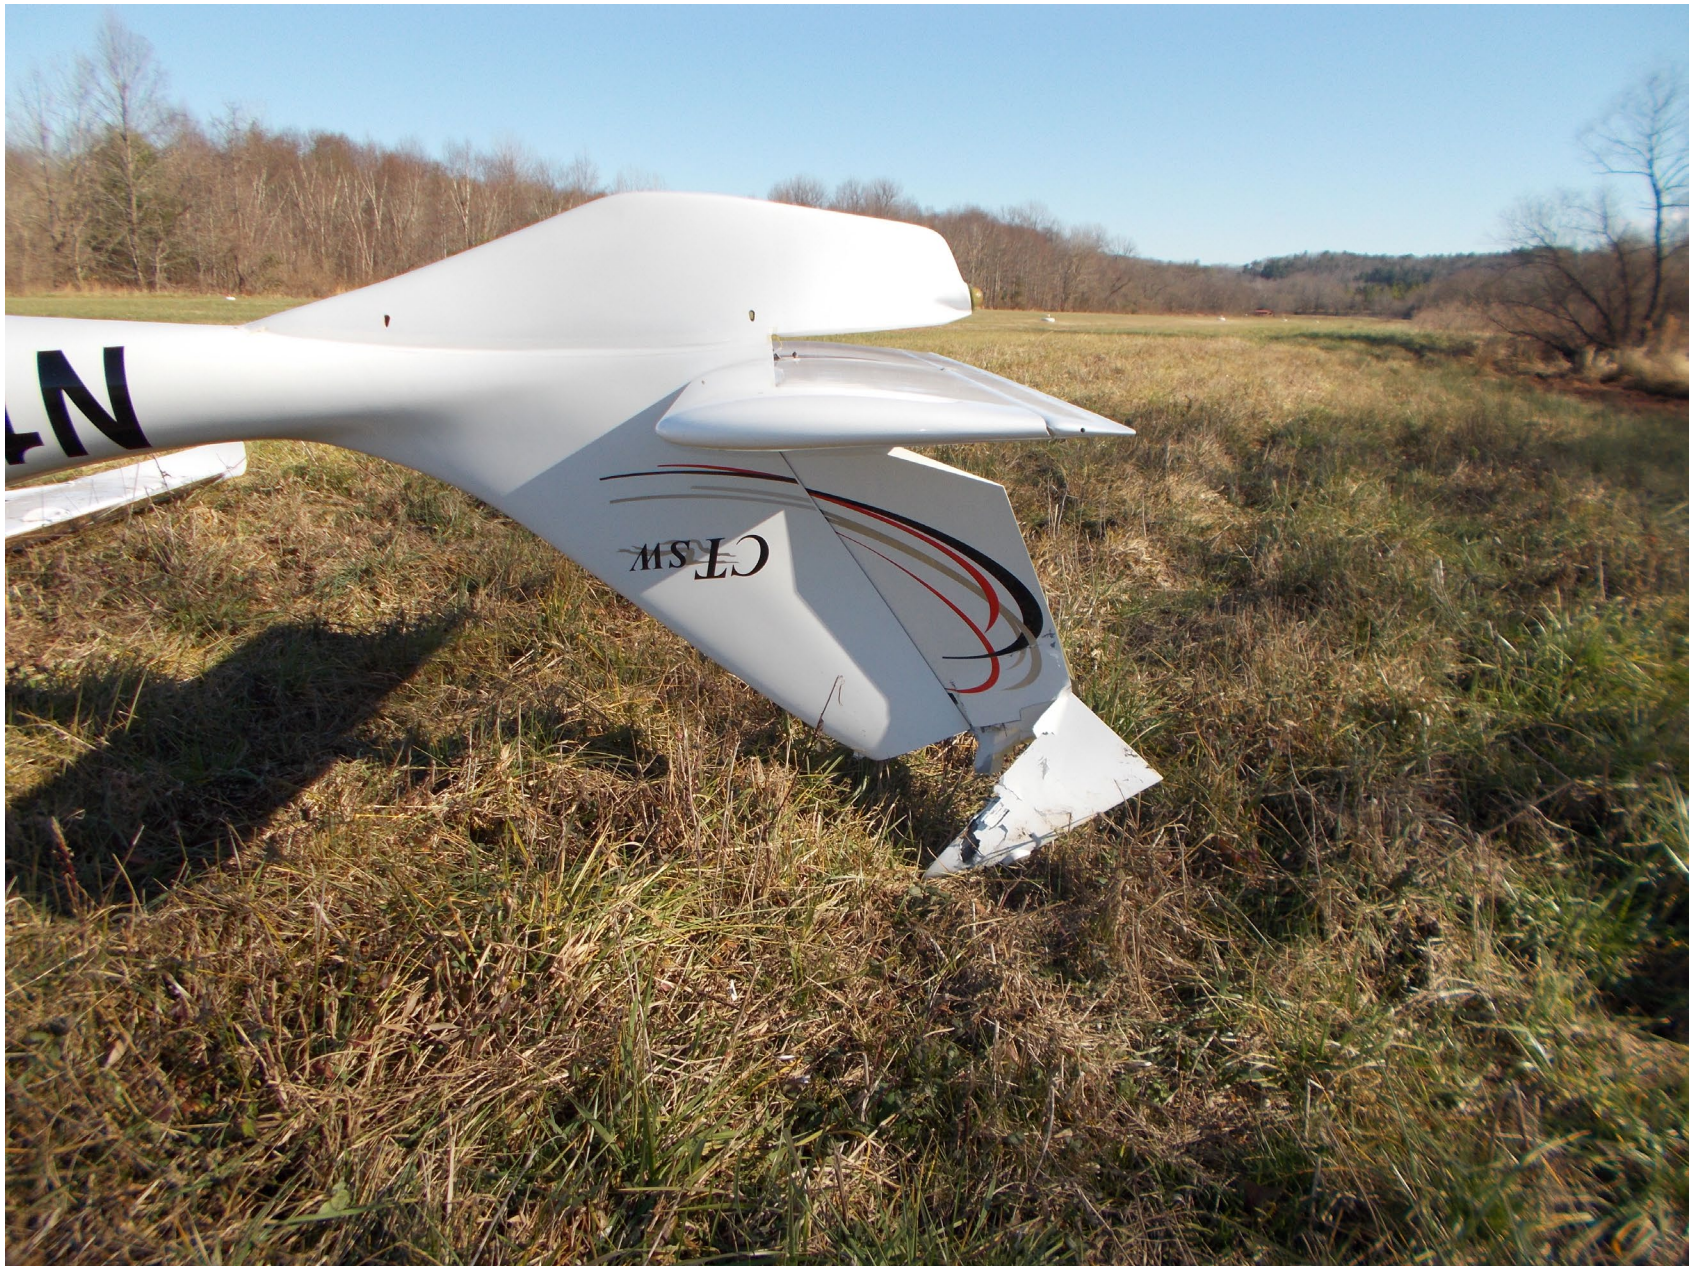
**Photo 3 - Empennage (FAA Photo)**

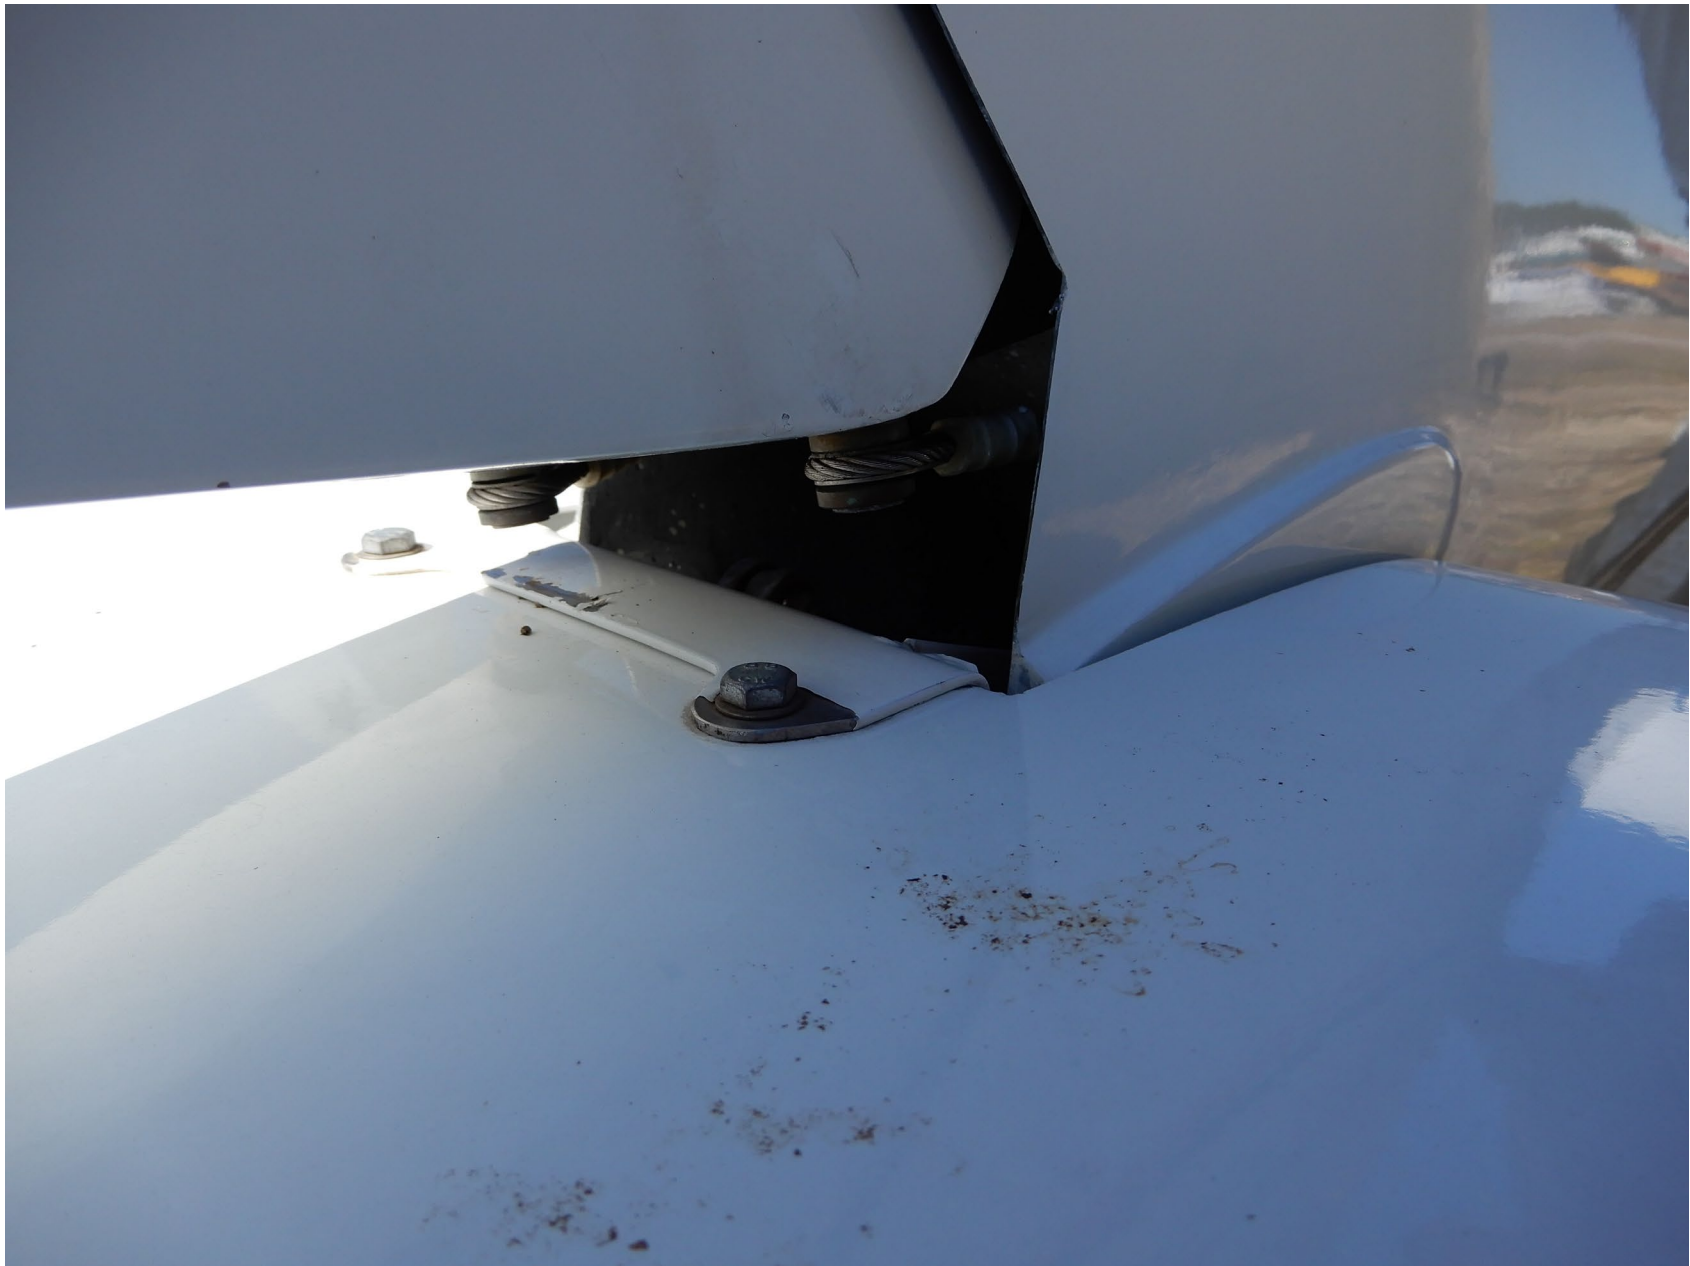
**Photo 4 – Rudder Cables (NTSB Photo)**

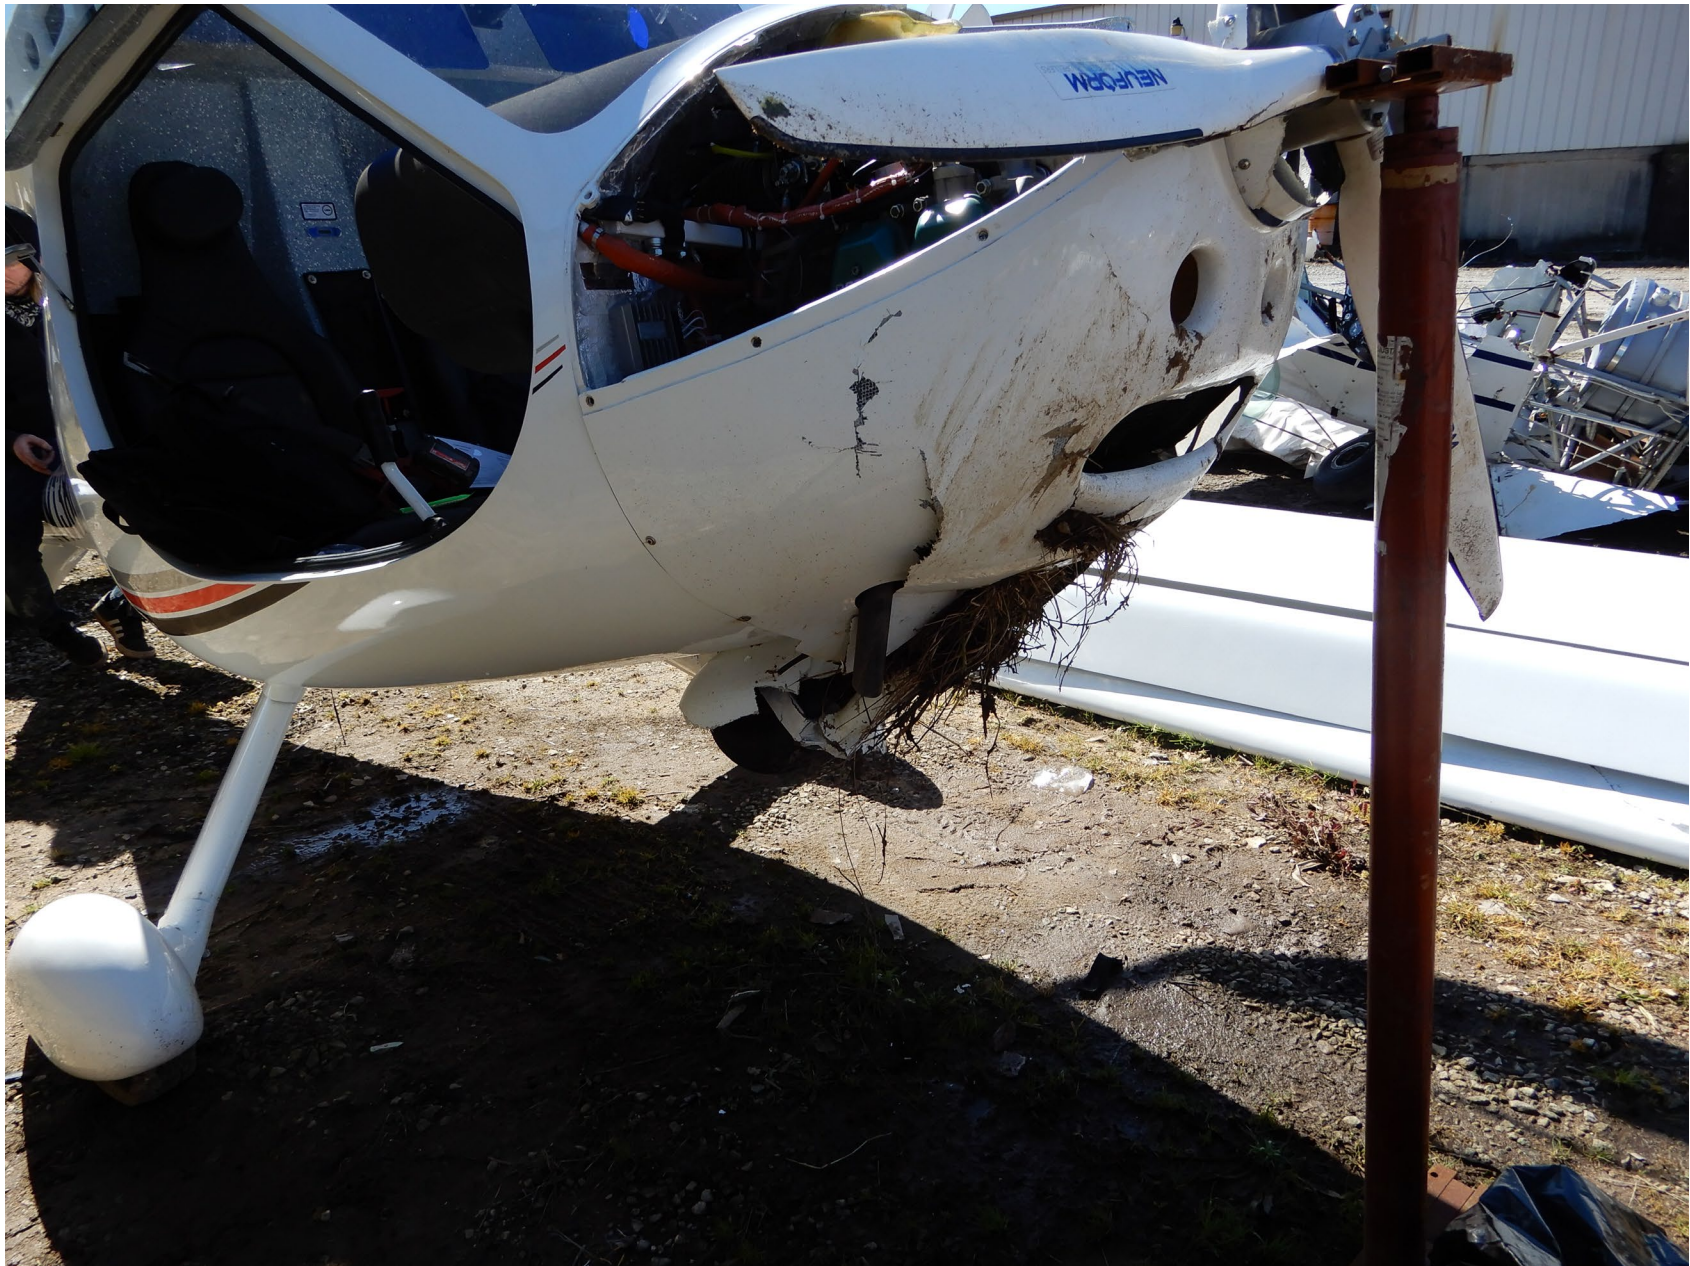
**Photo 5 – Nose Gear Damage (NTSB Photo)**

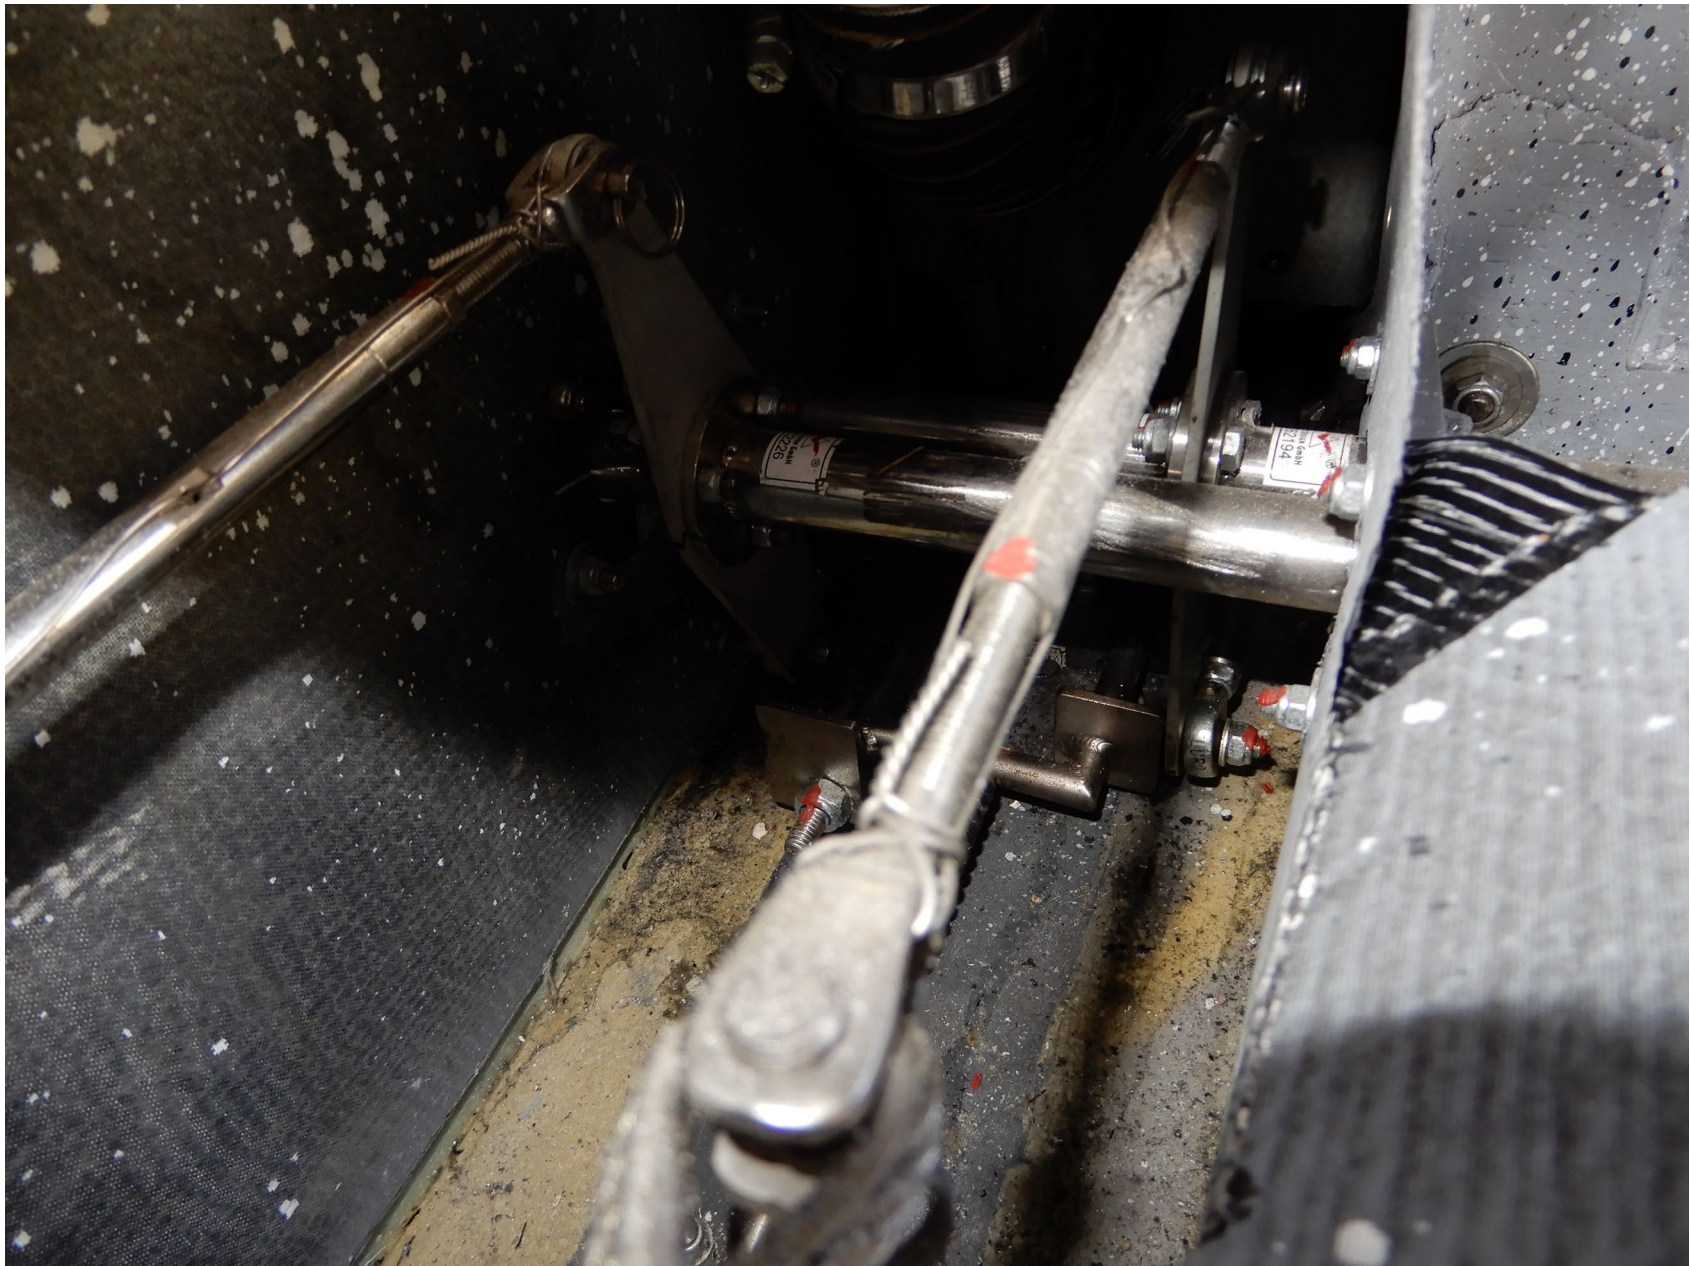
**Photo 6 - Rudder Cables (NTSB Photo)**

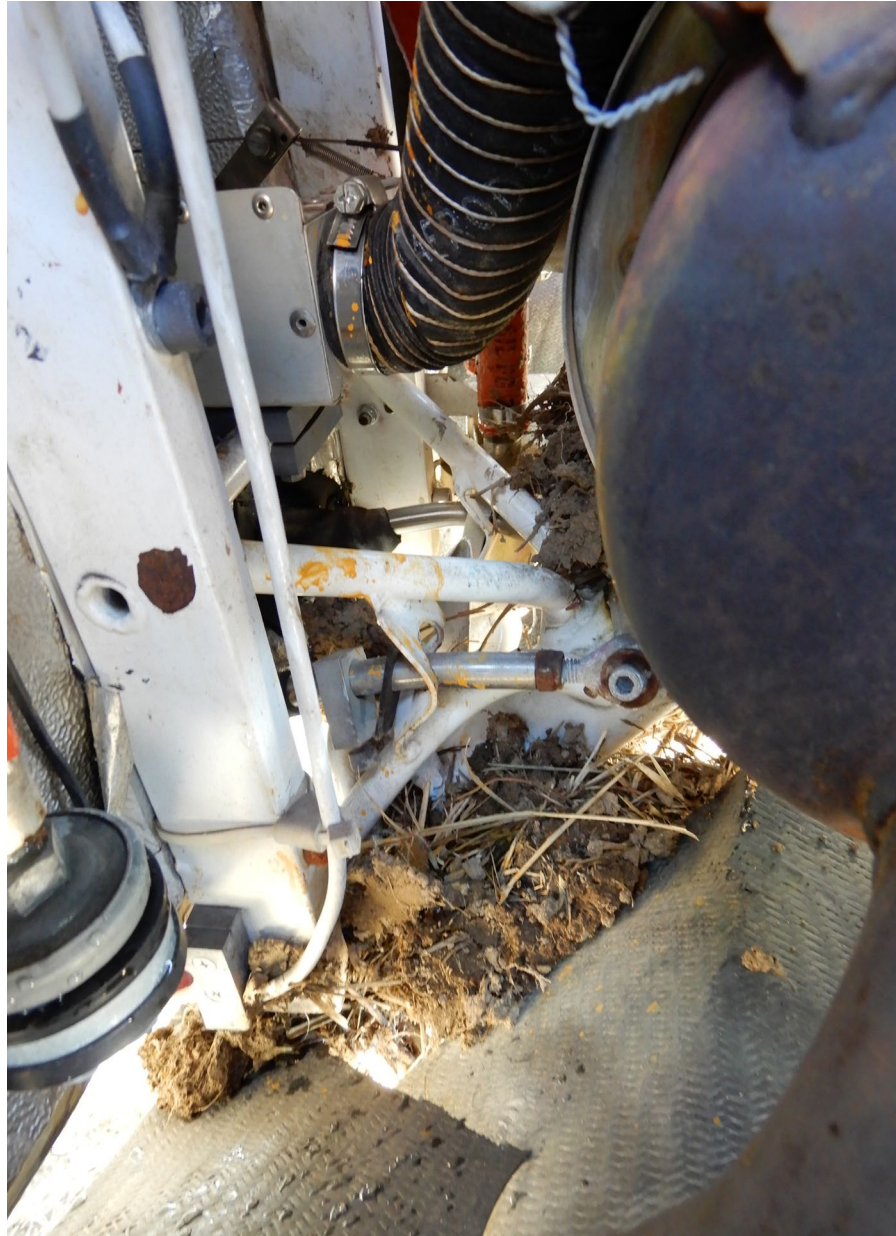
**Photo 7 – Bent Rod Between Rudder Pedals and Nose Landing Gear (NTSB Photo)**
