## MEMORANDUM FOR RECORD

**Subject: Post accident examination conducted by owner/operator; email summary/paraphrase of findings.** The owner/operator, with NTSB IIC and FAA approval agreed to allow the owner/operator to conduct his own examination with regular updates. The owner/operator followed through and sent an e-mail detailing his findings.

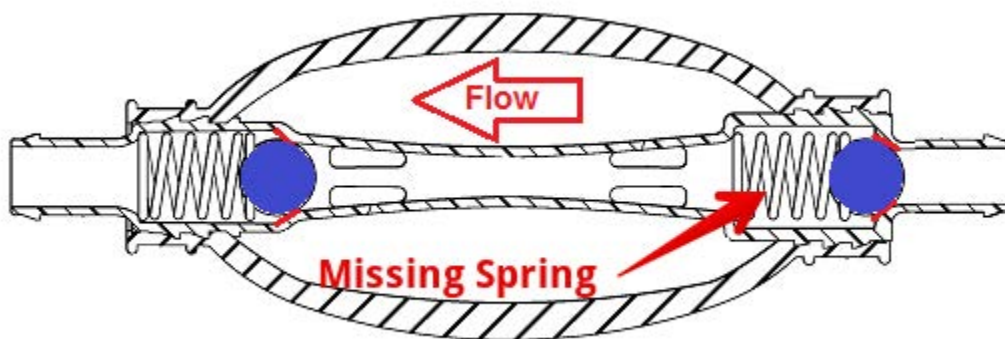
Looking into the root cause of the accident, the owner determined that this was not an actual engine failure, but a fuel starvation issue. Based on conversations with the NTSB IIC and FAA, it was discussed beforehand, that many times, the issue could be “upstream or downstream” of the engine, so he shifted his focus from the engine to the fuel lines. He checked both fuel pickups and found nothing wrong, then checked the fuel filter and found it to be 100% serviceable. He then moved to the primer bulb as shown in the drawing. (Figure 1)

*Figure 1 Primer bulb drawing*

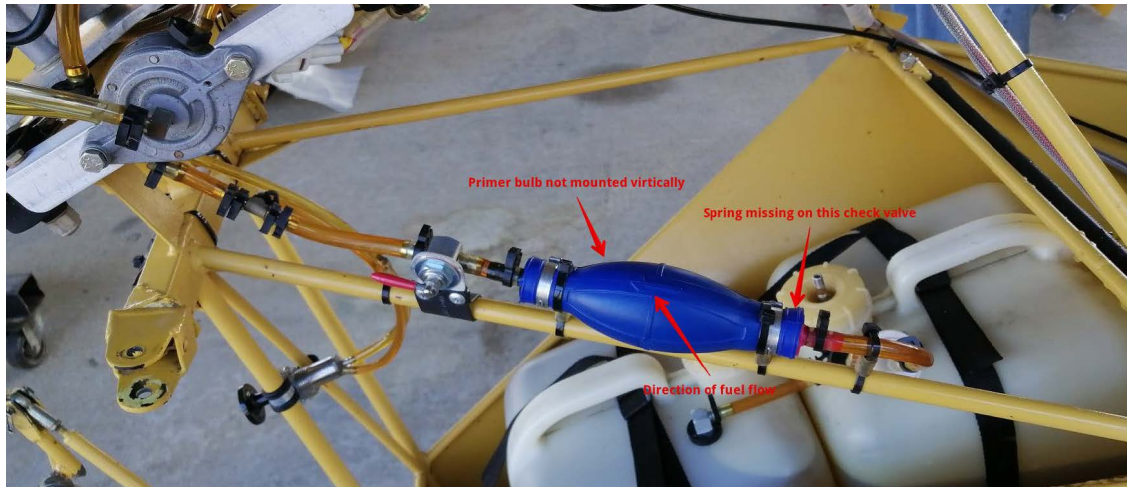
He found that the spring closest to the fuel tanks was missing. This meant that during the priming phase, gravity was letting the check ball drop to the bottom, which closed the valve. However, nothing was preventing it from migrating to the top during normal operation. As you can see from the installation on the airplane (Figure 2) the primer bulb was not mounted vertically. Though he cannot find conclusive evidence that the bulb should be mounted vertically, there were indications that the bulbs work better when vertically mounted. Though he can't prove it, had it been mounted vertically, gravity may

have been sufficient to keep the check ball from migrating to the top end and blocking off the fuel flow. “I could hardly believe that this was the cause, so I started looking at forums to research if this had happened to anyone in the past.” A quick search yielded similar findings (4) from other owner/operators.

*Figure 2 Primer bulb as installed on accident airplane.*
