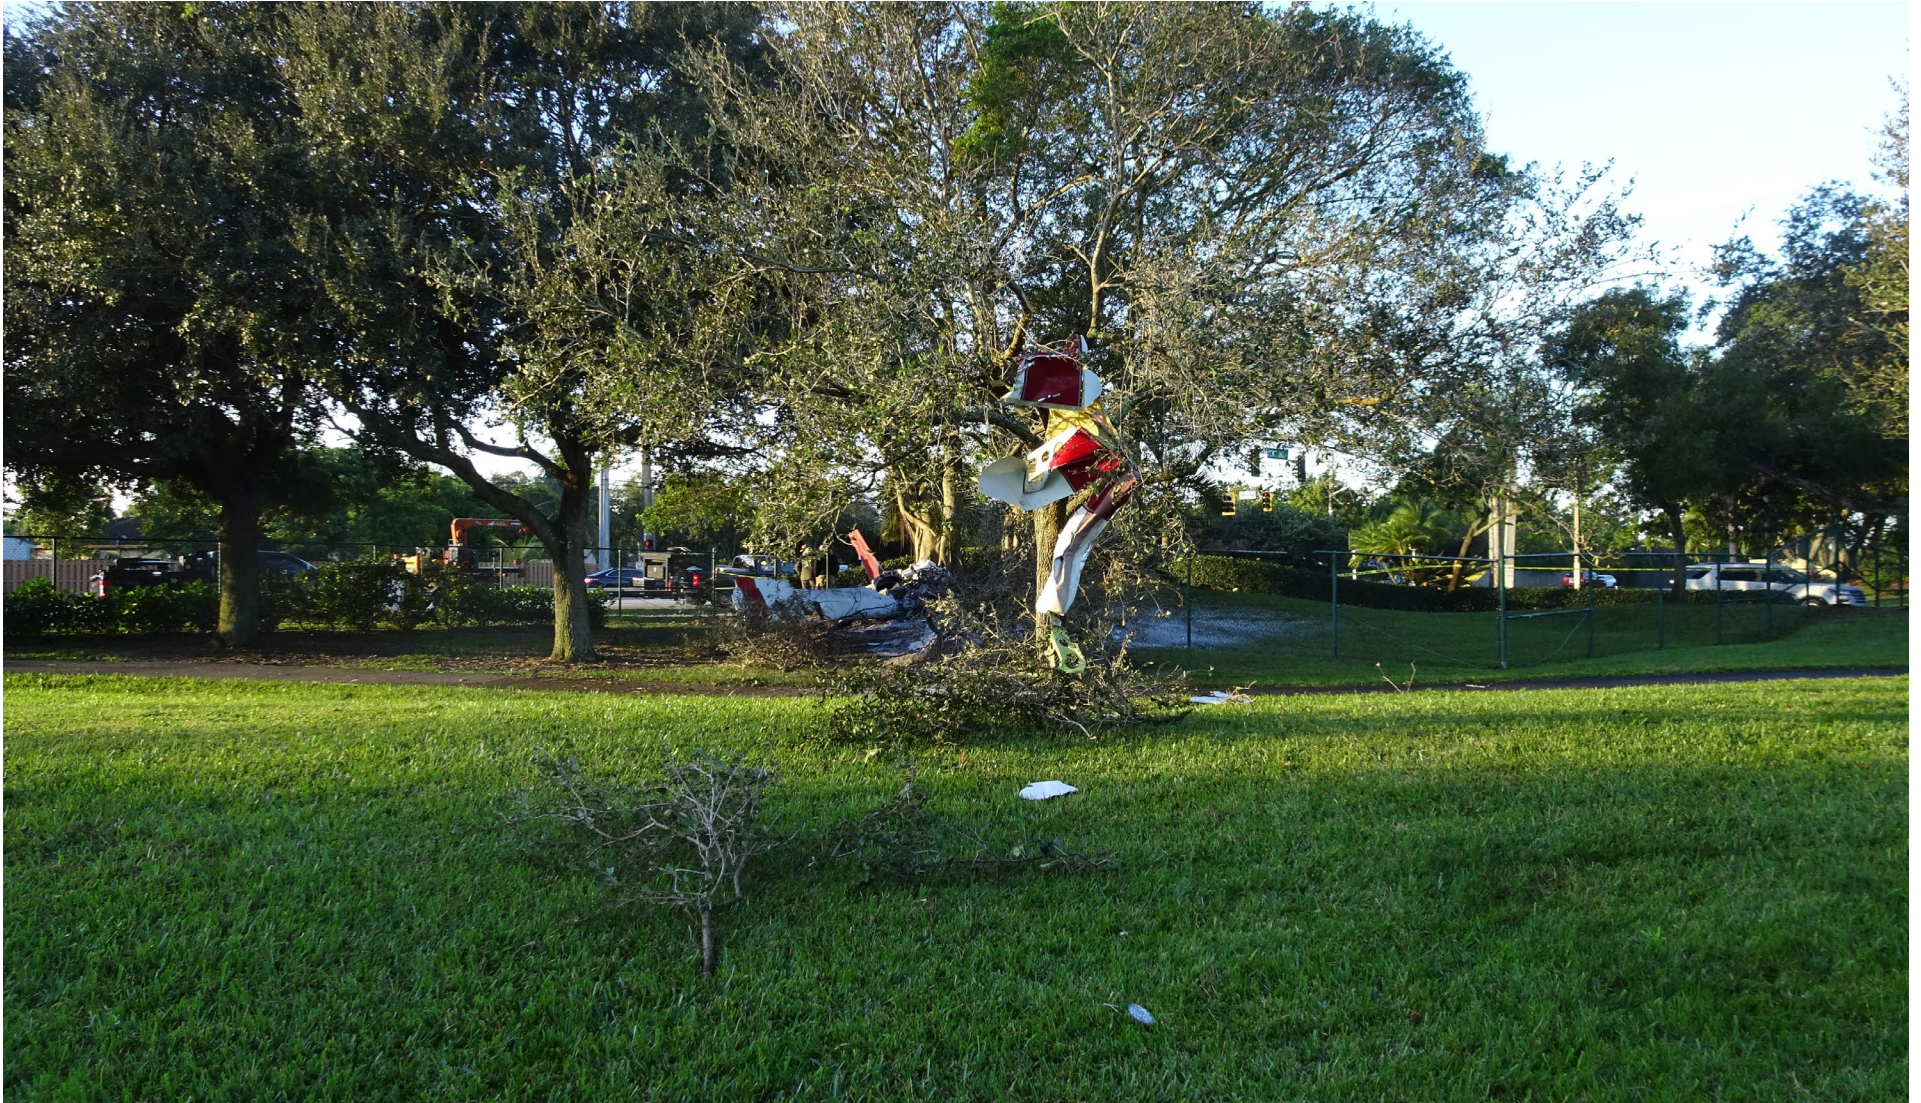
**Photo 1 – Digital Photograph From Daher. View Depicting the Wreckage Suspended in the Impacted Tree and Main Wreckage in the background.**

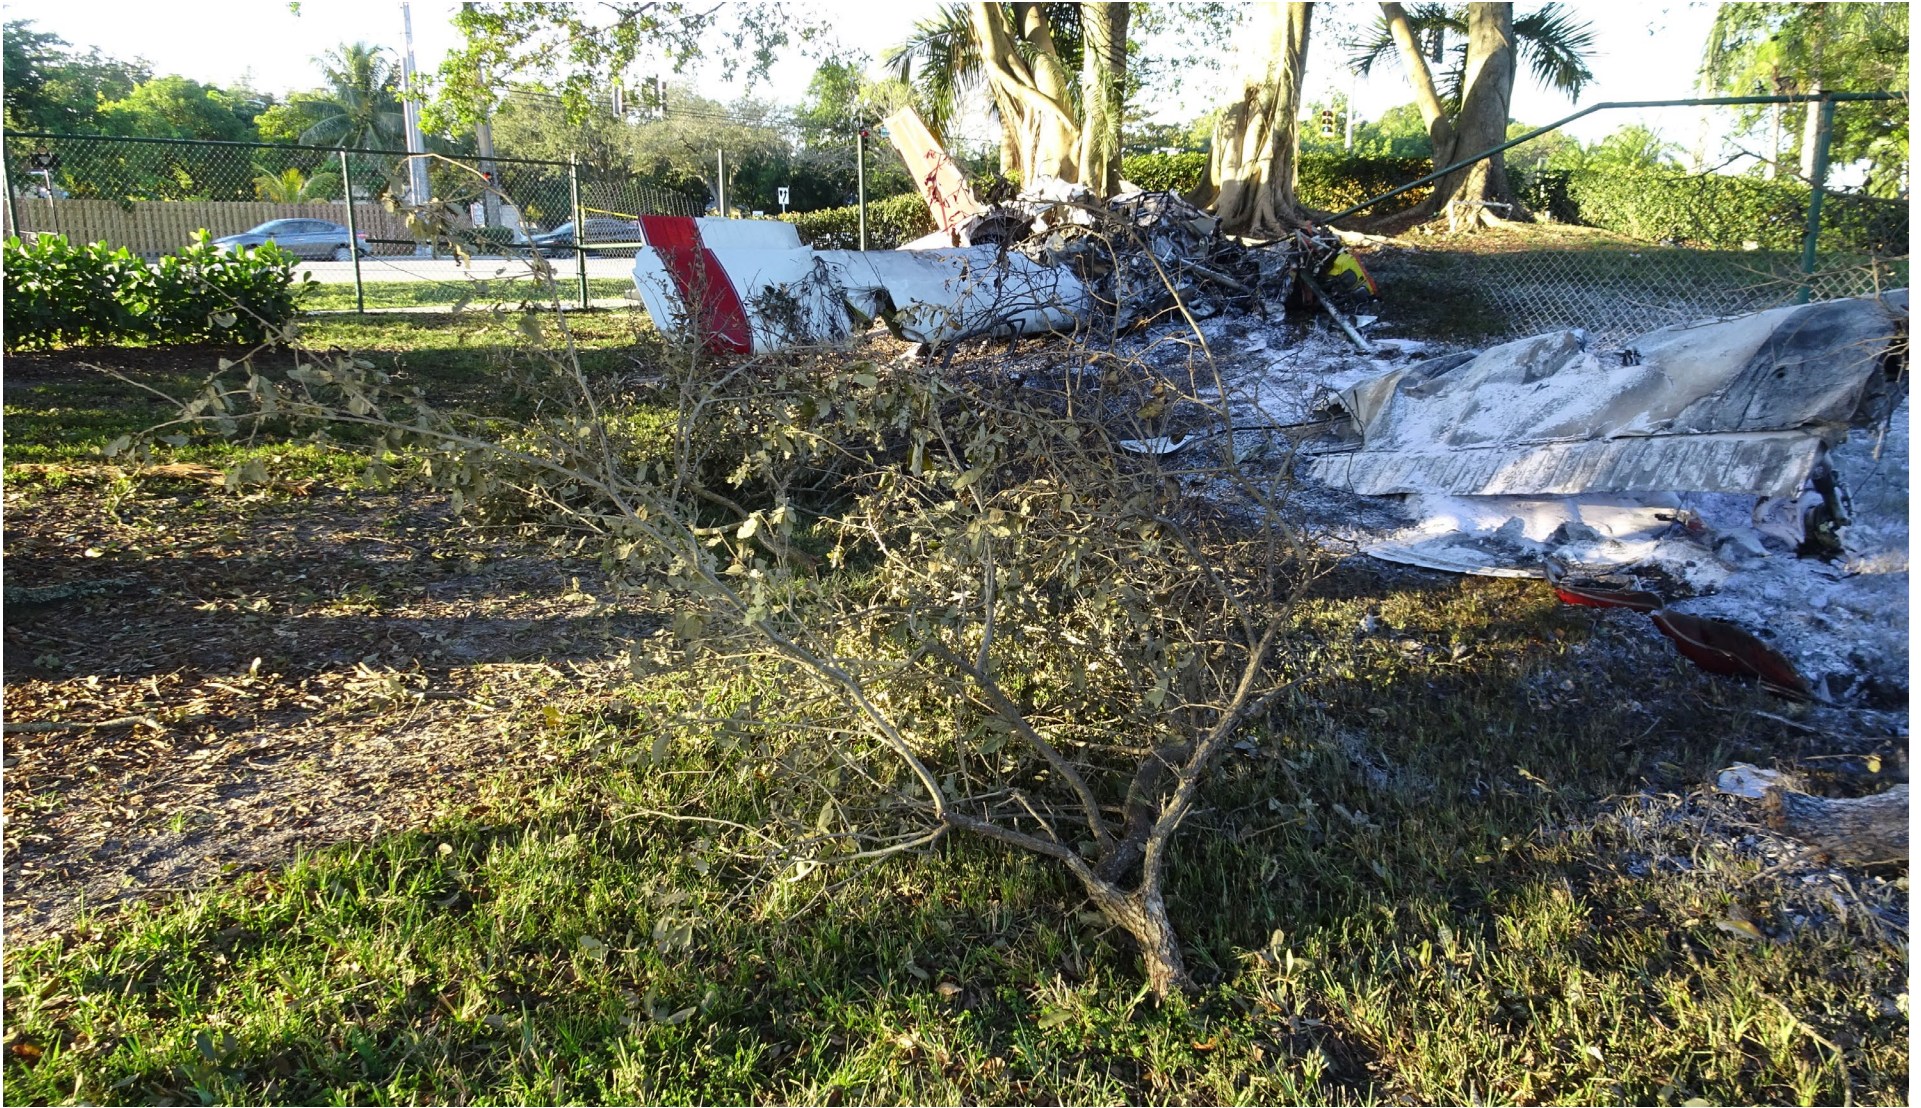
**Photo 2 - Digital Photograph From Daher. View Depicting the Separated Portion of the Left Wing in the Foreground, Right Wing and Main Wreckage in the Background.**

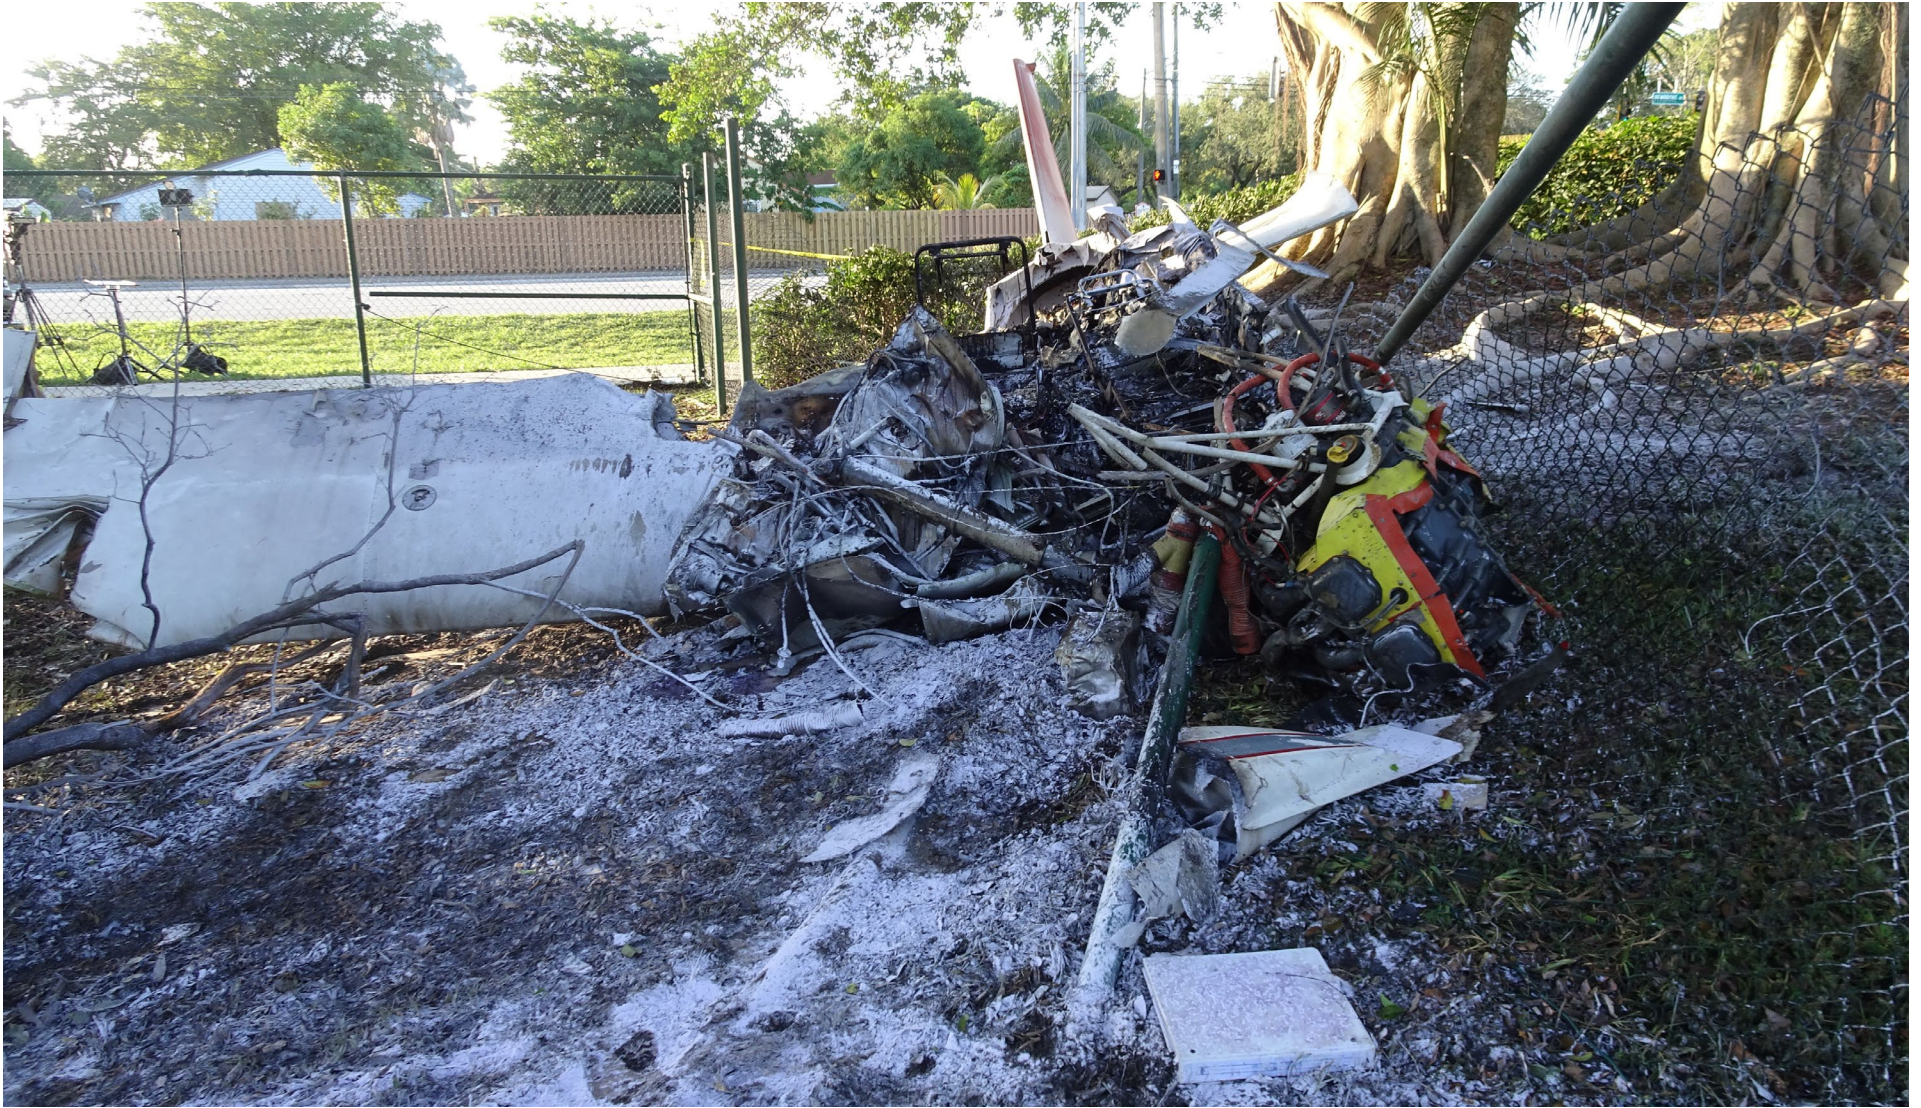
**Photo 3 - Digital Photograph From Daher. View Depicting The Right Wing, Separated Engine, and Fuselage. Note the Extensive Postcrash Fire Damage to the Cockpit and Cabin.**

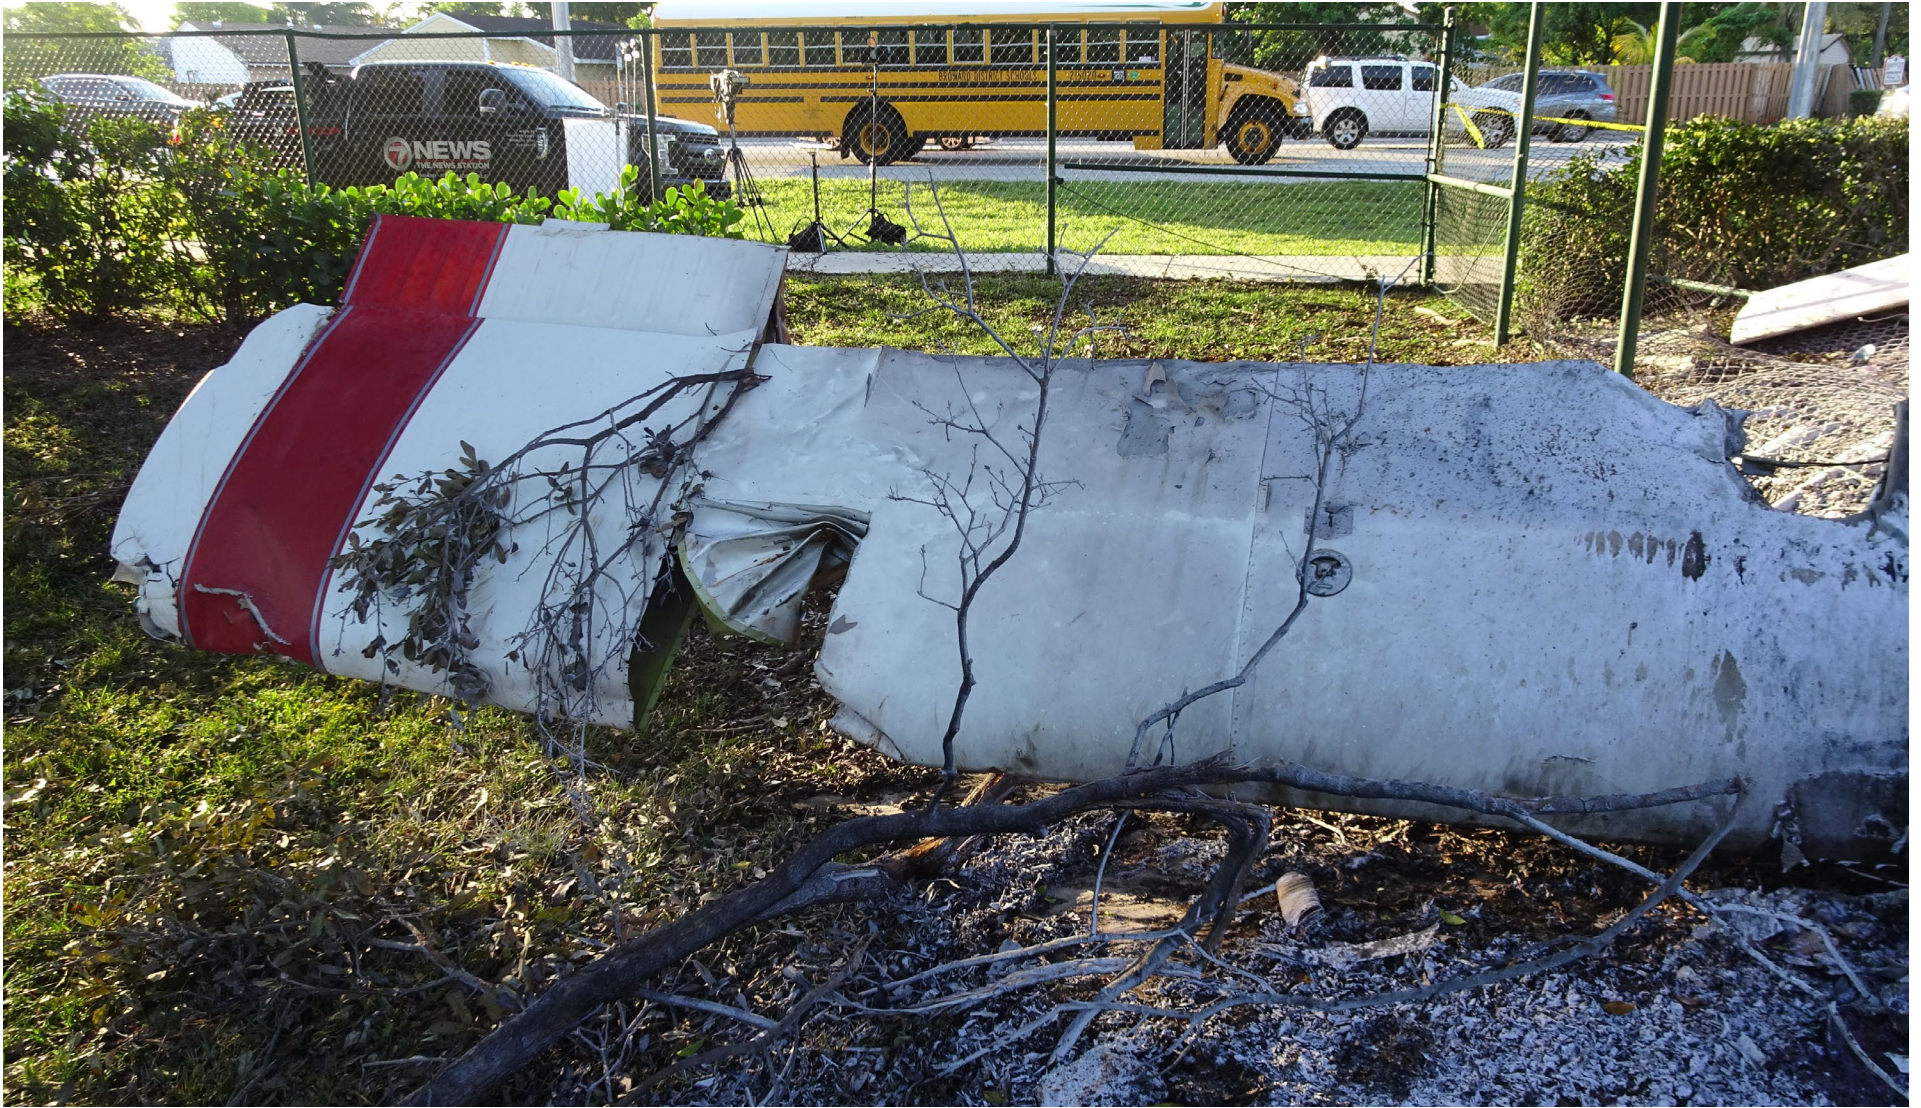
**Photo 4 - Digital Photograph From Daher. View Depicting The Majority of the Right Wing. Note the Impact Damage to the Outer Leading Edge and the fire damage to the Inboard Section of the Wing.**

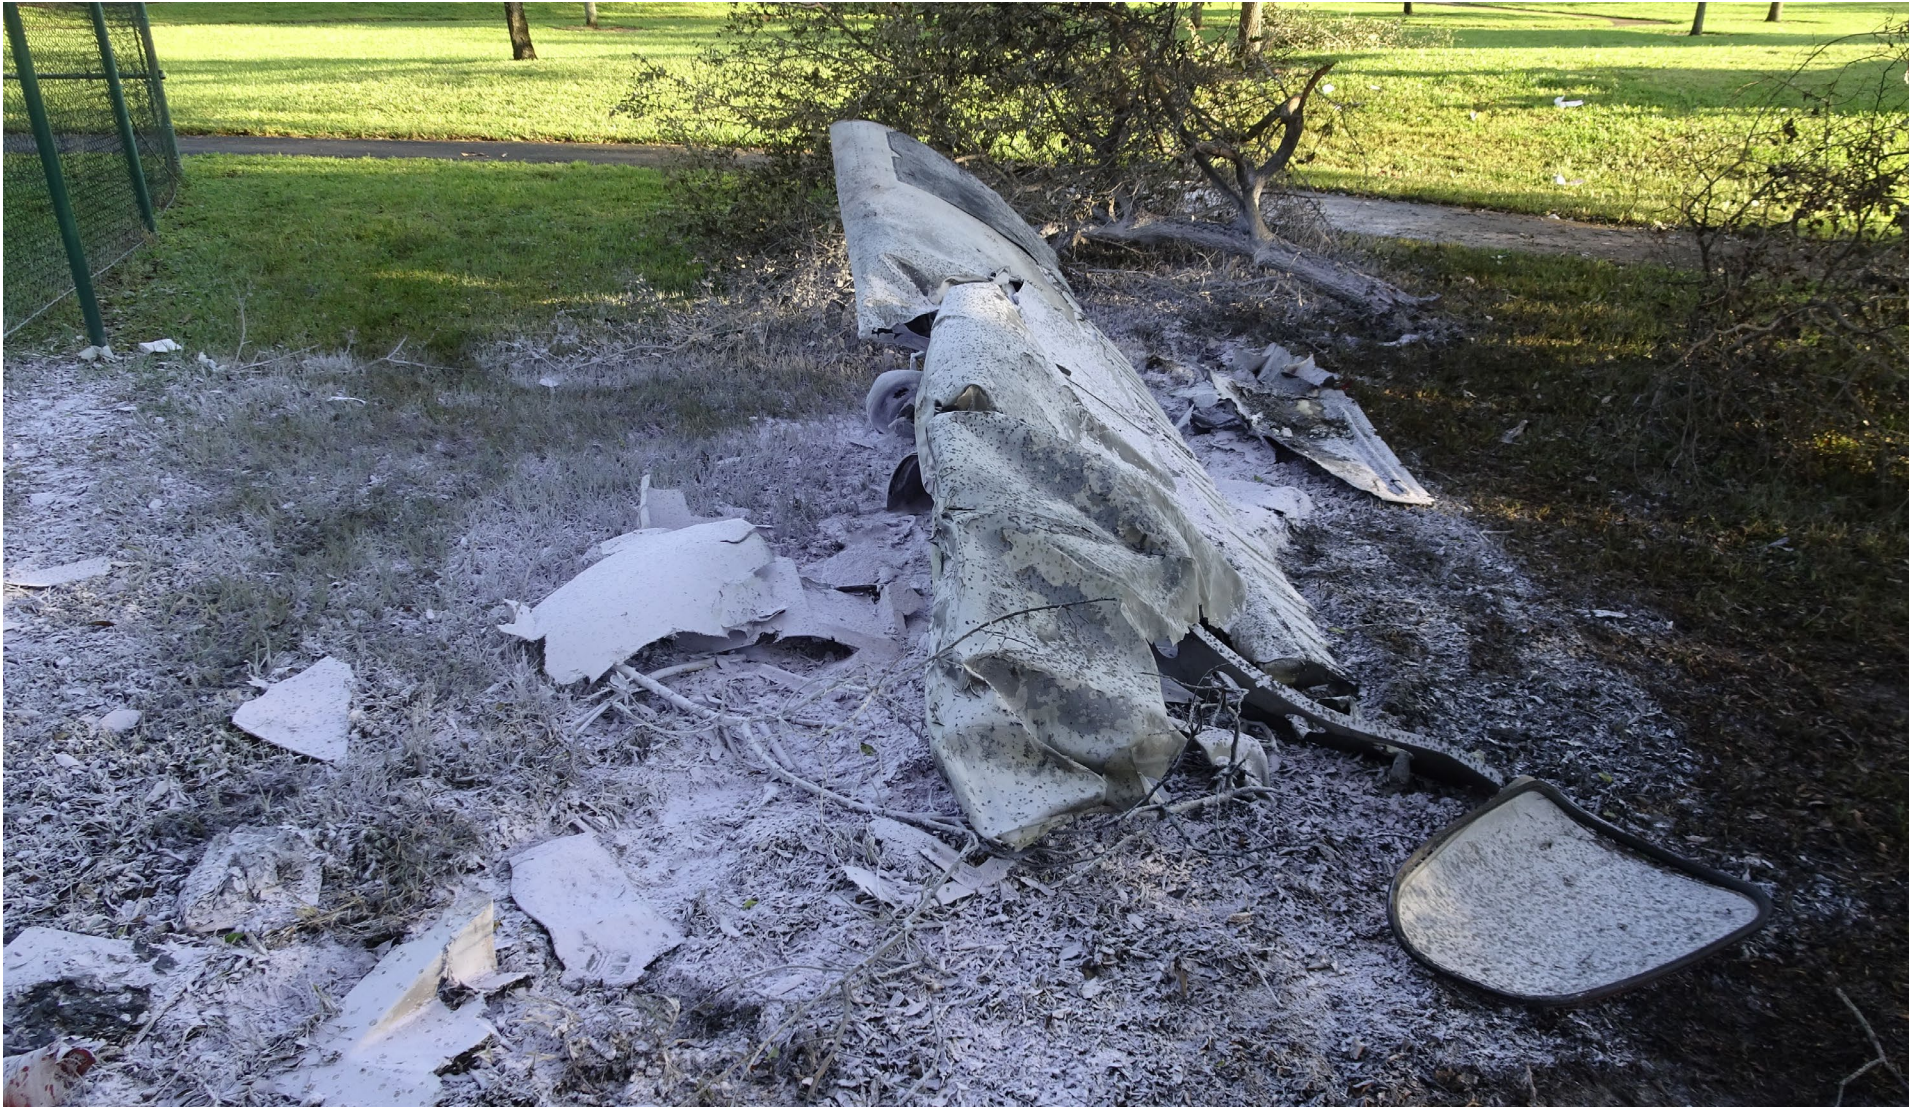
**Photo 5 - Digital Photograph From Daher. View Depicting The Inboard Portion of the Left Wing.**

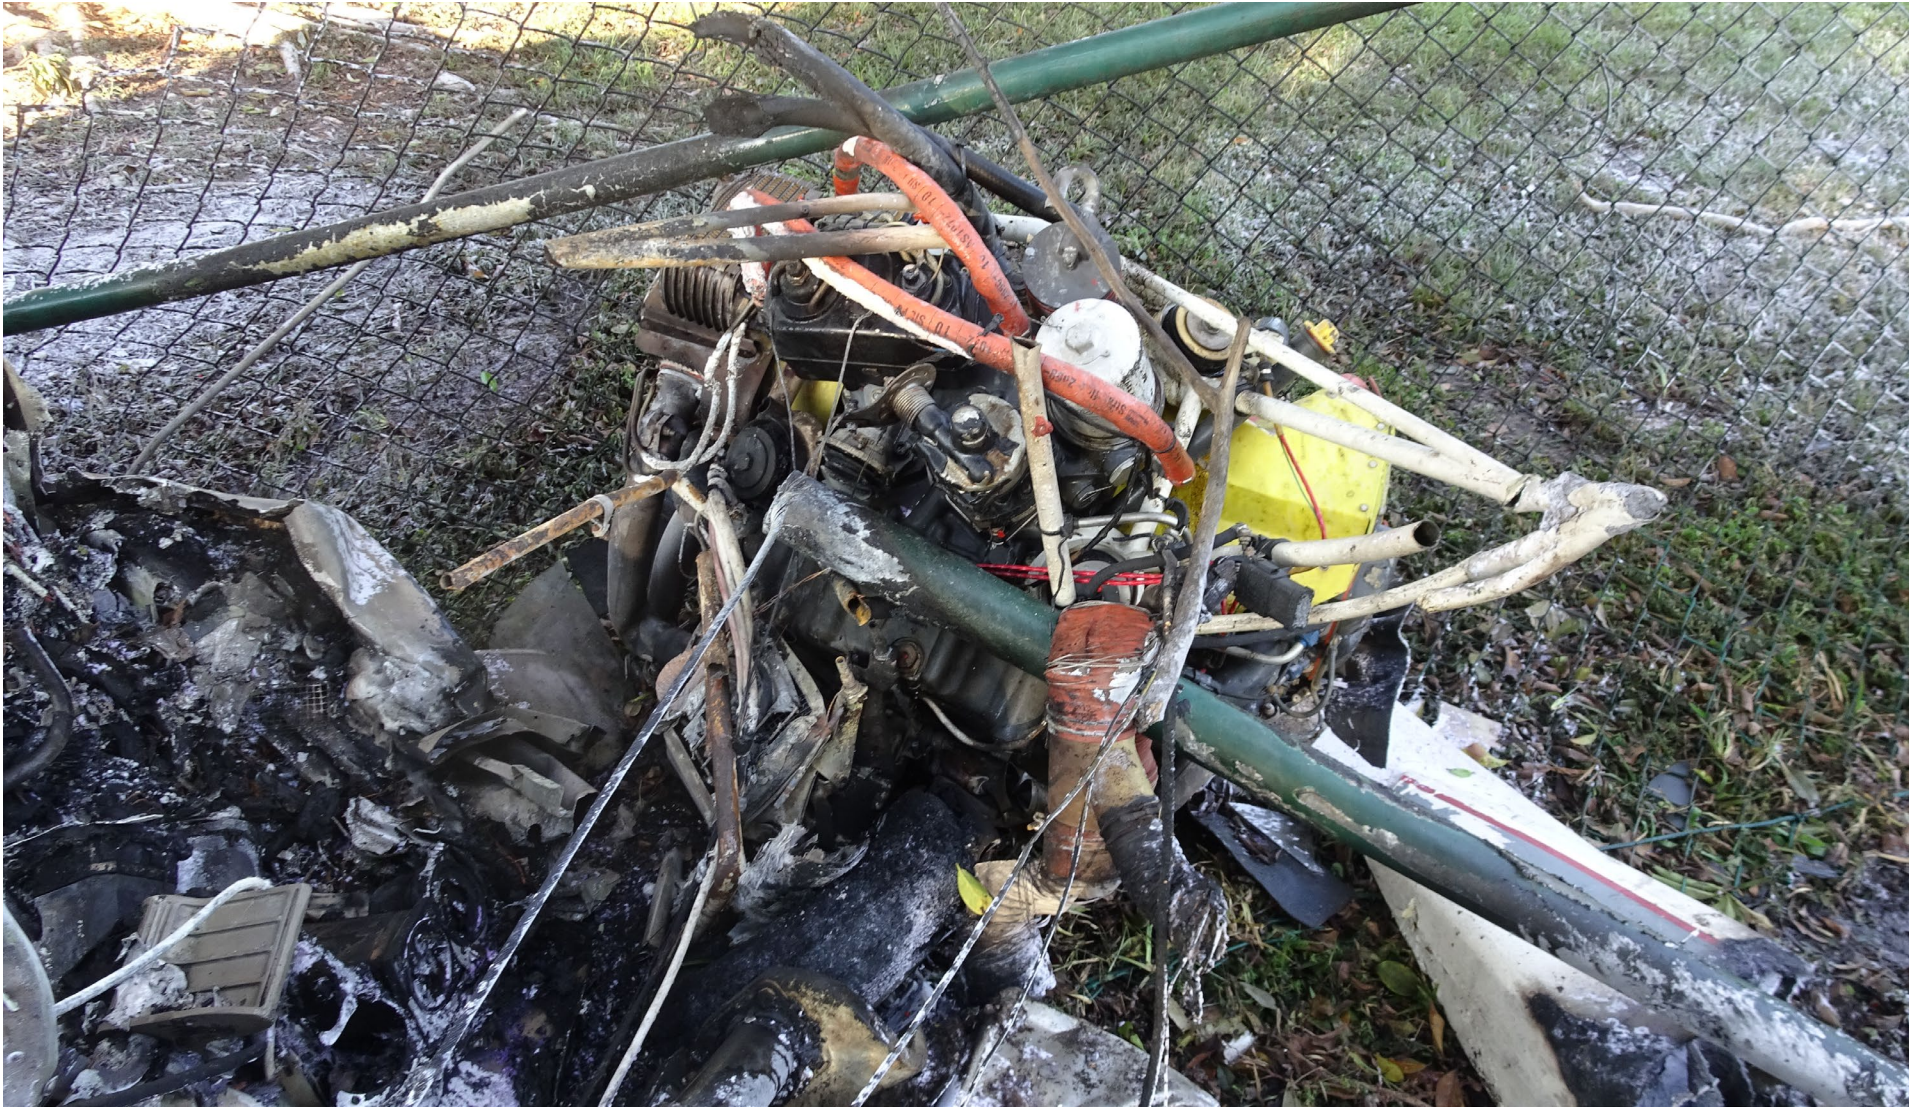
**Photo 6 - Digital Photograph From Daher. View Depicting The Separated Engine Assembly.**

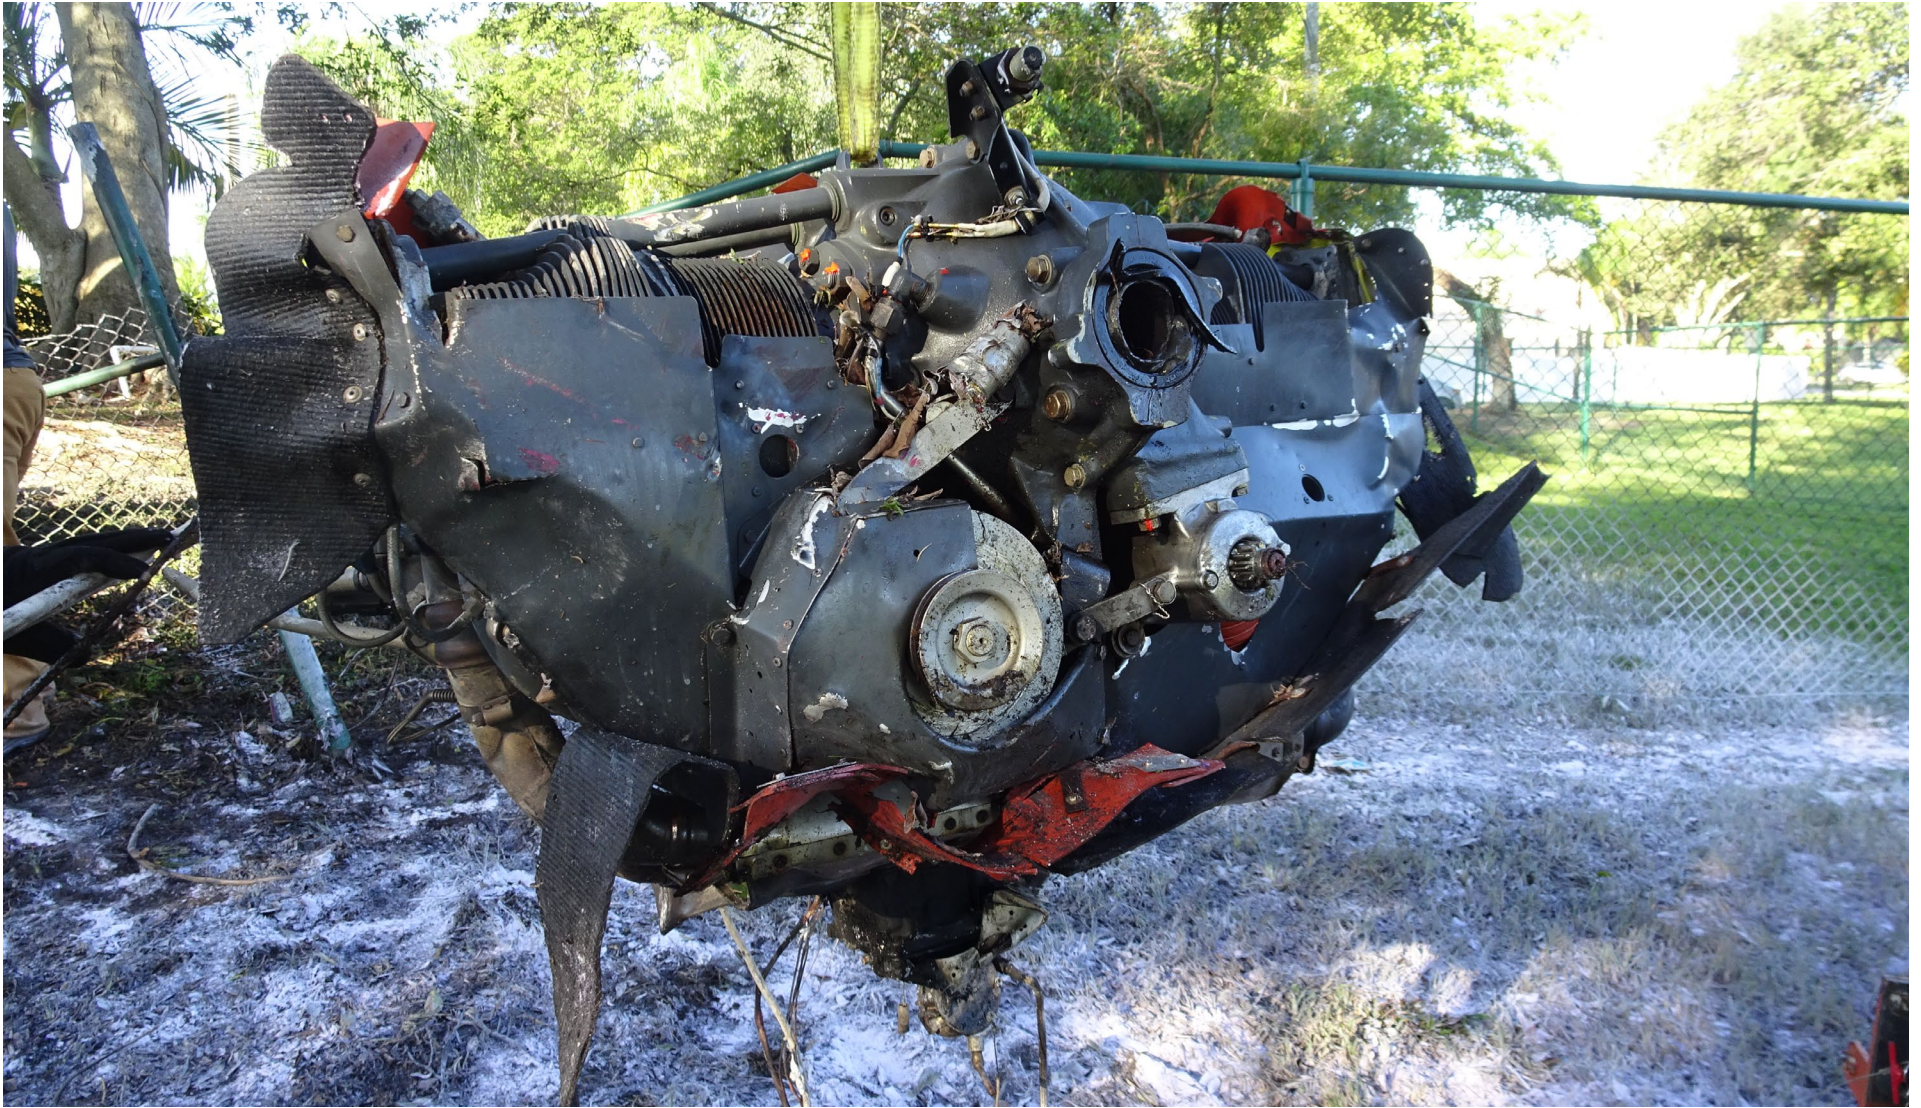
**Photo 7 - Digital Photograph From Daher. View Depicting The Separated Engine Assembly. Note the Fractured Crankshaft.**

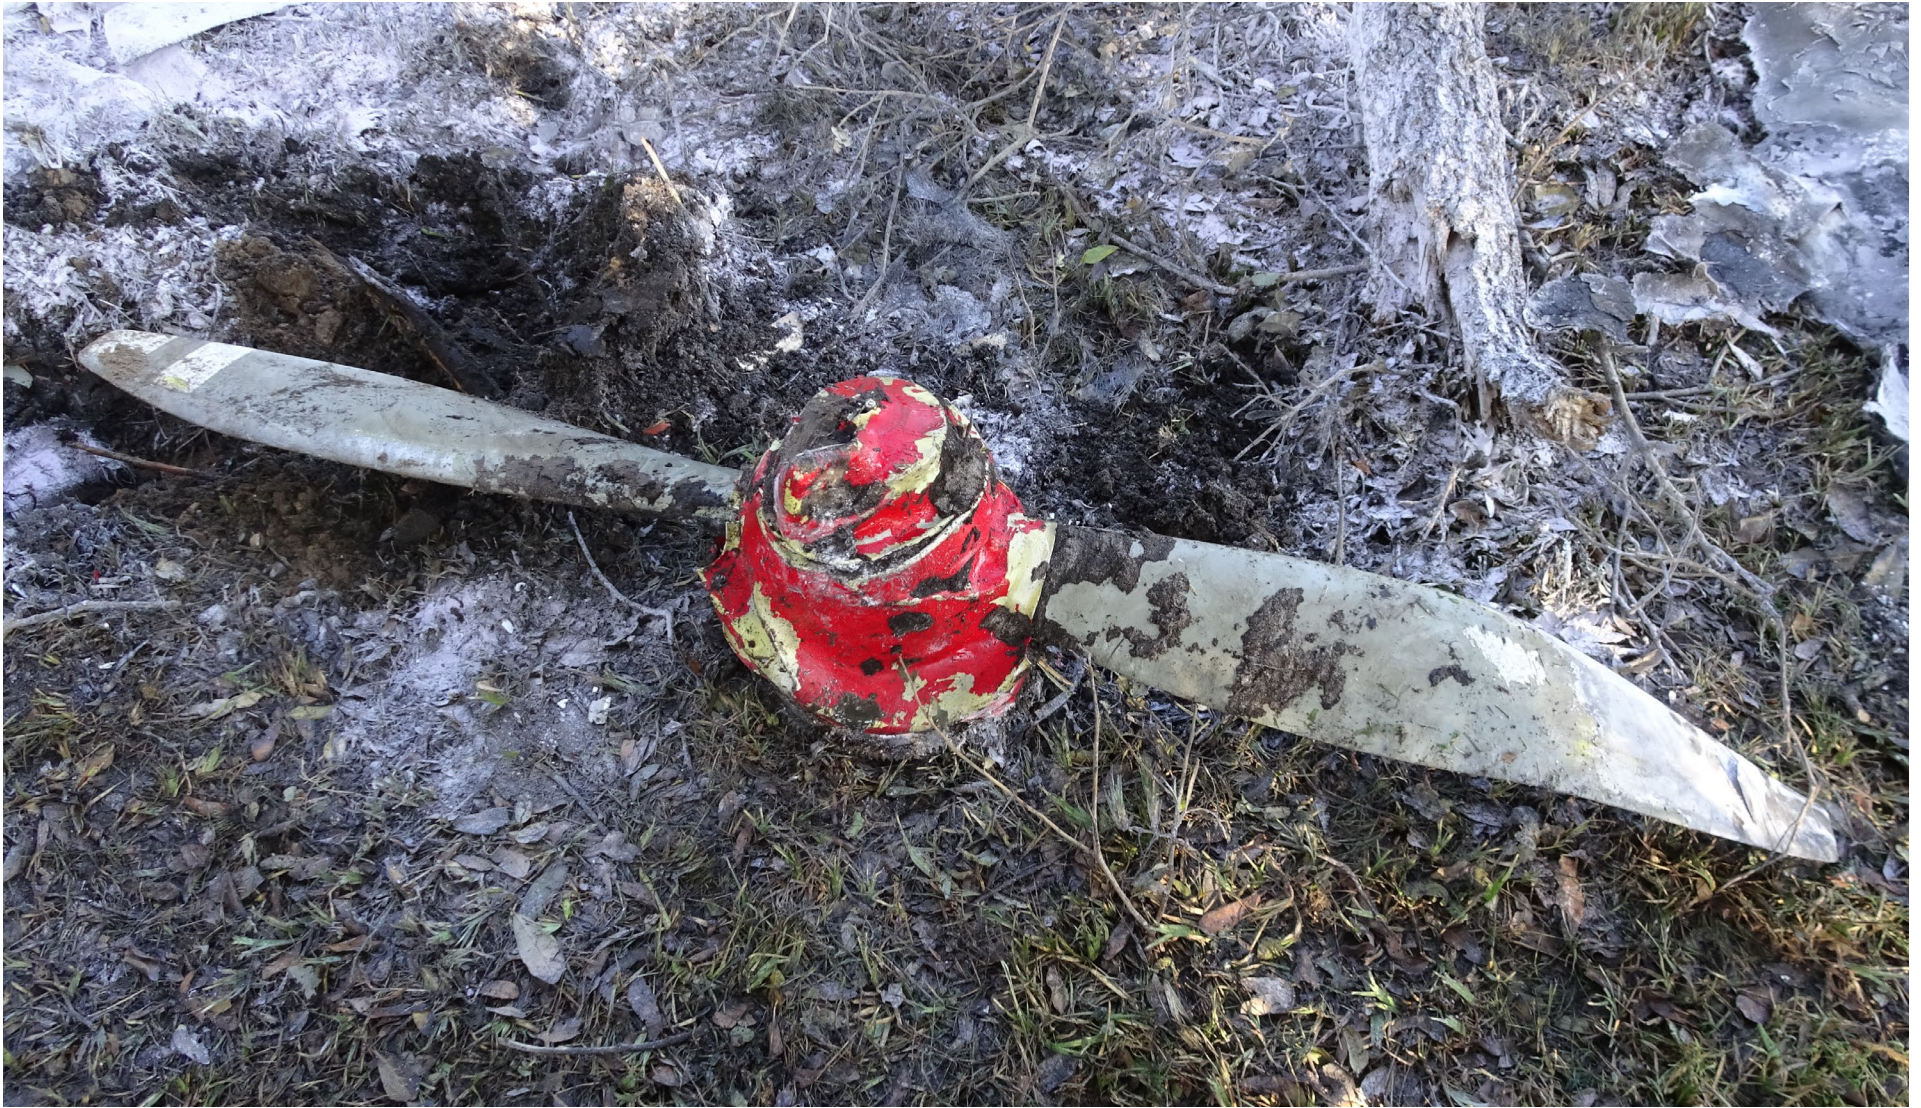
**Photo 8 - Digital Photograph From Daher. View Depicting The Separated Propeller Assembly.**
