# NATIONAL TRANSPORTATION SAFETY BOARD

## MATERIALS LABORATORY FACTUAL REPORT

Report No. 22-048

Place : Pembroke Pines, FL  
Date : December 17, 2020  
Vehicle : Socata TB10, N5547Y  
NTSB No. : ERA21LA080  
Investigator : Timothy Monville (AS-ERA)

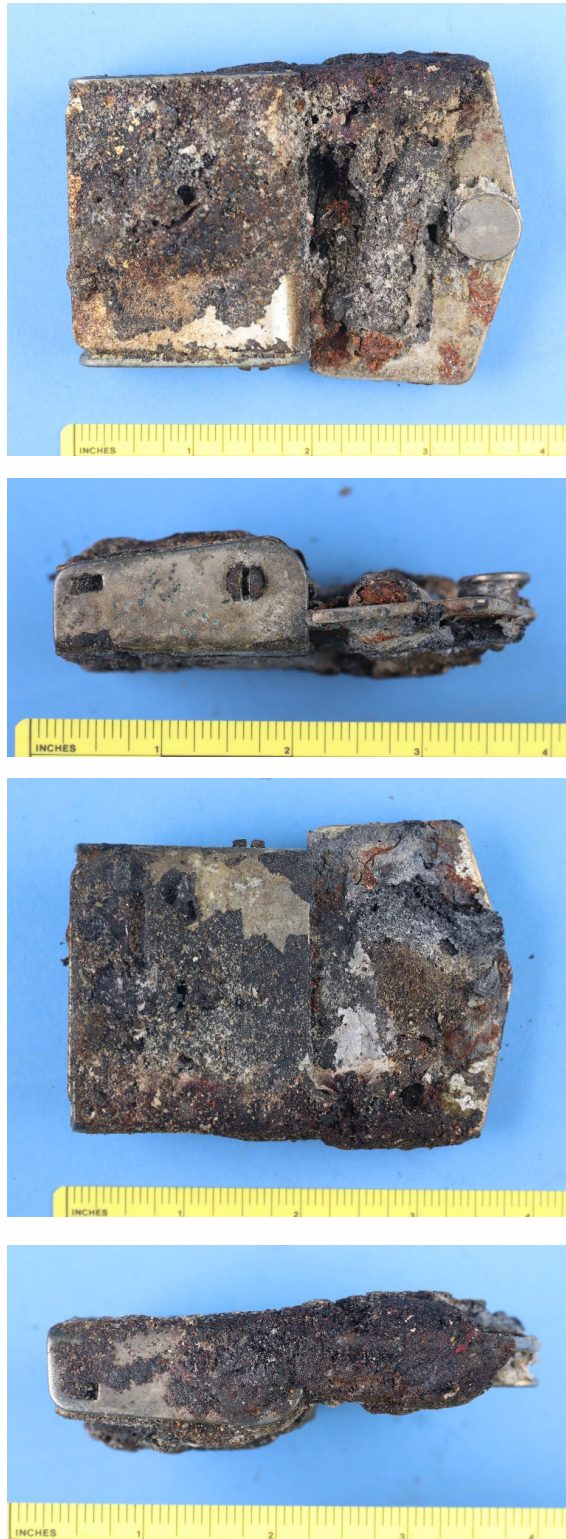
Views of the left and right seat belt buckles are shown in Figures 1 and 2, respectively. The left buckle had the link connector (male portion of the assembly) still engaged within the buckle (female portion of the assembly); the right buckle was submitted without an assembled link connector. Both buckles had darkened due to fire exposure and were coated with melted aluminum from the burned aircraft structure.

Figure 1: Macro photos of the left rear seat belt buckle with the link connector still engaged. The views are rotated 90 degrees from each other, top to bottom.

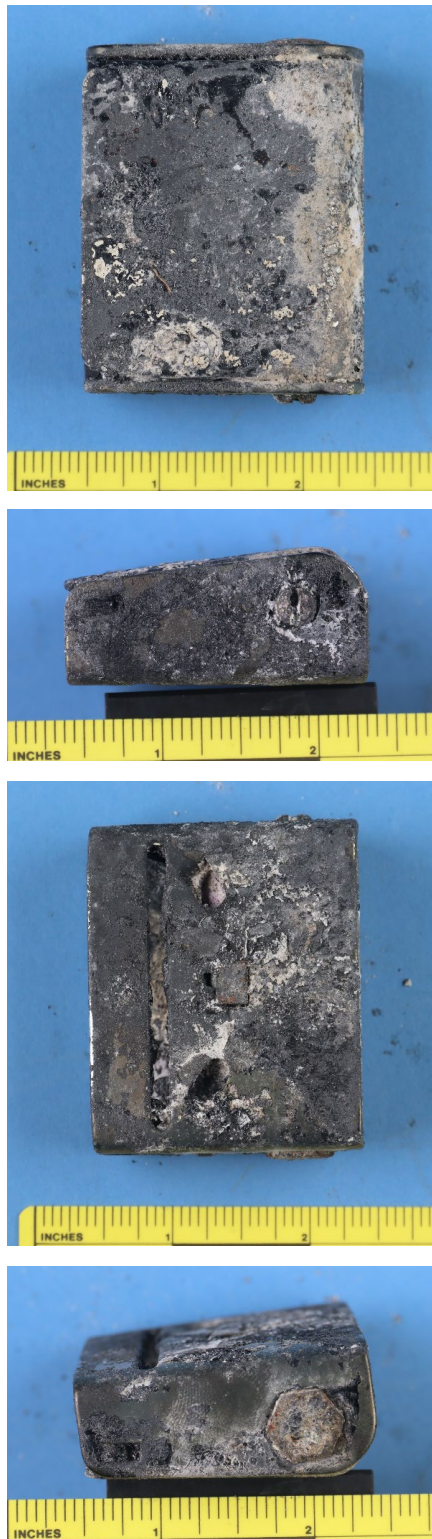
Figure 2: Macro photos of the right rear seat belt buckle that did not have a link connector still engaged. The views are rotated 90 degrees from each other, top to bottom.

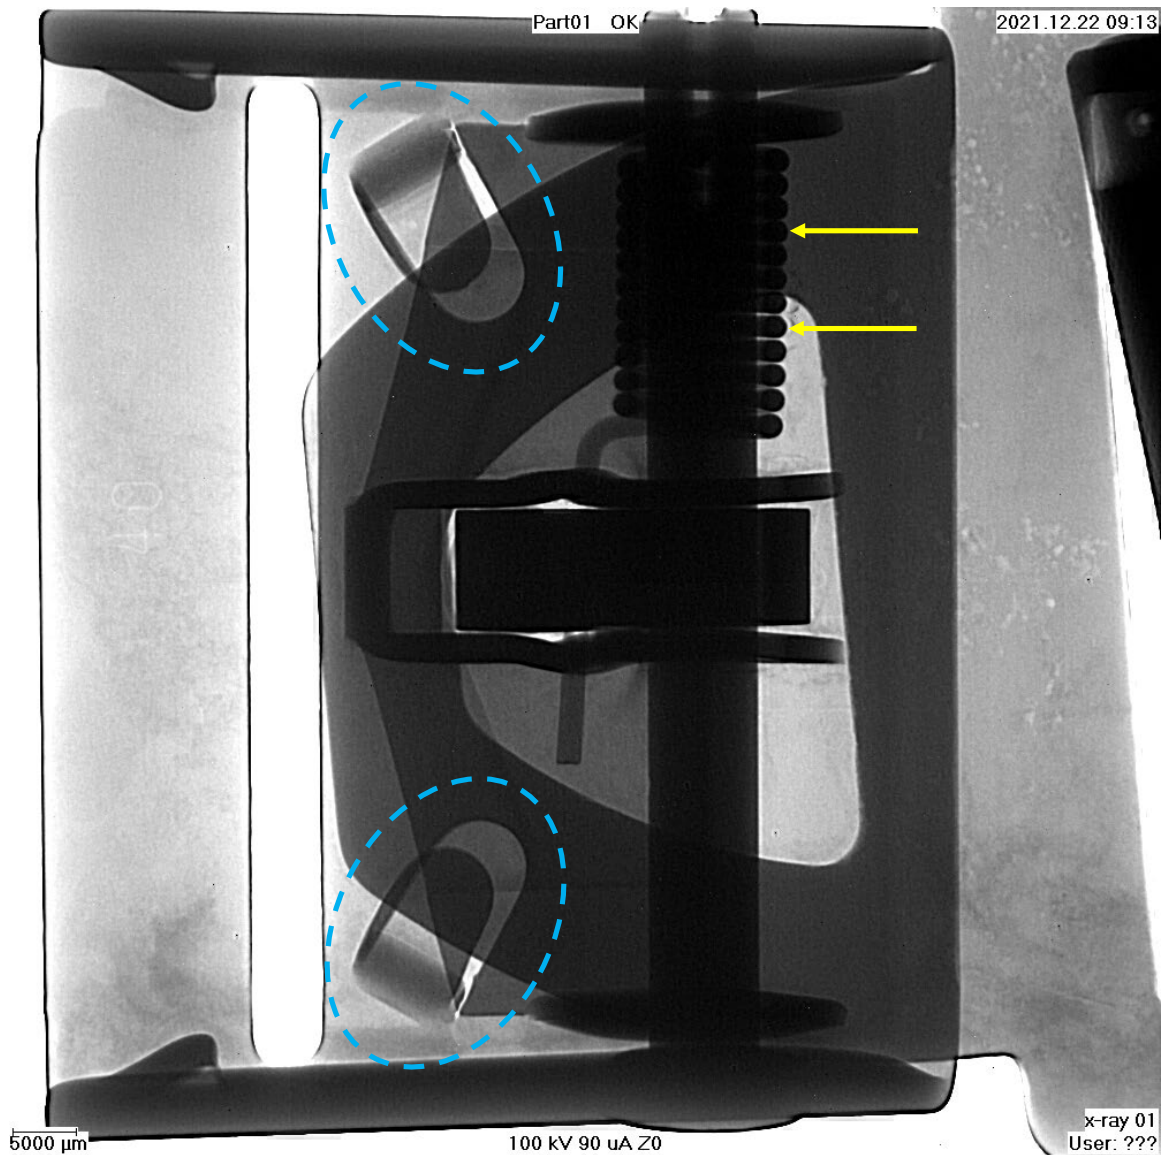
The left buckle was x-rayed to examine the internal components. X-ray images of the buckle are shown in Figures 3 and 4. The link connector appeared to align normally with the internal clips (blue dashed circles, Figure 3). The amount of rotation of the link connector within the buckle also appeared normal and would not be expected to interfere with unlatching.

The locking of the link connector to the buckle is accomplished using two internal springs, one torsion spring and one compression spring. The yellow arrows in Figure 3 point to the torsion spring, which was in the correct location and configuration, and appeared undamaged. A closer x-ray at higher power revealed the presence of the compression spring between the cover and the locking dog (yellow arrows, Figure 4), which also appeared undamaged.

In summary, the components of the left rear seat belt buckle appeared to all be present and assembled correctly, with no obvious visual damage. Consequently, there appeared to be nothing mechanically wrong with the buckle or connector link that would have precluded normal unlatching and operation.

Figure 3: X-ray image showing the left rear seat belt buckle with the link connector still engaged. The blue dashed circles highlight the internal clips. The yellow arrows point to the internal torsion spring.

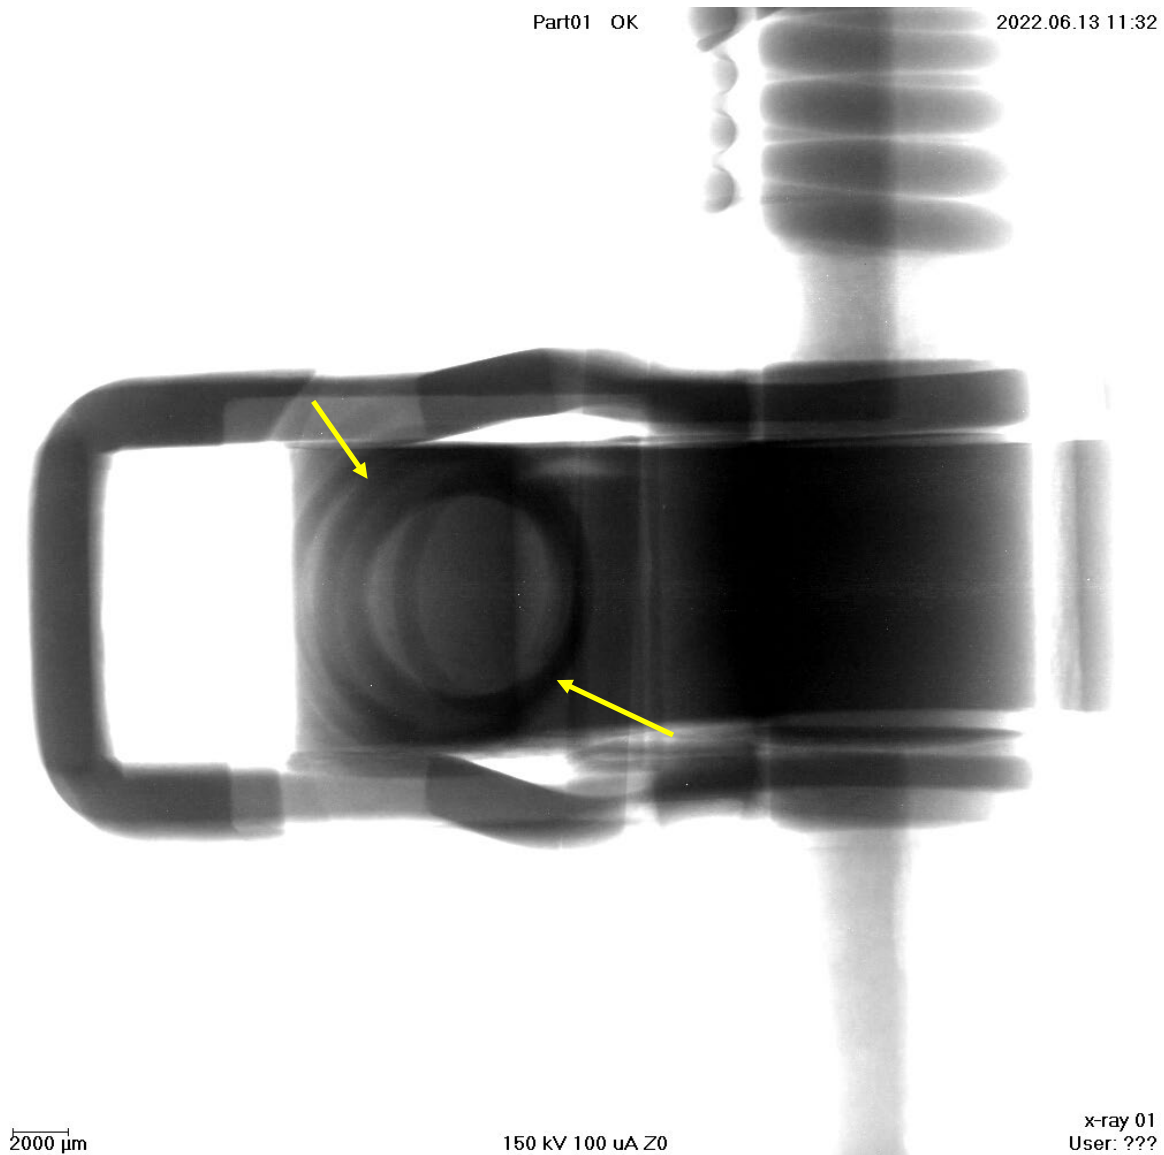
Figure 4: X-ray image showing a close-up of the locking dog in the center of the left rear seat belt buckle. The yellow arrows point to the internal compression spring.
