## **NATIONAL TRANSPORTATION SAFETY BOARD**

### **Specialist's Report**

# **METEOROLOGY**

ERA21LA085

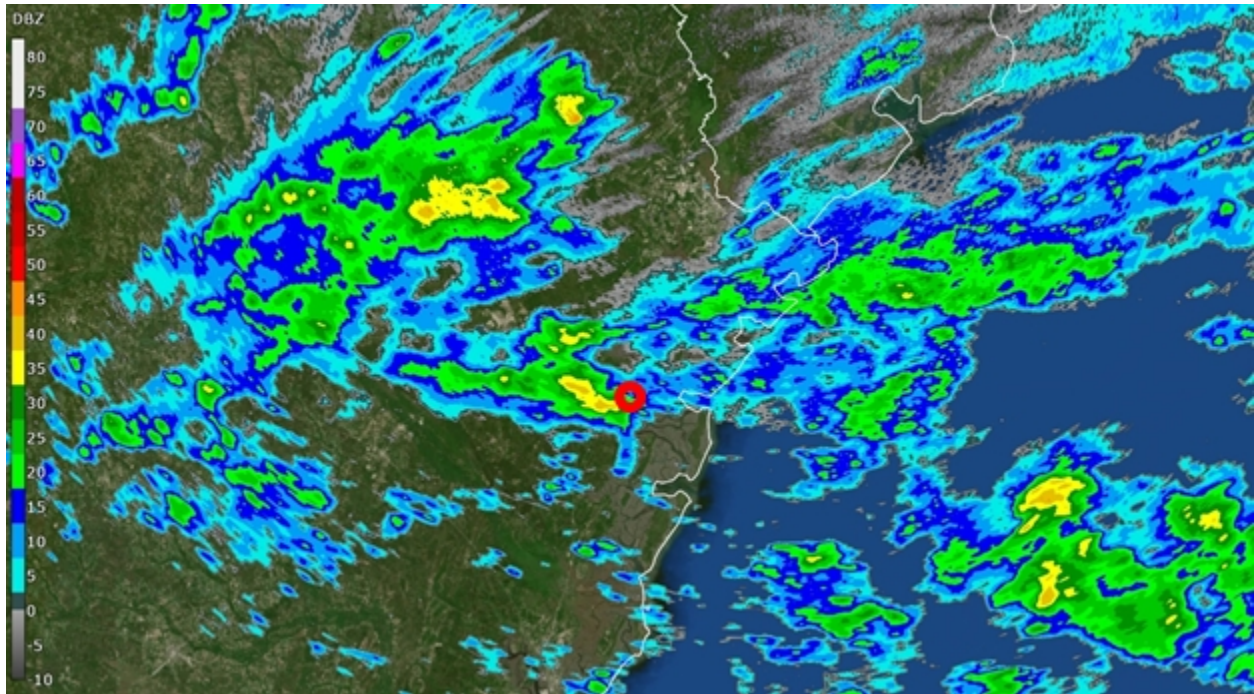
WSR-88D Level-II weather radar imagery from Charleston, South Carolina (KCLX), are presented in figures 1-3. KCLX was located about 58 miles north-northeast of the accident location at an elevation of about 230 feet. Assuming standard refraction and considering the 0.95° beam width for the WSR-88D radar beam, the KCLX 0.352° tilt would have “seen” altitudes above the accident location of between about 1,700 and 7,500 feet msl. These images depict light to heavy levels of precipitation in the immediate vicinity of the accident location moving from the southwest. A vertical cross-section of the Level-II weather radar imagery around this time along a southwest-to-northeast-oriented line that goes through the accident location is presented in figure 3. This image depicts the vertical reflectivity pattern “tilting” to the northeast with increasing height.

**Figure 1** – KCLX 0.352° Level-II base reflectivity product from a sweep initiated at 2004:20 EST. Accident location is within the red circle.

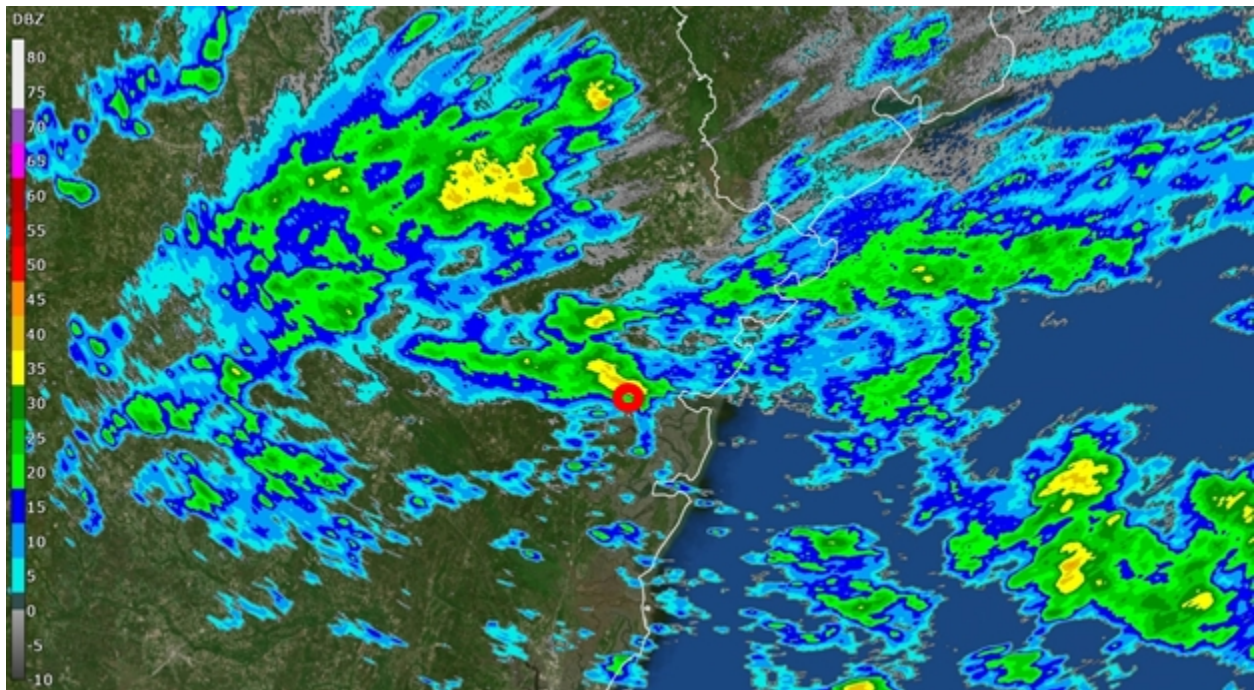
**Figure 2** – KCLX 0.352° Level-II base reflectivity product from a sweep initiated at 2009:51 EST. Accident location is within the red circle.

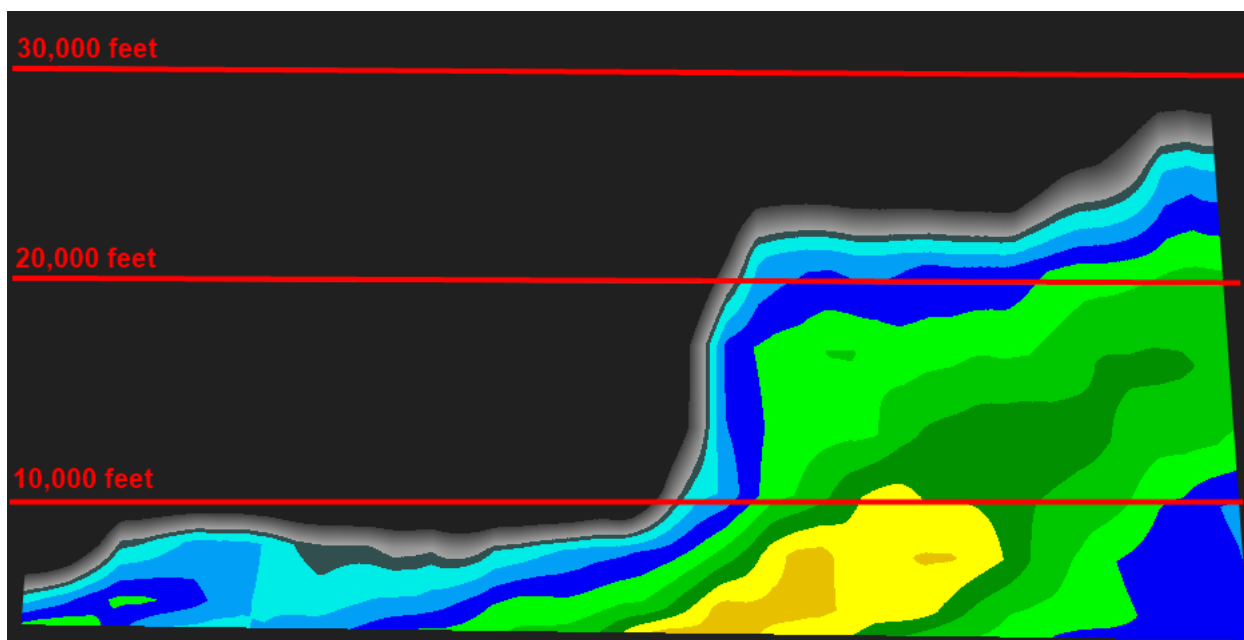
**Figure 3** – Vertical cross-section of the KCLX Level-II weather radar imagery for the volume scan initiated at 2009 EST. Color table is as presented in figures 1 and 2. The left-hand-side surface coordinates are 31.684376° latitude, -81.384193° longitude; the right-hand-side surface coordinates are 31.765274° latitude, -81.233818° longitude.

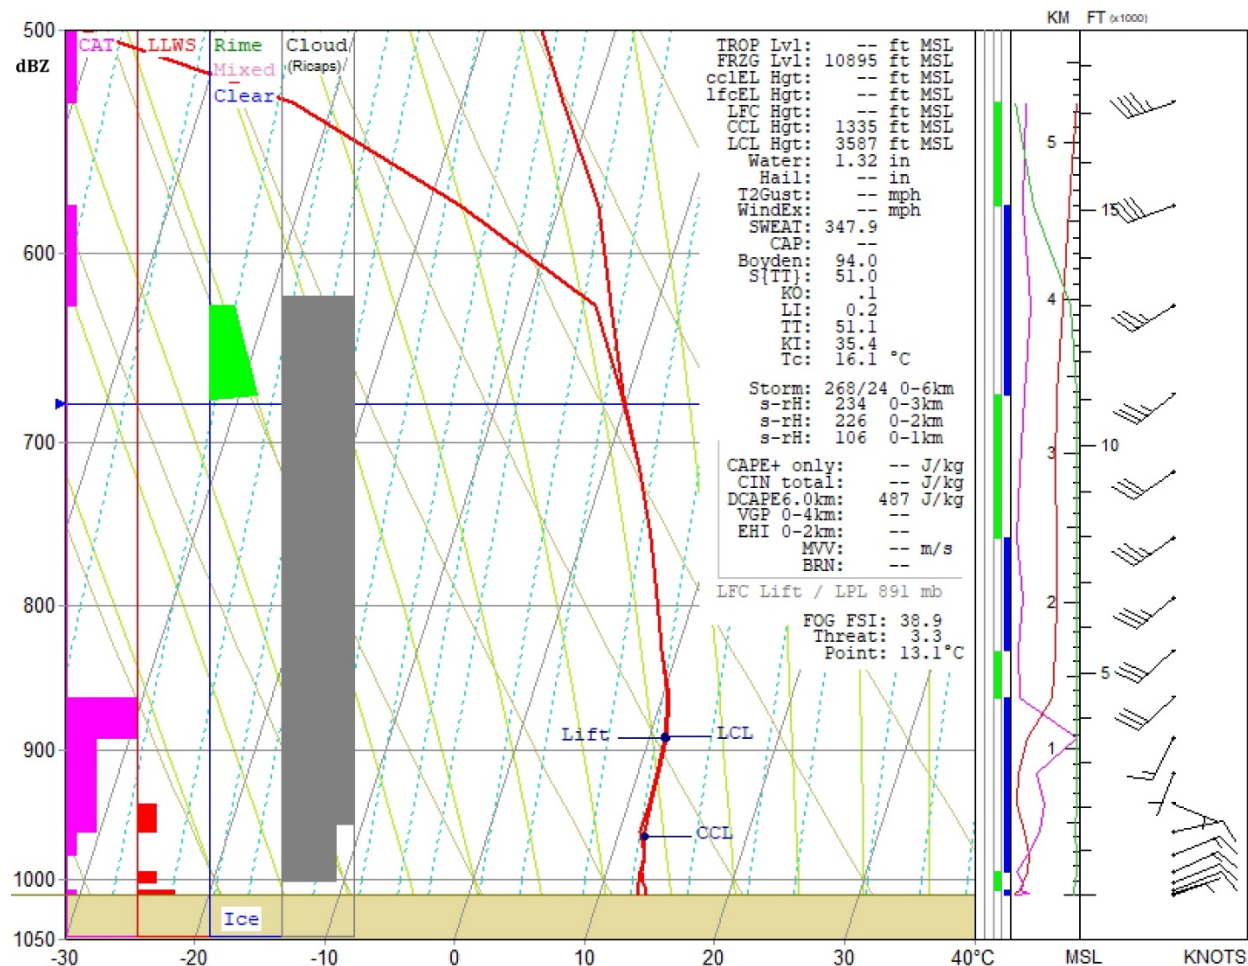
A High-Resolution Rapid Refresh (HRRR) model<sup>6</sup> sounding (figure 4) for the accident site at 2000 EST was retrieved from the National Oceanic and Atmospheric Administration's Air Resources Laboratory. Nearest the surface the wind was from the east-northeast at magnitude of 5 knots and remained from this direction through about 1,400 feet with magnitudes increasing to 10-15 knots in the layer. Above this layer the wind veered<sup>7</sup> to a southwest wind of about 35 knots at about 6,700 feet. The relative humidity was 97 percent or greater from near the surface to about 12,000

feet, and the Rawinsonde Observation Program (RAOB) identified cloudy conditions between about 300 and 13,000 feet. RAOB identified moderate low-level wind shear at the surface.

**Figure 4** – HRRR model sounding data in SkewT/LogP format for 2000 EST at the accident site, surface to 500 hPa.

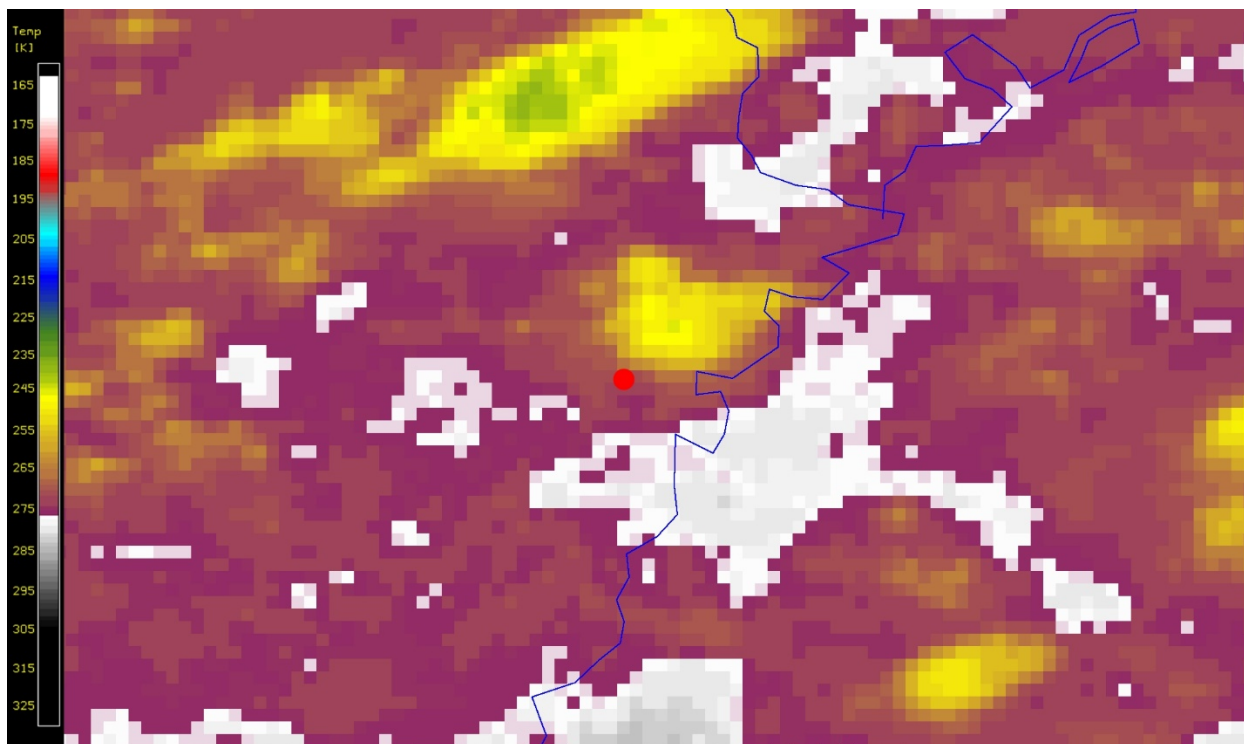
Geostationary Operational Environmental Satellite (GOES)-16 infrared (10.3 $\mu$ m) data were obtained from an archive at the Space Science Engineering Center at the University of Wisconsin-Madison. Imagery from 2011 EST is presented in figure 5. The GOES-16 infrared brightness temperatures over the accident location were -1°C, which, when considering the HRRR model sounding, corresponded to cloud top heights of about 11,500 feet.

**Figure 5** – GOES-16 infrared brightness temperature imagery from 2011 EST. Accident location is denoted by the red circle. This image has not been corrected for any parallax error.
