## **NATIONAL TRANSPORTATION SAFETY BOARD**

Office of Aviation Safety  
Eastern Region

**Photo Array**

**ERA21LA091**

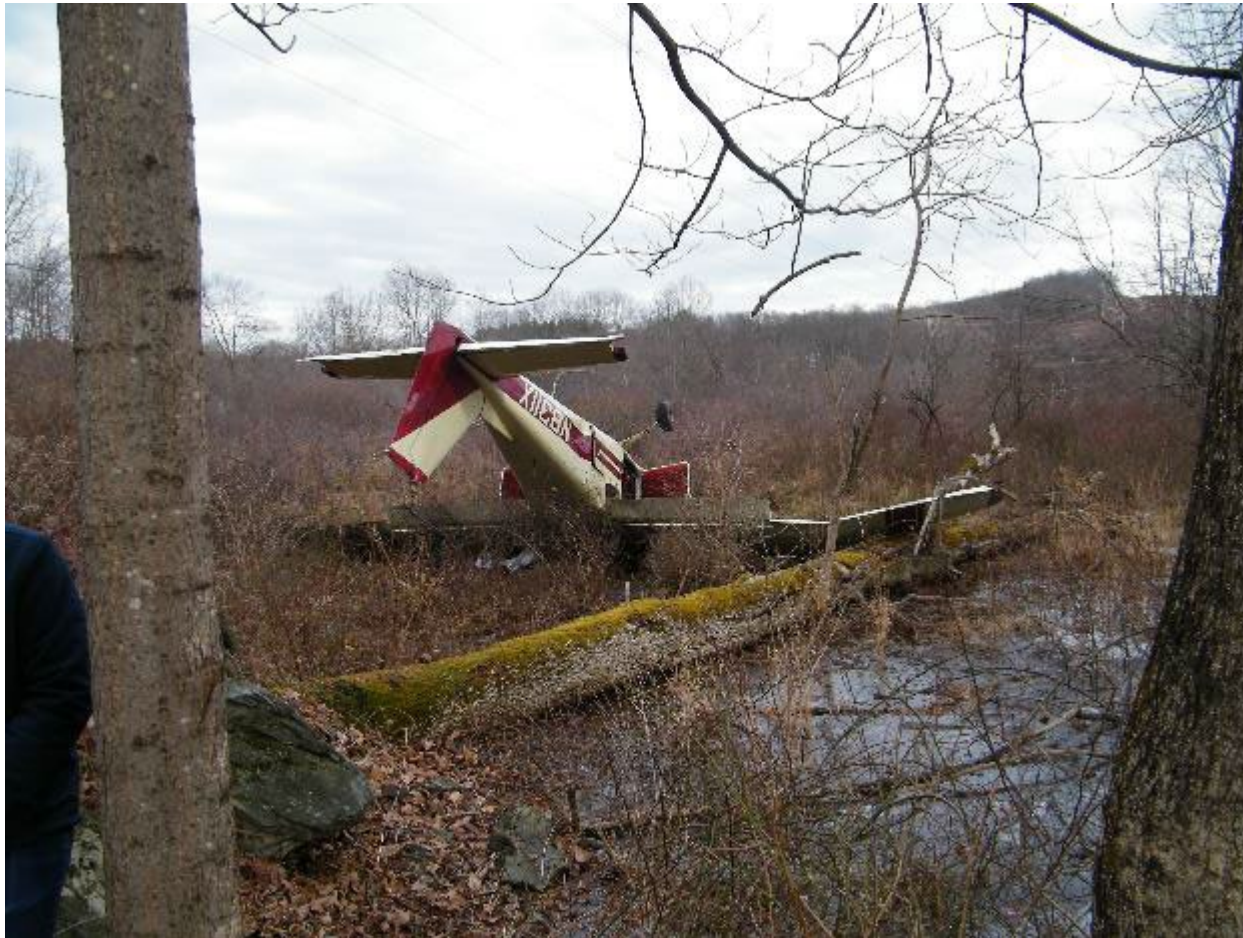
**Photo 1 – View of the airplane inverted where it came to rest. (Photo courtesy of FAA)**

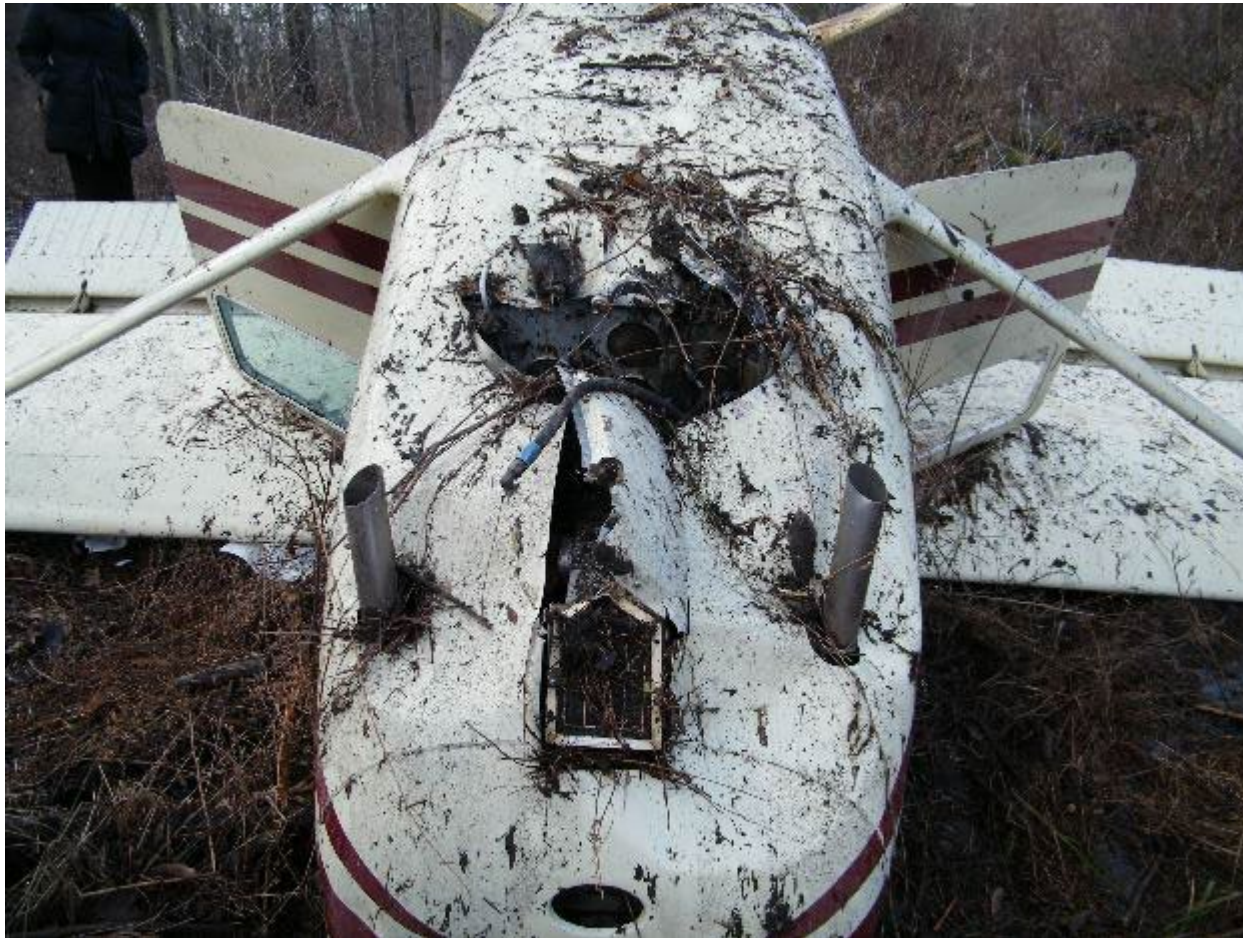
**Photo 2 – View of the damage belly of the airplane. (Photo courtesy of FAA)**

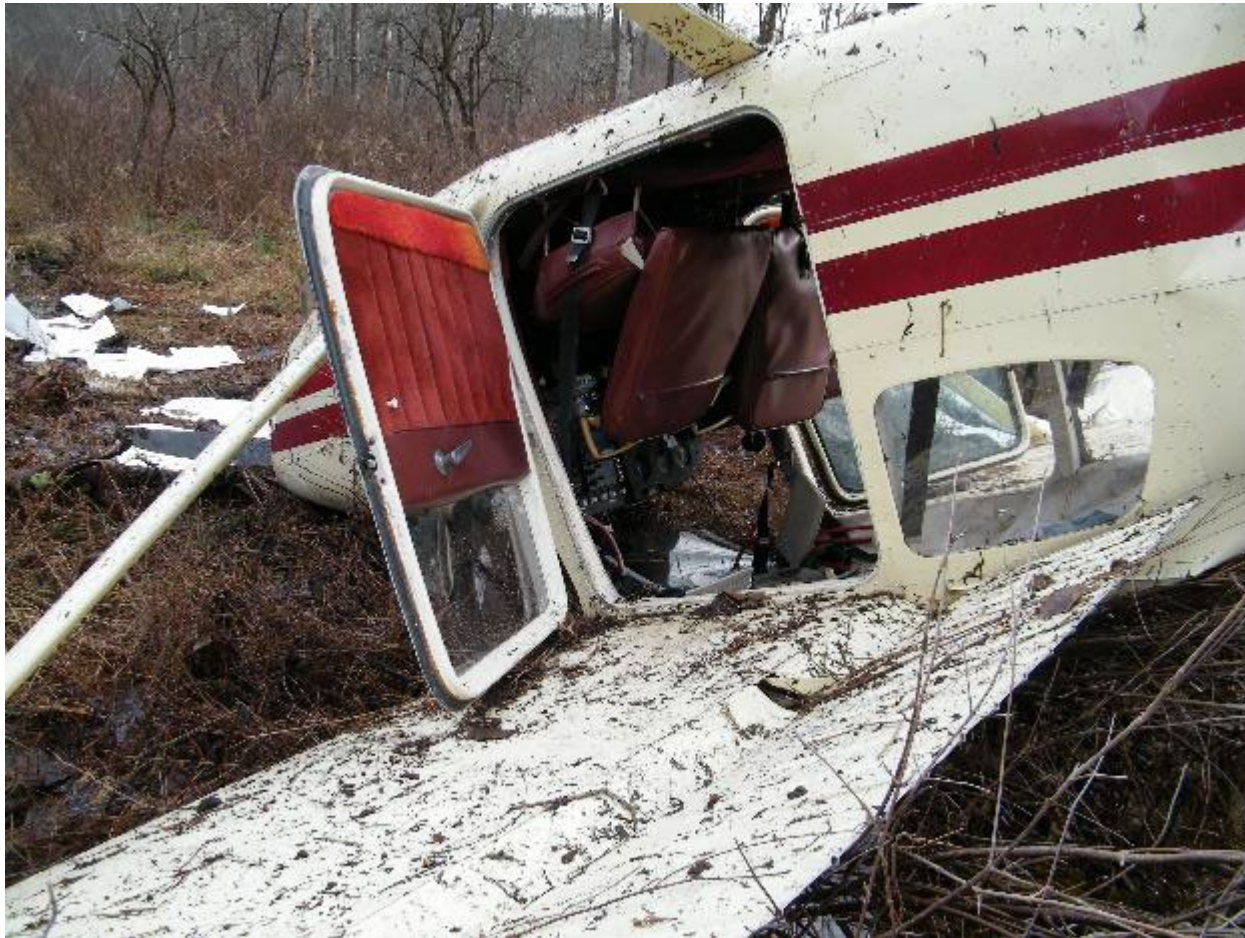
**Photo 3 – View of the right side of the airplane. (Photo Courtesy of FAA)**
