## **Magneto Examination Report**

NTSB ACCIDENT NUMBER: **ERA21FA091**

AIRCRAFT REGISTRATION: N8311X

AIRCRAFT TYPE: Cessna 172

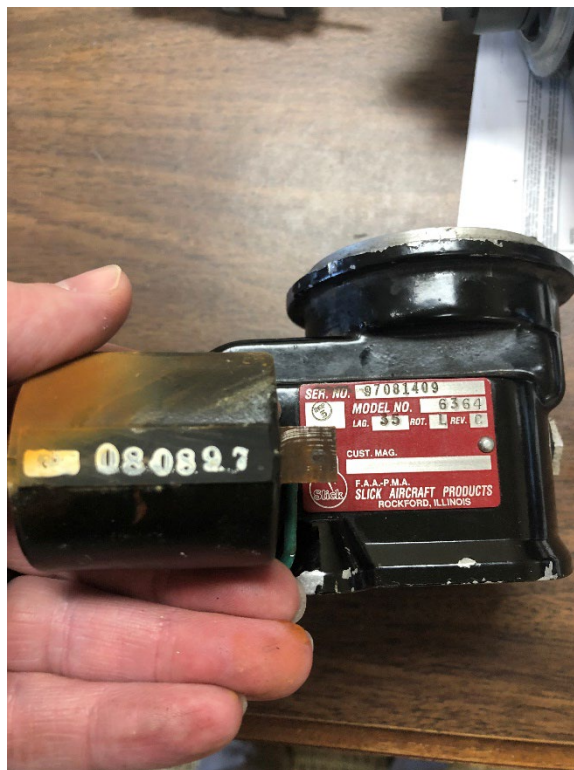
- Manufactured in 1997
- Impulse couplings, and ignition harness were in good condition. The gears were removed for bench testing.
- A wire attached to the magneto showed several areas of fractured insulation.

- P-lead has washer and nut to connect to ignition switch.
- The gear retainer nut was not torqued, it was hand-tight, loosened, and removed by hand. The maintenance manual requires specific torquing of the nut.

- Bench test: no spark with impulse coupler, a little spark at high speed, no voltage.
- Capacitor nut in good condition.
- Impulse coupling in new condition, pawls in good condition.

- Rotor shaft had dimples consistent with normal wear.
- Rust, debris, and corrosion in the magneto housing and distributor gear housing.
- Finger on distributor gear had normal wear and some debris present.

- The magneto points were in good condition.
- Underneath the bearing plate caps rusted.
- Rotor had extensive rust and dimpling, coil and coil wires in good condition.

- Extensive rust corrosion around the coil laminations and coil housing.

Figure 1: View of the left magneto and coil. (Photo courtesy of Champion)

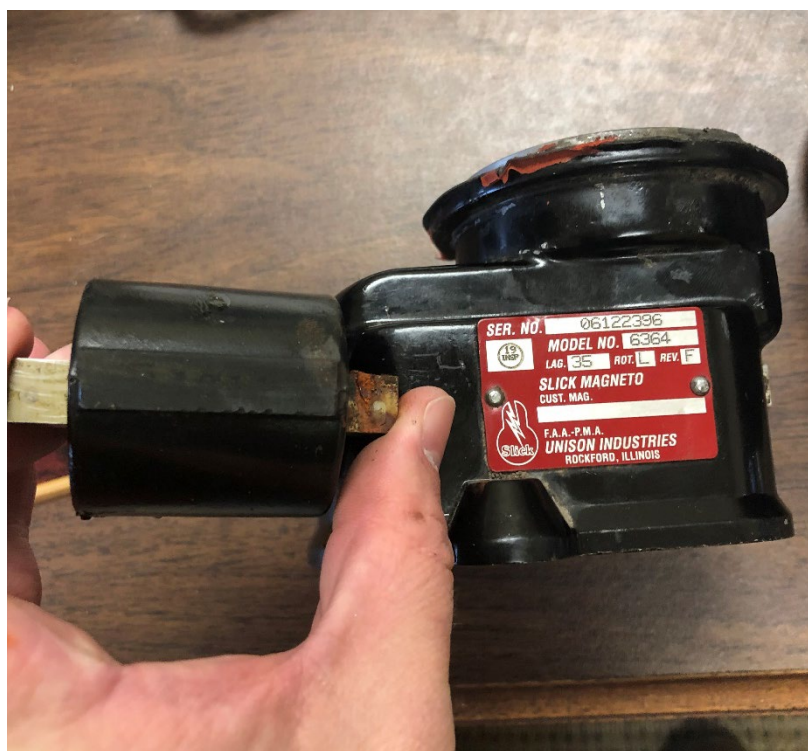
- Manufactured in 2006
- The impulse couplings and ignition harness were in good condition.
- There was no cotter pin in the gear assembly. The gears were removed for bench testing.

- The gear retainer nut was not torqued, it was hand-tight, loosened, and removed by hand. The maintenance manual requires specific torquing of the nut.

- P-lead missing washer and nut to hold to connect to ignition switch.
- Bench test: no spark with impulse coupler, a little spark at high speed, no voltage.

- The impulse coupling was tight and in good condition.
- The terminal and housing assembly were in good condition.
- Moisture present, rust present on the lamination.

- Distributer gear had arcing present, there were markings on the distributor points
- Rotor gear and cam in good condition. The points assembly was worn where the cam hits, normal wear on the cam.

- Arcing was present throughout the distributor gear and points.
- Rotor bearing plate screws and cap had rust and corrosion present. Rotor had grease and rust present.

- Bearing leaking grease. Rust and grease present on the laminations in the rotor.
- Capacitor in good condition, there was extensive corrosion present on capacitor nut.

Figure 2: View of the right magneto and coil. (Photo courtesy of Textron)
