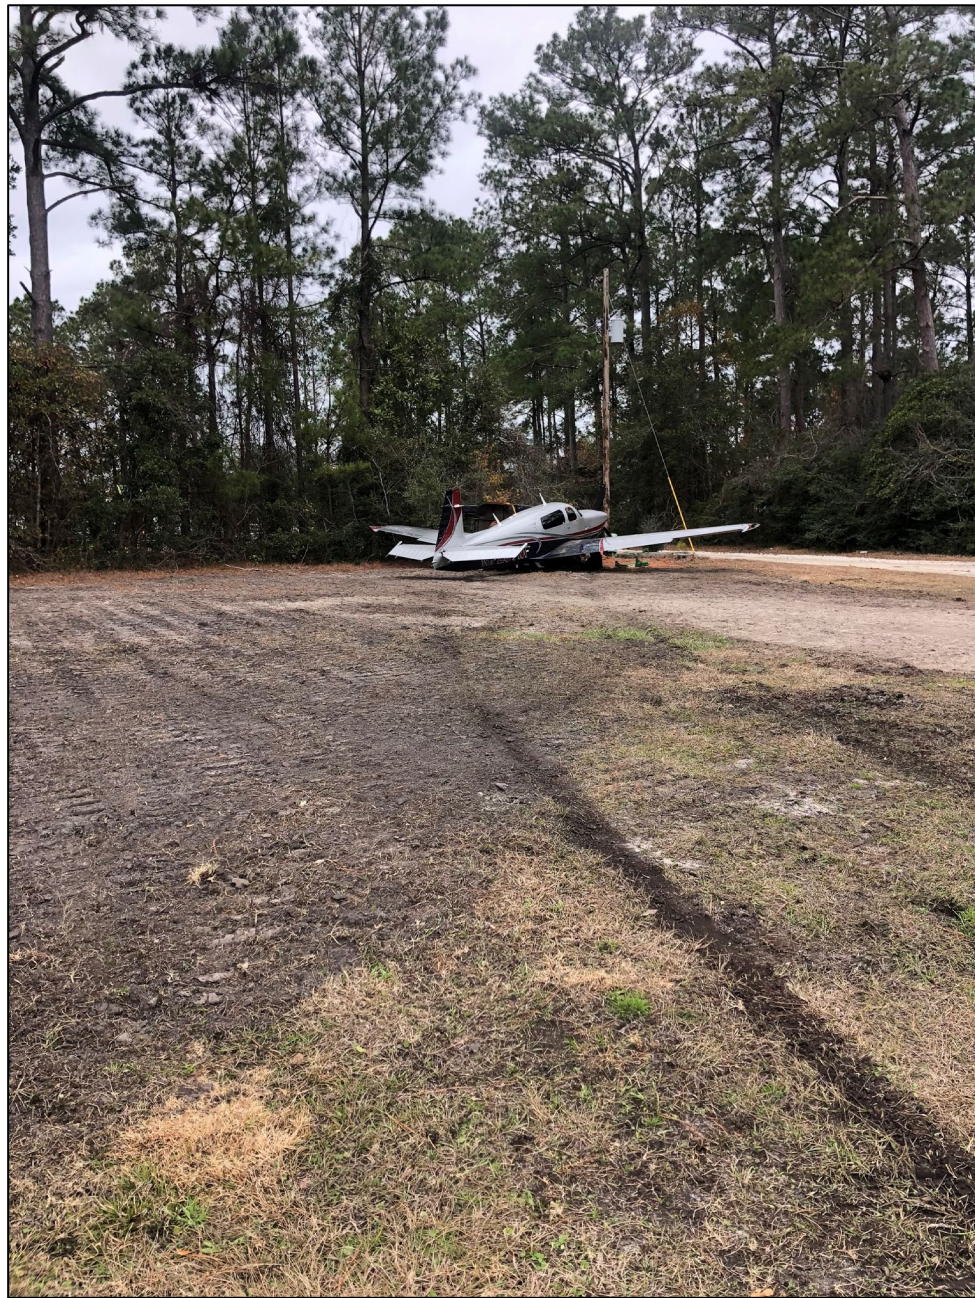
Photo 1 – View of the airplane and ground scarring from the runway excursion (Photo Courtesy of FAA)

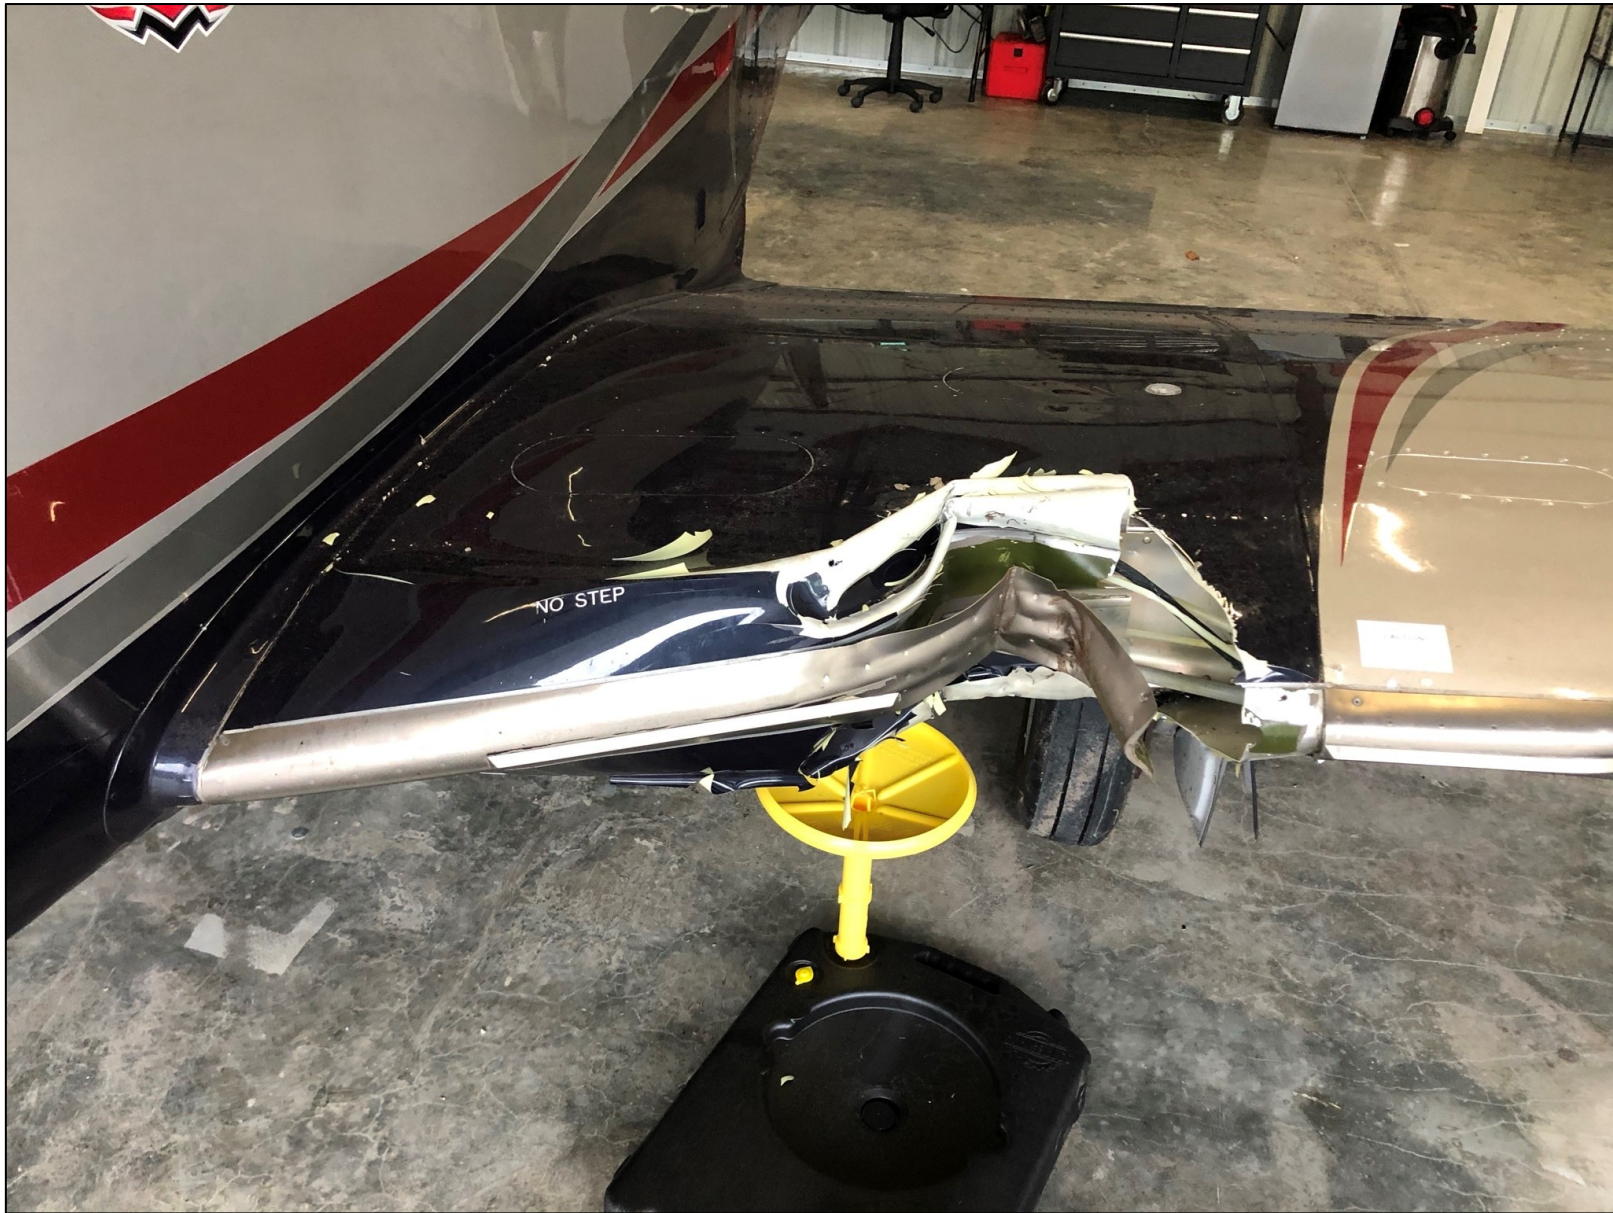
Photo 2 – View of the substantially damaged left wing (Photo Courtesy of FAA)
