# NATIONAL TRANSPORTATION SAFETY BOARD

## MATERIALS LABORATORY FACTUAL REPORT

Report No. 21-042

Place : Leesburg, Virginia  
Date : January 19, 2021  
Vehicle : American AA-5, N5880L  
NTSB No. : ERA21LA106  
Investigator : Timothy W. Monville, AS-ERA

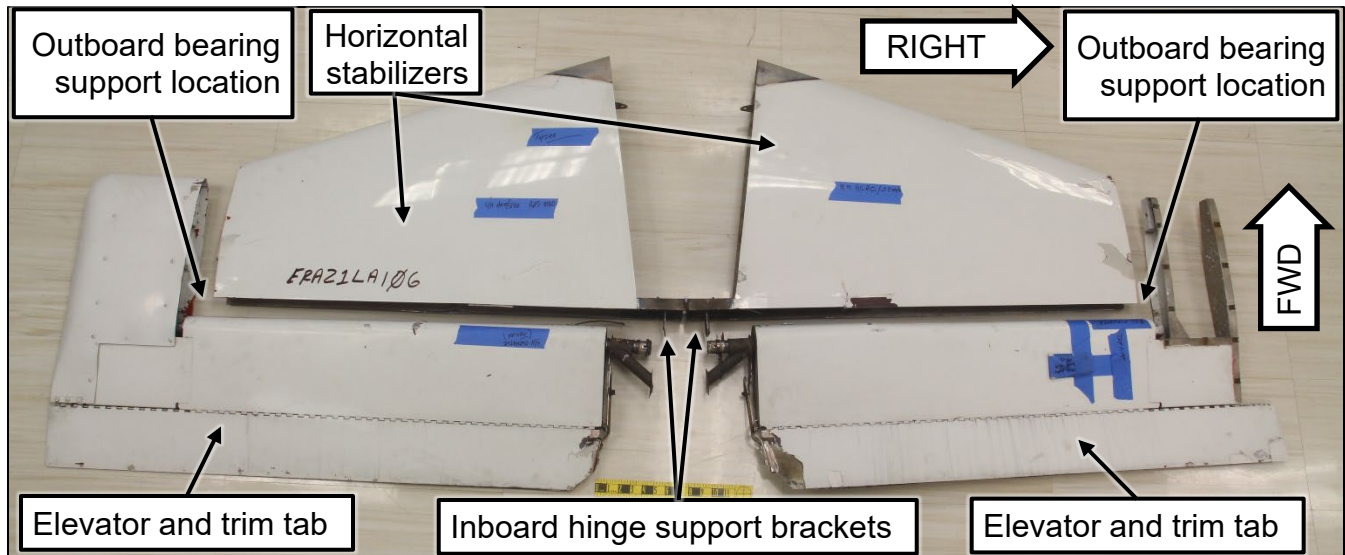
An overall view of the submitted horizontal stabilizers, elevators, and elevator trim tabs from the accident airplane is shown as-received in figure 1. The elevators and trim tabs were received disassembled from the horizontal stabilizers, and the tip assembly had been removed from the outboard end of the right elevator. The aft spars were fractured near mid span on both the left and right horizontal stabilizers. The outboard rib on the left horizontal stabilizer was fractured as shown in figure 2, and the fractured piece was missing. The outboard bearing support bracket for the left elevator was missing along with the fractured rib piece. The outboard bearing support bracket associated with the right elevator was disassembled from the outboard rib of the right horizontal stabilizer and was included with the submitted components. White-colored oxides covered much of the interior surfaces of each of the components. Drain holes in the lower skins of the horizontal stabilizers were open and free of debris.

Figure 1. Overall view of the submitted horizontal stabilizer, elevator, and elevator trim tab assemblies from the accident airplane as received.

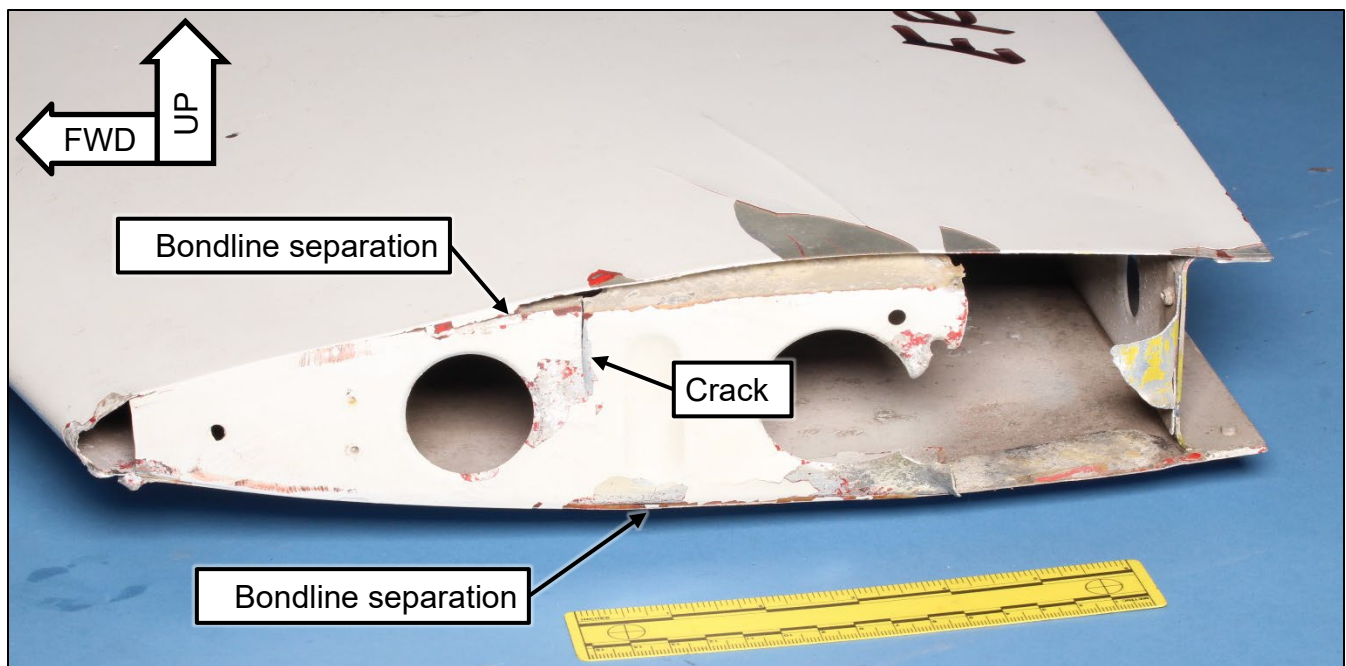
Figure 2. Left end of the horizontal stabilizer assembly showing the fractured and cracked outboard rib.

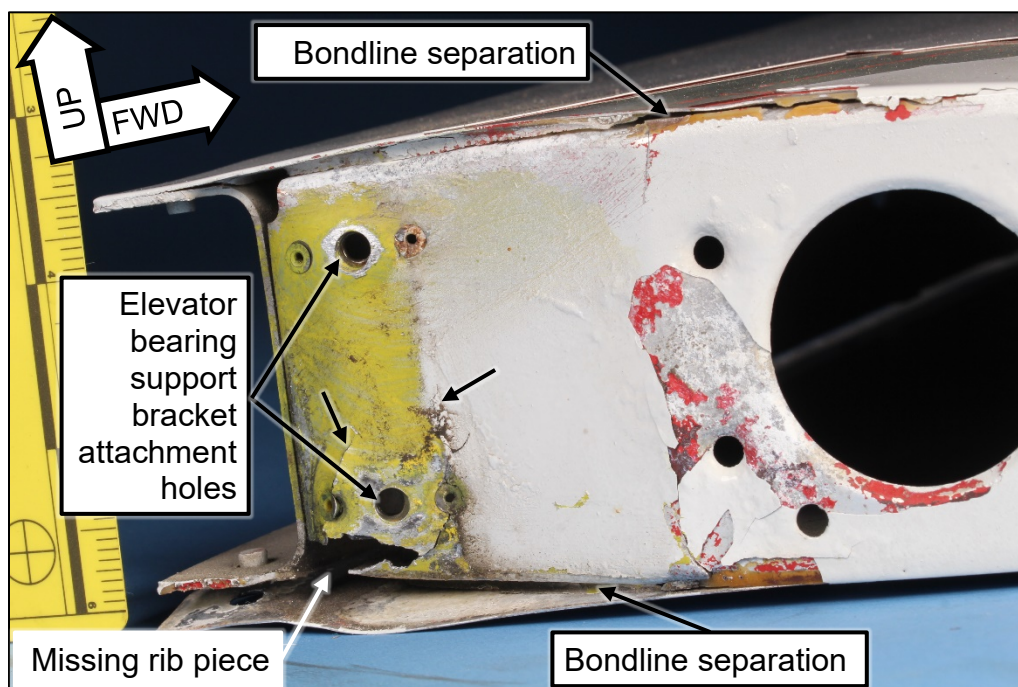
Figure 3. Right end of the horizontal stabilizer assembly showing the aft end of the outboard rib. Unlabeled arrows point to cracks extending upward from rivet holes associated with the lower nut plate for the outboard elevator bearing support bracket attachment.

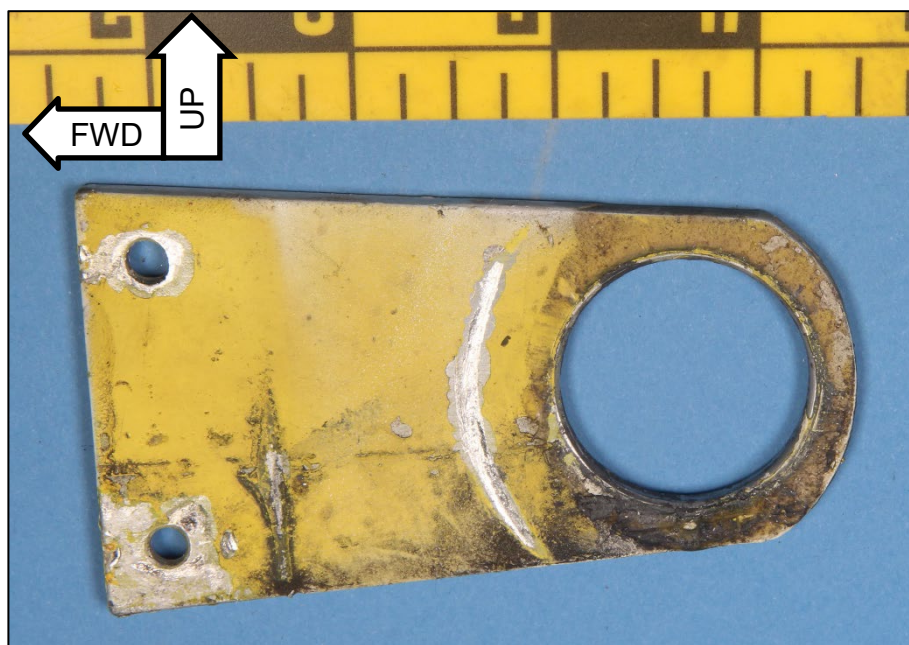
Figure 4. Right elevator outboard bearing support bracket.

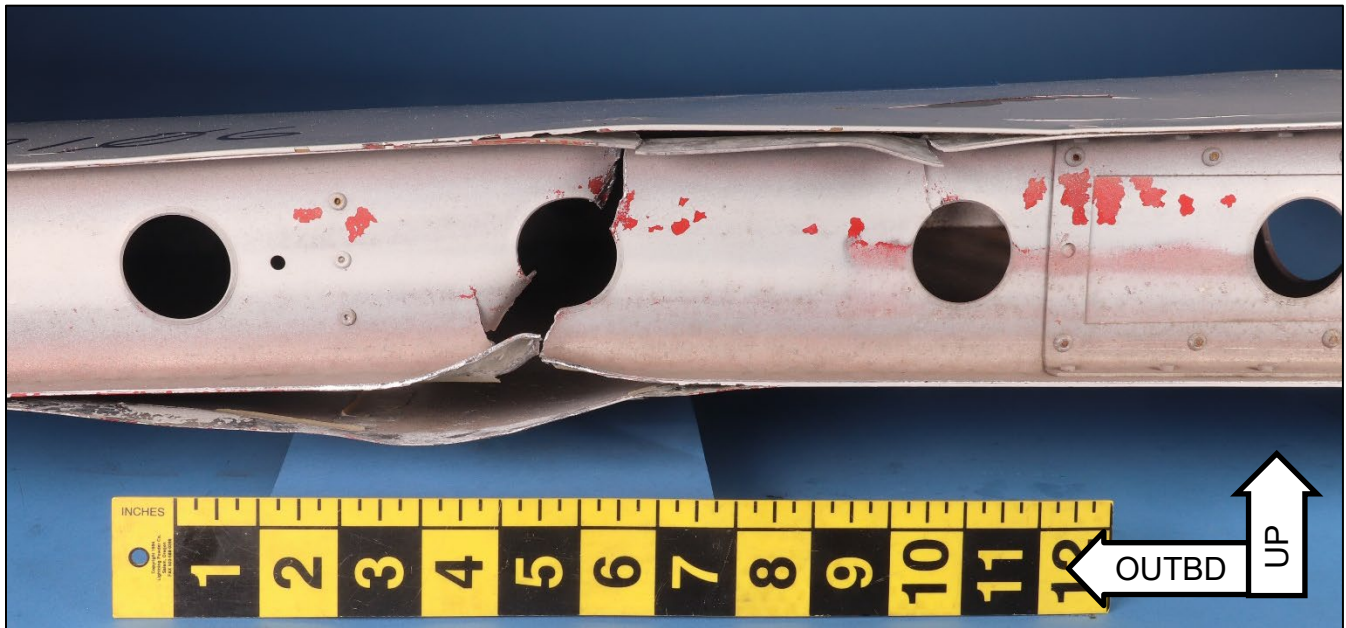
The aft spars on the horizontal stabilizers were fractured at approximately left station 19 to 20 and right station 14<sup>1</sup> as shown in figures 5 and 6. On the left horizontal stabilizer aft spar, the upper flange was fractured at left station 19 and buckled and cracked at left station 14.75, and the lower flange was buckled and fractured at left station 20. On the right horizontal stabilizer aft spar, the lower flange was buckled and the upper flange was slightly buckled near the fracture at right station 14. The lower flange was also buckled and cracked at right station 17. The upper and lower skins around each aft spar damage area also showed buckling deformation.

Bondline separations were observed between the aft spar and the upper skin on the left horizontal stabilizer along 1.5 inches from the inboard end and between left stations 13 to 21.5. The aft spar was separated from the lower skin at the bondline between left stations 16.75 to 27.5. On the right horizontal stabilizer, a 5-inch separation was observed between the upper skin and the aft spar where the skin was buckled outboard of the spar fracture. The lower skin was disbonded from the aft spar along the entire length of the spar outboard of the outboard rivet for the spar connector. Additionally, a rivet at the outboard end of the bondline had pulled through the lower skin.

Figure 5. Fractured and buckled aft spar on the left horizontal stabilizer.

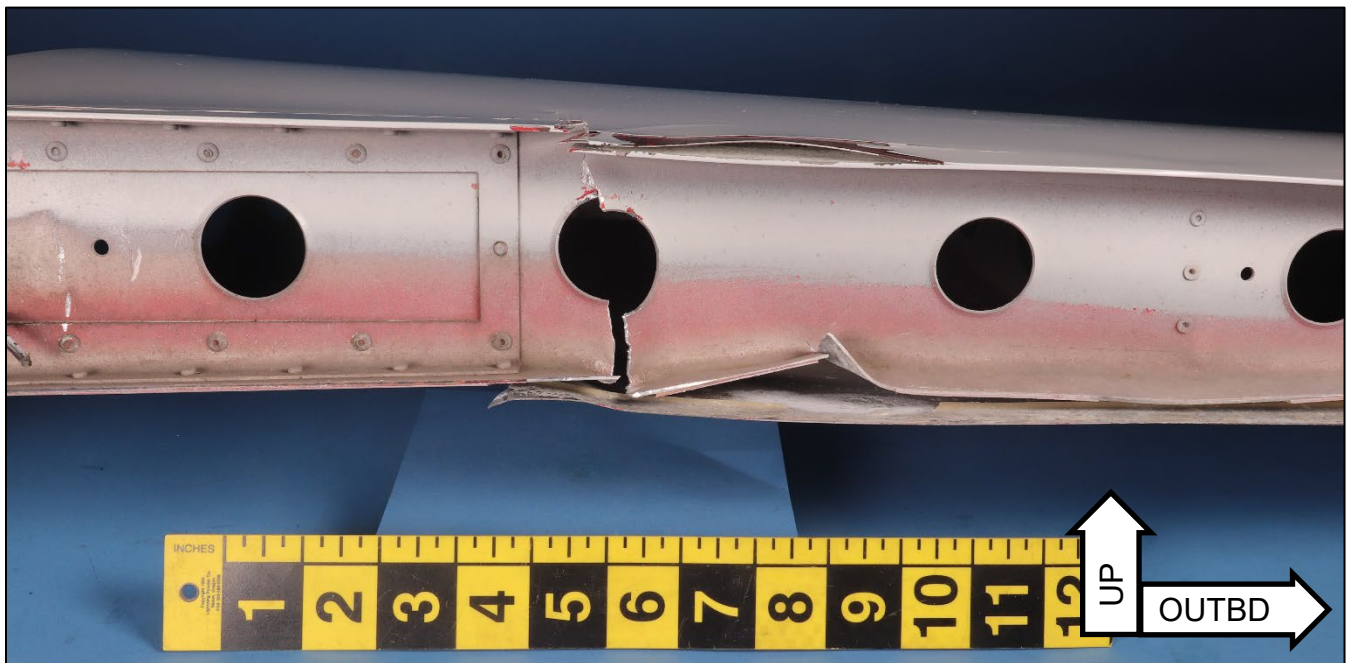
Figure 6. Fractured and buckled aft spar on the right horizontal stabilizer.

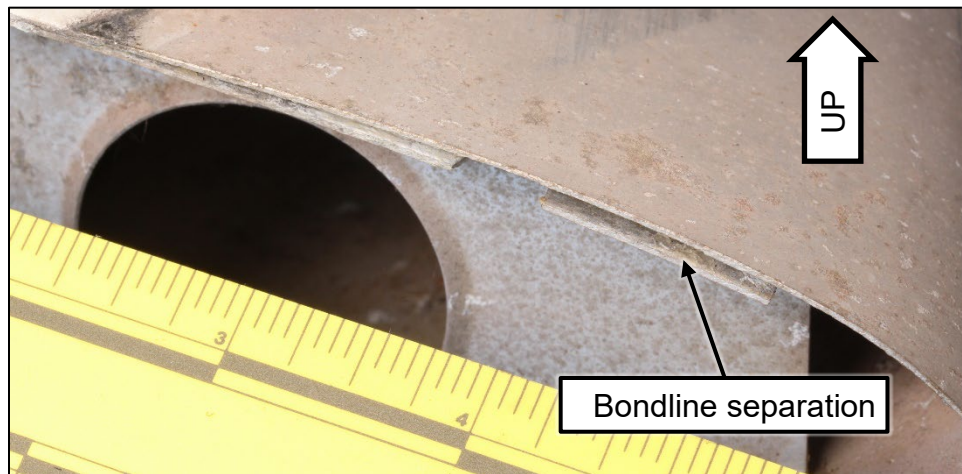
Bondline separations were also observed between the ribs and the skins on both horizontal stabilizers. On the left horizontal stabilizer, bondline separations were observed between the inboard rib and the skin extending 3 inches aft from the leading edge at the upper bondline (see figure 7) and 13 inches forward from the aft edge at the lower bondline. The middle rib for the left horizontal stabilizer was also separated from the lower skin. At the outboard rib, the upper skin was bowed upward at the bondline, and the rib was separated from the upper skin extending 8 inches forward from the aft spar. The lower bondline for the outboard rib was separated extending 7.5 inches forward from the aft spar. The skin at the leading edge was also deformed, and 0.5-inch-long bondline separations were observed extending from the leading edge of the outboard rib along the upper and lower flanges.

Figure 7. Bondline separation between the inboard rib flange and the upper skin on the left horizontal stabilizer at the forward end of the rib.

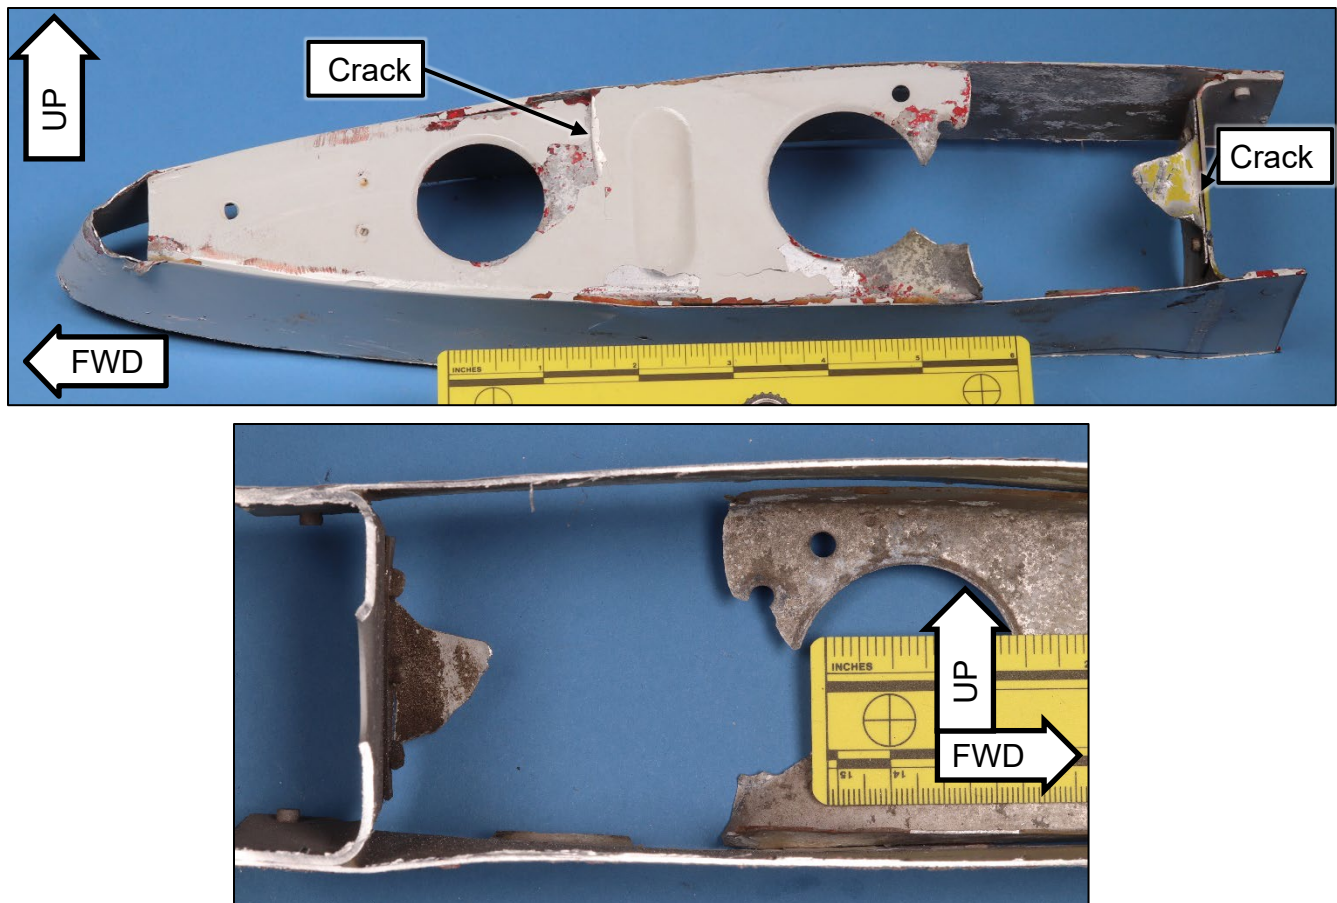
In order to more closely examine cracks and fractures in the outboard ribs, portions of the outboard ends of the horizontal stabilizer were cut from the remainder of the assemblies as shown in figures 8 and 9. As shown in figure 8, the outboard rib for the left horizontal stabilizer was fractured adjacent to the aft spar and through the aft lightening hole. The fractures intersecting the aft lightening hole extended from cutouts in the upper and lower flanges associated with a bend in the rib web. A vertical crack also extended from the upper side of the rib through approximately half the rib aft of the forward lightening hole.

On the fractures intersecting the aft lightening hole, rough fracture features with out-of-plane bending deformation were observed, features consistent with ductile overstress fracture. The upper flange was bent downward relative to the rib web, and the adjacent fracture in the web was bent outward near the lightening hole. On the lower side of the fracture aft of the lightening hole, the lower flange was bent upward, and the adjacent web fracture was bent downward and outboard. At the aft end of the outboard rib, the aft flange and a triangular-shaped piece remained attached to the aft spar. The forward tip of the triangular piece was bent inboard, and contact marks were observed on the outboard face. A portion of the lower aft side of the triangular piece was curled up and aft with associated contact marks on the inboard face, consistent with contact with the lower nut plate. A vertical crack extended upward along the bend between the aft flange and the triangular-shaped web piece to approximately the middle of the web.

Figure 8. Outboard piece of the left horizontal stabilizer after it was cut from the rest of the assembly showing the outboard face (upper image) and the inboard face (lower image) of the fractured outboard rib.

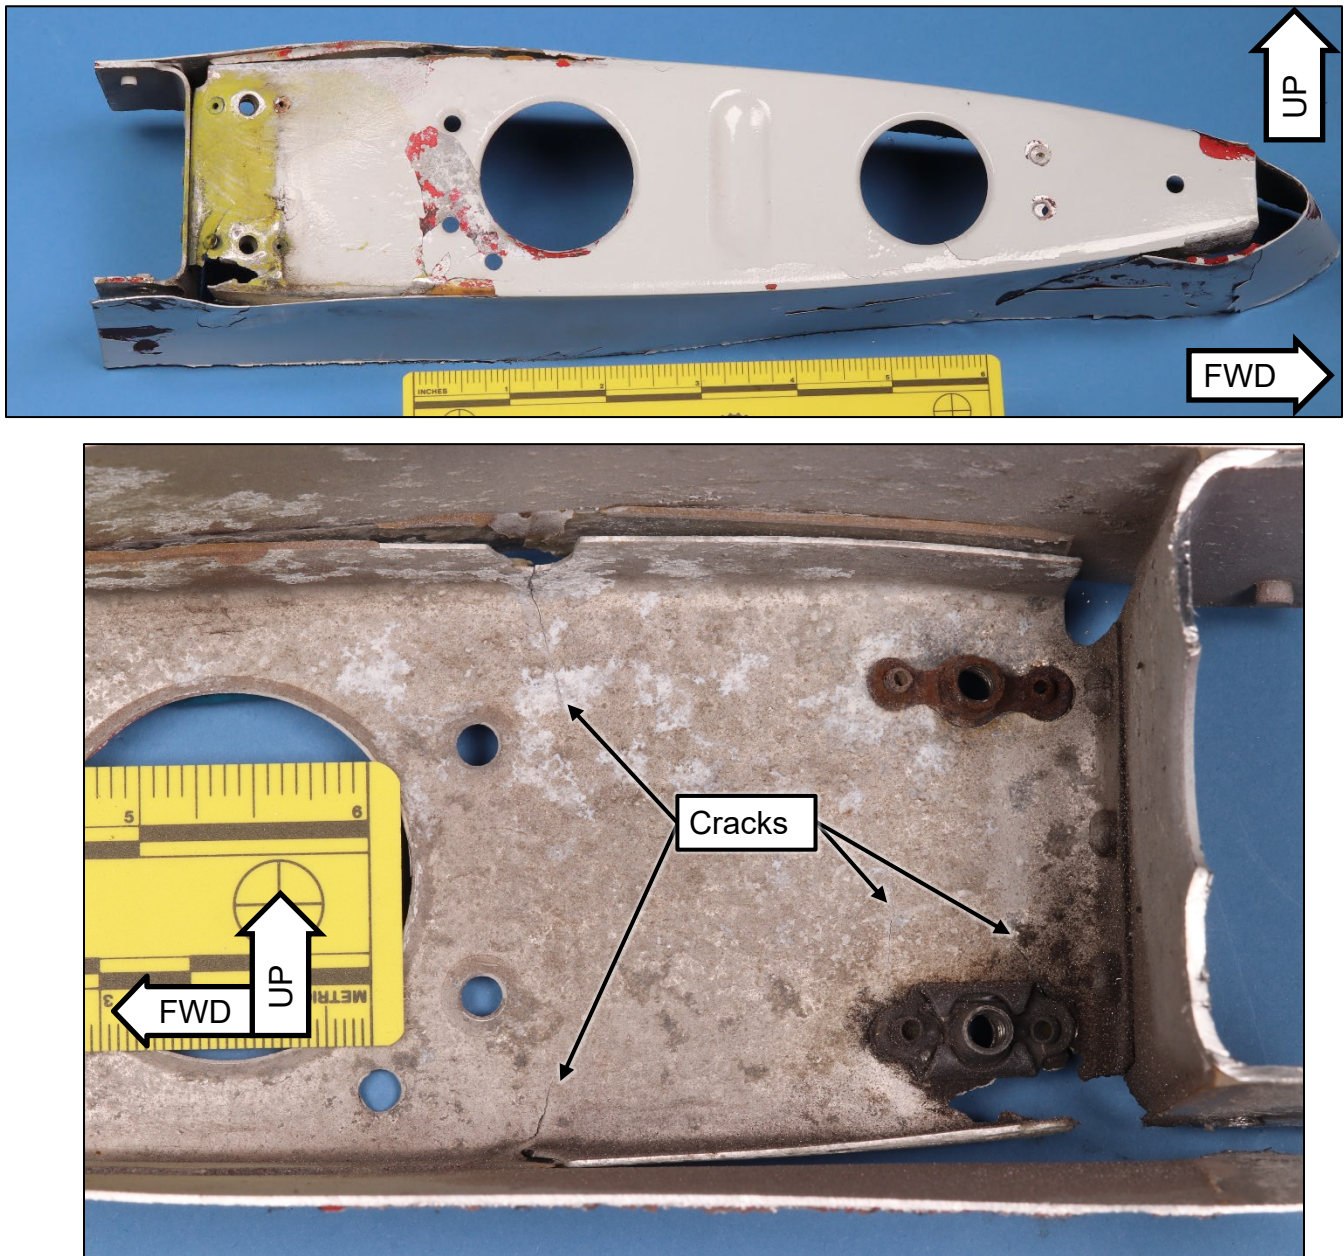
The outboard piece cut from the right horizontal stabilizer is shown in figure 9. Cracks extended into the outboard rib web from the cutouts in the upper and lower flanges aft of the aft lightening hole as shown in figure 9. Additionally, cracks extended upward from rivets for the lower bearing support attachment nut plate, also indicated in figure 9. A portion of the outboard rib web between the lower nut plate and the lower flange was fractured and missing.

The fracture extending from the cutout in the upper flange of the outboard rib had slant angles extending into the web, consistent with ductile overstress fracture. The fracture on the lower flange was heavily damaged with out-of-plane deformation consistent with post-fracture recontact between the fracture surfaces. The features associated with the crack extending upward into the web from the lower flange was examined using an SEM, and elongated dimples consistent with ductile overstress fracture were observed, and most of the fracture features on the lower flange were obliterated by post-fracture contact. However, an area with intact fracture features near the bend between the flange and the web had relatively coarse striations intermixed with dimple features, consistent with cyclic overstress.

Figure 9. Outboard piece of the right horizontal stabilizer after it was cut from the rest of the assembly showing the outboard face (upper image) and the inboard face (lower image) of the cracked outboard rib.

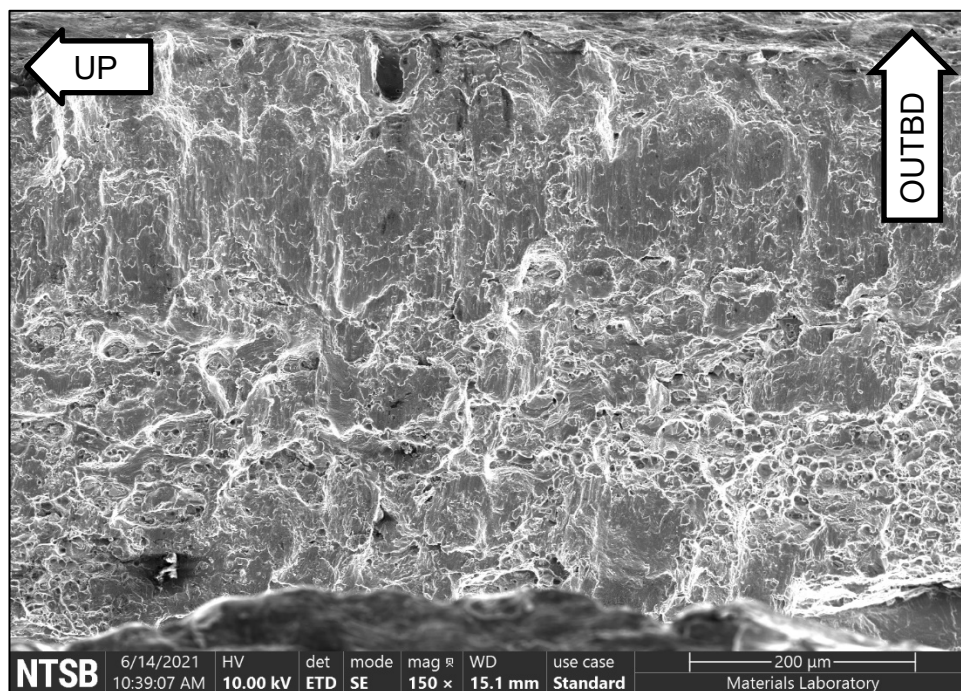
The aft piece of the left horizontal stabilizer outboard rib was cut from the remainder of the aft spar to facilitate an examination of the fracture surfaces using a scanning electron microscope (SEM). The sectioned piece was immersed in acetone and cleaned using an ultrasonic cleaner. SEM imaging of the fracture surfaces showed dimple features consistent with ductile overstress fracture (see figure 10).

Figure 10. SEM image of typical dimple features observed on fractures at the aft end of the left horizontal stabilizer outboard rib.

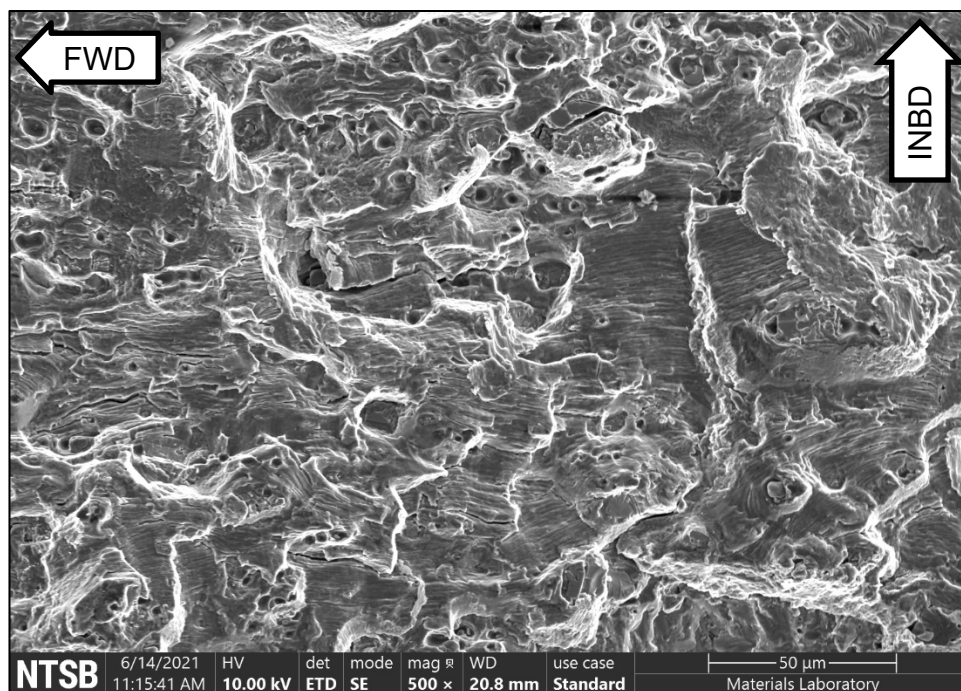
Rough fracture features approximately perpendicular to the web plane were observed on the web fracture below the lower nut plate and on the crack extending upward from the forward rivet. The fracture features were further examined using the SEM, and results showed relatively coarse striations intermixed with dimple features, features consistent with cyclic overstress loading. Figure 11 shows cyclic overstress

features from the horizontal fracture below the lower nut plate. Similar fracture features were also observed on the crack extending upward from the forward rivet.

Figure 11. SEM image of coarse striations with dimple features observed on fractures at the aft end of the right horizontal stabilizer outboard rib.

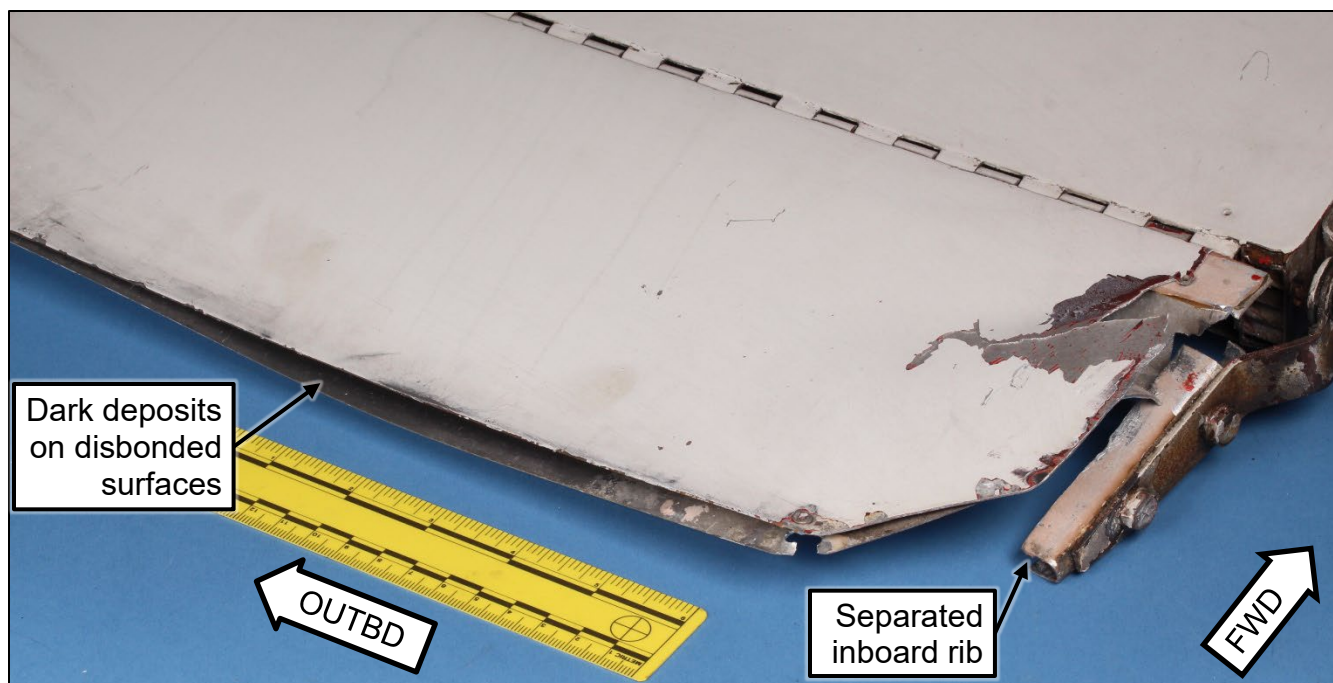
Views of the inboard and outboard ends of the left elevator trim tab are shown in figures 12 and 13. The inboard rib remained attached to the trim control arm but was separated from the upper skin and the vertical and lower horizontal portions of the lower skin. Pieces of the upper and lower skin were fractured and missing, and the entire area showed evidence of post-fracture contact. The bondline at the trailing edge of the trim tab was separated from the inboard end out to the rivet at the outboard end shown in figure 13. The rivet hole at the inboard end of the lower skin was enlarged and broken out to the edge (see figure 12). Dark deposits were observed on the bondline surfaces as indicated in figure 12 near the inboard end between 1.75 inches and 20 inches from the inboard end. A sample of the dark deposits was collected onto a carbon-coated stub and examined using energy dispersive x-ray spectroscopy. The EDS spectra for the deposits typically showed high peaks of aluminum, oxygen, carbon, and silicon with smaller peaks of sodium, magnesium, silicon, phosphorus, sulfur, chlorine, potassium, calcium, titanium, and iron.

Figure 12. Inboard end of the left elevator trim tab showing separations at the bondlines and cracks and fractures in the spar and skin at the inboard rib.

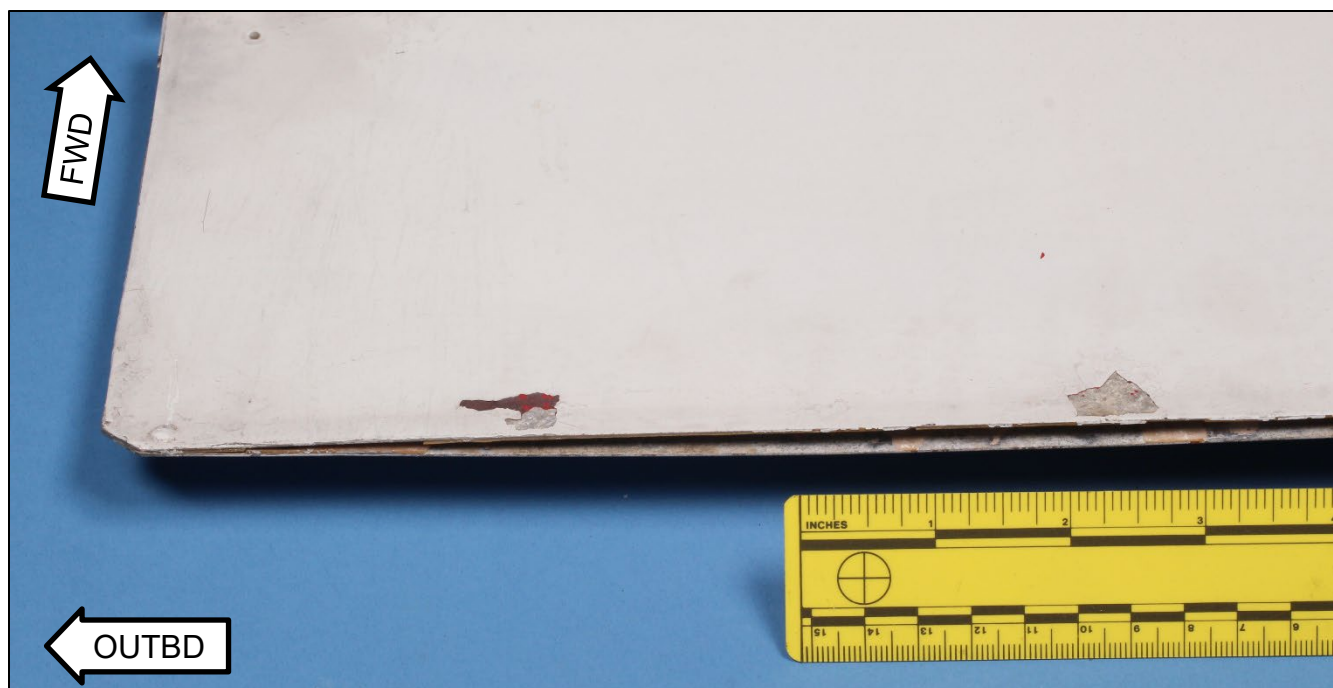
Figure 13. Outboard end of the left elevator trim tab showing bondline separation, corrosion, and bubbled paint along the trailing edge.

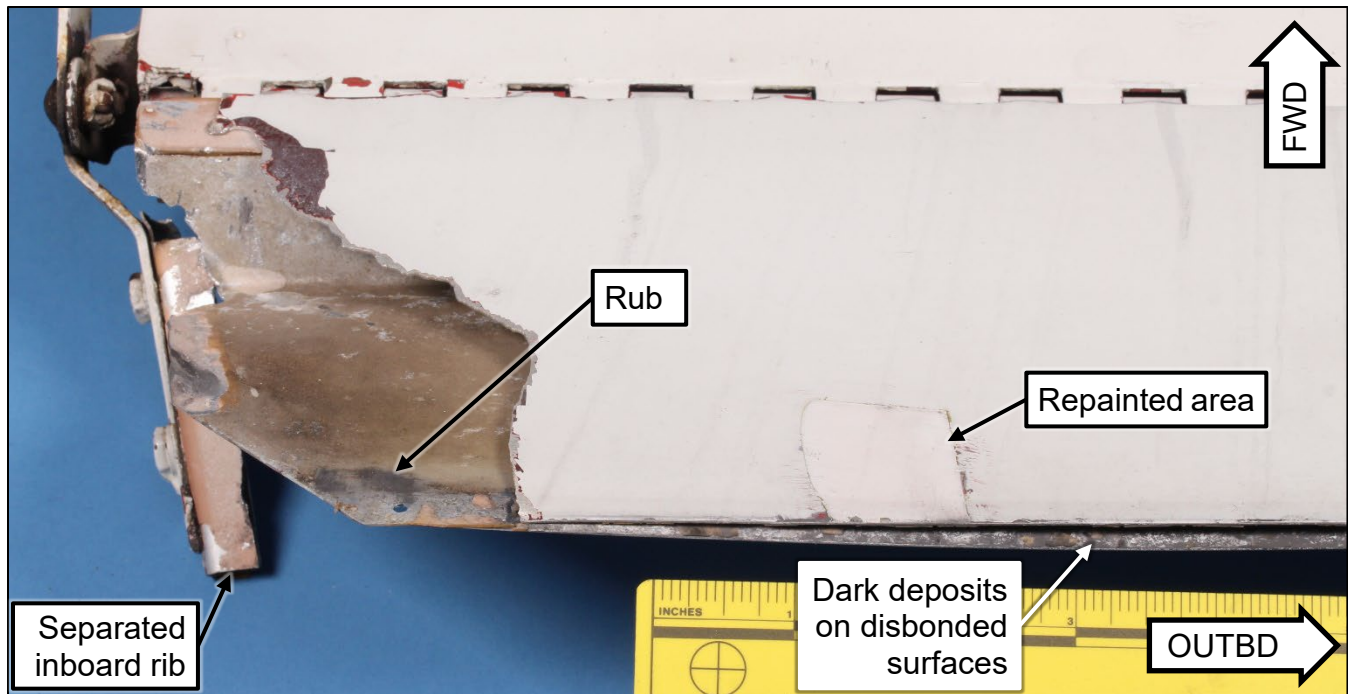
Views of the inboard and outboard ends of the right elevator trim tab are shown in figures 14 and 15. The inboard rib remained attached to the trim control arm but was separated from the upper skin and the vertical and lower horizontal portions of the lower skin. The entire inboard end of the upper skin was missing, and portions of the lower skin were also fractured and missing. Marks consistent with post-fracture contact between the inboard rib and the lower skin were observed. The bondline at the trailing edge of the trim tab was separated from the inboard end out to within 3 inches of the outboard end, and dark deposits were observed on the bondline surfaces along most of the disbanded length. The interior surface of the lower skin forward of the inboard rivet hole appeared darkened and rubbed consistent with movement between the upper and lower skins near the rivet location. Fretting damage was also observed around the inboard rivet hole on

the lower surface of the lower skin consistent with movement between the lower skin and the inboard rivet buck tail. Bubbled or missing paint consistent with corrosion was observed at the trailing edge, and several areas appeared to have been repainted as indicated in figures 14 and 15.

Figure 14. Inboard end of the right elevator trim tab showing separations at the bondlines, cracks and fractures in the spar and skin at the separated inboard rib, and an area that appeared repainted.

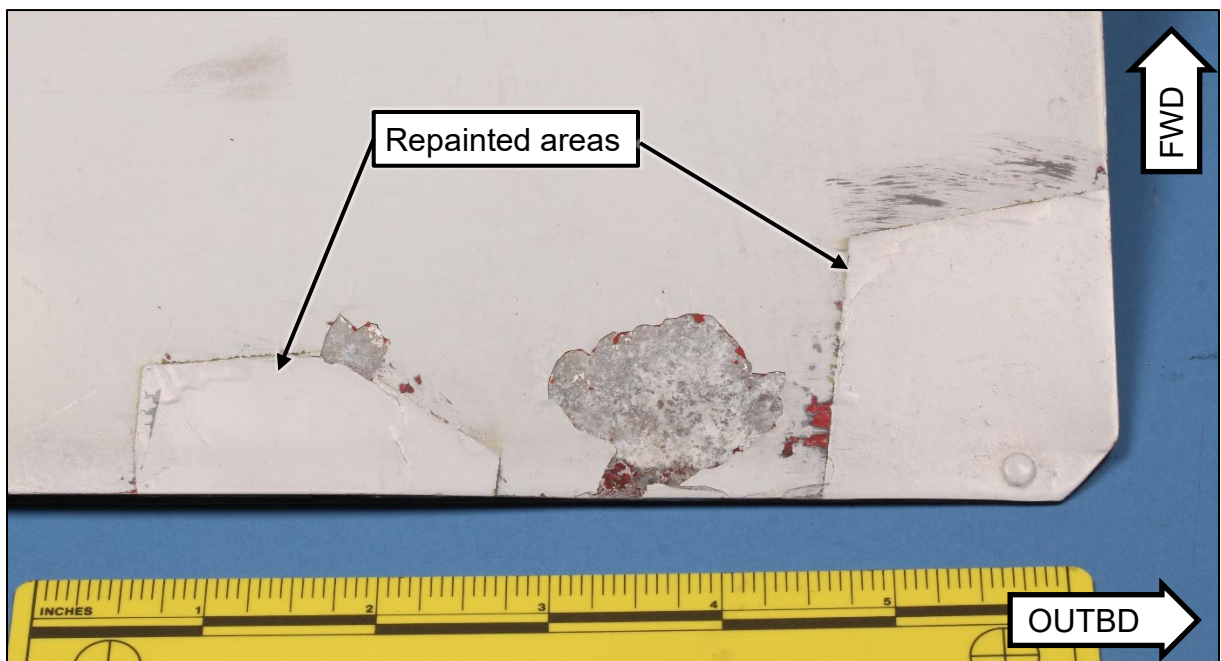
Figure 15. Outboard end of the left elevator trim tab showing corrosion and bubbled paint along the trailing edge and two areas that appeared repainted.

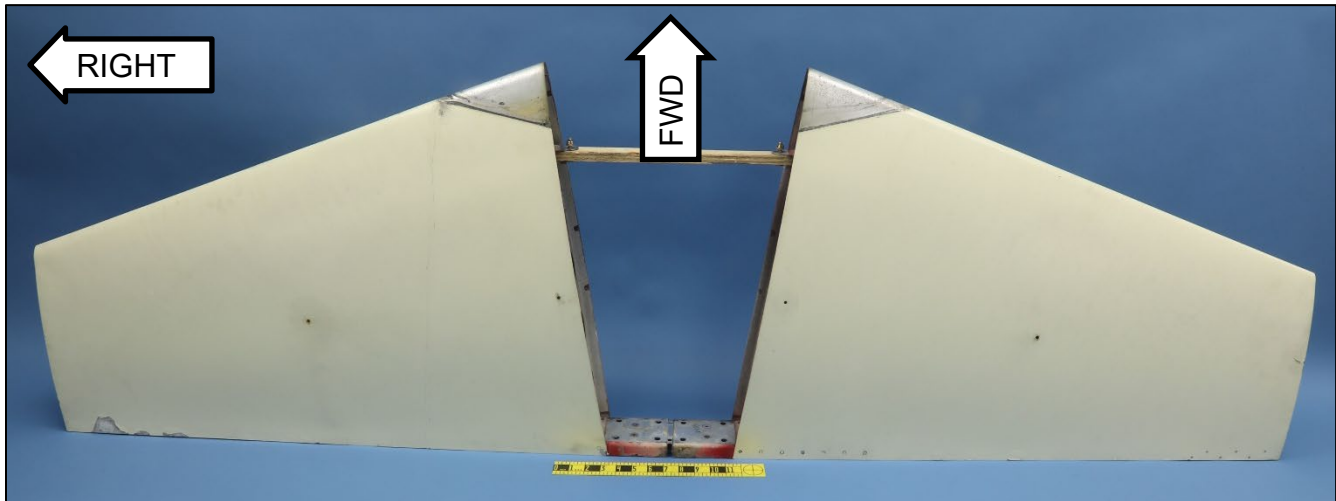
Horizontal stabilizers from another American AA-5 airplane were submitted for nondestructive examination. An overall view of the lower side of the horizontal stabilizers is shown in figure 16. The horizontal stabilizers were connected by the rear spar connector and by a temporary wood support piece at the forward fuselage connection flanges. Interior surfaces were partially covered with white oxides.

On the lower skin shown in figure 16, the outboard drain hole in the right horizontal stabilizer and the inboard drain hole on the left horizontal stabilizer were blocked with debris. Bubbled and missing paint was observed on the lower skin along most of the trailing edge as shown in figures 17 and 18. On the left horizontal stabilizer, 7 flush-head rivets (including 1 original rivet) were observed at the outboard end of the bondline between the upper skin and the aft spar, and 21 rivets (including 1 original rivet) were observed at the outboard end of the bondline between the lower skin and the aft spar, consistent with a riveted repair of the bondlines.

Figure 16. Lower surface of an exemplar horizontal stabilizer from another American AA-5 airplane as-received for nondestructive examination.

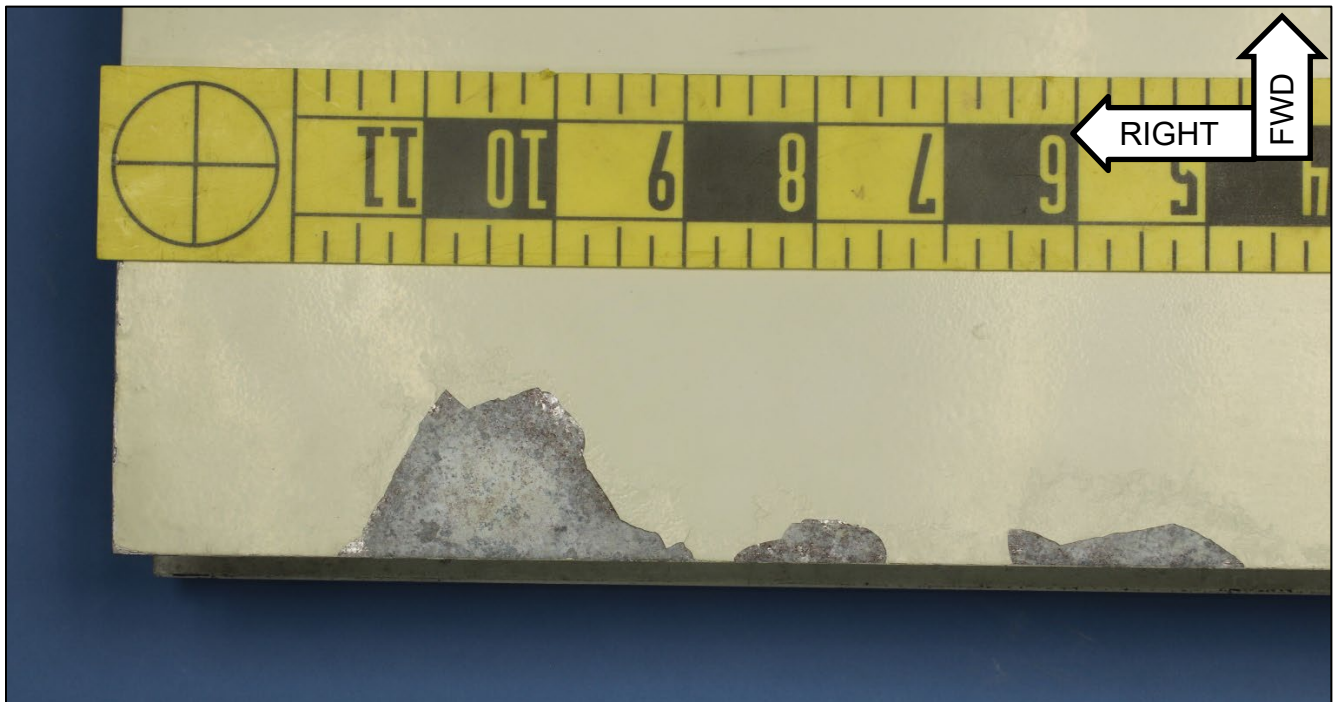
Figure 17. Outboard end of the exemplar right horizontal stabilizer showing corrosion with bubbled and missing paint on the lower skin at the trailing edge.

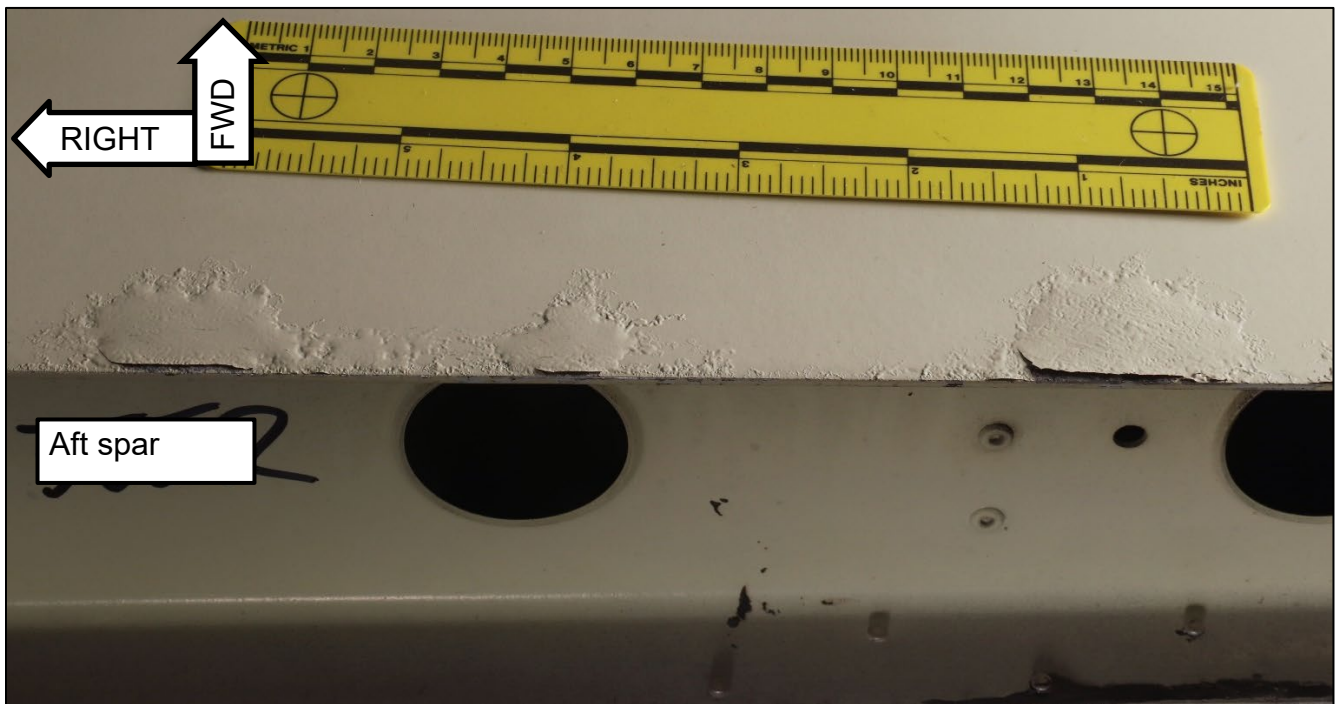
Figure 18. Trailing edge of the exemplar right horizontal stabilizer showing indications of corrosion with bubbled paint at the trailing edge of the lower skin near mid span.

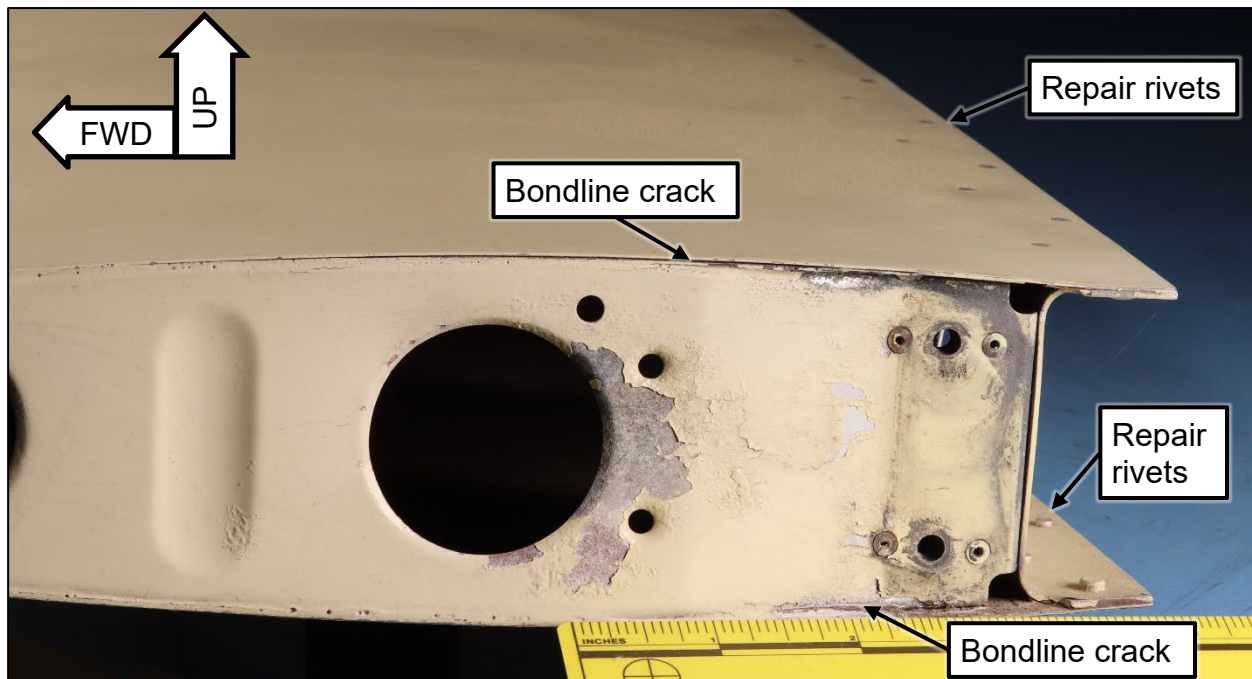
At bondlines between the outboard rib and skins for the left horizontal stabilizer, a 6.5-inch-long crack was observed at the aft end of the upper bondline, and a 1.75-inch-long crack was observed at the aft end of the lower bondline as shown in figure 19. A dull tapping sound was heard on the upper skin along the bondline to the outboard rib between 2 and 5 inches away from the aft spar.

Figure 19. Outboard end of the exemplar left horizontal stabilizer showing cracks indicating bondline separations between the outboard rib flanges and the upper and lower skins.

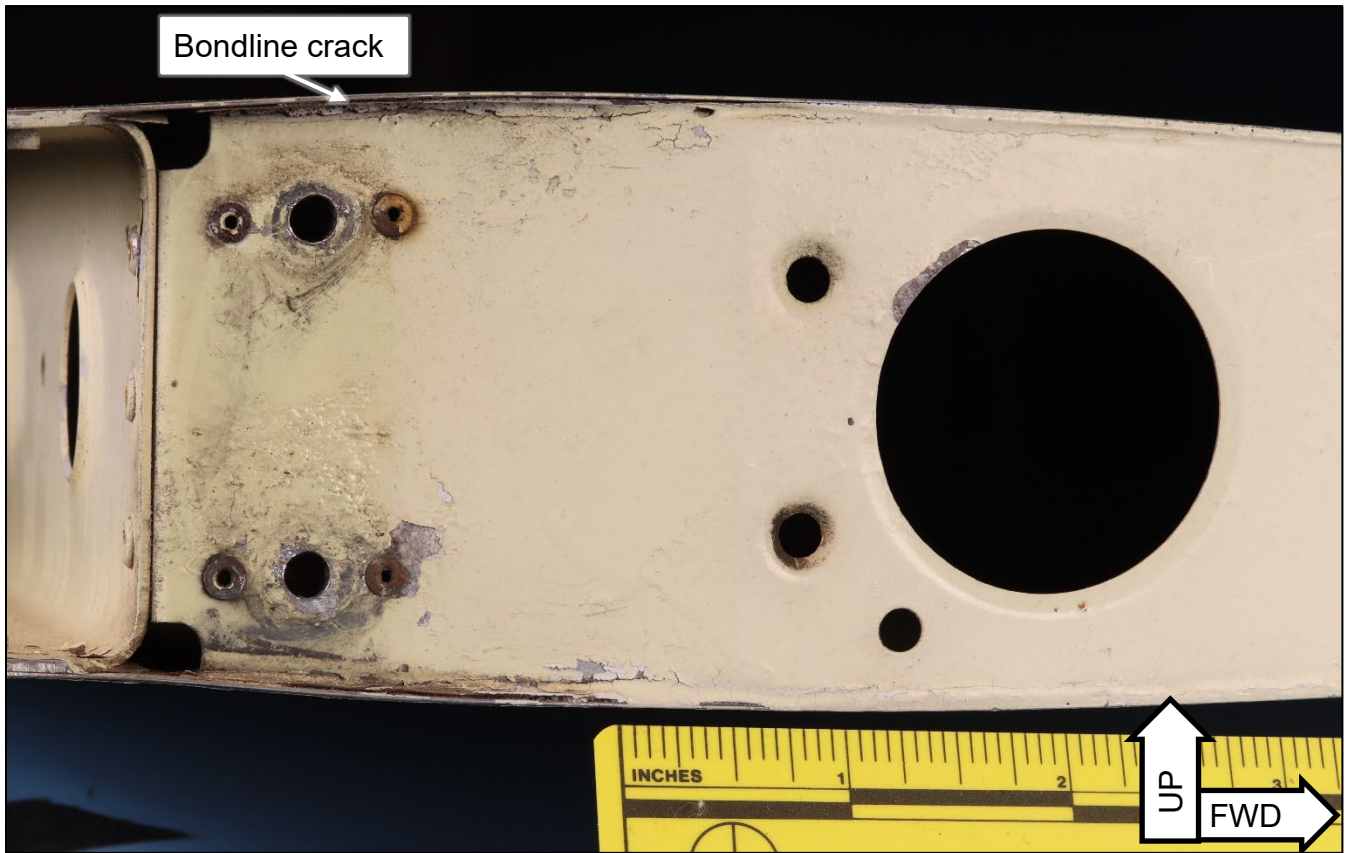
At the bondlines between the outboard rib and skins for the right horizontal stabilizer, a 3.25-inch-long crack was observed at the aft end of the upper bondline as shown in figure 20, and a 3.625-inch-long crack was observed at the lower bondline from

5.5 inches to 9.125 inches away from the aft end. Additionally, a 0.75-inch-long crack was observed at the forward end of the lower bondline. Although sealant appeared to be missing from at the aft two inches of the lower bondline, the bondline did not appear to be separated. A dull tapping sound was heard along the bondlines to the outboard rib between 1.5 and 2.5 inches away from the aft spar on the upper skin and between 6 and 8 inches away from the aft spar on the lower skin.

Figure 20. Outboard end of the exemplar right horizontal stabilizer showing cracks indicating bondline separations between the outboard rib flanges and the upper and lower skins.
