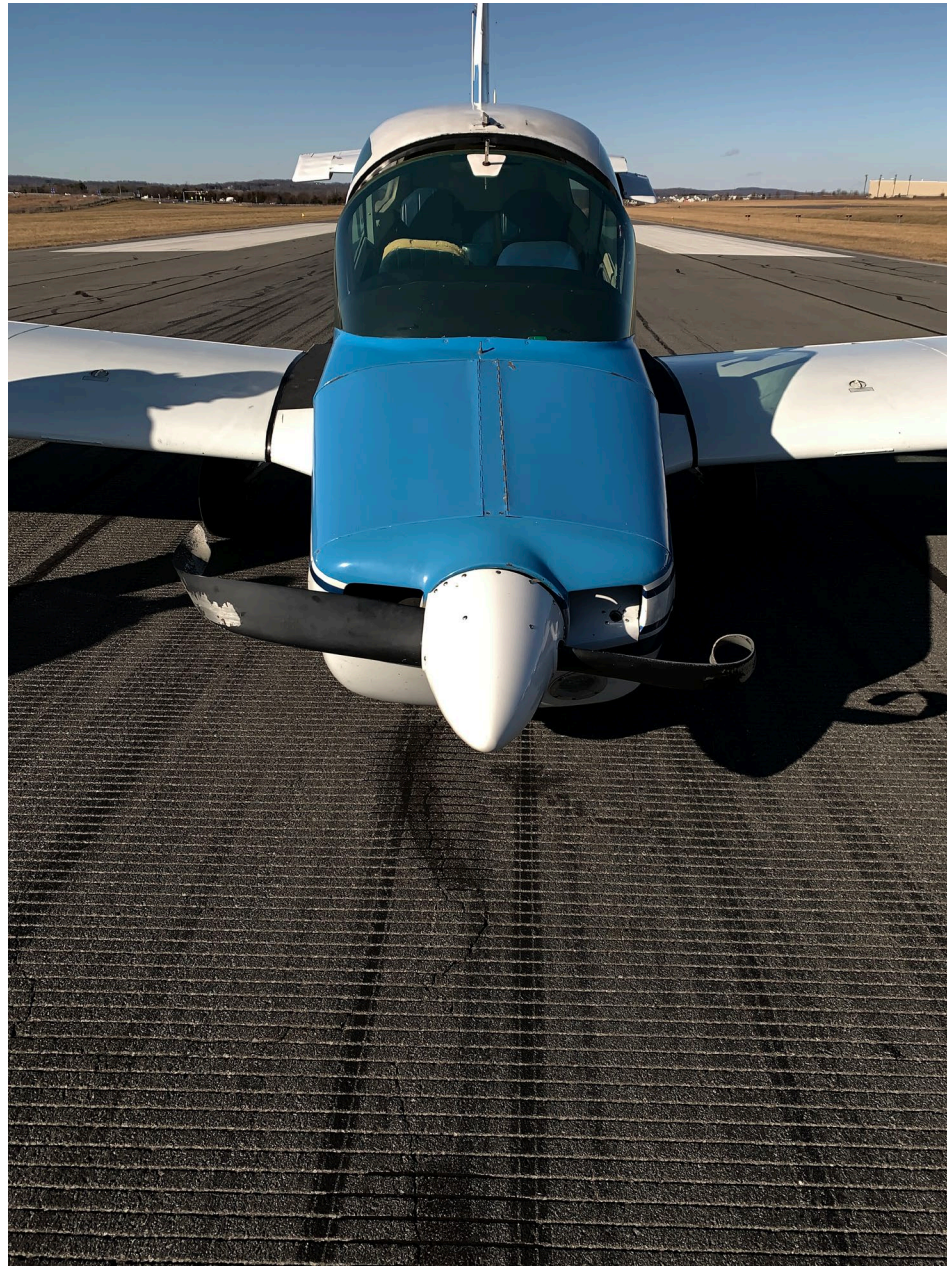
**Photo 1 – FAA Digital Photograph. Frontal View of the Airplane on the Runway. Note the collapsed Nose Landing gear.**

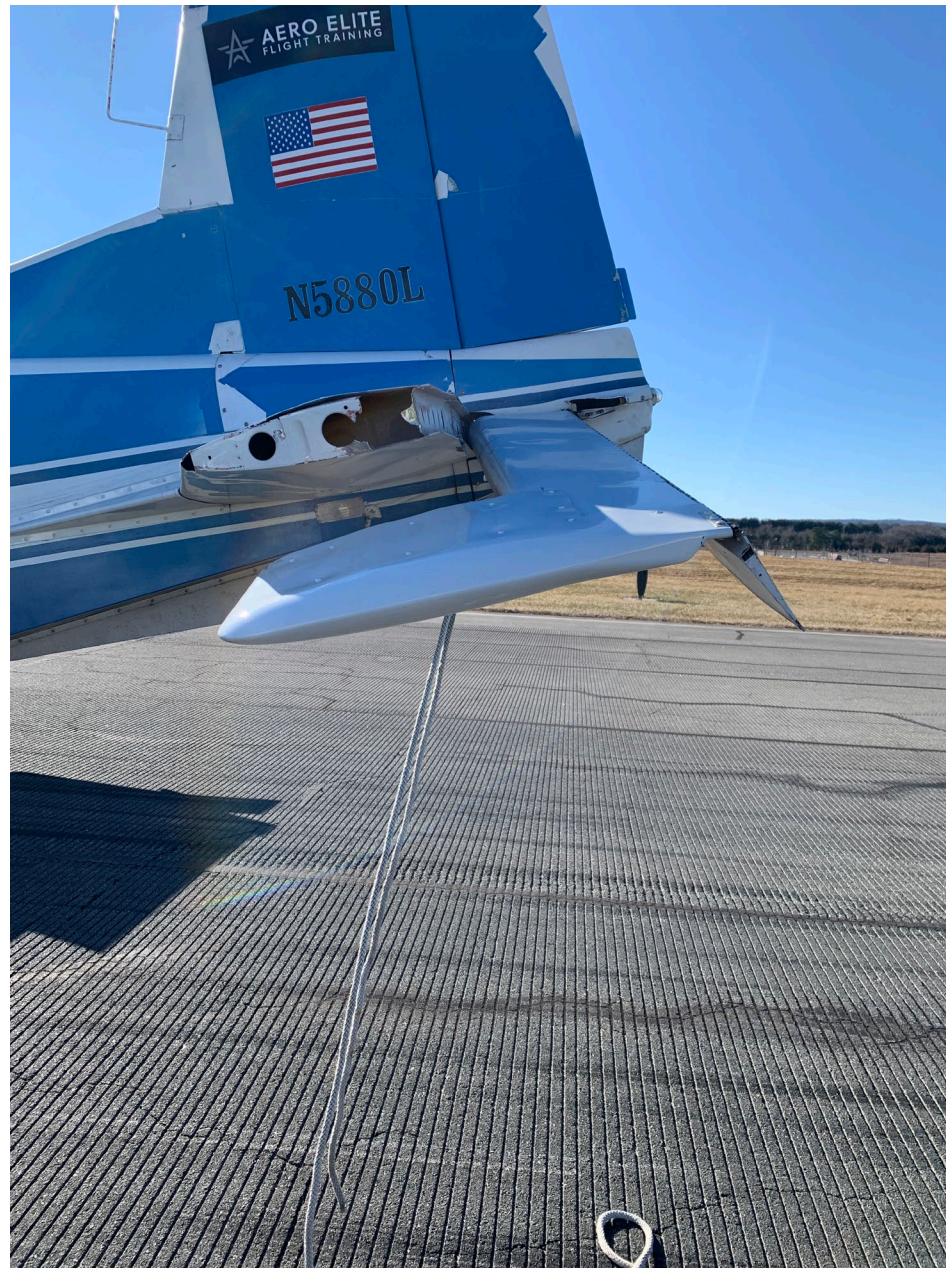
**Photo 2 – FAA Digital Photograph. Left Side View Showing the Aft Empennage, Left Horizontal Stabilizer, Portion of the Vertical Stabilizer and rudder, and Displaced Left Elevator.**

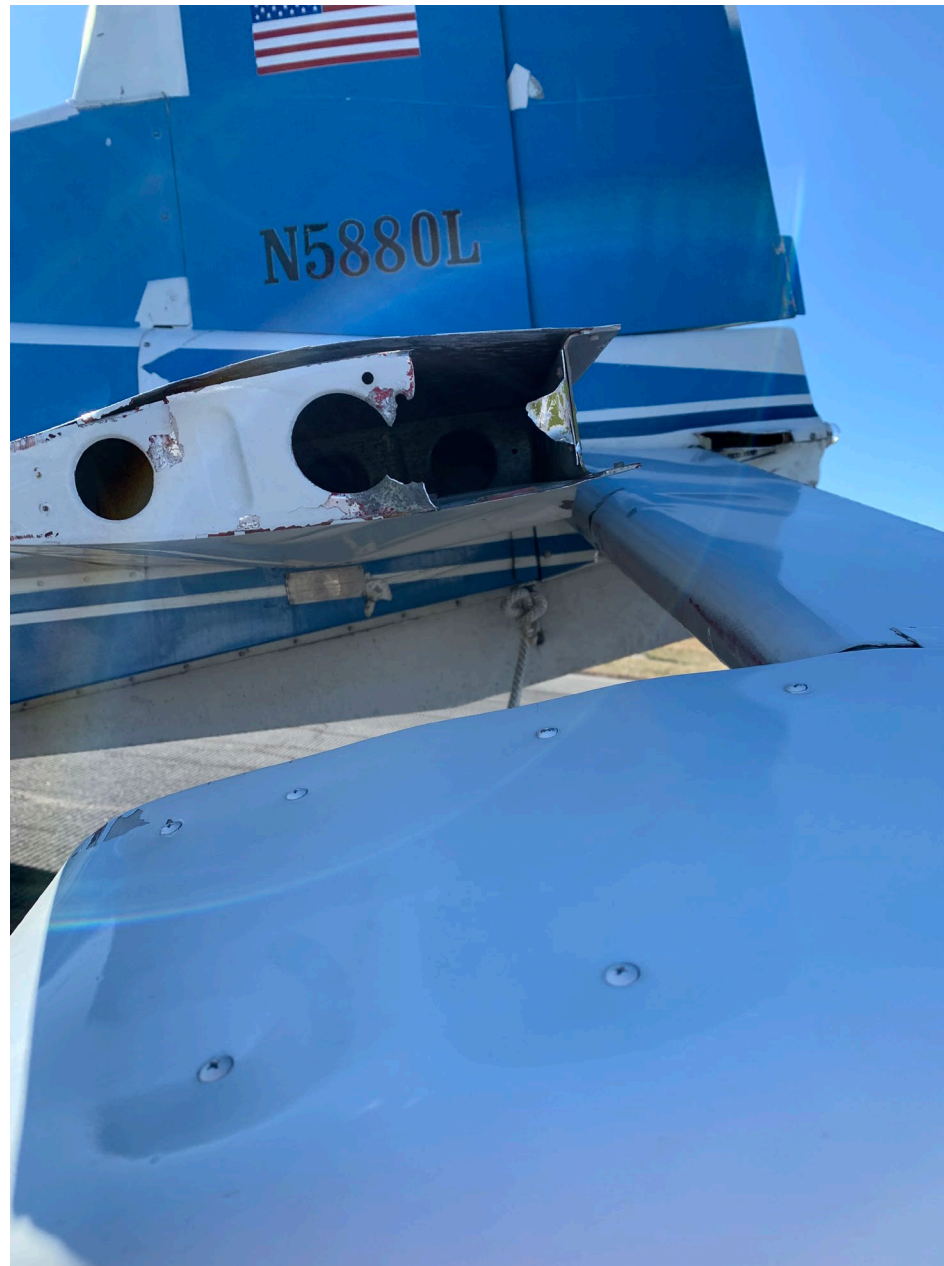
**Photo 3 - FAA Digital Photograph. Left Side Close-Up View of the Damaged Outboard Rib of the Left Stabilizer, Displaced Left Elevator, and Portion of Vertical Stabilizer and Rudder.**

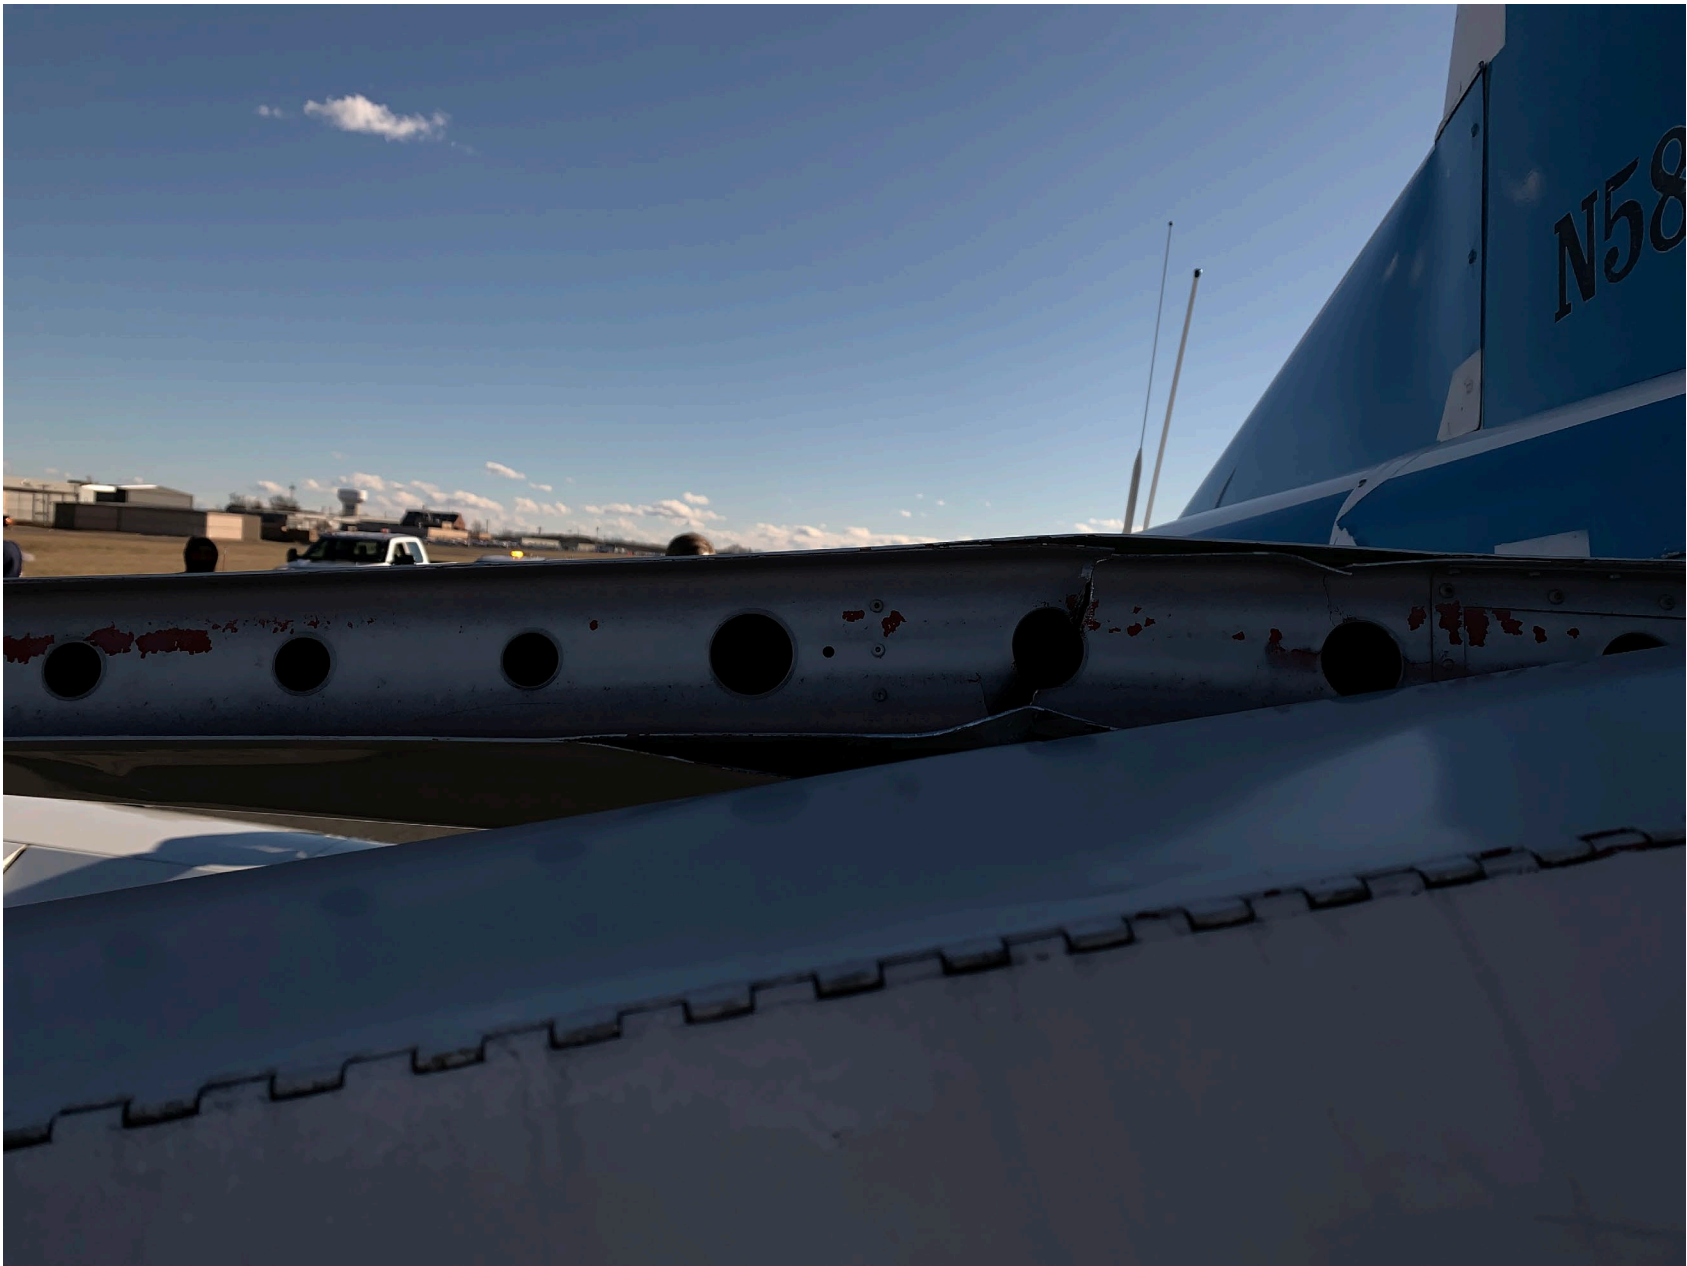
**Photo 4 - FAA Digital Photograph. Aft Side View of the Structurally Damaged Aft Spar of the Left Stabilizer, Portion of Displaced Left Elevator.**

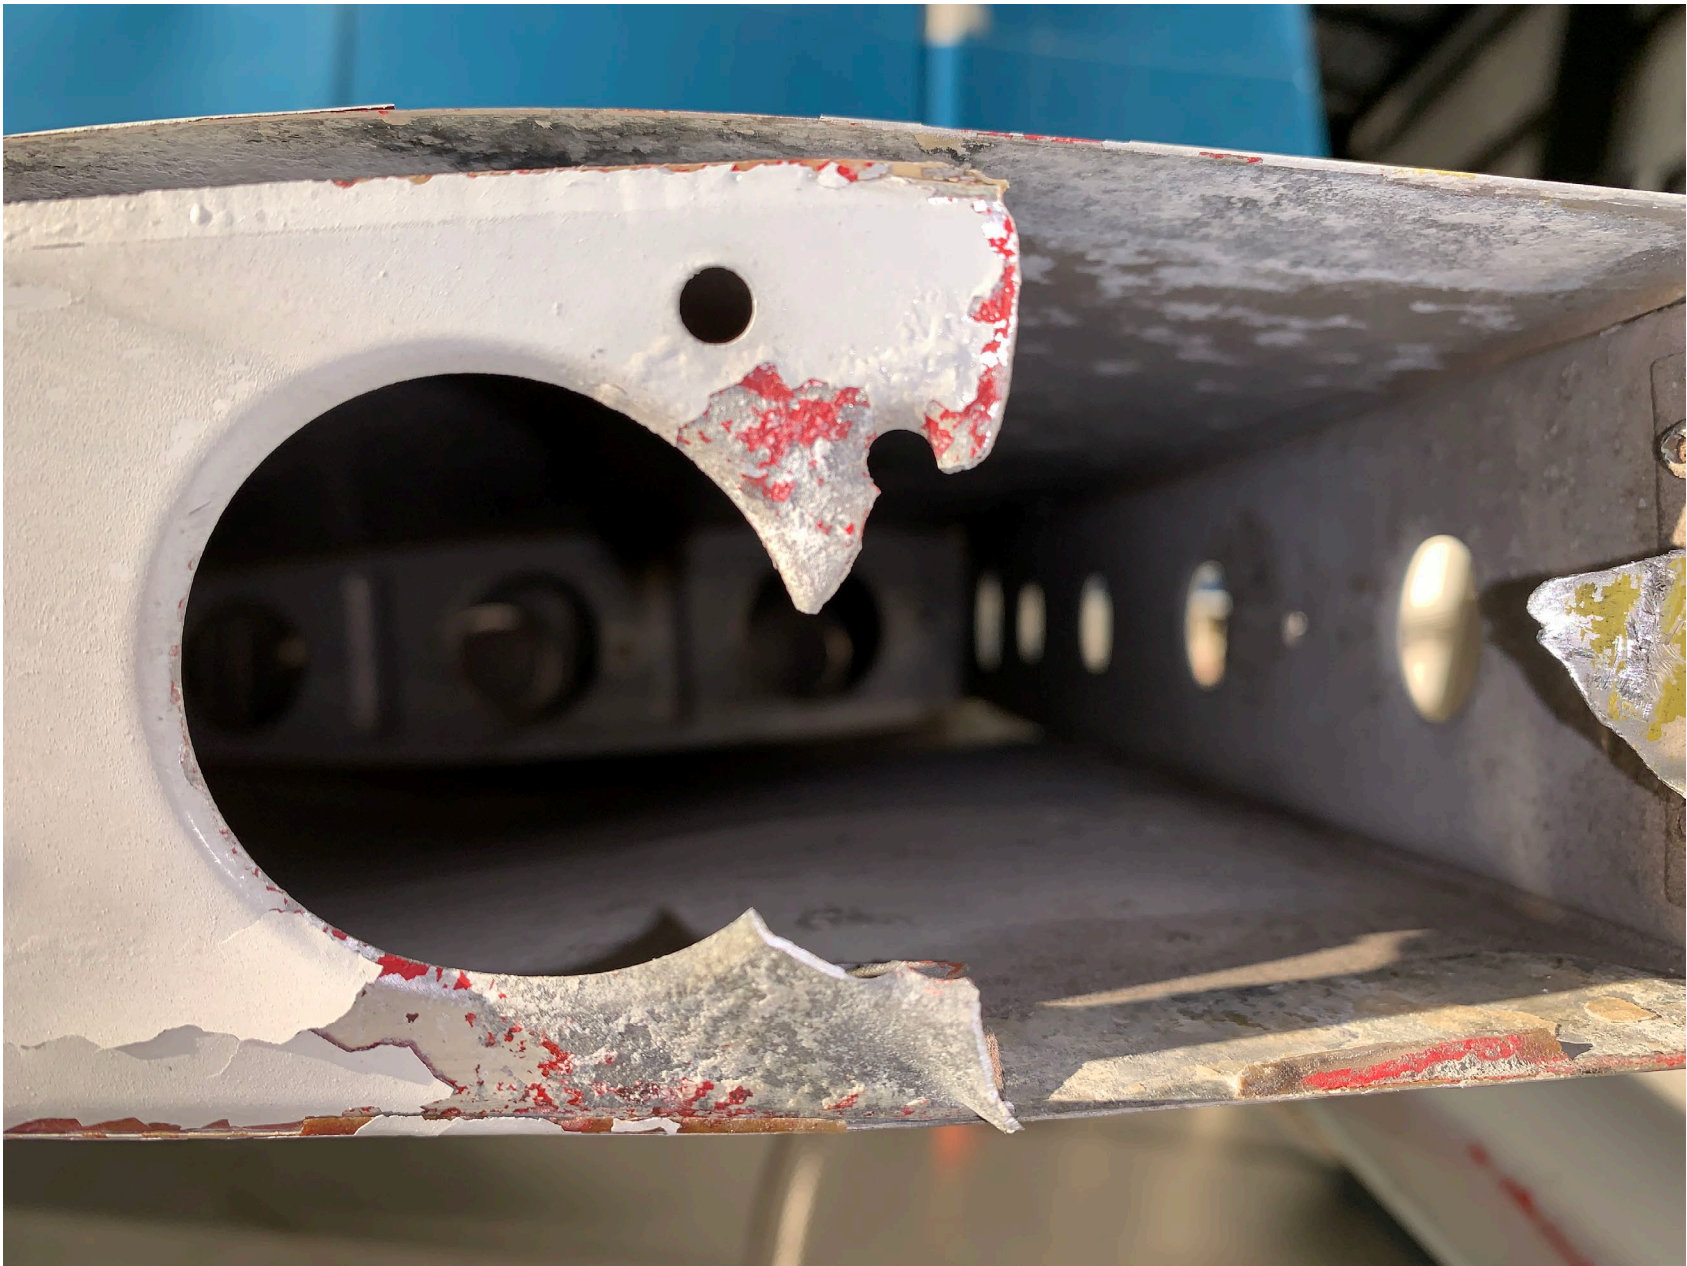
**Photo 5 - FAA Digital Photograph. Close-Up View of the Aft Portion of the Outboard Rib of the Left Horizontal Stabilizer. Note the Missing section and Corrosion on the rib and also the Interior Surface of the Upper Skin.**
