# NATIONAL TRANSPORTATION SAFETY BOARD

## MATERIALS LABORATORY FACTUAL REPORT

Report No. 21-052

Place : Minneola, Florida  
Date : January 21, 2021  
Vehicle : Plante Quad City Challenger II, N4469Z  
NTSB No. : ERA21LA109  
Investigator : Leah Read, AS-ERA

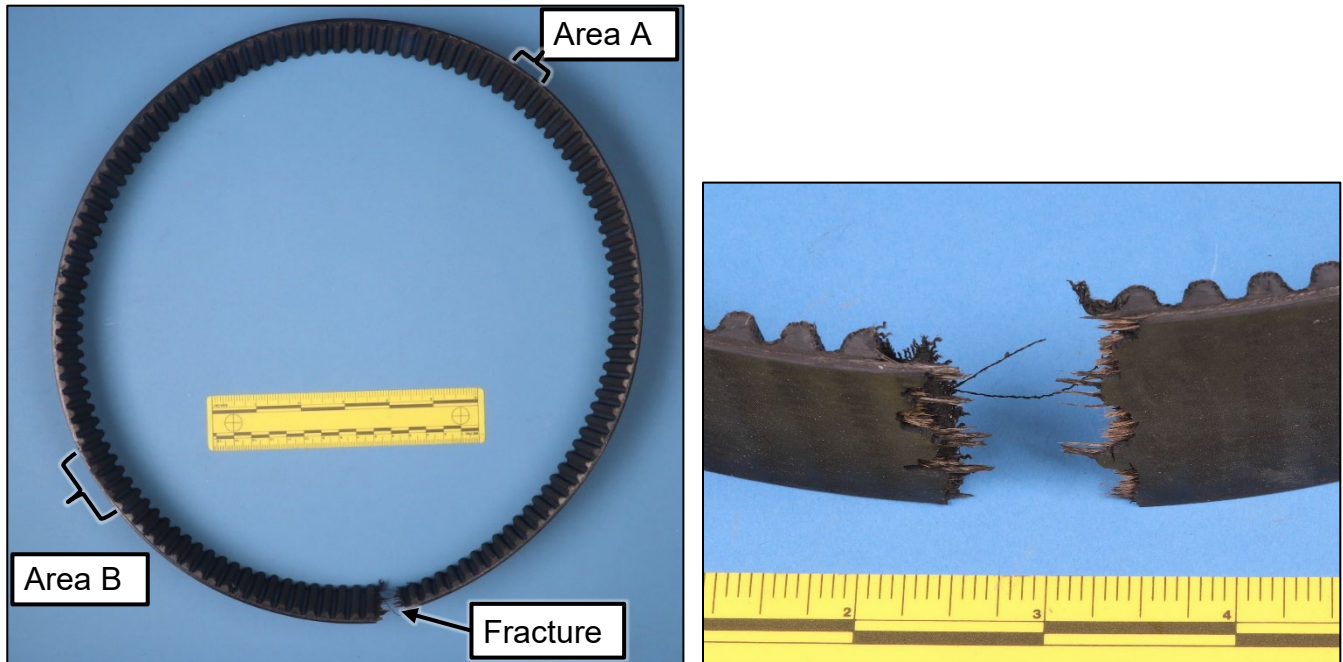
An overall view of the submitted synchronous drive belt is shown in figure 1. The belt had a transverse fracture that intersected a tooth root at the interior side and had a more jagged transverse path through the glass reinforcement core strands as shown in the right image in figure 1, features consistent with a tensile overload failure.

The edges of the belt appeared rubbed with exposed core strands in several areas consistent with lateral travel or tracking. On the side shown in the overall image in figure 1, rub with exposed core strands was observed between area B and the fracture surface (a length encompassing 19 teeth). On the opposite side of the belt, rubbed edges with exposed core strands were observed on either side of the fracture along a length encompassing 71 teeth (25 teeth on one side of the fracture and 46 teeth on the other). The belt had a total of 120 teeth.

Markings on the exterior surface of the belt indicated the belt was a PowerGrip GT3 960-8MGT-50 synchronous belt manufactured by the Gates Corporation.<sup>1</sup> The belt had been installed to connect the engine output sprocket to the propeller drive sprocket on the accident engine. However, the Gates PowerGrip GT3 Drive Design Manual includes a “Safety Policy” for primary in-flight aircraft systems that states, “Do not use Gates belts, pulleys or sprockets on aircraft, propeller or rotor drive systems or in-flight accessory drives. Gates belt drive systems are not intended for aircraft use.”

Figure 1. Overall view of the submitted synchronous drive belt (left) with a closer view of the fracture (right).

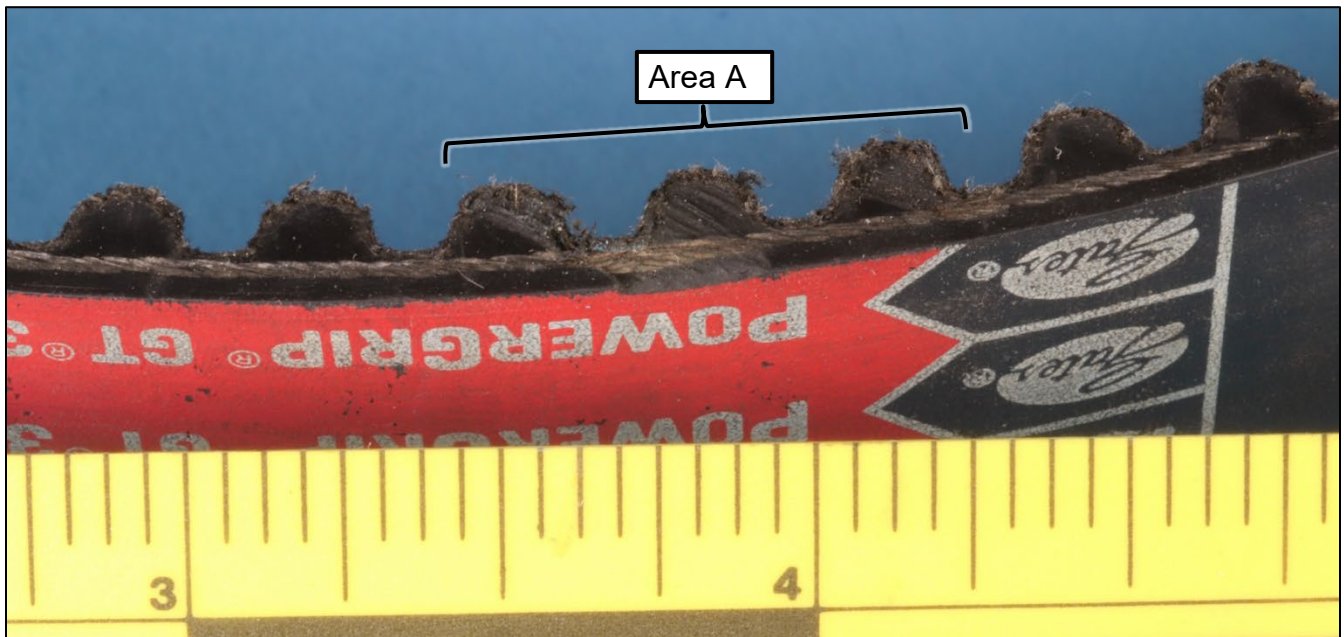
Damage was observed on the sides of several teeth in two areas arbitrarily denoted "A" and "B" in figure 1. In these areas, the sides of the teeth appeared gouged consistent with sliding contact with another object. The sides of three teeth were damaged in area A as shown in figure 2, and the sides of 5 teeth were damaged in area B shown in figure 3.

Figure 2. Tooth damage at the edge of the synchronous drive belt in area A.

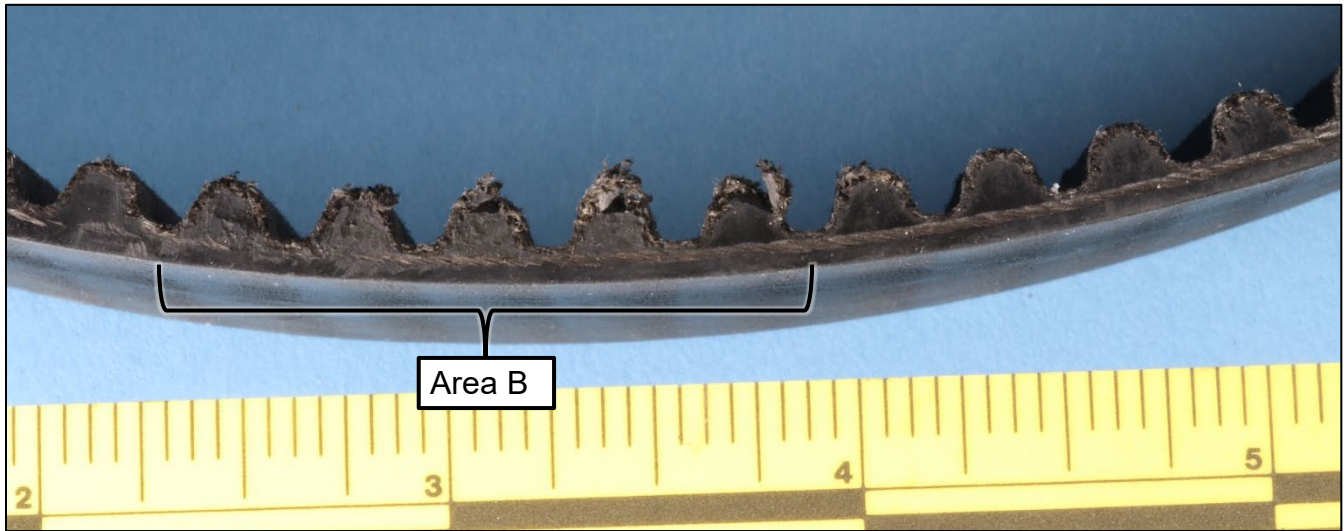
Figure 3. Tooth damage at the edge of the synchronous drive belt in area B.

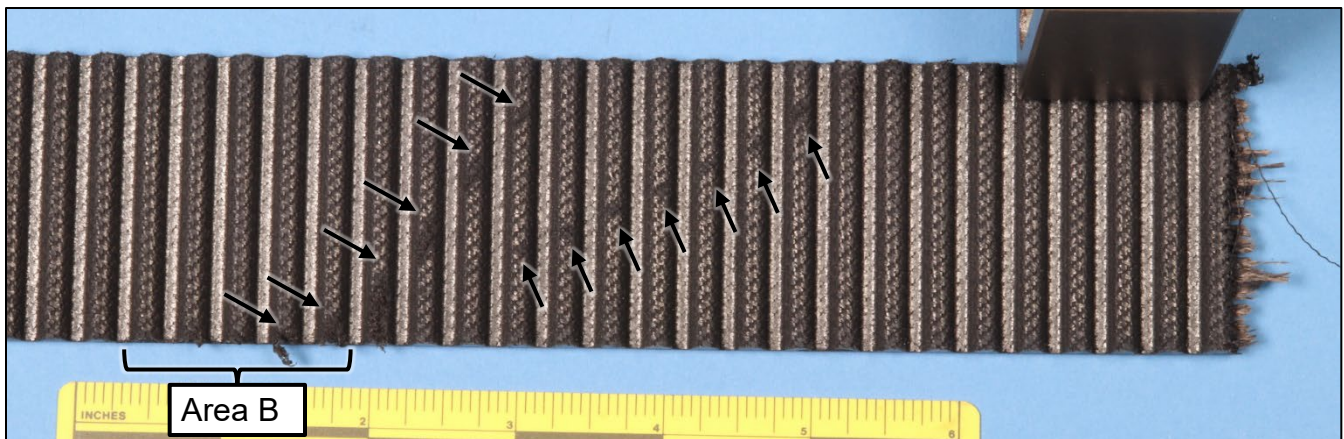
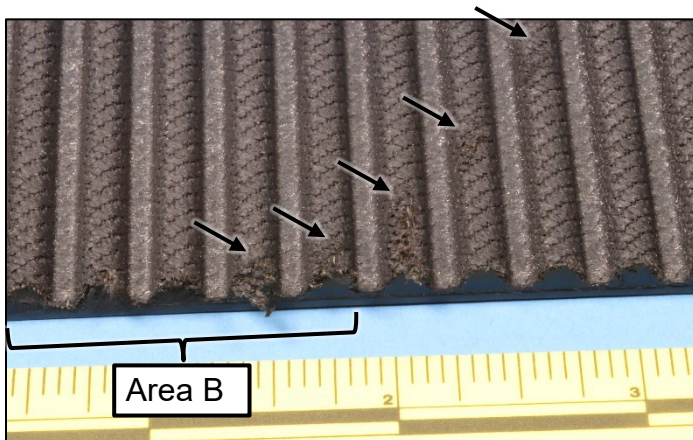
The interior surfaces of the drive belt generally appeared free of significant wear. However, discrete fiber damage was observed on the interior surface as shown in figure 4. The tooth peaks were damaged on approximately a dozen teeth near area B. The damage was greatest near area B, and two lines of damage appeared to angle across the width of the belt from area B.

Figure 4. Views of discrete tooth peak damage (indicated with unlabeled arrows) on the interior surface at area B and on adjacent teeth.
