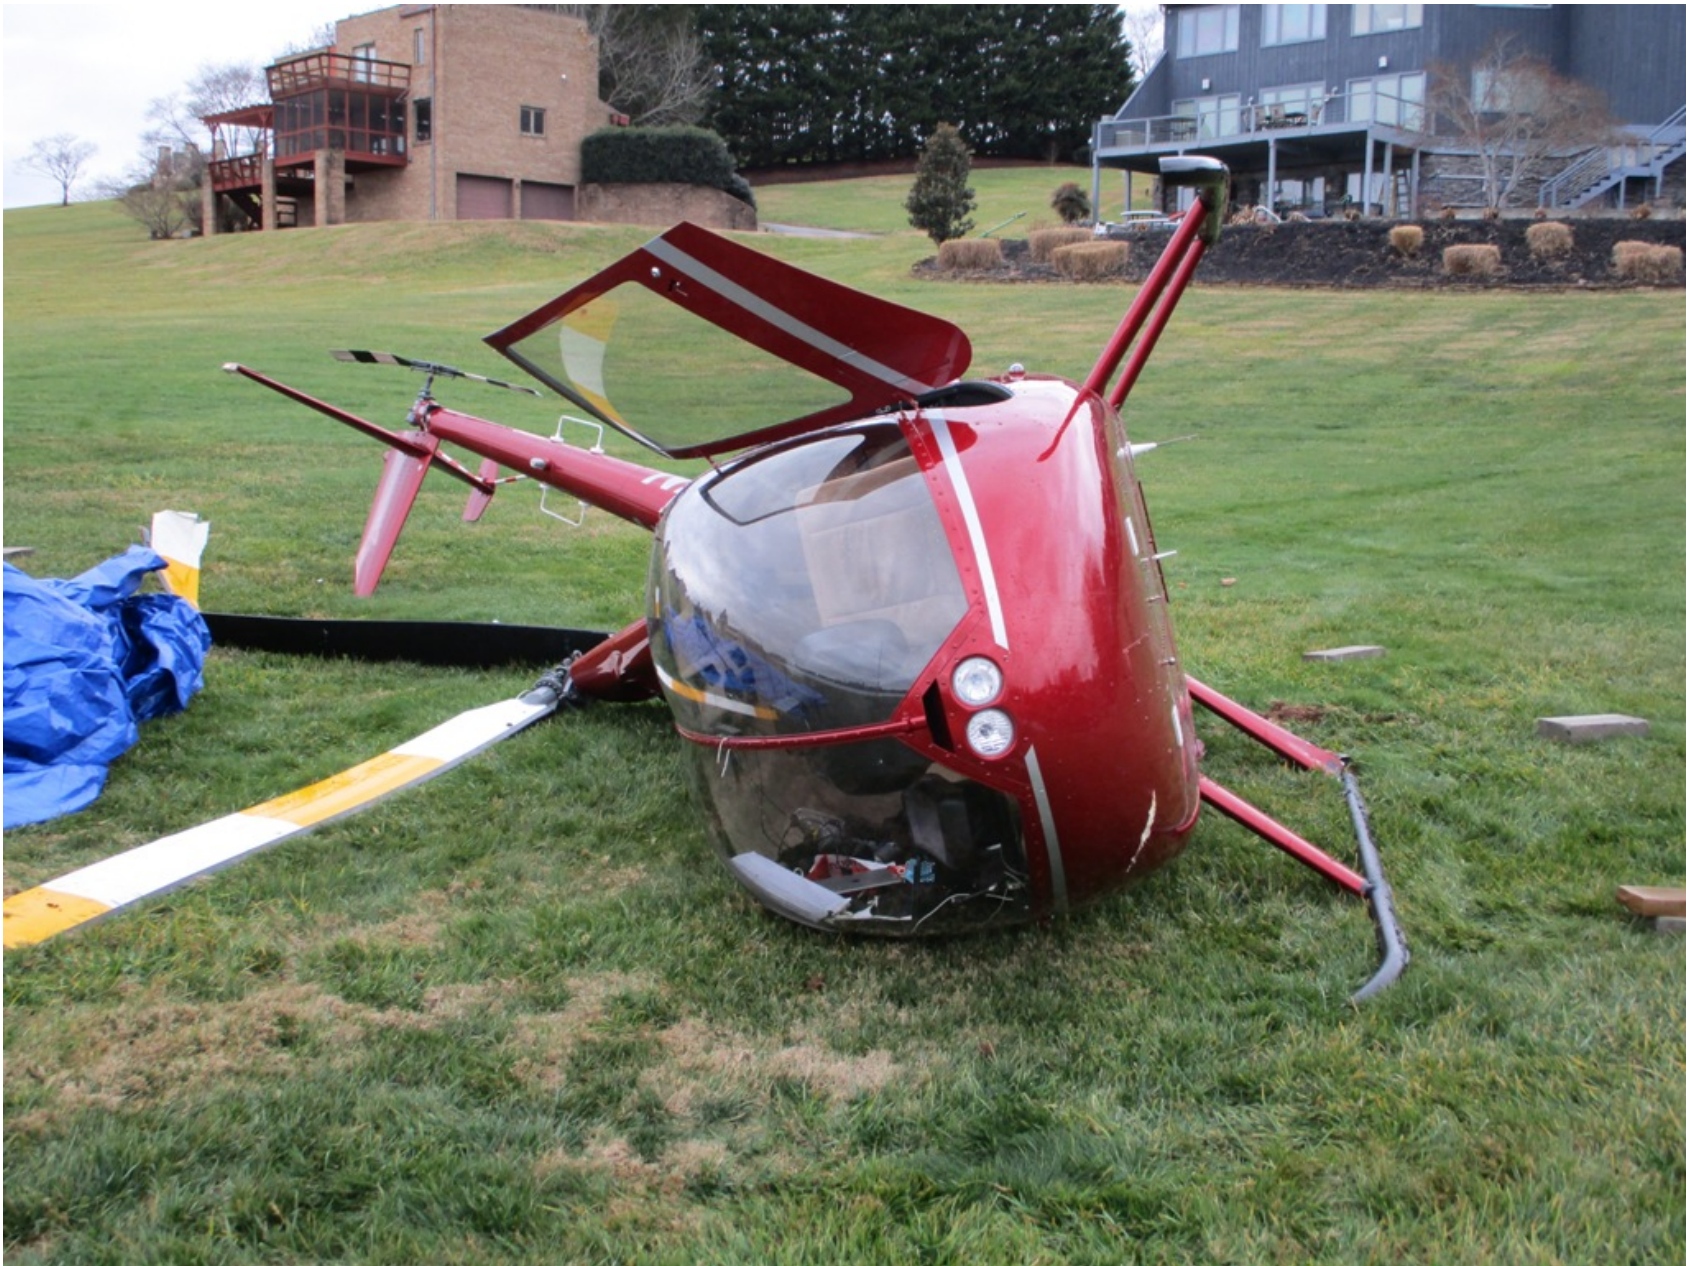
**Photo 1 – FAA Digital Photograph. Frontal View of the Helicopter Resting on Its Right Side at the Accident Site. Note the Displaced Tailboom Assembly.**

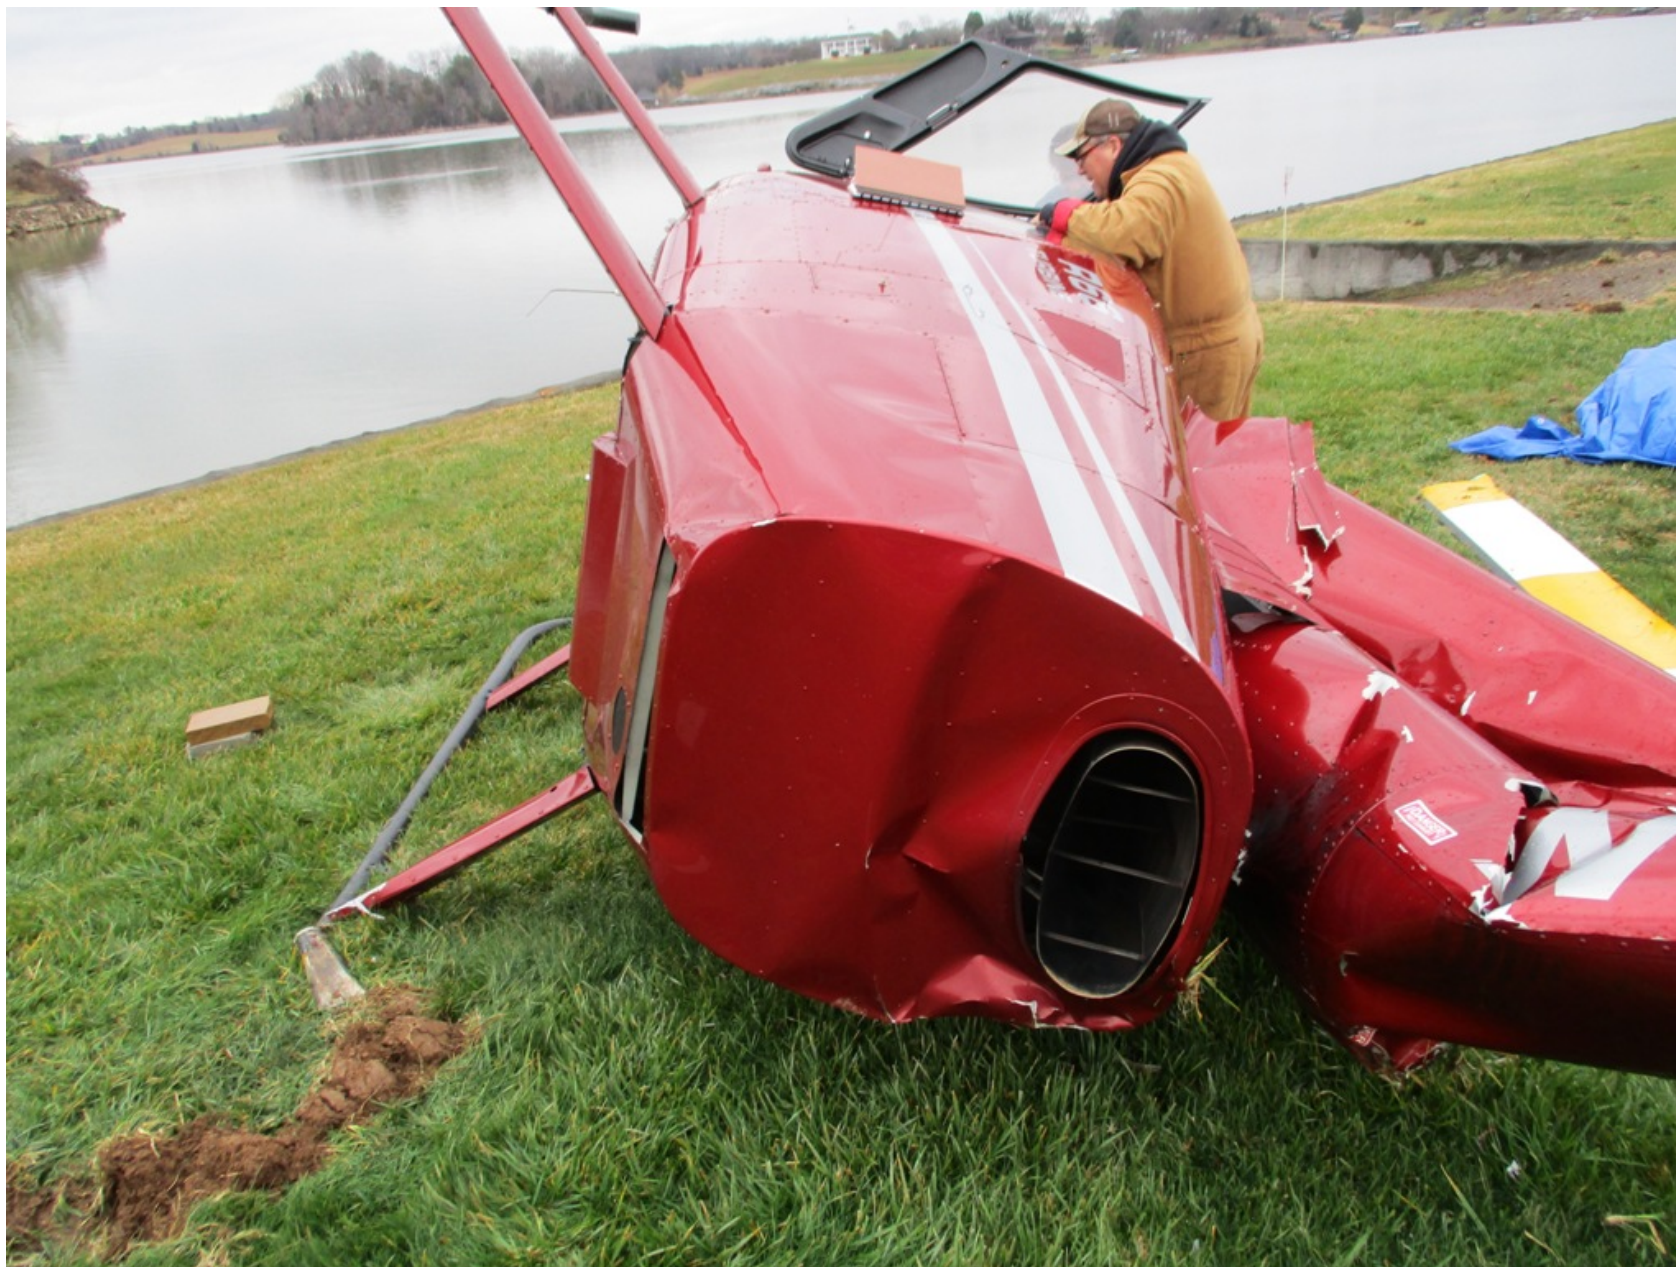
**Photo 2 - FAA Digital Photograph. Rear View of the Helicopter Resting on Its Right Side at the Accident Site. Note the Damaged Tailboom Assembly and the Ground Scar near the Rear Right Skid.**

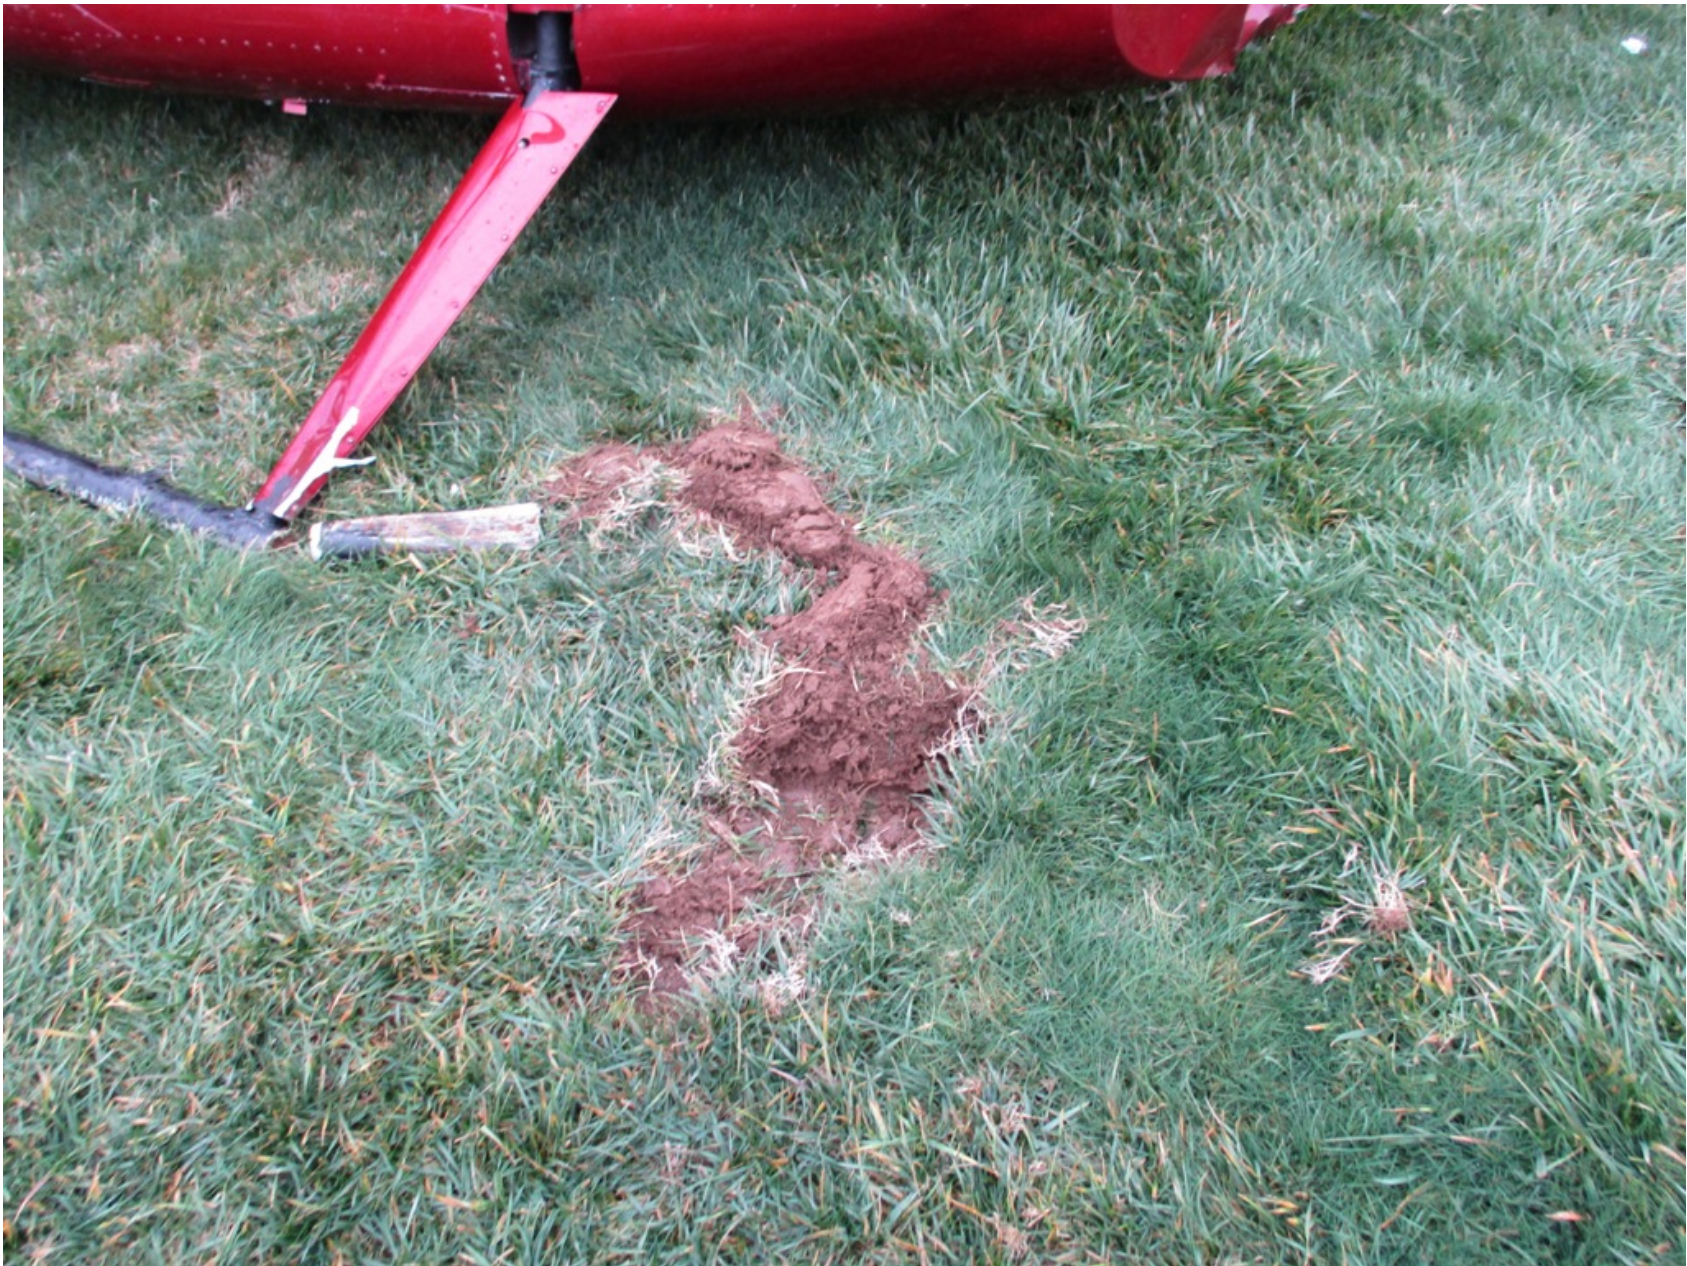
**Photo 3 - FAA Digital Photograph. Close-Up View of the Ground Scar Made by and in Close Proximity to the Rear Portion of the Right Skid.**

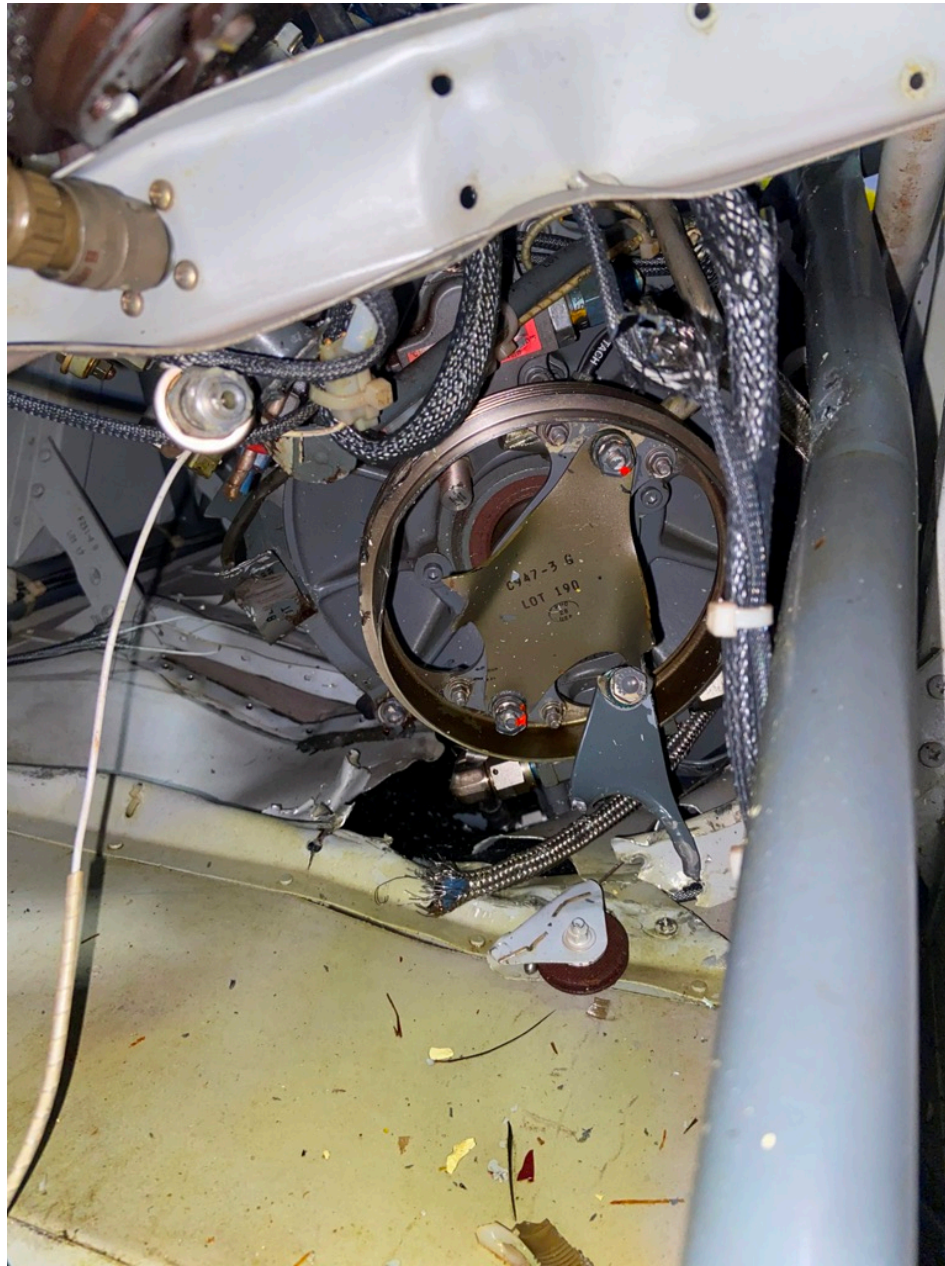
**Photo 4 – Digital Photograph Provided by Jim Garst of Sevier County Choppers. View Depicting the Flex Plate Assembly Attached to the Yoke, the deformed and Fractured Flex Plate.**

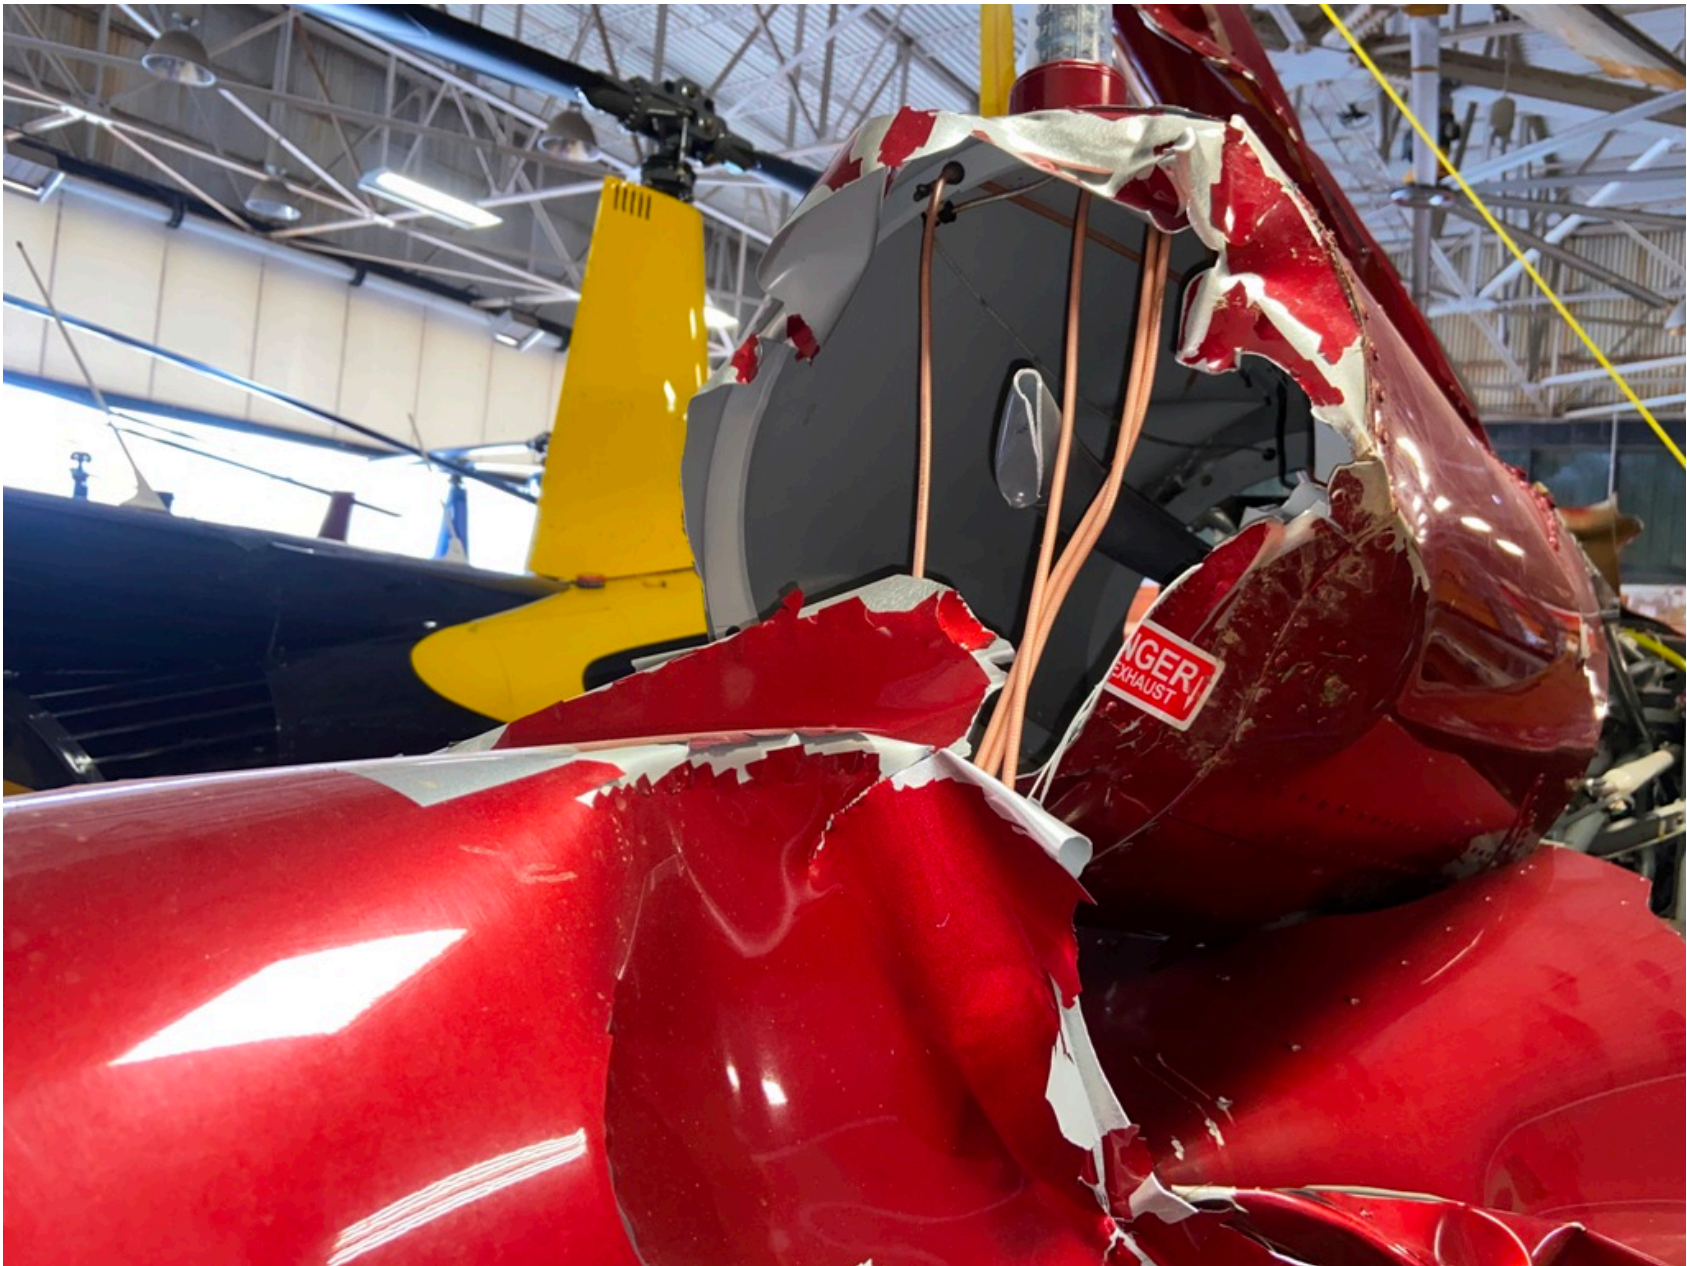
**Photo 5 – Digital Photograph Provided by Jim Garst of Sevier County Choppers. View Depicting One end of the Fractured Tail Rotor Drive Shaft. Note the Deformation.**

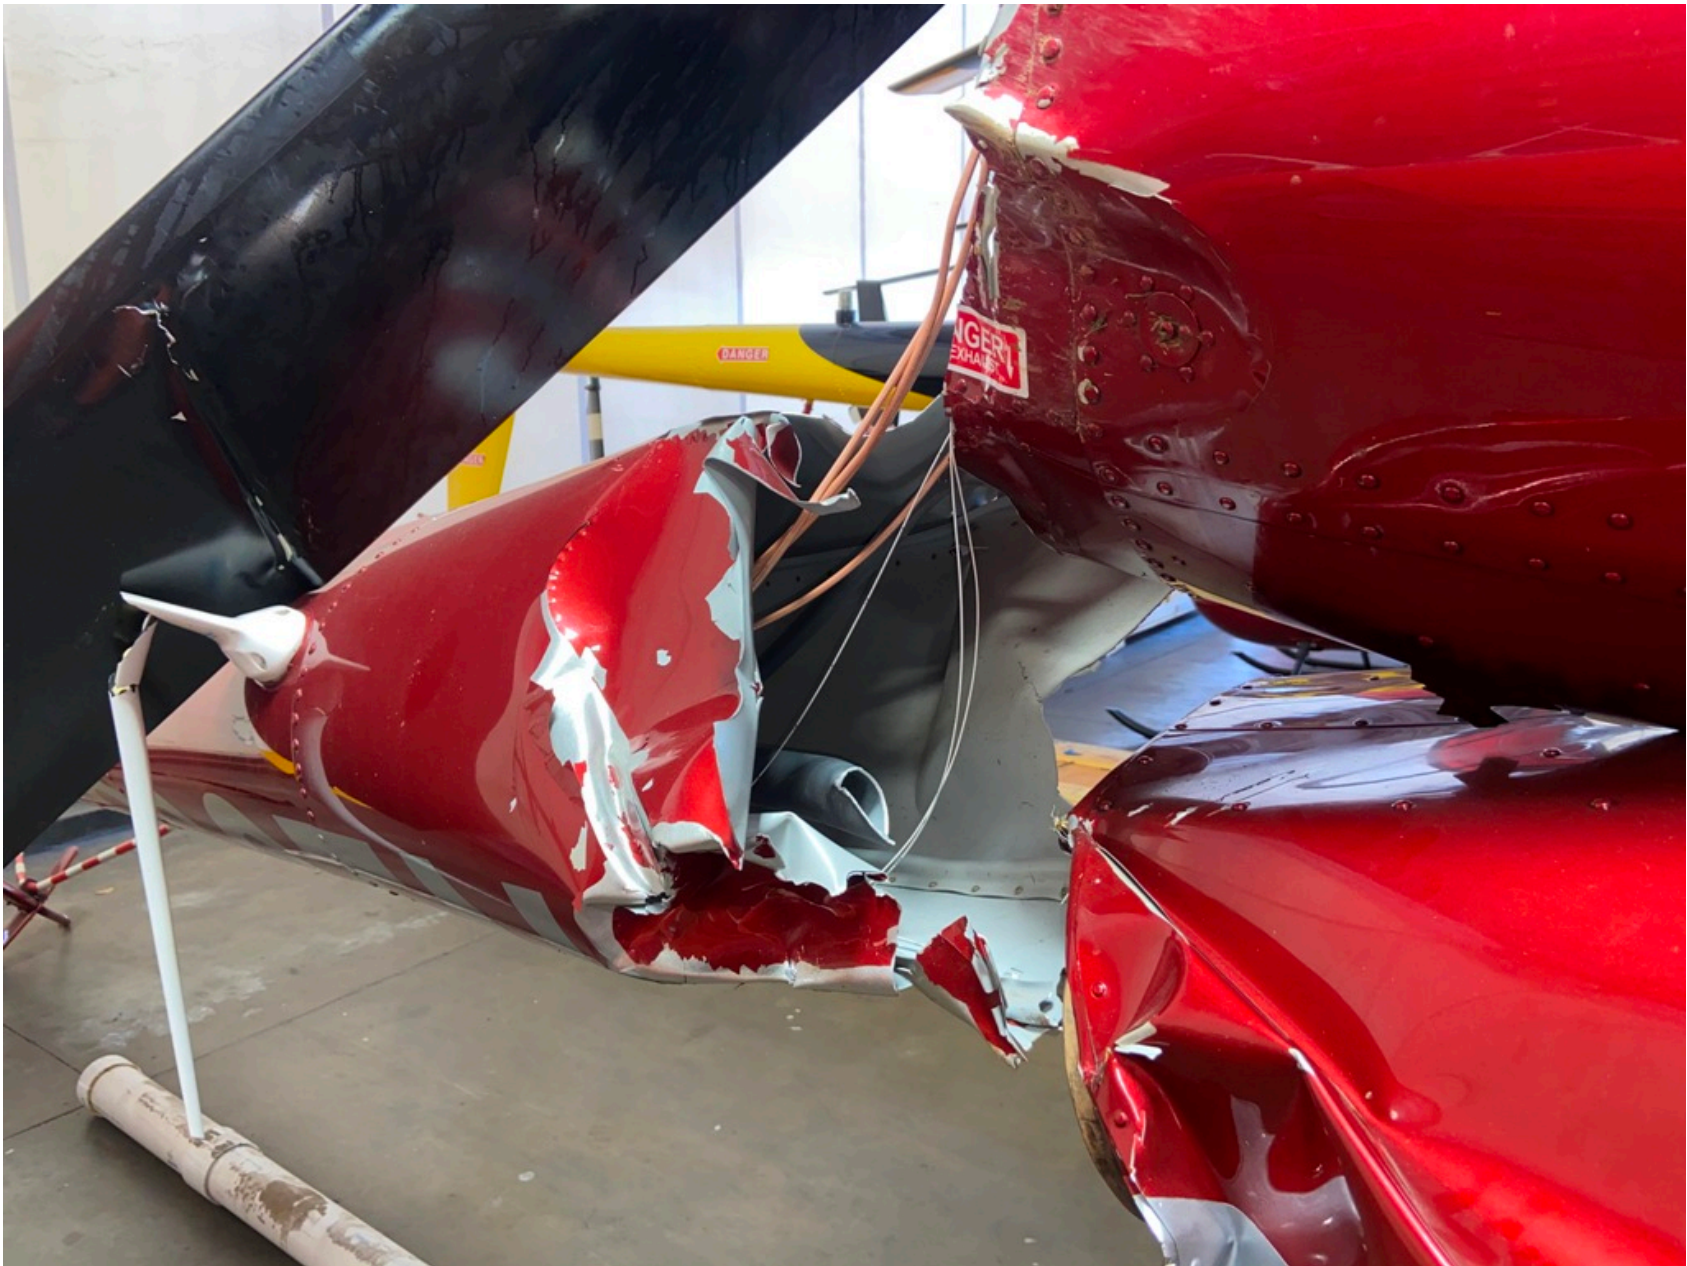
**Photo 6 – Digital Photograph Provided by Jim Garst of Sevier County Choppers. View Depicting Opposite end of the Fractured Tail Rotor Drive Shaft. Note the “D” Shaped Deformation.**

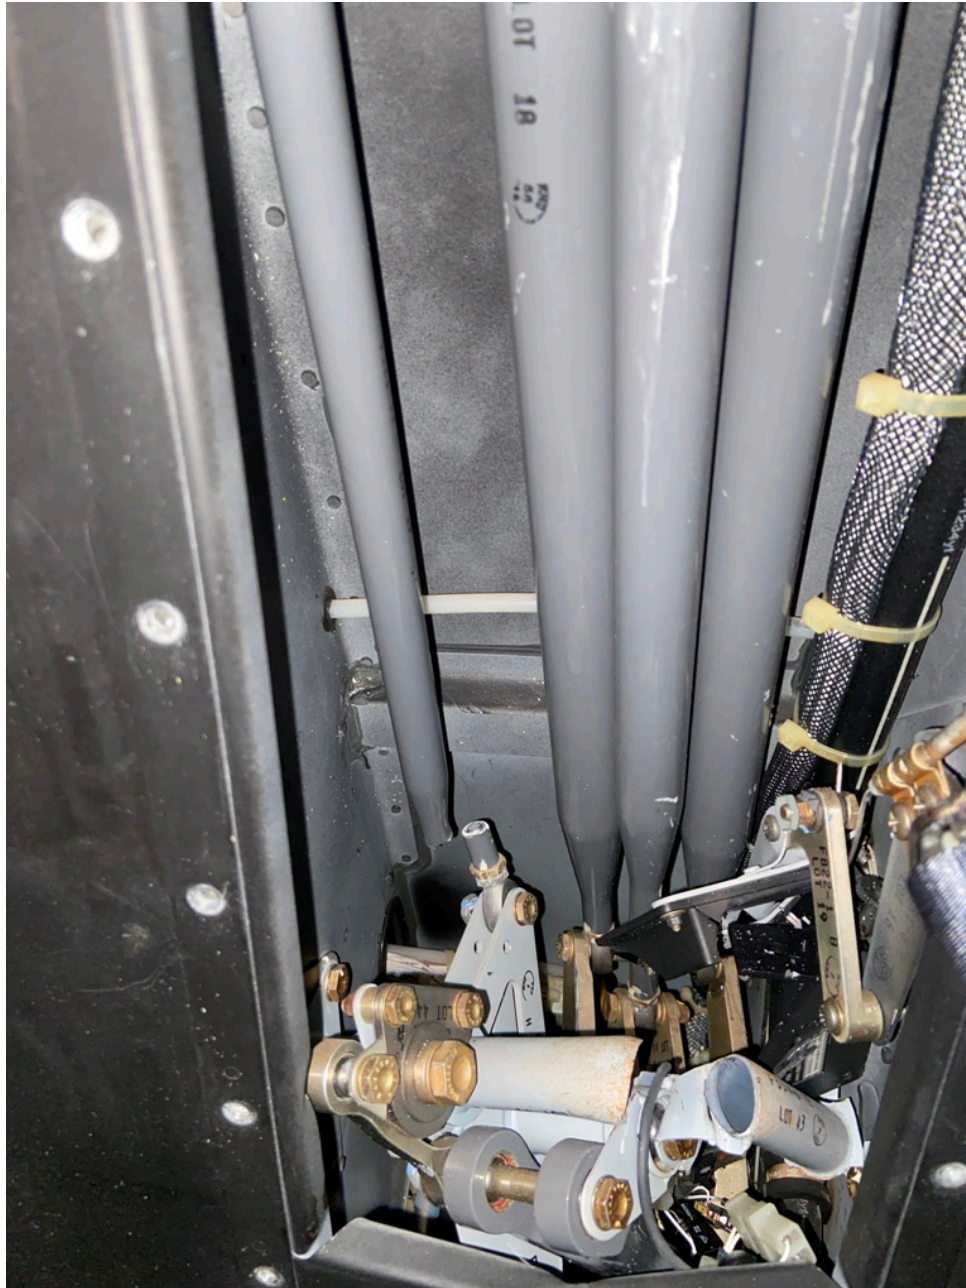
Photo 7 – Digital Photograph Provided by Jim Garst of Sevier County Choppers. View Depicting the Fractured Push-Pull Tube Assembly of the Anti-Torque Control. Note the Fractured Aft Support.

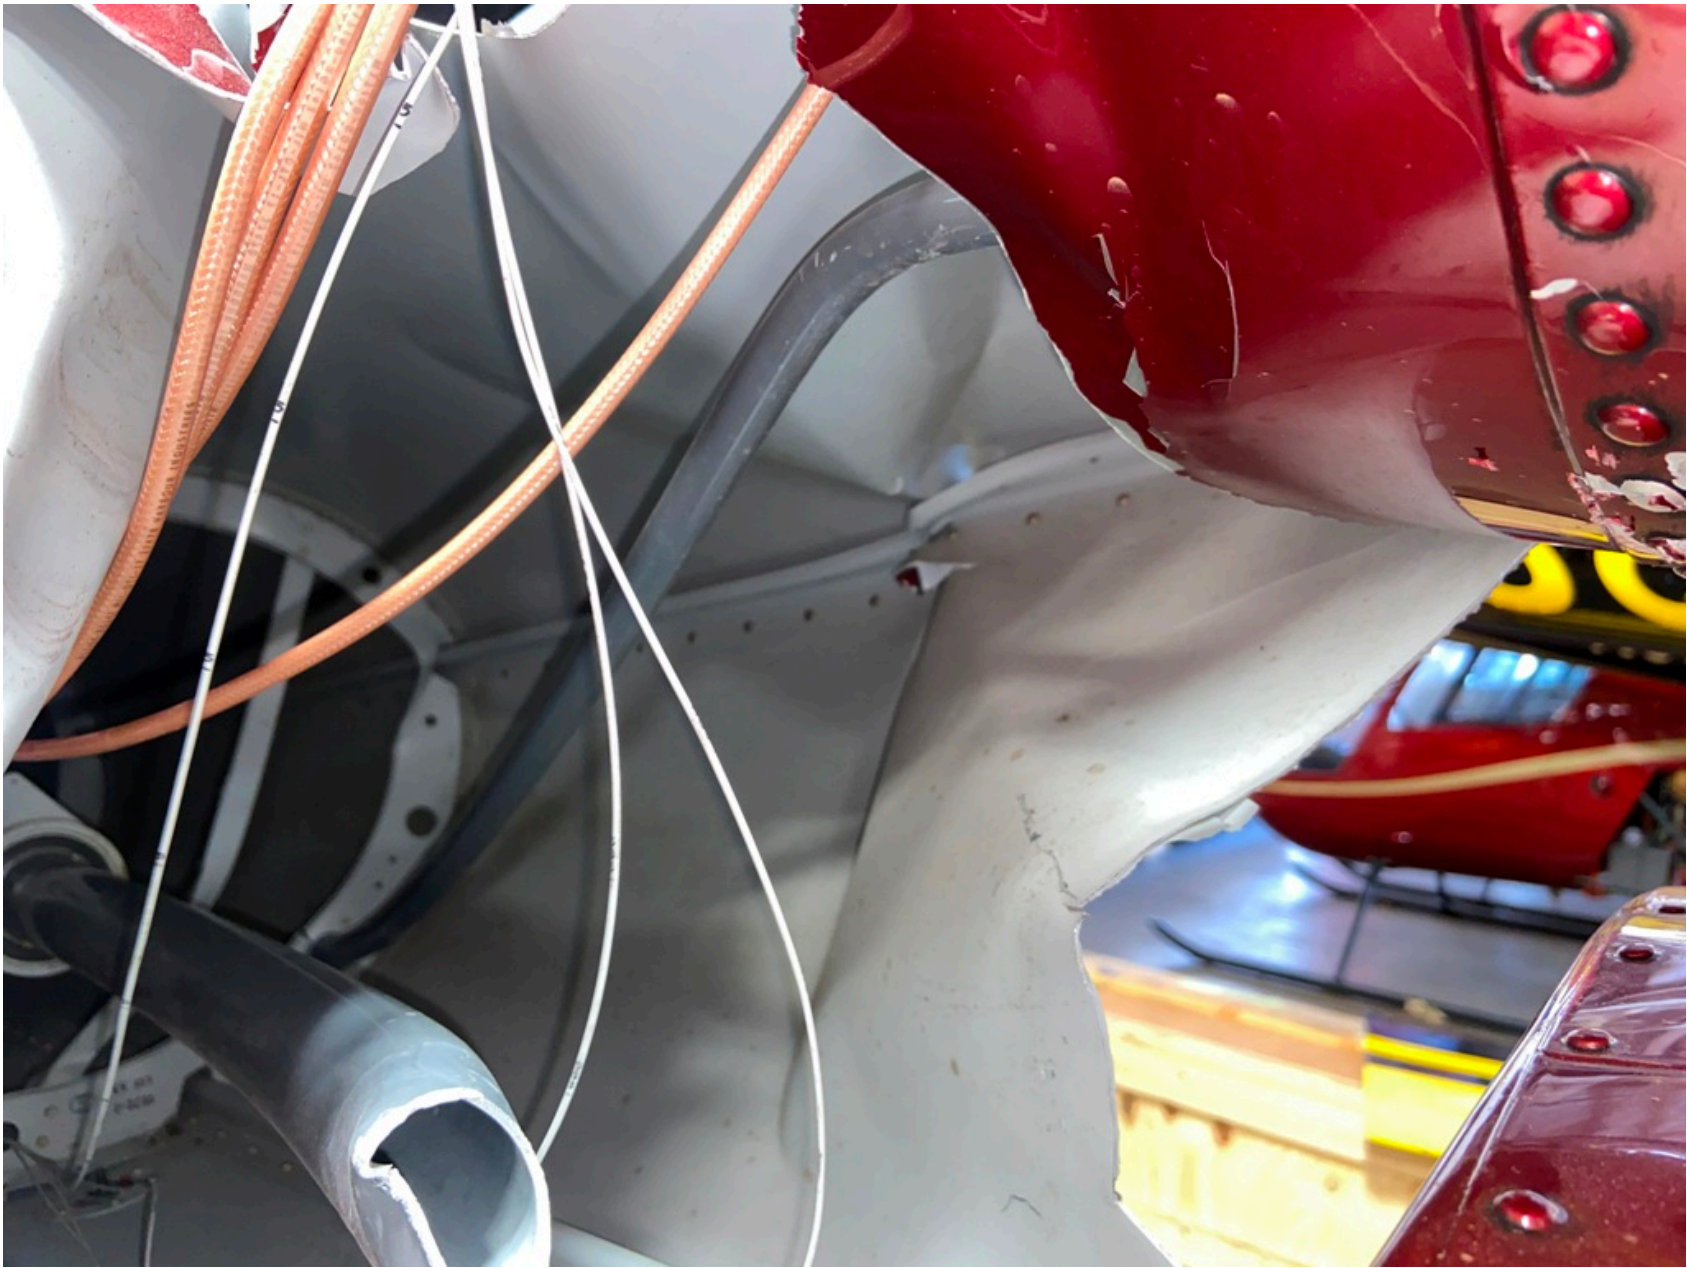
Photo 8 – Digital Photograph Provided by Jim Garst of Sevier County Choppers. View Depicting the Bending Deformation of the Push-Pull Tube Assembly P/N C121-17.
