**NATIONAL TRANSPORTATION SAFETY BOARD**

**AIRFRAME AND ENGINE EXAMINATION**

**ERA21LA132**

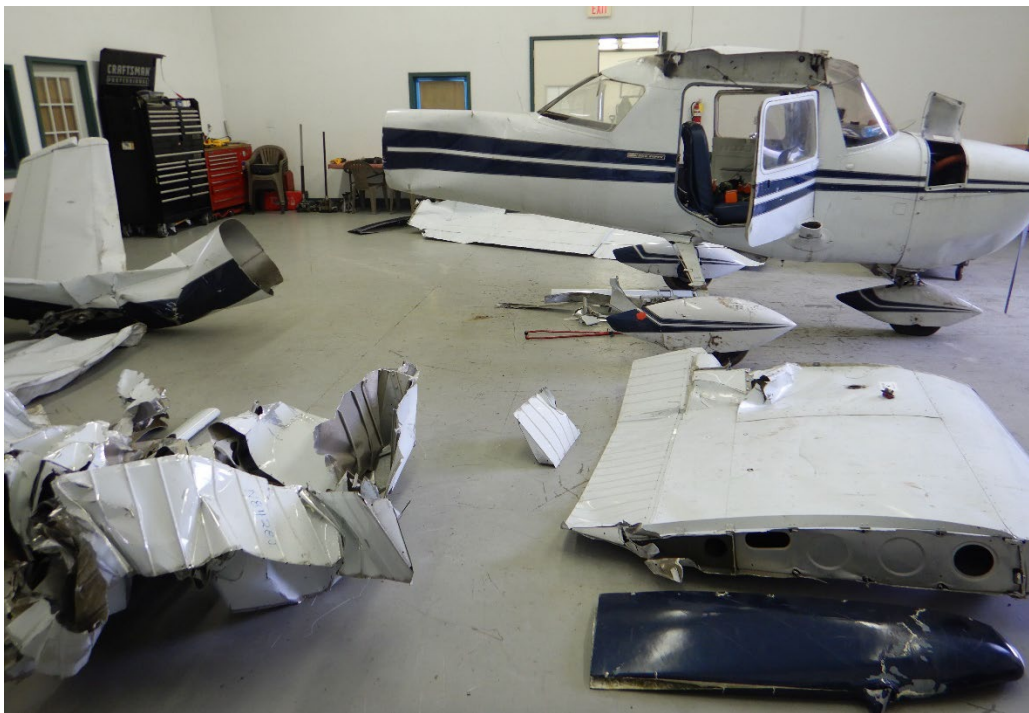
The airplane wings and tail were removed for recovery and transport. The tail cone was cut about 18 inches forward of the dorsal fin. All portions of the airplane were accounted for during the examination. The fuselage was intact and did not sustain any significant impact damage. The lower engine cowling had a small dent, and the right side of the tail was dented. The cabin capacity was not reduced.

The aircraft was observed separated into multiple sections which consisted of the left wing, right wing inboard section with flap attached, right wing outboard section with aileron attached, and the tail. The aircraft pieces were placed in their corresponding positions to resemble a properly oriented aircraft.

*Figure 1: Wreckage viewed from right*

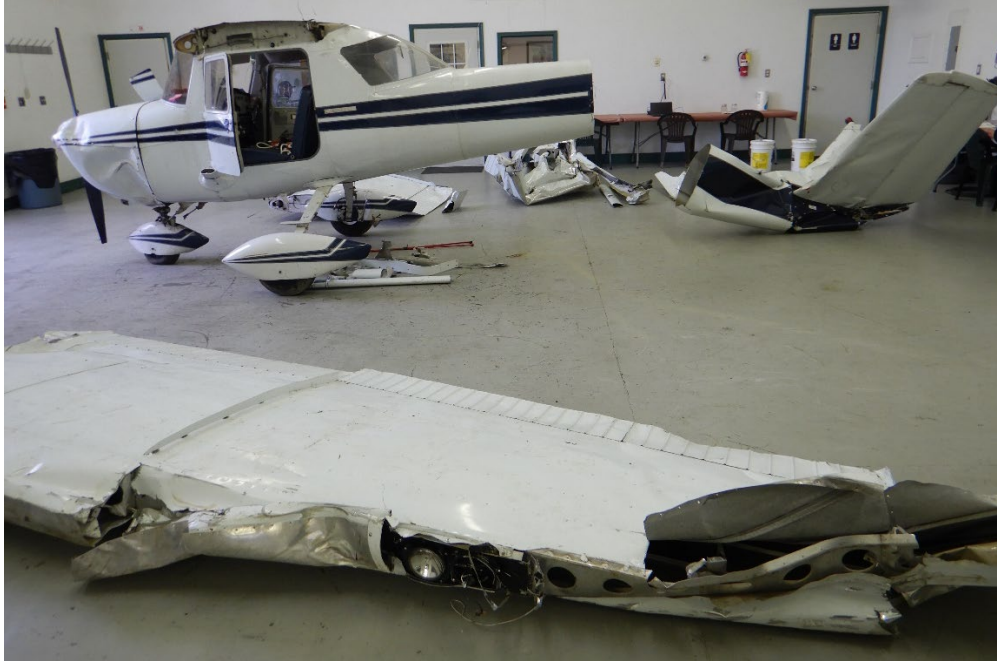
The left wing was cut from the aircraft at the wing root and remained principally intact. The leading edge of the left wing sustained significant tree impact damage near the flap/aileron intersection and the leading edge skin was separated outboard of the landing light. The left wing leading edge skin had been replaced and was not painted. The outboard left wing exhibited tapering compression damage near the wingtip. The majority of the left aileron remained attached to the left wing. An approximately 15" section of the outboard left aileron was

*Figure 2: Wreckage viewed from left*

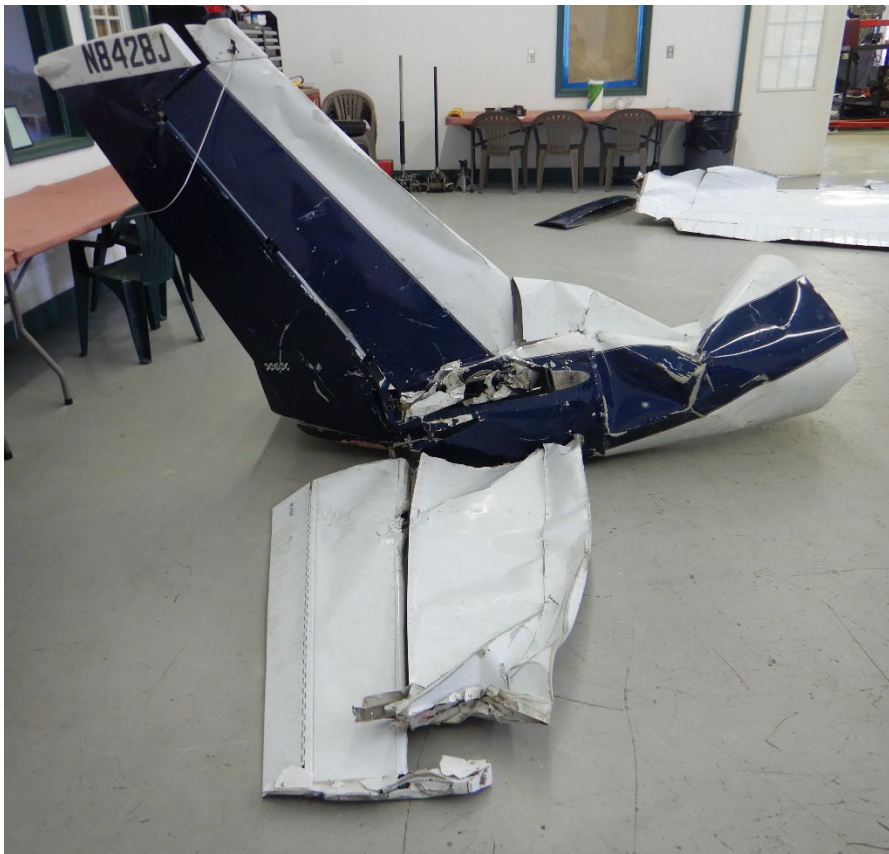
The empennage was cut by recovery personnel approximately 18" forward of the dorsal. The left horizontal stabilizer and elevator remained attached to the tail. The leading edge sustained impact damage consistent with tree impact. The vertical stabilizer sustained leading edge impact damage. The rudder remained attached. The right horizontal stabilizer and elevator sustained tree impact damage and were separated from the tail. The leading edge sustained damage consistent with tree impact, and the elevator remained attached.

*Figure 3: Empennage viewed from right*

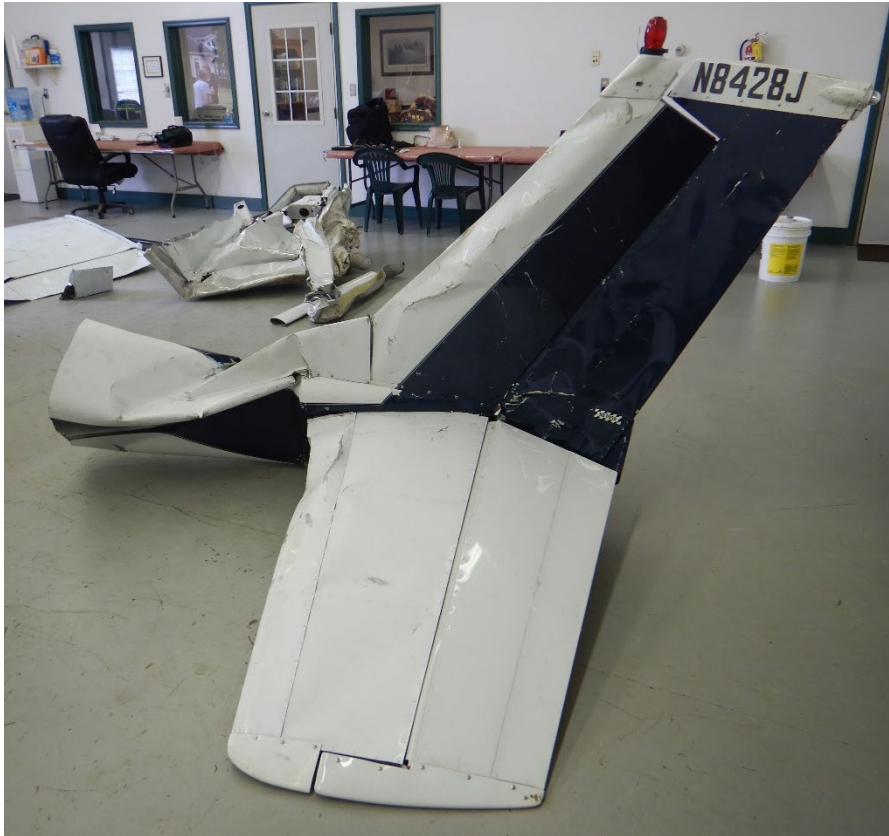
*Figure 4: Empennage viewed from left*

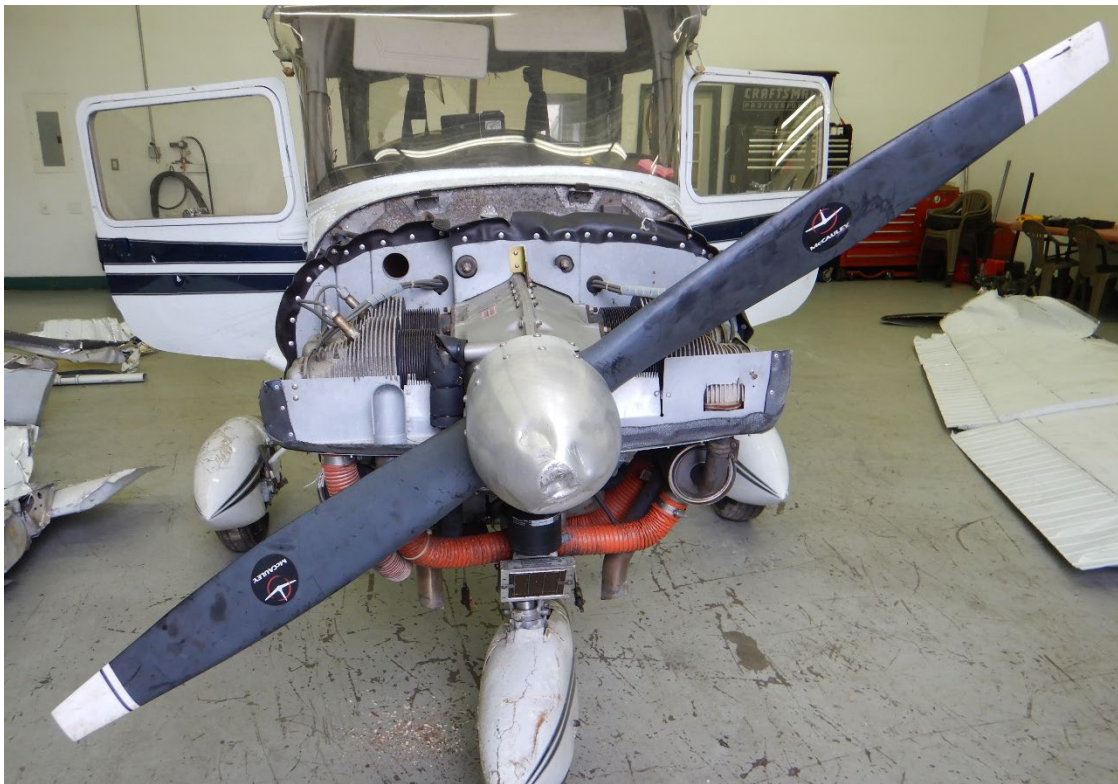
*Figure 5: Propeller*

The engine was equipped with a 2-bladed fixed pitched propeller, which remained attached. Neither blade exhibited s-bending or chordwise scratching. The spinner exhibited impact damage.

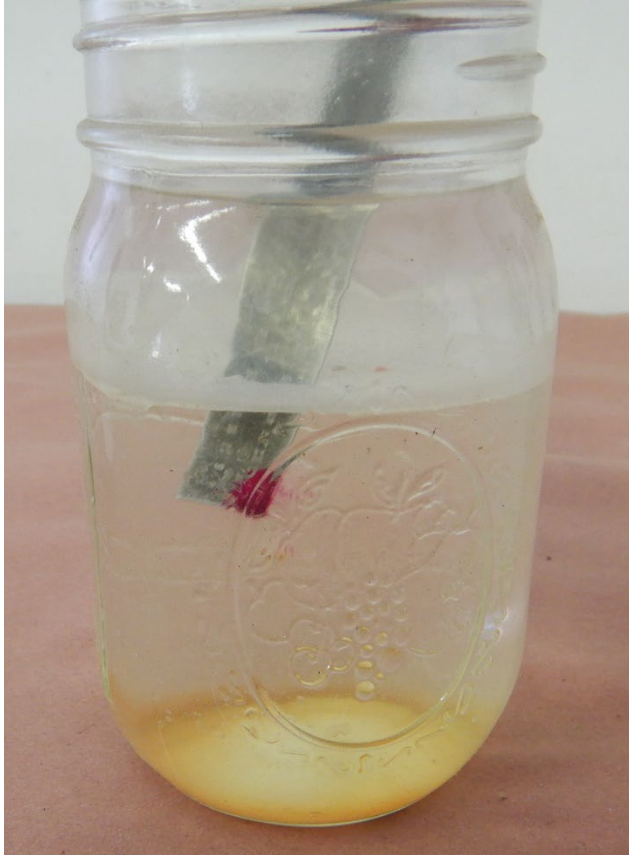
*Figure 6: Left wing fuel sample with water contamination*

The engine did not exhibit any external anomalies. Fuel drained from the fuel strainer assembly was light blue in color and tested negative for water contamination with water paste. Fuel tested from the left fuel tank revealed about 1 ½ cups of water in the 1 ¾ cup sample upon testing. Fuel tested from the right fuel tank revealed no water upon testing, and about 1 teaspoon of white sediment in the bottom of the jar. Both fuel samples recovered from the accident site had lost their blue color; however, both samples exhibited an odor consistent with 100LL fuel. Two 5-gallon containers of fuel were recovered from the accident site and were light blue in color and exhibited an odor consistent with 100LL fuel.

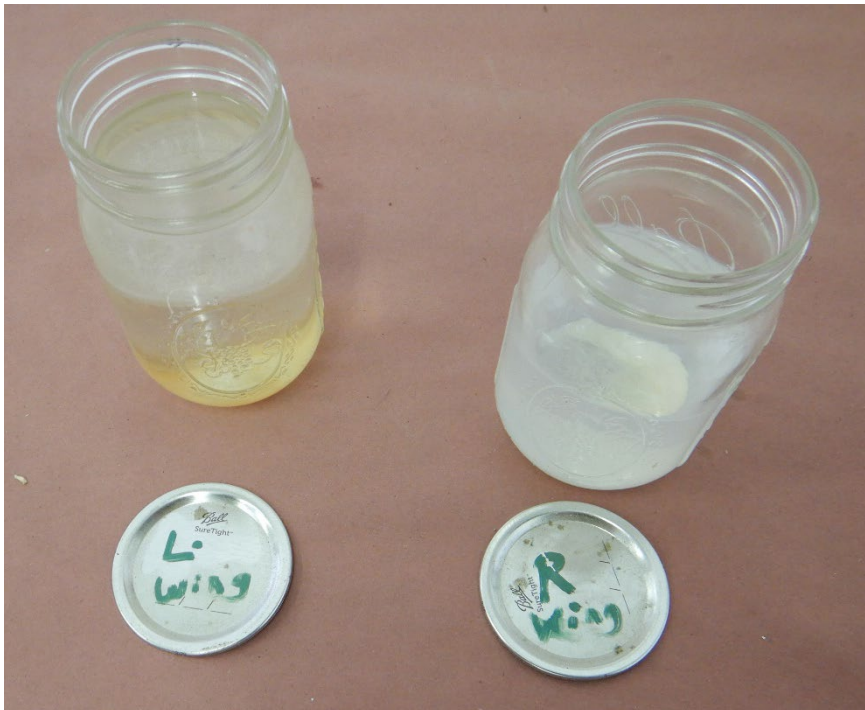
Both left- and right-wing fuel tanks remained intact and were devoid of fuel (recovery personnel drained about 10 gallons of fuel at the accident site). White sediment was recovered from the fuel samples taken from the left and right fuel tanks at the accident site. Additionally, water was recovered from the fuel sample taken from the left wing fuel tank at the accident site. The fuel selector was positioned to the "ON" position.

*Figure 7: Left- and right-wing fuel samples from accident site showed contamination*

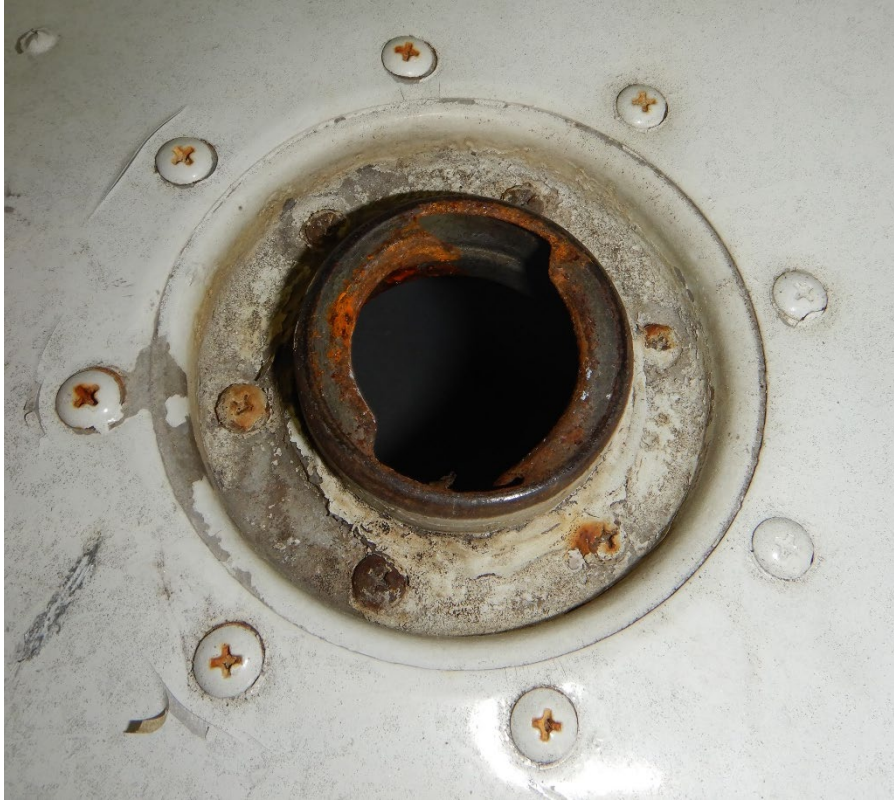
The inboard aft corner of the right fuel tank sustained impact damage and was bent upward. The right fuel cap remained in place. It was opened and the chain was found to be disconnected from the clip. The vented cap appeared to have a new rubber gasket. The fuel filler neck appeared to be rusted and exhibited a significant amount of corrosion around the exterior. The right fuel tank was examined using an endoscope. No significant debris was noted inside. The right fuel quantity transmitter was removed from the fuel tank. It was wired to the aircraft and tested using the ship's battery. It functioned normally for EMPTY but displayed approximately  $\frac{3}{4}$  tank in the FULL position. The finger screen and sump were removed; they appeared normal, and no debris was observed. The fuel sump exhibited rust and corrosion around the pick-up holes which was indicative of water exposure. The right sump was depressed with a screwdriver. The spring compressed about halfway. About half the capacity of the right sump fuel pick-up holes were exposed. This could have potentially caused the fuel to drain more slowly from the right wing sump during the preflight inspection as was reported by the owner.

*Figure 8: Right fuel filler neck exhibited corrosion*

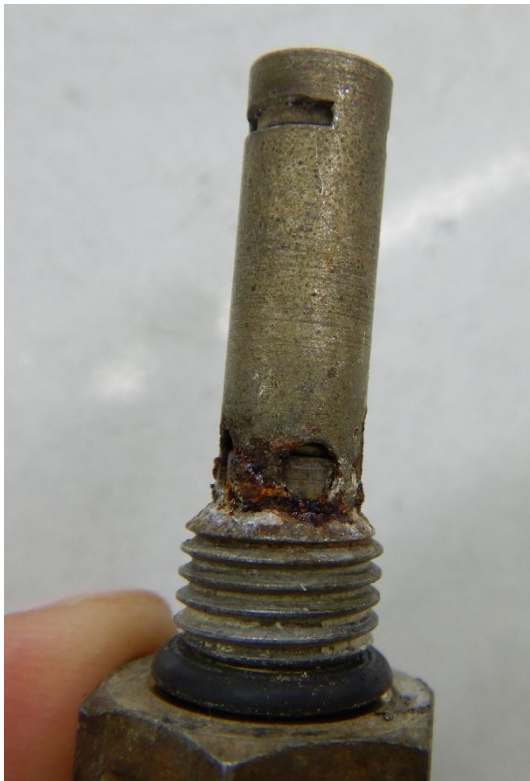
*Figure 9: Right fuel sump exhibiting corrosion*

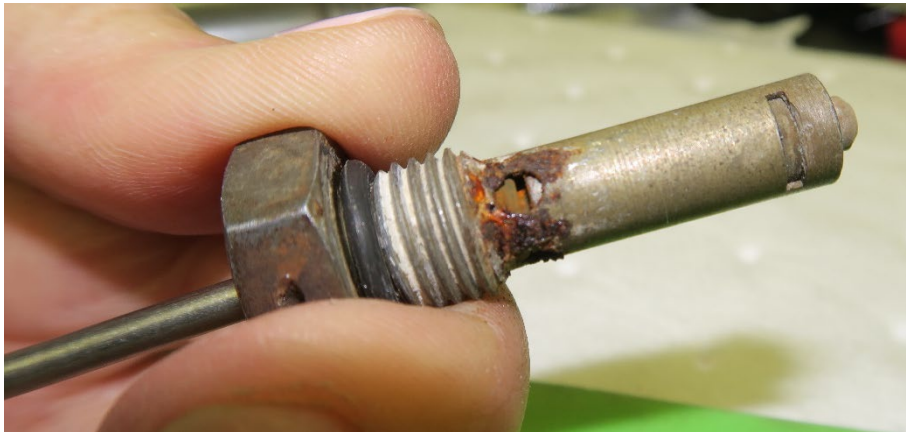
*Figure 10: Right fuel sump with screwdriver inserted*

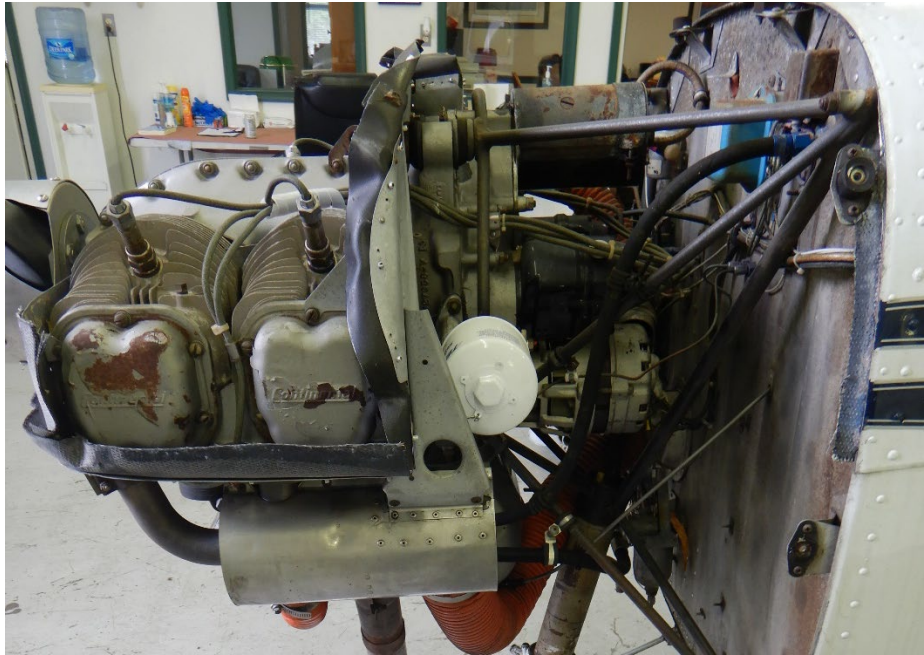
*Figure 11: Engine viewed from left with cowling removed*

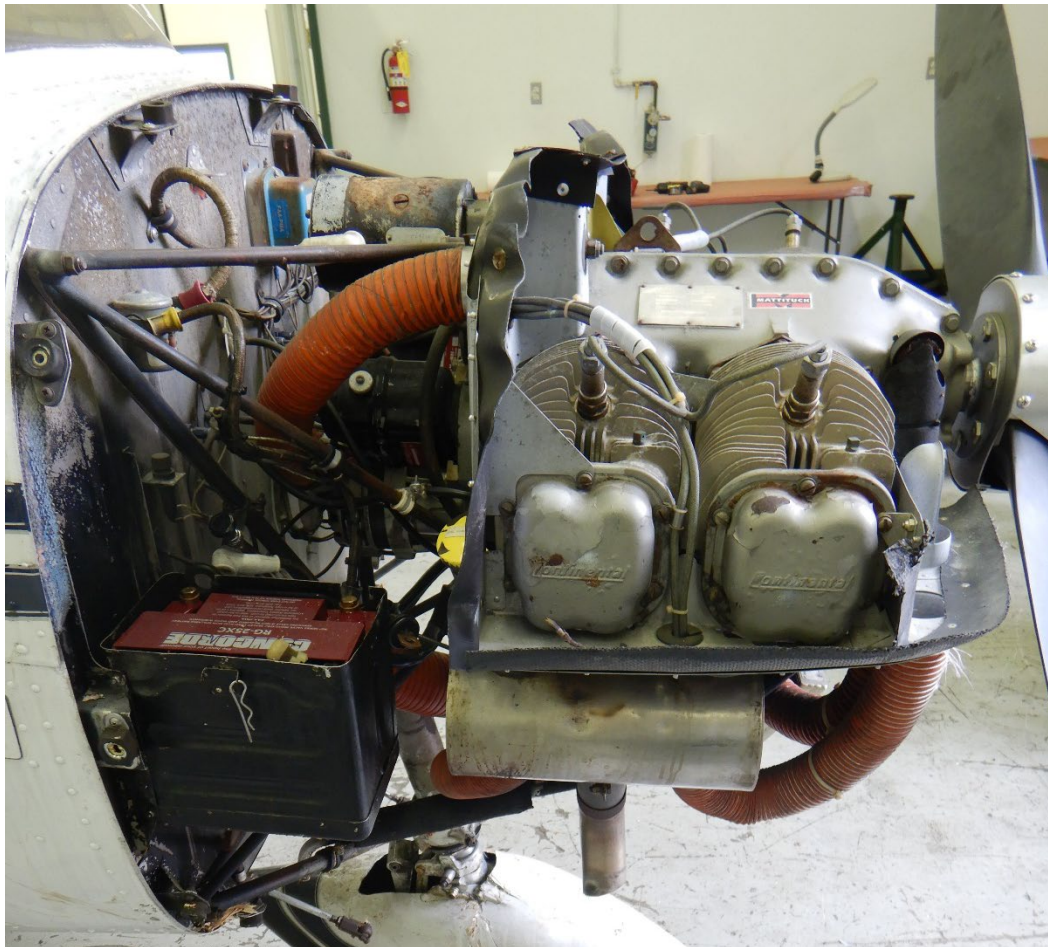
*Figure 12: Engine viewed from right with cowling removed*

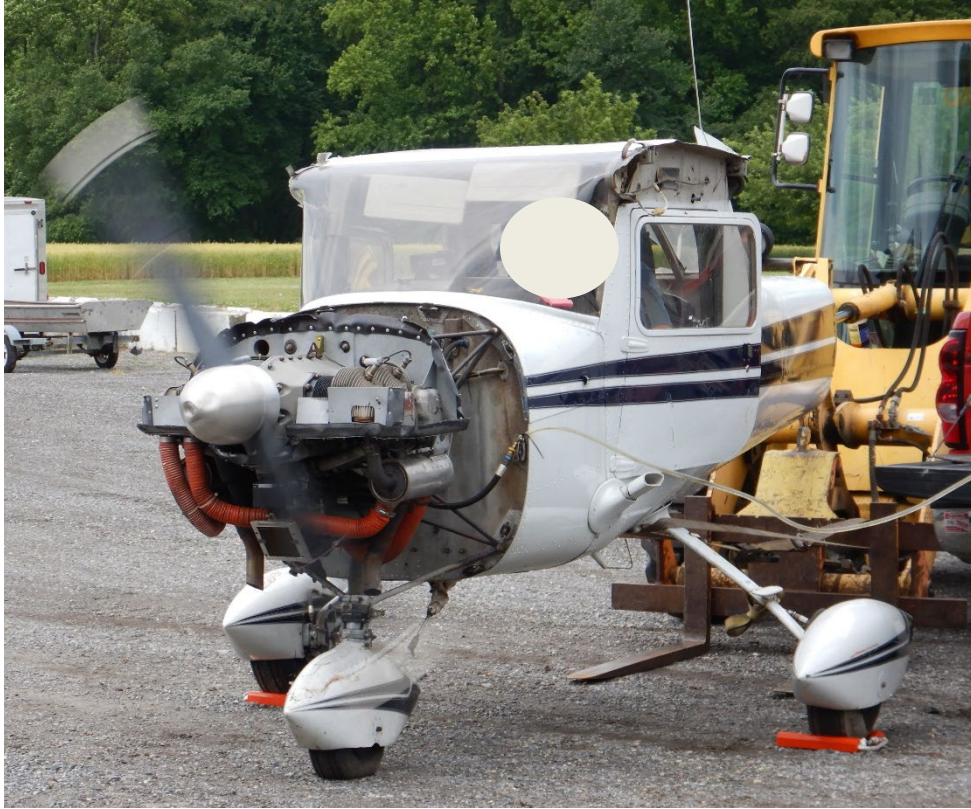
The NTSB hired a mechanic to examine the engine and perform an operational test run. Prior to operating the engine, the top spark plugs were removed, and a compression check was performed. The cylinder compressions were 1 - 65, 2 - 80, 3 - 64, 4 - 70. A portable fuel tank was plumbed directly to the carburetor and the engine was operated normally for several minutes. The magneto and carburetor heat checks produced normal RPM drops.

*Figure 13: Engine start and run-up*
