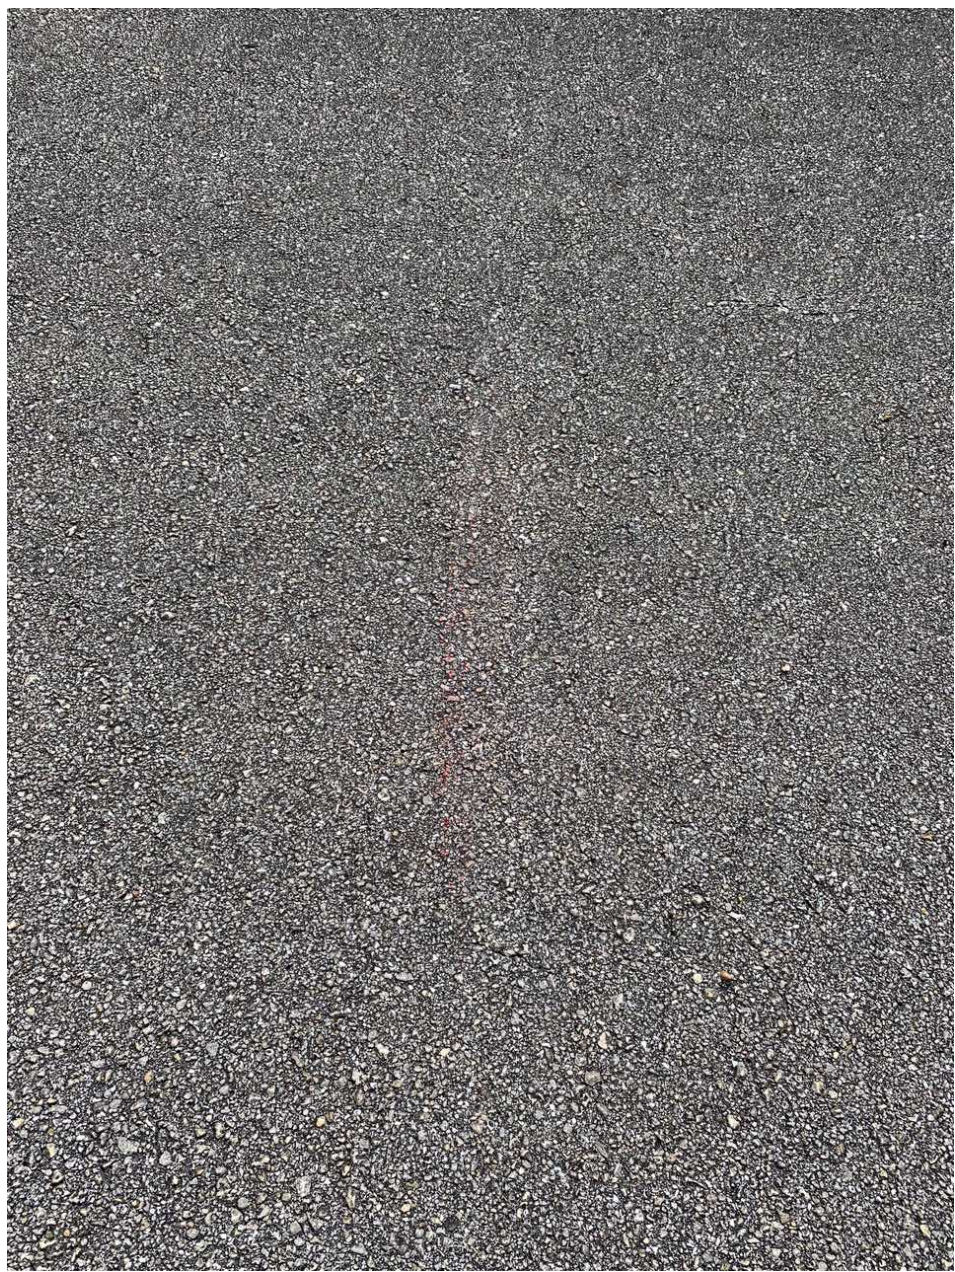
**Photo 1 – Paint Transfer Mark on Right Side of Runway – Courtesy of Aviator College**

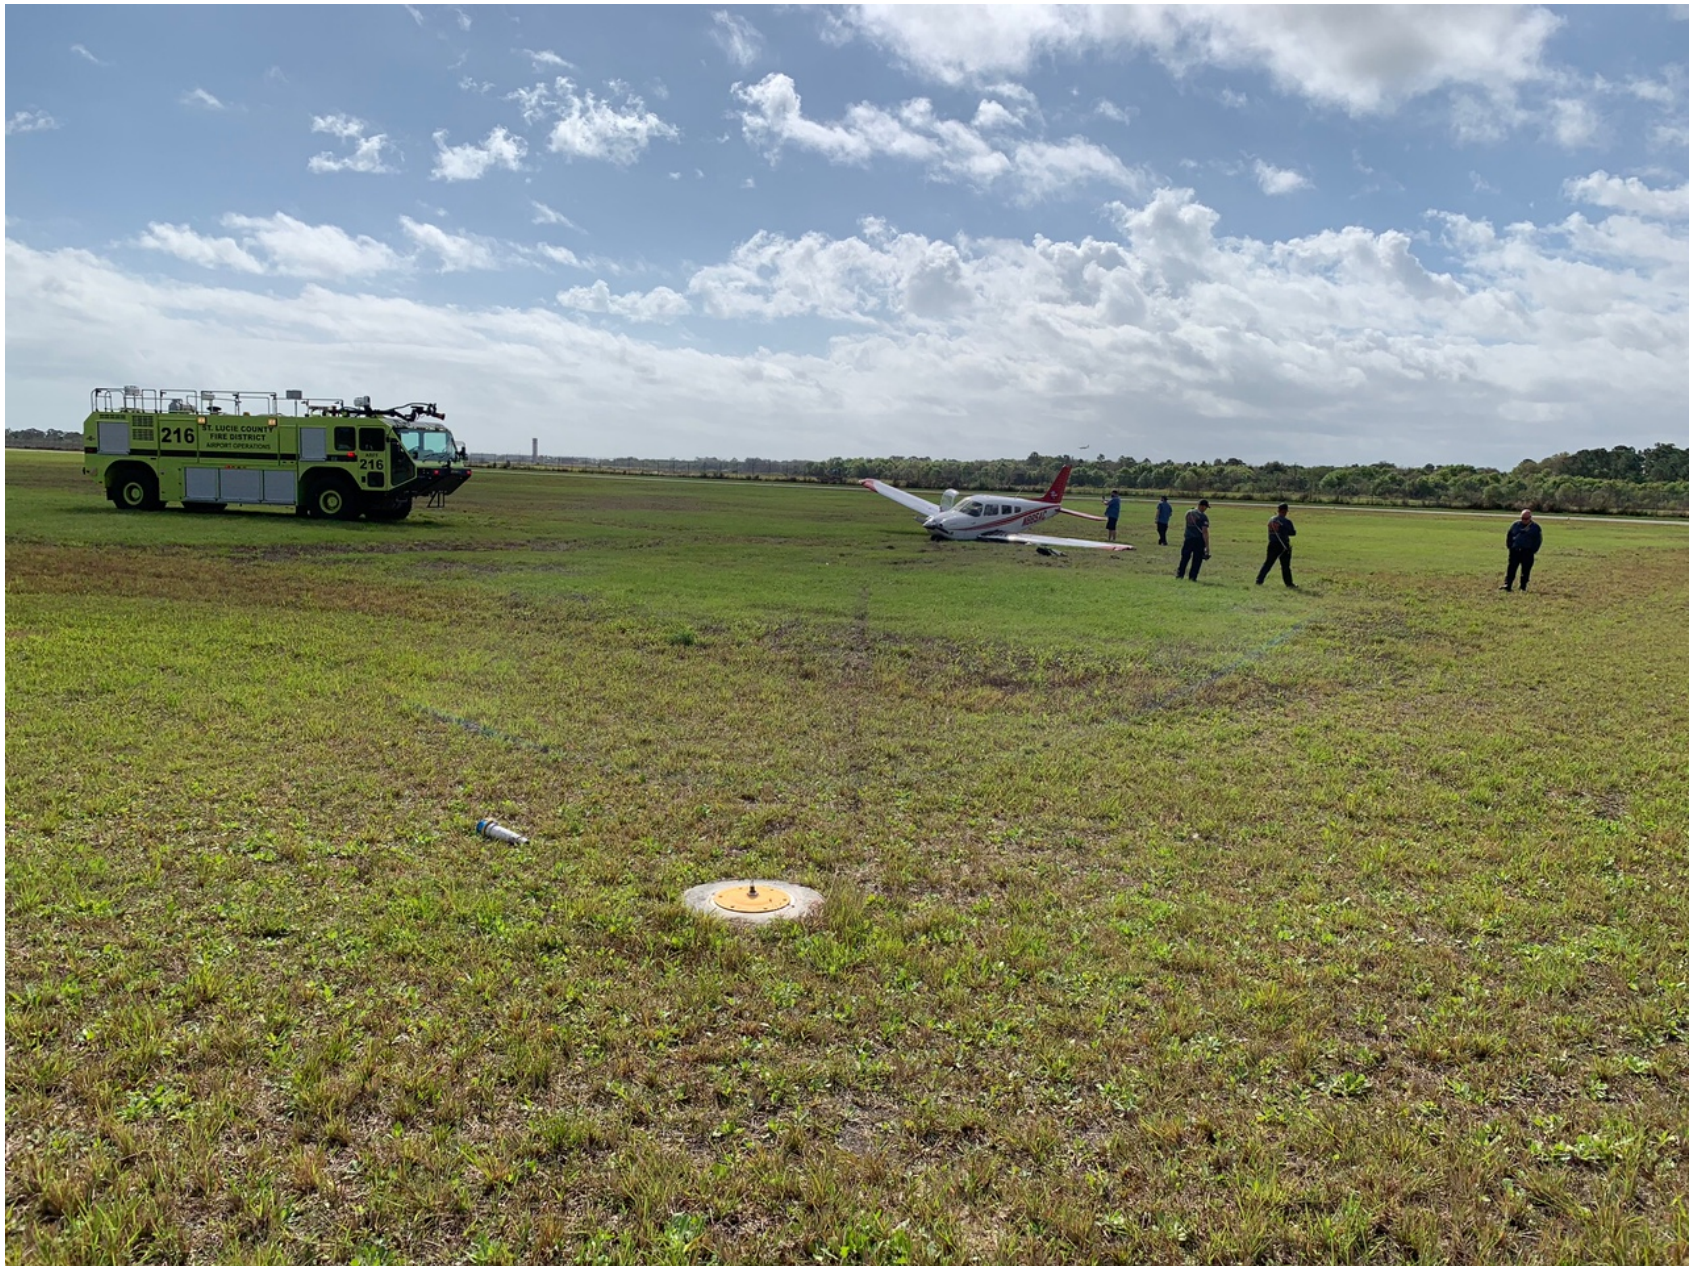
**Photo 2 -Accident Site as Viewed from Runway – Courtesy of Aviator College**

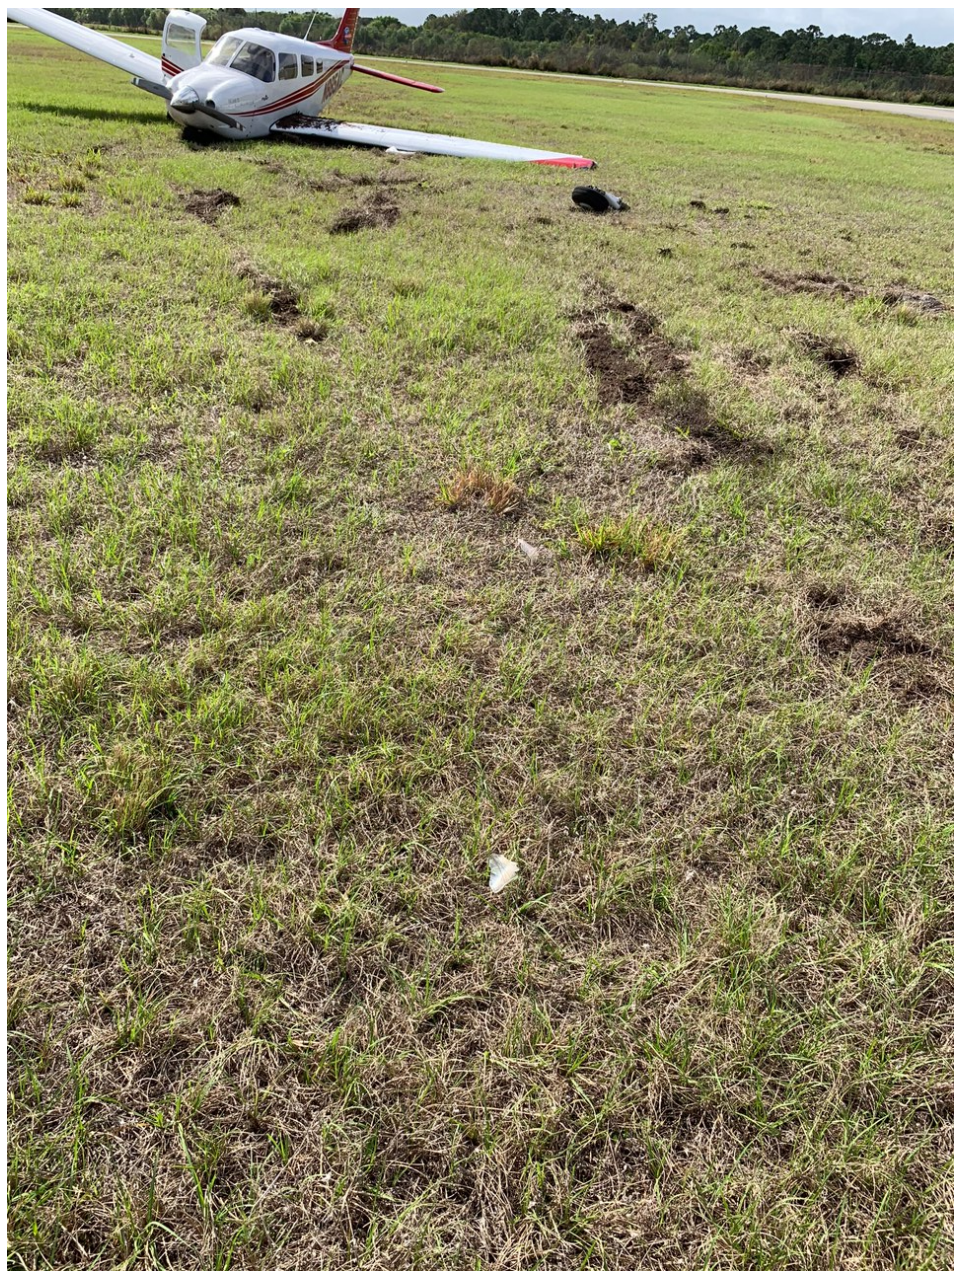
**Photo 3 – Ground Scarring and Debris Leading up to Main Wreckage – Courtesy of Aviator College**

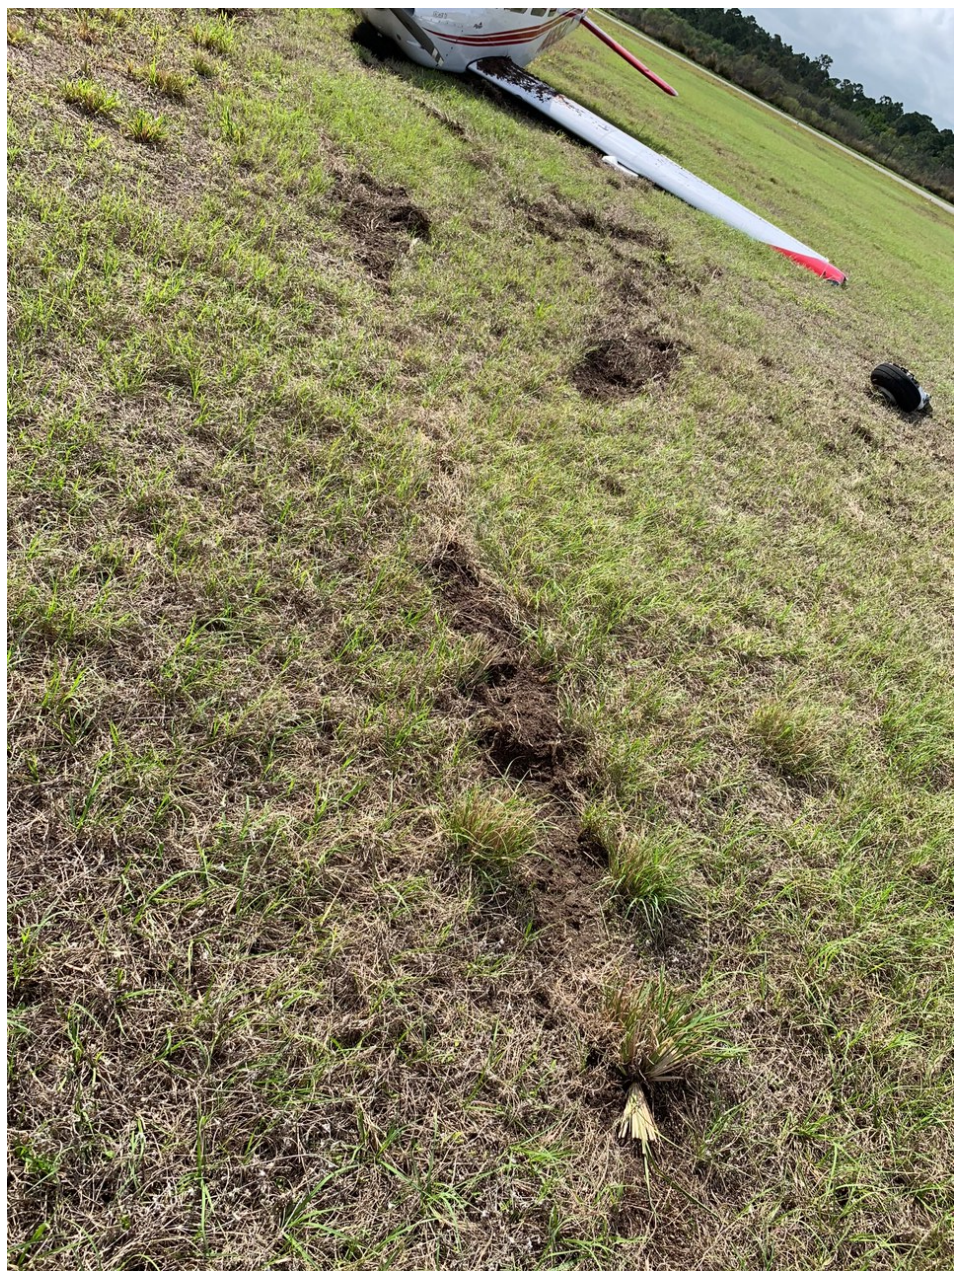
**Photo 4 – Close Up of Ground Scars – Courtesy of Aviator College**

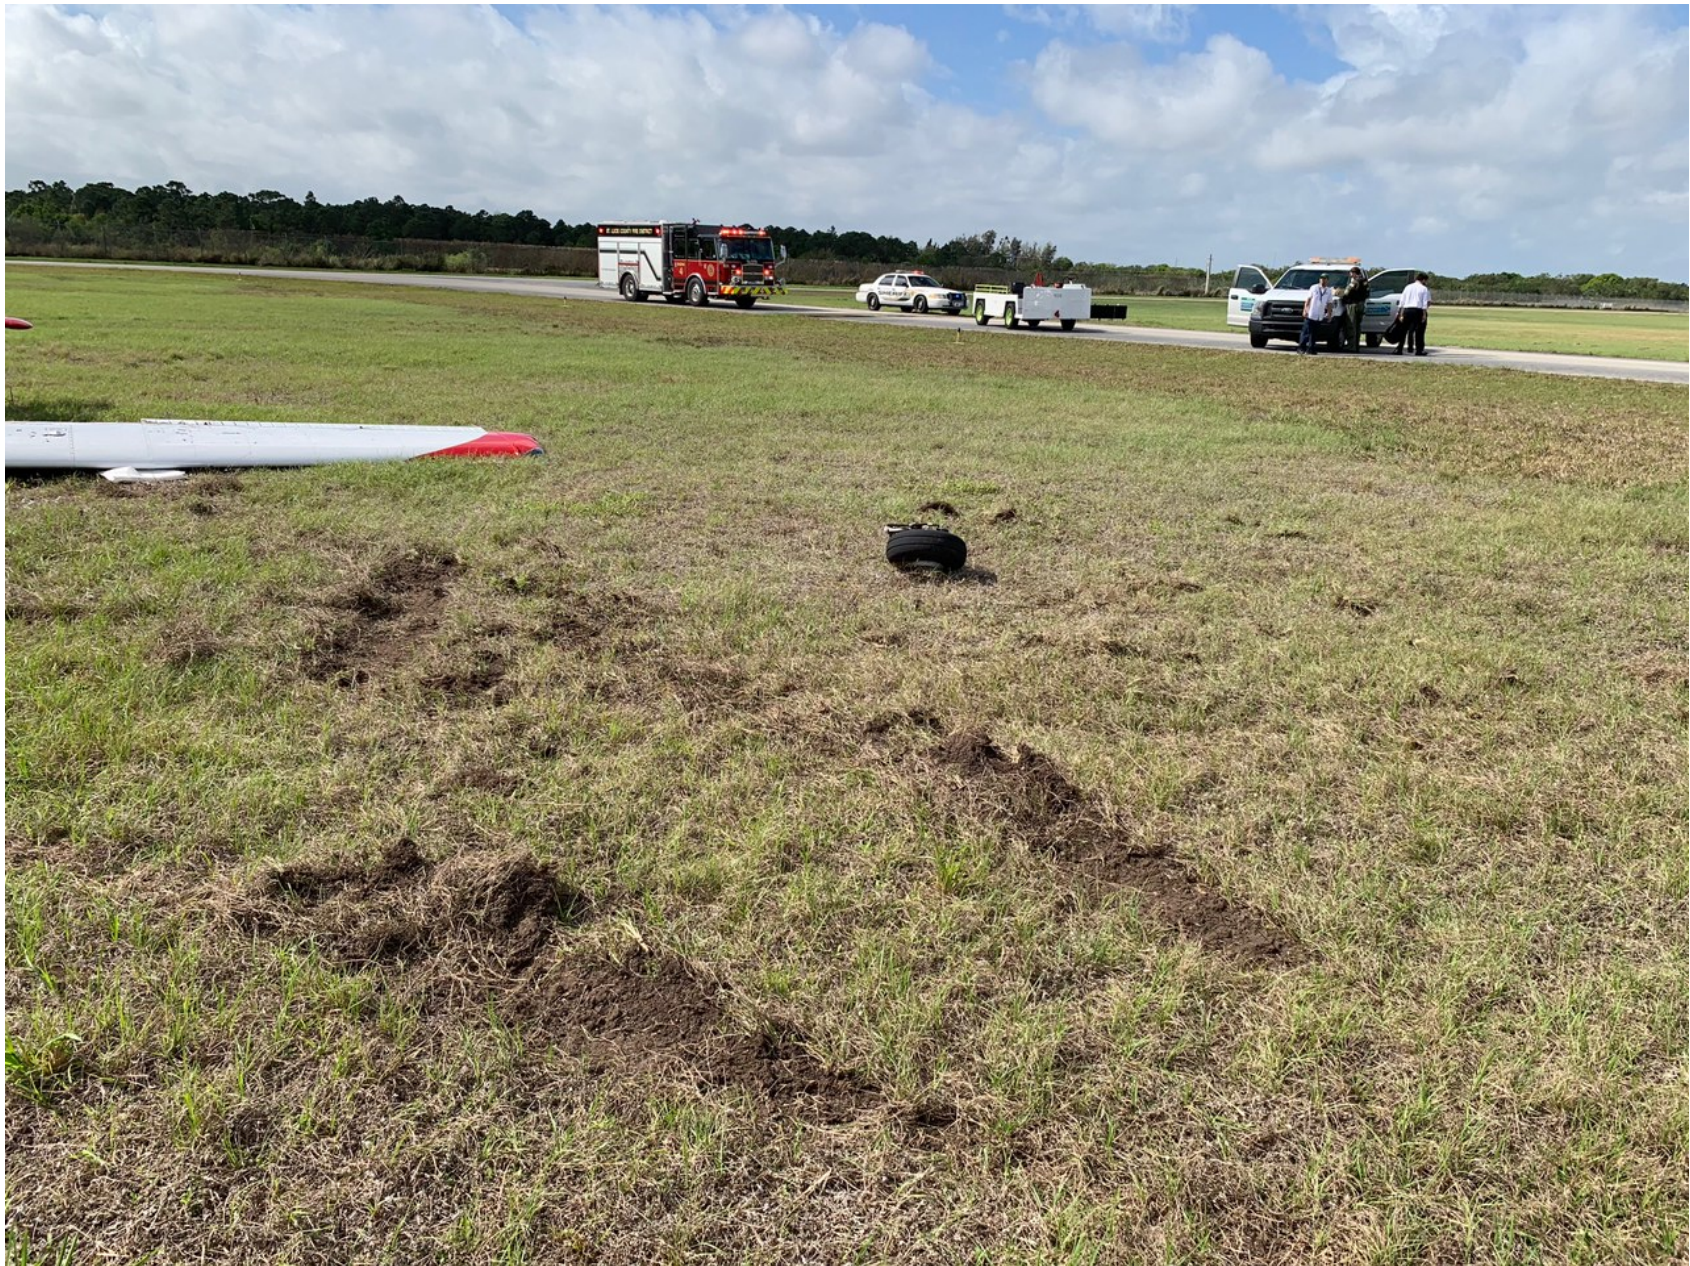
**Photo 5 – Close Up of Scarring from Main Landing Gear and Tail – Courtesy of Aviator College**

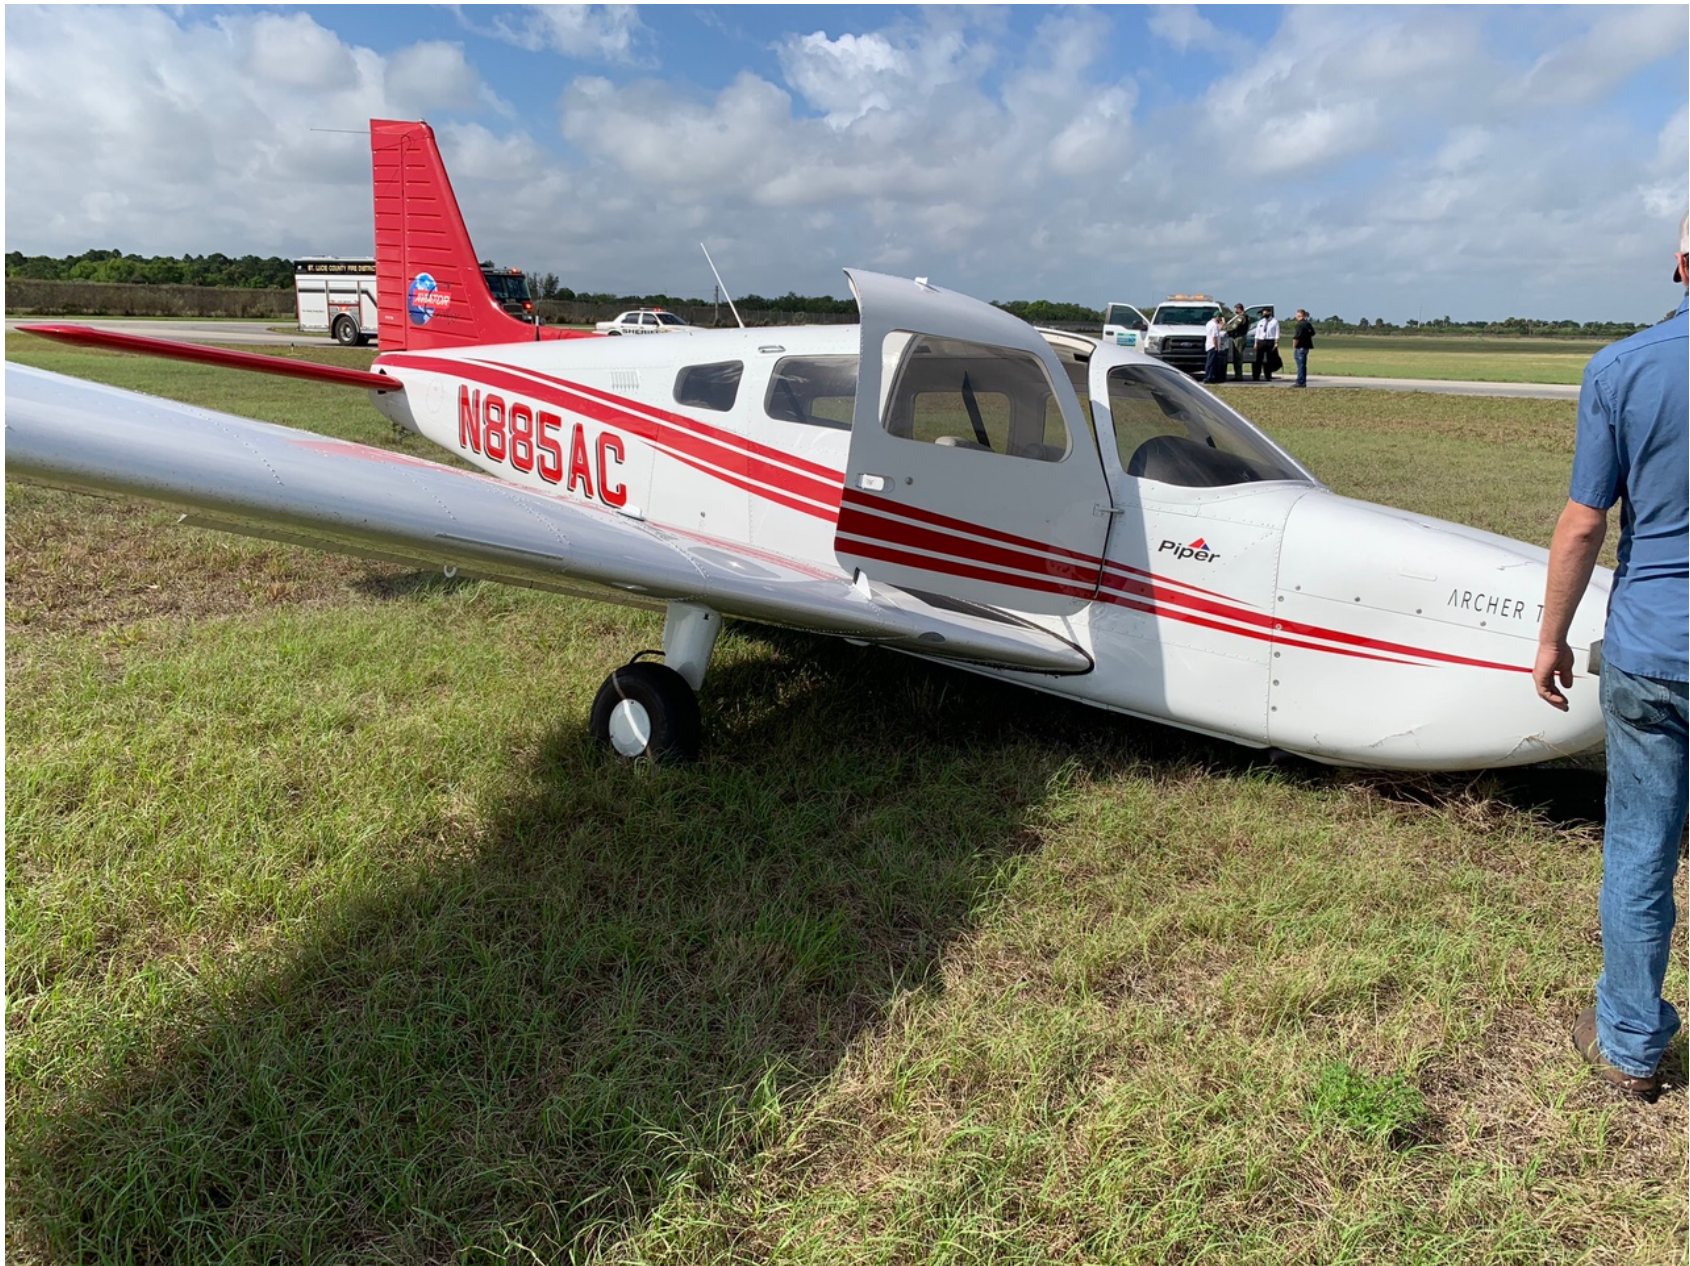
**Photo 6 – Right Side View of Airplane – Courtesy of Aviator College**

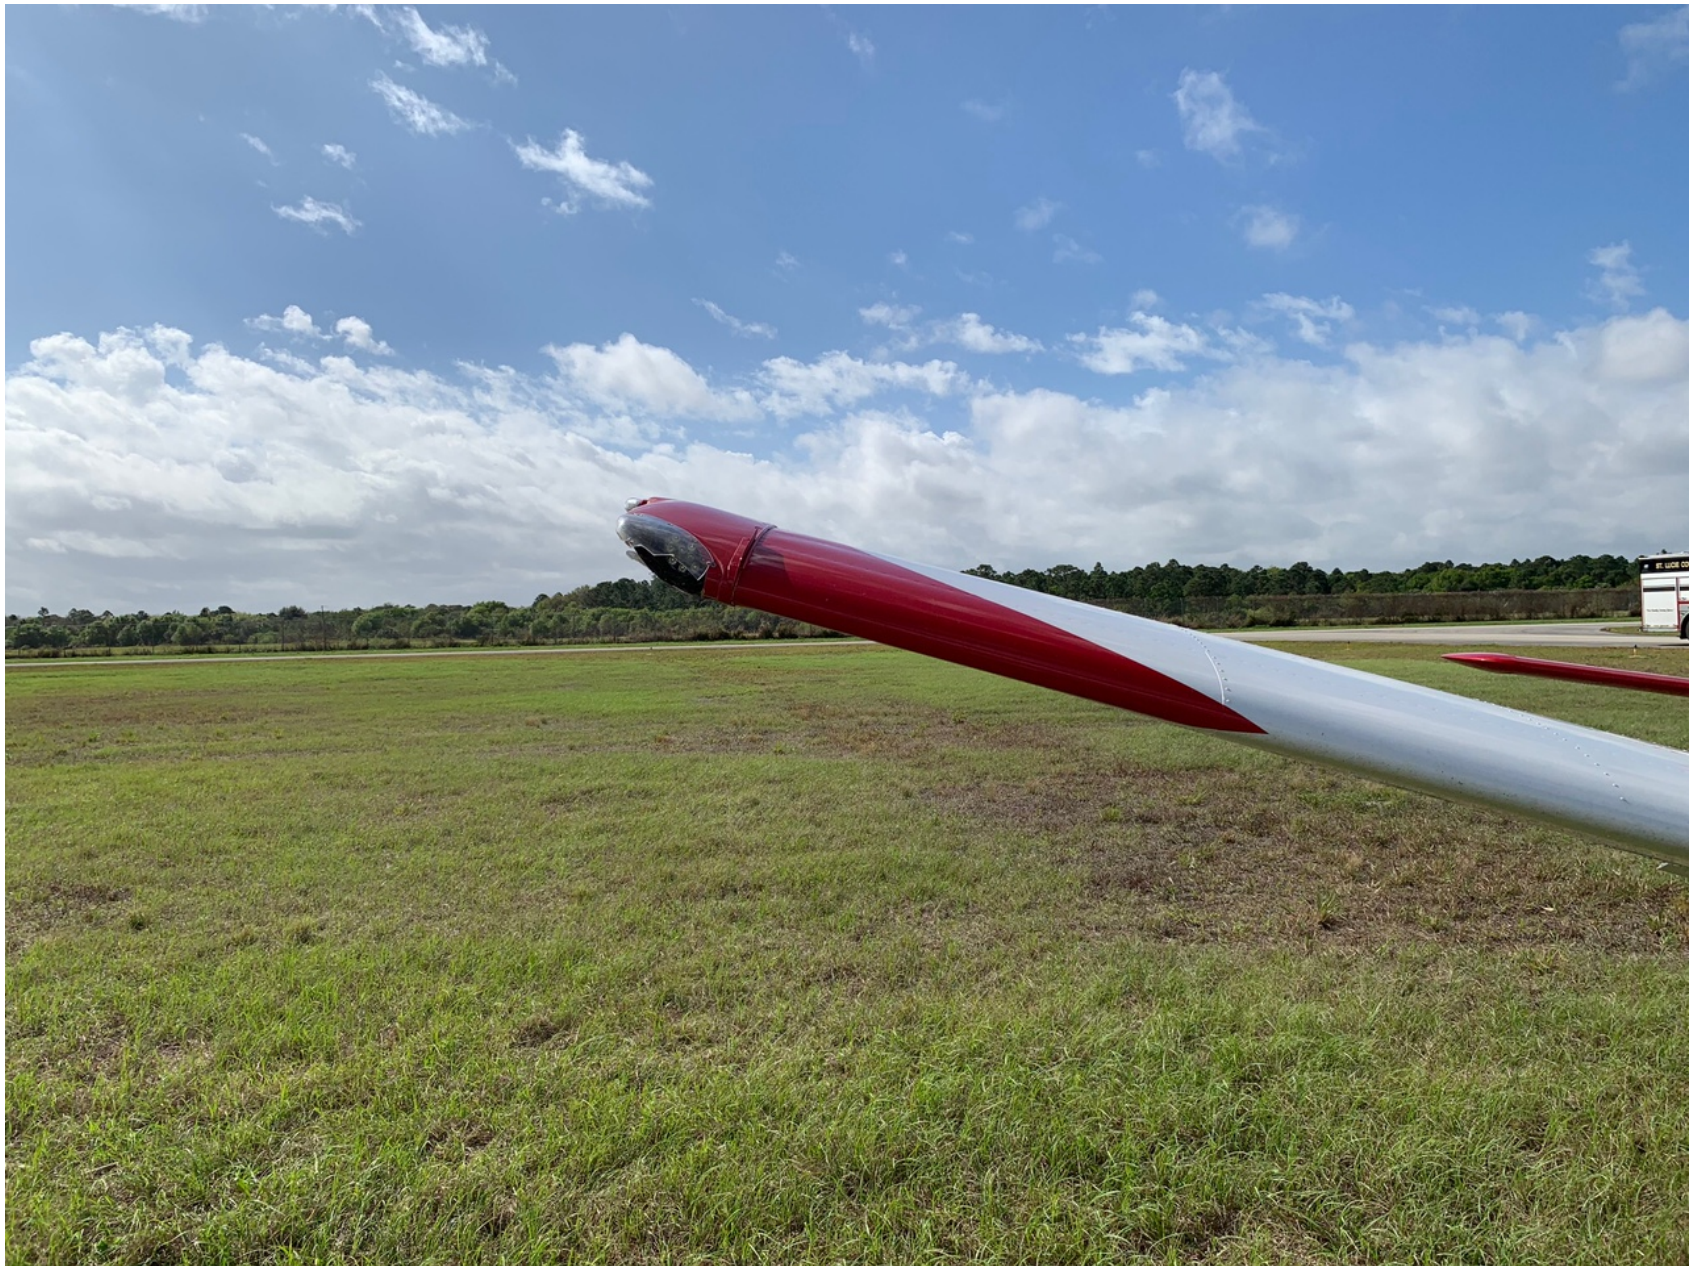
**Photo 7 – Right Wing Tip – Courtesy of Aviator College**

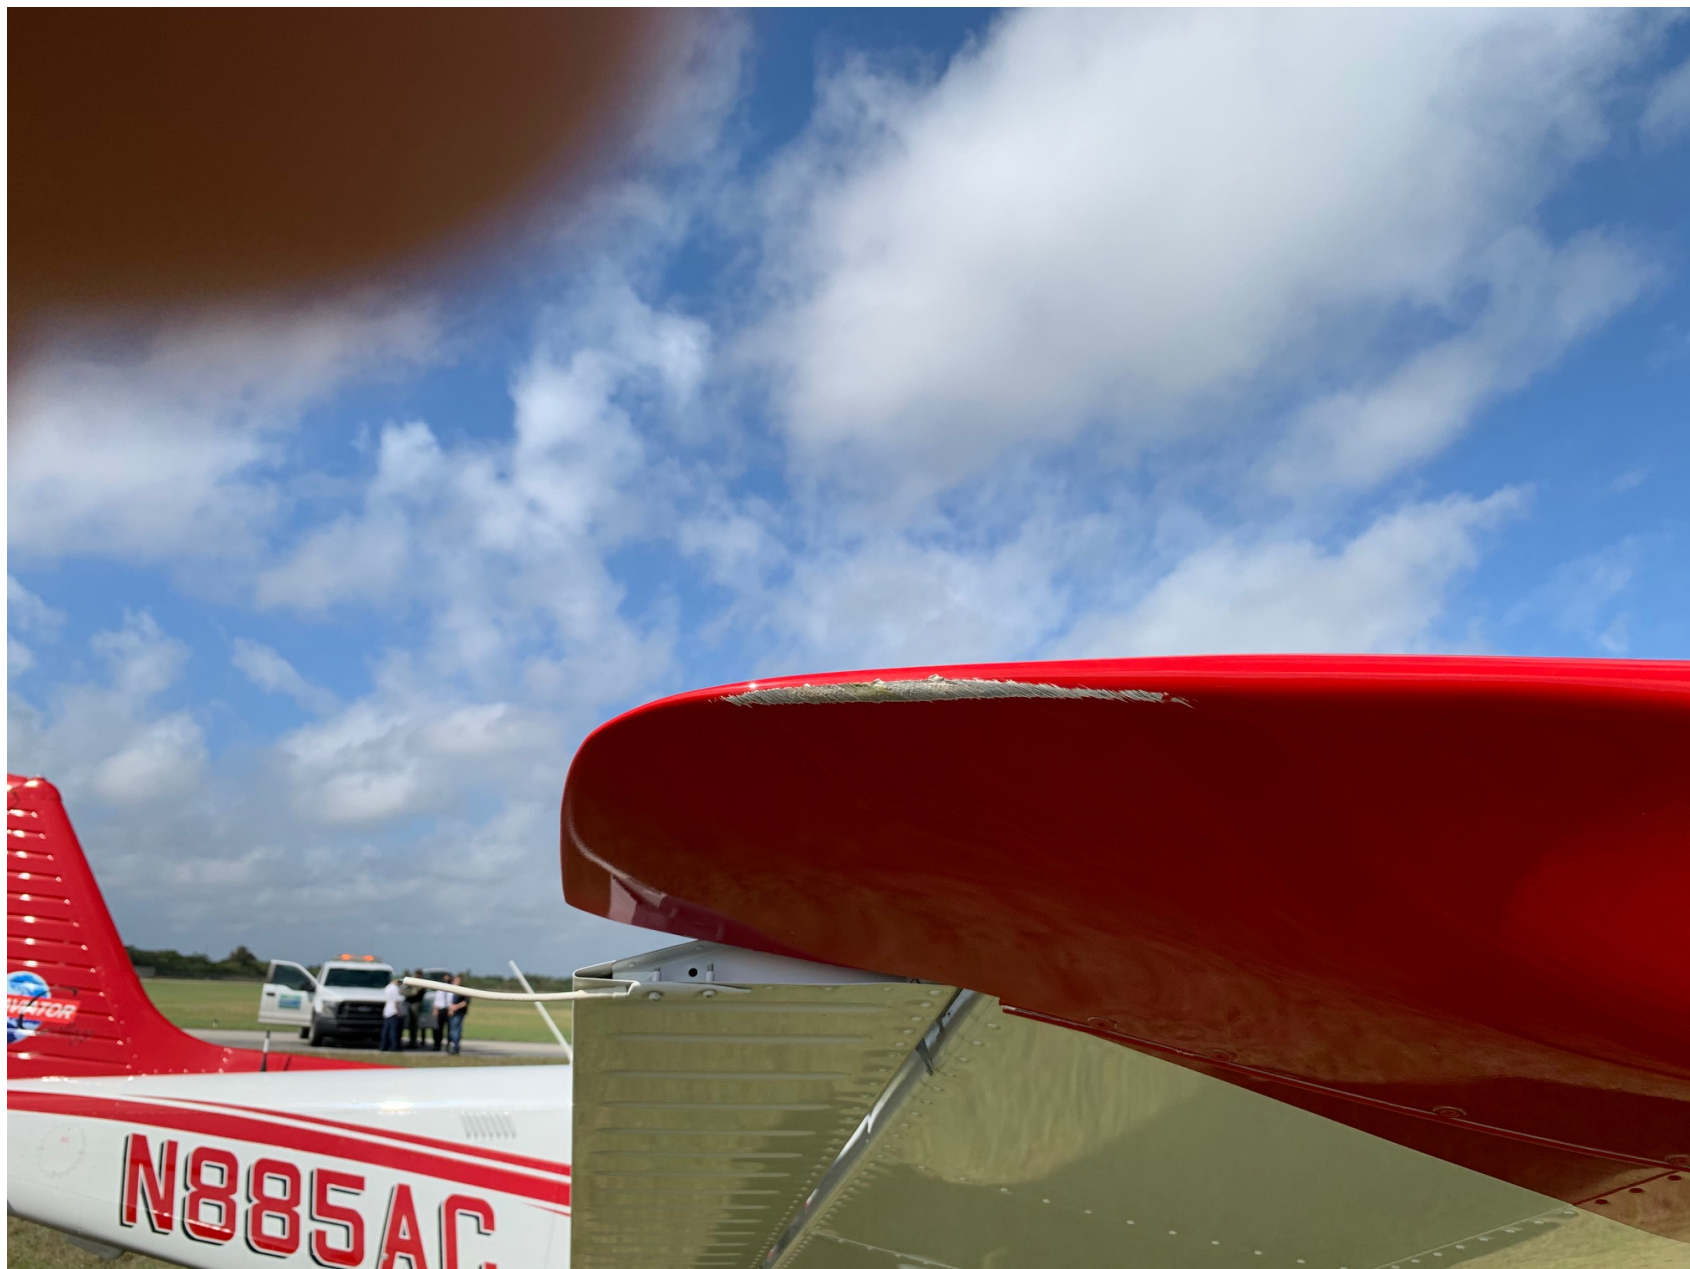
**Photo 8 – Side View of Right Wingtip Trailing Edge – Courtesy of Aviator College**

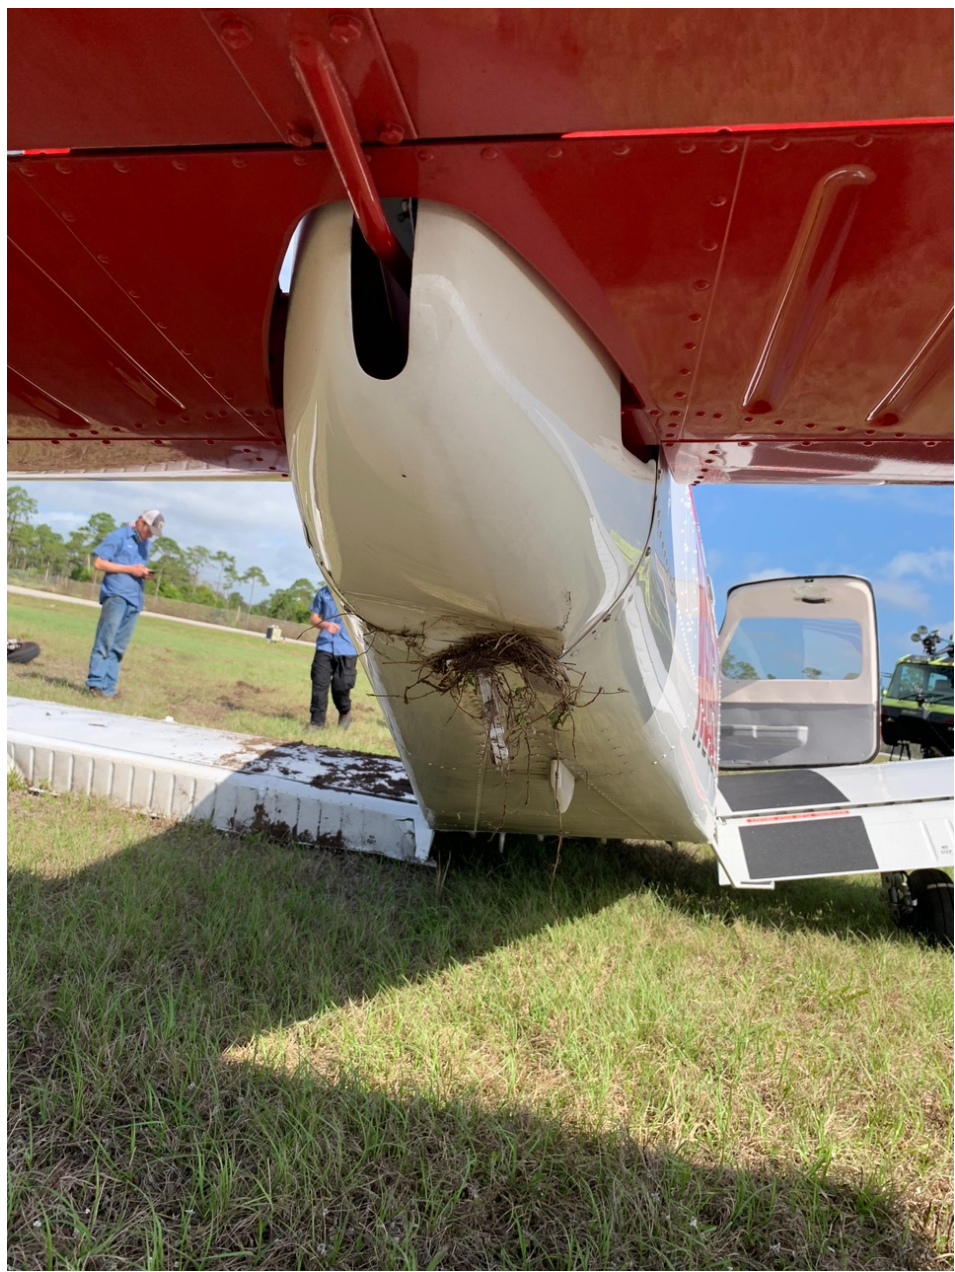
**Photo 9 – Underside of Aft Fuselage – Courtesy of Aviator College**

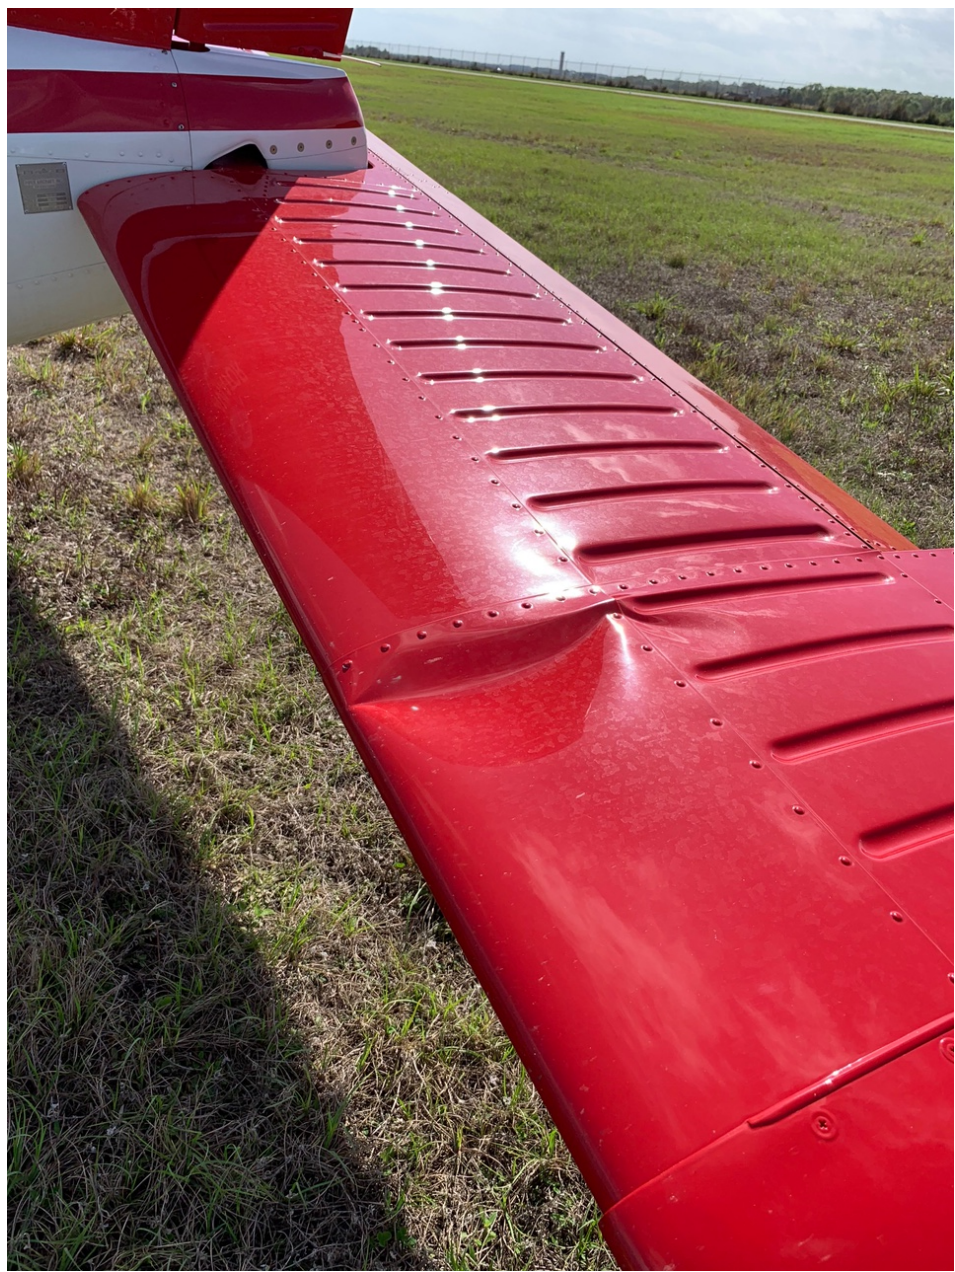
**Photo 10 – Top View of Left Side of Stabilator – Courtesy of Aviator College**

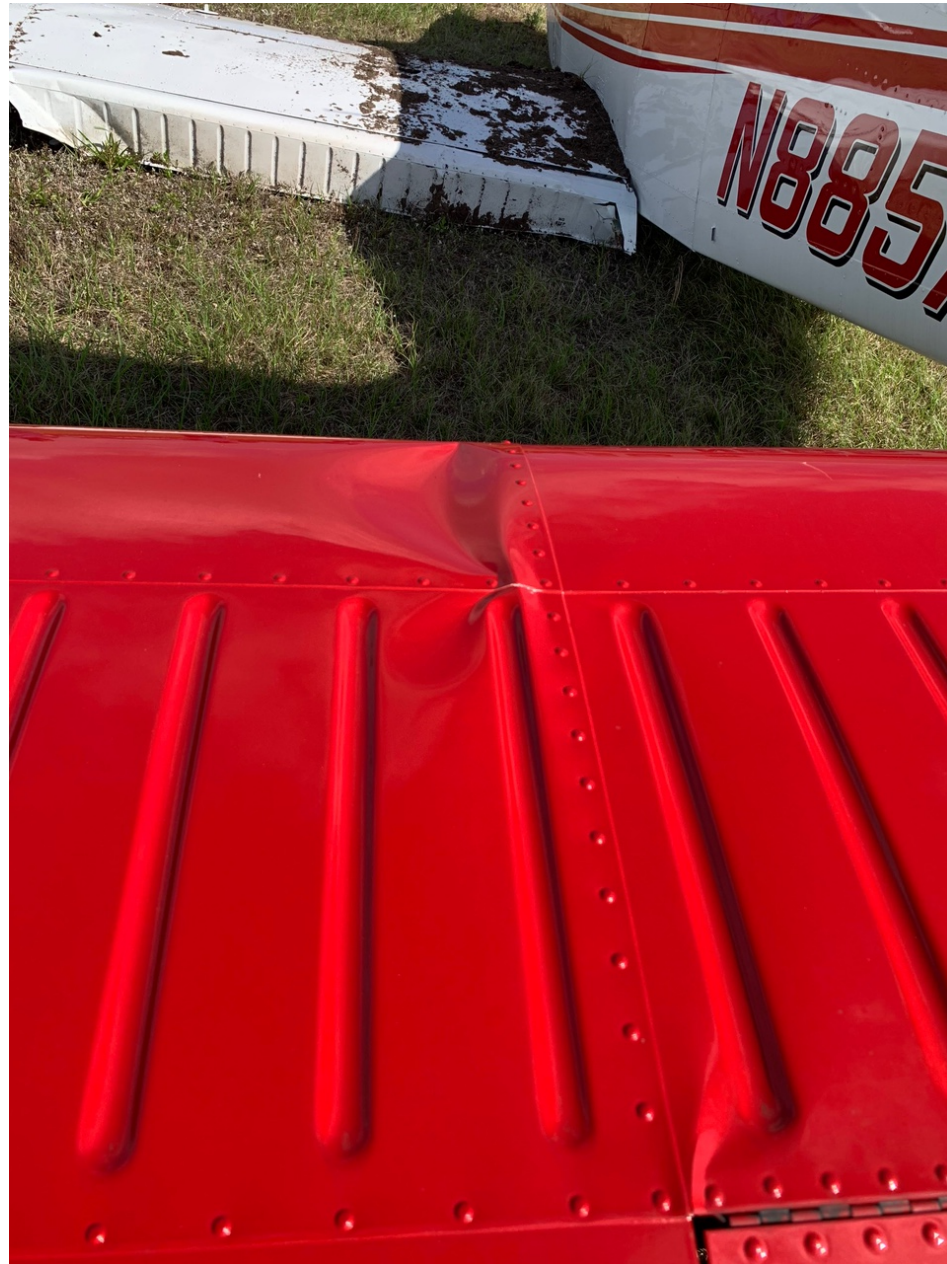
**Photo 11 – Close Up of Stabilator – Courtesy of Aviator College**

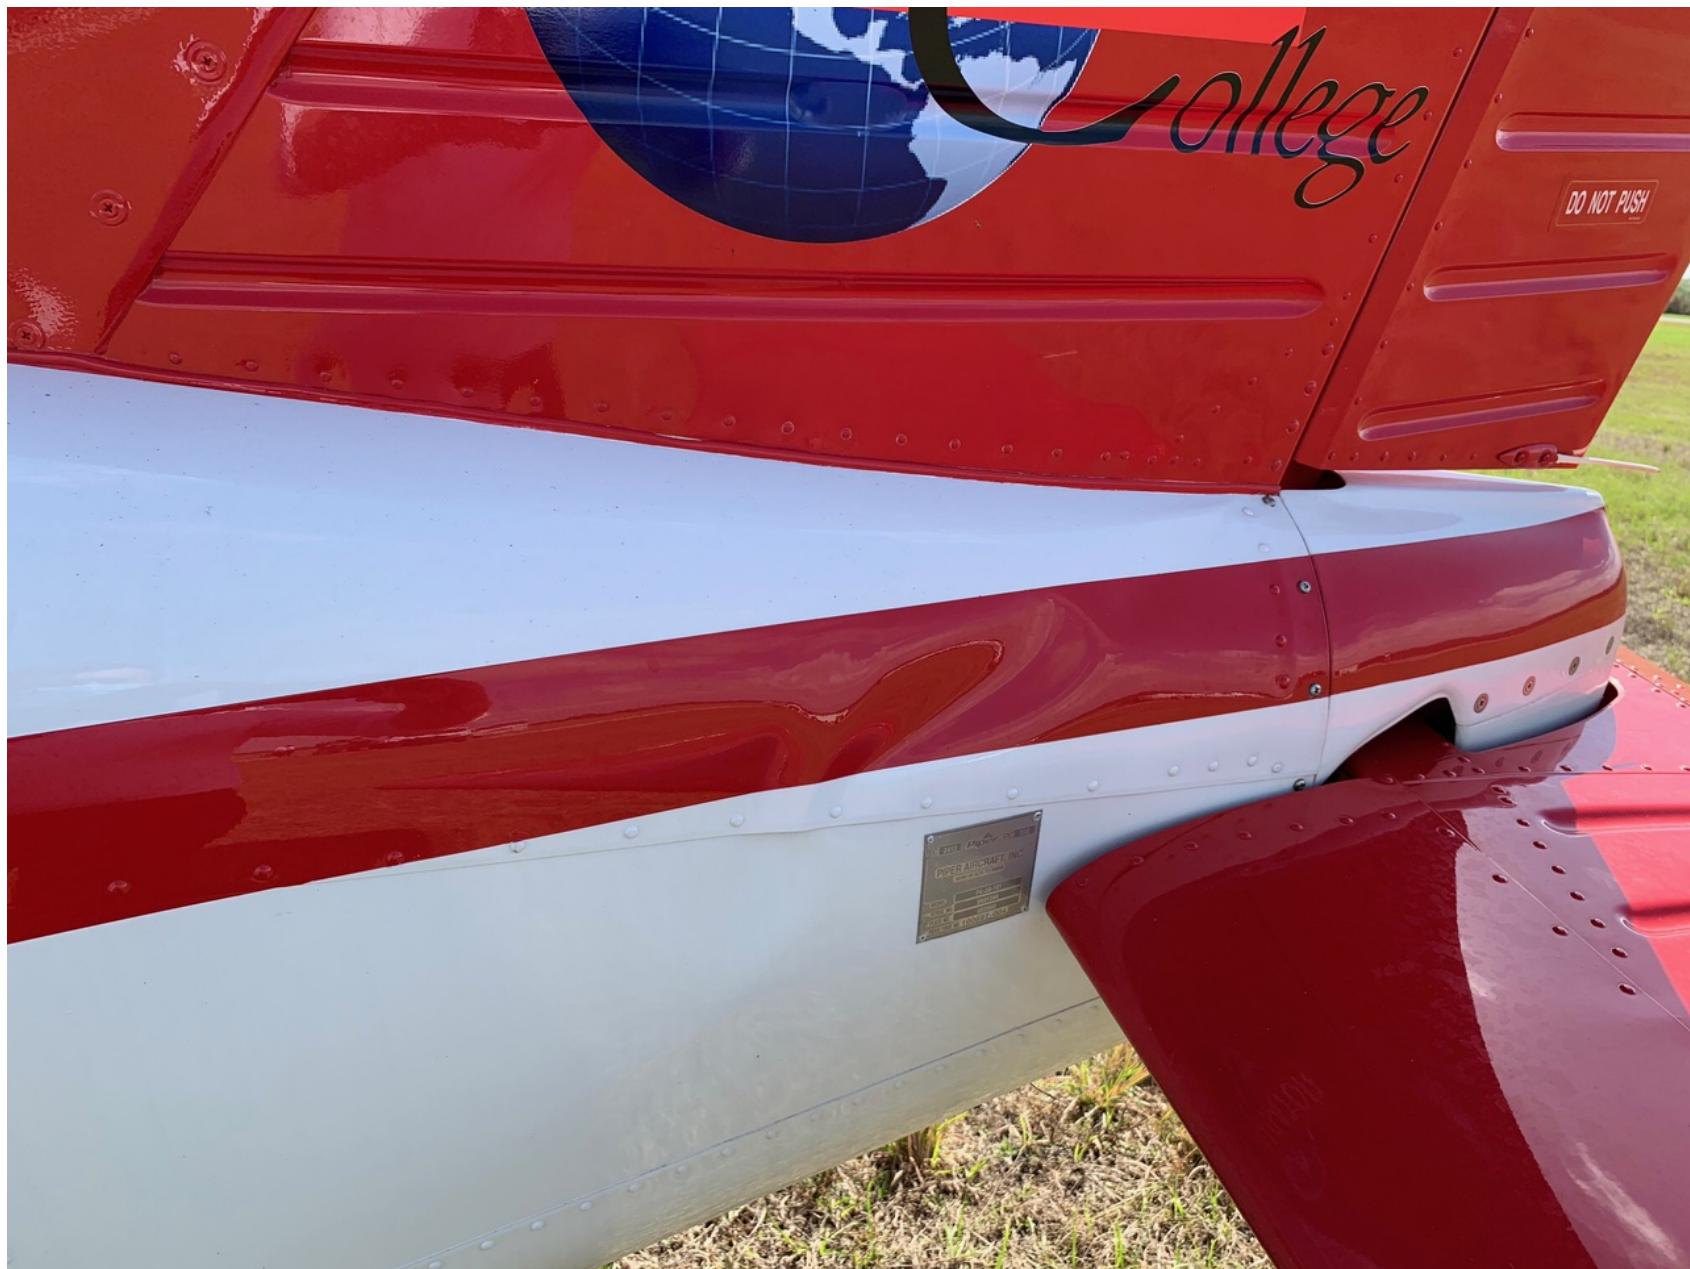
**Photo 12 – Left Side of Aft Fuselage – Courtesy of Aviator College**

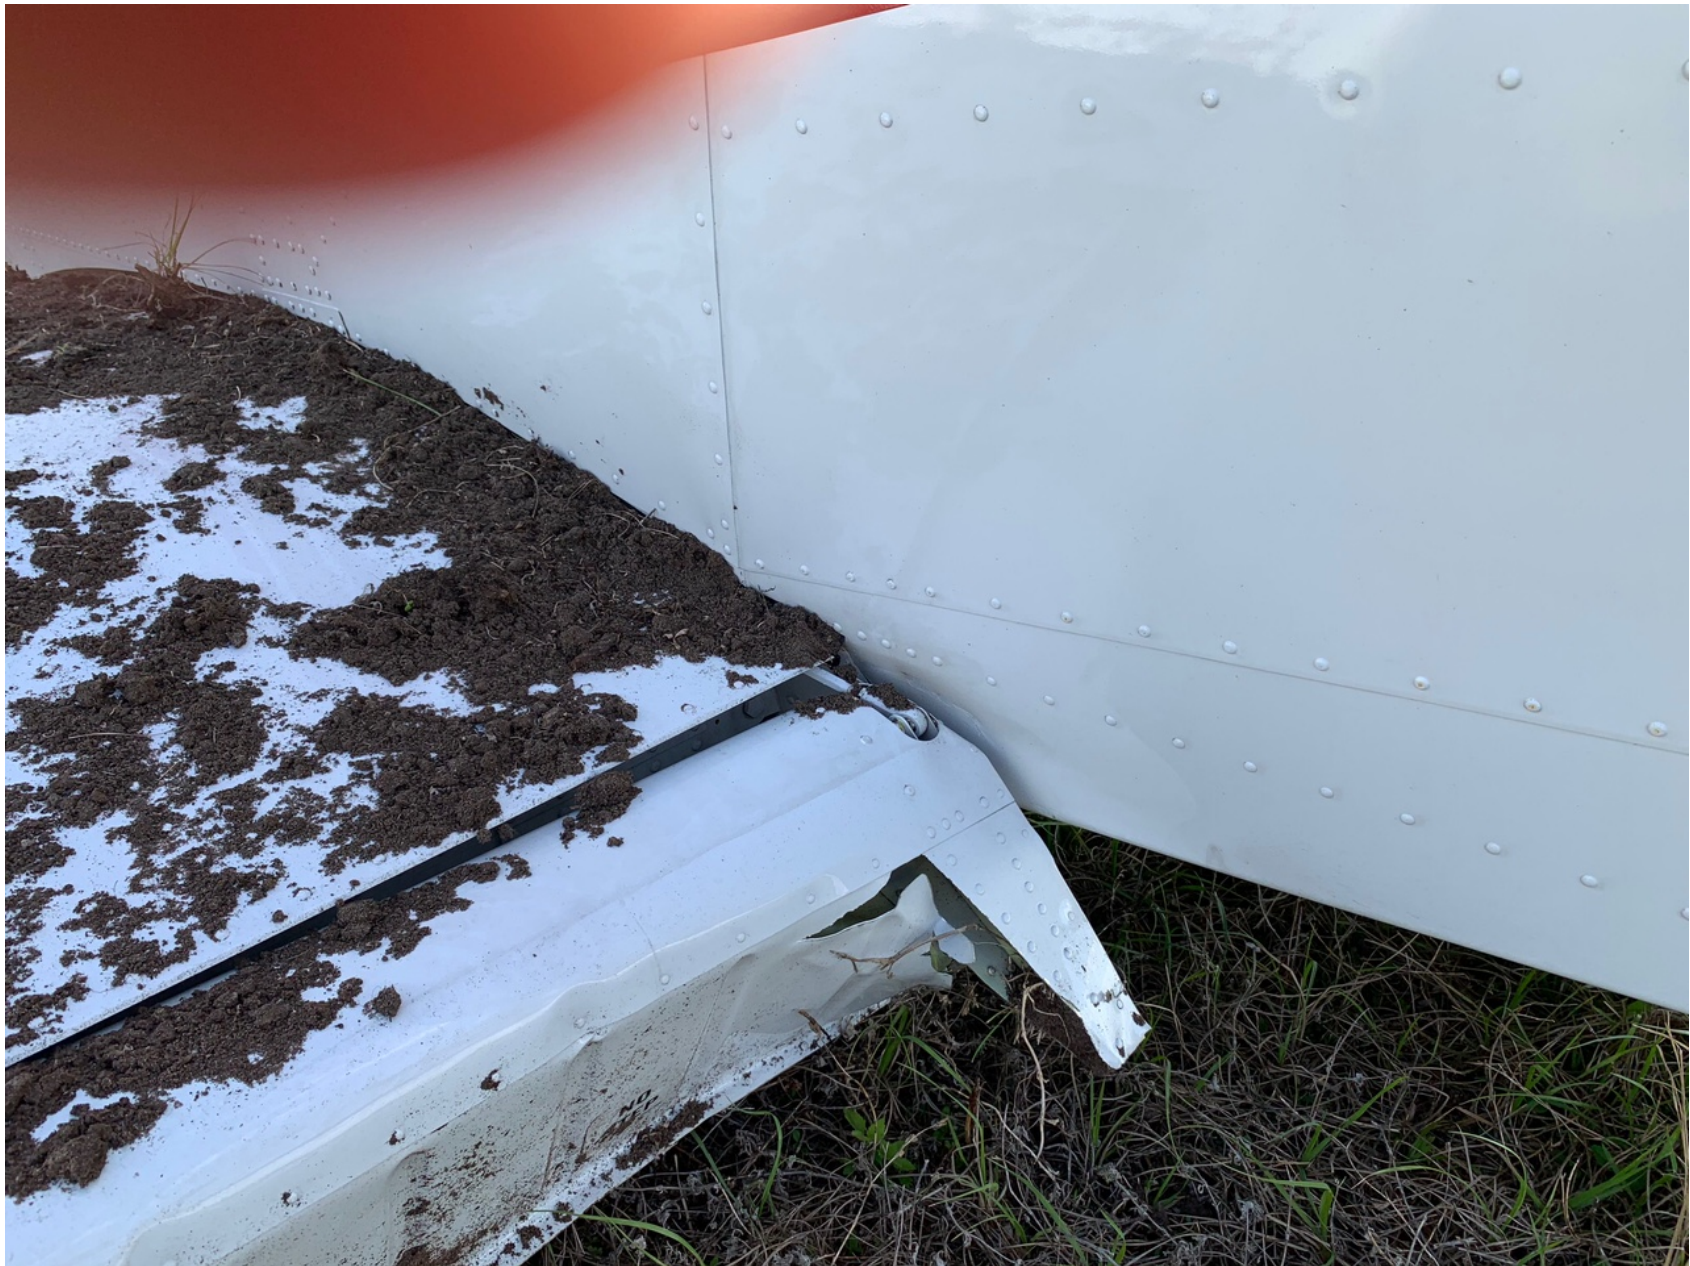
**Photo 13 – Left Flap and Wing Juncture – Courtesy of Aviator College**
