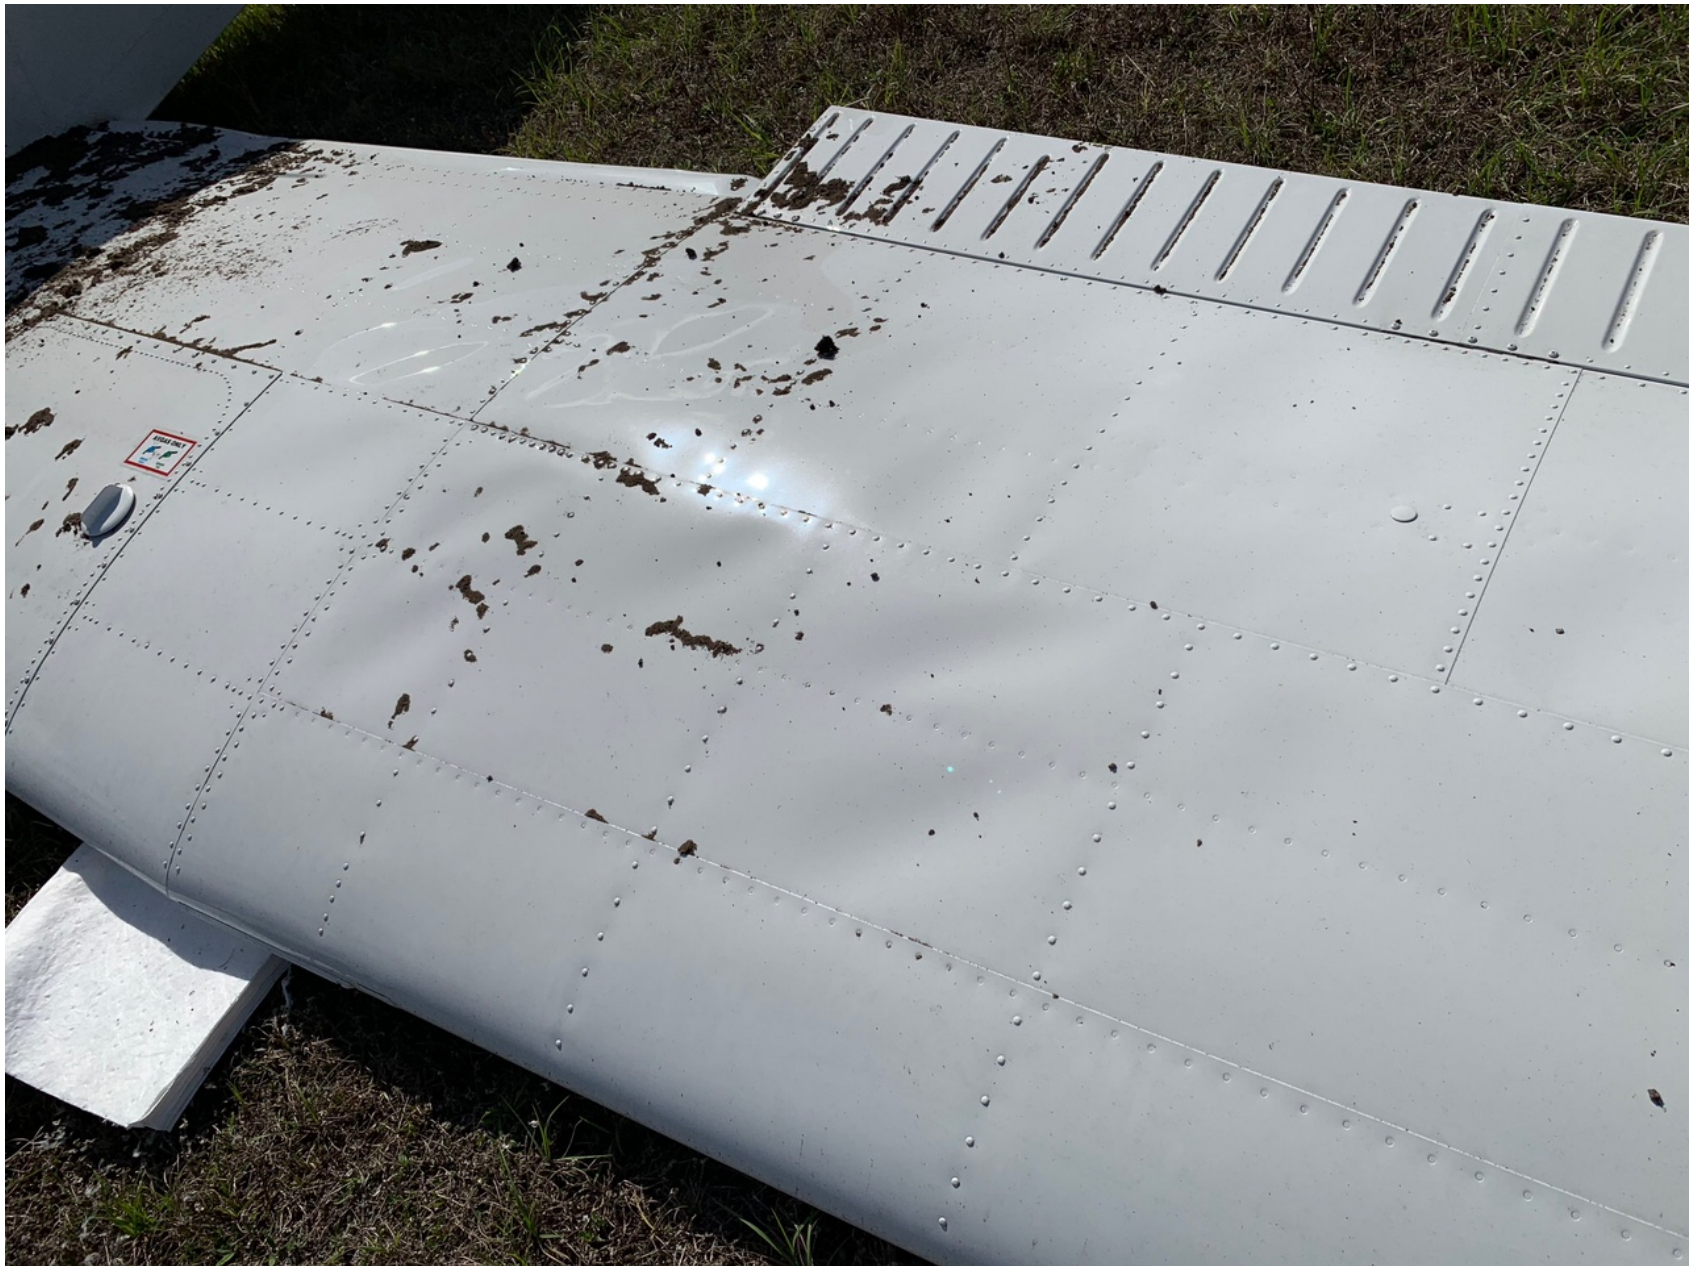
**Photo 14 -Top View of Left Wing – Courtesy of Aviator College**

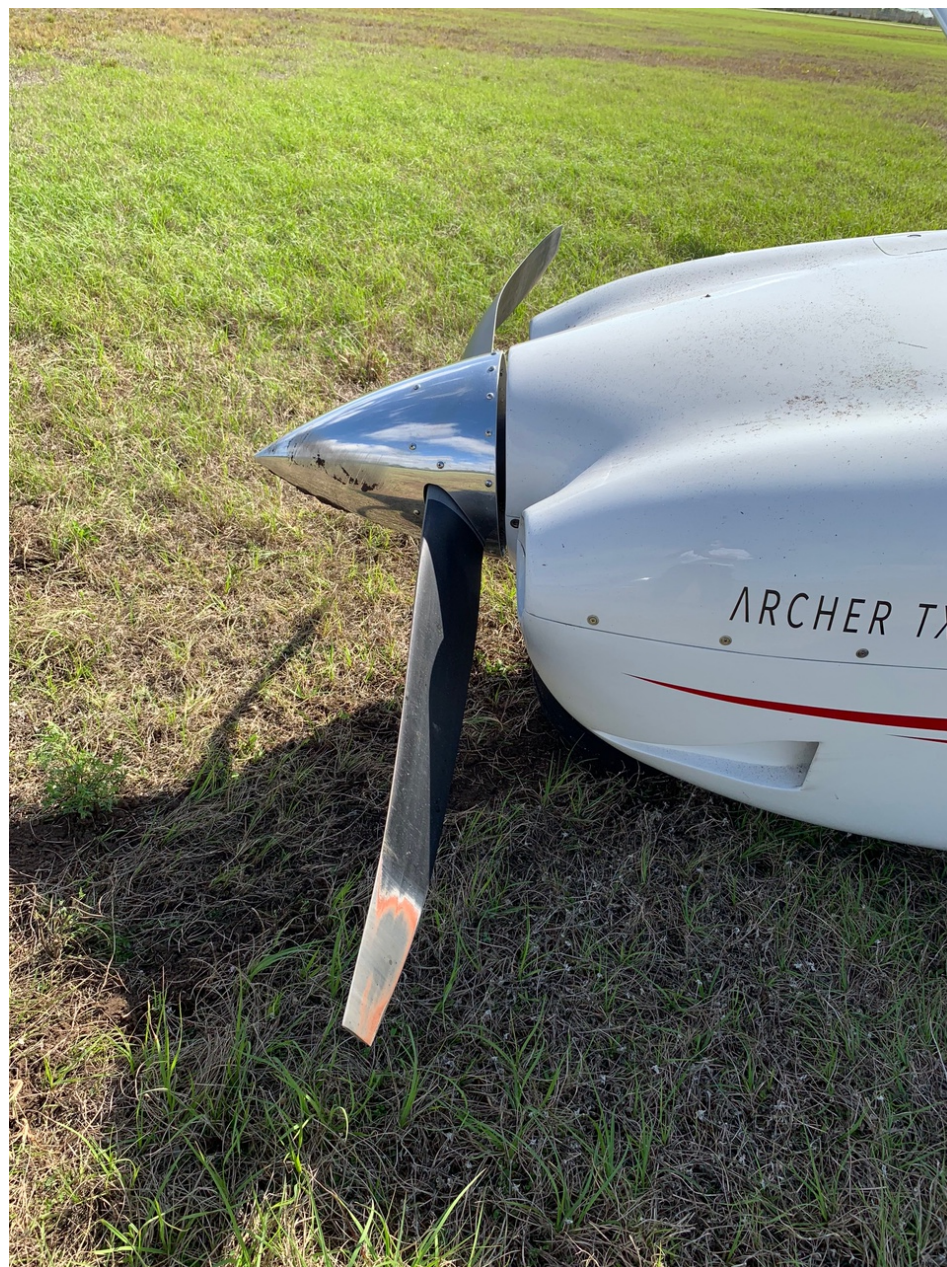
**Photo 15 – Propeller – Courtesy of Aviator College**

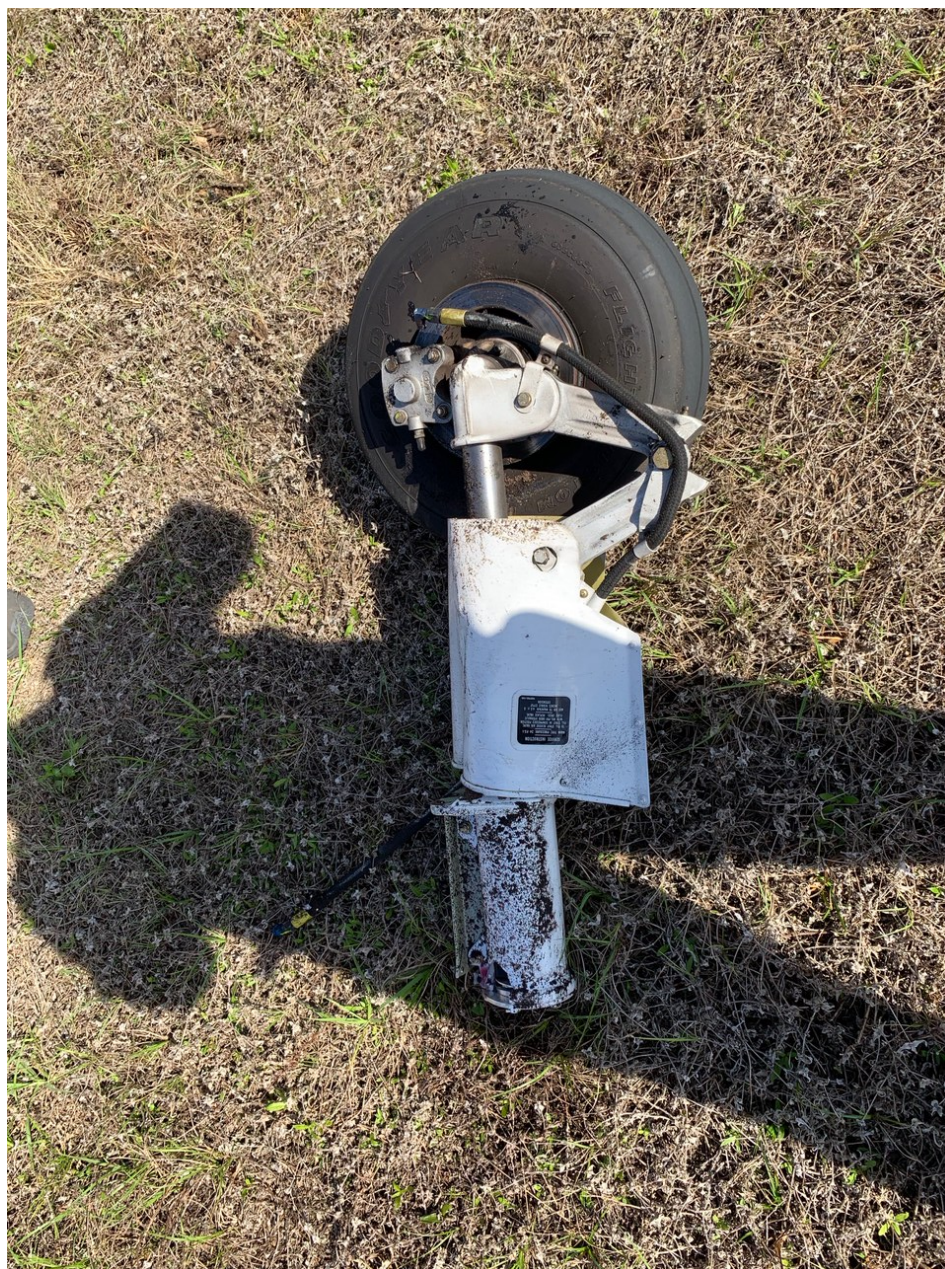
**Photo 16 – Left Main Landing Gear – Courtesy of Aviator College**
