U.S. Department  
of Transportation  
**Federal Aviation  
Administration**

Juan C. Garcia FAA, IIC  
Inspectors Statement/Accident Investigation

**Registration:** N5631E  
**Make:** 1979 Cessna  
**Model:** CE-172N  
**Serial Number:** 17271906  
**SAS Activity Code:** T-SO19-FY21-0517  
**SAS Task Activity Code:** T-SO19-FY21-0517  
**ATQA No.:** ASO1921030  
**NTSB No.:** ERA21LA144  
**AFTT:** 15947  
**Tach:** 1820  
**100 Hour/Annual Inspection:** 02/13/2021

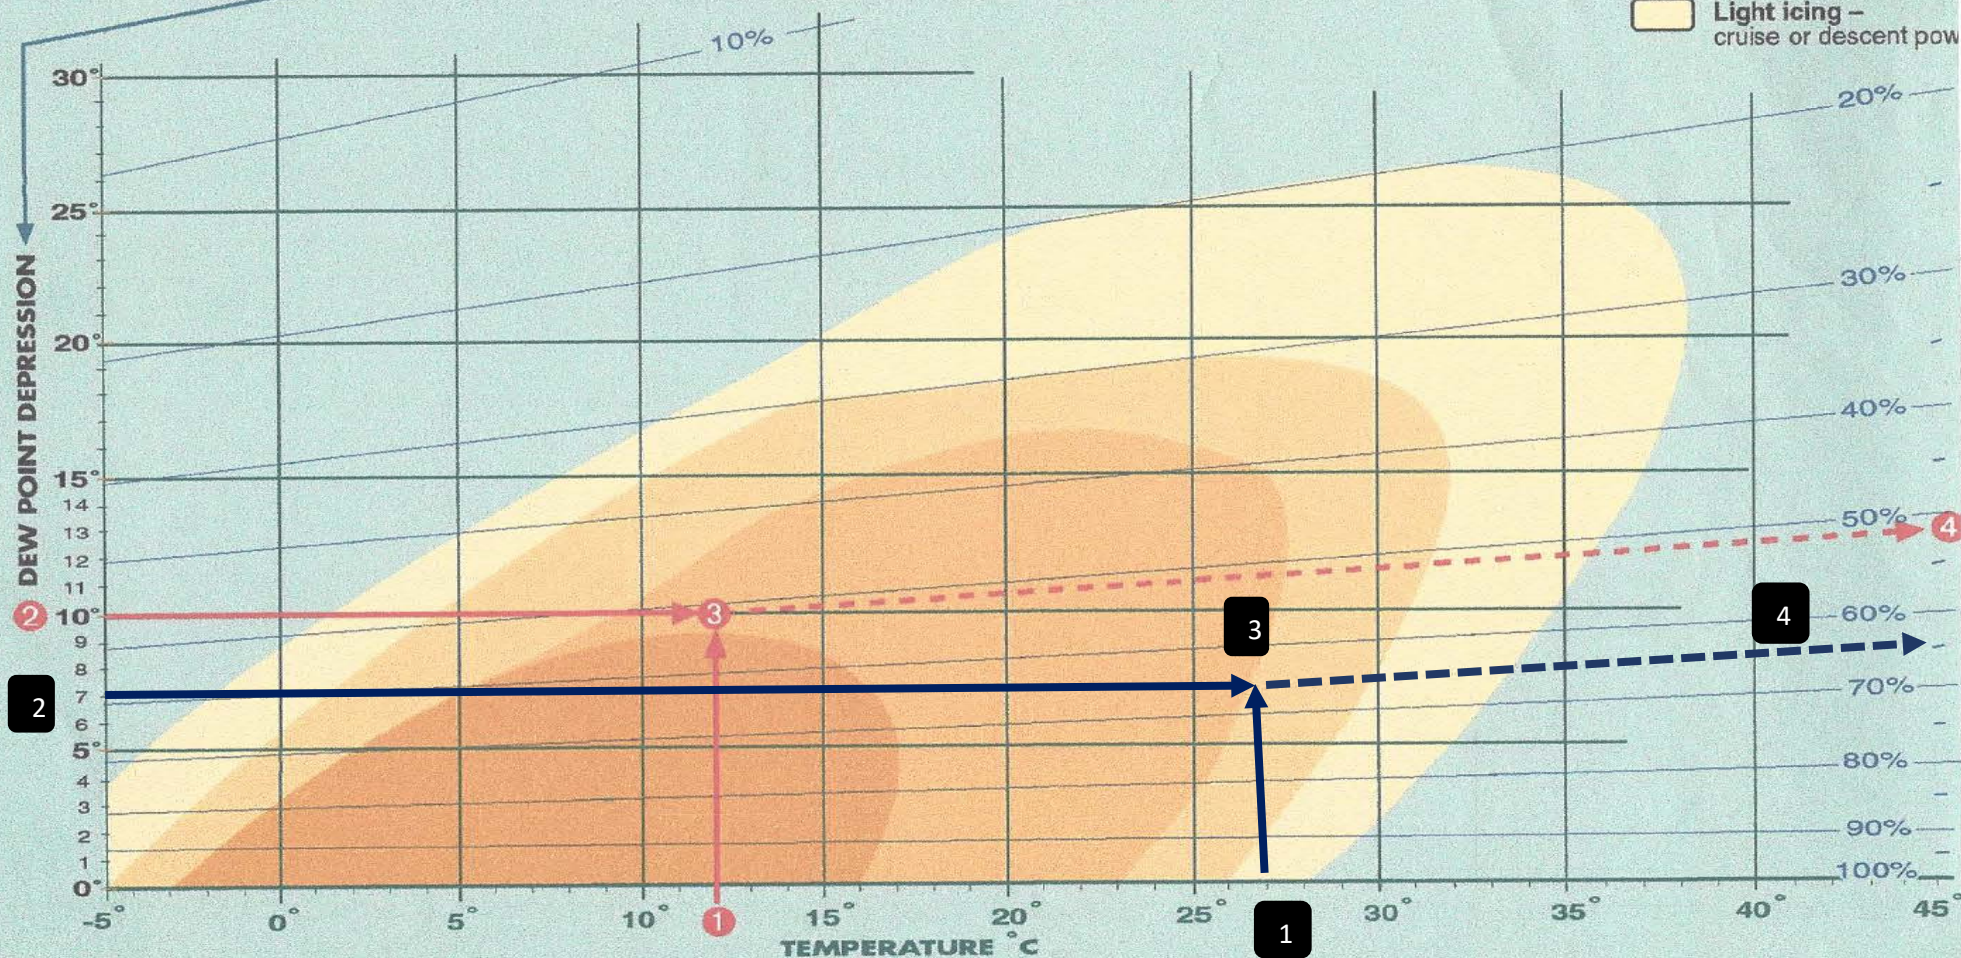
# New Carburettor icing-probability chart

Carburetor Icing-Probability calculation was preformed using historical West Palm Beach weather from the day and time of the accident. The indicated temperature at 81° F = 27° C, dew-point at 69° F = 20° C with relative humidity at 65%. The Carburetor Icing-Probability Chart data indicates N5631E was operating in Serious Icing conditions with descent power settings.

Data used:  
Temperature: 81° F = 27°C  
Dew point: 69° F = 20°C  
Relative Humidity - 65%
