# NATIONAL TRANSPORTATION SAFETY BOARD

## MATERIALS LABORATORY FACTUAL REPORT

Report No. 22-056

Place : Monroe, Georgia  
Date : March 15, 2021  
Vehicle : Socata MS894A, N42BF  
NTSB No. : ERA21LA155  
Investigator : Todd Gunther, AS-WPR

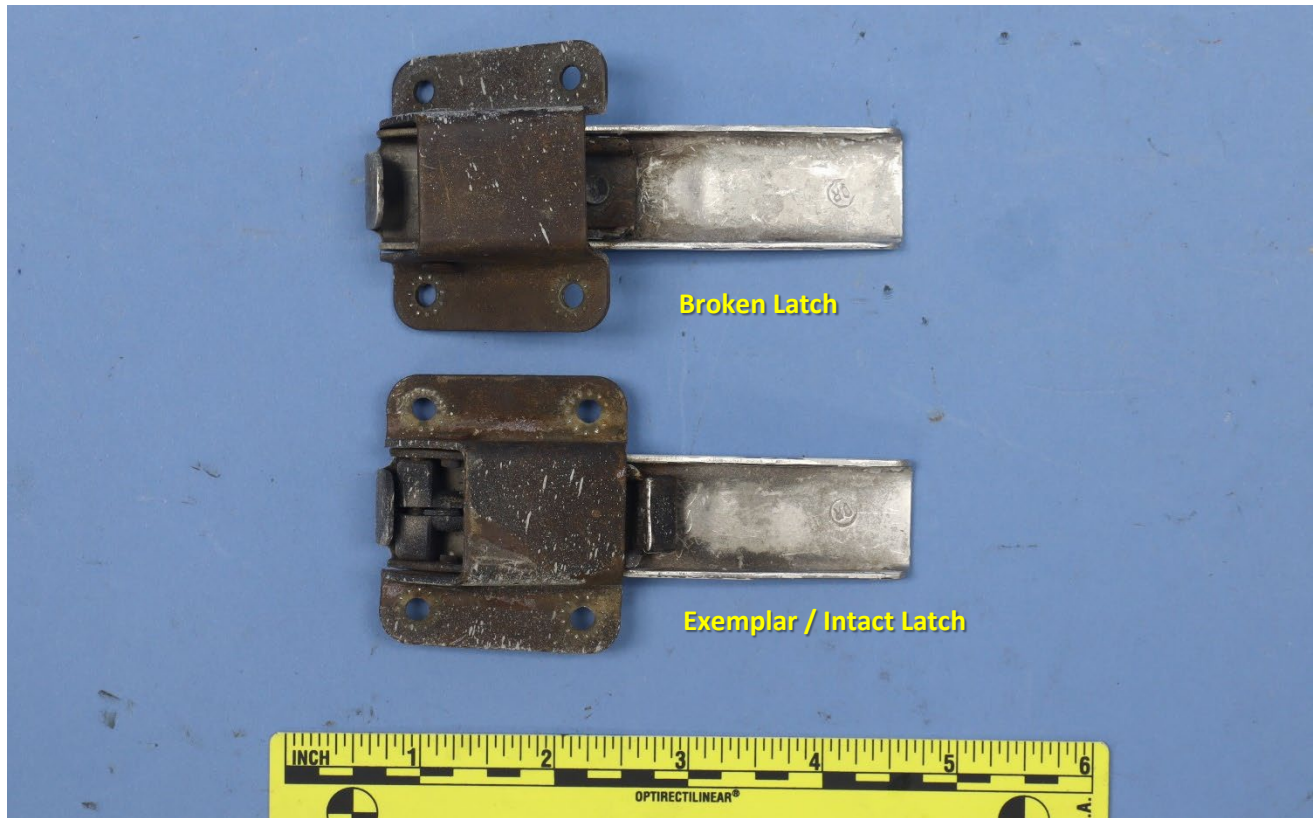
Figure 1 and Figure 2 show the cowling latches, as received, from opposite sides. The latches consisted of an outer housing that could be actuated over the latch assembly, affixed by two separate rivets. On the intact latch, used as an exemplar in this examination, there was a hook affixed to the latch through a riveted U-shaped clasp, inserted into a T-shaped shaft and held in place via a cotter pin. This shaft was joined to the latch body by a pin. This hook and shaft subassembly was missing in the broken latch, as exemplified in the open positions in Figure 3.

Figure 1 – View of the cowling latches, as received, in the closed position.

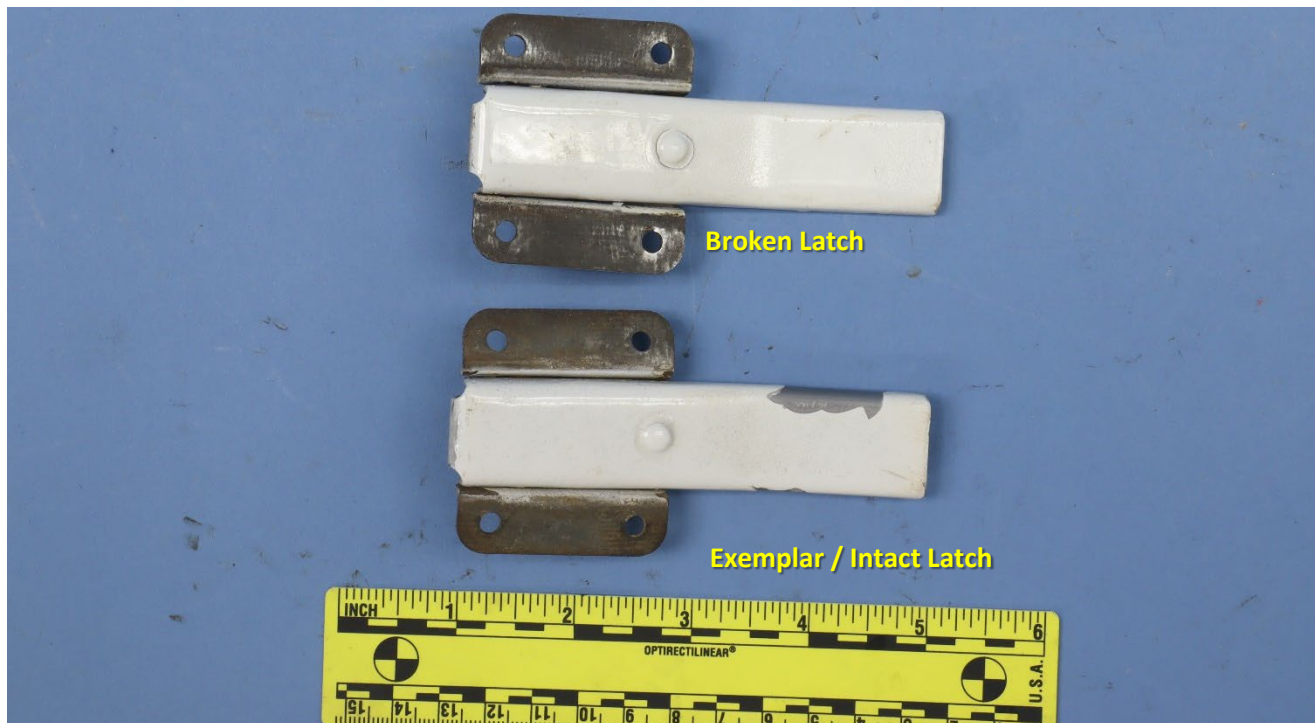
Figure 2 – View of the opposite side of the cowling latches in Figure 1.

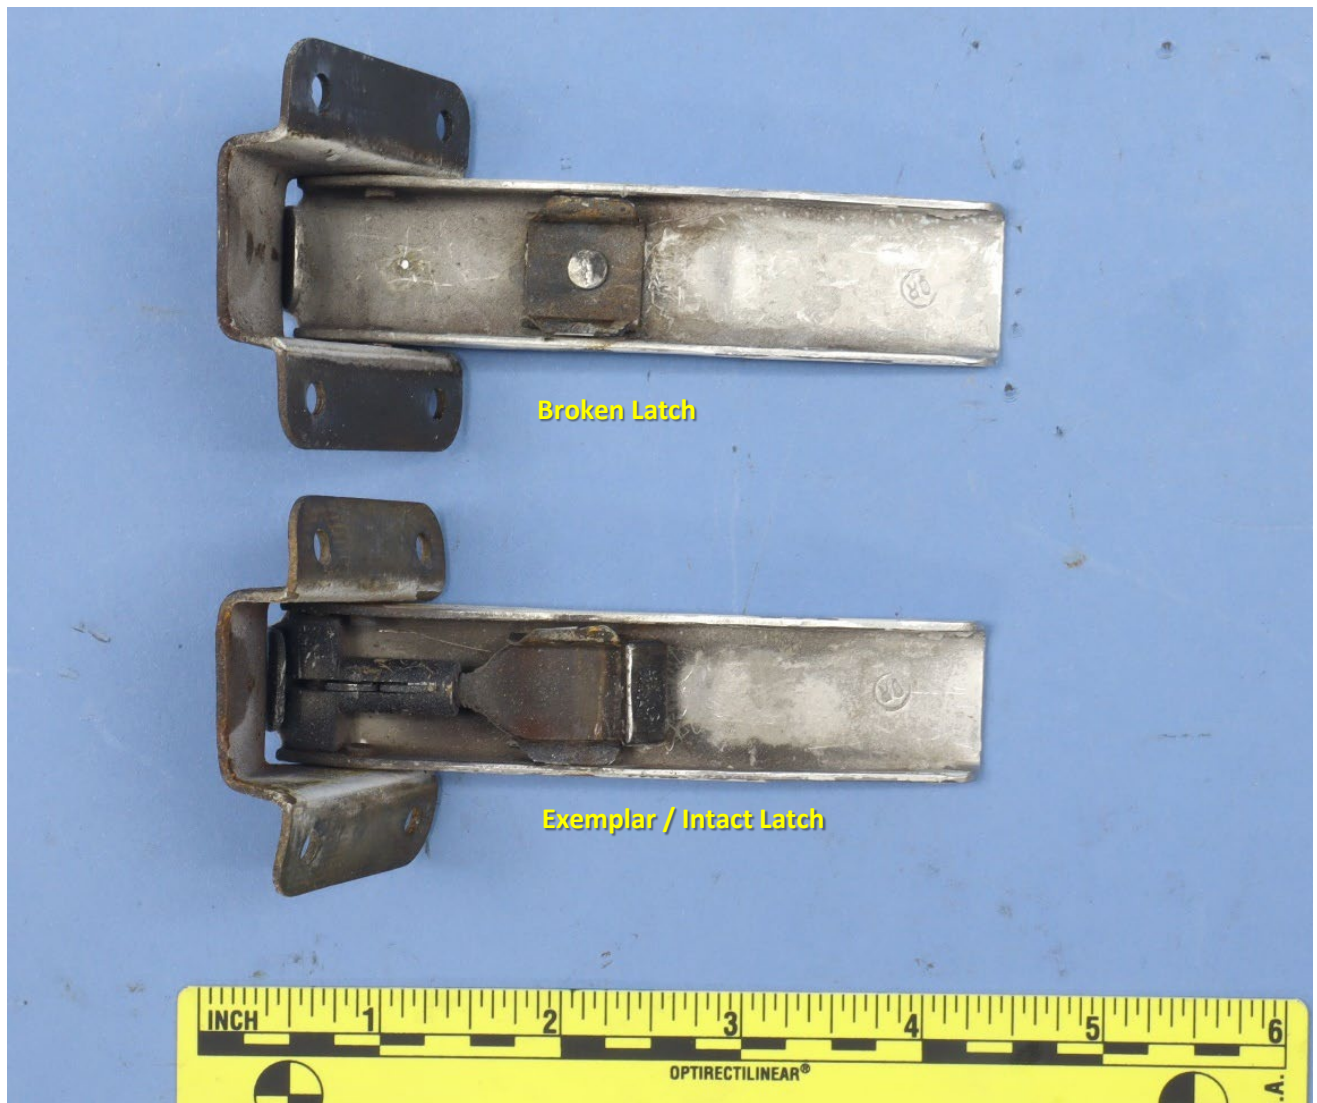
Figure 3 – View of the cowling latches, as received. The latches are in the open position, showing the missing hook and shaft subassembly in the upper latch.

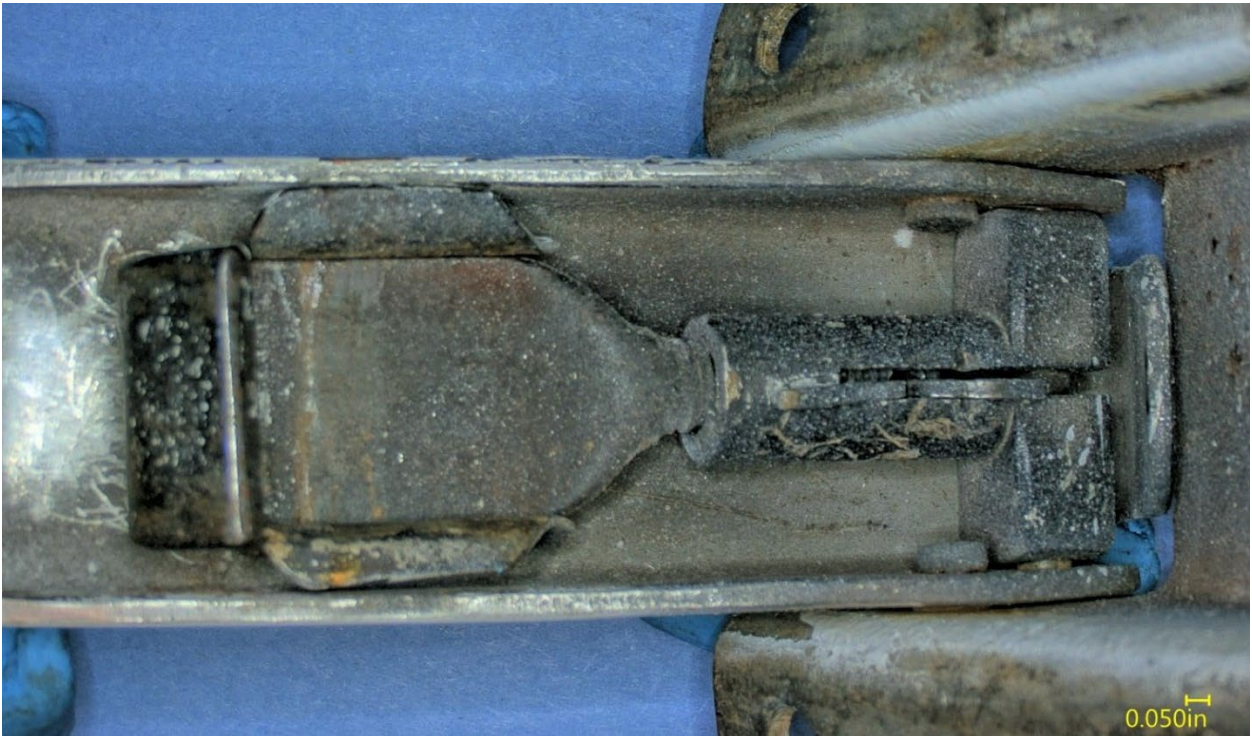
Figures 4 and 5 show views of the hook and shaft subassembly of the intact latch. The flattened hook face narrowed to a small cylindrical shape, which fastened into the T-shaped shaft. The hook was held stationary by the cotter pin, shown in Figure 4. Just outside of the hook and clasp were randomly-oriented scratch marks located on the inside face (see Figures 4 and 5). These scratches were also on the inside surface of the latch

Figure 4 – View of the inside of the intact latch, showing the hook, shaft, and cotter pin subassembly attached to the latch by a pin.

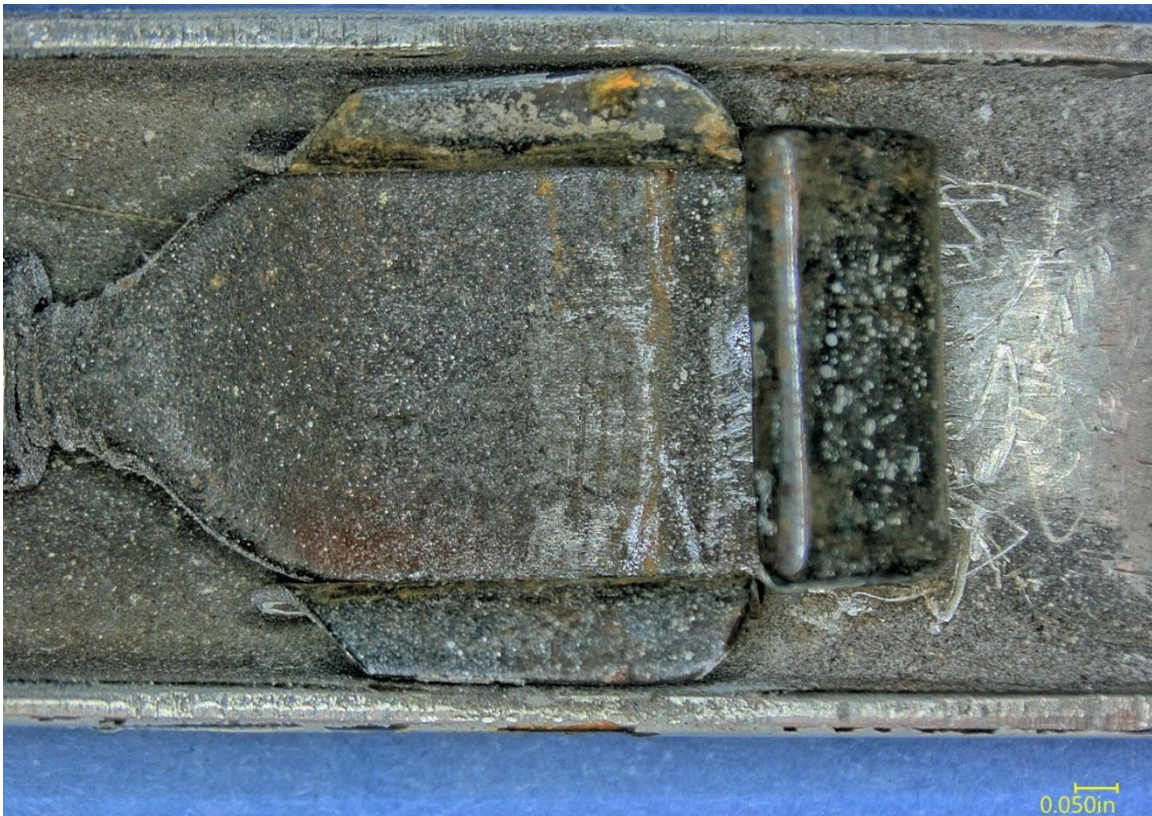
Figure 5 – View of the hook end of the intact latch.

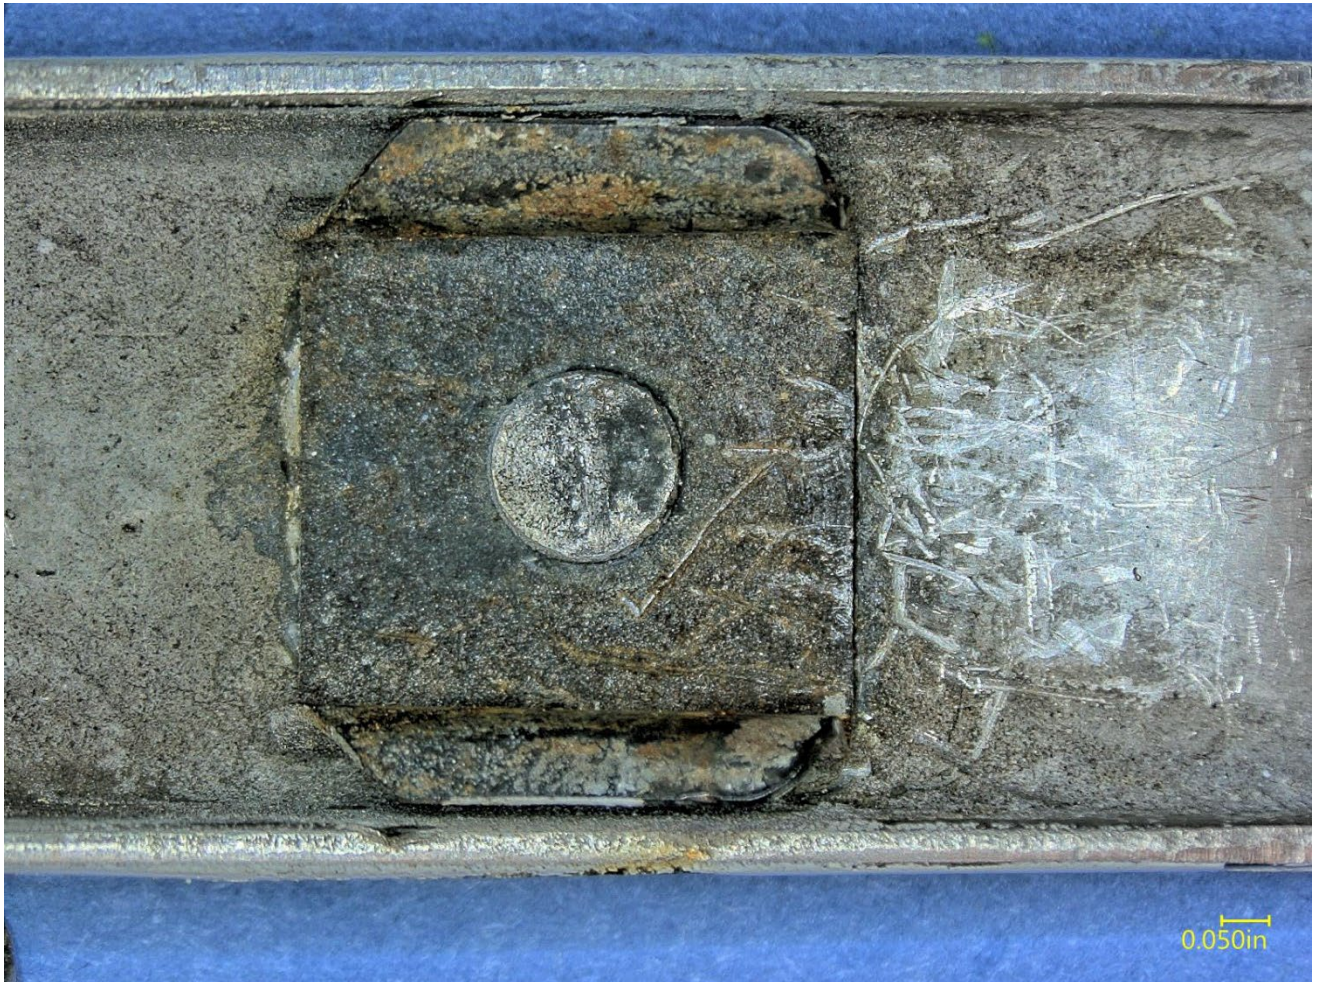
body on the broken latch, as illustrated in Figure 6. The number of scratches, their depth and location were comparable on both latch interiors.

While the clasp was still riveted to the latch (Figure 6), the hook subassembly was missing. Figure 7 and Figure 8 contrast the riveted side walls of the housing and latch body interiors of the intact and broken latches, respectively. As shown in Figure 8, the pin was missing from the pinhole on the right side, though the riveted connection was still intact.

Figure 6 – View of the riveted clasp of the fractured latch.

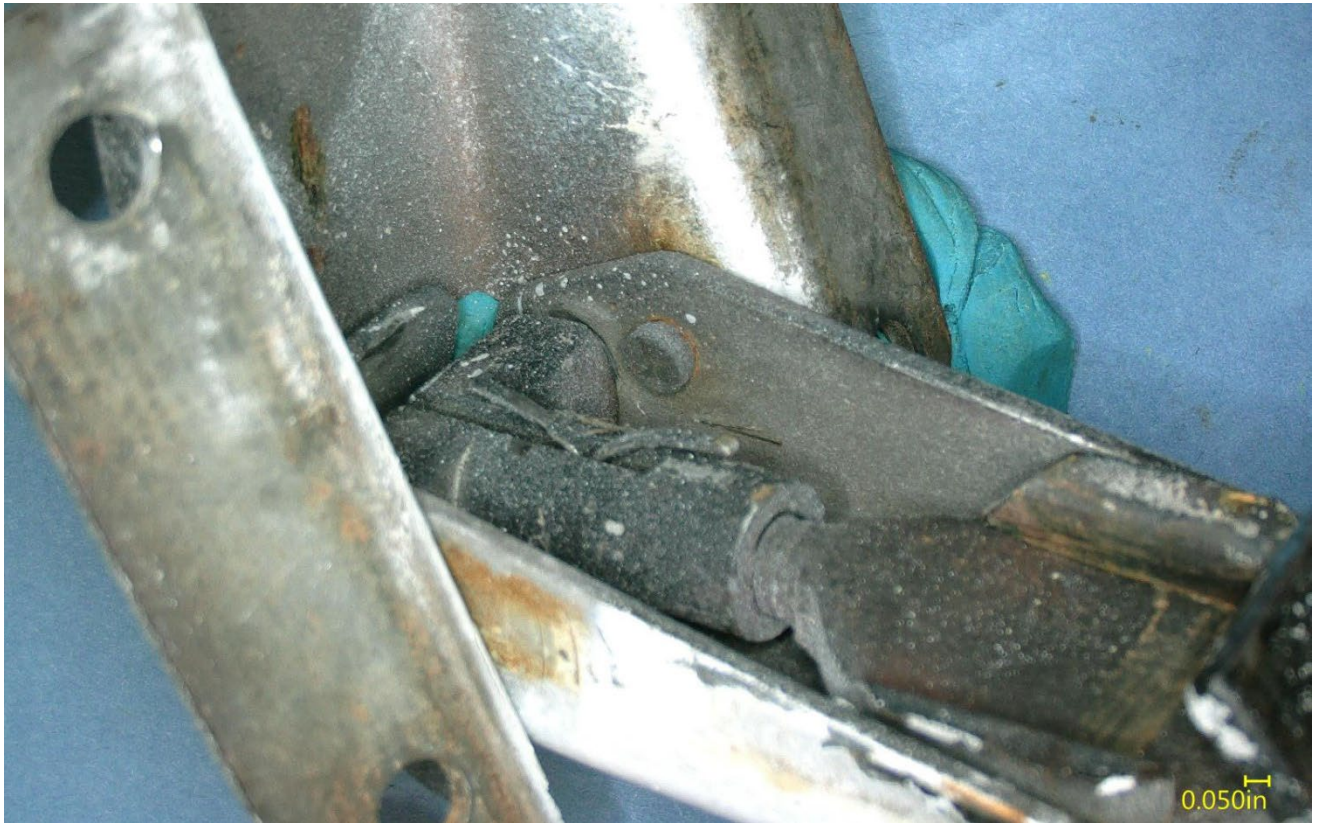
Figure 7 – Angled view of the right side pin and rivet attachments of the intact latch.

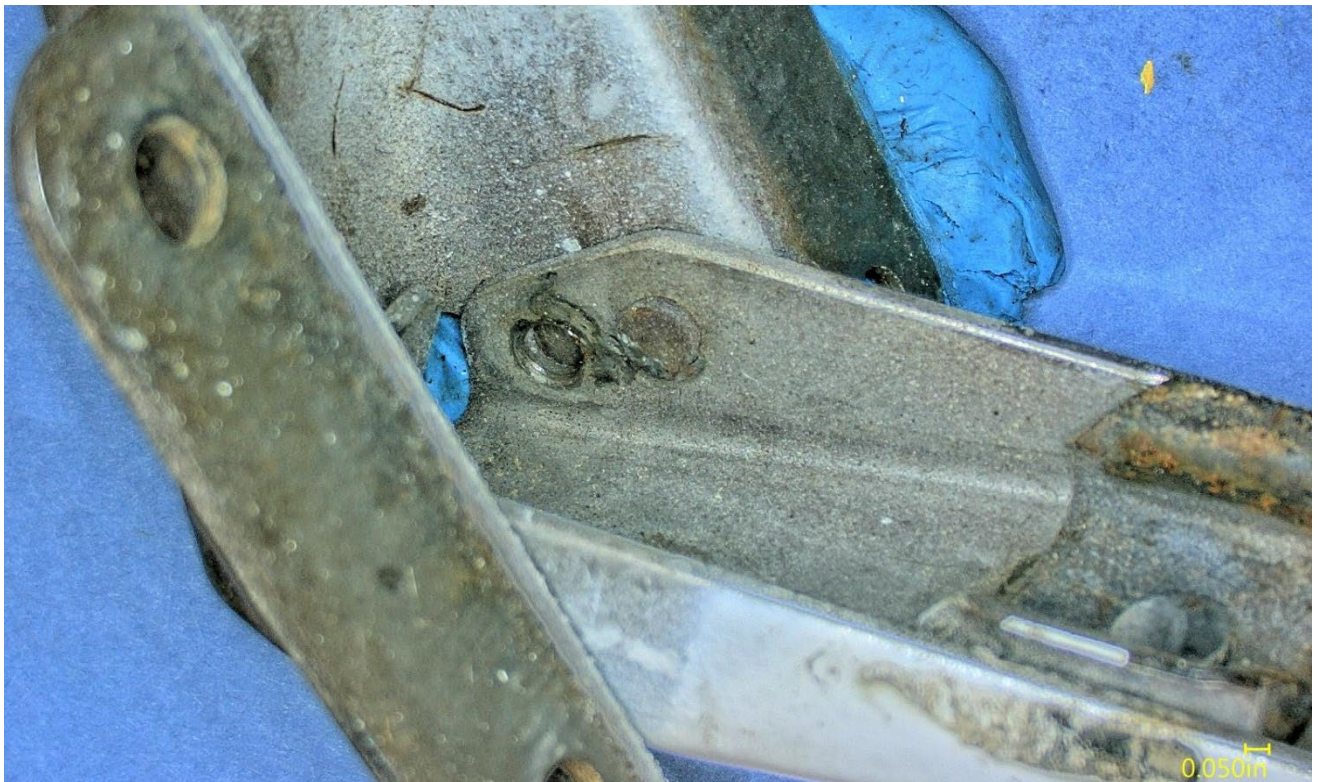
Figure 8 – Angled view of the right side pinhole and rivet of the broken latch.

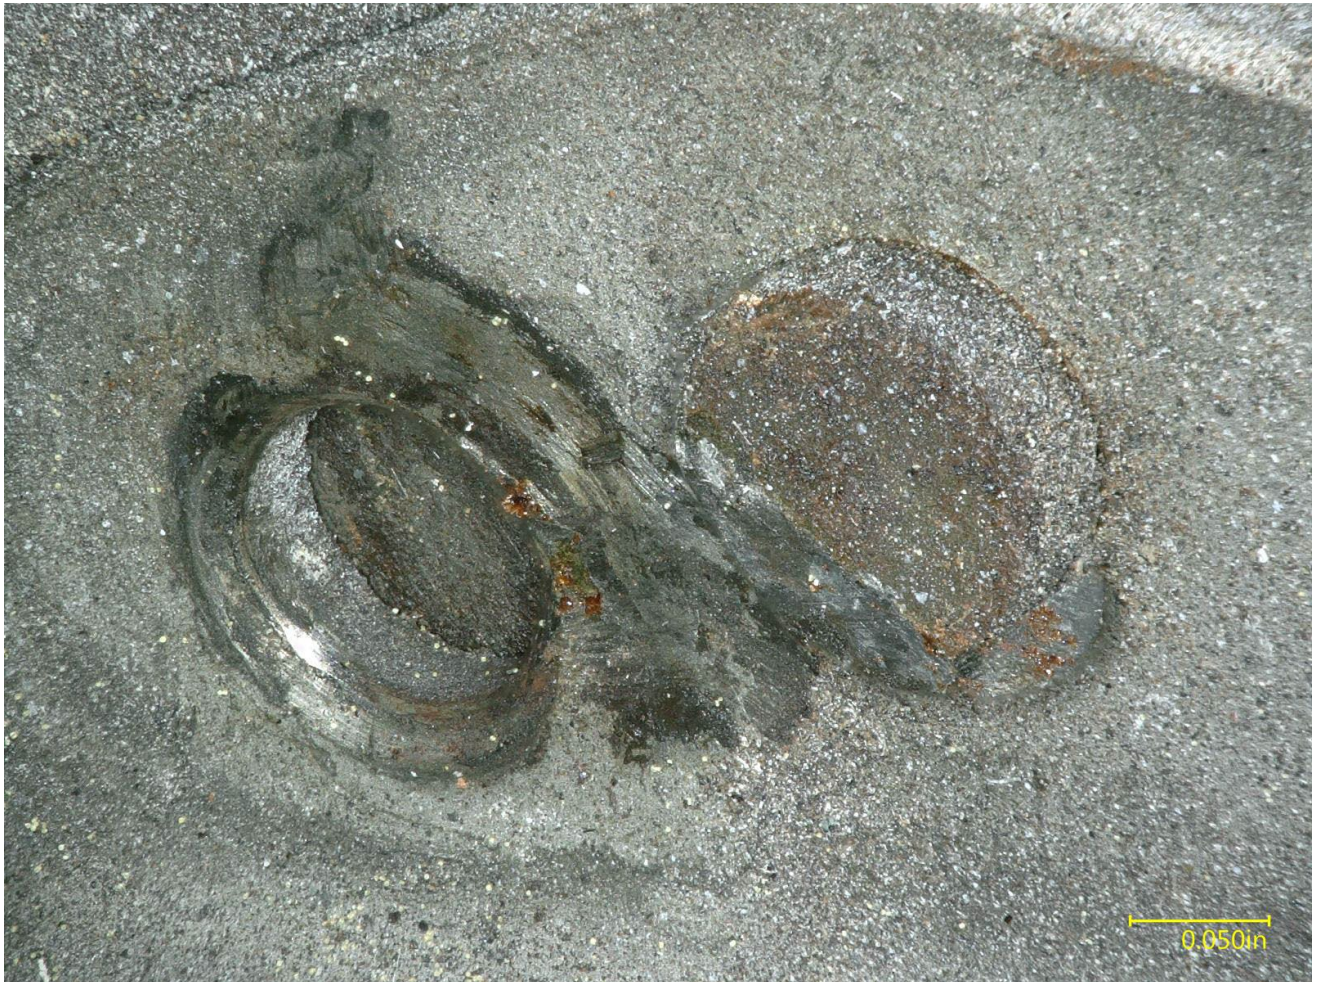
Figure 9 shows a closer view of this area, illustrating the damage on the latch body interior. Figure 10 shows the annotated image of the damage around the pin hole shown in Figure 9. Overall, the damage was consistent with smearing of material, consistent with an adjacent component sliding along the surfaces shown. The smearing direction was generally outward, parallel to the sliding and impact damage on the adjacent rivet head. In addition, there was material deformed outward from the pin hole, including outward smearing on the hole edge. This deformation was parallel to and consistent with the other smearing features on the latch body interior.

Figure 9 – Closer view of the right side rivet and pin hole from the latch interior in Figure 8.

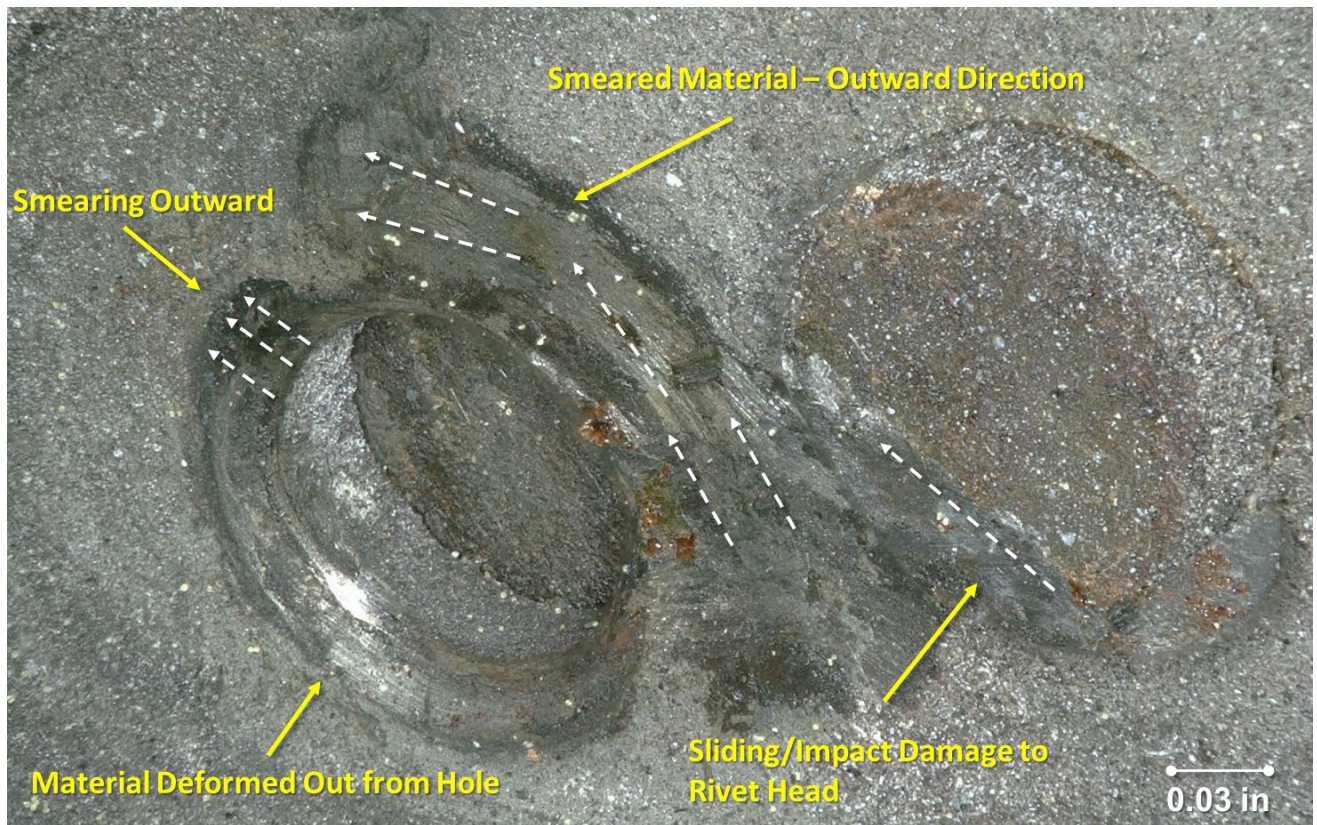
Figure 10 – Annotated view of Figure 9, showing the damage and witness marks present.

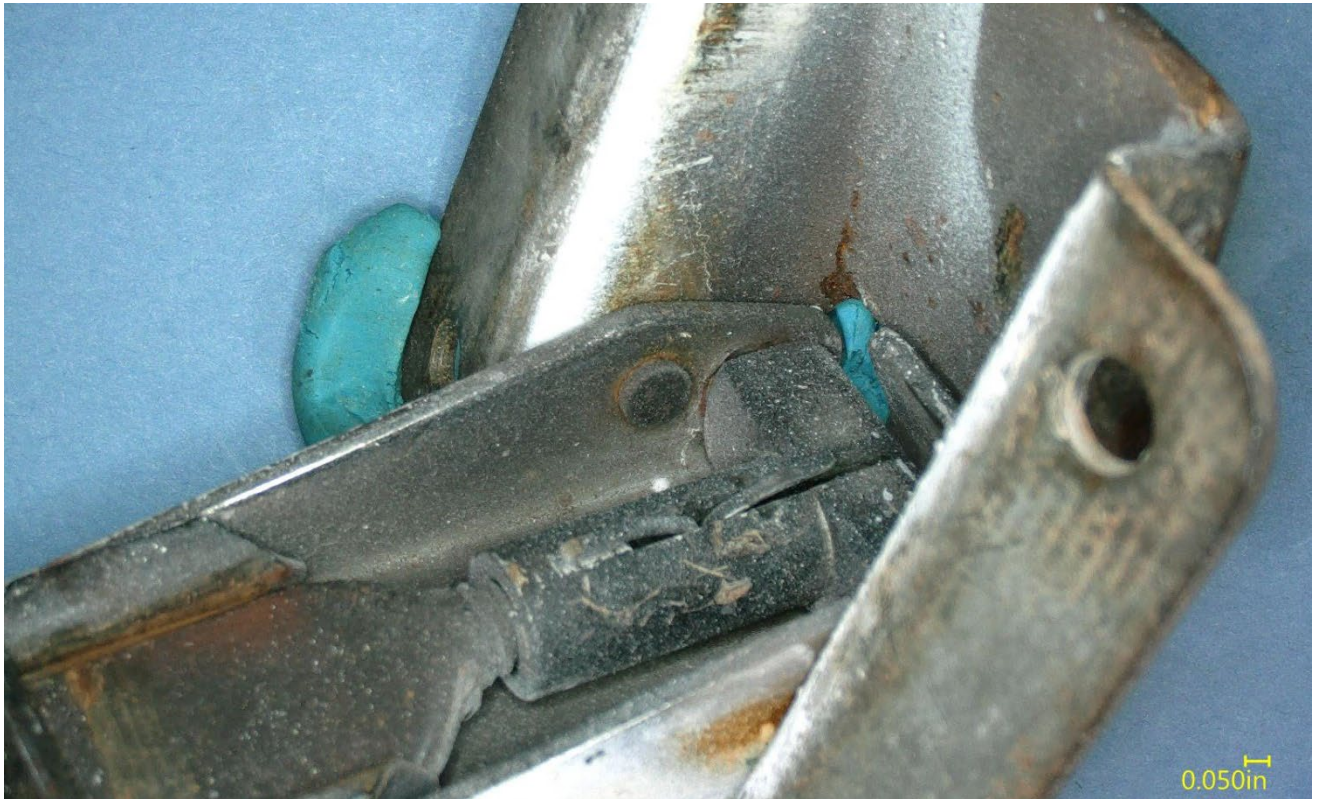
Figures 11 and 12 show the opposite interior sides of the intact and broken latch, respectively. Like with the right side, this left side of the latch body interior exhibited a riveted connection with the outer housing adjacent to the pinhole.

Figure 11 – Angled view of the left side pin and rivet attachments of the intact latch.

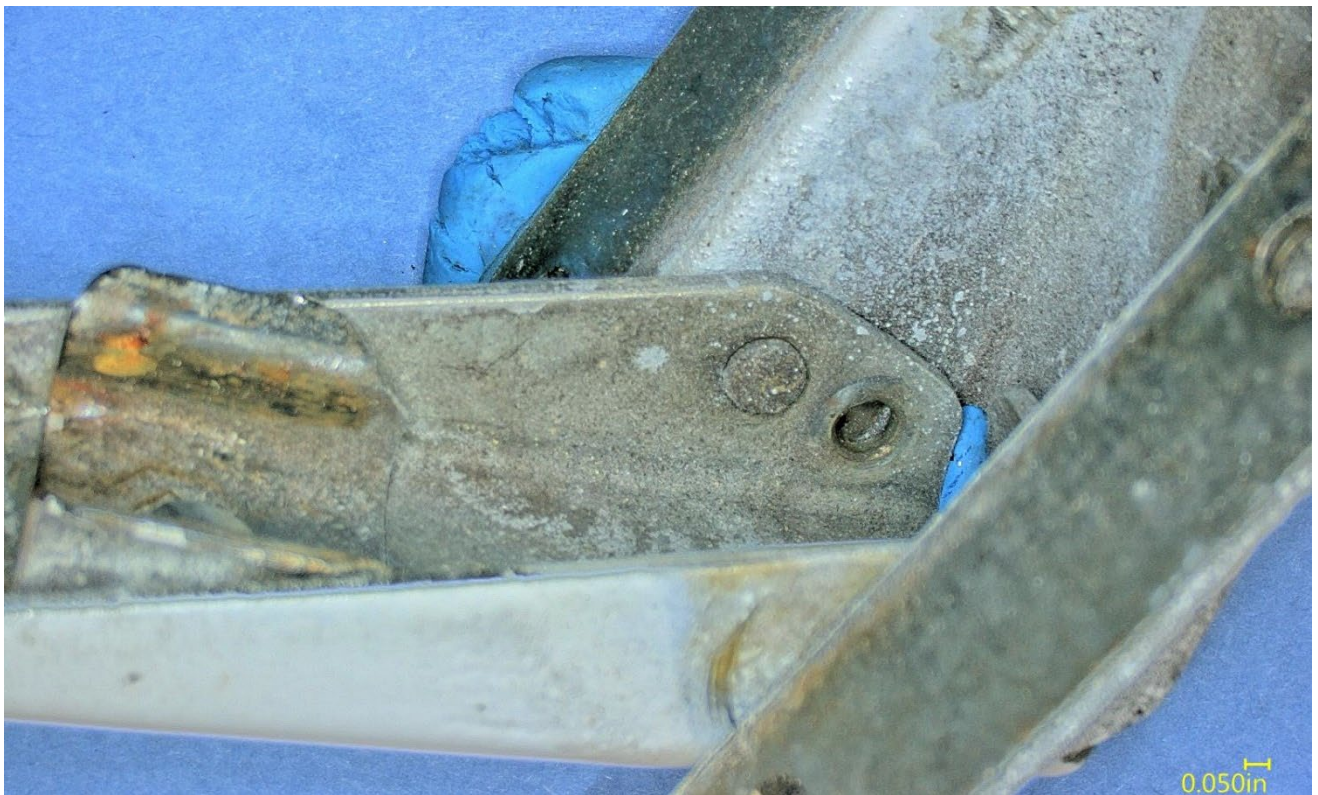
Figure 12 – Angled view of the left side pinhole and rivet of the broken latch.

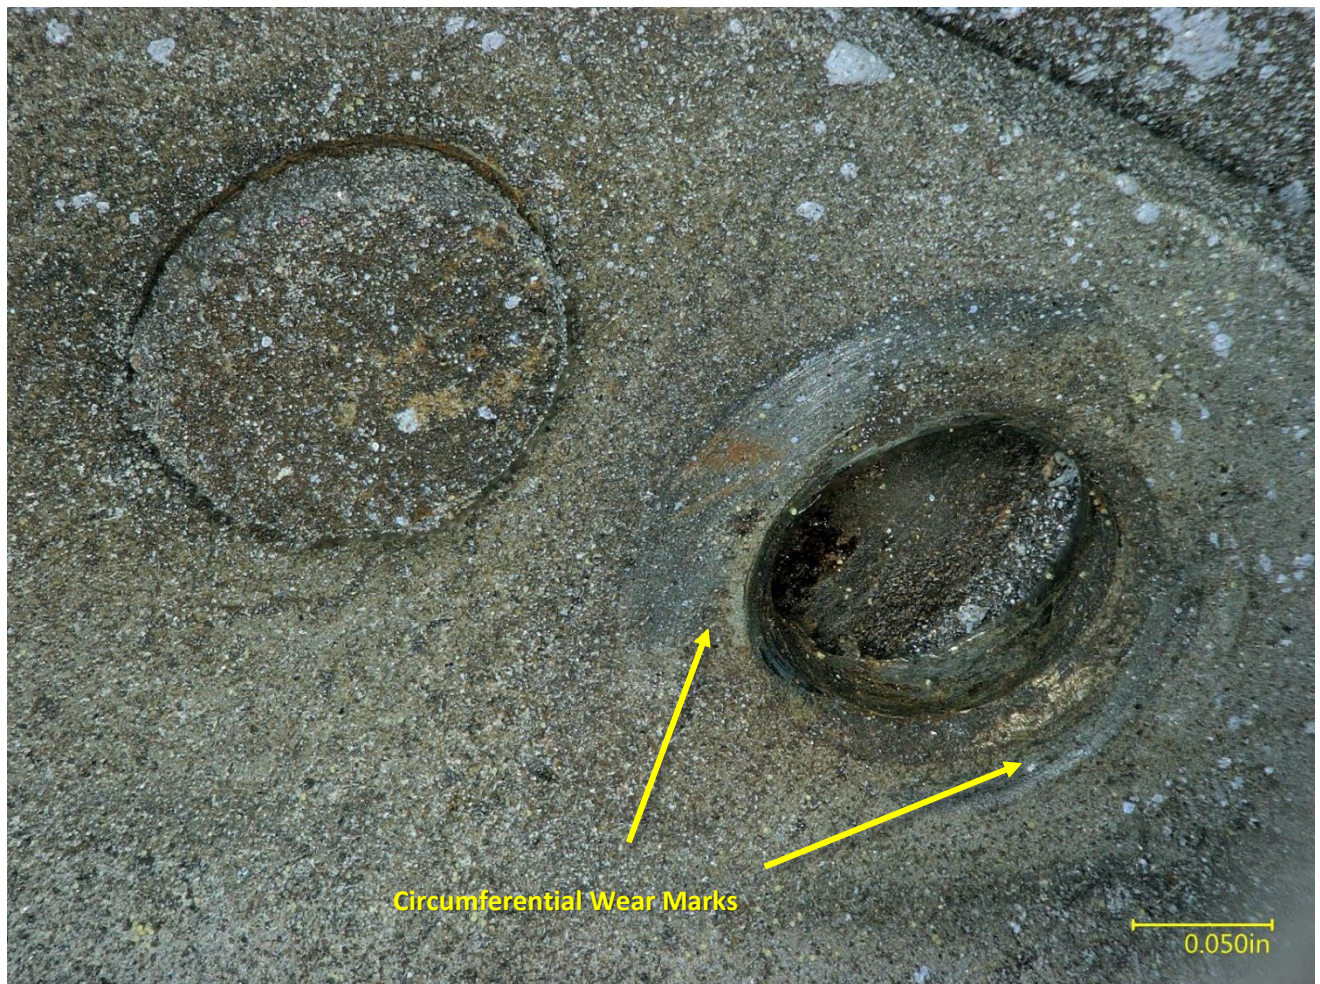
Figure 13 shows a closer view of the pinhole adjacent to the rivet on the left side. Unlike the previous interior face, the amount of damage was confined to circular wear marks around the pin hole. These wear marks were approximately 0.03 inches in width and were located around opposite sides of the pin. These marks were consistent with interaction of the latch body surface with the side wall of the T-shaped shaft.

Figure 13 – Closer view of the left side rivet and pin hole from the latch interior in Figure 12.
