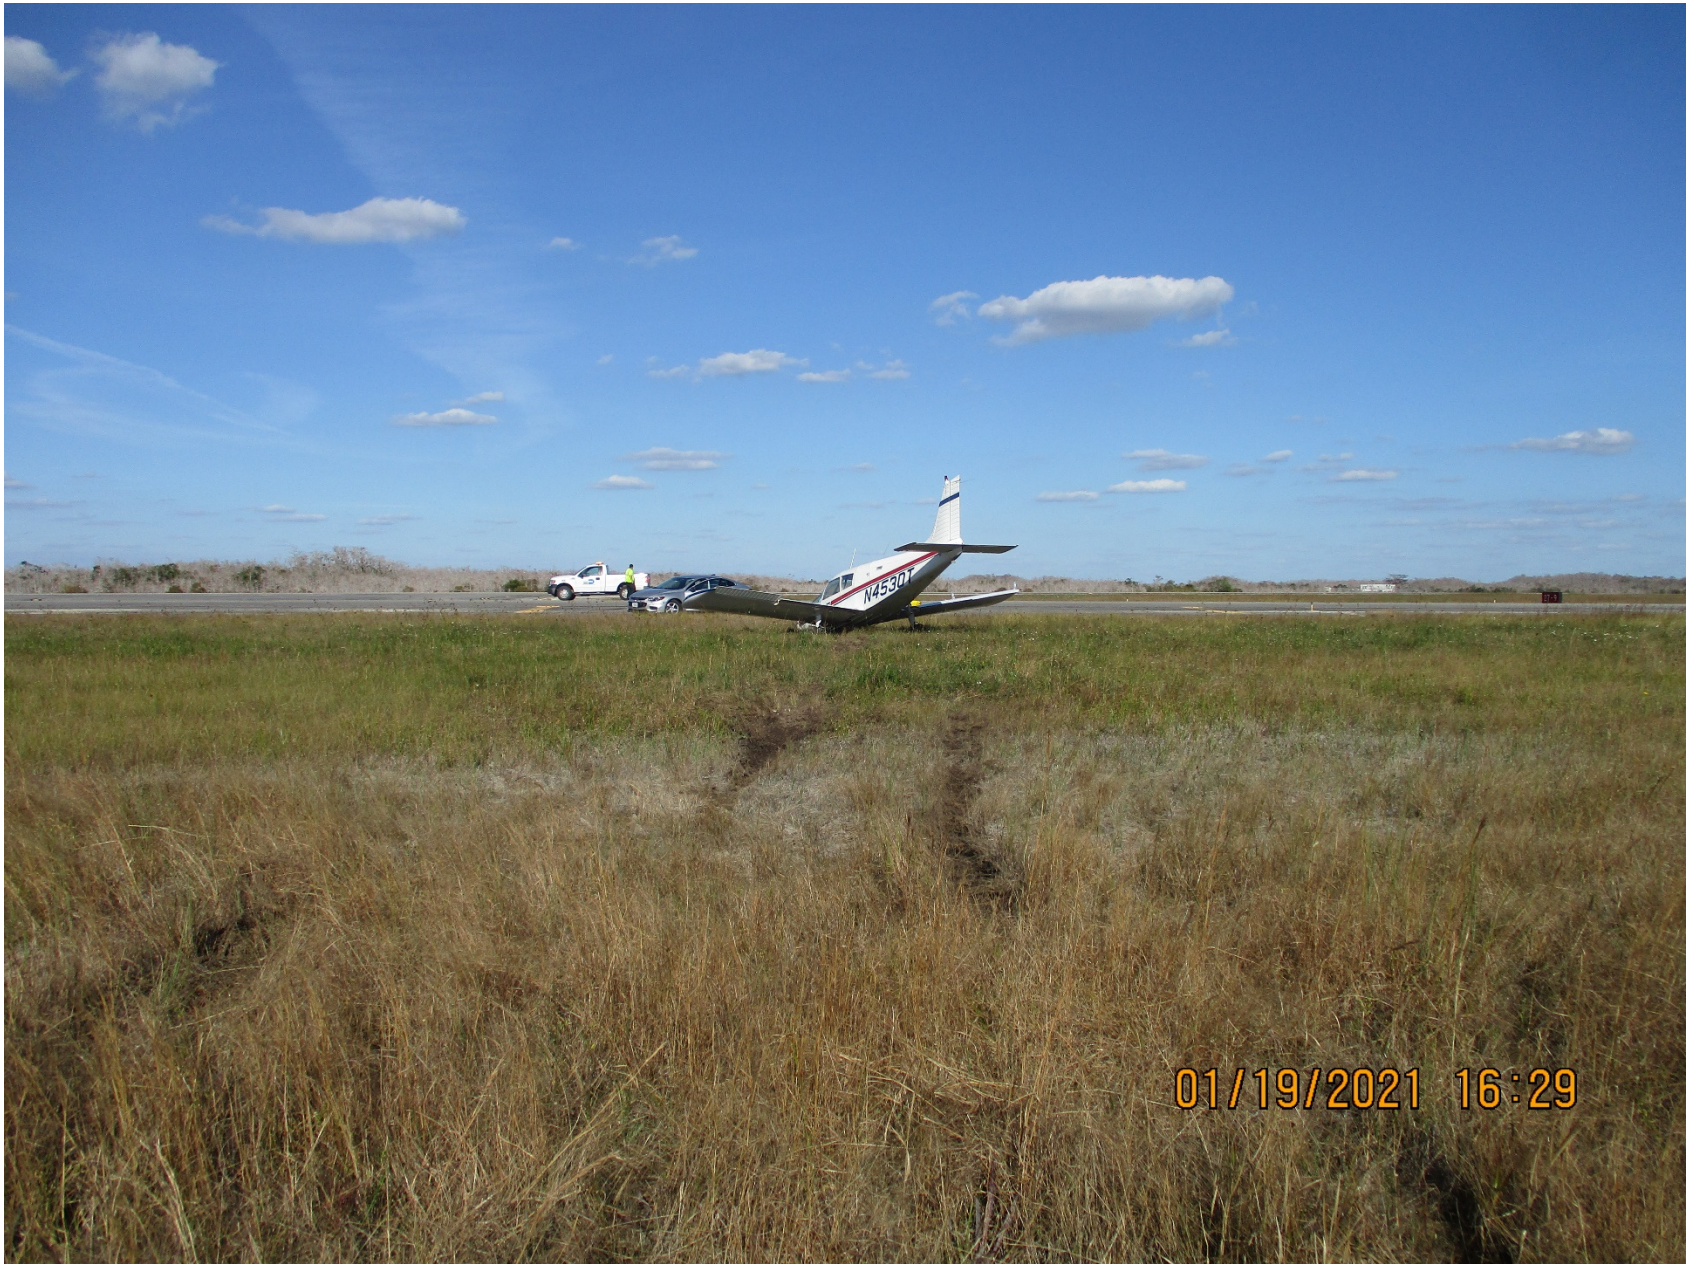
**Photo 1 – Tail view of main wreckage**

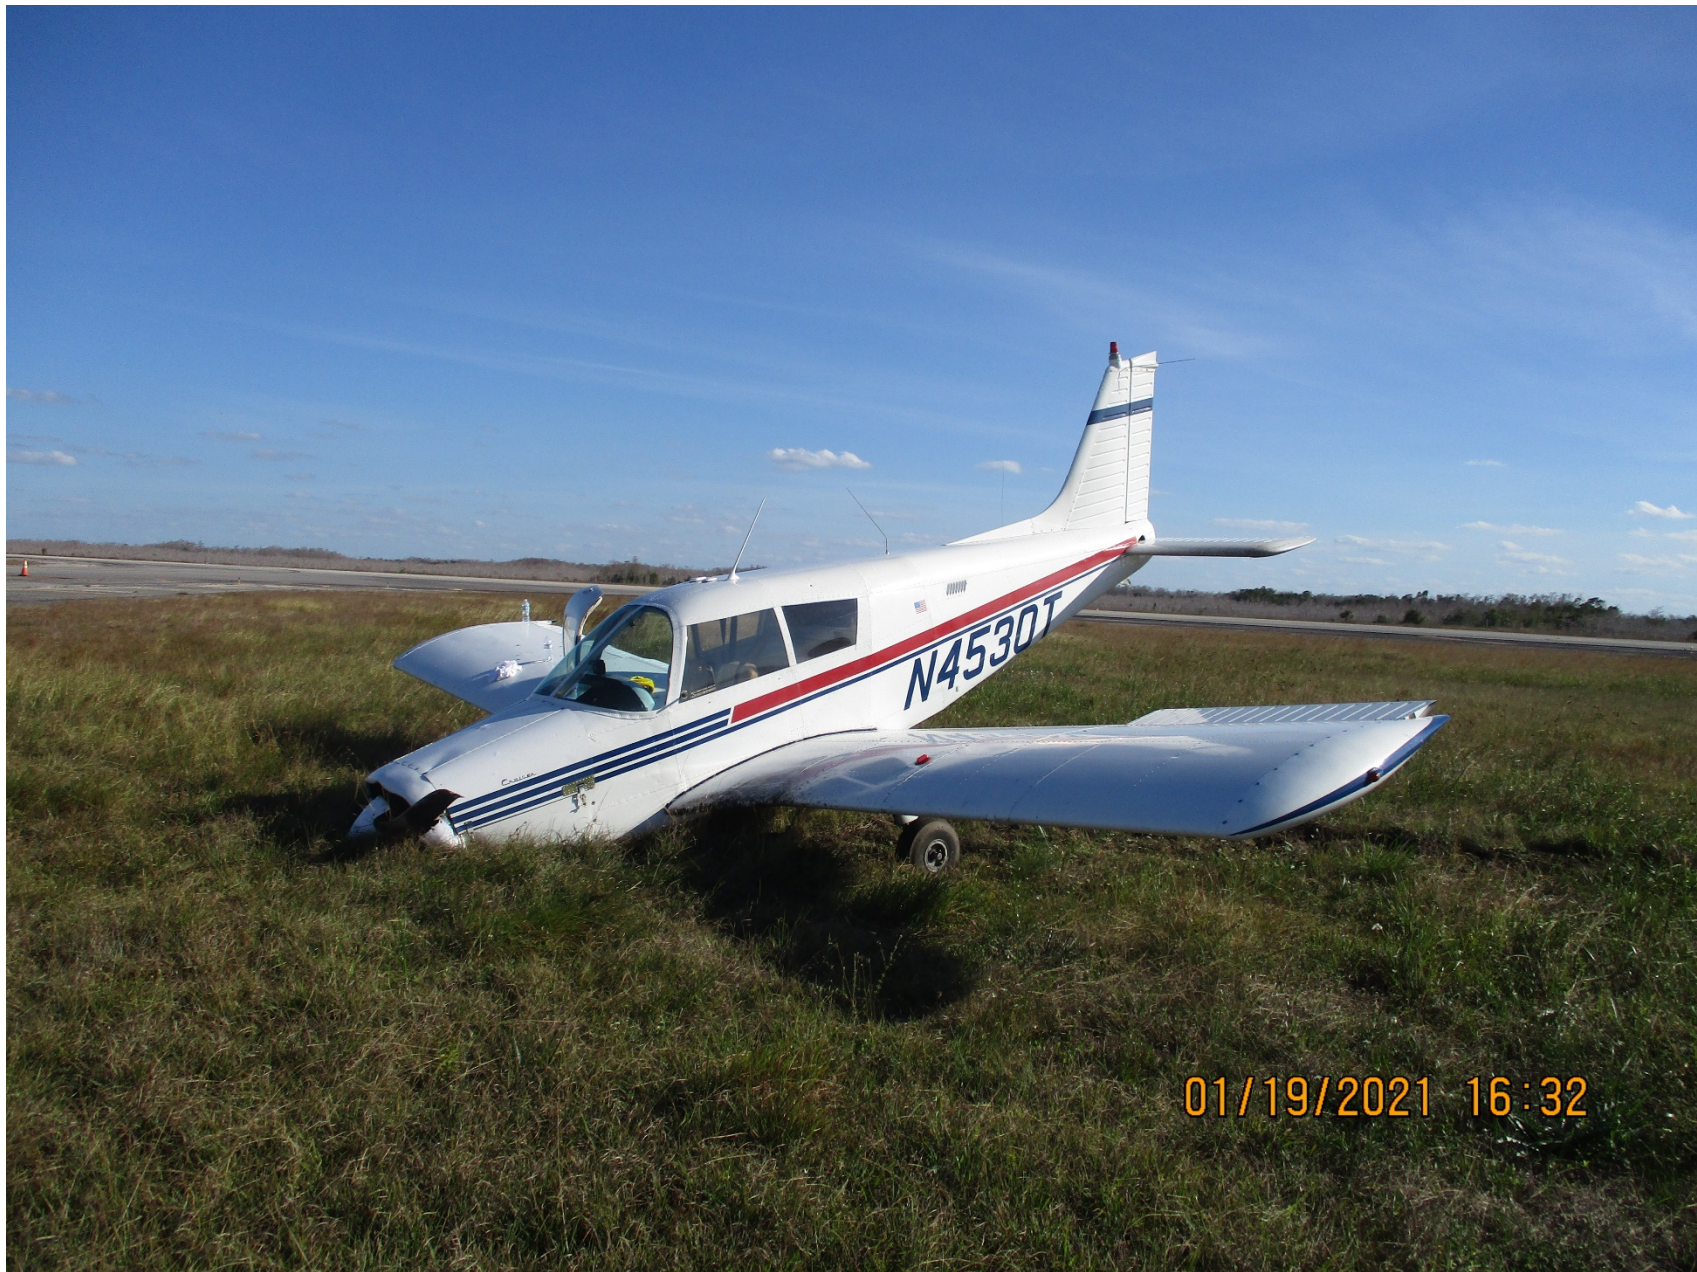
**Photo 2 – view of main wreckage, left wing**

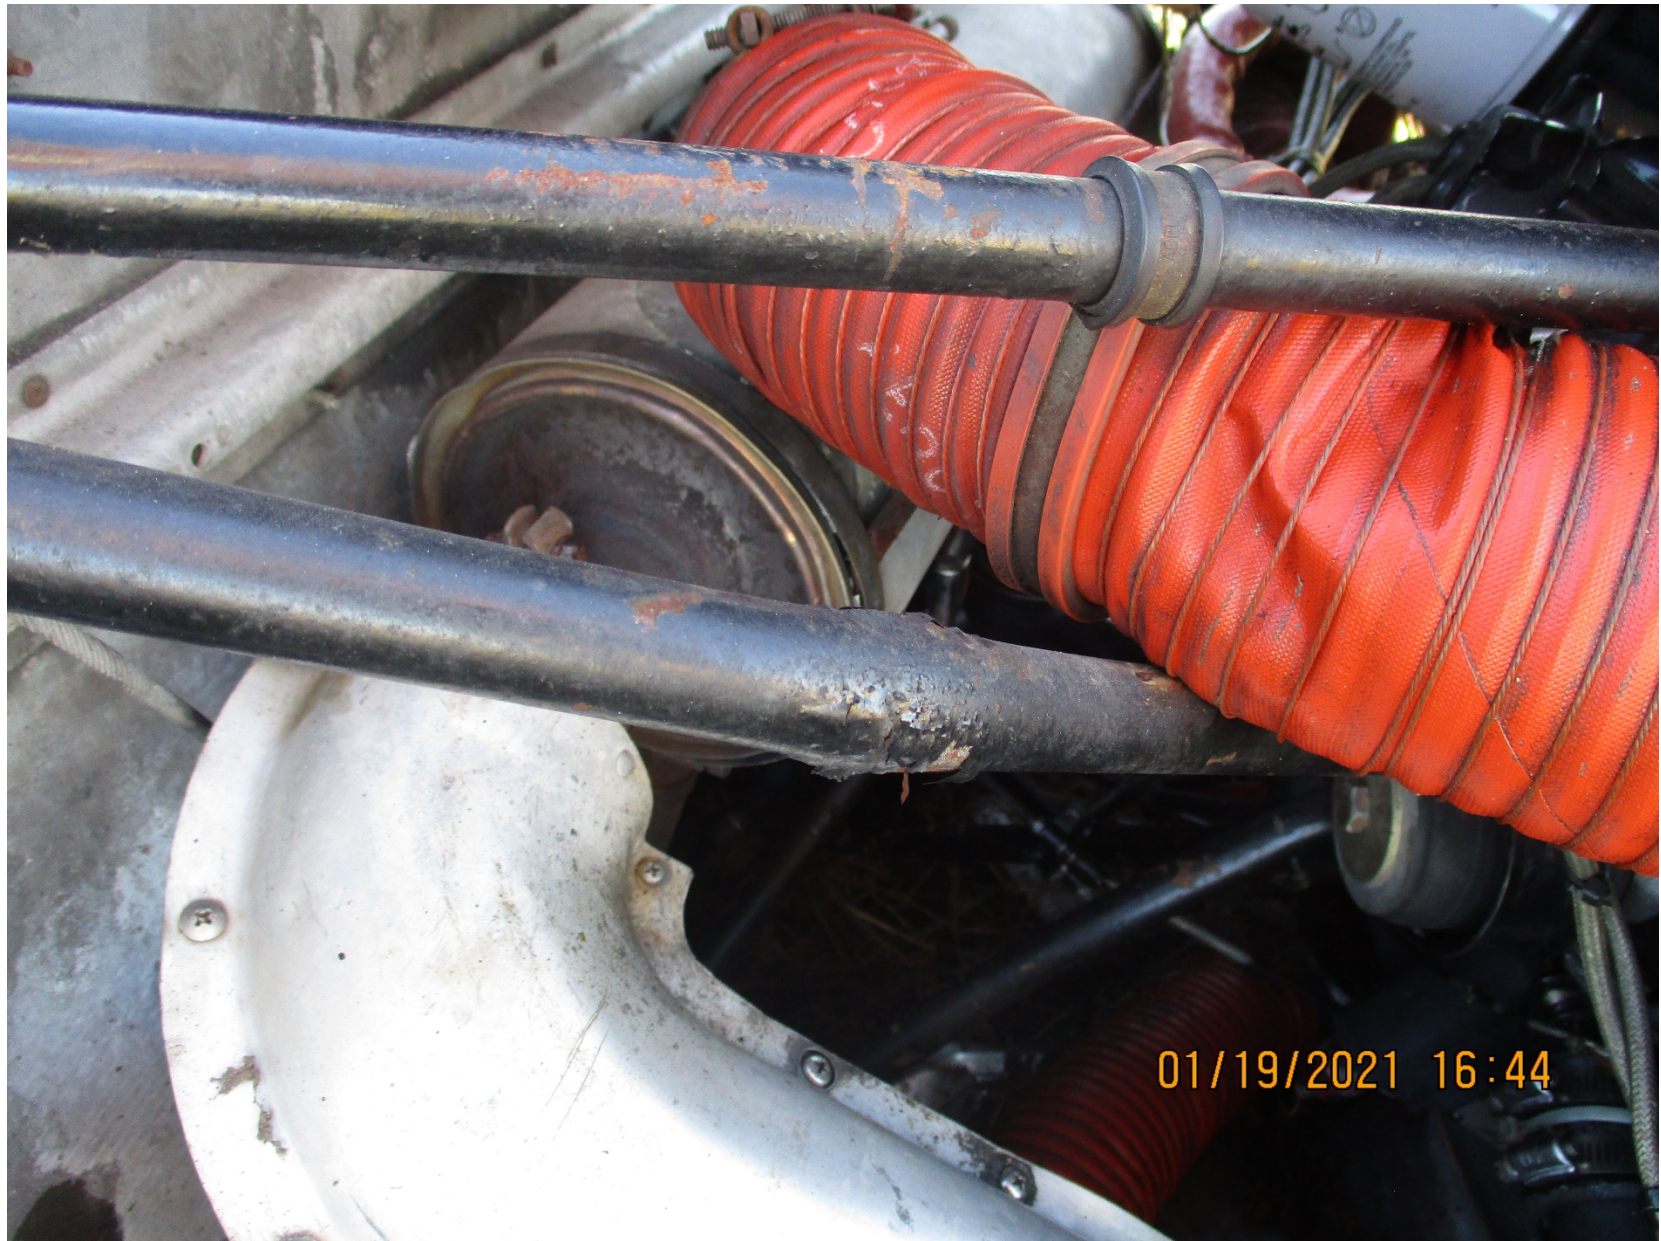
**Photo 3 – Bent motor mount (FAA)**
