## **NATIONAL TRANSPORTATION SAFETY BOARD**

**Photo Array**

**ERA21LA166**

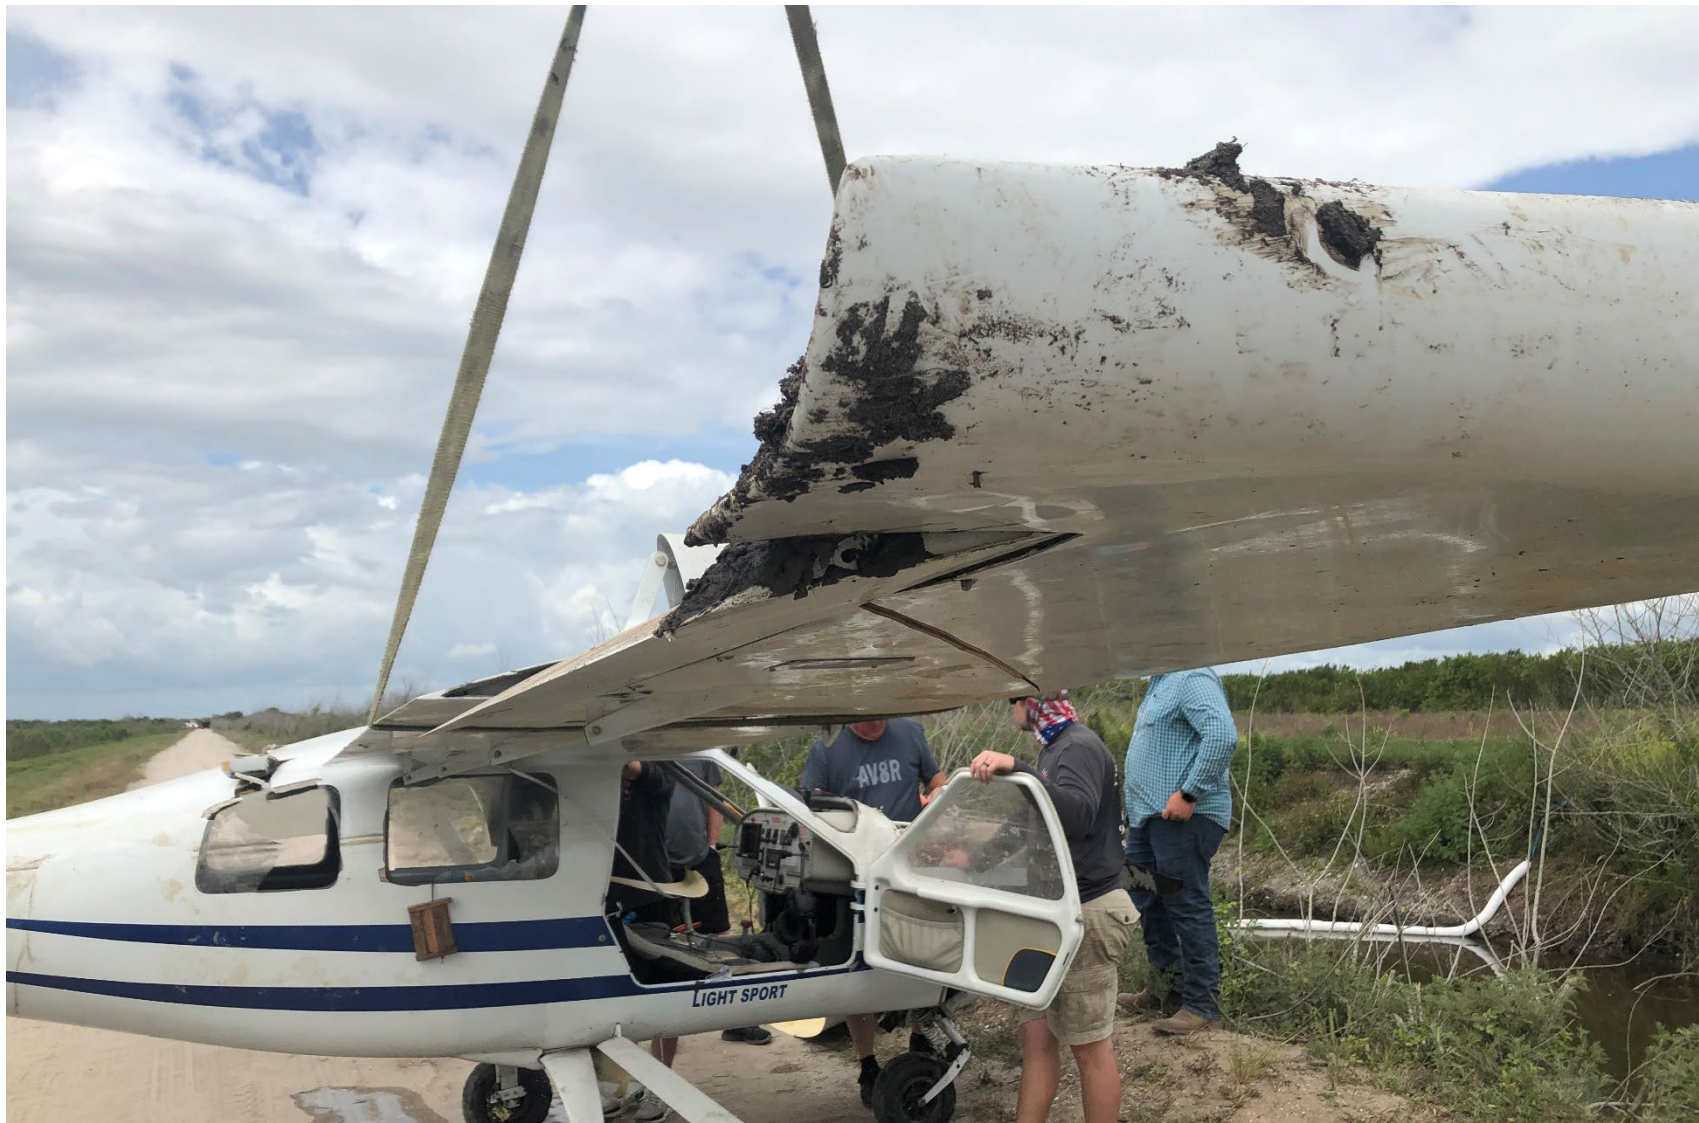
**Photo 1 – View of the right side of the airplane. (Photo Courtesy of FAA)**

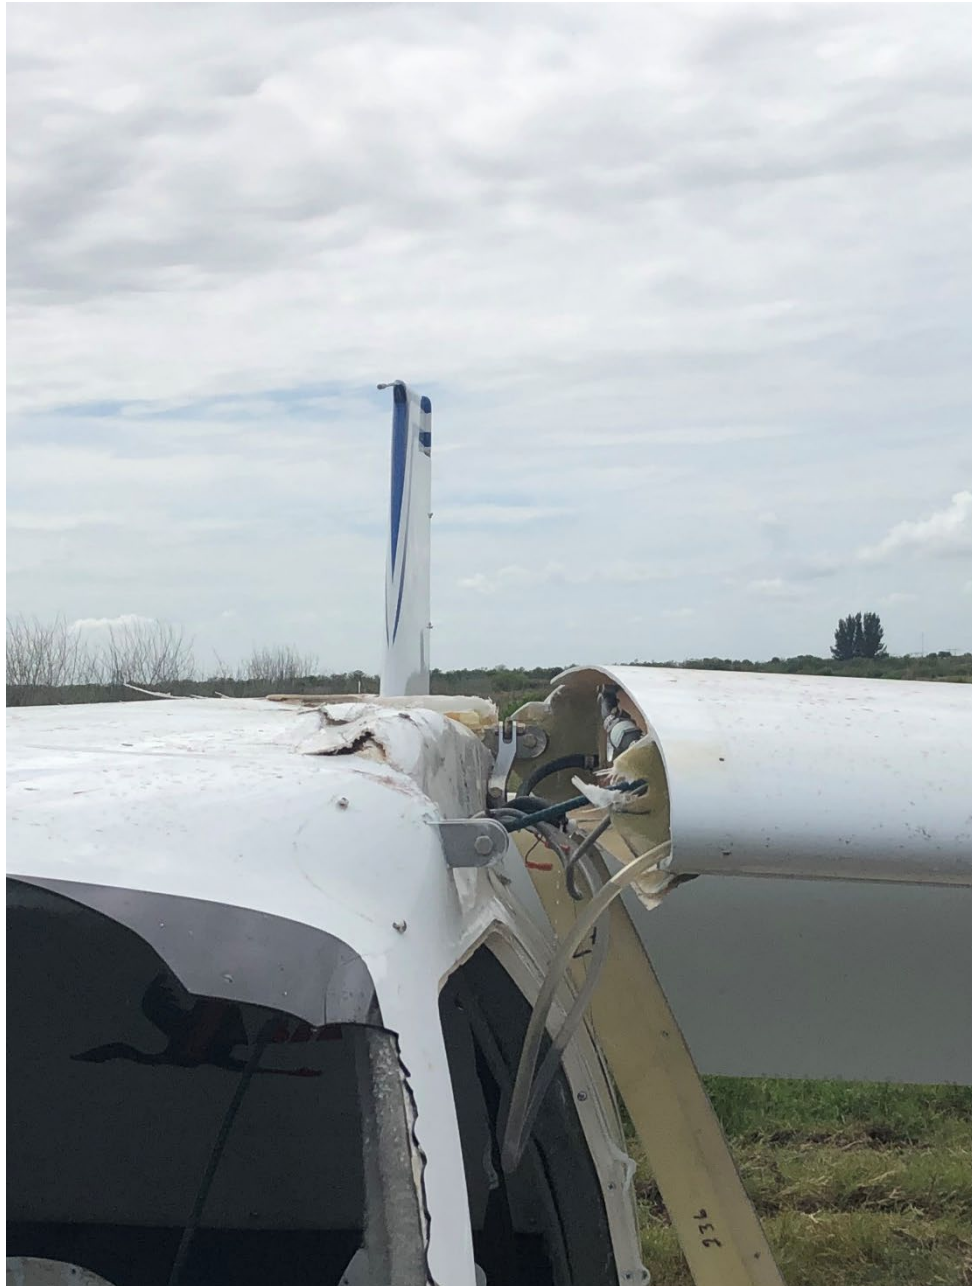
**Photo 2 – View of the damage to the left wing. (Photo Courtesy of FAA)**

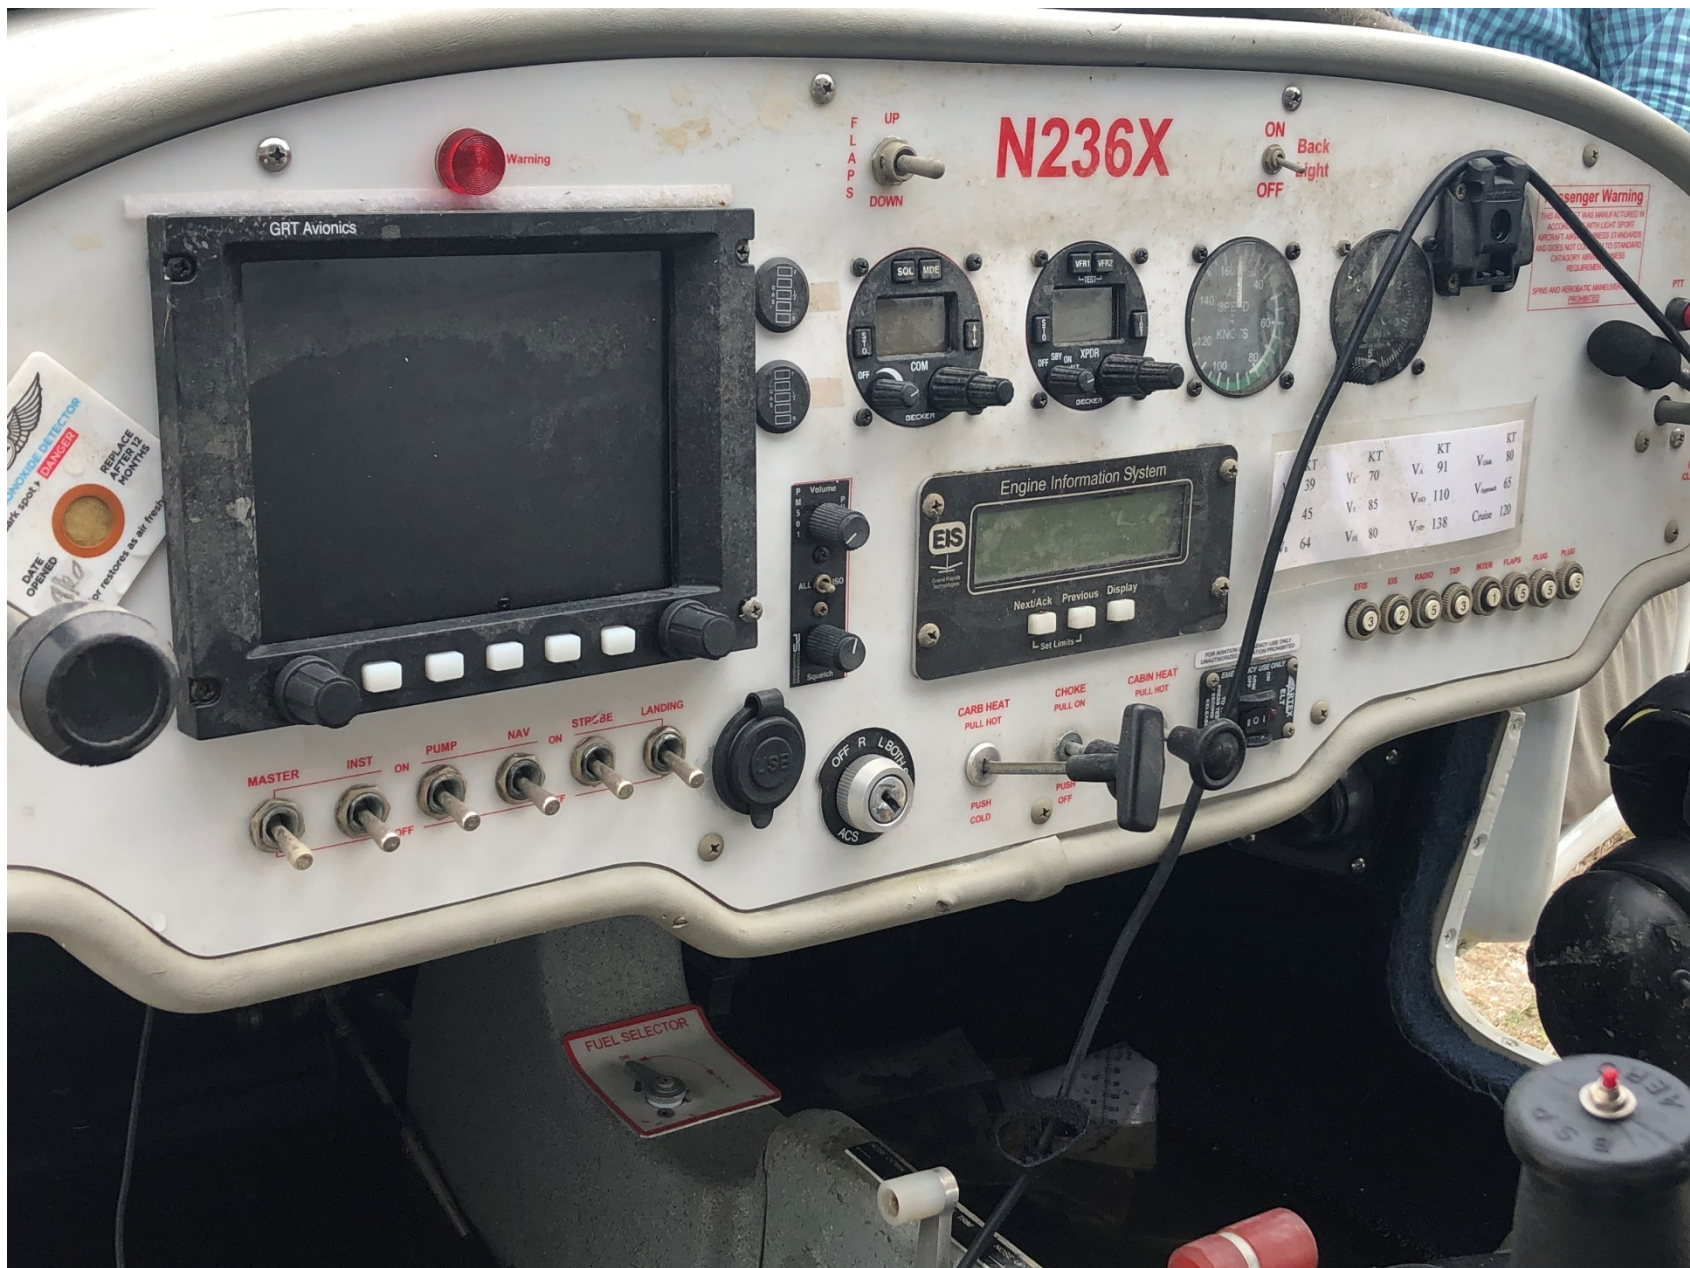
**Photo 3 – View of the instrument panel. (Photo Courtesy of FAA)**
