## **Mooney Accident – Additional Panel Testing**

Testing was conducted on November 30, 2021 at the Naples site of Parker Aerospace. The purpose of the testing was to determine if there was leakage between the aircraft panel and the gravity fill adaptor and/or between the gravity fill adapter and the cap.

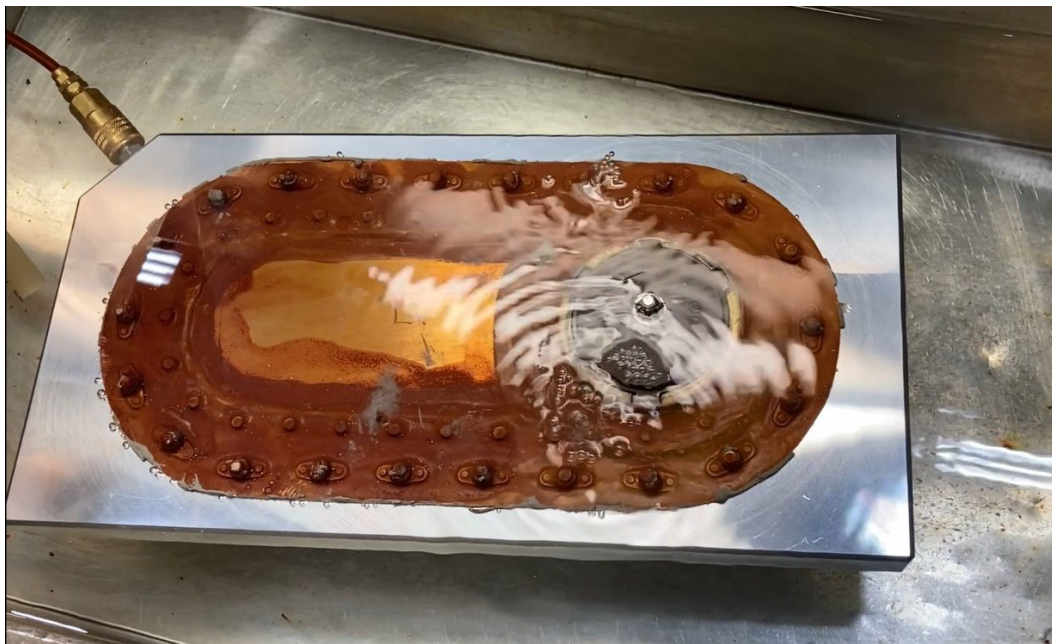
Figure 4: Left Panel Leak Test .28 psi

3. The fixture assembly was then slowly pressurized to 25 psi. It was observed that at a pressure of 0.1 psi, there was a steady stream of bubbles coming from between the aircraft panel and the gravity fill adaptor (Figure 4) at the 7 o'clock position (as installed in the test stand). As the pressure was increased, additional leakage was seen at .45 psi (12 o'clock position, Figure 5). At 25 psi, a large amount of bubbles were coming from each of these locations with the most extreme being at the 7 o'clock position (Figure 6).

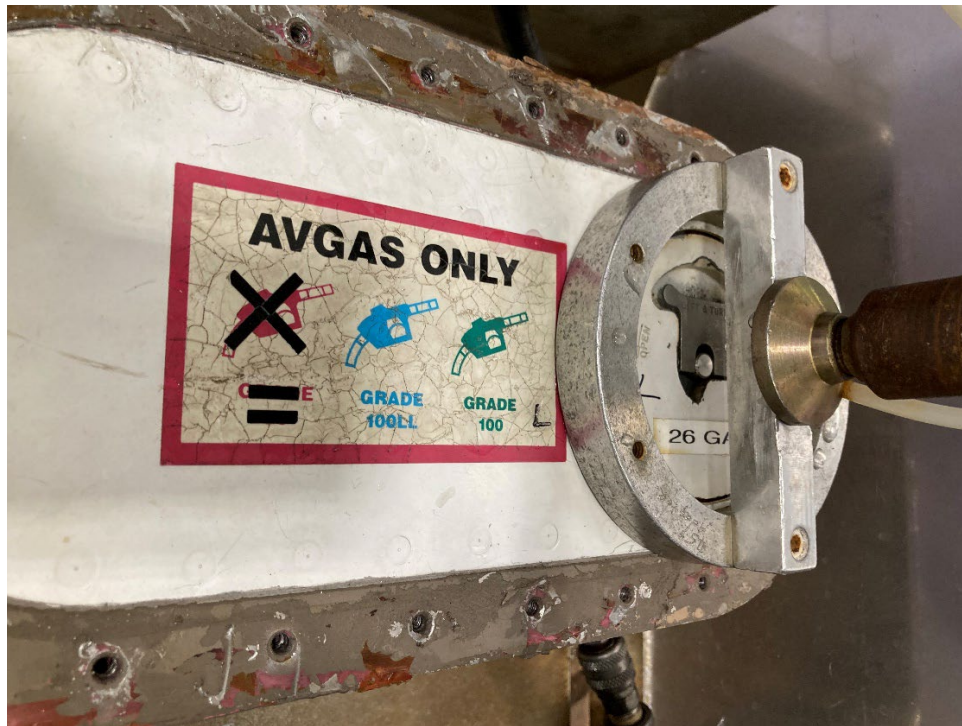
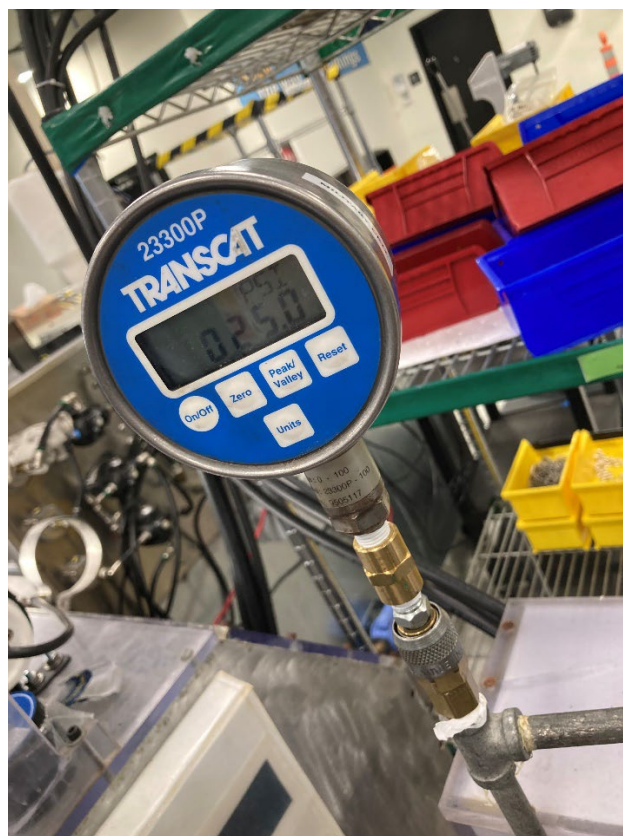
4. There was no leakage noted between the gravity fill adapter and the cap, so replacement of the cap was not necessary.
5. The panel was then removed from the test fixture and installed into another test stand to provide an additional check for leakage between the gravity fill adapter and the cap (see Figures 7 & 8). In this test, pressure was applied to the back side of the panel, with water covering the cap and adapter. The setup was then slowly pressurized to 25 psi. Again, there was no leakage noted between the Left gravity fill adapter and the cap.

Figure 7: Left Cap-Adapter Leak Test 25 psi

Figure 8: Left Cap-Adapter Leak Test 25 psi Gage

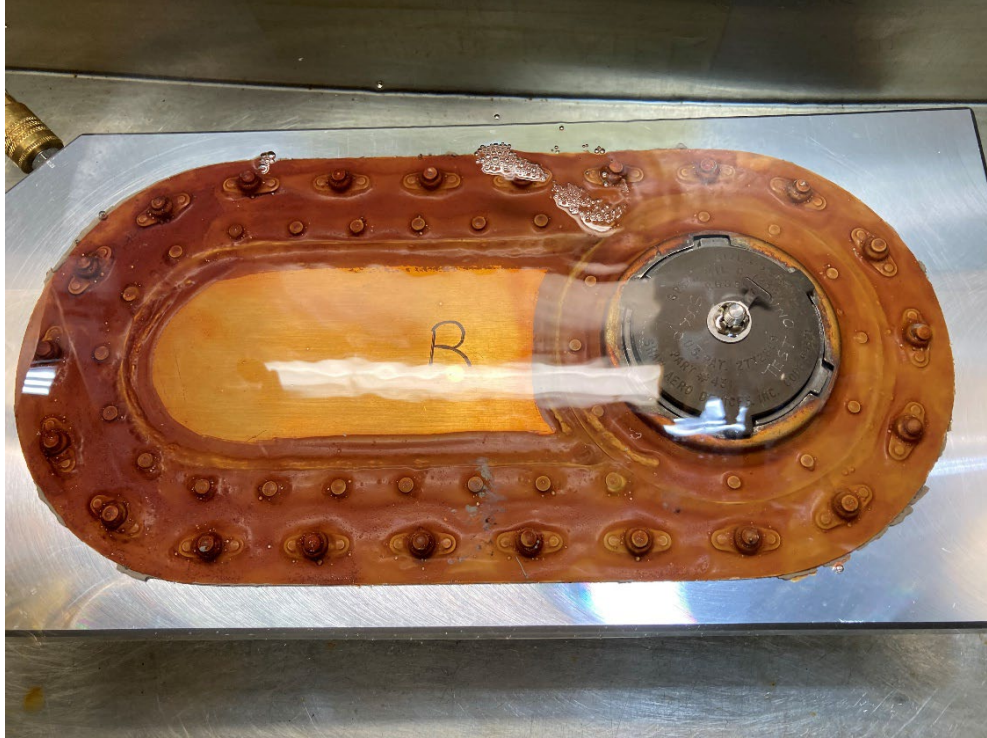
Figure 9: Right Panel Leak Test .28 psi

3. The fixture assembly was then slowly pressurized to 25 psi. It was observed that at a pressure of 0.28 psi, there was a steady stream of bubbles coming from between the aircraft panel and the gravity fill adaptor (Figure 9) at the 10 o'clock position (as installed in the test stand). As the pressure was increased, no additional leakage positions found. At 25 psi, a massive amount of bubbles were coming from the 10 o'clock position (Figures 10 & 11).

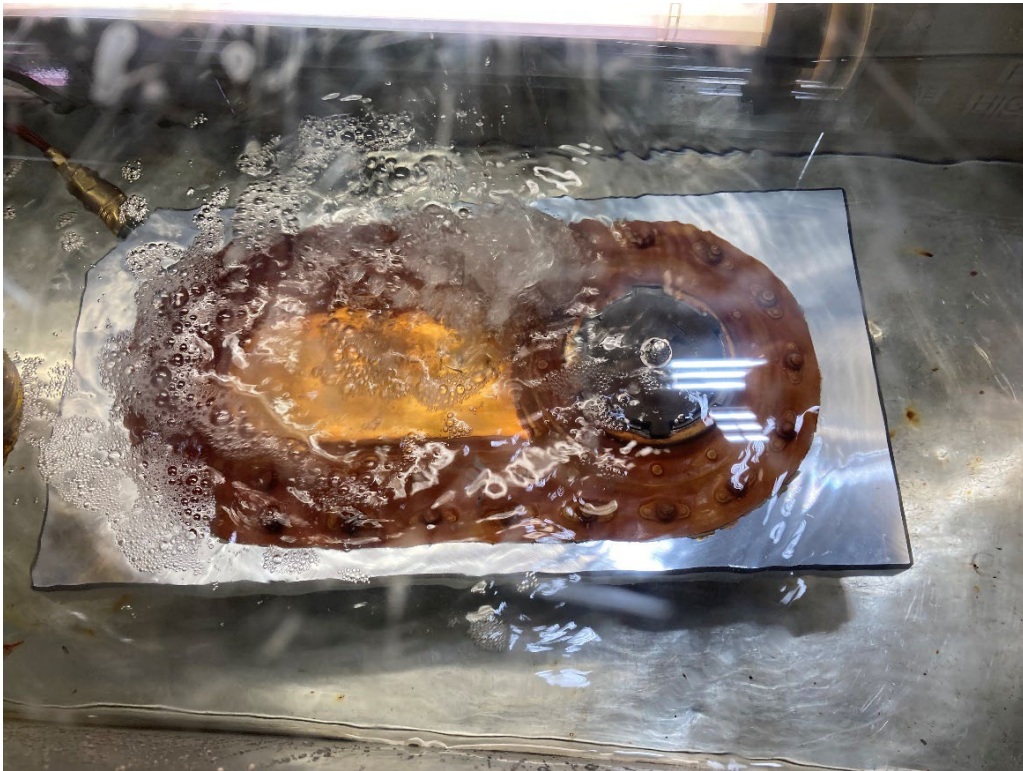
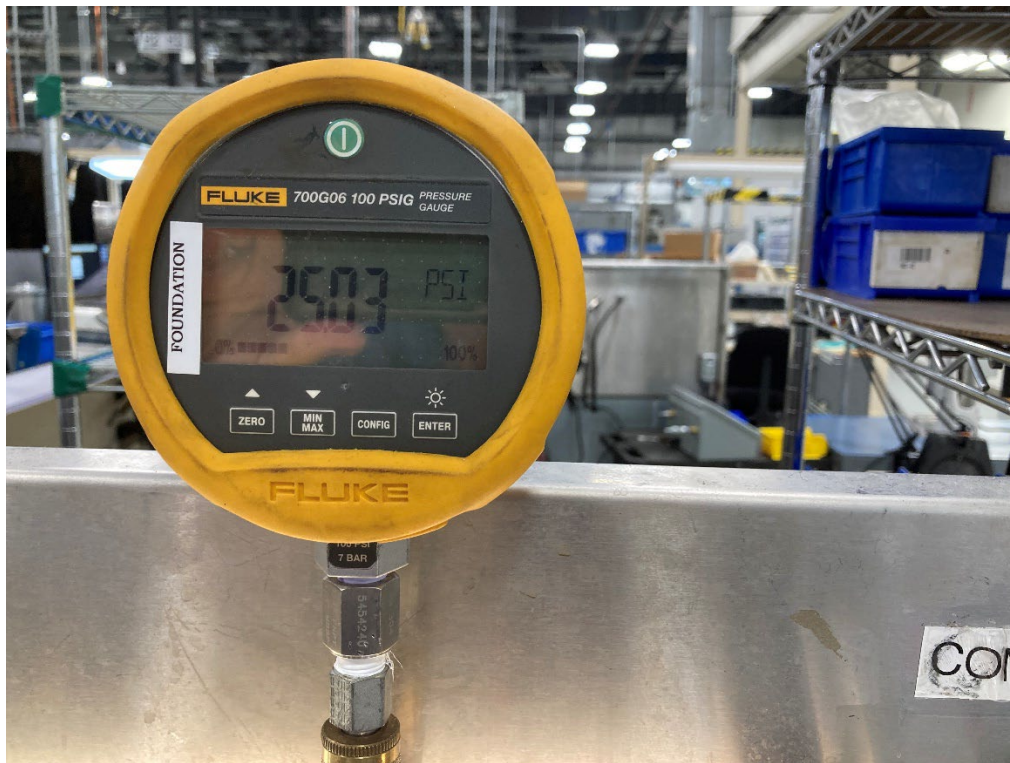
Figure 10: Right Panel Leak Test 25 psi

Figure 11: Right Panel Leak Test 25 psi Gage

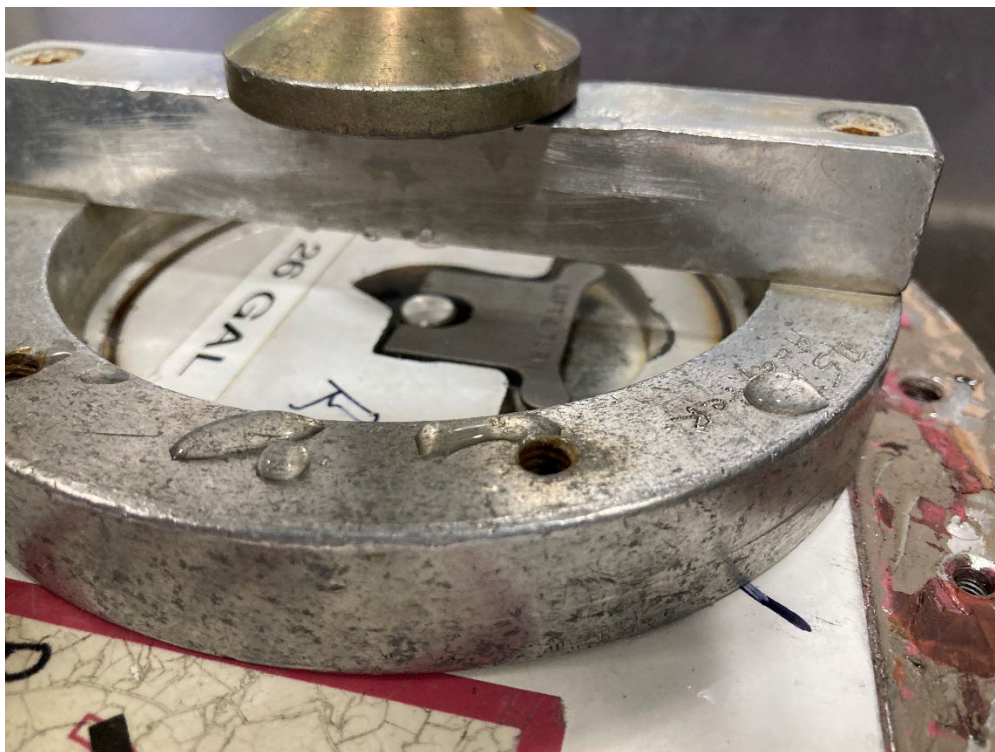
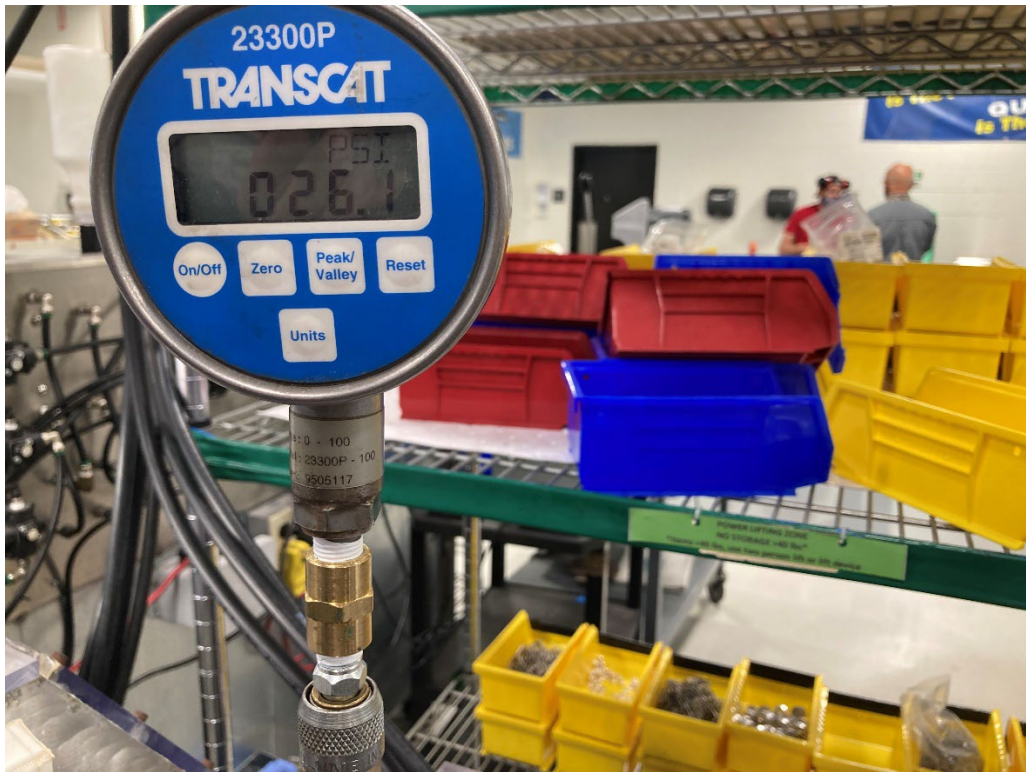
4. There was no leakage noted between the gravity fill adapter and the cap, so replacement of the cap was not necessary.
5. The panel was then removed from the test fixture and installed into another test stand to provide an additional check for leakage between the gravity fill adapter and the cap (see Figures 12 & 13). In this test, pressure was applied to the back side of the panel, with water covering the cap and adapter. The setup was then slowly pressurized to 25 psi. Again, there was no leakage noted between the Right gravity fill adapter and the cap.

Figure 12: Right Cap-Adapter Leak Test 25 psi

Figure 13: Right Cap-Adapter Leak Test 25 psi Gage
