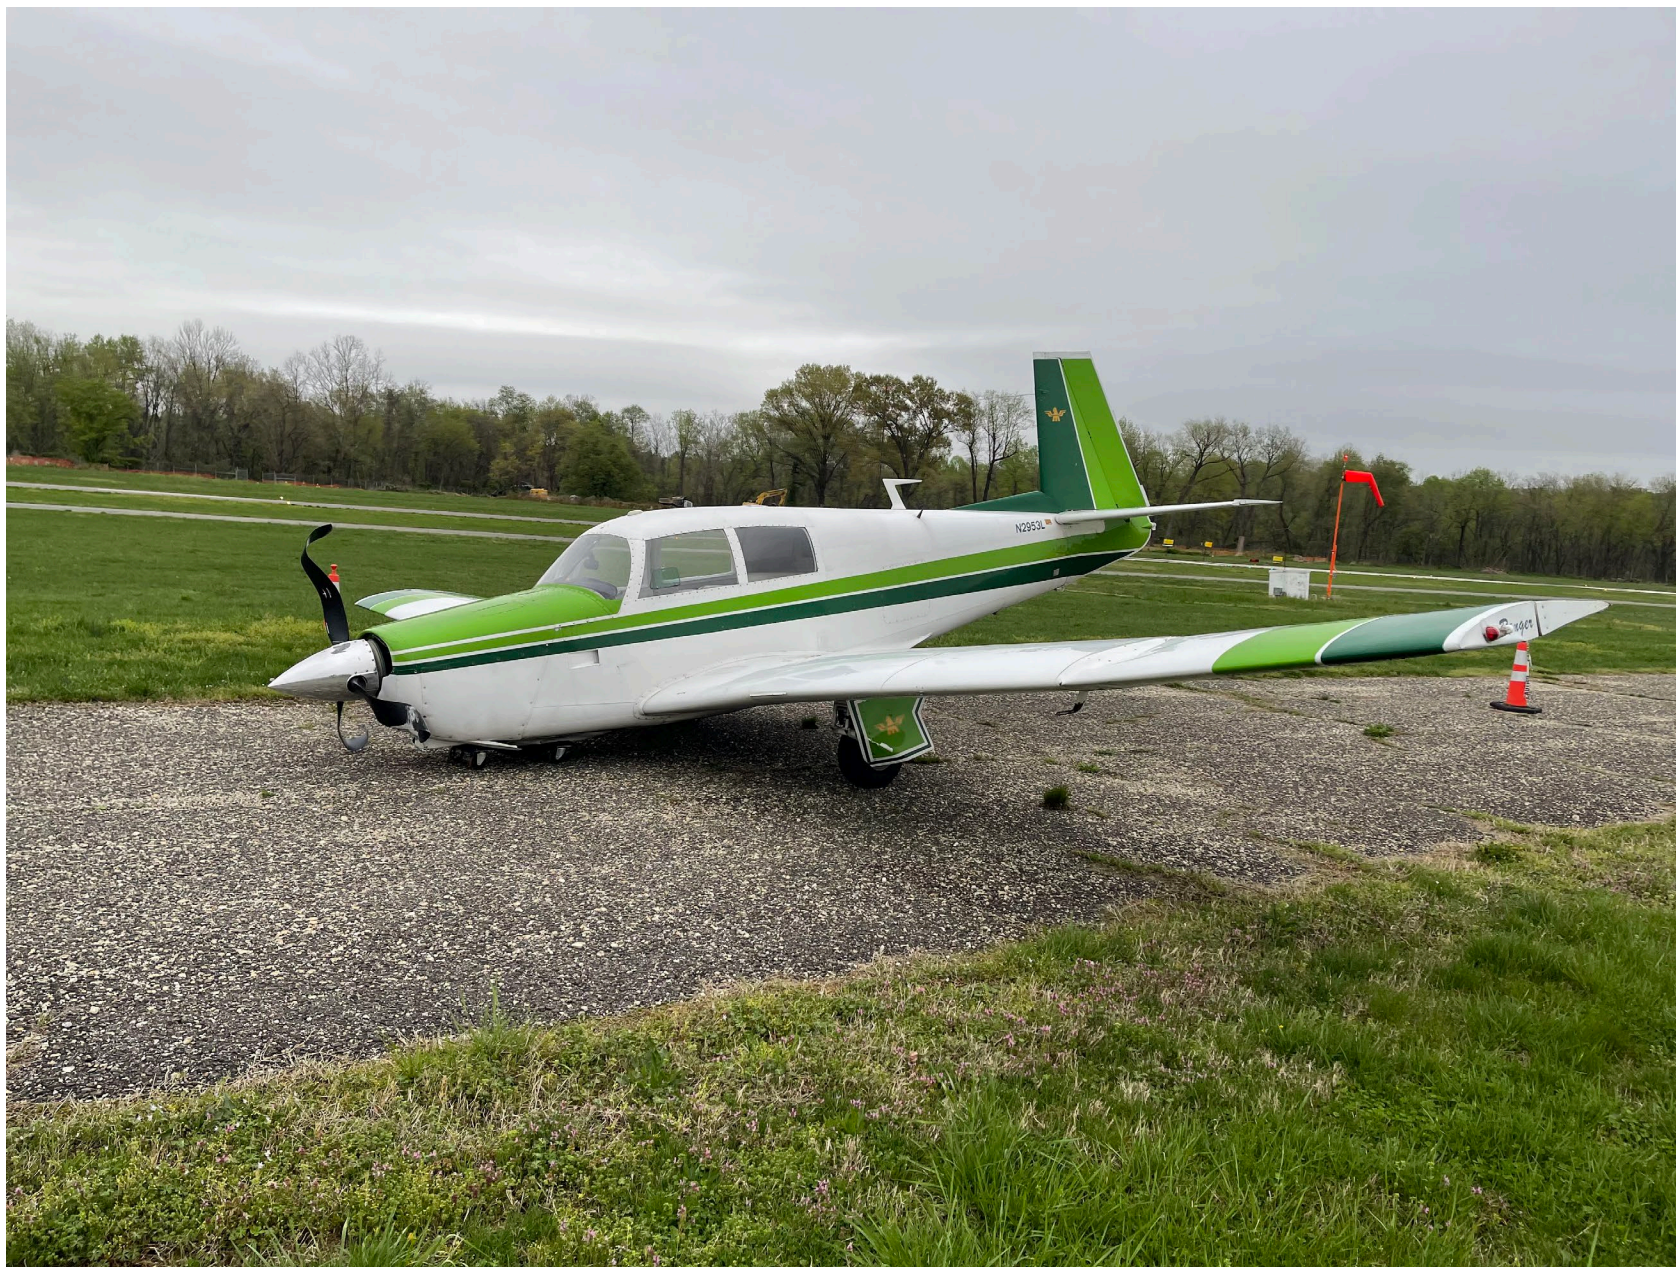
**Photo 1 – Digital Photograph From Recovery Company. Left Forward Quartering View of the Airplane Following Removal From Runway.**

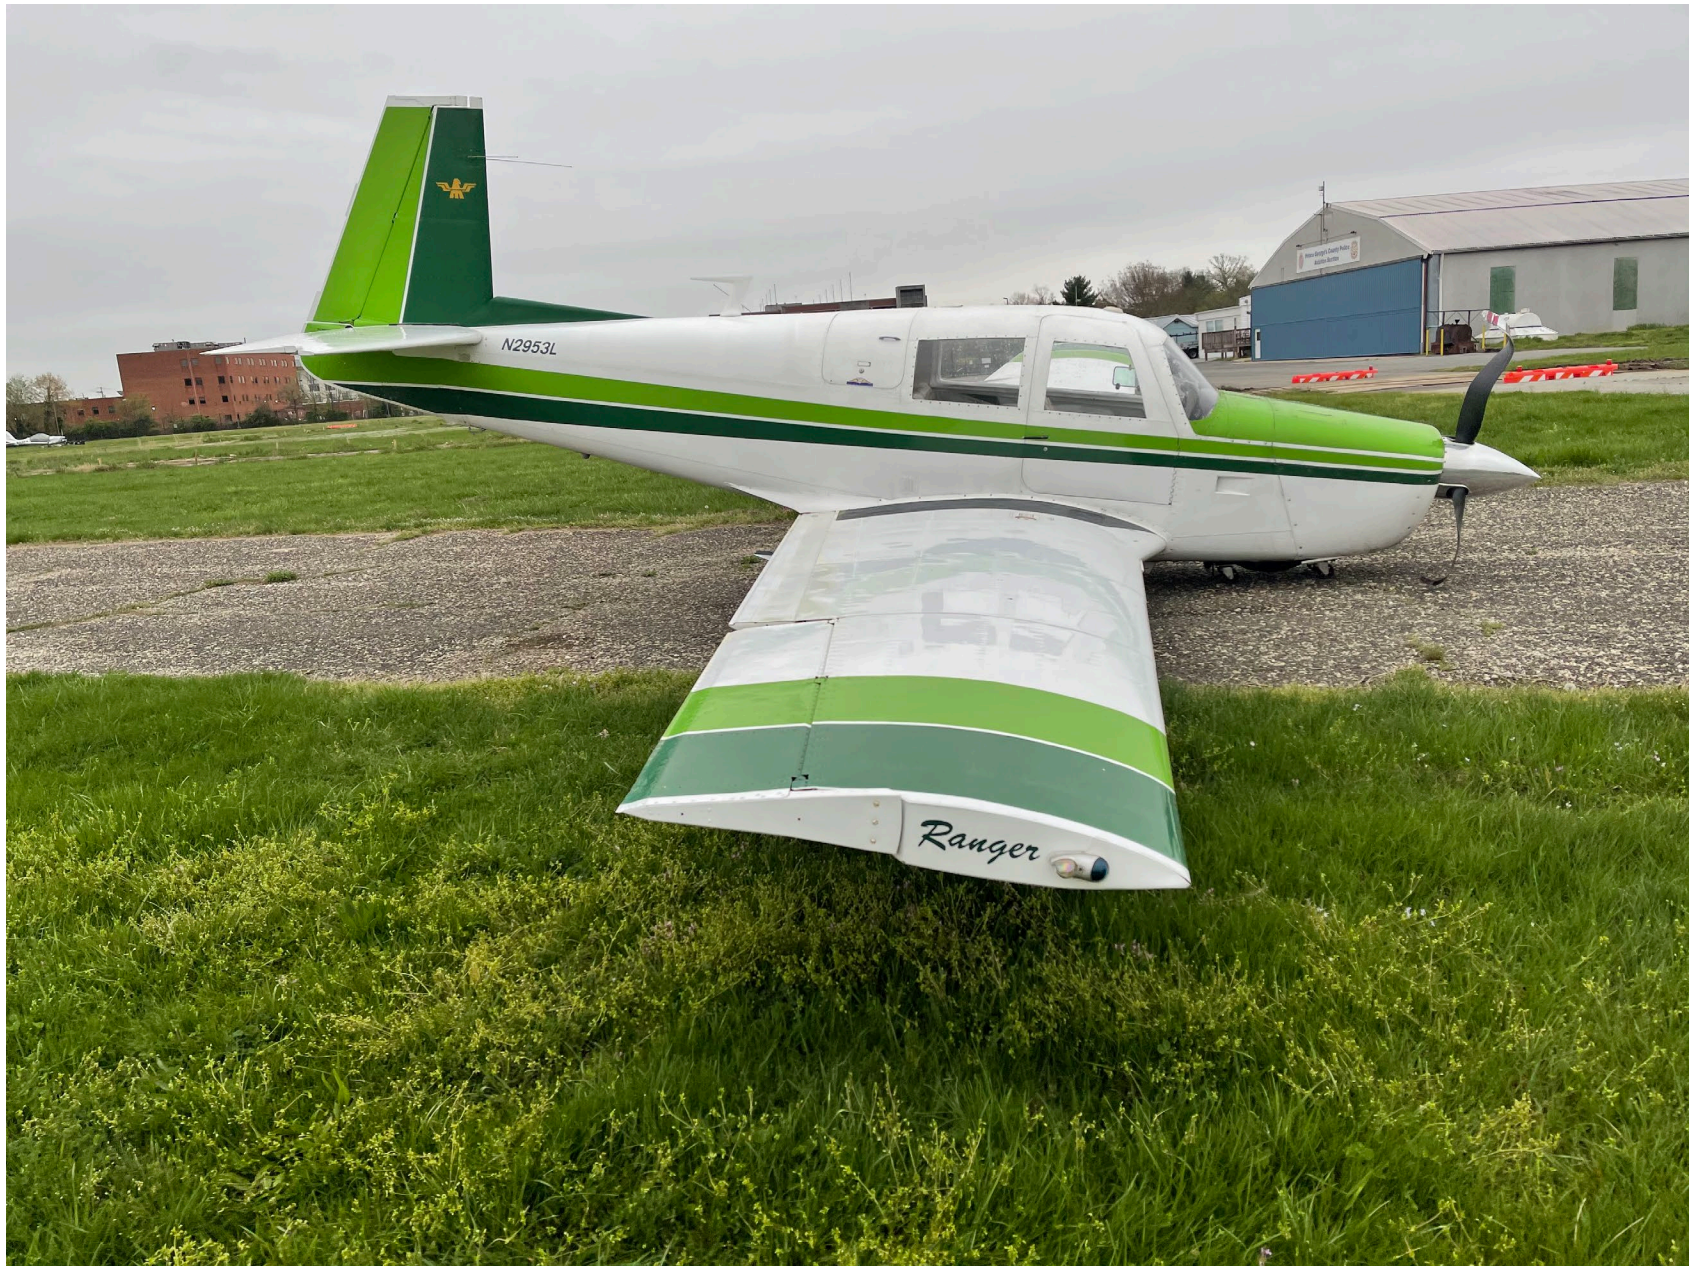
**Photo 2 - Digital Photograph From Recovery Company. Right Side View of the Airplane Following Removal From Runway.**

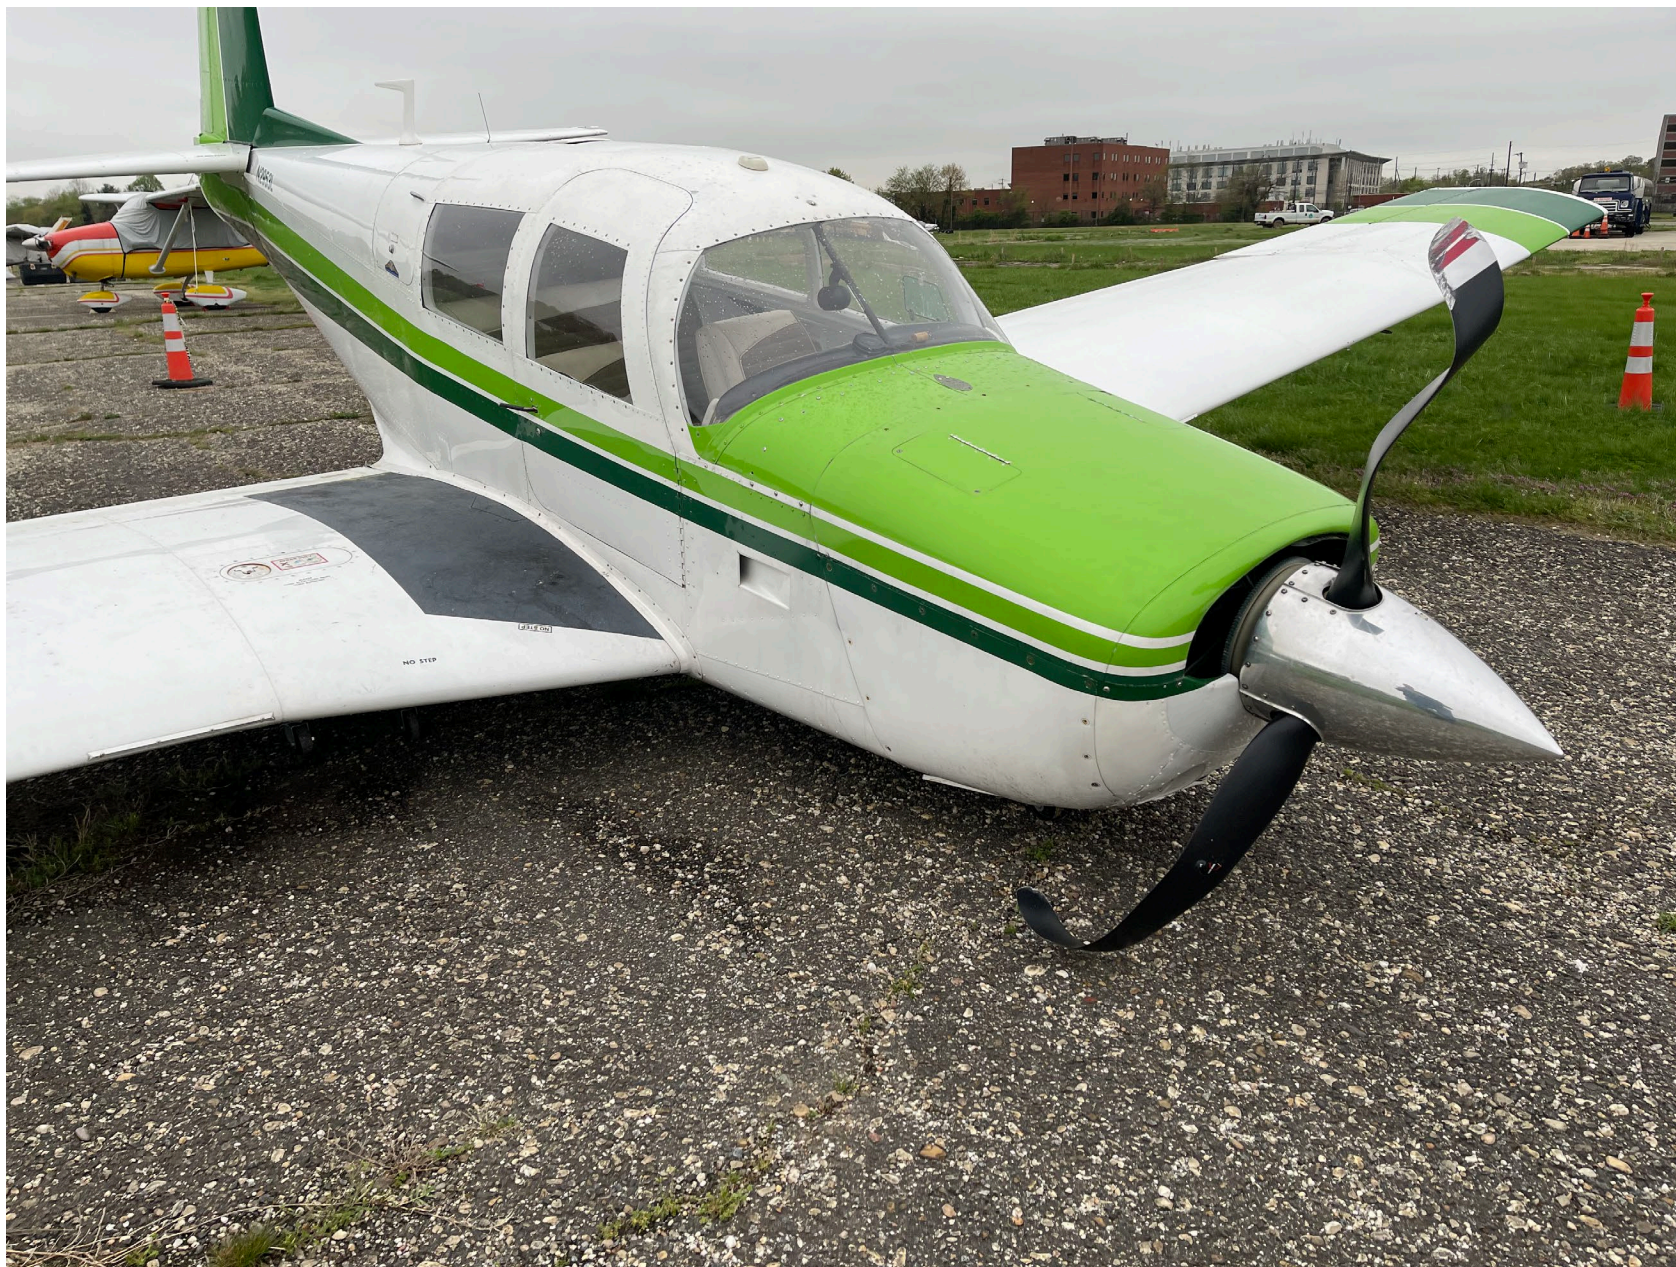
**Photo 3 - Digital Photograph From Recovery Company. Right Forward Quartering View of the Airplane Following Removal From Runway.**

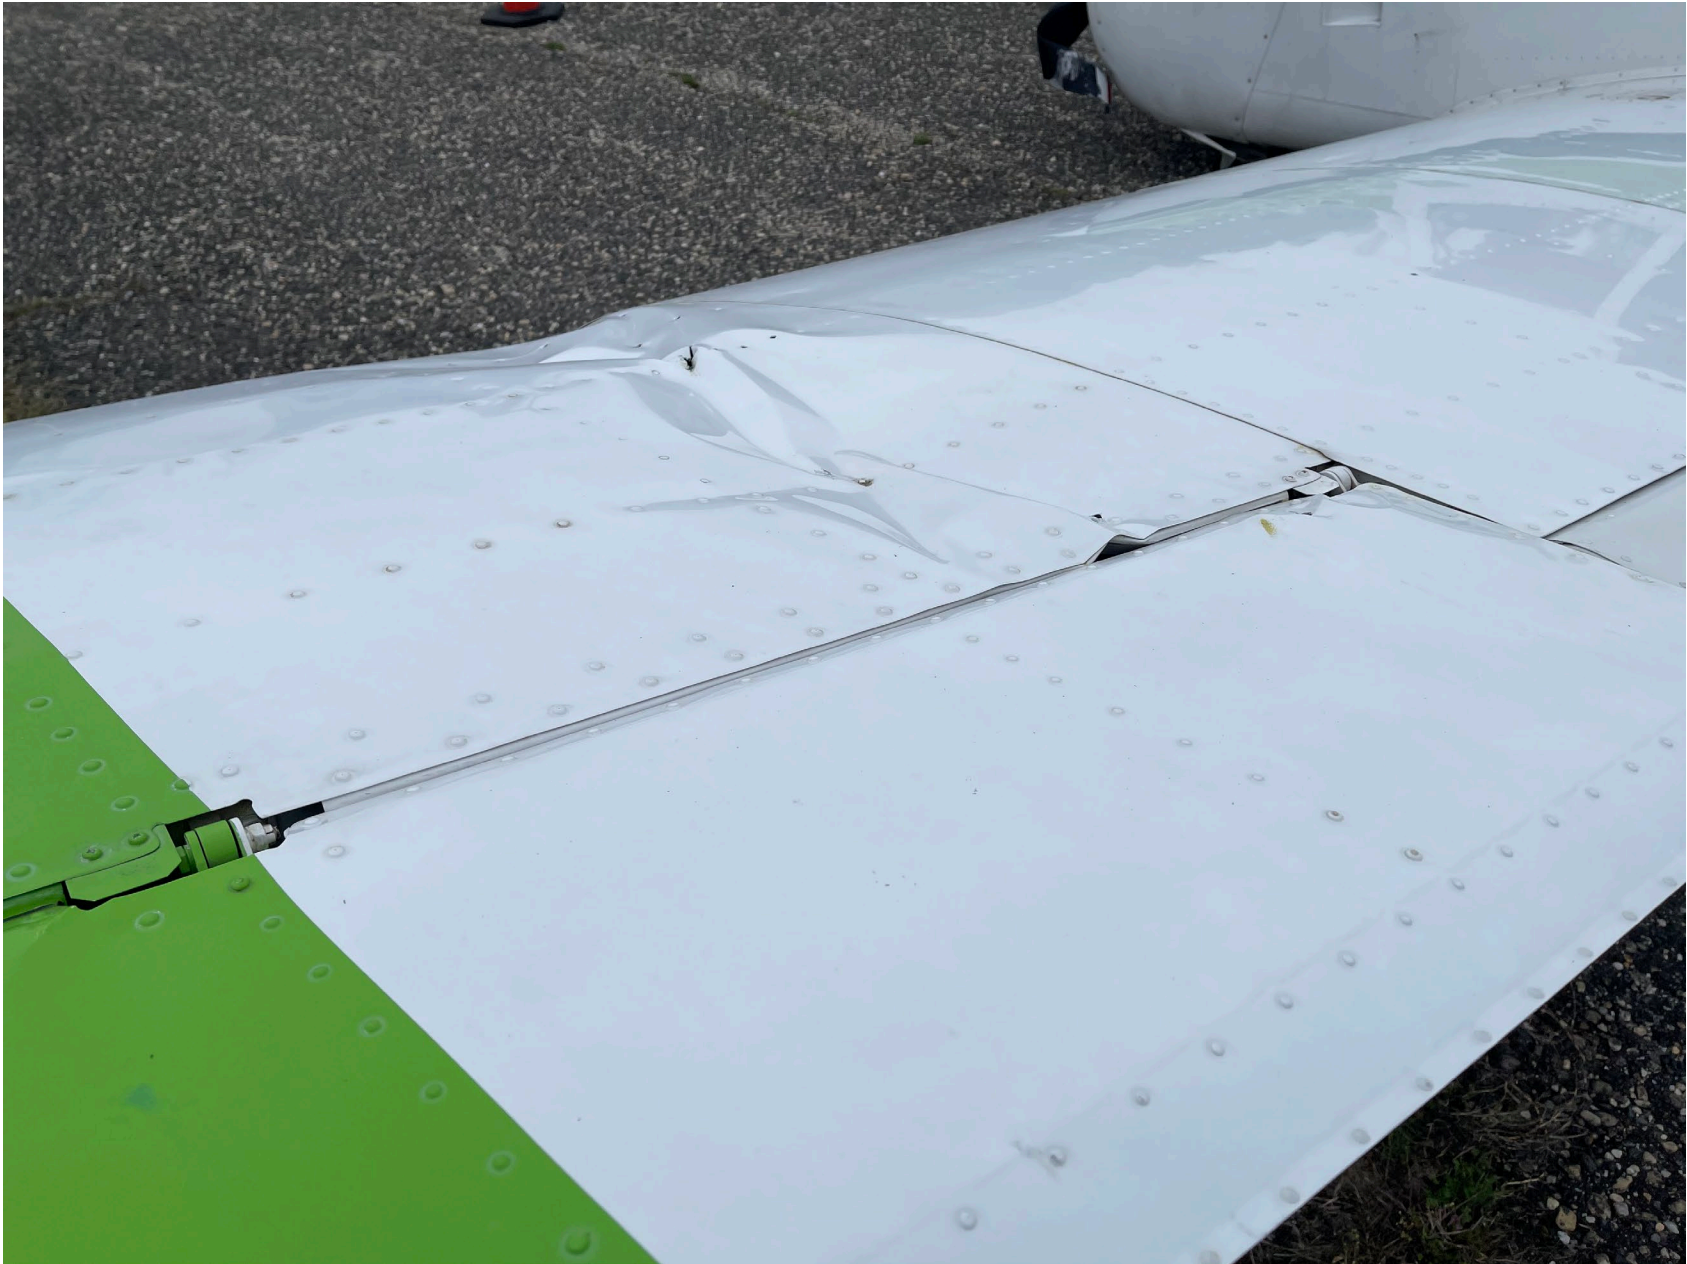
**Photo 4 - Digital Photograph From Recovery Company. Rear View Looking Forward of a Portion of the Left Wing Depicting Structural Damage.**

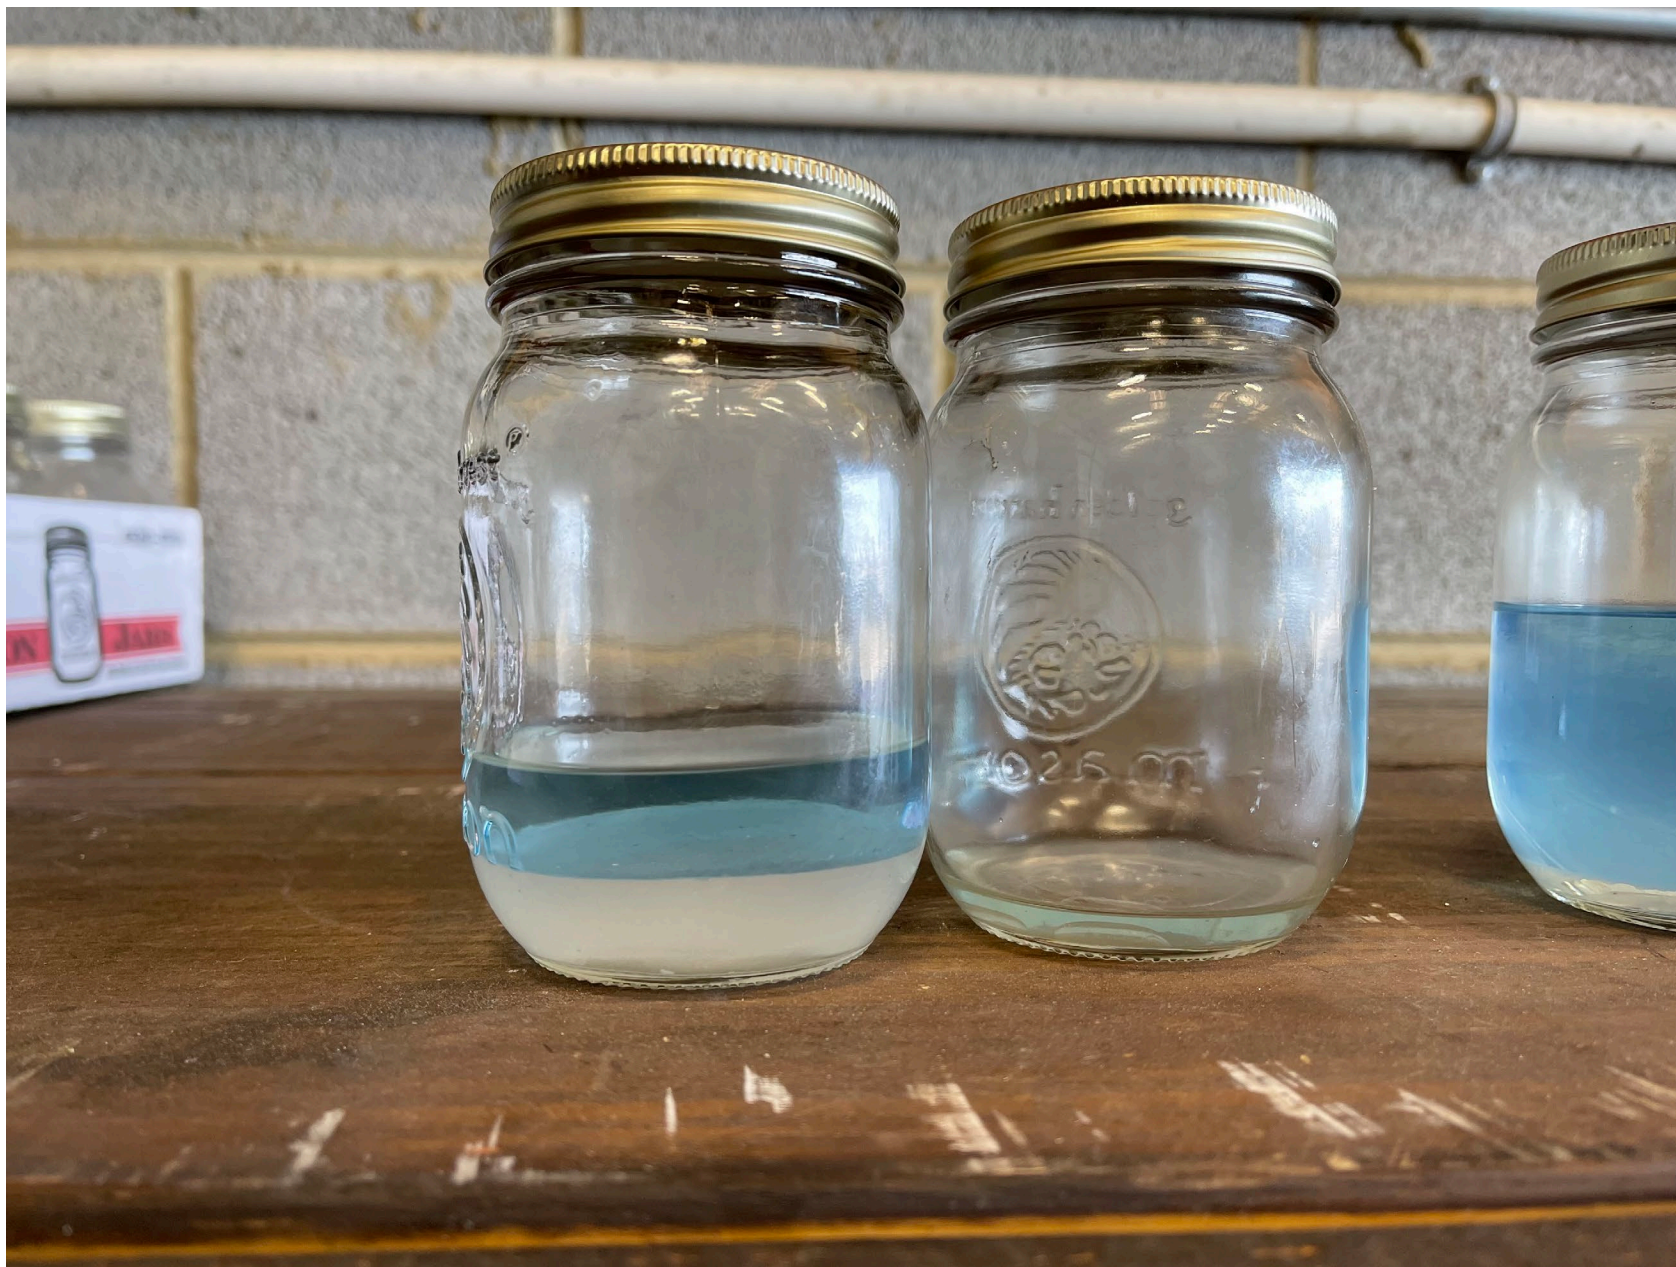
**Photo 5 - Digital Photograph From Recovery Company. Left Glass Jar Contains 2.5 ounces of Blue Colored Fuel and 2.5 ounces of Water Drained from Carburetor During Postaccident Inspection.**

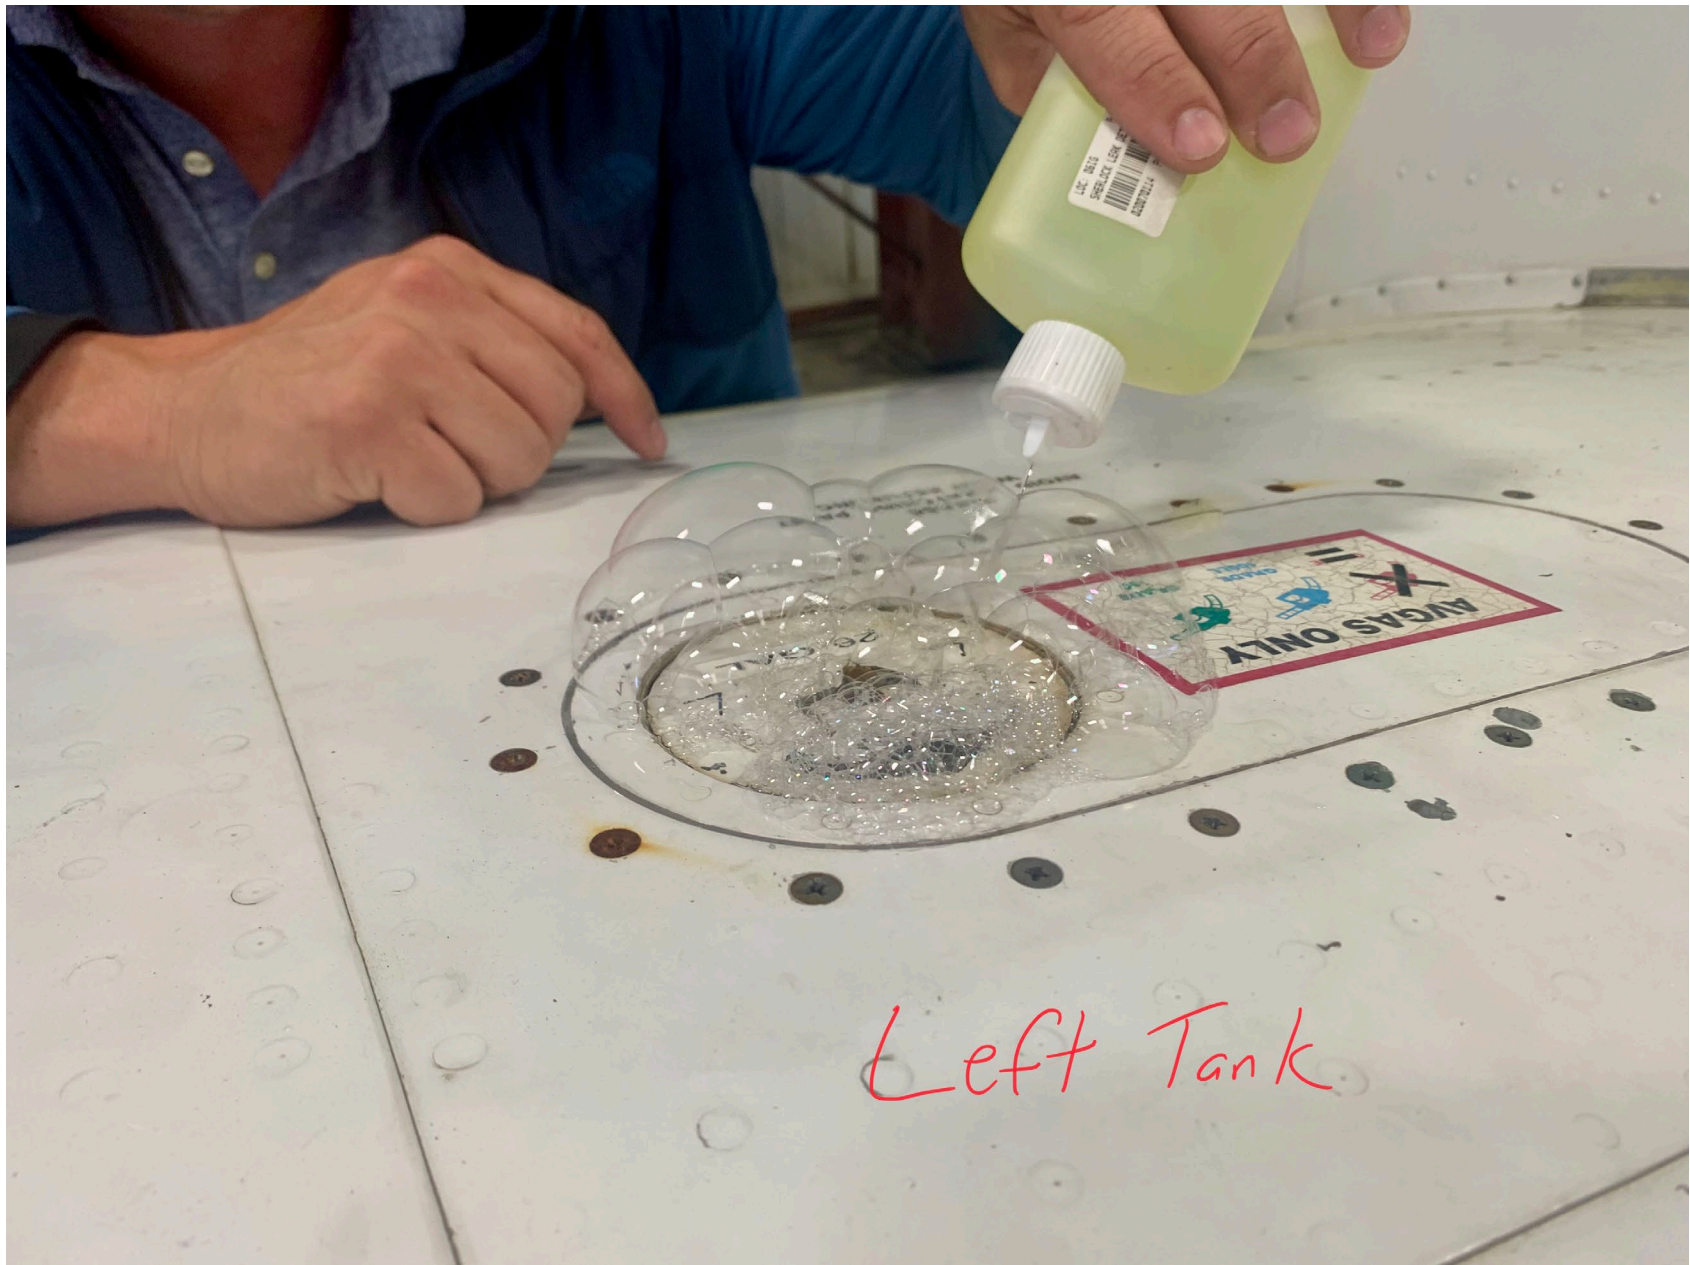
**Photo 6 - Digital Photograph From Recovery Company. Postaccident Pressure Testing of Left Fuel Cap.**

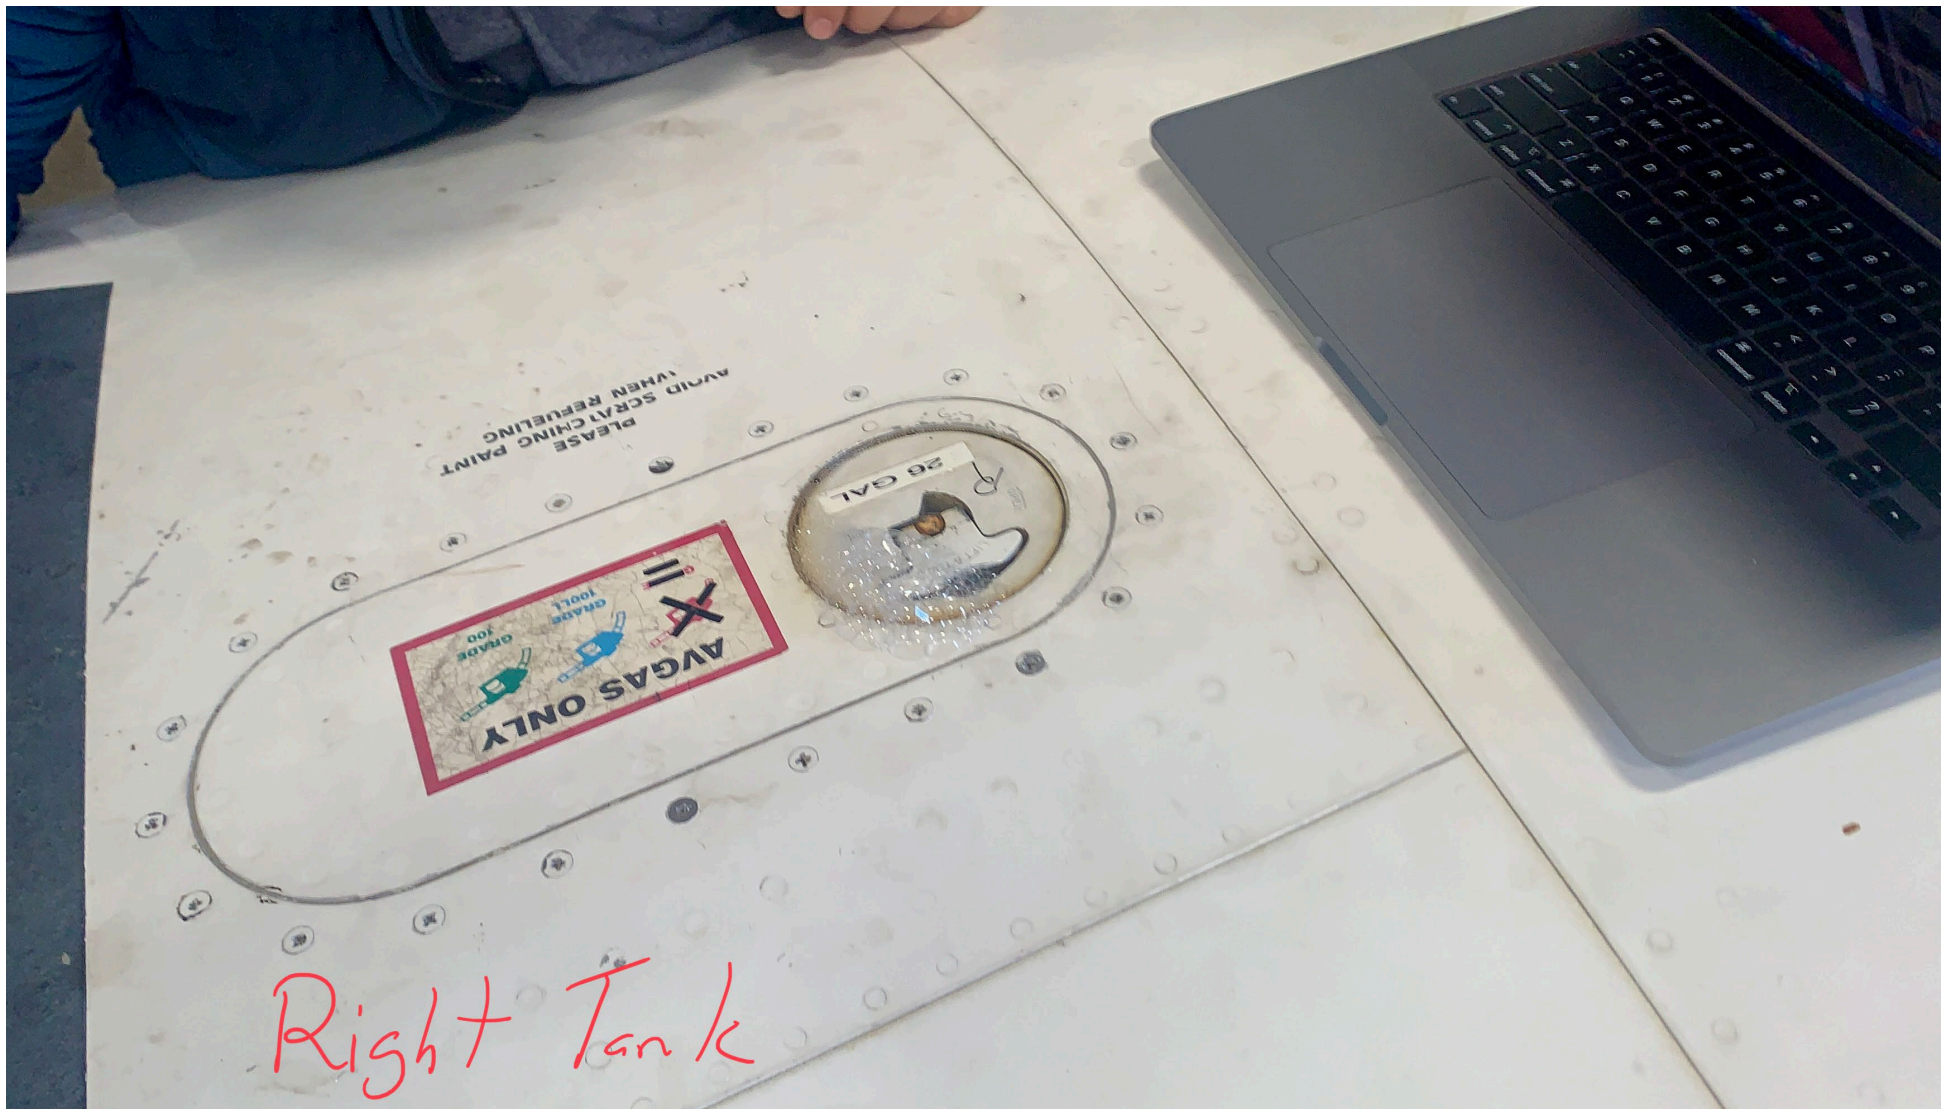
Right Tank

**Photo 7 - Digital Photograph From Recovery Company. Postaccident Pressure Testing of Right Fuel Cap.**

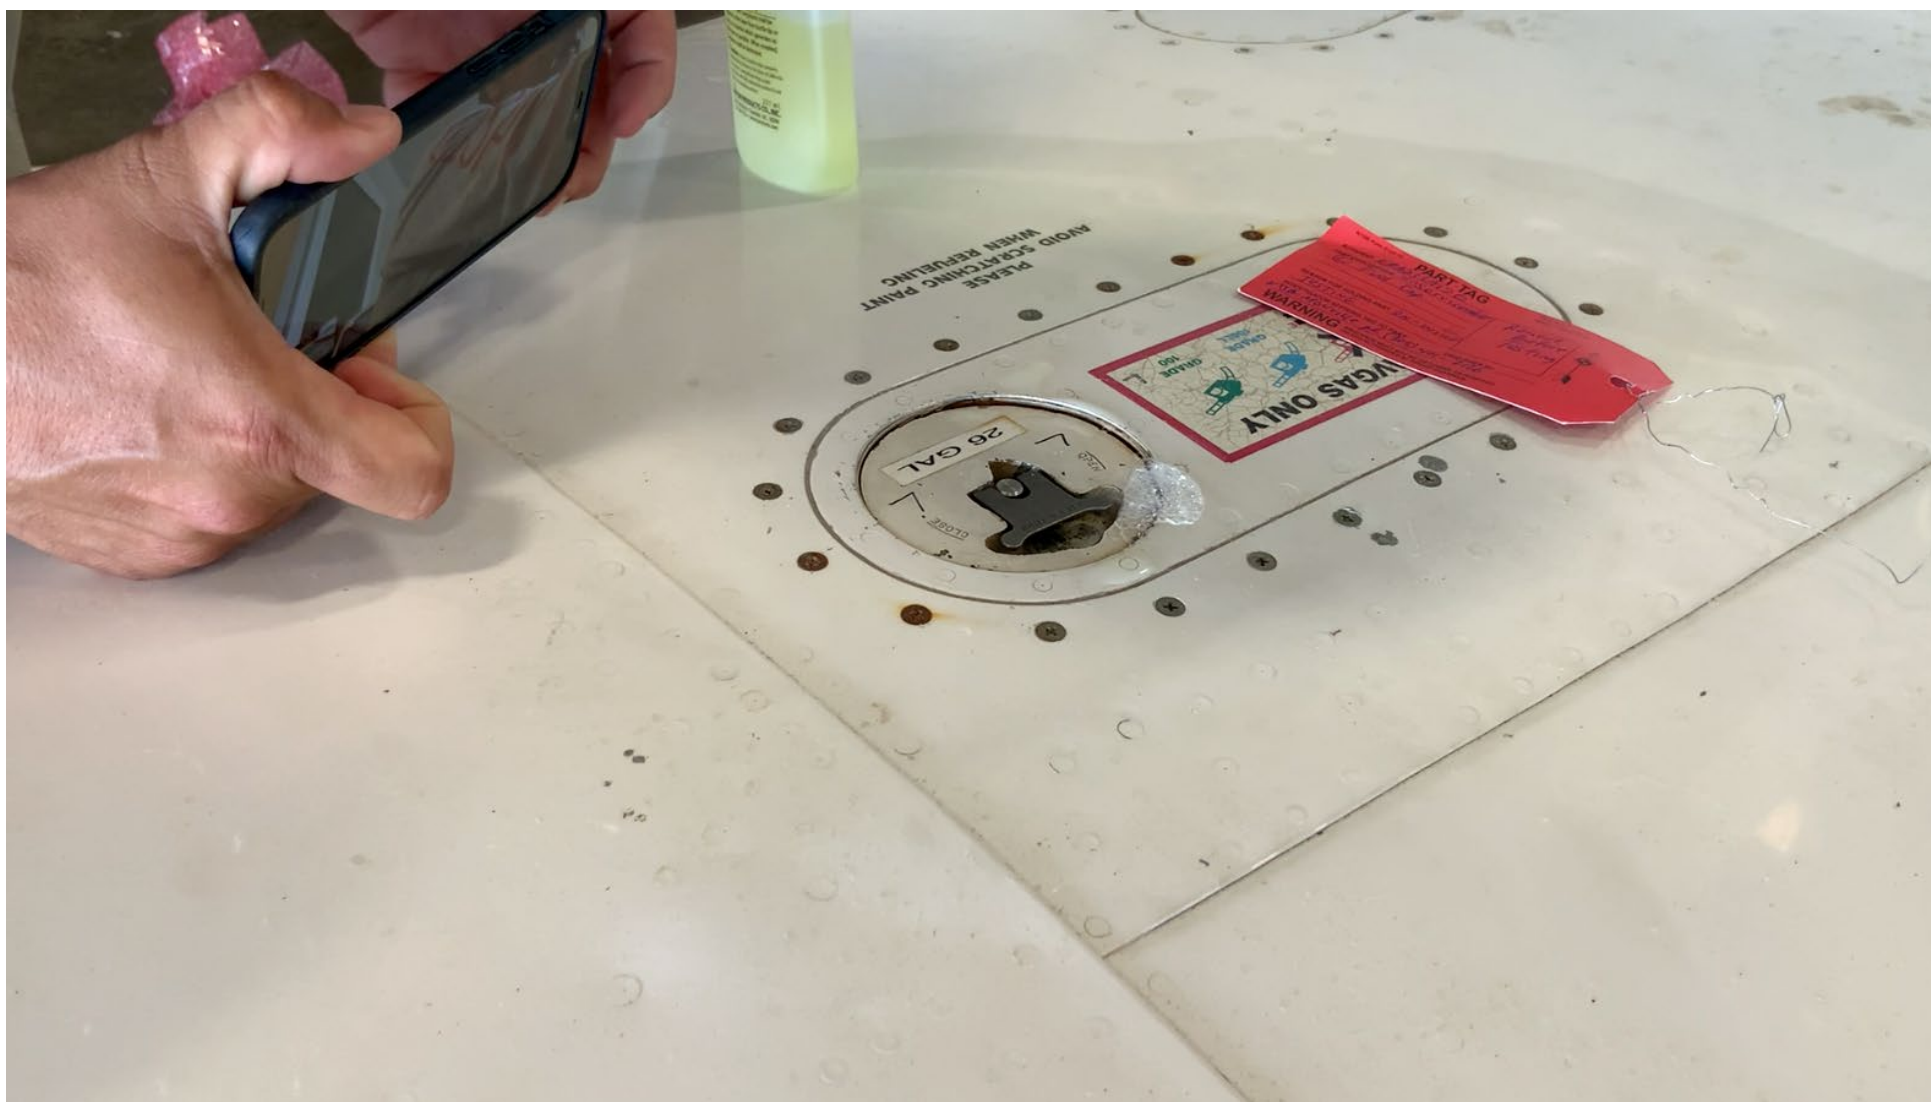
**Photo 8 - Digital Photograph From Recovery Company. Postaccident Pressure Testing On-Wing of Left Fuel Cap After Fuel Cap Passed Individual Acceptance Test Procedure.**

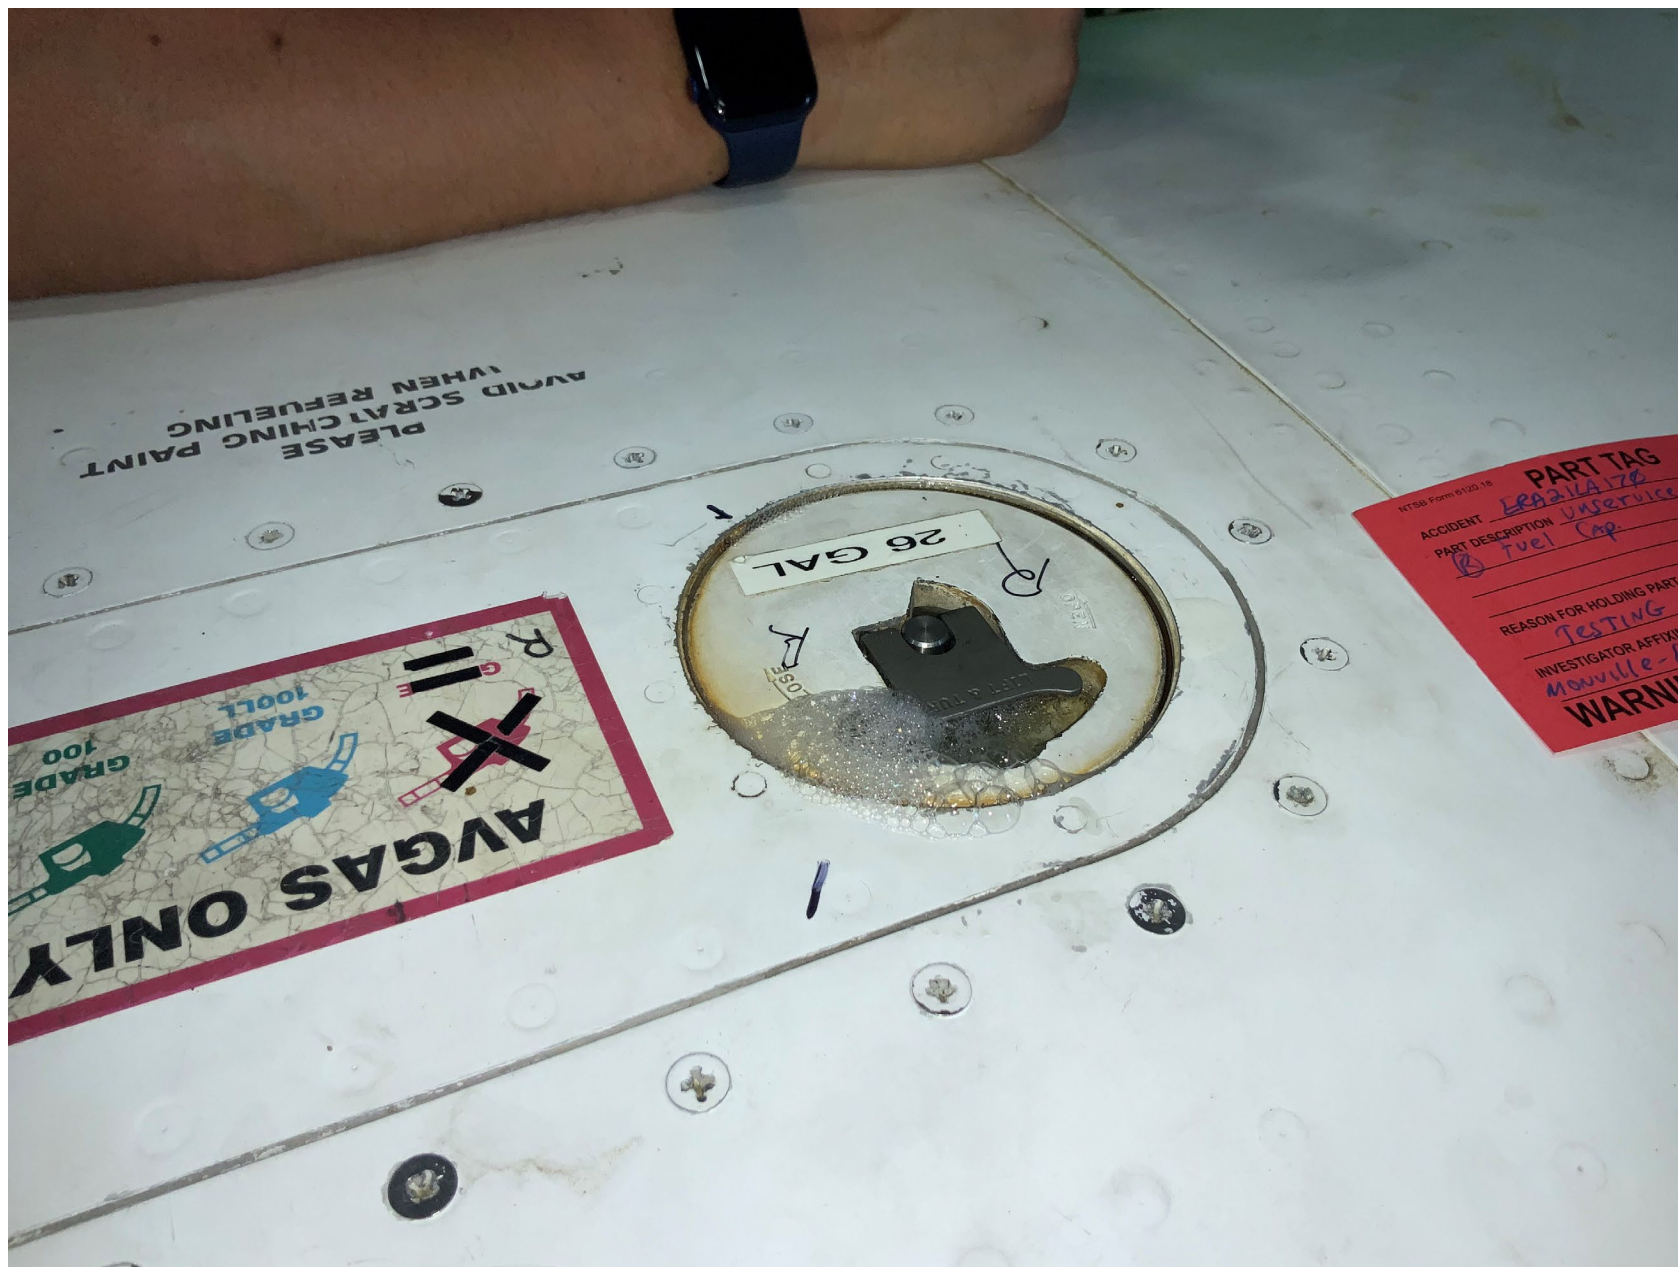
**Photo 9 - Digital Photograph From Recovery Company. Postaccident Pressure Testing On-Wing of Right Fuel Cap After Fuel Cap Passed Individual Acceptance Test Procedure.**
