## RECORD OF CONVERSATION

**Date: April 14, 2021**  
**Person Contacted: Lee D. Babcock**  
**NTSB Accident Number: ERA21LA170**

**Date: April 27, 2021**  
**Person Contacted: Dave Stanton**  
**NTSB Accident Number: ERA21LA170**

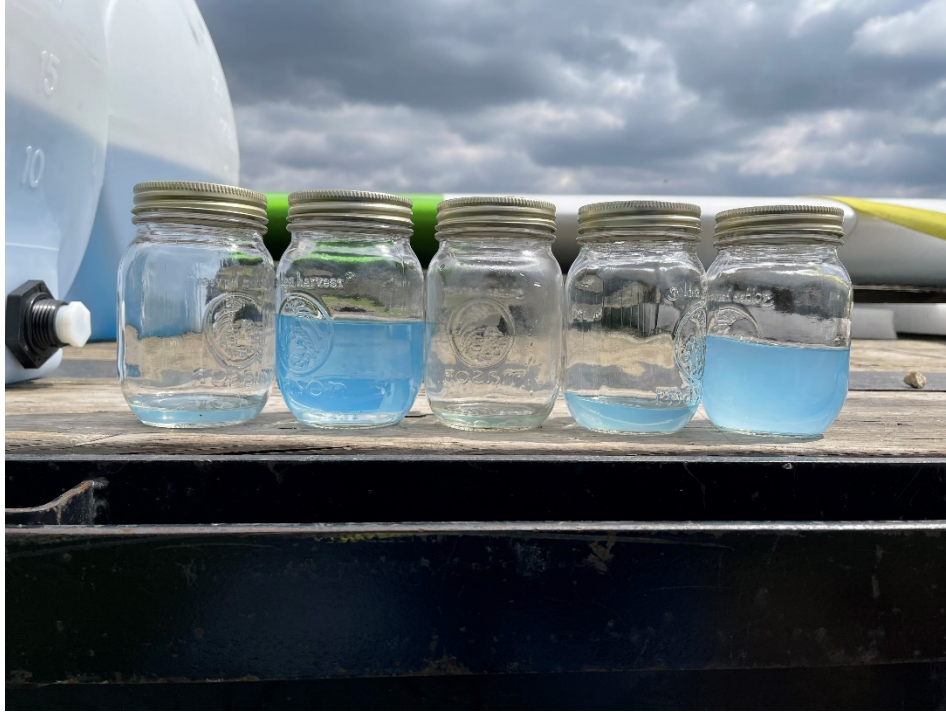
He indicated that as part of the recovery which occurred on April 13<sup>th</sup>, 1/4 quart of water was drained from the left fuel tank. As part of the NTSB request after draining the fuel tanks he inspected each wing fuel tank sump drain and noted different part numbers. Also as part of the request he took fuel samples from various parts of the airplane (Figures 1 and 2).

He provided an e-mail on April 13, 2021, at 1719 EDT, indicating, "The recovery went well. We took the samples as requested and capped/stowed the lines. I have attached the fuel samples we took. The left wing sump from the cockpit had 1/4" of water in the sample. The fuel line disconnected from the firewall was mostly water. I have attached a few pictures of the samples and will give you a call if you have time to talk."

Figure 1: Photograph Taken by Dave Stanton. View of the Fuel Samples Taken During Recovery of the Airplane. 3<sup>rd</sup> Jar from the Left is the Fluid Drained From the Flexible Hose From the Firewall Fitting to the Inlet of the Engine-Driven Fuel Pump.

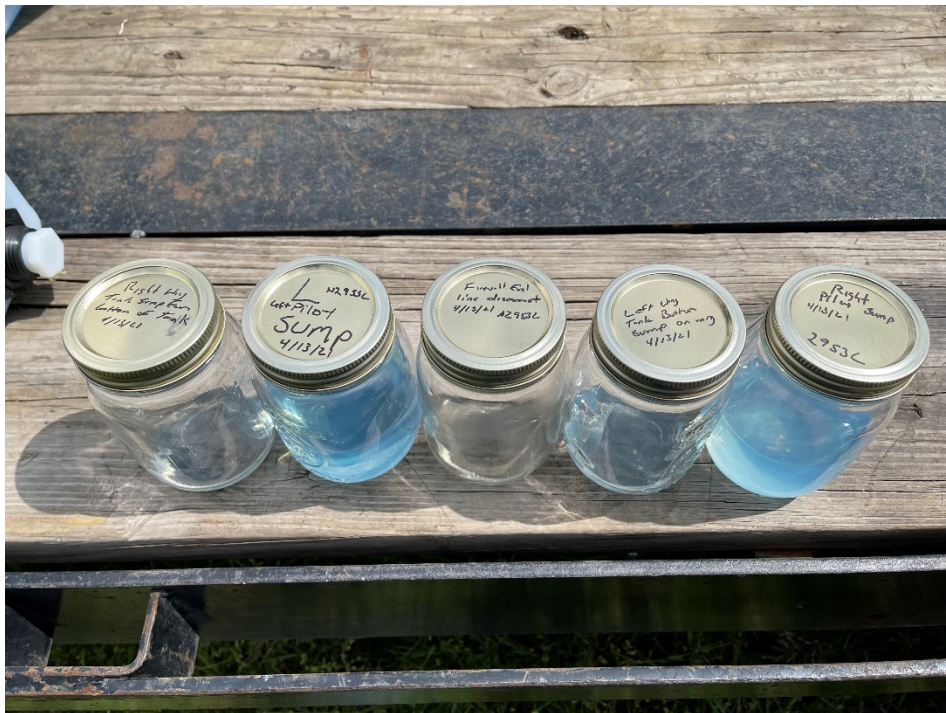
Figure 2: Top View of Sample Jars in Same Orientation as Figure 1 Depicting Labeling of Jars. 3<sup>rd</sup> Jar from the Left is the Fluid Drained From the Flexible Hose From the Firewall Fitting to the Inlet of the Engine-Driven Fuel Pump.

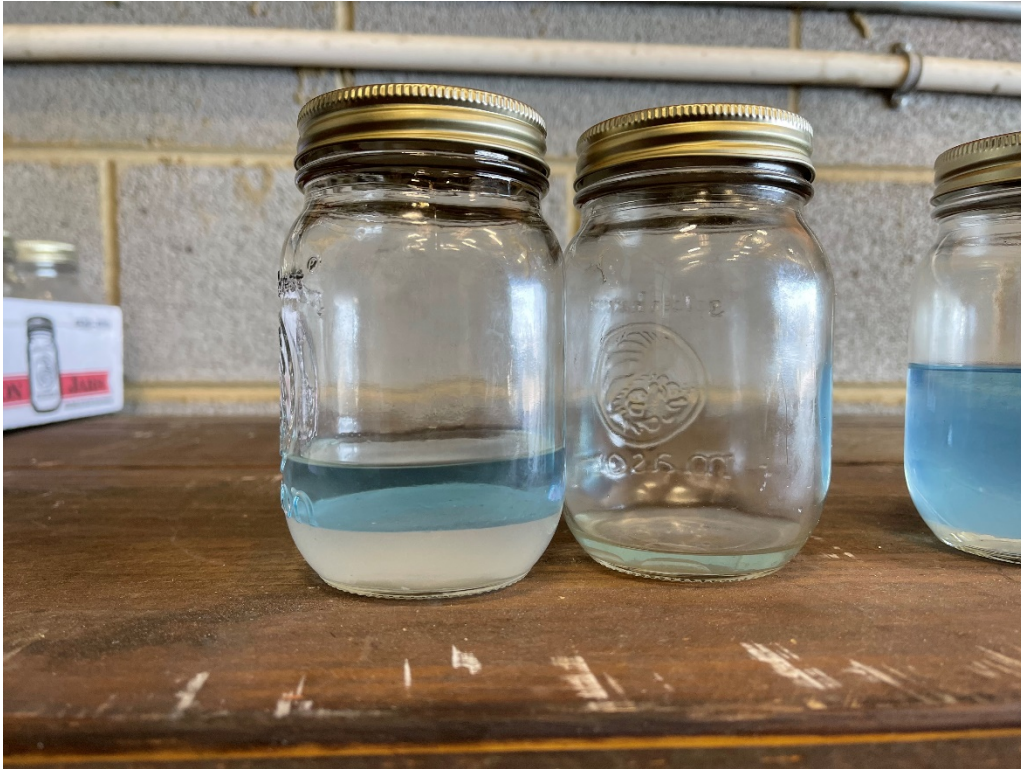
During the phone call on April 20<sup>th</sup>, he indicated that the carburetor bowl contained about 5 ounces of fluid, which was about equal parts water and fuel (Figure 3).

Figure 3: Jar on Left Depicts the Fluids Drained From the Carburetor Bowl. Note The Total Drained Amount was About 5 Ounces and was About Equal Parts Fuel and Water.
